Case No. 5:16-cv-07013-LHK (SVK)

**DECLARATION OF JEFFREY SCOTT  
MASTIN IN SUPPORT OF PLAINTIFFS'  
MOTION FOR CLASS CERTIFICATION**

NEVAREZ V 49ERS - ACCESSIBILITY ASSESSMENT

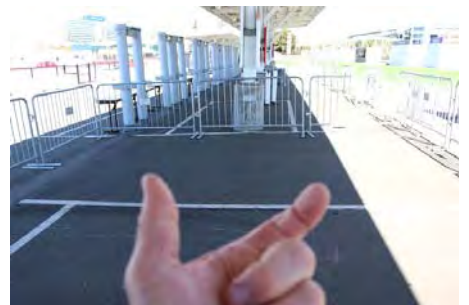
COD	CONDITION DESCRIPTION	ACTUAL
B17	Running slope (parallel to direction of travel) is 1:20 (5.0%) max. (ADAS 403.3)	5.0% to 5.7% for 40' L between DAS and security device, up to 5.8% just East of security device.

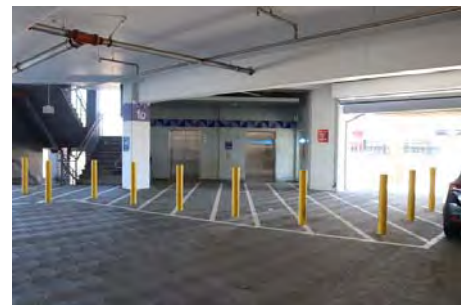
COD	CONDITION DESCRIPTION	ACTUAL
B41	Stall is located as close as practical to entrance. (ADAS 208.3.1)	There are standard stalls that are closer to the SE entrance than are these 12 DAS.

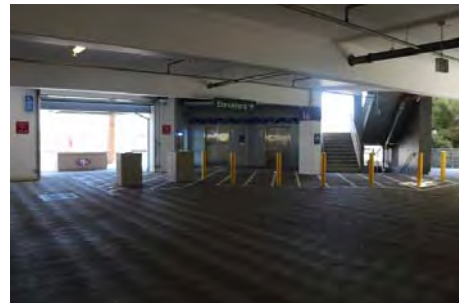
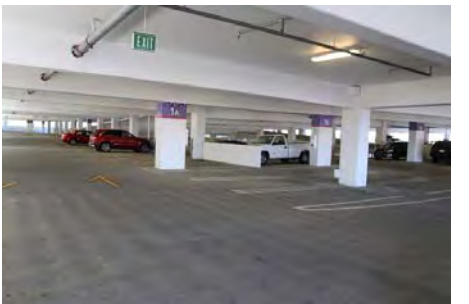
COD	CONDITION DESCRIPTION	ACTUAL
B41	Stall is located as close as practical to entrance. (ADAS 208.3.1)	There are standard stalls that are closer to the SW entrance than are 10 of these DAS.

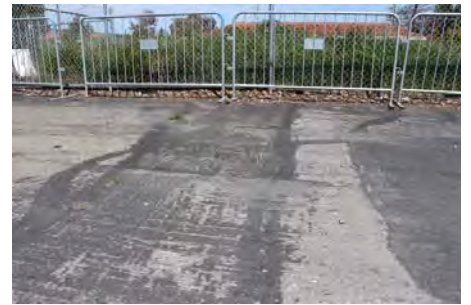
COD	CONDITION DESCRIPTION	ACTUAL
B15	No level changes greater than 1/2" (except by accessible ramp or other means). (ADAS 303.4)	Multiple raised edges 1" high.

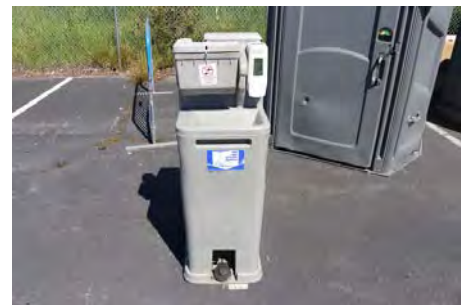
COD	CONDITION DESCRIPTION	ACTUAL
B02	Operable parts are operable with one hand, using max 5lbs force, and not requiring tight grasping, pinching, or twisting of the wrist. (ADAS 309.4)	Water is foot operated, not hand operated.

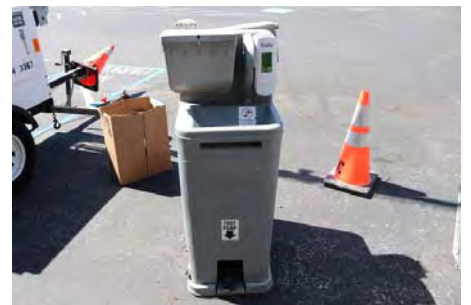
COD	CONDITION DESCRIPTION	ACTUAL
B02	Operable parts are operable with one hand, using max 5lbs force, and not requiring tight grasping, pinching, or twisting of the wrist. (ADAS 309.4)	Water operated by foot pump.

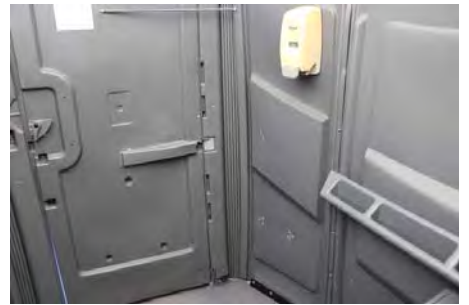
COD	CONDITION DESCRIPTION	ACTUAL
B21	Unobstructed forward or side approach reach range is min 15" to max 48" AFF. (ADAS 308.2.1, 308.3.1)	51 3/4" to hand sanitizer.

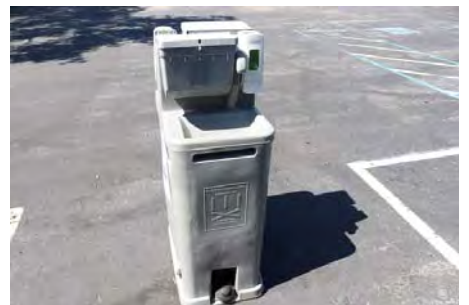
COD	CONDITION DESCRIPTION	ACTUAL
B02	Operable parts are operable with one hand, using max 5lbs force, and not requiring tight grasping, pinching, or twisting of the wrist. (ADAS 309.4)	Water operation by foot pedal.

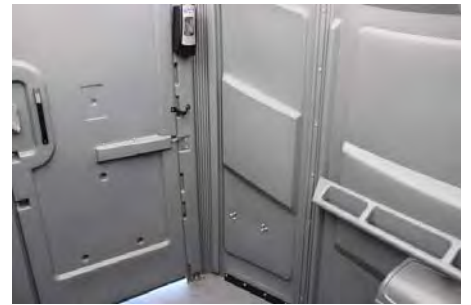
COD	CONDITION DESCRIPTION	ACTUAL
B21	Unobstructed forward or side approach reach range is min 15" to max 48" AFF. (ADAS 308.2.1, 308.3.1)	55" to hand sanitizer.

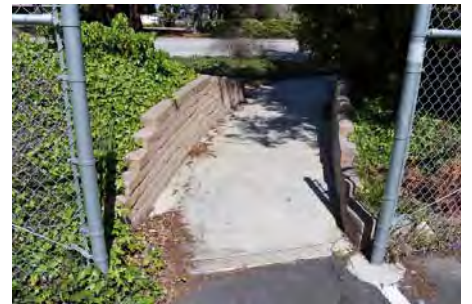
COD	CONDITION DESCRIPTION	ACTUAL
B04	Cross slope of ramp is 1:48 (2.08%) max. (ADAS 405.3)	Cross slope is 4.0% at the top.
B12	Landings are sloped 1:48 (2.08%) max. and are firm, stable and slip resistant without gaps or edges. (ADAS 405.7.1)	Btm. Landing is 3.9%, top landing is 5.0% and top landing partially covered by debris.
B14	Top landing is min. 60" long. (ADAS 405.7.3)	Top landing is 48".
B31	Handrails are provided at both sides (ADA: except at ramp with max 6" rise / 72" run) (CBC: except adjacent to assembly seating, or at door landing ramp with max 6" rise / 72" run). (ADAS 405.8)	None, approx. 12' long.

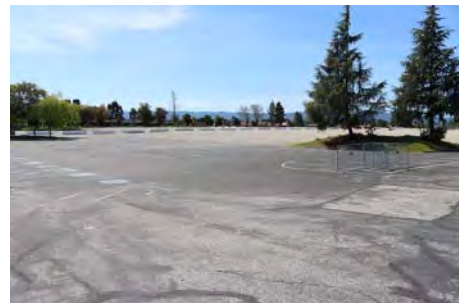
COD	CONDITION DESCRIPTION	ACTUAL
A5	Acc parking stalls are located on the shortest ACC route from parking to ACC entrance. (ADAS 208.3.1)	Many standard stalls are closer to both walkways to the public right of way, at the E side and the N side, than are some of the DAS.

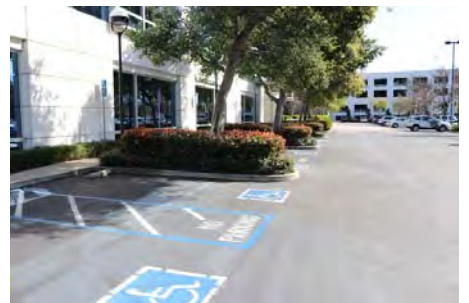
COD	CONDITION DESCRIPTION	ACTUAL
B41	Stall is located as close as practical to entrance. (ADAS 208.3.1)	Many spaces are closer to the public right of way.

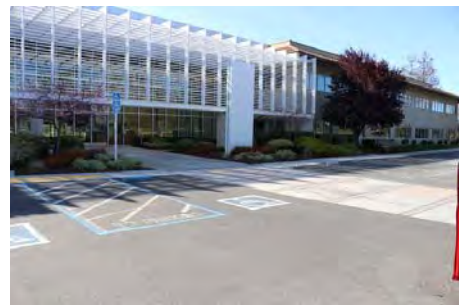
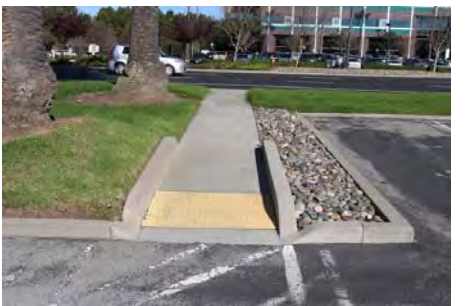
COD	CONDITION DESCRIPTION	ACTUAL
B31	Slopes do not exceed 1:48 (2.08%). (ADAS 502.4)	3.8% to 4.1% at head end of stalls and access aisle.

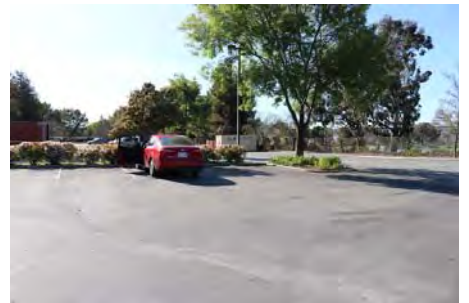
COD	CONDITION DESCRIPTION	ACTUAL
B41	Stall is located as close as practical to entrance. (ADAS 208.3.1)	Many other standard stalls are closer to routes to the public right of way.

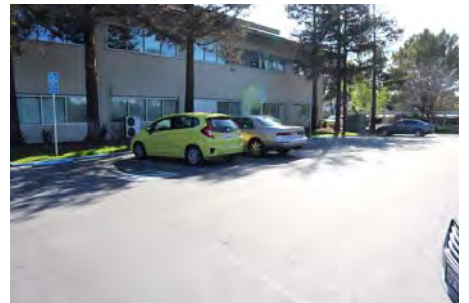
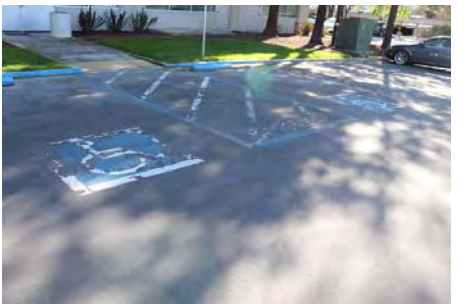
COD	CONDITION DESCRIPTION	ACTUAL
B41	Stall is located as close as practical to entrance. (ADAS 208.3.1)	Many other standard stalls are closer to routes to the public right of way.

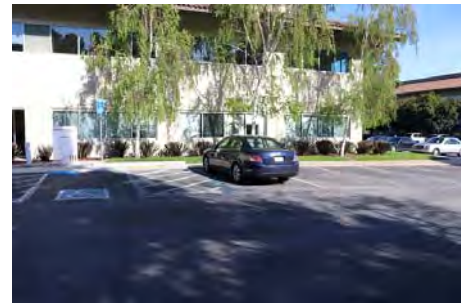
COD	CONDITION DESCRIPTION	ACTUAL
B41	Stall is located as close as practical to entrance. (ADAS 208.3.1)	Many other standard stalls are closer to routes to the public right of way.

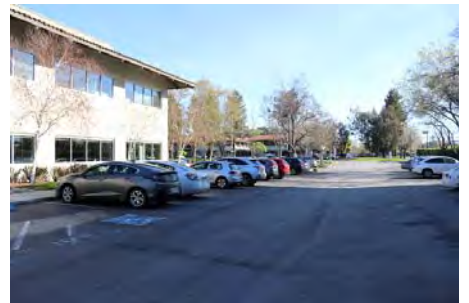
COD	CONDITION DESCRIPTION	ACTUAL
B41	Stall is located as close as practical to entrance. (ADAS 208.3.1)	Many other standard stalls are closer to routes to the public right of way.

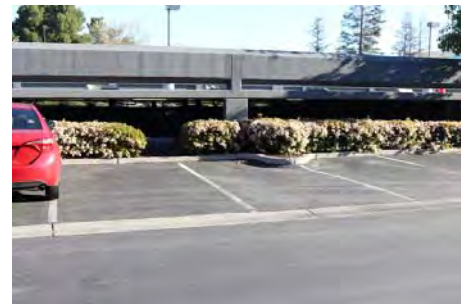
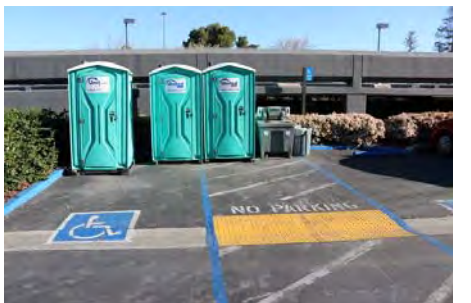
COD	CONDITION DESCRIPTION	ACTUAL
B11	Parking space is marked to define a width of min.8' wide (9' CBC). (ADAS 502.2)	Obstructed by portable toilet.
B12	Access aisle is marked to define a width of min. 5' wide. (ADAS 502..3.1)	Obstructed by portable toilet.
B31	Slopes do not exceed 1:48 (2.08%). (ADAS 502.4)	18.5% at tail end of stalls and access aisles at swale.
B32	Stall & access aisle has no gaps or changes in level and is firm, stable and slip resistant. (ADAS 502.4)	Detectable warnings placed in the access aisle which are unnecessary.
B41	Stall is located as close as practical to entrance. (ADAS 208.3.1)	Many other standard stalls are closer to routes to the public right of way.
C42	Accessible route from stall does not pass behind other parked cars. (2013 CBC 11B-502.7.1).	Must pass behind other vehicles en route to the public right of way.

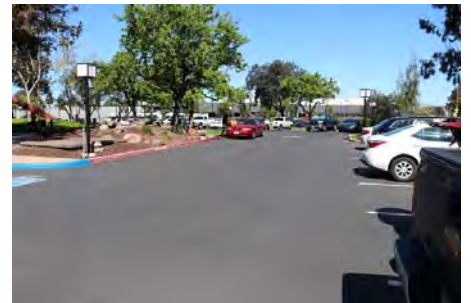
COD	CONDITION DESCRIPTION	ACTUAL
B31	Slopes do not exceed 1:48 (2.08%). (ADAS 502.4)	Asphalt patch along entire length of S stall creates slopes up to 8.2%.
B32	Stall & access aisle has no gaps or changes in level and is firm, stable and slip resistant. (ADAS 502.4)	Asphalt patch across entire length of S stall creates depression over 1 1/2" deep.
B41	Stall is located as close as practical to entrance. (ADAS 208.3.1)	Many other standard stalls are closer to routes to the public right of way.
C42	Accessible route from stall does not pass behind other parked cars. (2013 CBC 11B-502.7.1).	Must pass behind other vehicles en route to the public right of way.

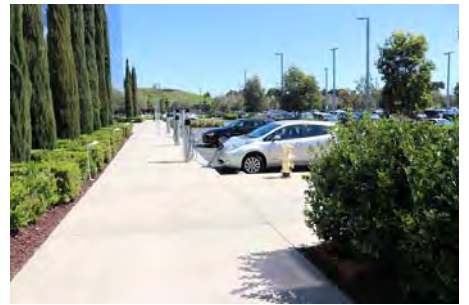
COD	CONDITION DESCRIPTION	ACTUAL
B41	Stall is located as close as practical to entrance. (ADAS 208.3.1)	Many other standard stalls are closer to routes to the public right of way.

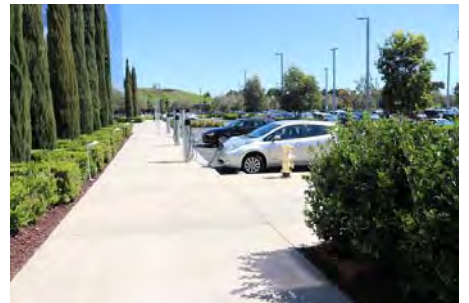
COD	CONDITION DESCRIPTION	ACTUAL
B41	Stall is located as close as practical to entrance. (ADAS 208.3.1)	Many other standard stalls are closer to routes to the public right of way.

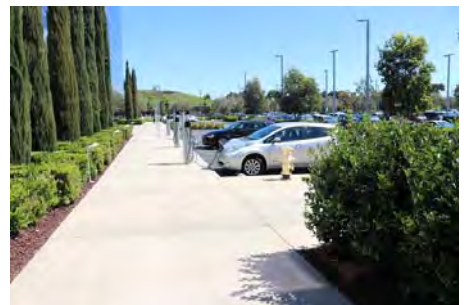
COD	CONDITION DESCRIPTION	ACTUAL
B41	Stall is located as close as practical to entrance. (ADAS 208.3.1)	Many other standard stalls are closer to routes to the public right of way.

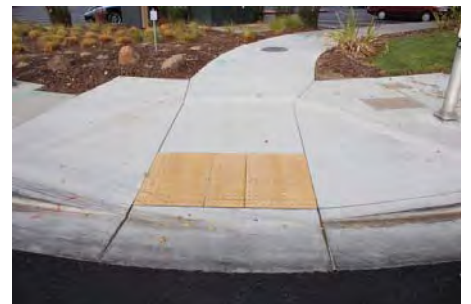
COD	CONDITION DESCRIPTION	ACTUAL
B03	Running slope of ramp is 1:12 (8.33%) max. (ADAS 405.2)	11.7% at btm. 2", 8.8% at top 24" portion.
B05	Surface of ramp and landings complies with requirements for an accessible path of travel (stable, firm, slip-resistant, without gaps over 1/2" wide or edges over 1/4" high). (ADAS 302.1, 403.2, 403.3, 403.4)	3/4" high vertical edge at asphalt transition.
B14	Counter slopes of adjoining gutters and road surfaces immediately adjacent to and within 24 inches of the curb ramp are not steeper than 1:20 (5.0%). (ADAS 406.2)	6.0%

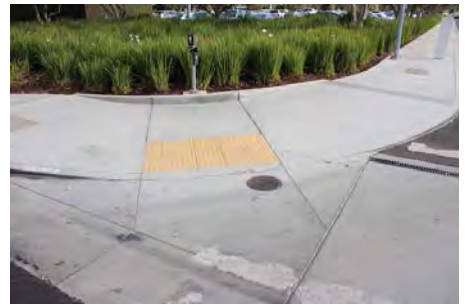
COD	CONDITION DESCRIPTION	ACTUAL
C11	Min. 48" x 48" turning space is provided at bottom of curb ramp. (ADAS 403.3)	19.0% for 3" L (approx. 5/8" H difference) 43" from btm. of curb ramp.

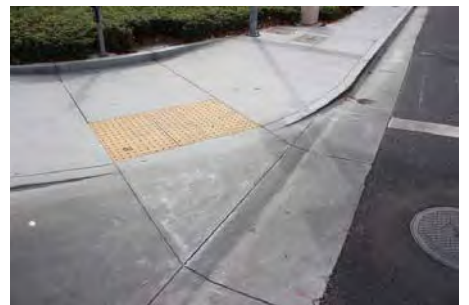
COD	CONDITION DESCRIPTION	ACTUAL
C12	Turning space at bottom of curb ramp slopes 1:48 (2.08%) max. in any direction (ADAS 403.3)	16.0% for 2" (approx. 7/8" H difference).

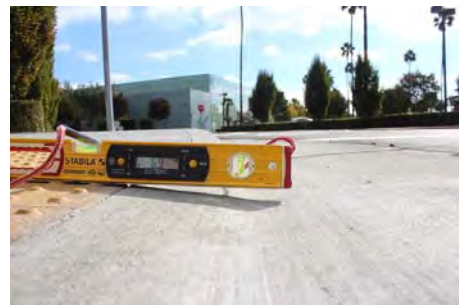
COD	CONDITION DESCRIPTION	ACTUAL
B03	Running slope of ramp is 1:12 (8.33%) max. (ADAS 405.2)	18.1% at btm. 2", 13.4% at btm. 2" to 6" portion.

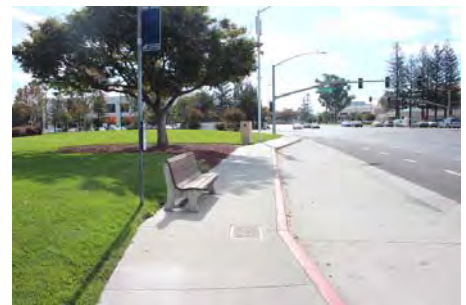
COD	CONDITION DESCRIPTION	ACTUAL
B16	Cross slope (perpendicular to direction of travel) is 1:48 (2.08%) max. (ADAS 403.3)	Approx. 320' L is 2.5% to 5.1%.

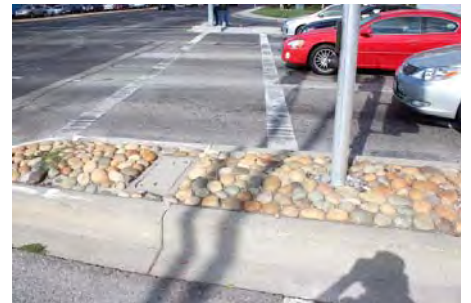
COD	CONDITION DESCRIPTION	ACTUAL
B41	Side reach over an obstruction greater than 10"d is max 46" AFF where the obstruction is max 34" AFF, and reach depth is no more than 24". (ADAS 308.3.2)	Over 24" from clear space in crossing.

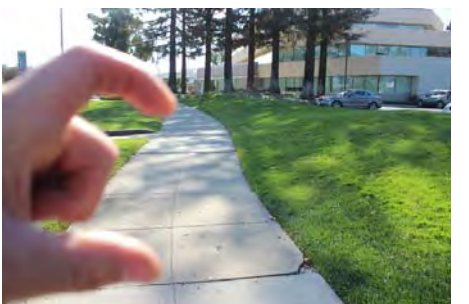
COD	CONDITION DESCRIPTION	ACTUAL
B12	Gaps/openings in ground or floor surfaces do not allow the passage of a sphere more than 1/2" in diameter. (ADAS 302.3)	Up to 2" W gap approx. 45' L.
B13	Gaps/openings are oriented perpendicular to dominant direction of travel. (ADAS 302.3)	Approx. 45' L gap in direction of travel.
B16	Cross slope (perpendicular to direction of travel) is 1:48 (2.08%) max. (ADAS 403.3)	Approx. 50' L is 2.7% to 3.0%.
B17	Running slope (parallel to direction of travel) is 1:20 (5.0%) max. (ADAS 403.3)	Approx. 10' L is up to 10.0%.

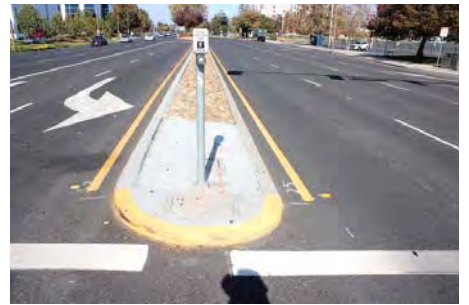
COD	CONDITION DESCRIPTION	ACTUAL
B15	No level changes greater than 1/2" (except by accessible ramp or other means). (ADAS 303.4)	User who cannot step up the curb must wait in traffic lanes.

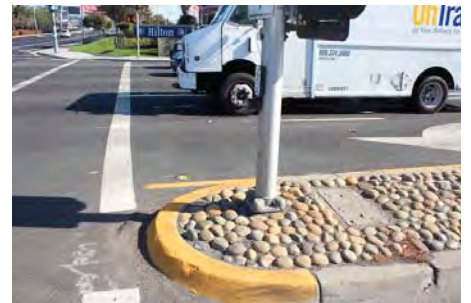
COD	CONDITION DESCRIPTION	ACTUAL
B15	No level changes greater than 1/2" (except by accessible ramp or other means). (ADAS 303.4)	Sign indicates to push button and wait for walk signal, however, user who cannot step up the curb must wait in traffic lanes.

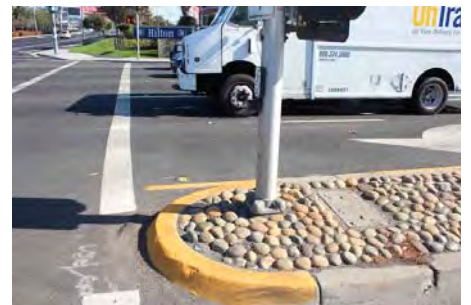
COD	CONDITION DESCRIPTION	ACTUAL
B41	Side reach over an obstruction greater than 10"d is max 46" AFF where the obstruction is max 34" AFF, and reach depth is no more than 24". (ADAS 308.3.2)	27" away from clear space.

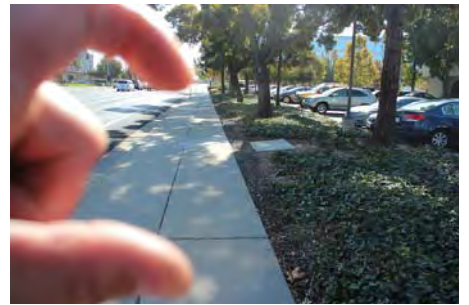
COD	CONDITION DESCRIPTION	ACTUAL
B16	Cross slope (perpendicular to direction of travel) is 1:48 (2.08%) max. (ADAS 403.3)	Approx. 80' L is 2.7% to 4.0%

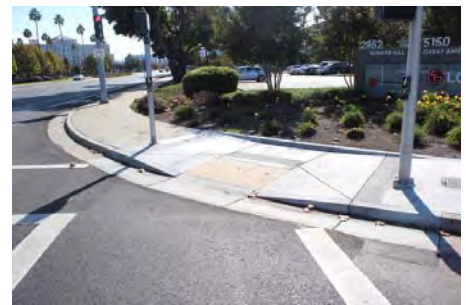
COD	CONDITION DESCRIPTION	ACTUAL
B03	Running slope of ramp is 1:12 (8.33%) max. (ADAS 405.2)	16.4% Across curb face.

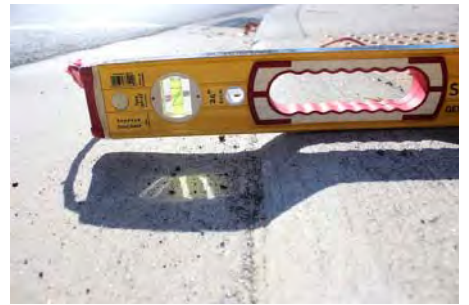
CODE	CONDITION DESCRIPTION	ACTUAL
B06 406.2)	Transition to walk, gutter or street is flush and free of abrupt changes. (ADAS 406.2)	1/2" high vertical edge.

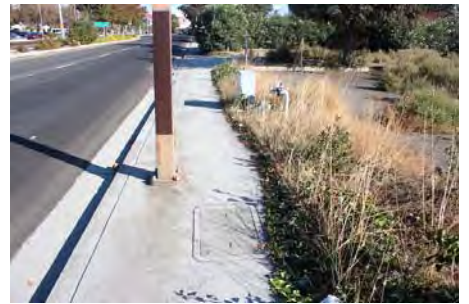
CODE	CONDITION DESCRIPTION	ACTUAL
B02	36" min. clear width of exterior walkway. (ADAS 403.5.1)	Landscape reduces width to 33" W at light post and 34" W near Ironsides drive.
B16	Cross slope (perpendicular to direction of travel) is 1:48 (2.08%) max. (ADAS 403.3)	Approx. 220' L is 2.6% to 4.5% and 5 drive aisles causing slopes from 4.5% to 10.8%.
B17	Running slope (parallel to direction of travel) is 1:20 (5.0%) max. (ADAS 403.3)	5 drive aisles causing slopes in 10 sections from 12.2% to 19.8%.

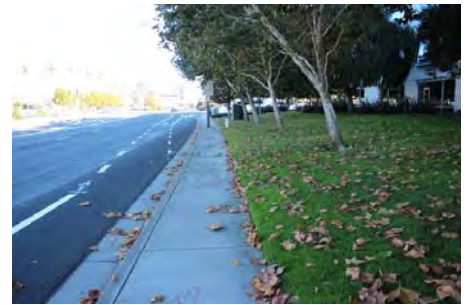
CODE	CONDITION DESCRIPTION	ACTUAL
B16	Cross slope (perpendicular to direction of travel) is 1:48 (2.08%) max. (ADAS 403.3)	Approx. 100' L is 2.7% to 4.1%.

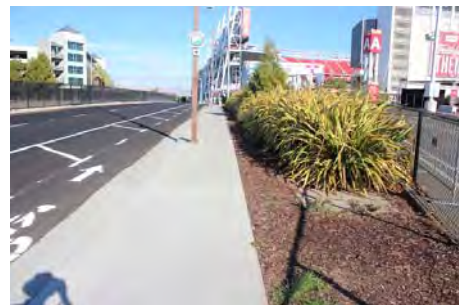
CODE	CONDITION DESCRIPTION	ACTUAL
B16	Cross slope (perpendicular to direction of travel) is 1:48 (2.08%) max. (ADAS 403.3)	Approx. 120' L is 2.8% to 3.5% and 2.7% across drive aisle.

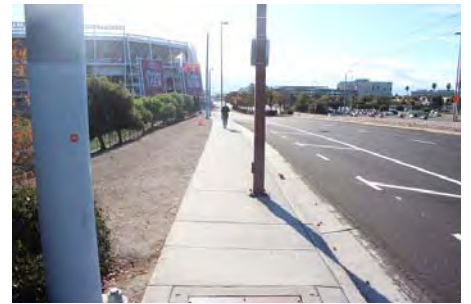
CODE	CONDITION DESCRIPTION	ACTUAL
B13	Gaps/openings are oriented perpendicular to dominant direction of travel. (ADAS 302.3)	2" W at bridge.
B15	No level changes greater than 1/2" (except by accessible ramp or other means). (ADAS 303.4)	1" high vertical edge at bridge.
B17	Running slope (parallel to direction of travel) is 1:20 (5.0%) max. (ADAS 403.3)	Long unbroken length of excessive running slope generally 4.5% and up to 6.3% at bridge.
