Case No. 5:16-cv-07013-LHK (SVK)

**DECLARATION OF JEFFREY SCOTT
MASTIN IN SUPPORT OF PLAINTIFFS'
MOTION FOR CLASS CERTIFICATION**

NEVAREZ V 49ERS - ACCESSIBILITY ASSESSMENT

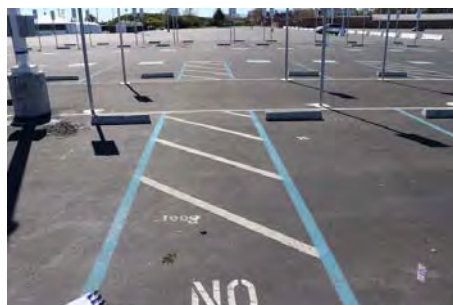
COD	CONDITION DESCRIPTION	ACTUAL
B32	Stall & access aisle has no gaps or changes in level and is firm, stable and slip resistant. (ADAS 502.4)	One hole in access aisle serving both DAS that is 1" in diameter.

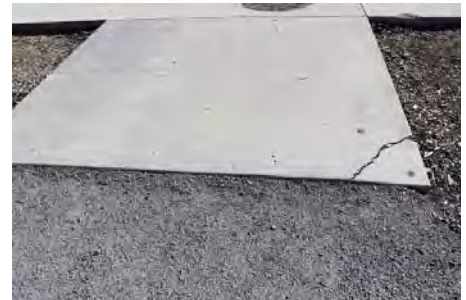
COD	CONDITION DESCRIPTION	ACTUAL
B11	Surface is firm, stable and slip-resistant. (ADAS 302.1)	loose rocks, sand and gravel.
B15	No level changes greater than 1/2" (except by accessible ramp or other means). (ADAS 303.4)	3/4 high vertical edge.

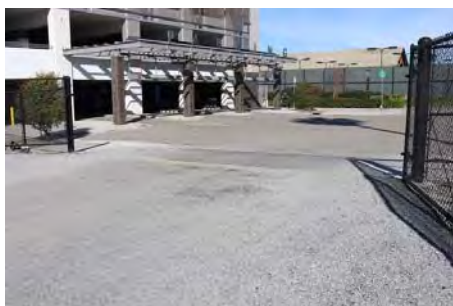
COD	CONDITION DESCRIPTION	ACTUAL
B11	Surface is firm, stable and slip-resistant. (ADAS 302.1)	Loose rocks, gravel and sand.
B12	Gaps/openings in ground or floor surfaces do not allow the passage of a sphere more than 1/2" in diameter. (ADAS 302.3)	Up to 2" deep gaps over 12" wide along transition to concrete.
B15	No level changes greater than 1/2" (except by accessible ramp or other means). (ADAS 303.4)	Up to 1" high vertical edge.

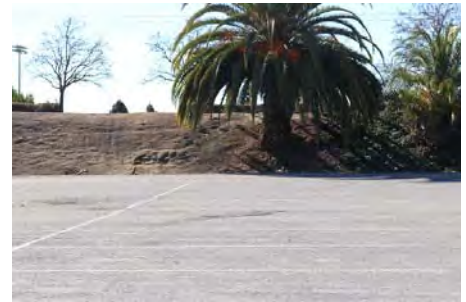
COD	CONDITION DESCRIPTION	ACTUAL
B11	Surface is firm, stable and slip-resistant. (ADAS 302.1)	Dirt
B17	Running slope (parallel to direction of travel) is 1:20 (5.0%) max. (ADAS 403.3)	Steep hillside.

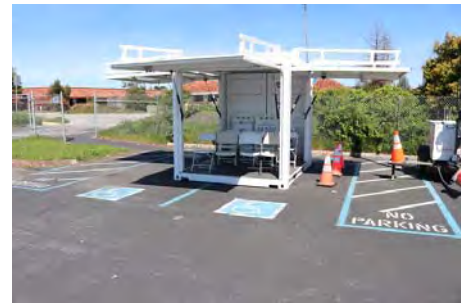
COD	CONDITION DESCRIPTION	ACTUAL
B11	Parking space is marked to define a width of min.8' wide (9' CBC). (ADAS 502.2)	West to stalls are obstructed by shelter.
B12	Access aisle is marked to define a width of min. 5' wide. (ADAS 502..3.1)	8 of the 11 access aisles are 58" to 59" wide.
B32	Stall & access aisle has no gaps or changes in level and is firm, stable and slip resistant. (ADAS 502.4)	Stalls and access aisles at eastern 3 stalls are partially covered by leaves and dirt.

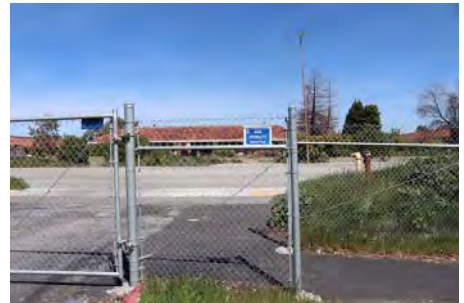
COD	CONDITION DESCRIPTION	ACTUAL
B04	Cross slope of ramp is 1:48 (2.08%) max. (ADAS 405.3)	2.6% to 4.0%.
B12	Landings are sloped 1:48 (2.08%) max. and are firm, stable and slip resistant without gaps or edges. (ADAS 405.7.1)	Top landing up to 3.2%.
B31	Handrails are provided at both sides (ADA: except at ramp with max 6" rise / 72" run) (CBC: except adjacent to assembly seating, or at door landing ramp with max 6" rise / 72" run). (ADAS 405.8)	None. Approx. 12' long.

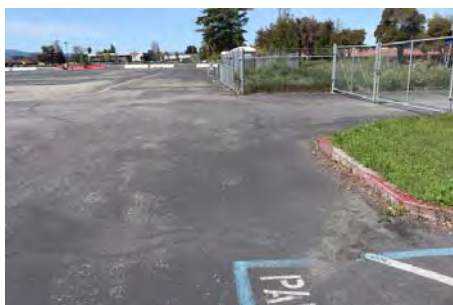
COD	CONDITION DESCRIPTION	ACTUAL
B15	No level changes greater than 1/2" (except by accessible ramp or other means). (ADAS 303.4)	Multiple raised edges 1" high.

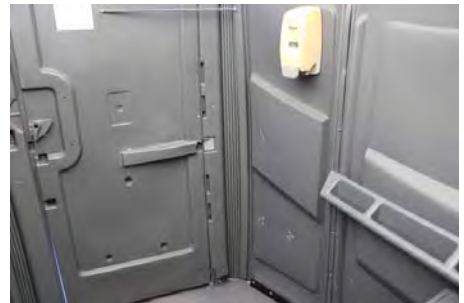
COD	CONDITION DESCRIPTION	ACTUAL
B21	Unobstructed forward or side approach reach range is min 15" to max 48" AFF. (ADAS 308.2.1, 308.3.1)	51 3/4" to hand sanitizer.

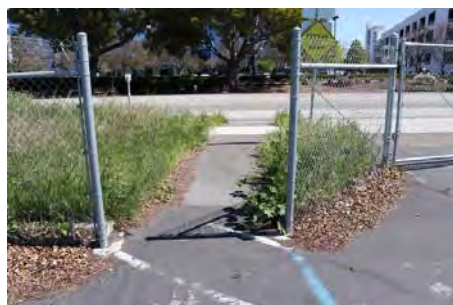
COD	CONDITION DESCRIPTION	ACTUAL
B16	Cross slope (perpendicular to direction of travel) is 1:48 (2.08%) max. (ADAS 403.3)	Up to 3.1% convoluted asphalt surface.

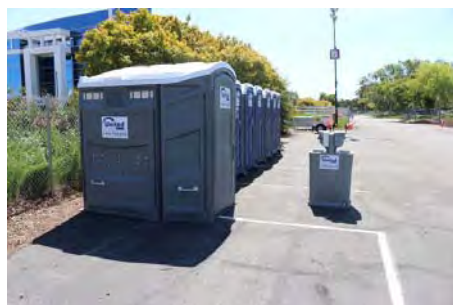
COD	CONDITION DESCRIPTION	ACTUAL
B02	Operable parts are operable with one hand, using max 5lbs force, and not requiring tight grasping, pinching, or twisting of the wrist. (ADAS 309.4)	Water operation by foot pedal.

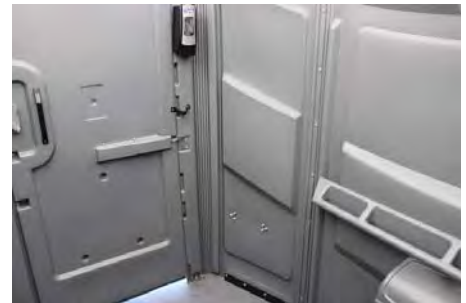
COD	CONDITION DESCRIPTION	ACTUAL
B21	Unobstructed forward or side approach reach range is min 15" to max 48" AFF. (ADAS 308.2.1, 308.3.1)	55" to hand sanitizer.

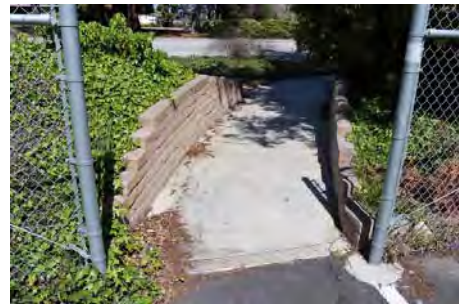
COD	CONDITION DESCRIPTION	ACTUAL
B04	Cross slope of ramp is 1:48 (2.08%) max. (ADAS 405.3)	Cross slope is 4.0% at the top.
B12	Landings are sloped 1:48 (2.08%) max. and are firm, stable and slip resistant without gaps or edges. (ADAS 405.7.1)	Btm. Landing is 3.9%, top landing is 5.0% and top landing partially covered by debris.
B14	Top landing is min. 60" long. (ADAS 405.7.3)	Top landing is 48".
B31	Handrails are provided at both sides (ADA: except at ramp with max 6" rise / 72" run) (CBC: except adjacent to assembly seating, or at door landing ramp with max 6" rise / 72" run). (ADAS 405.8)	None, approx. 12' long.

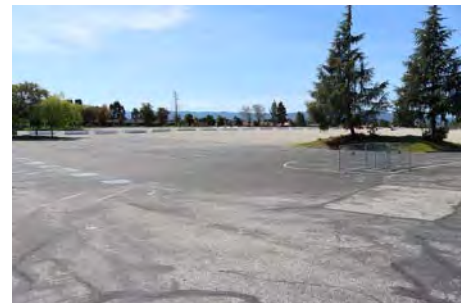
COD	CONDITION DESCRIPTION	ACTUAL
A5	Acc parking stalls are located on the shortest ACC route from parking to ACC entrance. (ADAS 208.3.1)	Many standard stalls are closer to both walkways to the public right of way, at the E side and the N side, than are some of the DAS.

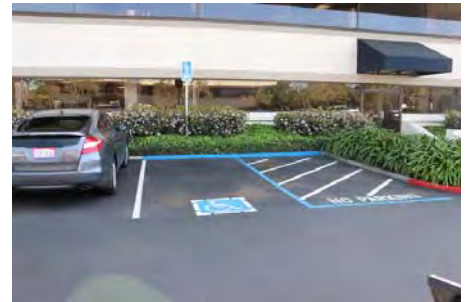
COD	CONDITION DESCRIPTION	ACTUAL
B41	Stall is located as close as practical to entrance. (ADAS 208.3.1)	Many other standard stalls closer to routes to the public right of way.
C42	Accessible route from stall does not pass behind other parked cars. (2013 CBC 11B-502.7.1).	Must pass behind other vehicles.

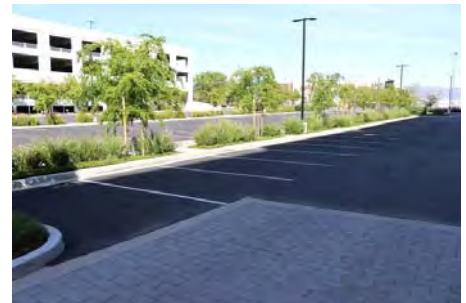
COD	CONDITION DESCRIPTION	ACTUAL
B41	Stall is located as close as practical to entrance. (ADAS 208.3.1)	Many standard spaces are closer to the public right of way.

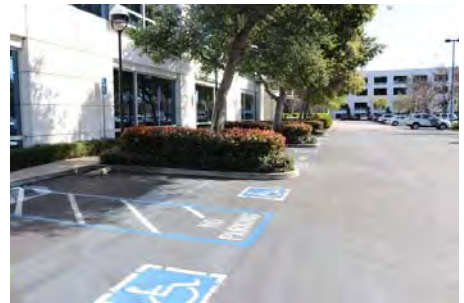
COD	CONDITION DESCRIPTION	ACTUAL
B41	Stall is located as close as practical to entrance. (ADAS 208.3.1)	Many spaces are closer to the public right of way.

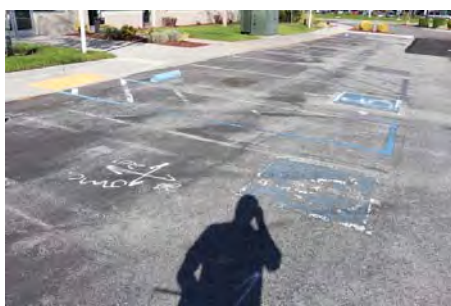
COD	CONDITION DESCRIPTION	ACTUAL
B11	Parking space is marked to define a width of min.8' wide (9' CBC). (ADAS 502.2)	Markings worn and faded.
B23	Access aisle is marked to discourage parking -in California: with "NO PARKING" in white with min. 12" high letters located at tail end of access aisle. (ADAS 502.3.3)	Markings worn and faded.
B31	Slopes do not exceed 1:48 (2.08%). (ADAS 502.4)	3.3% at access aisle.
B41	Stall is located as close as practical to entrance. (ADAS 208.3.1)	Many other standard stalls are closer to routes to the public right of way.

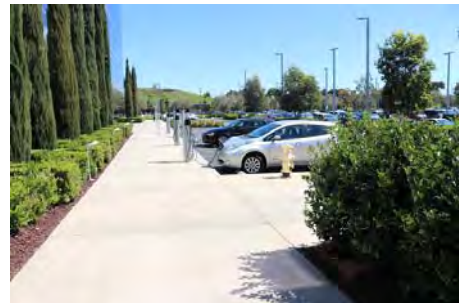
COD	CONDITION DESCRIPTION	ACTUAL
B41	Stall is located as close as practical to entrance. (ADAS 208.3.1)	Many other standard stalls are closer to routes to the public right of way.
