Case No. 5:16-cv-07013-LHK (SVK)

**DECLARATION OF JEFFREY SCOTT  
MASTIN IN SUPPORT OF PLAINTIFFS'  
MOTION FOR CLASS CERTIFICATION**

NEVAREZ V 49ERS - ACCESSIBILITY ASSESSMENT

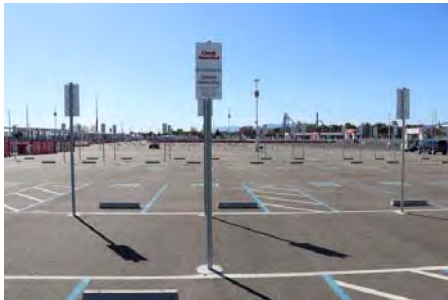
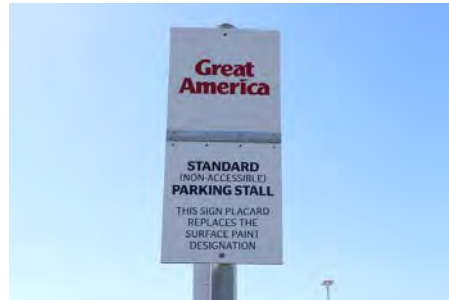
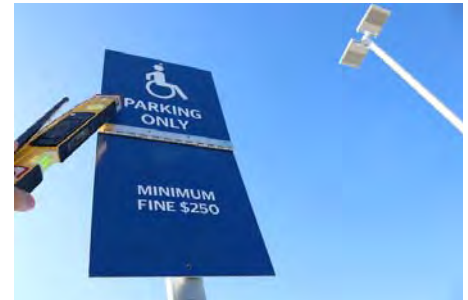
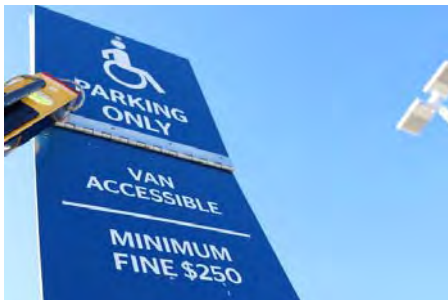
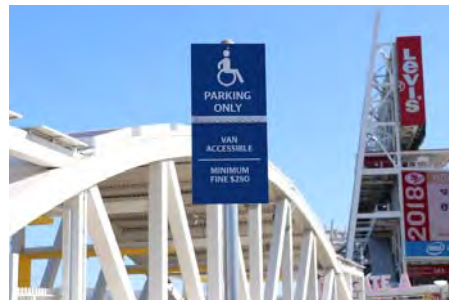
COD	CONDITION DESCRIPTION	ACTUAL
B02	I.D. sign with contrasting ISA (White on blue background per CVC 22511.7(b)(1)) is provided and located with bottom at min. 60" high. (ADAS 502.6)	ISA is not the standard symbol.
C03	I.D. sign is min. 70" square in size and reflectorized. (2013 CBC 11B-502.6.1)	Signs are not reflectorized.

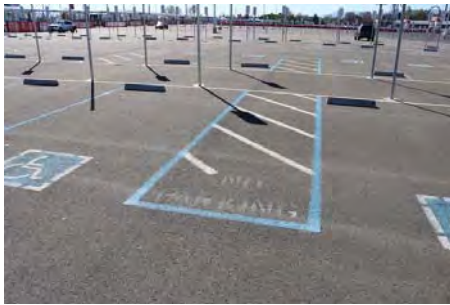
COD	CONDITION DESCRIPTION	ACTUAL
B23	Access aisle is marked to discourage parking -in California: with "NO PARKING" in white with min. 12" high letters located at tail end of access aisle. (ADAS 502.3.3)	Access aisle markings are faded (NO PARKING).

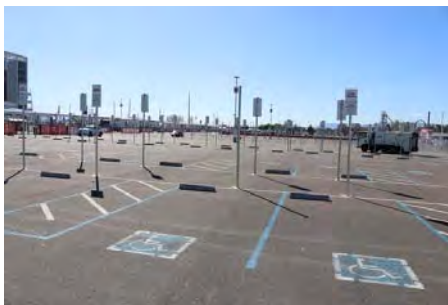
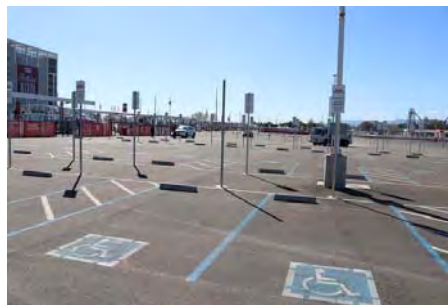
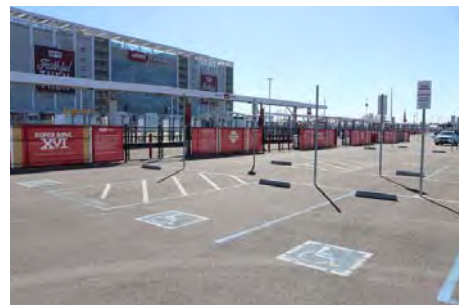
COD	CONDITION DESCRIPTION	ACTUAL
B02	I.D. sign with contrasting ISA (White on blue background per CVC 22511.7(b)(1)) is provided and located with bottom at min. 60" high. (ADAS 502.6)	None

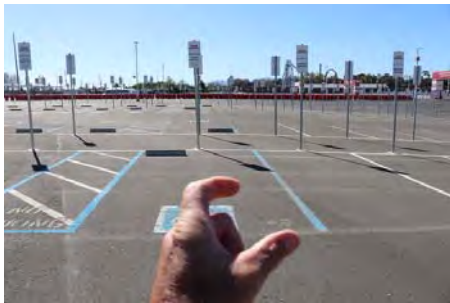
COD	CONDITION DESCRIPTION	ACTUAL
B31	Slopes do not exceed 1:48 (2.08%). (ADAS 502.4)	Up to 2.7%.

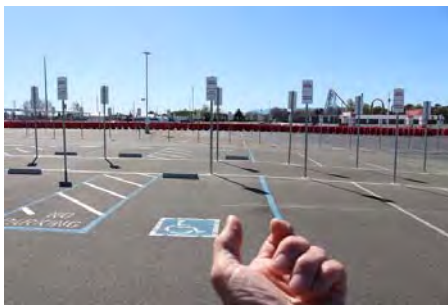
COD	CONDITION DESCRIPTION	ACTUAL
B31	Slopes do not exceed 1:48 (2.08%). (ADAS 502.4)	Up to 5.4%

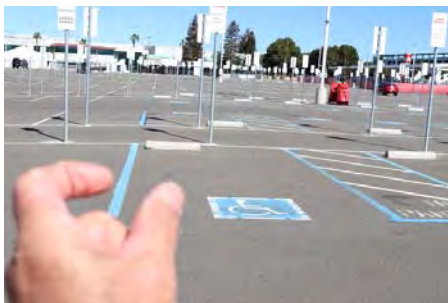
COD	CONDITION DESCRIPTION	ACTUAL
B31	Slopes do not exceed 1:48 (2.08%). (ADAS 502.4)	Up to 5.9%

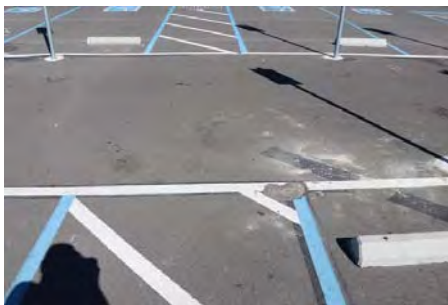
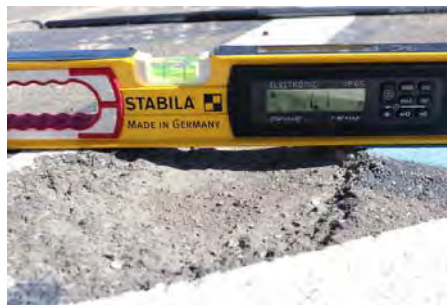
COD	CONDITION DESCRIPTION	ACTUAL
B32	Stall & access aisle has no gaps or changes in level and is firm, stable and slip resistant. (ADAS 502.4)	Pothole in access aisle serving both DAS that is 3/4" deep by 6" wide by 7" long.

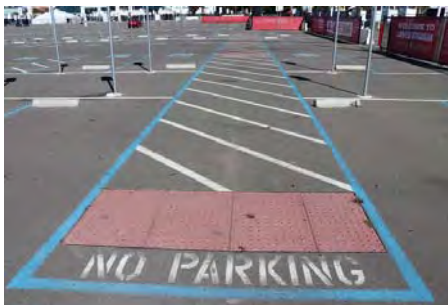
COD	CONDITION DESCRIPTION	ACTUAL
B32	Stall & access aisle has no gaps or changes in level and is firm, stable and slip resistant. (ADAS 502.4)	Detectable warnings are unnecessary and obstruct the access aisle for all 8 DAS.

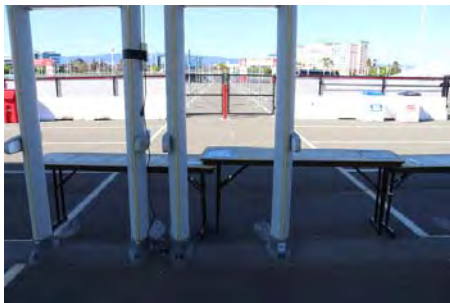
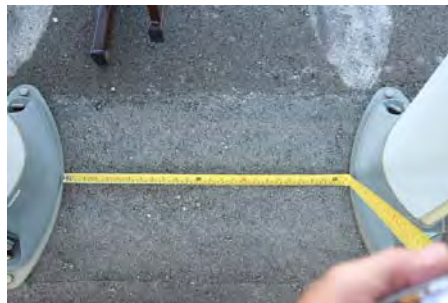
COD	CONDITION DESCRIPTION	ACTUAL
B03	If clear width is less than 36", it is min. 32" clear for 24" long max. and reduced width segments are separated by min. 48" long by 36" wide segments. (ADAS 403.5.1)	25" wide at the btm., 28" wide at the top at all security devices.

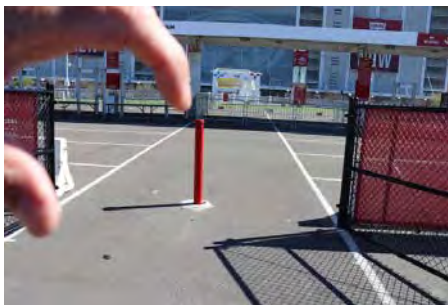
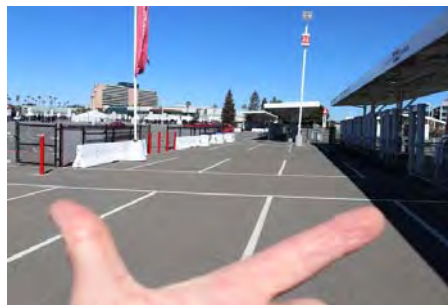
FACILITY/SITE: 10. Parking: Red Lot 1

COD	CONDITION DESCRIPTION	ACTUAL
B32	Stall & access aisle has no gaps or changes in level and is firm, stable and slip resistant. (ADAS 502.4)	Two holes 1" in diameter.

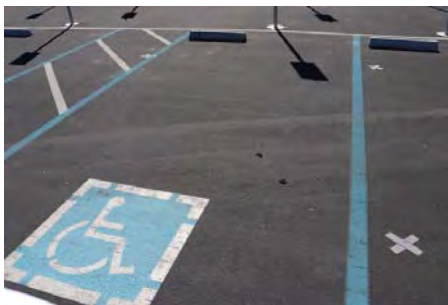
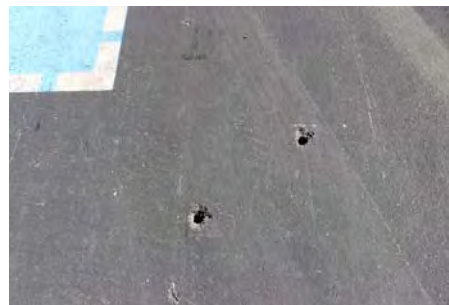
**FACILITY/SITE:** 10. Parking: Red Lot 1

COD	CONDITION DESCRIPTION	ACTUAL
B32	Stall & access aisle has no gaps or changes in level and is firm, stable and slip resistant. (ADAS 502.4)	Two holes 1" in diameter.

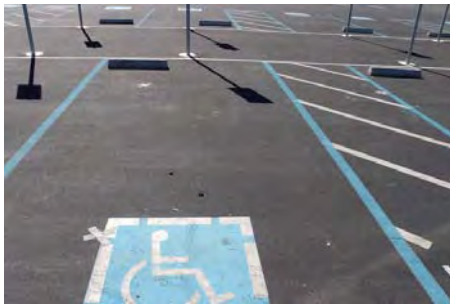
**FACILITY/SITE: 10. Parking: Red Lot 1**

COD	CONDITION DESCRIPTION	ACTUAL
B32	Stall & access aisle has no gaps or changes in level and is firm, stable and slip resistant. (ADAS 502.4)	One hole in access aisle serving both DAS that is 1" in diameter.

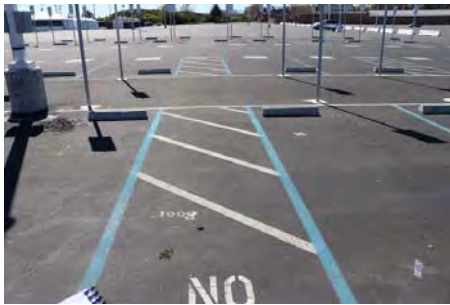
FACILITY/SITE: 10. Parking: Red Lot 1

COD	CONDITION DESCRIPTION	ACTUAL
B12	Access aisle is marked to define a width of min. 5' wide. (ADAS 502..3.1)	No access are provided, stall is 9' wide.

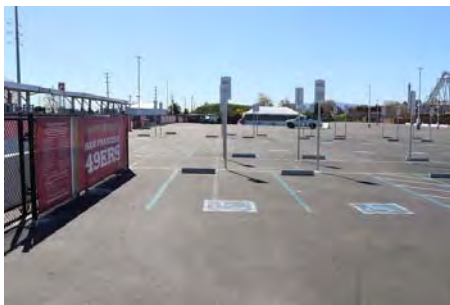
**FACILITY/SITE: 10. Parking: Red Lot 1**

COD	CONDITION DESCRIPTION	ACTUAL
C06	Signs are positioned with bottom min. 60" above surface of parking space, and are visible from, and located at projected width at head end, or are immediately adjacent to parking space.	None

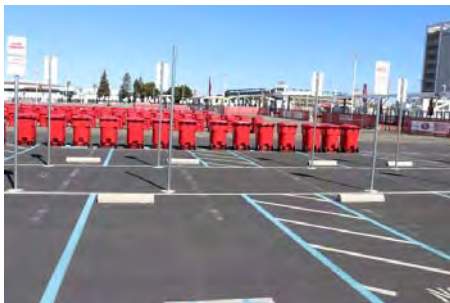
FACILITY/SITE: 10. Parking: Red Lot 1

COD	CONDITION DESCRIPTION	ACTUAL
B41	Stall is located as close as practical to entrance. (ADAS 208.3.1)	Many other standard parking spaces are closer to the bridge to gate C.

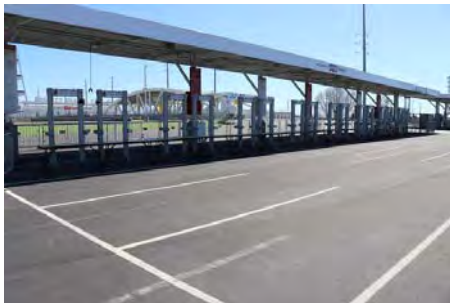
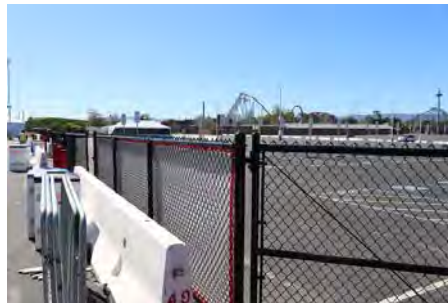
FACILITY/SITE: 10. Parking: Red Lot 1

COD	CONDITION DESCRIPTION	ACTUAL
B11	Parking space is marked to define a width of min.8' wide (9' CBC). (ADAS 502.2)	New surface markings are painted over old markings and determining extent of DAS is difficult.

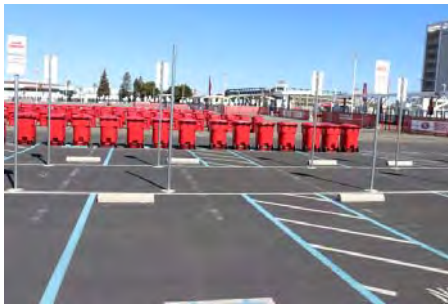
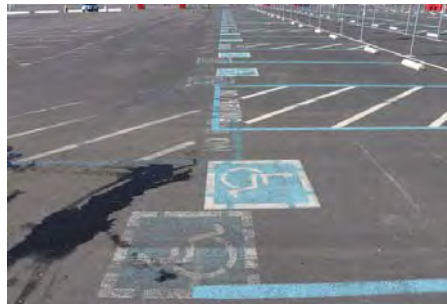
**FACILITY/SITE:** 10. Parking: Red Lot 1

COD	CONDITION DESCRIPTION	ACTUAL
A12	1 van stall provided for every 6 required acc stalls. (ADAS 208.2.4)	33 van stalls required, 15 provided.

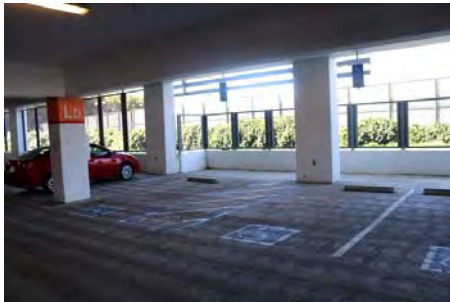
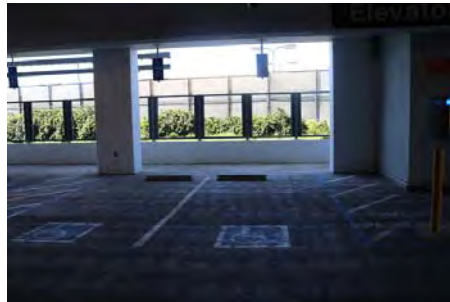
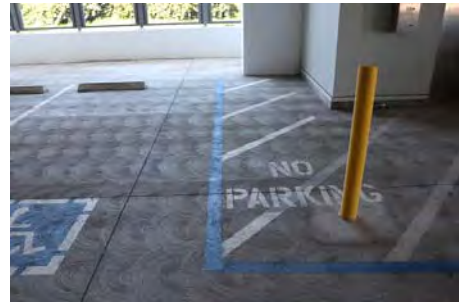
FACILITY/SITE: 11. Parking: Yellow Lot 1 Parking Structure

North space is signed for electrical vehicle charging only, however the charging cable for 2 DAS does not reach, and if it did it would obstruct the pedestrian accessible route to Stars and Stripes Blvd.

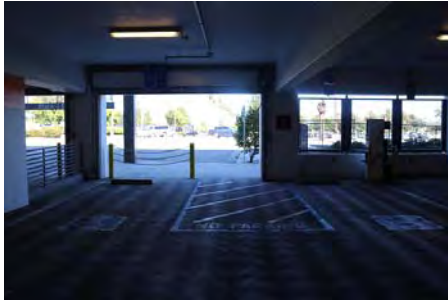
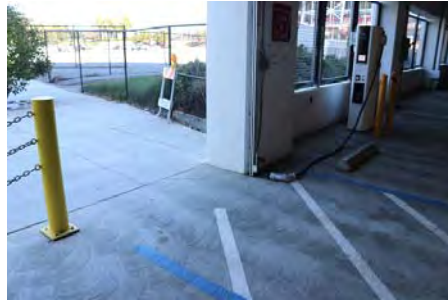
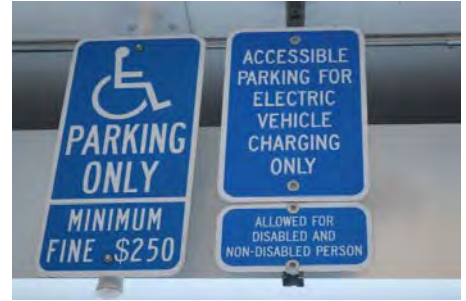
**FACILITY/SITE: 11. Parking: Yellow Lot 1 Parking Structure**

COD	CONDITION DESCRIPTION	ACTUAL
B02	36" min. clear width of exterior walkway. (ADAS 403.5.1)	If vehicle is parked in adjacent stall to S, the route is completely obstructed by the vehicle.
B03	If clear width is less than 36", it is min. 32" clear for 24" long max. and reduced width segments are separated by min. 48" long by 36" wide segments. (ADAS 403.5.1)	20" to wheel stop if no vehicle park to the South.

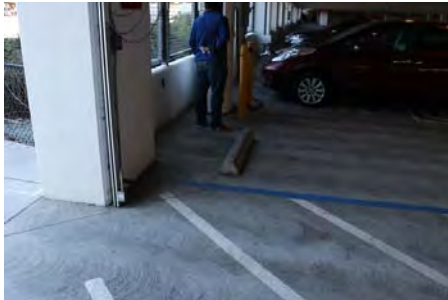
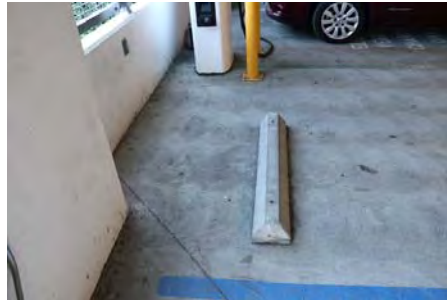
FACILITY/SITE: 11. Parking: Yellow Lot 1 Parking Structure

COD	CONDITION DESCRIPTION	ACTUAL
B31	Slopes do not exceed 1:48 (2.08%). (ADAS 502.4)	Up to 3.1% at head end of stalls and access aisle.

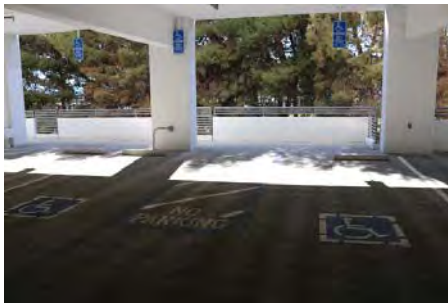
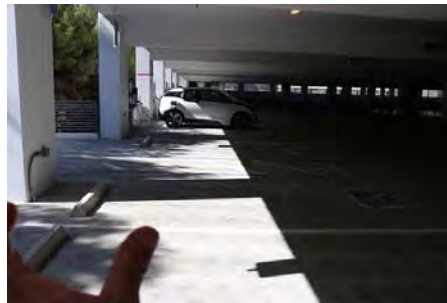
FACILITY/SITE: 11. Parking: Yellow Lot 1 Parking Structure

COD	CONDITION DESCRIPTION	ACTUAL
B31	Slopes do not exceed 1:48 (2.08%). (ADAS 502.4)	Up to 2.8% at head end of stalls and access aisle.

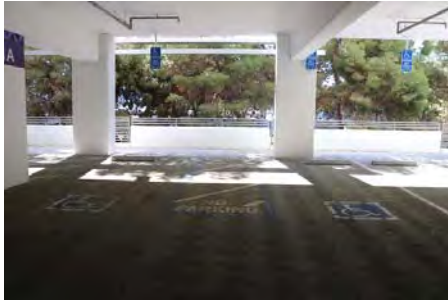
**FACILITY/SITE:** 11. Parking: Yellow Lot 1 Parking Structure

COD	CONDITION DESCRIPTION	ACTUAL
B13	Van parking space is marked to define a width of 11' wide (12' CBC) with 5' wide access aisle or 8' wide (9' CBC) with 8' wide access aisle. (ADAS 502.2, 502.3.1)	Access aisle obstructed by column (50" to column). Overall 13' wide to column stall portion is 9' wide.

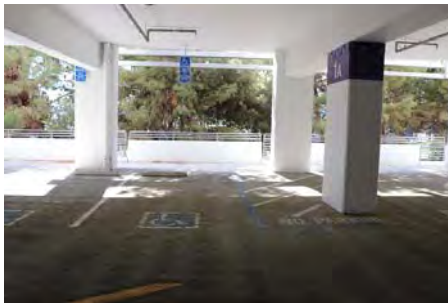
FACILITY/SITE: 11. Parking: Yellow Lot 1 Parking Structure

COD	CONDITION DESCRIPTION	ACTUAL
B31	Slopes do not exceed 1:48 (2.08%). (ADAS 502.4)	Up to 2.8% at North stall.

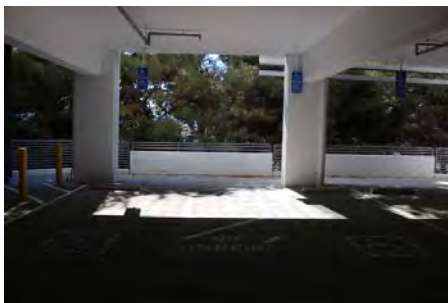
**FACILITY/SITE:** 11. Parking: Yellow Lot 1 Parking Structure

COD	CONDITION DESCRIPTION	ACTUAL
C42	Accessible routes coincide with or are located in the same area as general circulation paths. Where circulation paths are interior, required accessible routes are also interior (ADAS 206.3)	Route is exterior and exposed to weather whereas the route for the general public is interior and not exposed to weather.

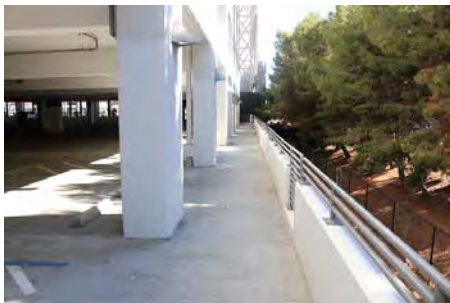
**FACILITY/SITE:** 11. Parking: Yellow Lot 1 Parking Structure

COD	CONDITION DESCRIPTION	ACTUAL
B12	Access aisle is marked to define a width of min. 5' wide. (ADAS 502..3.1)	Access aisle obstructed by concrete waste receptacle (28" to waste receptacle).

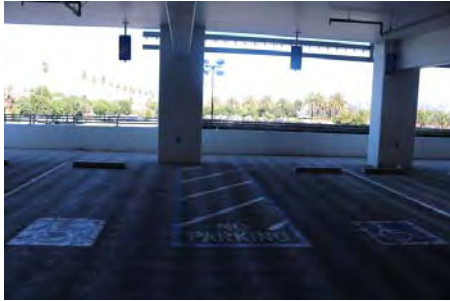
FACILITY/SITE: 11. Parking: Yellow Lot 1 Parking Structure

COD	CONDITION DESCRIPTION	ACTUAL
B31	Slopes do not exceed 1:48 (2.08%). (ADAS 502.4)	Up tp 3.5% in stalls and access aisle.

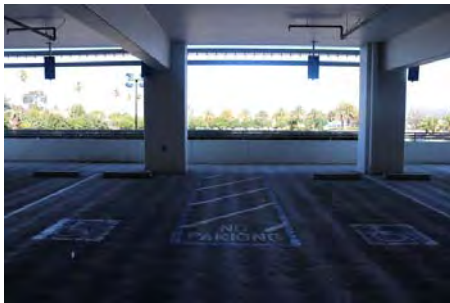
**FACILITY/SITE:** 11. Parking: Yellow Lot 1 Parking Structure

COD	CONDITION DESCRIPTION	ACTUAL
B31	Slopes do not exceed 1:48 (2.08%). (ADAS 502.4)	Up to 3.5% in stalls and access aisles.

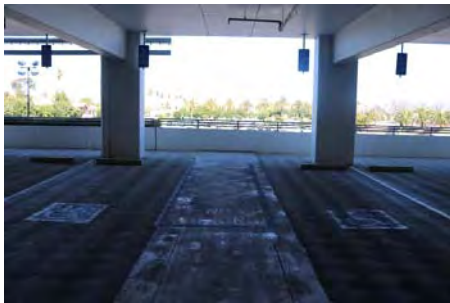
FACILITY/SITE: 11. Parking: Yellow Lot 1 Parking Structure

COD	CONDITION DESCRIPTION	ACTUAL
B31	Slopes do not exceed 1:48 (2.08%). (ADAS 502.4)	Up to 3.0% at North stall and access aisle.

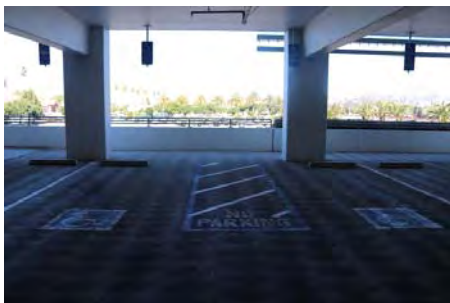
FACILITY/SITE: 11. Parking: Yellow Lot 1 Parking Structure

COD	CONDITION DESCRIPTION	ACTUAL
B13	Van parking space is marked to define a width of 11' wide (12' CBC) with 5' wide access aisle or 8' wide (9' CBC) with 8' wide access aisle. (ADAS 502.2, 502.3.1)	Access aisle obstructed by column (5' to column). Stall is 9' wide.

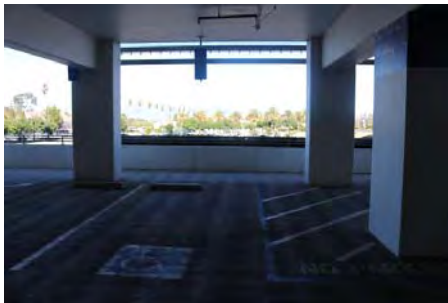
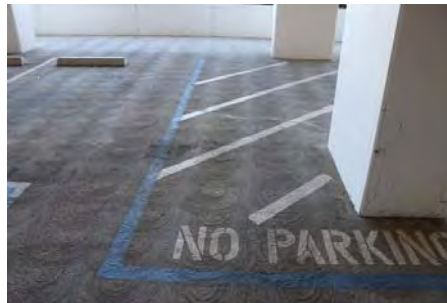
FACILITY/SITE: 11. Parking: Yellow Lot 1 Parking Structure

COD	CONDITION DESCRIPTION	ACTUAL
B31	Slopes do not exceed 1:48 (2.08%). (ADAS 502.4)	Up to 2.5% at South stall and access aisle.

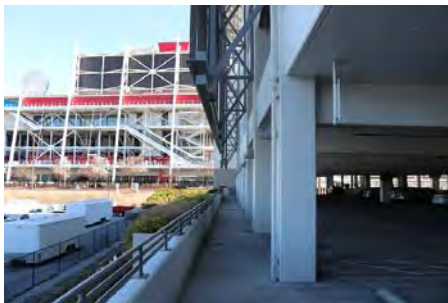
COD	CONDITION DESCRIPTION	ACTUAL
C42	Accessible routes coincide with or are located in the same area as general circulation paths. Where circulation paths are interior, required accessible routes are also interior (ADAS 206.3)	Route is exterior and exposed to weather whereas the route for the general public is interior and not exposed to weather.

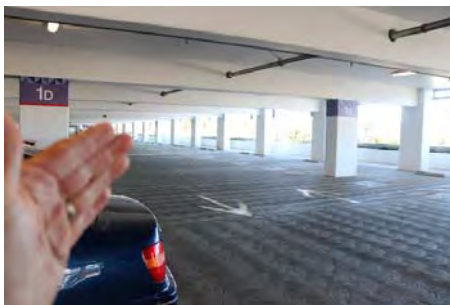
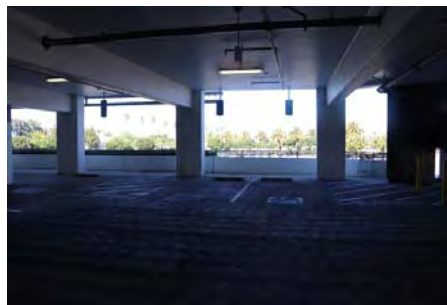
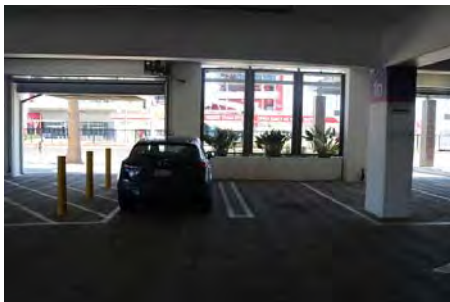
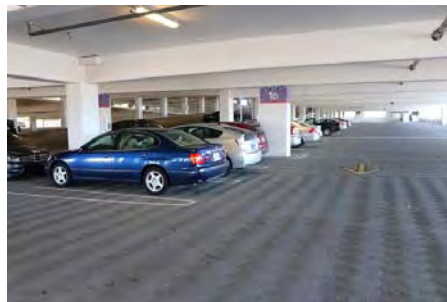
COD	CONDITION DESCRIPTION	ACTUAL
B41	Stall is located as close as practical to entrance. (ADAS 208.3.1)	There are standard stalls that are closer to the SE entrance than are these 12 DAS.

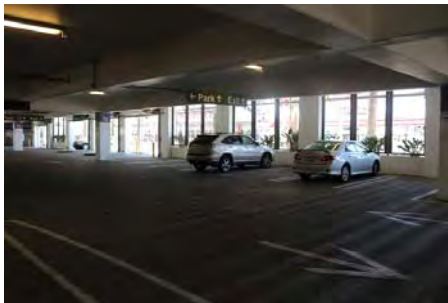
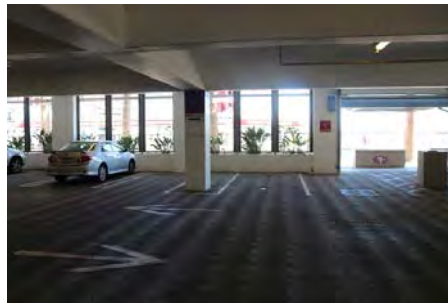
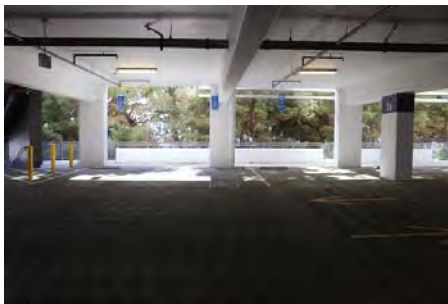
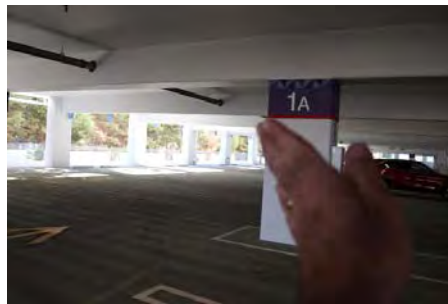
COD	CONDITION DESCRIPTION	ACTUAL
B41	Stall is located as close as practical to entrance. (ADAS 208.3.1)	There are standard stalls that are closer to the SW entrance than are 10 of these DAS.

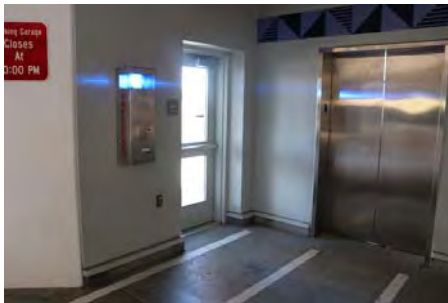
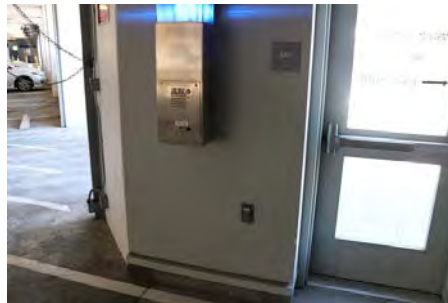
COD	CONDITION DESCRIPTION	ACTUAL
B21	Unobstructed forward or side approach reach range is min 15" to max 48" AFF. (ADAS 308.2.1, 308.3.1)	Help button is 52" AFF.

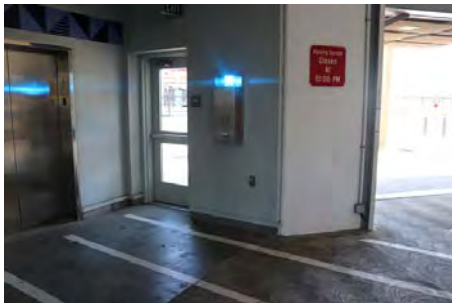
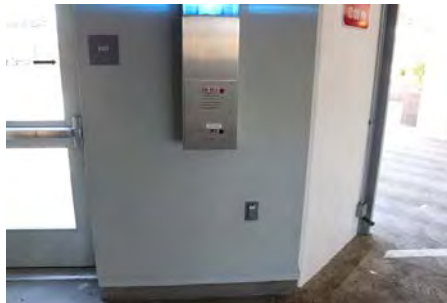
COD	CONDITION DESCRIPTION	ACTUAL
B21	Unobstructed forward or side approach reach range is min 15" to max 48" AFF. (ADAS 308.2.1, 308.3.1)	Help button is 52 1/2" AFF.

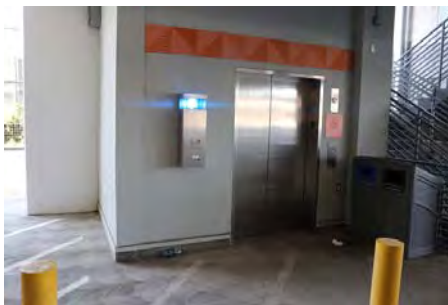
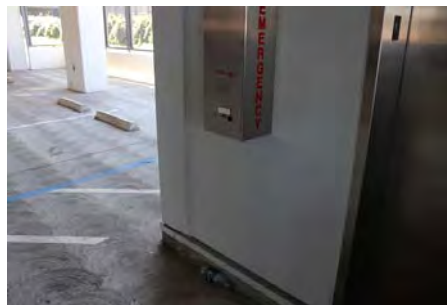
<b>COD</b>	<b>CONDITION DESCRIPTION</b>	<b>ACTUAL</b>
B21	Unobstructed forward or side approach reach range is min 15" to max 48" AFF. (ADAS 308.2.1, 308.3.1)	Help button is 52" AFF.

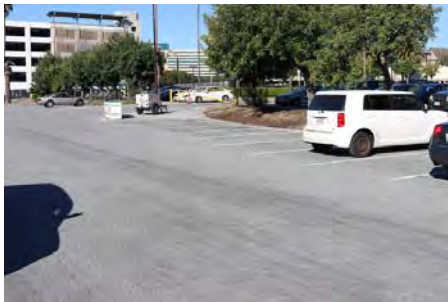
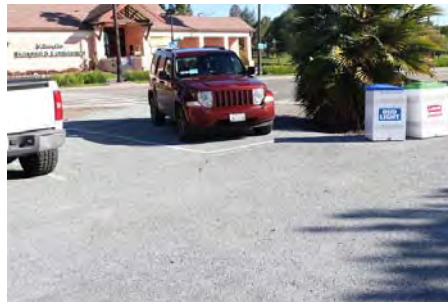
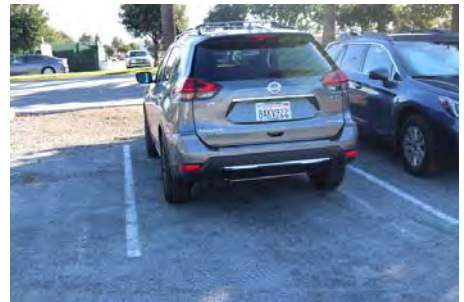
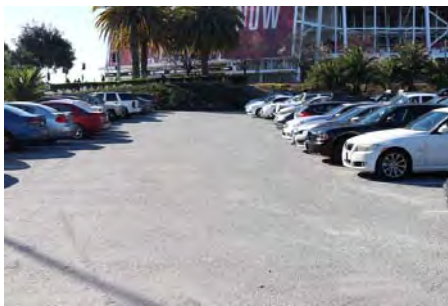
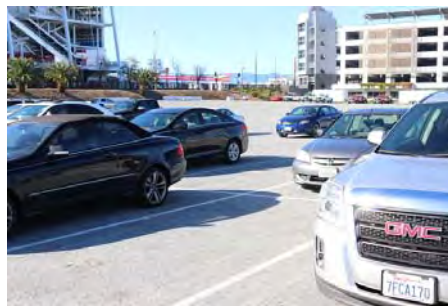
COD	CONDITION DESCRIPTION	ACTUAL
C10	Required number of acc stalls are provided as follows: 1-25=1, 26-50=2, 51-75=3, 76-100=4, 101-150=5, 151-200=6, 201-300=7, 301-400=8, 401-500=9, 501-1000=2% of total, 1001+=20+1 for each 100 over 1000. (ADAS 208.2)	8 required none provided
A12	1 van stall provided for every 6 required acc stalls. (ADAS 208.2.4)	2 required none provided

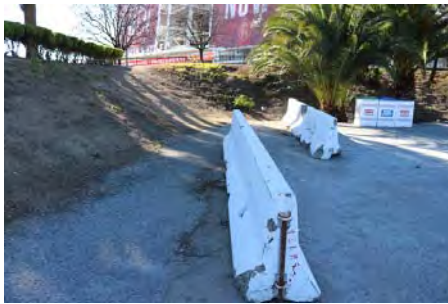
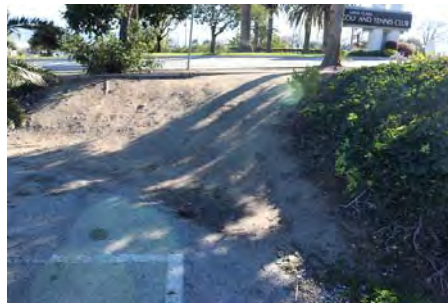
COD	CONDITION DESCRIPTION	ACTUAL
B11	Surface is firm, stable and slip-resistant. (ADAS 302.1)	Dirt surface.
B15	No level changes greater than 1/2" (except by accessible ramp or other means). (ADAS 303.4)	Multiple edges over 1 1/2" high.
B17	Running slope (parallel to direction of travel) is 1:20 (5.0%) max. (ADAS 403.3)	Steep uphill routes.

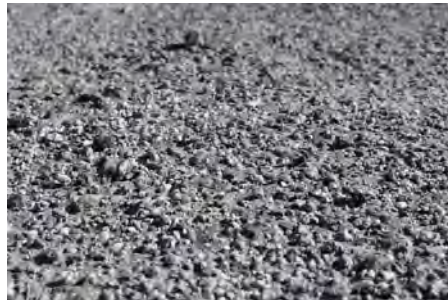
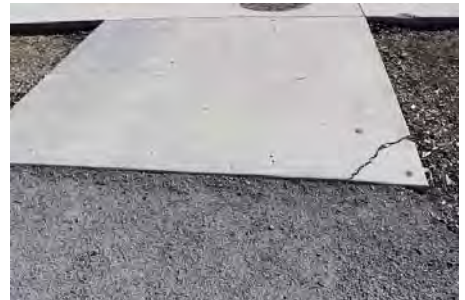
COD	CONDITION DESCRIPTION	ACTUAL
B11	Surface is firm, stable and slip-resistant. (ADAS 302.1)	loose rocks, sand and gravel.
B15	No level changes greater than 1/2" (except by accessible ramp or other means). (ADAS 303.4)	3/4 high vertical edge.

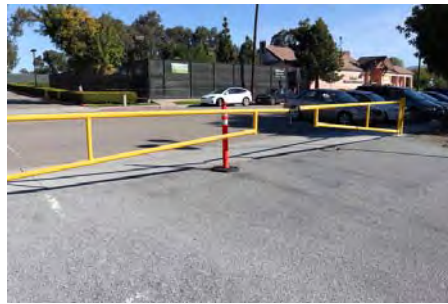
COD	CONDITION DESCRIPTION	ACTUAL
B11	Surface is firm, stable and slip-resistant. (ADAS 302.1)	Loose rocks.
B12	Gaps/openings in ground or floor surfaces do not allow the passage of a sphere more than 1/2" in diameter. (ADAS 302.3)	Large gaps over 2" deep x 12" wide along transition to concrete.
B15	No level changes greater than 1/2" (except by accessible ramp or other means). (ADAS 303.4)	Up to 2 1/2" high vertical edge at transition of concrete.

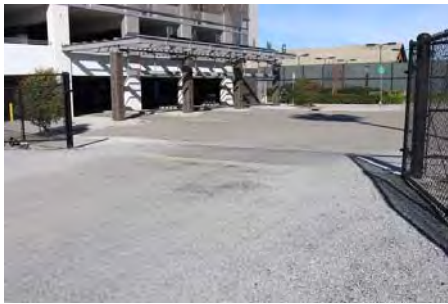
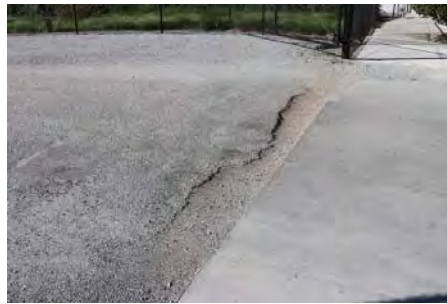
COD	CONDITION DESCRIPTION	ACTUAL
B11	Surface is firm, stable and slip-resistant. (ADAS 302.1)	Loose rocks, gravel and sand.
B12	Gaps/openings in ground or floor surfaces do not allow the passage of a sphere more than 1/2" in diameter. (ADAS 302.3)	Up to 2" deep gaps over 12" wide along transition to concrete.
B15	No level changes greater than 1/2" (except by accessible ramp or other means). (ADAS 303.4)	Up to 1" high vertical edge.

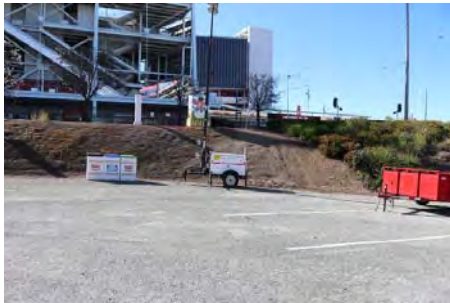
COD	CONDITION DESCRIPTION	ACTUAL
B11	Surface is firm, stable and slip-resistant. (ADAS 302.1)	Loose rocks, gravel and sand.
B12	Gaps/openings in ground or floor surfaces do not allow the passage of a sphere more than 1/2" in diameter. (ADAS 302.3)	Multiples gaps.
B15	No level changes greater than 1/2" (except by accessible ramp or other means). (ADAS 303.4)	Multiple vertical edges over 1/2" high.
B17	Running slope (parallel to direction of travel) is 1:20 (5.0%) max. (ADAS 403.3)	Steep hillside.

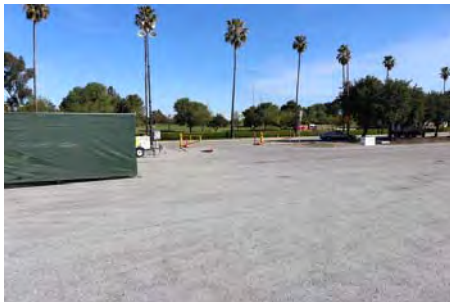
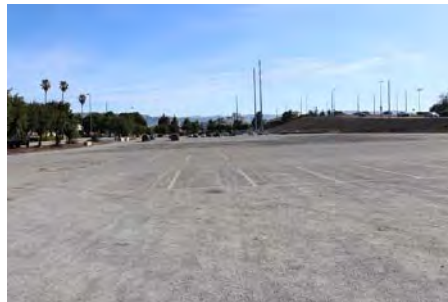
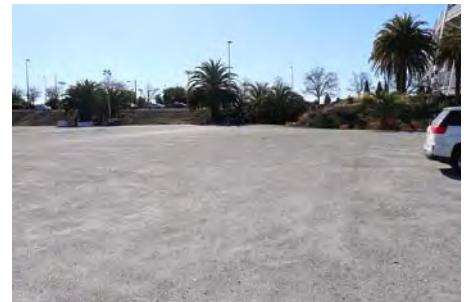
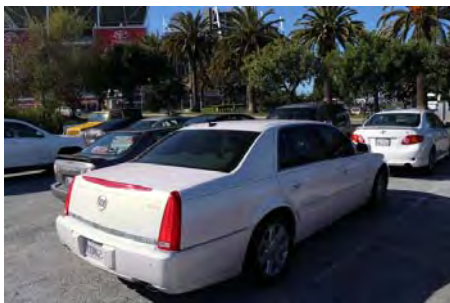
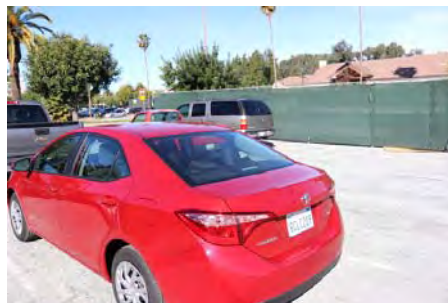
COD	CONDITION DESCRIPTION	ACTUAL
C10	Required number of acc stalls are provided as follows: 1-25=1, 26-50=2, 51-75=3, 76-100=4, 101-150=5, 151-200=6, 201-300=7, 301-400=8, 401-500=9, 501-1000=2% of total, 1001+=20+1 for each 100 over 1000. (ADAS 208.2)	None provided, 9 required.
A12	1 van stall provided for every 6 required acc stalls. (ADAS 208.2.4)	None provided, 2 required.

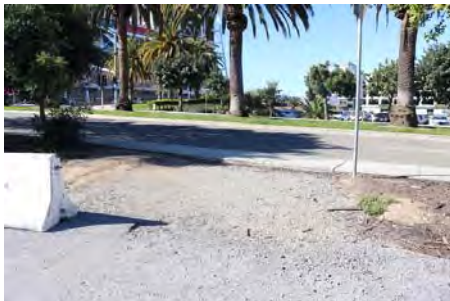
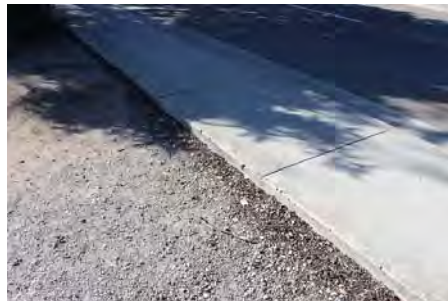
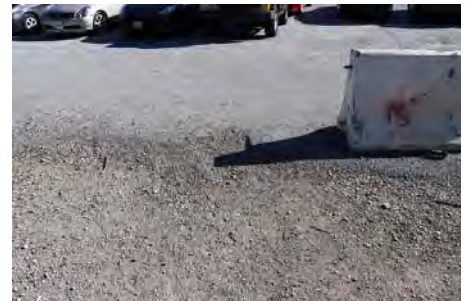
COD	CONDITION DESCRIPTION	ACTUAL
B11	Surface is firm, stable and slip-resistant. (ADAS 302.1)	Dirt, rocks, gravel and sand.
B12	Gaps/openings in ground or floor surfaces do not allow the passage of a sphere more than 1/2" in diameter. (ADAS 302.3)	Multiples gaps at asphalt to dirt transition.
B15	No level changes greater than 1/2" (except by accessible ramp or other means). (ADAS 303.4)	4" high vertical edge at concrete.
B17	Running slope (parallel to direction of travel) is 1:20 (5.0%) max. (ADAS 403.3)	Running slope 17.7% for approx. 12" at asphalt to dirt transition.

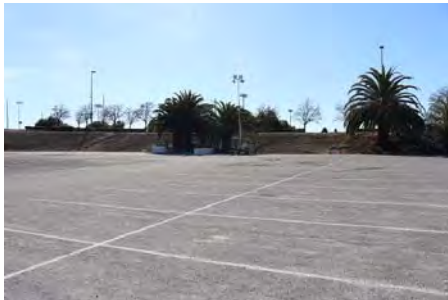
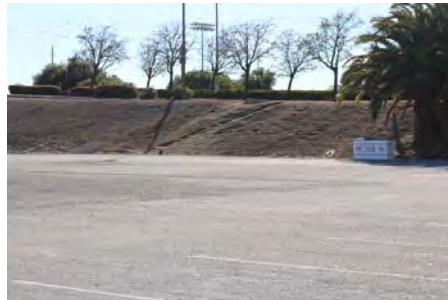
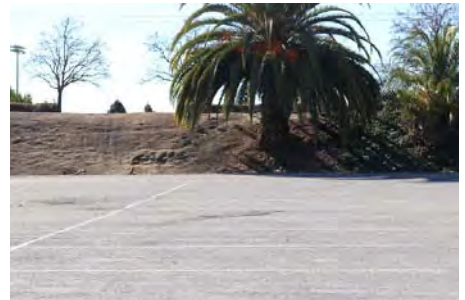
COD	CONDITION DESCRIPTION	ACTUAL
B11	Surface is firm, stable and slip-resistant. (ADAS 302.1)	Dirt
B17	Running slope (parallel to direction of travel) is 1:20 (5.0%) max. (ADAS 403.3)	Steep hillside.

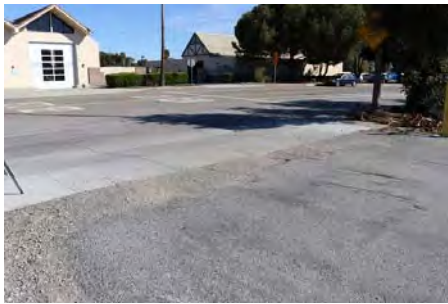
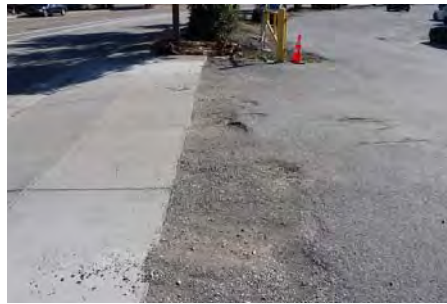
COD	CONDITION DESCRIPTION	ACTUAL
B11	Surface is firm, stable and slip-resistant. (ADAS 302.1)	Rocks, gravel, sand and dirt.
B12	Gaps/openings in ground or floor surfaces do not allow the passage of a sphere more than 1/2" in diameter. (ADAS 302.3)	Up to 2 1/2" deep gap over 18" wide along transition to concrete.
B15	No level changes greater than 1/2" (except by accessible ramp or other means). (ADAS 303.4)	Multiples edges up to 1 1/2".

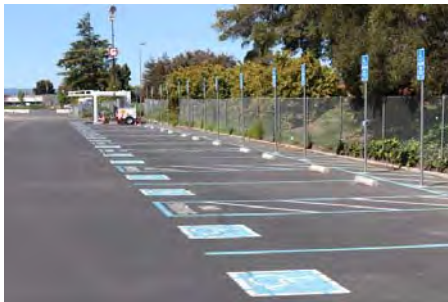
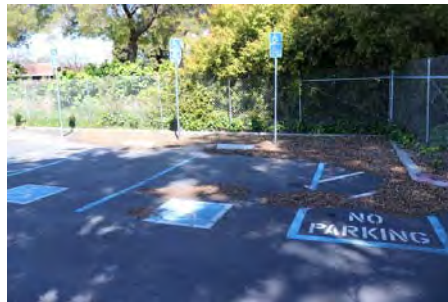
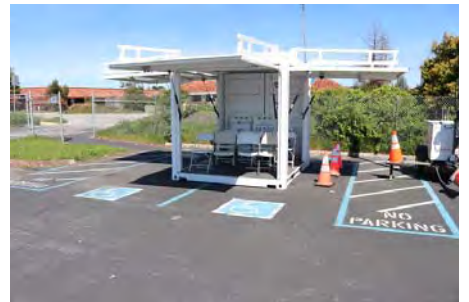
COD	CONDITION DESCRIPTION	ACTUAL
B11	Parking space is marked to define a width of min.8' wide (9' CBC). (ADAS 502.2)	West to stalls are obstructed by shelter.
B12	Access aisle is marked to define a width of min. 5' wide. (ADAS 502..3.1)	8 of the 11 access aisles are 58" to 59" wide.
B32	Stall & access aisle has no gaps or changes in level and is firm, stable and slip resistant. (ADAS 502.4)	Stalls and access aisles at eastern 3 stalls are partially covered by leaves and dirt.

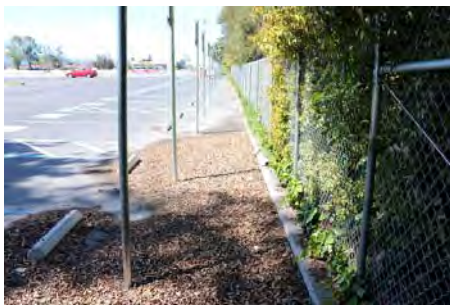
COD	CONDITION DESCRIPTION	ACTUAL
B11	Surface is firm, stable and slip-resistant. (ADAS 302.1)	Partially covered by leaves and dirt.

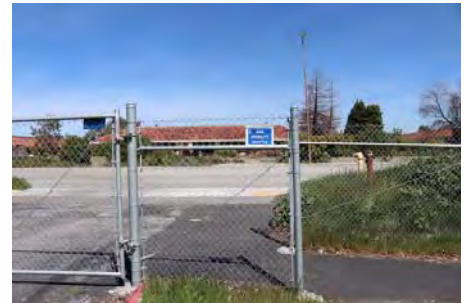
COD	CONDITION DESCRIPTION	ACTUAL
B04	Cross slope of ramp is 1:48 (2.08%) max. (ADAS 405.3)	2.6% to 4.0%.
B12	Landings are sloped 1:48 (2.08%) max. and are firm, stable and slip resistant without gaps or edges. (ADAS 405.7.1)	Top landing up to 3.2%.
B31	Handrails are provided at both sides (ADA: except at ramp with max 6" rise / 72" run) (CBC: except adjacent to assembly seating, or at door landing ramp with max 6" rise / 72" run). (ADAS 405.8)	None. Approx. 12' long.

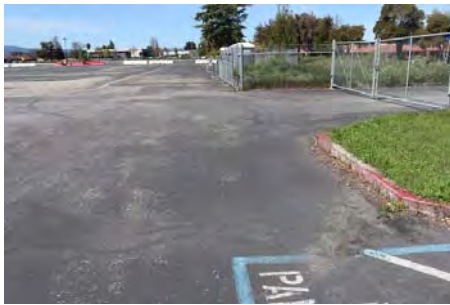
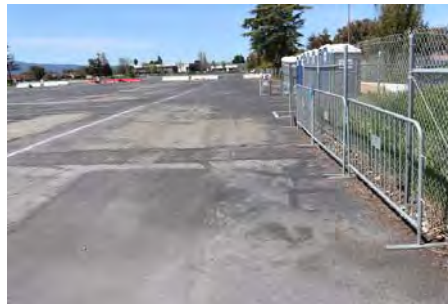
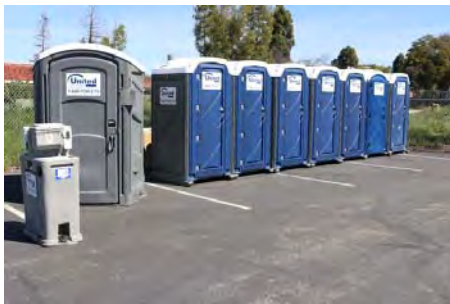
COD	CONDITION DESCRIPTION	ACTUAL
B15	No level changes greater than 1/2" (except by accessible ramp or other means). (ADAS 303.4)	Multiple raised edges 1" high.

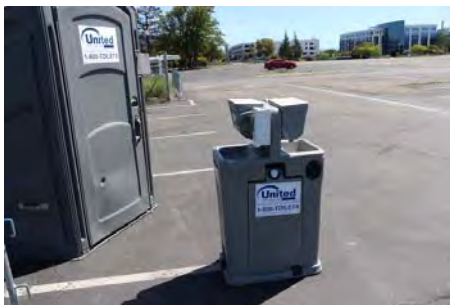
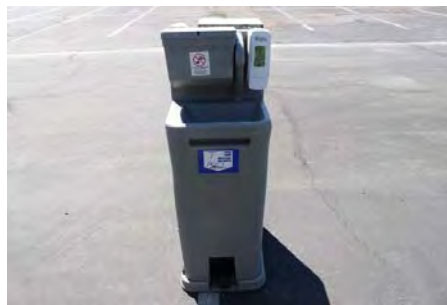
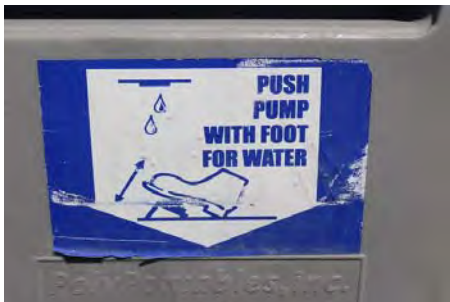
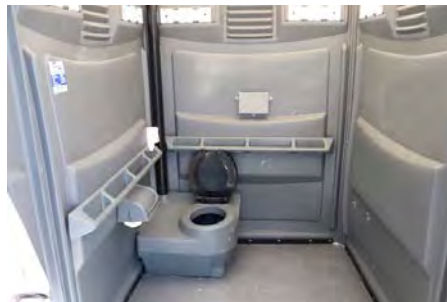
COD	CONDITION DESCRIPTION	ACTUAL
B02	Operable parts are operable with one hand, using max 5lbs force, and not requiring tight grasping, pinching, or twisting of the wrist. (ADAS 309.4)	Water is foot operated, not hand operated.

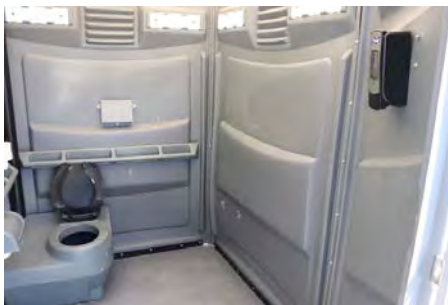
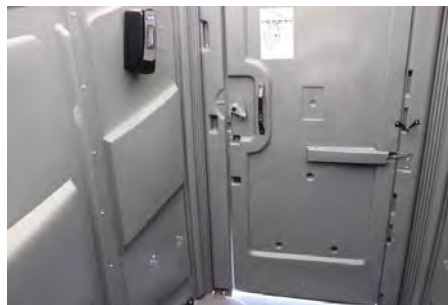
COD	CONDITION DESCRIPTION	ACTUAL
B21	Unobstructed forward or side approach reach range is min 15" to max 48" AFF. (ADAS 308.2.1, 308.3.1)	Hand sanitizer 54" high.

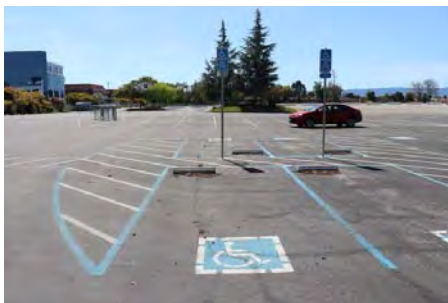
COD	CONDITION DESCRIPTION	ACTUAL
B12	Access aisle is marked to define a width of min. 5' wide. (ADAS 502..3.1)	Varies from 0" to 94".

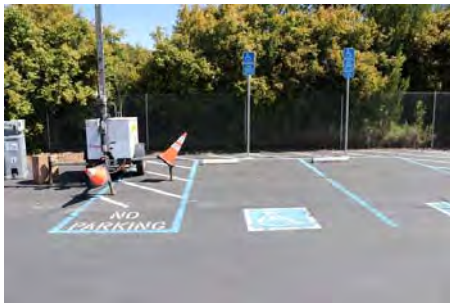
<b>COD</b>	<b>CONDITION DESCRIPTION</b>	<b>ACTUAL</b>
B12	Access aisle is marked to define a width of min. 5' wide. (ADAS 502..3.1)	Obstructed by equipment.

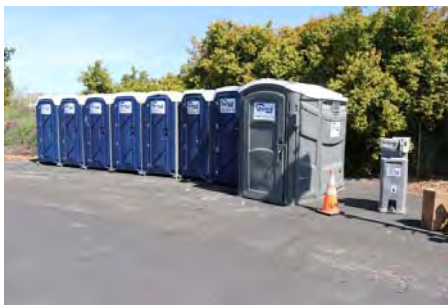
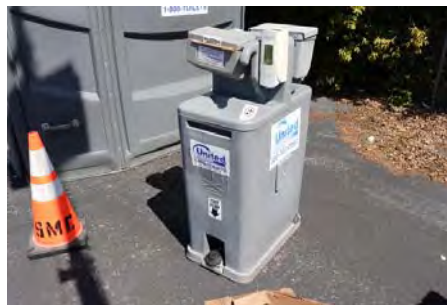
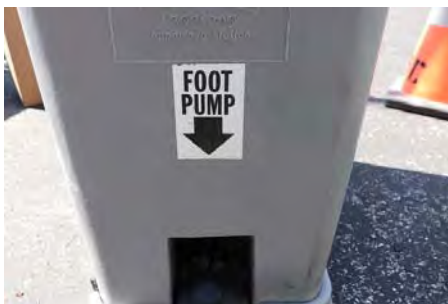
COD	CONDITION DESCRIPTION	ACTUAL
B02	Operable parts are operable with one hand, using max 5lbs force, and not requiring tight grasping, pinching, or twisting of the wrist. (ADAS 309.4)	Water operated by foot pump.

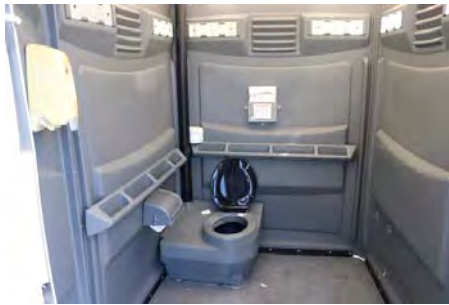
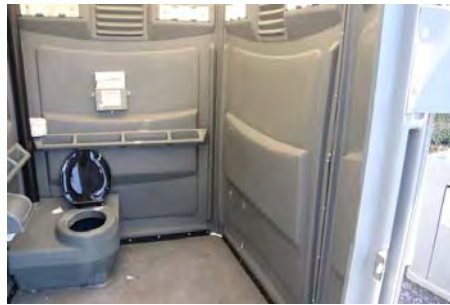
COD	CONDITION DESCRIPTION	ACTUAL
B21	Unobstructed forward or side approach reach range is min 15" to max 48" AFF. (ADAS 308.2.1, 308.3.1)	51 3/4" to hand sanitizer.

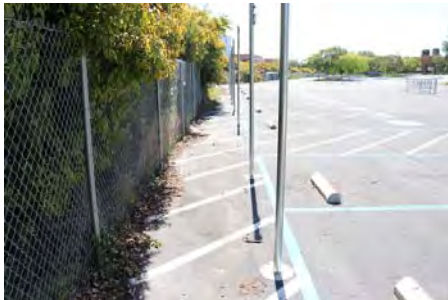
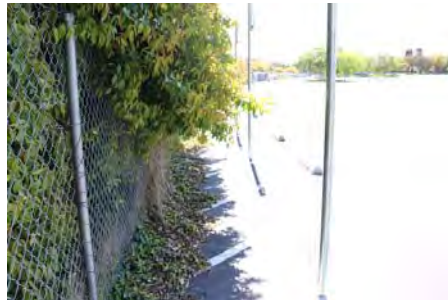
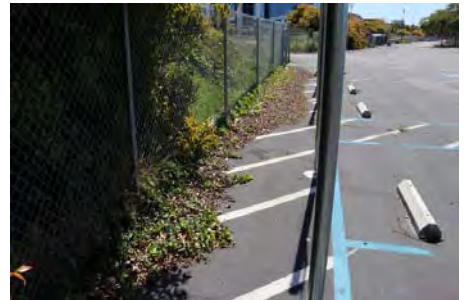
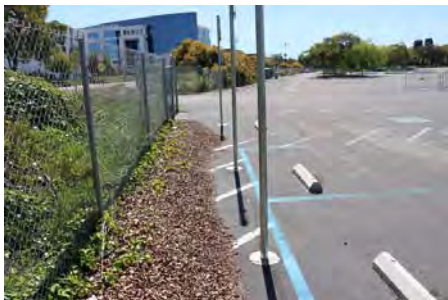
COD	CONDITION DESCRIPTION	ACTUAL
B02	36" min. clear width of exterior walkway. (ADAS 403.5.1)	Obstructed by trees and plants.
B11	Surface is firm, stable and slip-resistant. (ADAS 302.1)	Surface obstructed by leaves, dirt and debri.

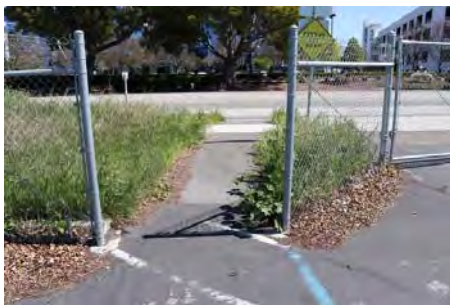
COD	CONDITION DESCRIPTION	ACTUAL
B16	Cross slope (perpendicular to direction of travel) is 1:48 (2.08%) max. (ADAS 403.3)	Up to 3.1% convoluted asphalt surface.

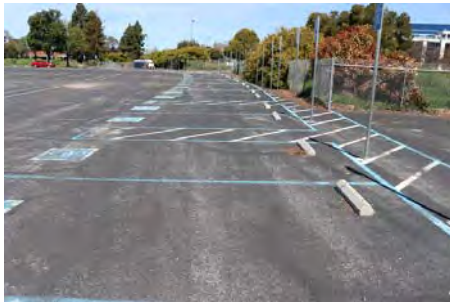
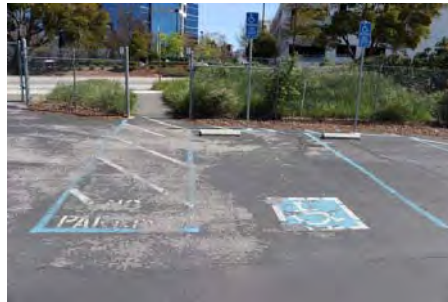
COD	CONDITION DESCRIPTION	ACTUAL
B23	Access aisle is marked to discourage parking -in California: with "NO PARKING" in white with min. 12" high letters located at tail end of access aisle. (ADAS 502.3.3)	North stall markings are worn away.
B31	Slopes do not exceed 1:48 (2.08%). (ADAS 502.4)	Slopes at the southern 8 stalls and access aisles are excessive up to 4.6%.

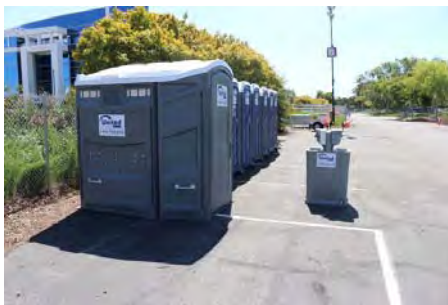
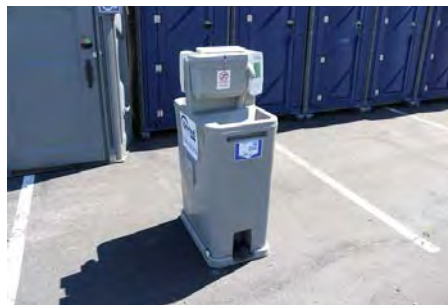
COD	CONDITION DESCRIPTION	ACTUAL
B02	Operable parts are operable with one hand, using max 5lbs force, and not requiring tight grasping, pinching, or twisting of the wrist. (ADAS 309.4)	Water operation by foot pedal.

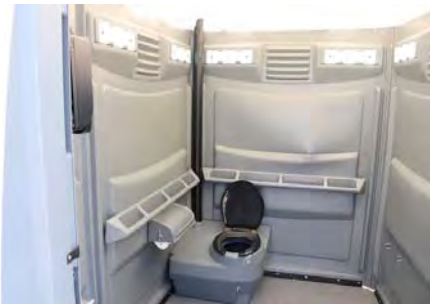
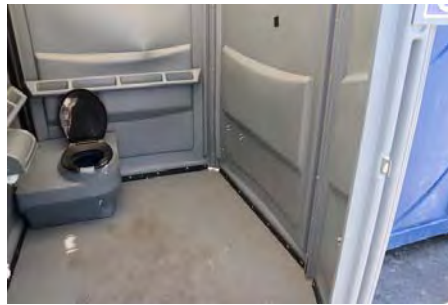
COD	CONDITION DESCRIPTION	ACTUAL
B21	Unobstructed forward or side approach reach range is min 15" to max 48" AFF. (ADAS 308.2.1, 308.3.1)	55" to hand sanitizer.

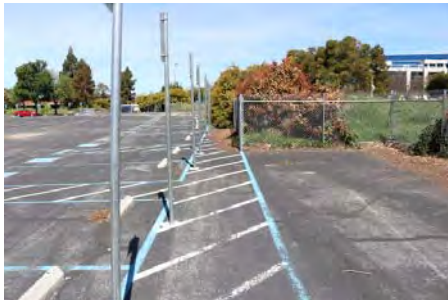
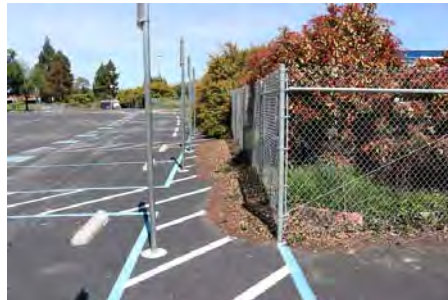
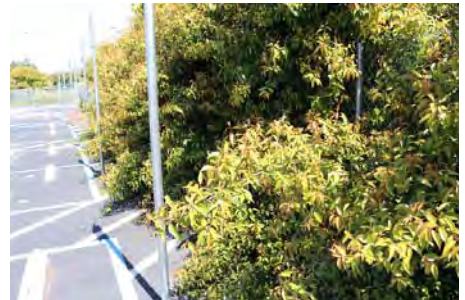
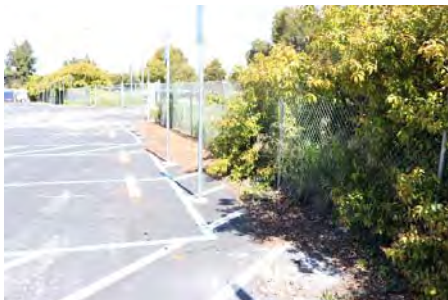
COD	CONDITION DESCRIPTION	ACTUAL
B02	36" min. clear width of exterior walkway. (ADAS 403.5.1)	Completely obstructed by bushes and trees.
B11	Surface is firm, stable and slip-resistant. (ADAS 302.1)	Covered by leaves, dirt and debris.

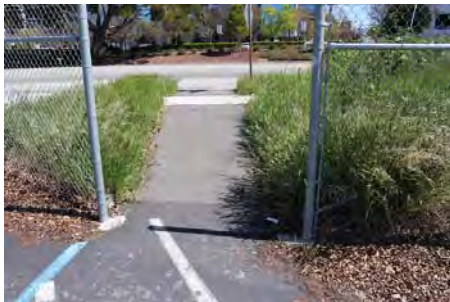
COD	CONDITION DESCRIPTION	ACTUAL
B03	Running slope is 1:12 (8.33%) max. (ADAS 405.2)	Up to 9.0%, running slope undulates from high to low and surface is not planar.
B31	Handrails are provided at both sides (ADA: except at ramp with max 6" rise / 72" run) (CBC: except adjacent to assembly seating, or at door landing ramp with max 6" rise / 72" run). (ADAS 405.8)	None, approx. 12' long.

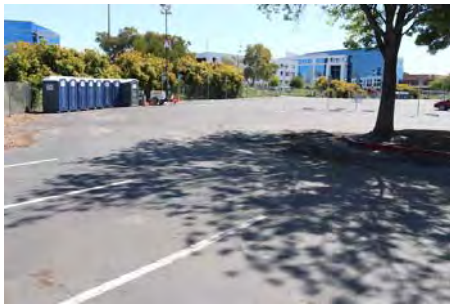
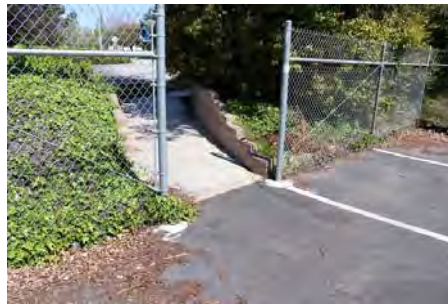
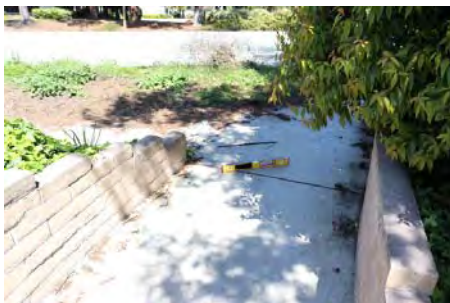
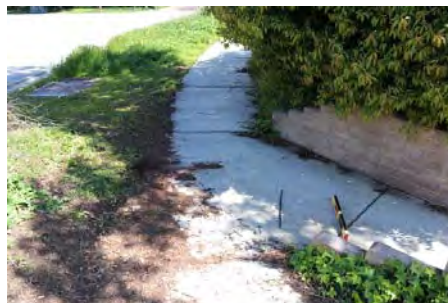
COD	CONDITION DESCRIPTION	ACTUAL
B04	Cross slope of ramp is 1:48 (2.08%) max. (ADAS 405.3)	Cross slope is 4.0% at the top.
B12	Landings are sloped 1:48 (2.08%) max. and are firm, stable and slip resistant without gaps or edges. (ADAS 405.7.1)	Btm. Landing is 3.9%, top landing is 5.0% and top landing partially covered by debris.
B14	Top landing is min. 60" long. (ADAS 405.7.3)	Top landing is 48".
B31	Handrails are provided at both sides (ADA: except at ramp with max 6" rise / 72" run) (CBC: except adjacent to assembly seating, or at door landing ramp with max 6" rise / 72" run). (ADAS 405.8)	None, approx. 12' long.
