Case No. 5:16-cv-07013-LHK (SVK)

**DECLARATION OF JEFFREY SCOTT  
MASTIN IN SUPPORT OF PLAINTIFFS'  
MOTION FOR CLASS CERTIFICATION**

NEVAREZ V 49ERS - ACCESSIBILITY ASSESSMENT

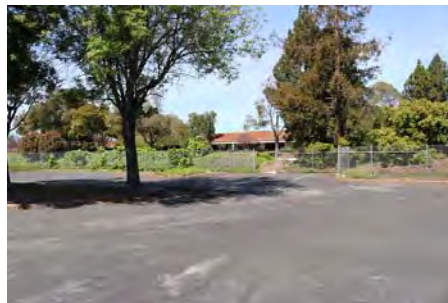
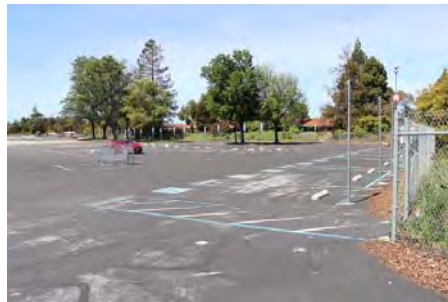
COD	CONDITION DESCRIPTION	ACTUAL
A5	Acc parking stalls are located on the shortest ACC route from parking to ACC entrance. (ADAS 208.3.1)	Many standard stalls are closer to both walkways to the public right of way, at the E side and the N side, than are some of the DAS.

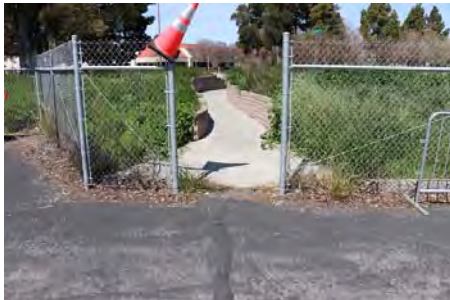
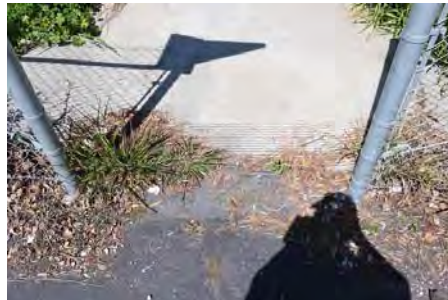
COD	CONDITION DESCRIPTION	ACTUAL
B03	Running slope is 1:12 (8.33%) max. (ADAS 405.2)	Up to 11.1%.
B12	Landings are sloped 1:48 (2.08%) max. and are firm, stable and slip resistant without gaps or edges. (ADAS 405.7.1)	Vegetation at the btm. transition. Top landing 3.1%.

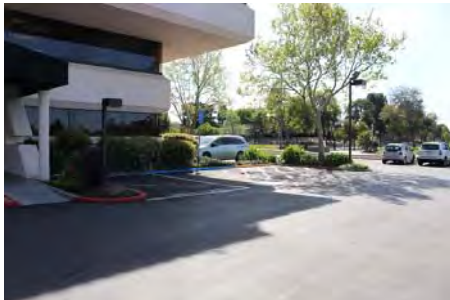
COD	CONDITION DESCRIPTION	ACTUAL
B41	Stall is located as close as practical to entrance. (ADAS 208.3.1)	Many other standard stalls closer to routes to the public right of way.
C42	Accessible route from stall does not pass behind other parked cars. (2013 CBC 11B-502.7.1).	Must pass behind other vehicles.

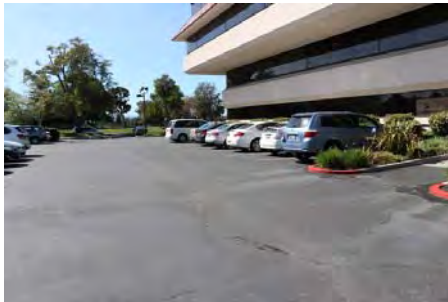
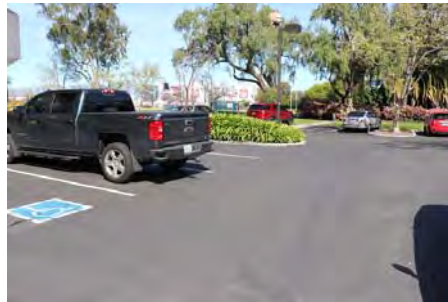
COD	CONDITION DESCRIPTION	ACTUAL
B41	Stall is located as close as practical to entrance. (ADAS 208.3.1)	Many other standard stalls closer to routes to the public right of way.
C42	Accessible route from stall does not pass behind other parked cars. (2013 CBC 11B-502.7.1).	Must pass behind other vehicles.

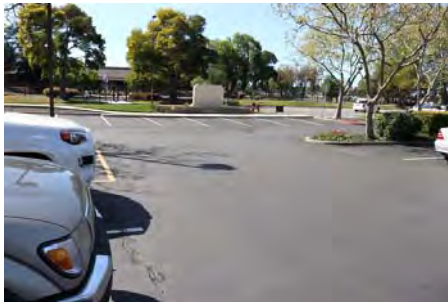
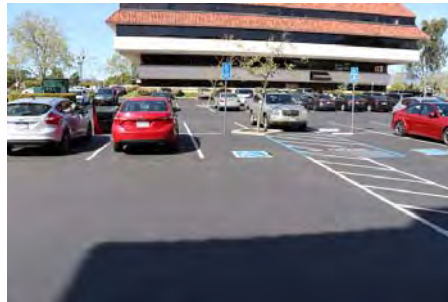
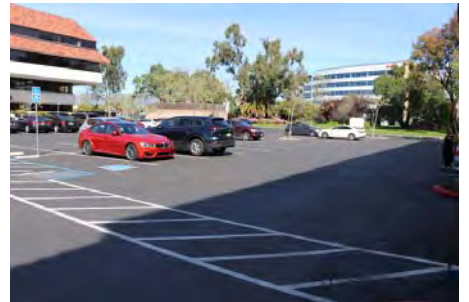
COD	CONDITION DESCRIPTION	ACTUAL
B41	Stall is located as close as practical to entrance. (ADAS 208.3.1)	Many other standard stalls closer to routes to the public right of way.
C42	Accessible route from stall does not pass behind other parked cars. (2013 CBC 11B-502.7.1).	Must pass behind other vehicles.

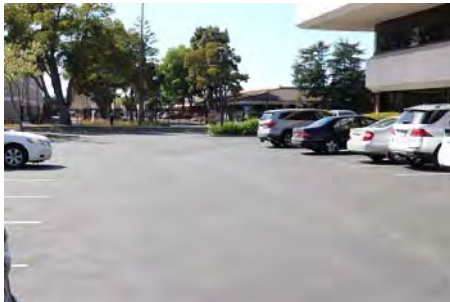
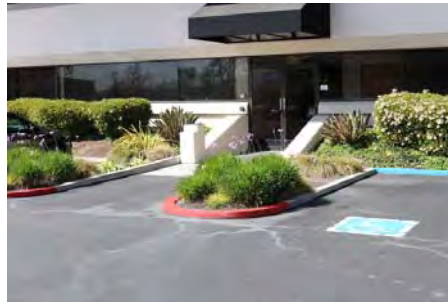
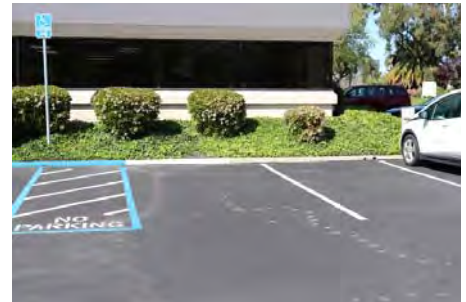
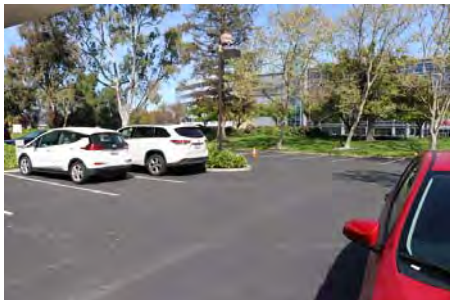
COD	CONDITION DESCRIPTION	ACTUAL
B41	Stall is located as close as practical to entrance. (ADAS 208.3.1)	Many other standard stalls closer to routes to the public right of way.
C42	Accessible route from stall does not pass behind other parked cars. (2013 CBC 11B-502.7.1).	Must pass behind other vehicles.

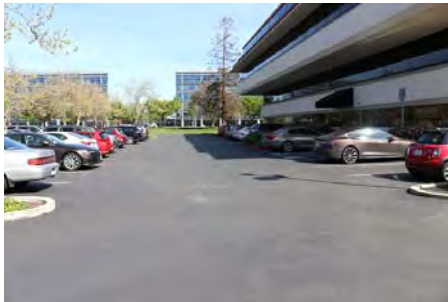
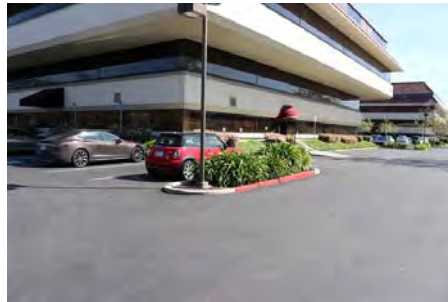
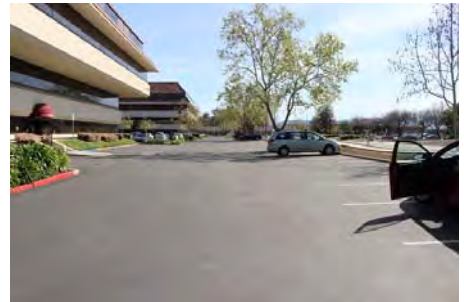
COD	CONDITION DESCRIPTION	ACTUAL
B41	Stall is located as close as practical to entrance. (ADAS 208.3.1)	Many other standard stalls closer to routes to the public right of way.
C42	Accessible route from stall does not pass behind other parked cars. (2013 CBC 11B-502.7.1).	Must pass behind other vehicles.

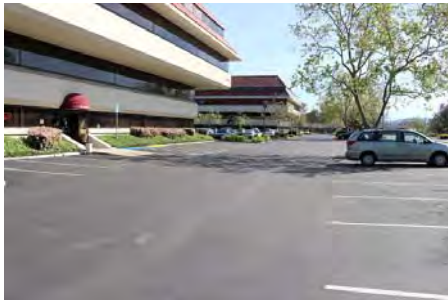
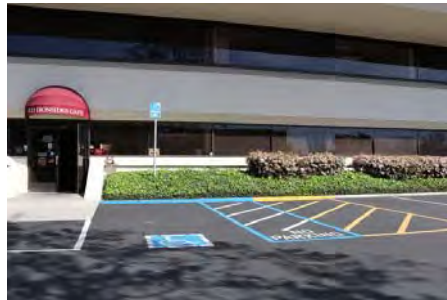
COD	CONDITION DESCRIPTION	ACTUAL
B41	Stall is located as close as practical to entrance. (ADAS 208.3.1)	Many other standard stalls closer to routes to the public right of way.
C42	Accessible route from stall does not pass behind other parked cars. (2013 CBC 11B-502.7.1).	Must pass behind other vehicles.

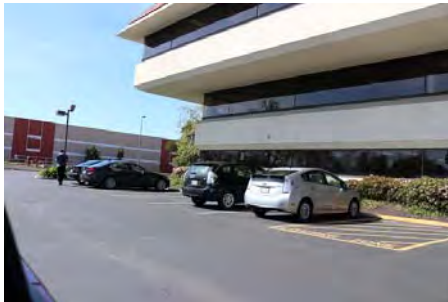
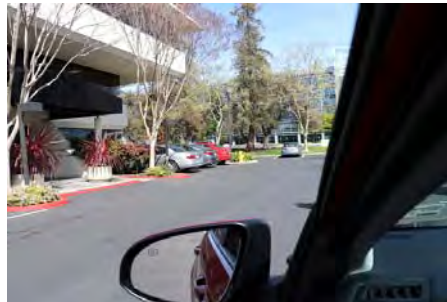
COD	CONDITION DESCRIPTION	ACTUAL
B41	Stall is located as close as practical to entrance. (ADAS 208.3.1)	Many other standard stalls closer to routes to the public right of way.
C42	Accessible route from stall does not pass behind other parked cars. (2013 CBC 11B-502.7.1).	Must pass behind other vehicles.

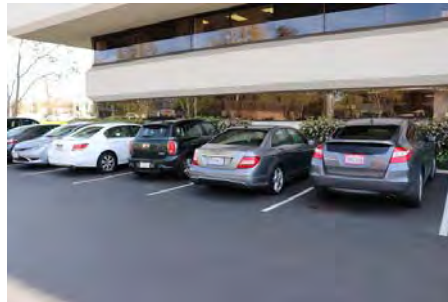
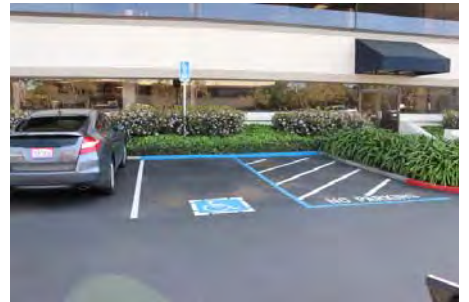
COD	CONDITION DESCRIPTION	ACTUAL
B41	Stall is located as close as practical to entrance. (ADAS 208.3.1)	Many other standard stalls closer to routes to the public right of way.
C42	Accessible route from stall does not pass behind other parked cars. (2013 CBC 11B-502.7.1).	Must pass behind other vehicles.

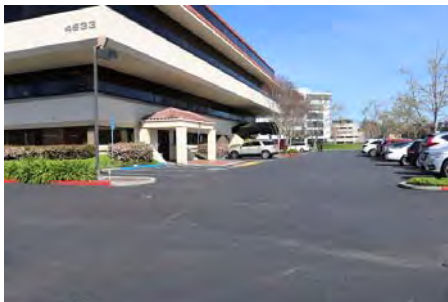
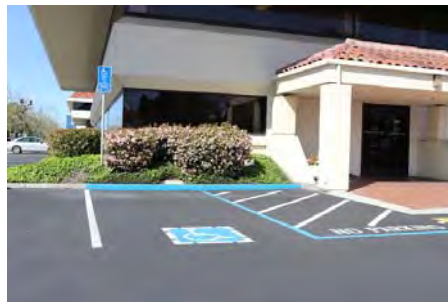
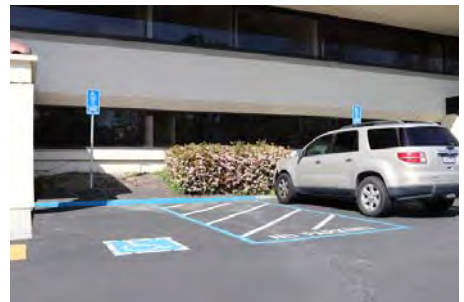
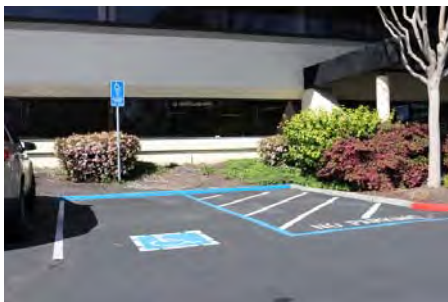
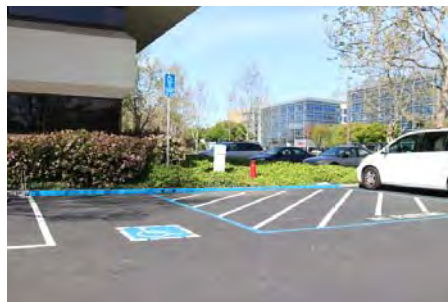
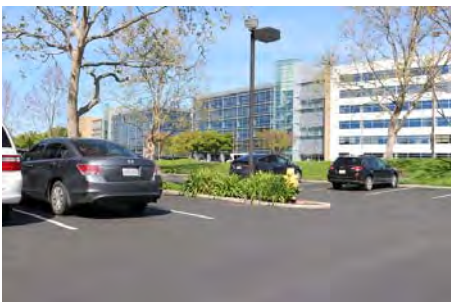
COD	CONDITION DESCRIPTION	ACTUAL
B41	Stall is located as close as practical to entrance. (ADAS 208.3.1)	Many other standard stalls closer to routes to the public right of way.
C42	Accessible route from stall does not pass behind other parked cars. (2013 CBC 11B-502.7.1).	Must pass behind other vehicles.

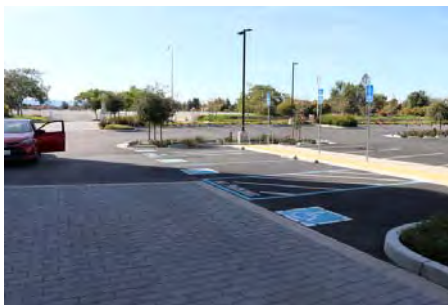
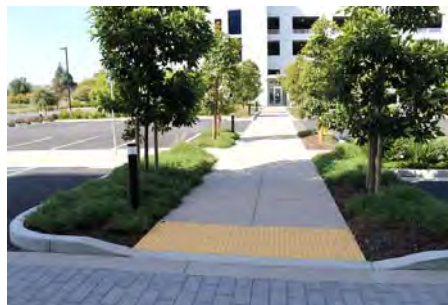
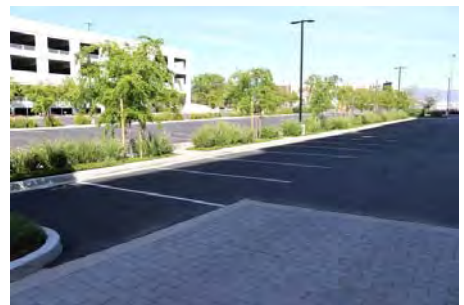
COD	CONDITION DESCRIPTION	ACTUAL
B41	Stall is located as close as practical to entrance. (ADAS 208.3.1)	Many standard spaces are closer to the public right of way.

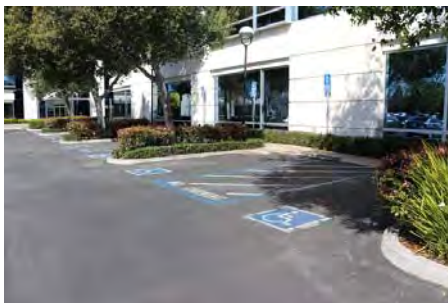
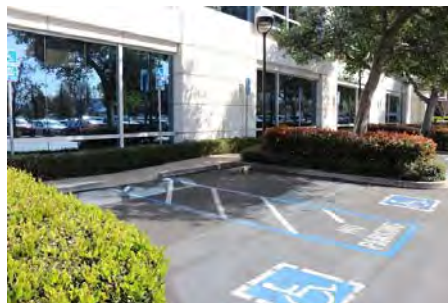
COD	CONDITION DESCRIPTION	ACTUAL
B41	Stall is located as close as practical to entrance. (ADAS 208.3.1)	Many spaces are closer to the public right of way.

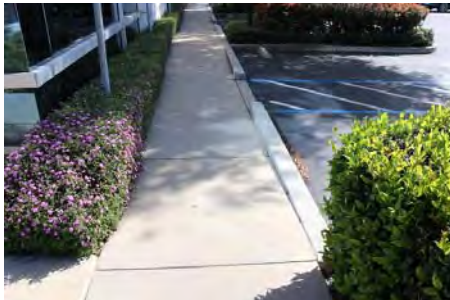
COD	CONDITION DESCRIPTION	ACTUAL
B04	Cross slope is 1:48 (2.08%) max. (ADAS 405.3)	3.5%
C12	Turning space at bottom of curb ramp slopes 1:48 (2.08%) max. in any direction (ADAS 403.3)	3.1%

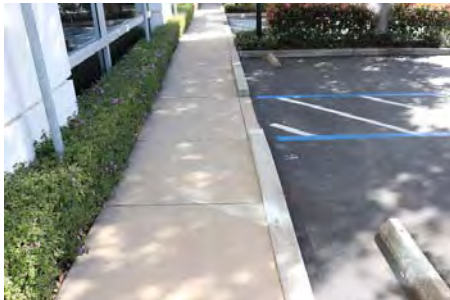
COD	CONDITION DESCRIPTION	ACTUAL
B04	Cross slope is 1:48 (2.08%) max. (ADAS 405.3)	3.2% at N ramp, 2.8% at S ramp.
C12	Turning space at bottom of curb ramp slopes 1:48 (2.08%) max. in any direction (ADAS 403.3)	3.0%

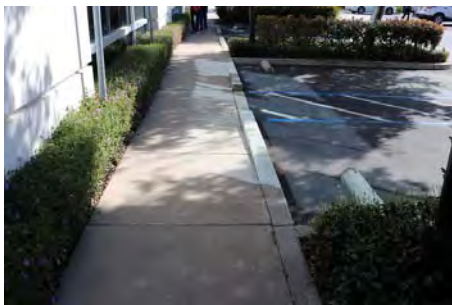
<b>COD</b>	<b>CONDITION DESCRIPTION</b>	<b>ACTUAL</b>
B04	Cross slope is 1:48 (2.08%) max. (ADAS 405.3)	3.0% at S ramp.

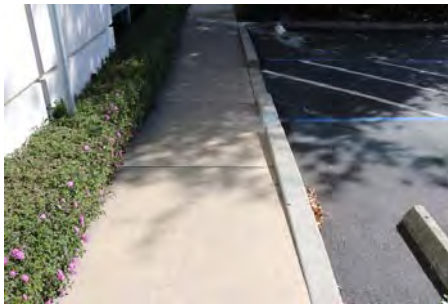
COD	CONDITION DESCRIPTION	ACTUAL
C12	Turning space at bottom of curb ramp slopes 1:48 (2.08%) max. in any direction (ADAS 403.3)	3.2%

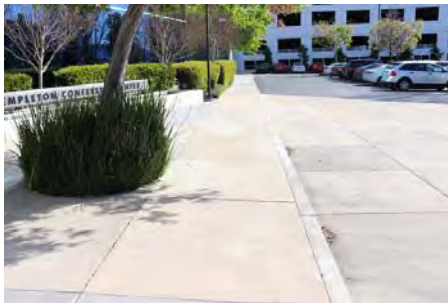
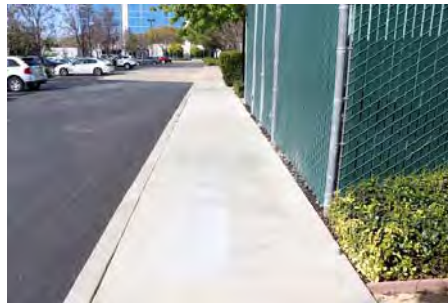
COD	CONDITION DESCRIPTION	ACTUAL
B16	Cross slope (perpendicular to direction of travel) is 1:48 (2.08%) max. (ADAS 403.3)	Approx. 120' L is 3.5% to 5.4%.

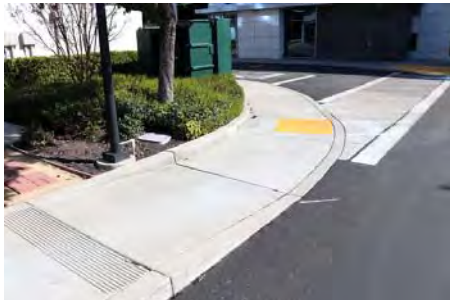
COD	CONDITION DESCRIPTION	ACTUAL
B04	Cross slope is 1:48 (2.08%) max. (ADAS 405.3)	3.0% at N ramp.
C12	Turning space at bottom of curb ramp slopes 1:48 (2.08%) max. in any direction (ADAS 403.3)	3.2%.

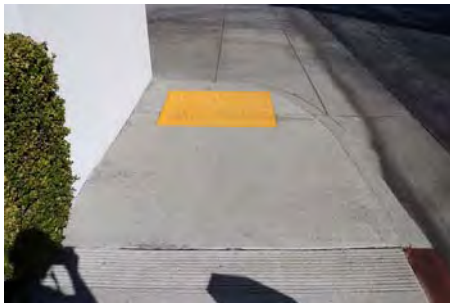
<b>COD</b>	<b>CONDITION DESCRIPTION</b>	<b>ACTUAL</b>
B04	Cross slope of ramp is 1:48 (2.08%). (ADAS 405.3)	3.8%

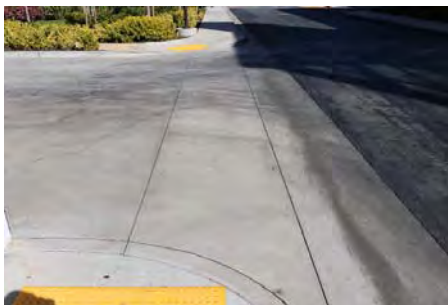
COD	CONDITION DESCRIPTION	ACTUAL
B16	Cross slope (perpendicular to direction of travel) is 1:48 (2.08%) max. (ADAS 403.3)	Approx. 20' L is 3.1% to 4.4%.

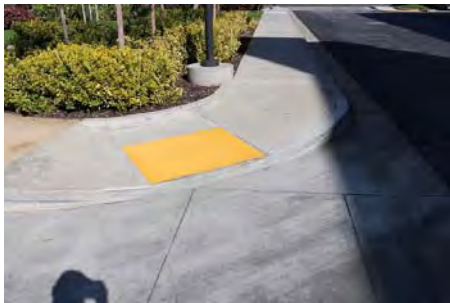
COD	CONDITION DESCRIPTION	ACTUAL
B03	Running slope is 1:12 (8.33%) max. (ADAS 405.2)	16.1% at N ramp.

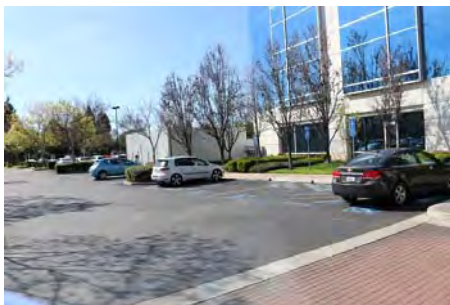
<b>COD</b>	<b>CONDITION DESCRIPTION</b>	<b>ACTUAL</b>
B41	Stall is located as close as practical to entrance. (ADAS 208.3.1)	Many standard spaces are closer to the public right of way.

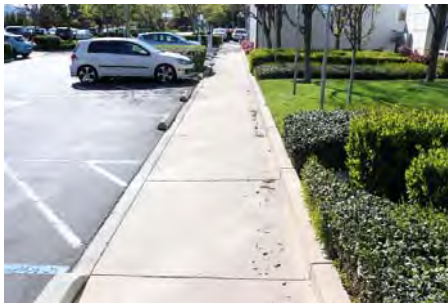
COD	CONDITION DESCRIPTION	ACTUAL
B16	Cross slope (perpendicular to direction of travel) is 1:48 (2.08%) max. (ADAS 403.3)	Approx. 80' L is 2.6% to 3.8%.

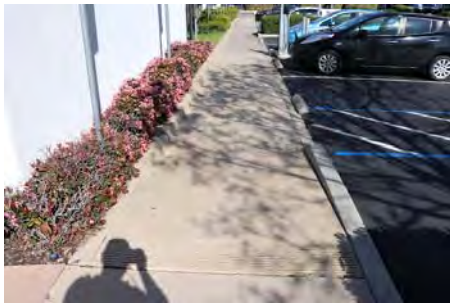
COD	CONDITION DESCRIPTION	ACTUAL
B04	Cross slope of ramp is 1:48 (2.08%). (ADAS 405.3)	2.6% to 3.7%.

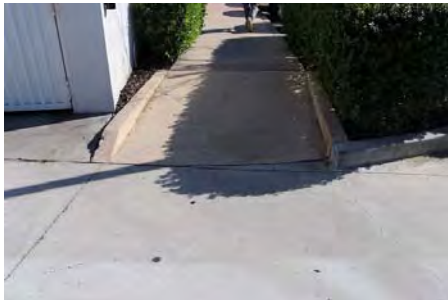
COD	CONDITION DESCRIPTION	ACTUAL
B03	Running slope of ramp is 1:12 (8.33%) max. (ADAS 405.2)	8.8% to 10.4%.
B04	Cross slope of ramp is 1:48 (2.08%). (ADAS 405.3)	3.1%

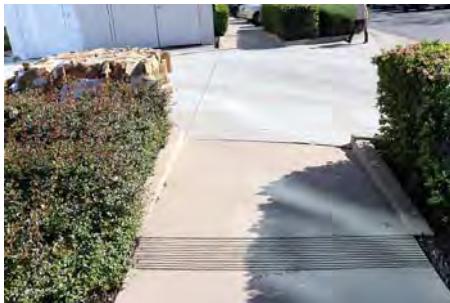
COD	CONDITION DESCRIPTION	ACTUAL
B16	Cross slope (perpendicular to direction of travel) is 1:48 (2.08%) max. (ADAS 403.3)	4.0%.

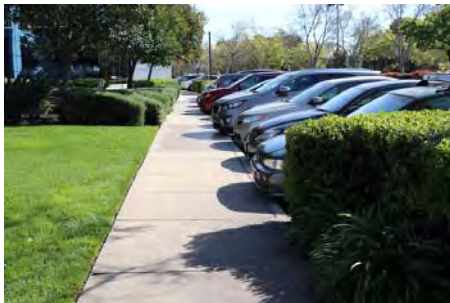
COD	CONDITION DESCRIPTION	ACTUAL
B16	Cross slope (perpendicular to direction of travel) is 1:48 (2.08%) max. (ADAS 403.3)	Approx. 100' L is 2.6% to 4.0%.

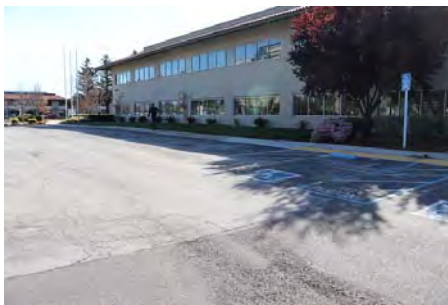
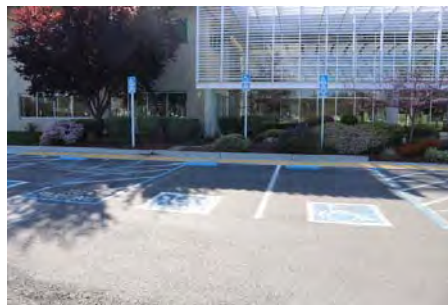
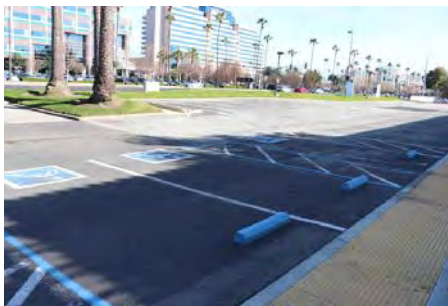
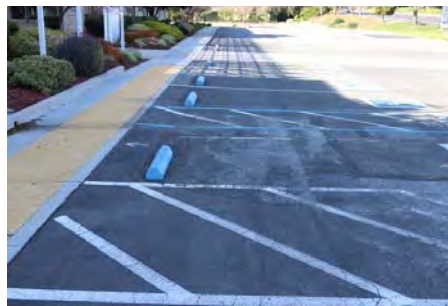
COD	CONDITION DESCRIPTION	ACTUAL
B31	Slopes do not exceed 1:48 (2.08%). (ADAS 502.4)	3.8% to 4.1% at head end of stalls and access aisle.

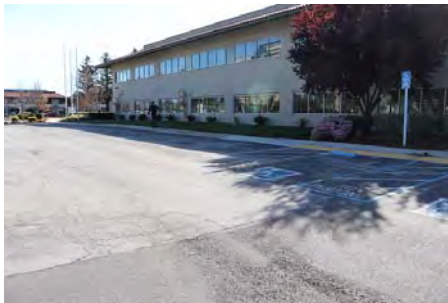
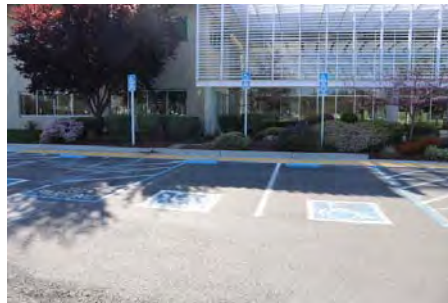
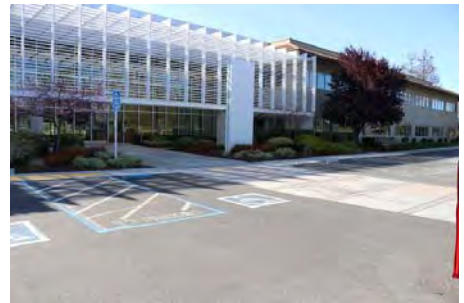
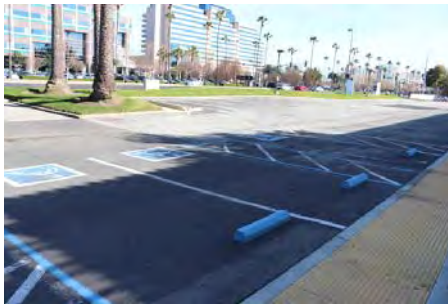
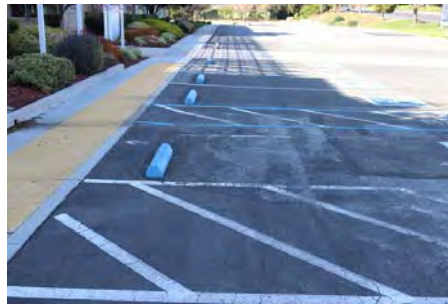
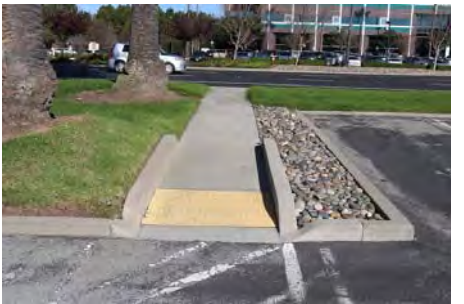
COD	CONDITION DESCRIPTION	ACTUAL
B31	Slopes do not exceed 1:48 (2.08%). (ADAS 502.4)	3.6% to 5.4% at head end of stalls and access aisle.

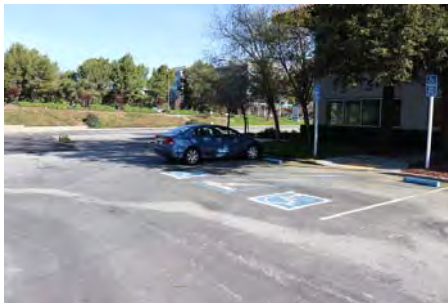
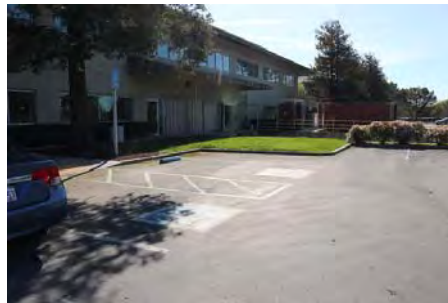
COD	CONDITION DESCRIPTION	ACTUAL
B41	Stall is located as close as practical to entrance. (ADAS 208.3.1)	Many other standard stalls are closer to routes to the public right of way.

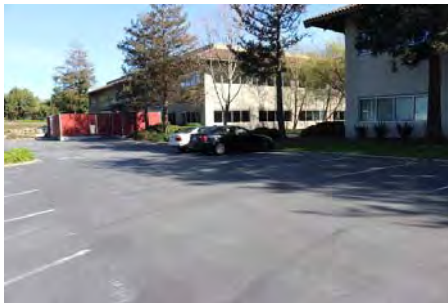
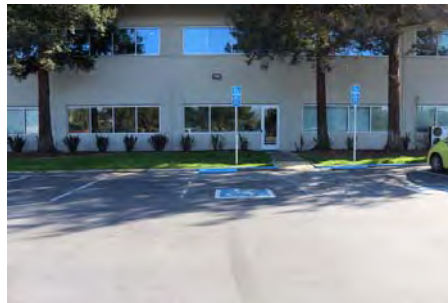
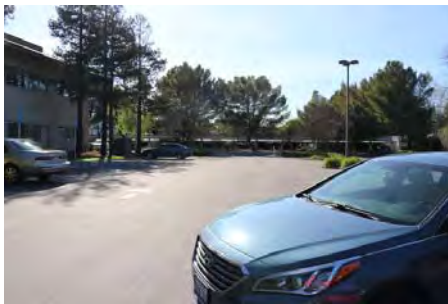
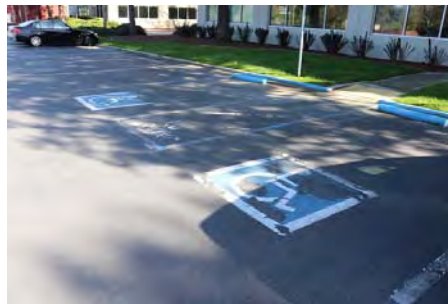
**FACILITY/SITE:** 18. Red Lot 3  
**FEATURE:** #5 PARKING STALL

COD	CONDITION DESCRIPTION	ACTUAL
B41	Stall is located as close as practical to entrance. (ADAS 208.3.1)	Many other standard stalls are closer to routes to the public right of way.

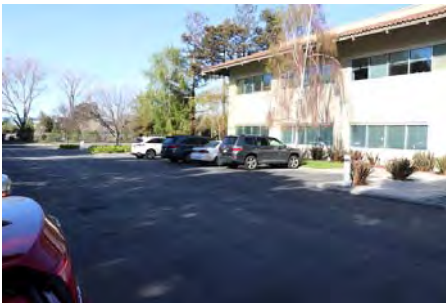
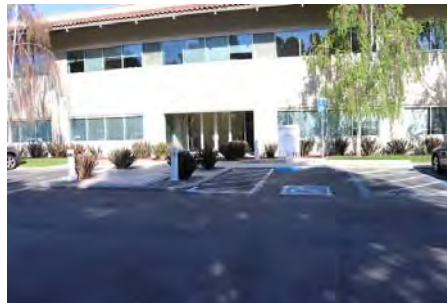
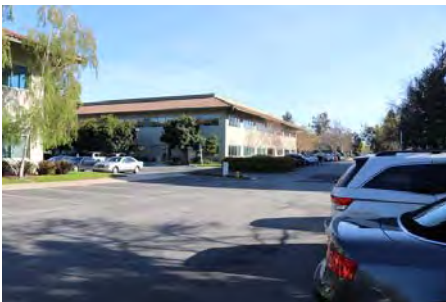
**FACILITY/SITE:** 18. Red Lot 3  
**FEATURE:** #5 PARKING STALL

COD	CONDITION DESCRIPTION	ACTUAL
B41	Stall is located as close as practical to entrance. (ADAS 208.3.1)	Many other standard stalls are closer to routes to the public right of way.

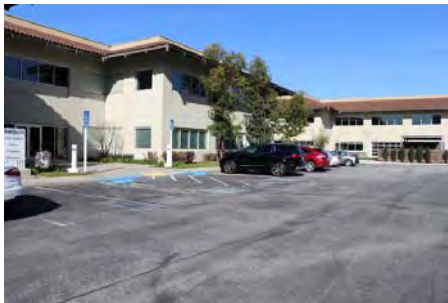
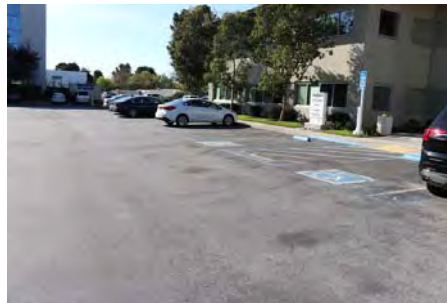
**FACILITY/SITE:** 18. Red Lot 3  
**FEATURE:** #5 PARKING STALL

COD	CONDITION DESCRIPTION	ACTUAL
B41	Stall is located as close as practical to entrance. (ADAS 208.3.1)	Many other standard stalls are closer to routes to the public right of way.

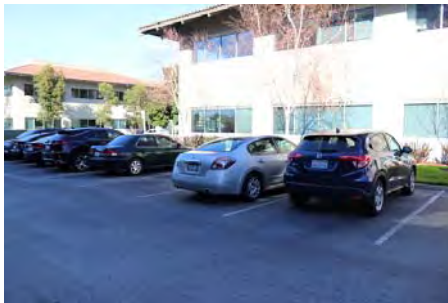
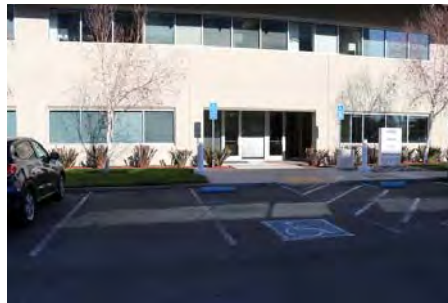
**FACILITY/SITE:** 18. Red Lot 3  
**FEATURE:** #5 PARKING STALL

COD	CONDITION DESCRIPTION	ACTUAL
B41	Stall is located as close as practical to entrance. (ADAS 208.3.1)	Many other standard stalls are closer to routes to the public right of way.

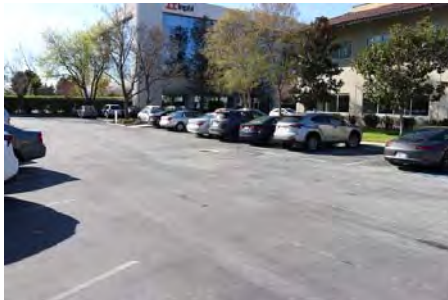
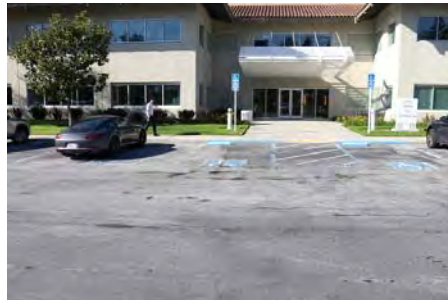
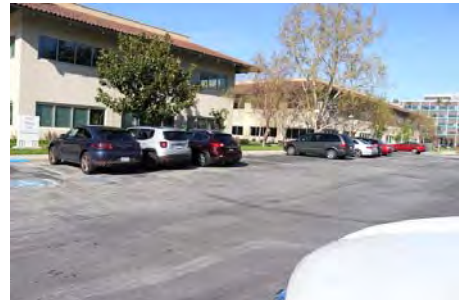
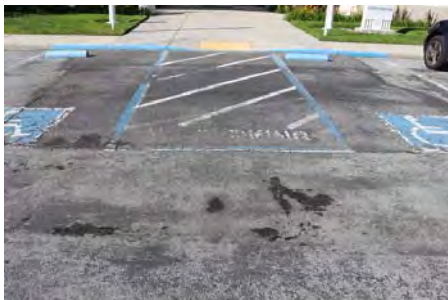
**FACILITY/SITE:** 18. Red Lot 3  
**FEATURE:** #5 PARKING STALL

COD	CONDITION DESCRIPTION	ACTUAL
B11	Parking space is marked to define a width of min.8' wide (9' CBC). (ADAS 502.2)	Markings worn and faded.
B41	Stall is located as close as practical to entrance. (ADAS 208.3.1)	Many other standard stalls are closer to routes to the public right of way.

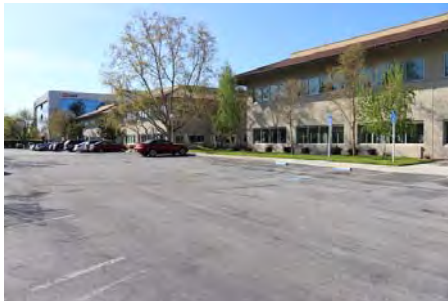
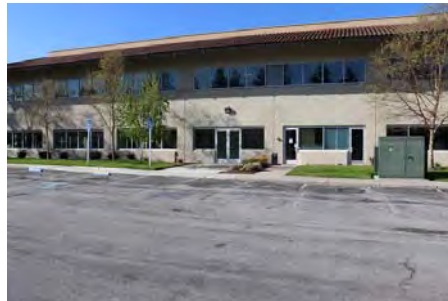
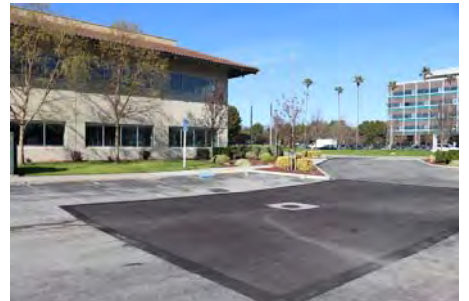
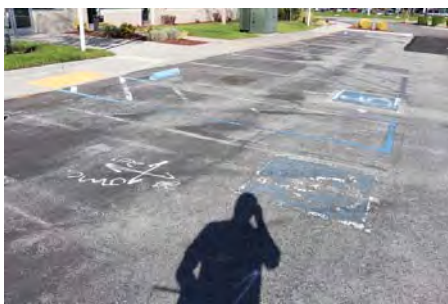
**FACILITY/SITE: 18. Red Lot 3**  
**FEATURE: #5 PARKING STALL**

COD	CONDITION DESCRIPTION	ACTUAL
B11	Parking space is marked to define a width of min.8' wide (9' CBC). (ADAS 502.2)	Markings worn and faded.
B23	Access aisle is marked to discourage parking -in California: with "NO PARKING" in white with min. 12" high letters located at tail end of access aisle. (ADAS 502.3.3)	Markings worn and faded.
B31	Slopes do not exceed 1:48 (2.08%). (ADAS 502.4)	3.3% at access aisle.
B41	Stall is located as close as practical to entrance. (ADAS 208.3.1)	Many other standard stalls are closer to routes to the public right of way.

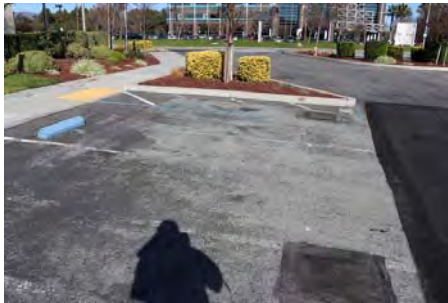
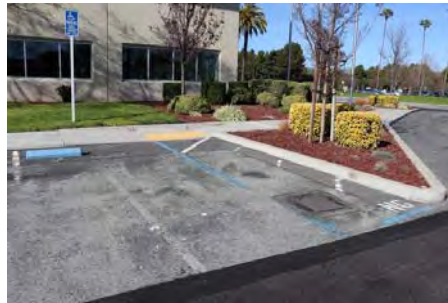
**FACILITY/SITE:** 18. Red Lot 3  
**FEATURE:** #5 PARKING STALL

COD	CONDITION DESCRIPTION	ACTUAL
B11	Parking space is marked to define a width of min.8' wide (9' CBC). (ADAS 502.2)	Markings worn and faded.
B23	Access aisle is marked to discourage parking -in California: with "NO PARKING" in white with min. 12" high letters located at tail end of access aisle. (ADAS 502.3.3)	Markings worn and faded.
B31	Slopes do not exceed 1:48 (2.08%). (ADAS 502.4)	5.5%
B41	Stall is located as close as practical to entrance. (ADAS 208.3.1)	Many other standard stalls are closer to routes to the public right of way.

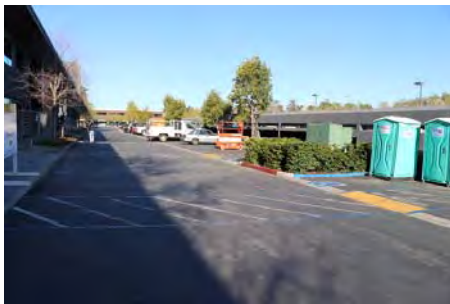
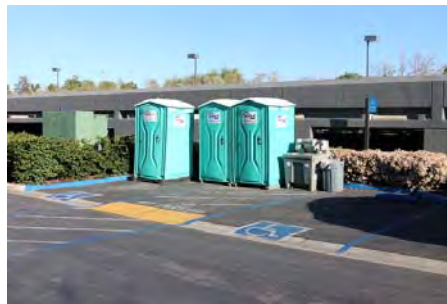
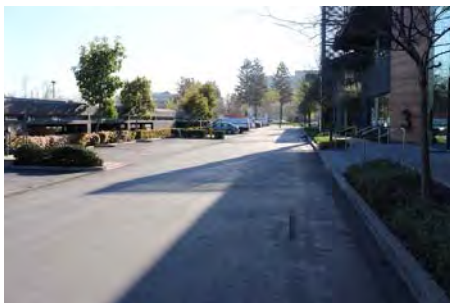
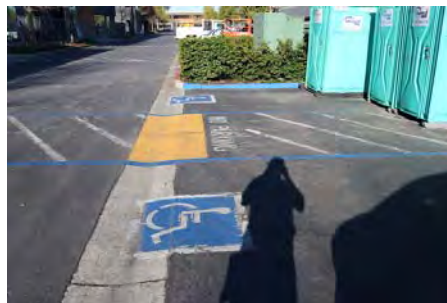
COD	CONDITION DESCRIPTION	ACTUAL
B11	Parking space is marked to define a width of min.8' wide (9' CBC). (ADAS 502.2)	Obstructed by portable toilet.
B12	Access aisle is marked to define a width of min. 5' wide. (ADAS 502..3.1)	Obstructed by portable toilet.
B31	Slopes do not exceed 1:48 (2.08%). (ADAS 502.4)	18.5% at tail end of stalls and access aisles at swale.
B32	Stall & access aisle has no gaps or changes in level and is firm, stable and slip resistant. (ADAS 502.4)	Detectable warnings placed in the access aisle which are unnecessary.
B41	Stall is located as close as practical to entrance. (ADAS 208.3.1)	Many other standard stalls are closer to routes to the public right of way.
C42	Accessible route from stall does not pass behind other parked cars. (2013 CBC 11B-502.7.1).	Must pass behind other vehicles en route to the public right of way.

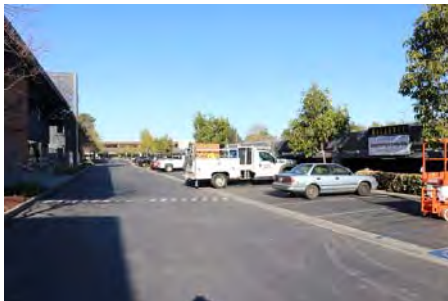
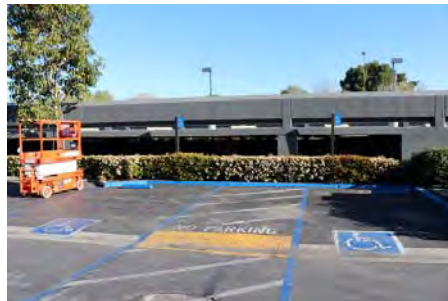
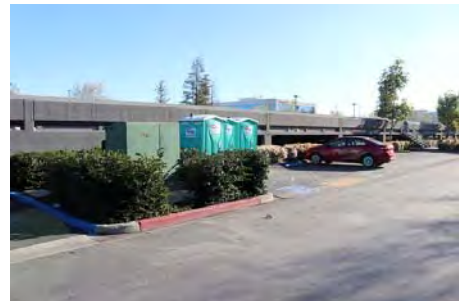
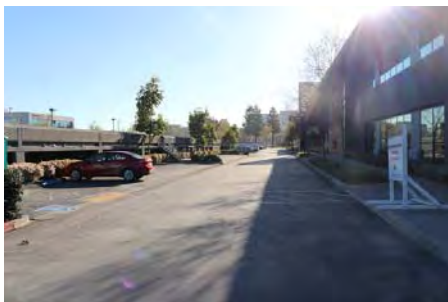
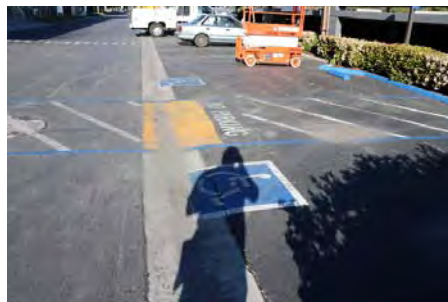
FACILITY/SITE: 19. Red Lot 4  
FEATURE: #5 PARKING STALL

COD	CONDITION DESCRIPTION	ACTUAL
B31	Slopes do not exceed 1:48 (2.08%). (ADAS 502.4)	15.4% at tail end of stalls and access aisles at swale.
B32	Stall & access aisle has no gaps or changes in level and is firm, stable and slip resistant. (ADAS 502.4)	Detectable warnings placed in the access aisle which are unnecessary.
B41	Stall is located as close as practical to entrance. (ADAS 208.3.1)	Many other standard stalls are closer to routes to the public right of way.
C42	Accessible route from stall does not pass behind other parked cars. (2013 CBC 11B-502.7.1).	Must pass behind other vehicles en route to the public right of way.

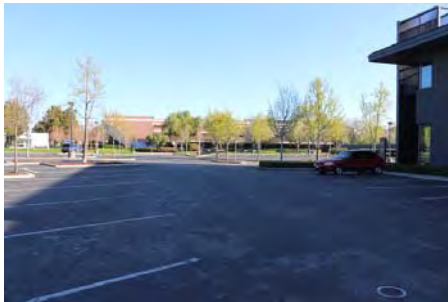
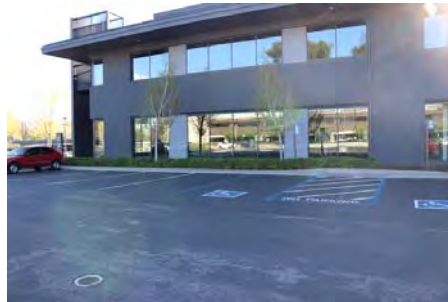
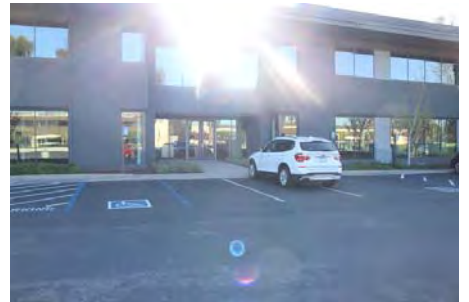
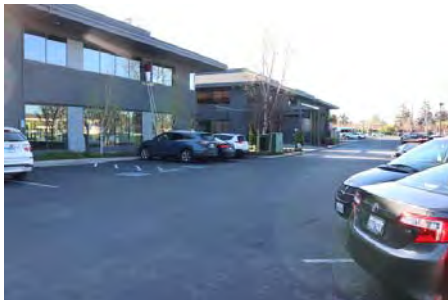
**FACILITY/SITE:** 19. Red Lot 4

COD	CONDITION DESCRIPTION	ACTUAL
B41	Stall is located as close as practical to entrance. (ADAS 208.3.1)	Many other standard stalls are closer to routes to the public right of way.
C42	Accessible route from stall does not pass behind other parked cars. (2013 CBC 11B-502.7.1).	Must pass behind other vehicles en route to the public right of way.

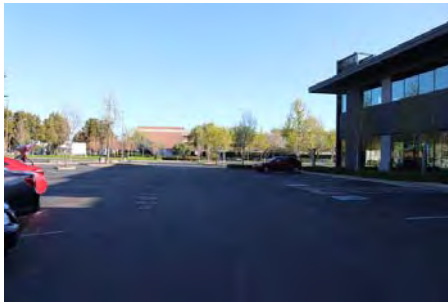
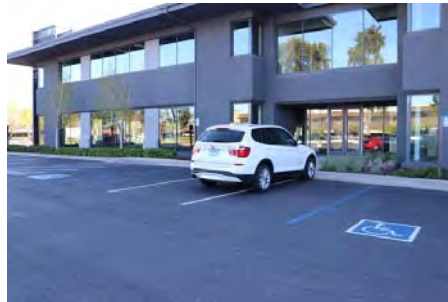
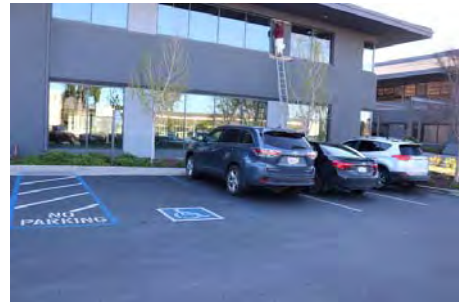
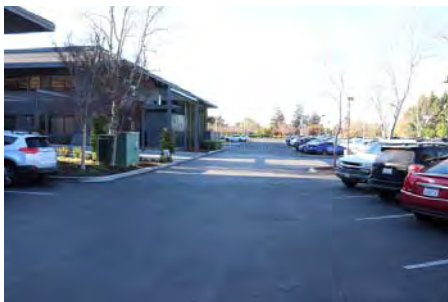
**FACILITY/SITE:** 19. Red Lot 4  
**FEATURE:** #5 PARKING STALL

COD	CONDITION DESCRIPTION	ACTUAL
B31	Slopes do not exceed 1:48 (2.08%). (ADAS 502.4)	6.7% at access aisle.
B41	Stall is located as close as practical to entrance. (ADAS 208.3.1)	Many other standard stalls are closer to routes to the public right of way.
C42	Accessible route from stall does not pass behind other parked cars. (2013 CBC 11B-502.7.1).	Must pass behind other vehicles en route to the public right of way.

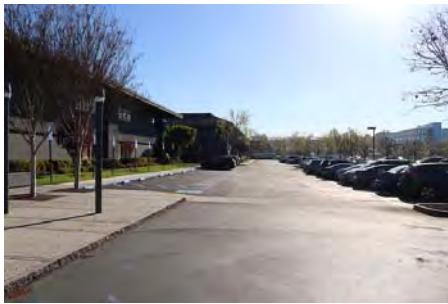
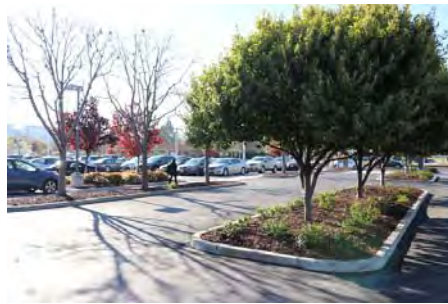
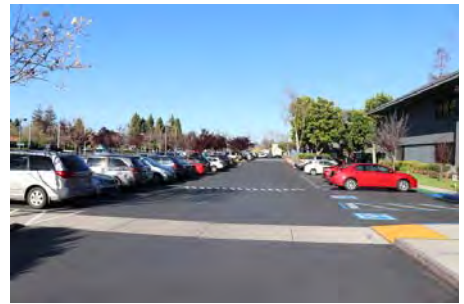
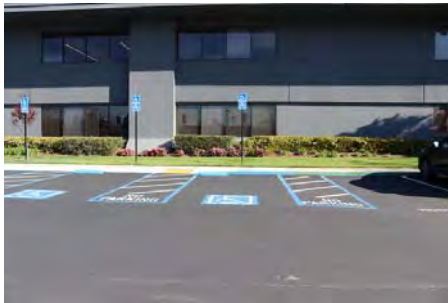
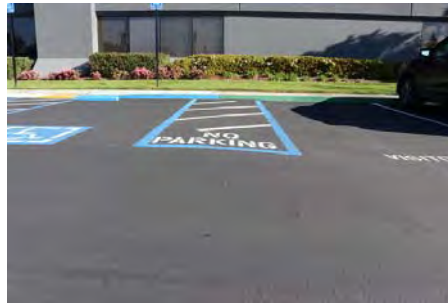
**FACILITY/SITE:** 19. Red Lot 4  
**FEATURE:** #5 PARKING STALL

COD	CONDITION DESCRIPTION	ACTUAL
B41	Stall is located as close as practical to entrance. (ADAS 208.3.1)	Many other standard stalls are closer to routes to the public right of way.
C42	Accessible route from stall does not pass behind other parked cars. (2013 CBC 11B-502.7.1).	Must pass behind other vehicles en route to the public right of way.

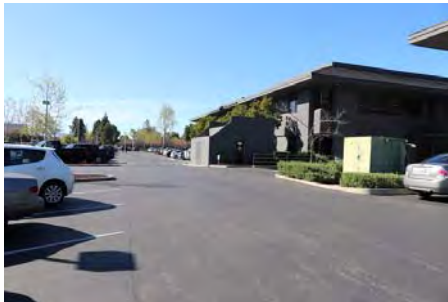
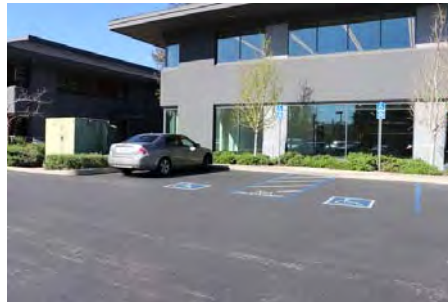
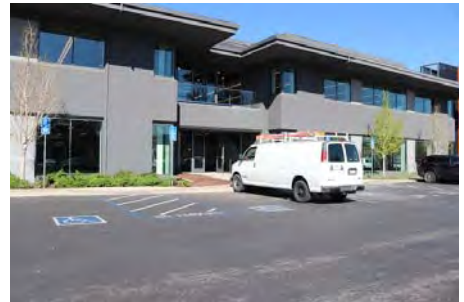
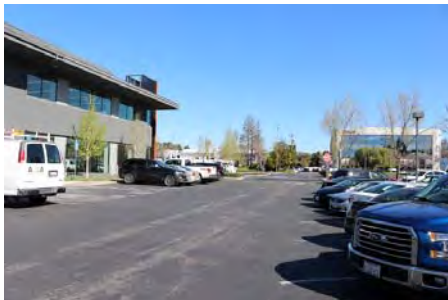
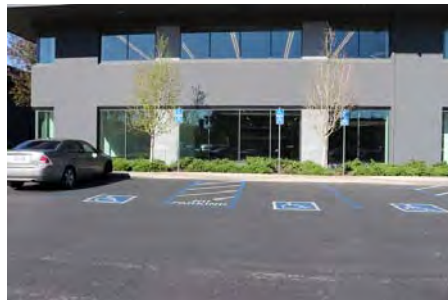
**FACILITY/SITE:** 19. Red Lot 4  
**FEATURE:** #5 PARKING STALL

COD	CONDITION DESCRIPTION	ACTUAL
B41	Stall is located as close as practical to entrance. (ADAS 208.3.1)	Many other standard stalls are closer to routes to the public right of way.
C42	Accessible route from stall does not pass behind other parked cars. (2013 CBC 11B-502.7.1).	Must pass behind other vehicles en route to the public right of way.

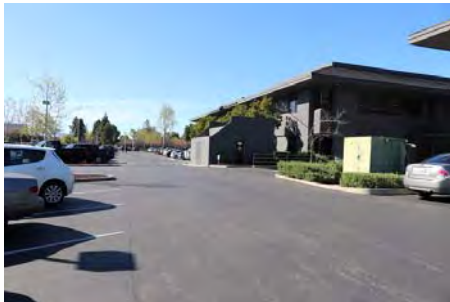
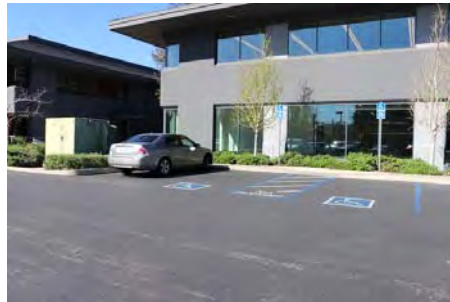
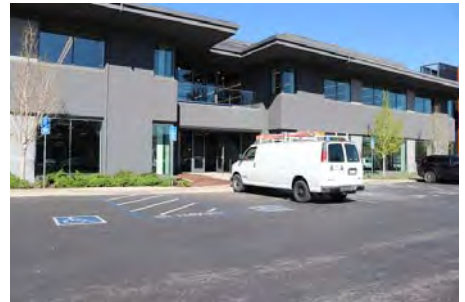
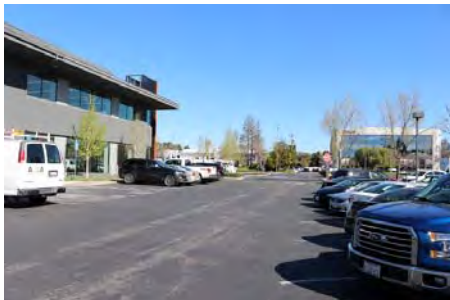
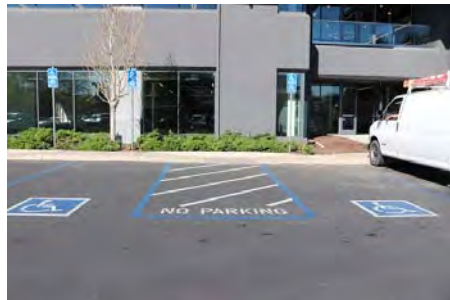
**FACILITY/SITE:** 19. Red Lot 4  
**FEATURE:** #5 PARKING STALL

COD	CONDITION DESCRIPTION	ACTUAL
B41	Stall is located as close as practical to entrance. (ADAS 208.3.1)	Many other standard stalls are closer to routes to the public right of way.
C42	Accessible route from stall does not pass behind other parked cars. (2013 CBC 11B-502.7.1).	Must pass behind other vehicles en route to the public right of way.

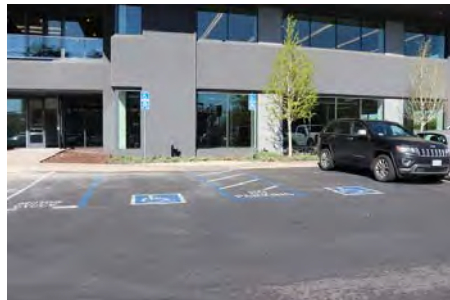
<b>FACILITY/SITE:</b> 19. Red Lot 4	<b>SEQ. #</b>	<b>1909</b>
<b>FEATURE:</b> #2 PARKING LOT

<b>COD</b>	<b>CONDITION DESCRIPTION</b>	<b>ACTUAL</b>
C10	Required number of acc stalls are provided as follows: 1-25=1, 26-50=2, 51-75=3, 76-100=4, 101-150=5, 151-200=6, 201-300=7, 301-400=8, 401-500=9, 501-1000=2% of total, 1001+=20+1 for each 100 over 1000. (ADAS 208.2)	17 required, 14 provided.

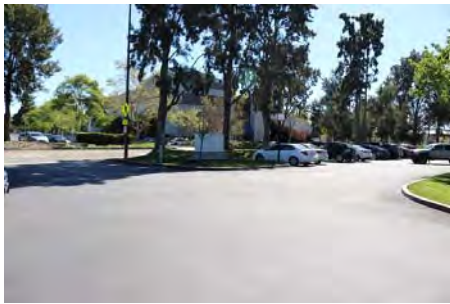
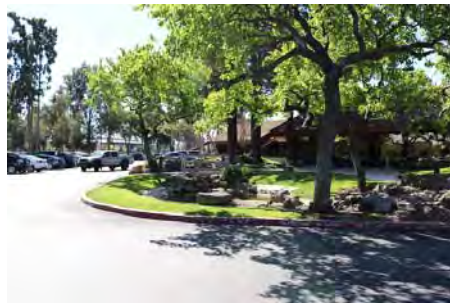
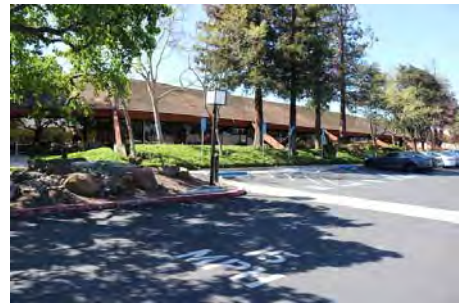
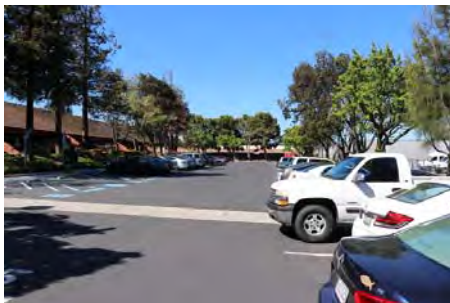
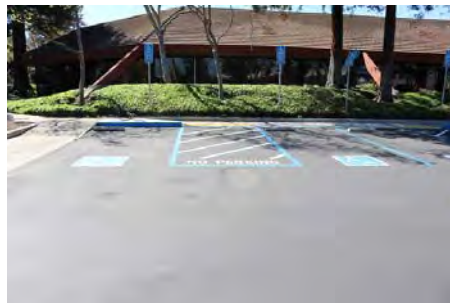
**FACILITY/SITE:** 20. Red Lot 5  
**FEATURE:** #5 PARKING STALL

COD	CONDITION DESCRIPTION	ACTUAL
B41	Stall is located as close as practical to entrance. (ADAS 208.3.1)	Many other standard stalls are closer to routes to the public right of way.
C42	Accessible route from stall does not pass behind other parked cars. (2013 CBC 11B-502.7.1).	Must pass behind other vehicles en route to the public right of way.

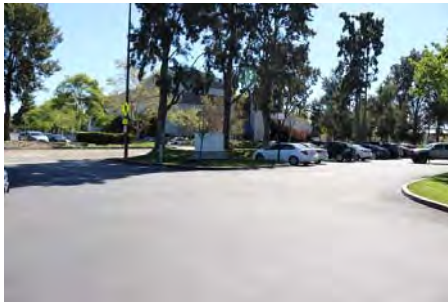
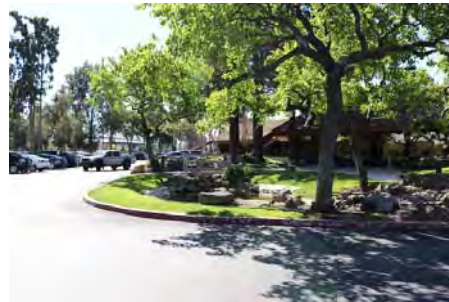
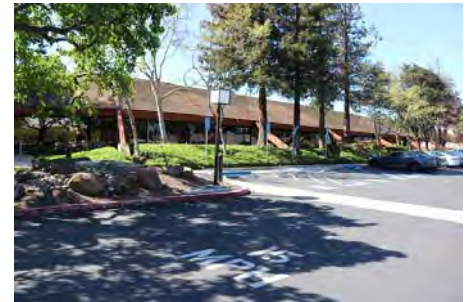
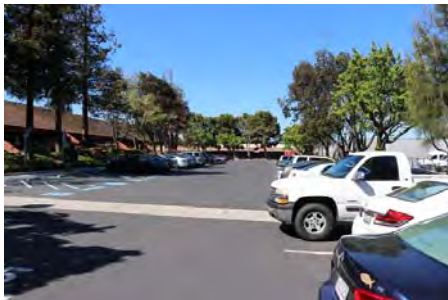
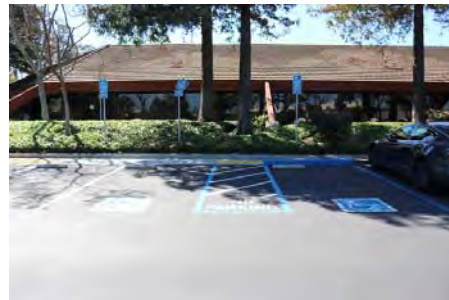
**FACILITY/SITE:** 20. Red Lot 5  
**FEATURE:** #5 PARKING STALL

COD	CONDITION DESCRIPTION	ACTUAL
B31	Slopes do not exceed 1:48 (2.08%). (ADAS 502.4)	Asphalt patch along entire length of S stall creates slopes up to 8.2%.
B32	Stall & access aisle has no gaps or changes in level and is firm, stable and slip resistant. (ADAS 502.4)	Asphalt patch across entire length of S stall creates depression over 1 1/2" deep.
B41	Stall is located as close as practical to entrance. (ADAS 208.3.1)	Many other standard stalls are closer to routes to the public right of way.
C42	Accessible route from stall does not pass behind other parked cars. (2013 CBC 11B-502.7.1).	Must pass behind other vehicles en route to the public right of way.

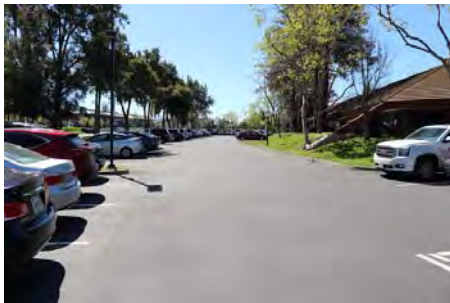
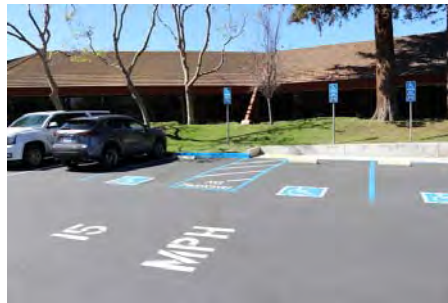
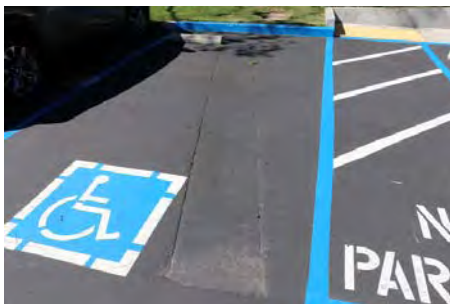
**FACILITY/SITE:** 20. Red Lot 5  
**FEATURE:** #5 PARKING STALL

COD	CONDITION DESCRIPTION	ACTUAL
B41	Stall is located as close as practical to entrance. (ADAS 208.3.1)	Many other standard stalls are closer to routes to the public right of way.
C42	Accessible route from stall does not pass behind other parked cars. (2013 CBC 11B-502.7.1).	Must pass behind other vehicles en route to the public right of way.

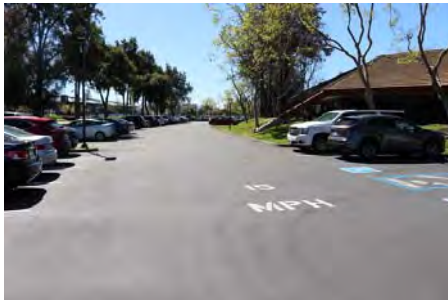
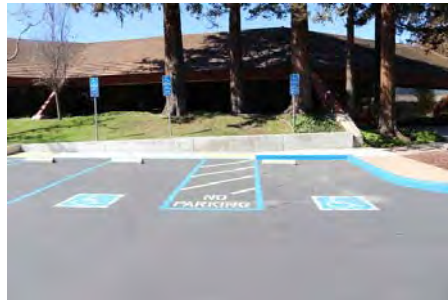
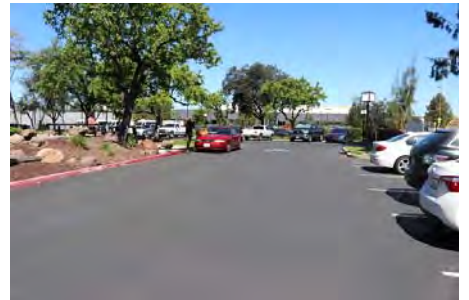
**FACILITY/SITE:** 20. Red Lot 5  
**FEATURE:** #5 PARKING STALL

COD	CONDITION DESCRIPTION	ACTUAL
B41	Stall is located as close as practical to entrance. (ADAS 208.3.1)	Many other standard stalls are closer to routes to the public right of way.
C42	Accessible route from stall does not pass behind other parked cars. (2013 CBC 11B-502.7.1).	Must pass behind other vehicles en route to the public right of way.

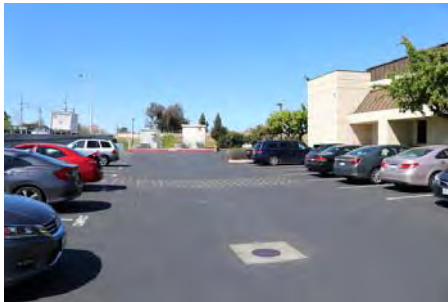
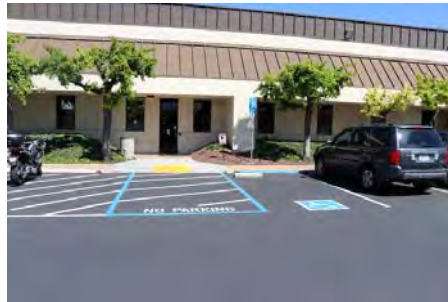
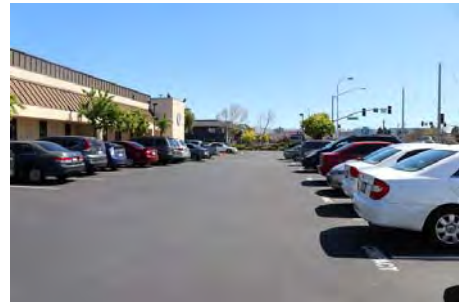
**FACILITY/SITE:** 20. Red Lot 5  
**FEATURE:** #5 PARKING STALL

COD	CONDITION DESCRIPTION	ACTUAL
B41	Stall is located as close as practical to entrance. (ADAS 208.3.1)	Many other standard stalls are closer to routes to the public right of way.
C42	Accessible route from stall does not pass behind other parked cars. (2013 CBC 11B-502.7.1).	Must pass behind other vehicles en route to the public right of way.
