Case No. 5:16-cv-07013-LHK (SVK)

**DECLARATION OF JEFFREY SCOTT  
MASTIN IN SUPPORT OF PLAINTIFFS'  
MOTION FOR CLASS CERTIFICATION**

NEVAREZ V 49ERS - ACCESSIBILITY ASSESSMENT

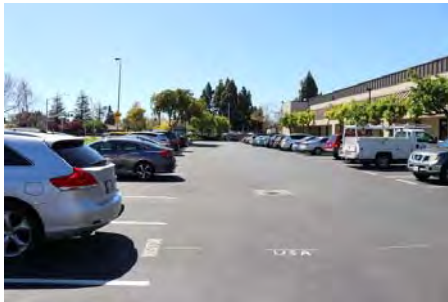
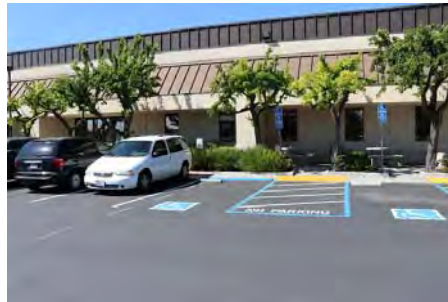
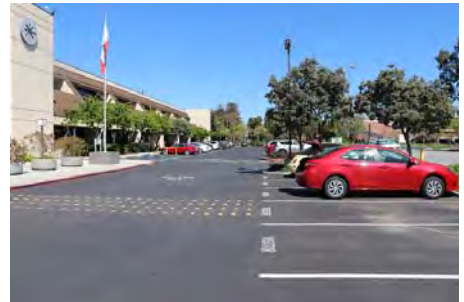
**FACILITY/SITE:** 20. Red Lot 5  
**FEATURE:** #5 PARKING STALL

COD	CONDITION DESCRIPTION	ACTUAL
B41	Stall is located as close as practical to entrance. (ADAS 208.3.1)	Many other standard stalls are closer to routes to the public right of way.
C42	Accessible route from stall does not pass behind other parked cars. (2013 CBC 11B-502.7.1).	Must pass behind other vehicles en route to the public right of way.

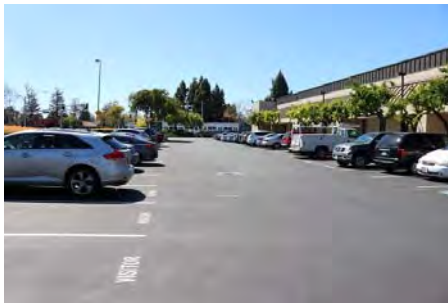
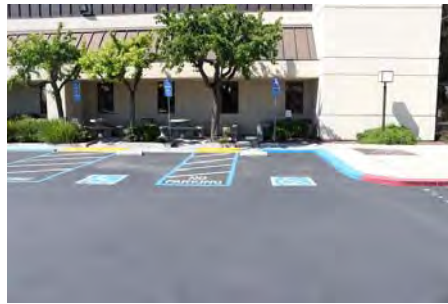
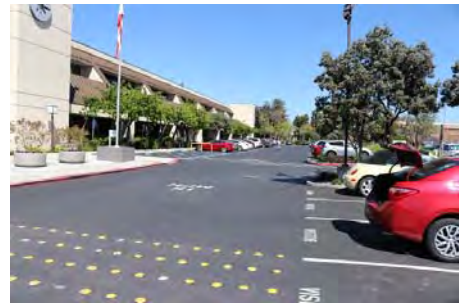
**FACILITY/SITE:** 20. Red Lot 5  
**FEATURE:** #5 PARKING STALL

COD	CONDITION DESCRIPTION	ACTUAL
B31	Slopes do not exceed 1:48 (2.08%). (ADAS 502.4)	Up to 7.8% at N stall.
B41	Stall is located as close as practical to entrance. (ADAS 208.3.1)	Many other standard stalls are closer to routes to the public right of way.
C42	Accessible route from stall does not pass behind other parked cars. (2013 CBC 11B-502.7.1).	Must pass behind other vehicles en route to the public right of way.

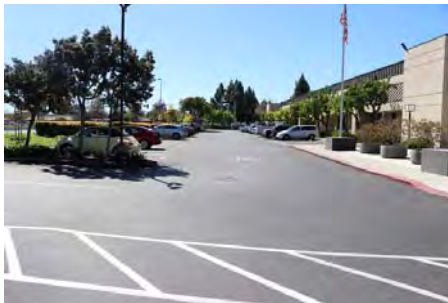
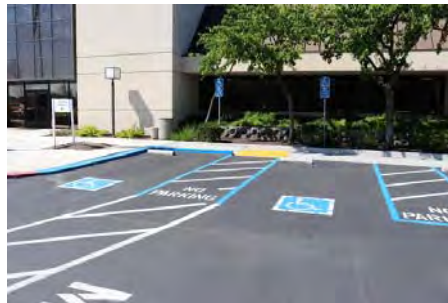
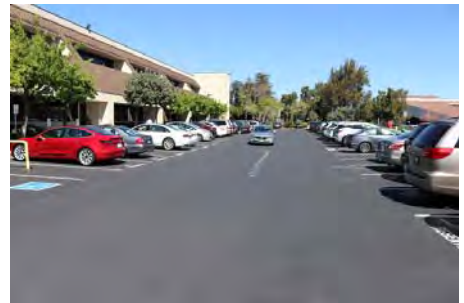
**FACILITY/SITE:** 20. Red Lot 5  
**FEATURE:** #5 PARKING STALL

COD	CONDITION DESCRIPTION	ACTUAL
B41	Stall is located as close as practical to entrance. (ADAS 208.3.1)	Many other standard stalls are closer to routes to the public right of way.

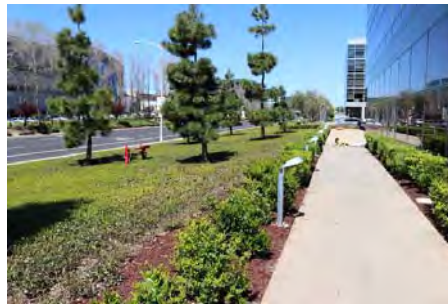
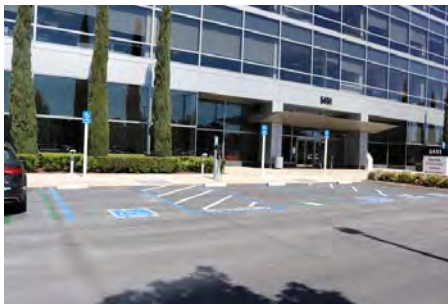
COD	CONDITION DESCRIPTION	ACTUAL
B41	Stall is located as close as practical to entrance. (ADAS 208.3.1)	Many other standard stalls are closer to routes to the public right of way.

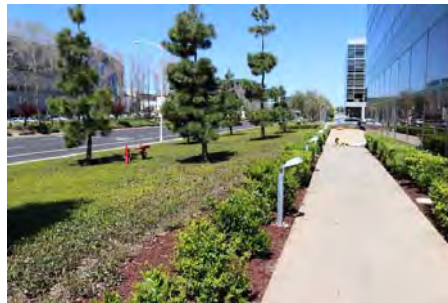
**FACILITY/SITE:** 21. Red Lot 7  
**FEATURE:** #5 PARKING STALL

COD	CONDITION DESCRIPTION	ACTUAL
B41	Stall is located as close as practical to entrance. (ADAS 208.3.1)	Many other standard stalls are closer to routes to the public right of way.

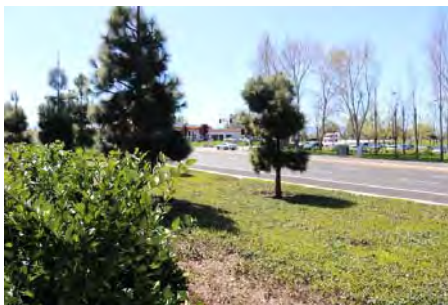
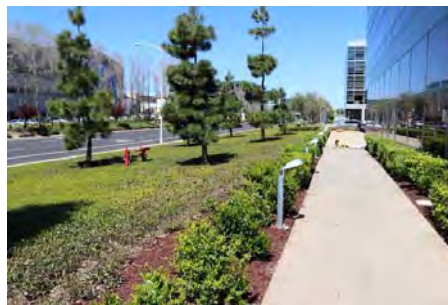
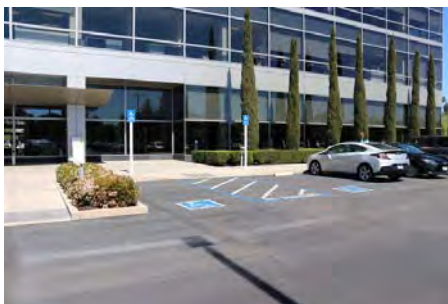
**FACILITY/SITE:** 21. Red Lot 7  
**FEATURE:** #5 PARKING STALL

COD	CONDITION DESCRIPTION	ACTUAL
B41	Stall is located as close as practical to entrance. (ADAS 208.3.1)	Many other standard stalls are closer to routes to the public right of way.

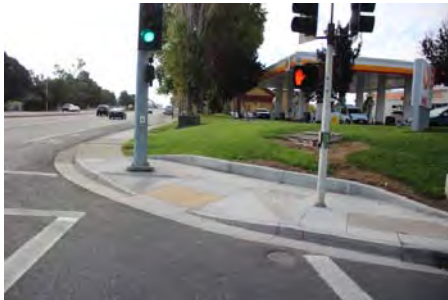
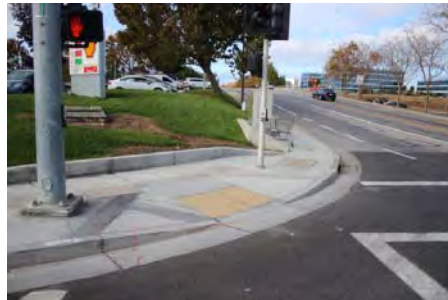
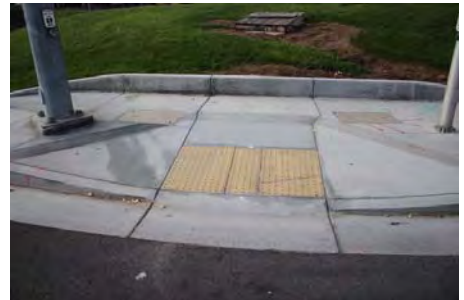
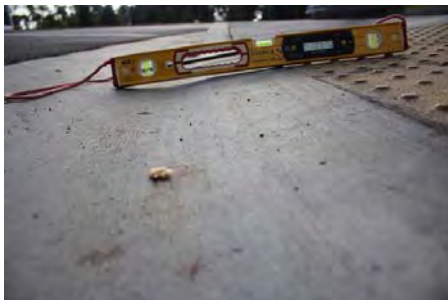
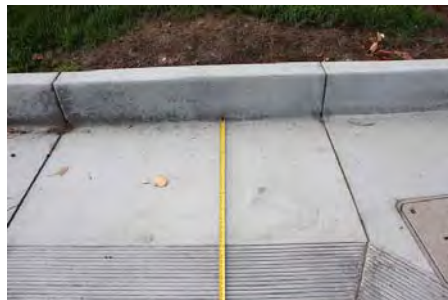
COD	CONDITION DESCRIPTION	ACTUAL
B03	Running slope of ramp is 1:12 (8.33%) max. (ADAS 405.2)	16.8% at btm. 3", 11.9% at btm. 3" to 8" portion.
B14	Counter slopes of adjoining gutters and road surfaces immediately adjacent to and within 24 inches of the curb ramp are not steeper than 1:20 (5.0%). (ADAS 406.2)	8.0%

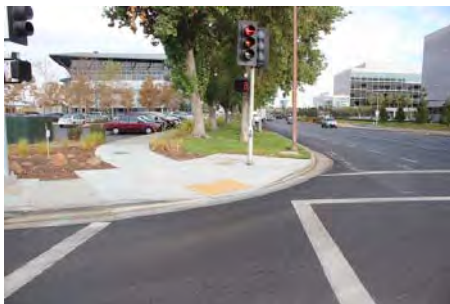
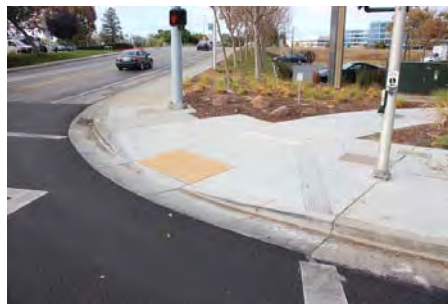
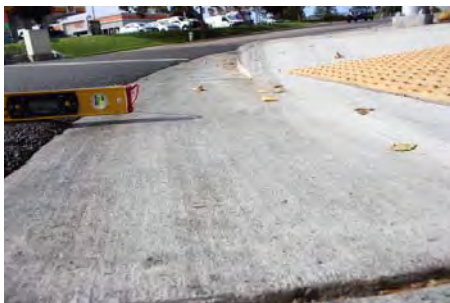
**FACILITY/SITE:** 1. Great America Pky.

COD	CONDITION DESCRIPTION	ACTUAL
B03	Running slope of ramp is 1:12 (8.33%) max. (ADAS 405.2)	11.7% at btm. 2", 8.8% at top 24" portion.
B05	Surface of ramp and landings complies with requirements for an accessible path of travel (stable, firm, slip-resistant, without gaps over 1/2" wide or edges over 1/4" high). (ADAS 302.1, 403.2, 403.3, 403.4)	3/4" high vertical edge at asphalt transition.
B14	Counter slopes of adjoining gutters and road surfaces immediately adjacent to and within 24 inches of the curb ramp are not steeper than 1:20 (5.0%). (ADAS 406.2)	6.0%

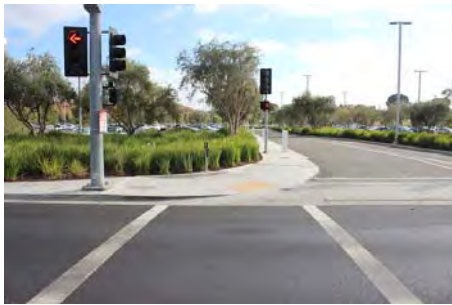
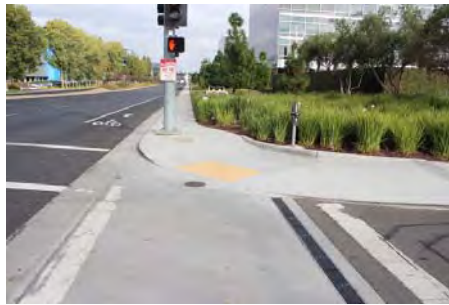
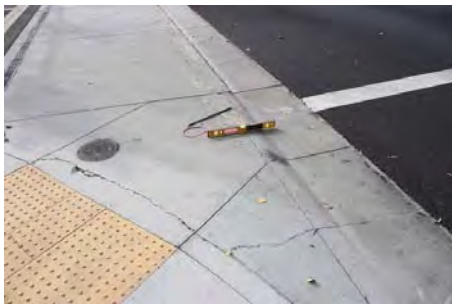
FACILITY/SITE: 1. Great America Pky.

COD	CONDITION DESCRIPTION	ACTUAL
C11	Min. 48" x 48" turning space is provided at bottom of curb ramp. (ADAS 403.3)	19.0% for 3" L (approx. 5/8" H difference) 43" from btm. of curb ramp.

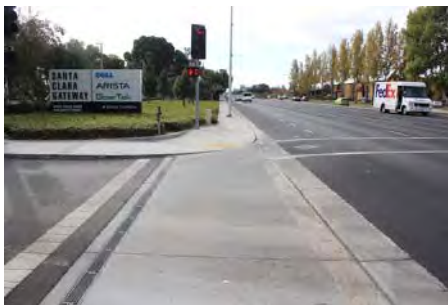
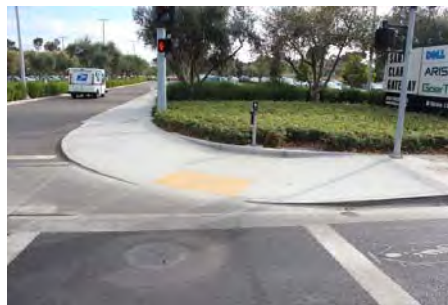
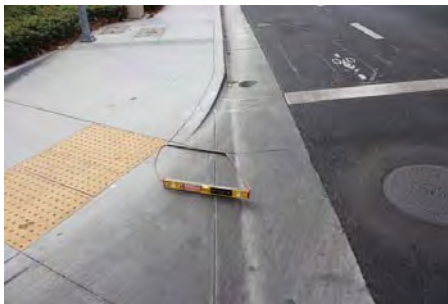
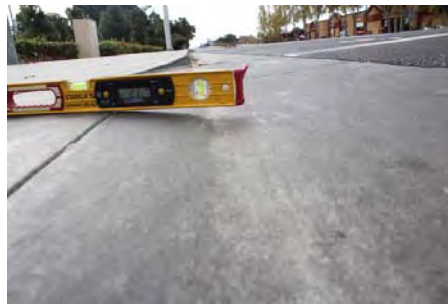
COD	CONDITION DESCRIPTION	ACTUAL
C12	Turning space at bottom of curb ramp slopes 1:48 (2.08%) max. in any direction (ADAS 403.3)	16.0% for 2" (approx. 7/8" H difference).

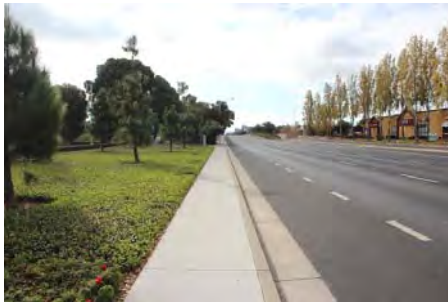
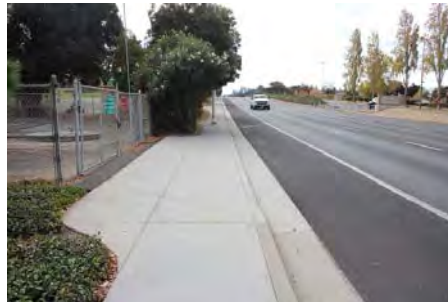
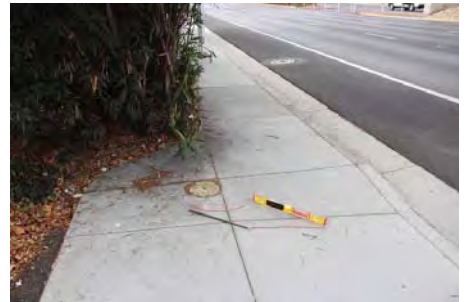
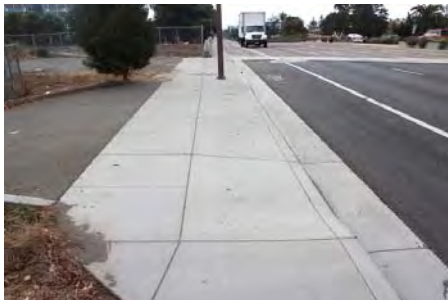
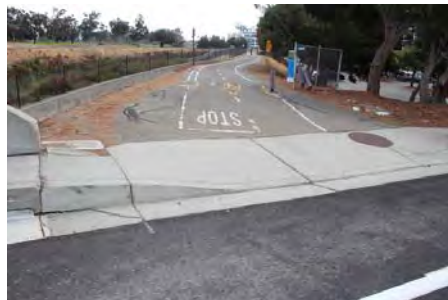
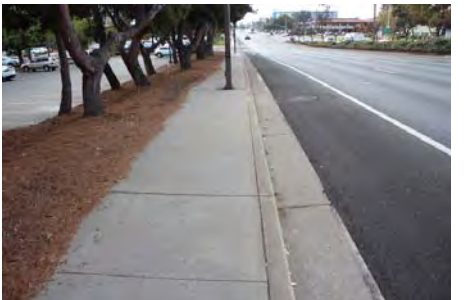
COD	CONDITION DESCRIPTION	ACTUAL
B16	Cross slope (perpendicular to direction of travel) is 1:48 (2.08%) max. (ADAS 403.3)	Approx. 130' L is 2.5% to 5.0% and 3.2% at sign post.
B17	Running slope (parallel to direction of travel) is 1:20 (5.0%) max. (ADAS 403.3)	10.8% and 12.2% at drive apron sides at S side of bridge.

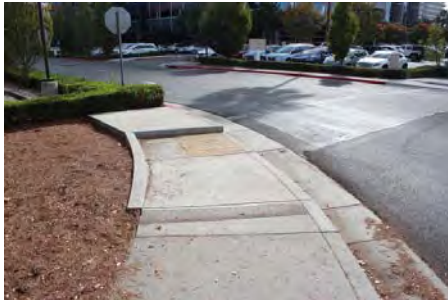
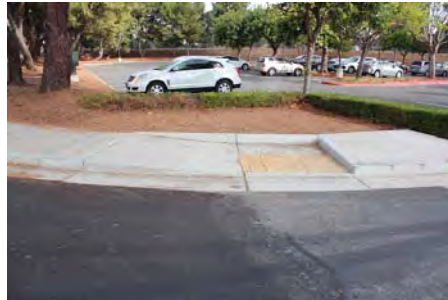
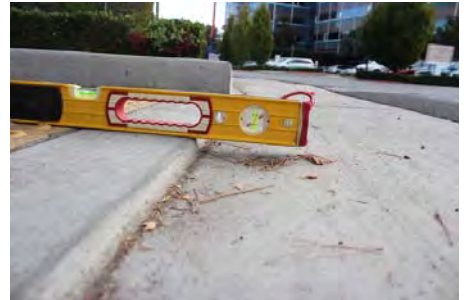
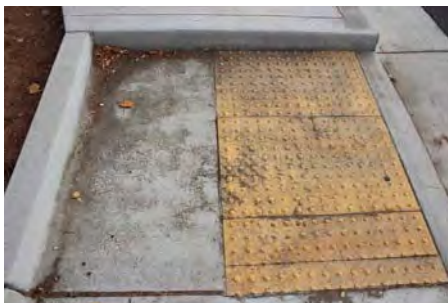
COD	CONDITION DESCRIPTION	ACTUAL
B05	Surface of ramp and landings complies with requirements for an accessible path of travel (stable, firm, slip-resistant, without gaps over 1/2" wide or edges over 1/4" high). (ADAS 405.4)	sand and debris
B06	Transition to walk, gutter or street is flush and free of abrupt changes. (ADAS 406.2)	1 1/8" high vertical edge

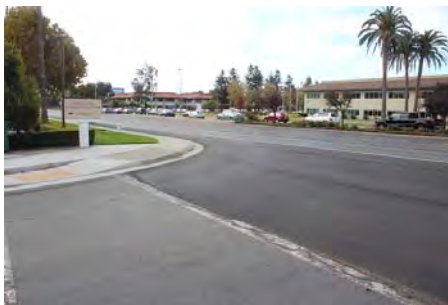
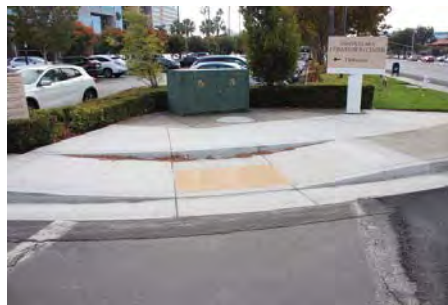
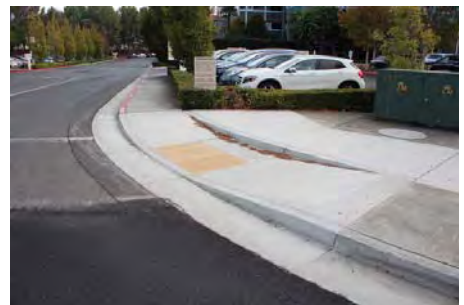
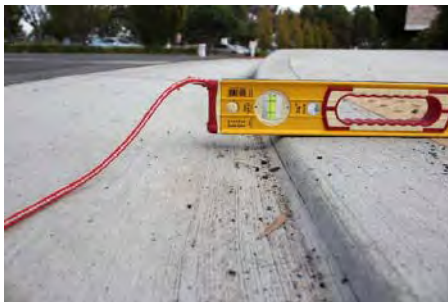
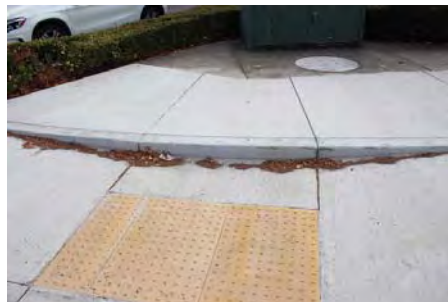
COD	CONDITION DESCRIPTION	ACTUAL
B06 406.2)	Transition to walk, gutter or street is flush and free of abrupt changes. (ADAS	3/4" high vertical edge

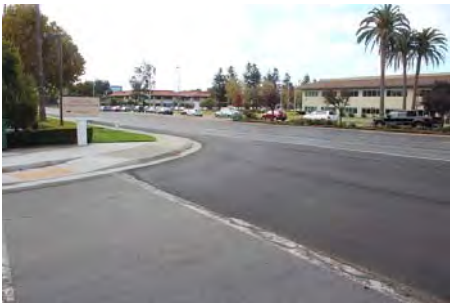
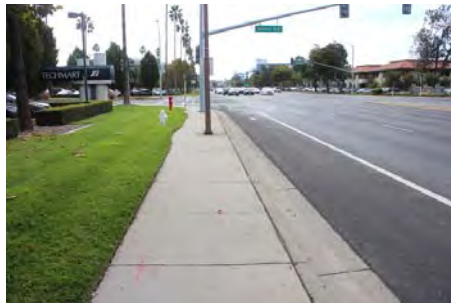
COD	CONDITION DESCRIPTION	ACTUAL
B16	Cross slope (perpendicular to direction of travel) is 1:48 (2.08%) max. (ADAS 403.3)	Approx. 40' L is 2.5% to 4.0%

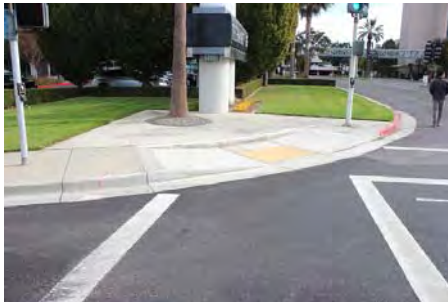
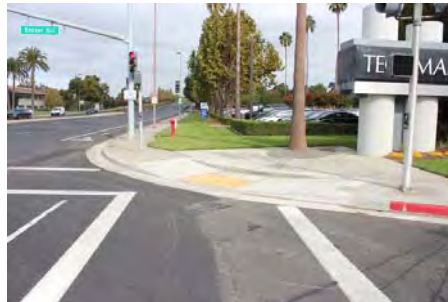
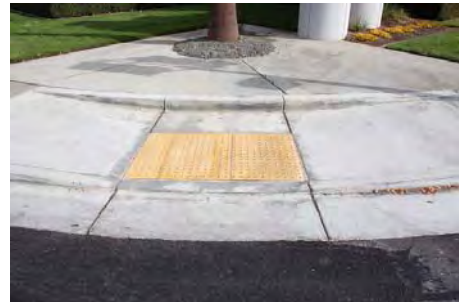
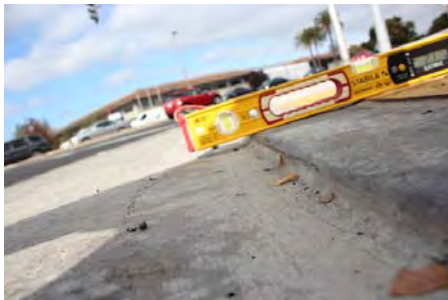
COD	CONDITION DESCRIPTION	ACTUAL
B06	Transition to walk, gutter or street is flush and free of abrupt changes. (ADAS 406.2)	5/8" vertical edge
B13	Counter slopes of adjoining gutters and road surfaces immediately adjacent to and within 24 inches of the curb ramp are not steeper than 1:20 (5.0%). (ADAS 406.2)	8.3%

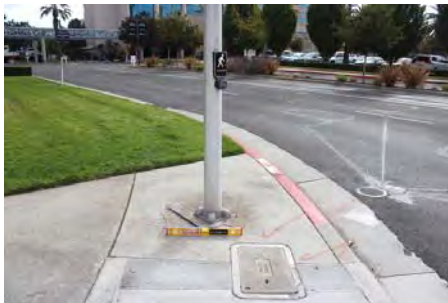
COD	CONDITION DESCRIPTION	ACTUAL
B11	The clear floor space is without changes in level except for slopes up to 1:48 (2.08%). (ADAS 305.2)	3.8% back side, 4.6% front side.

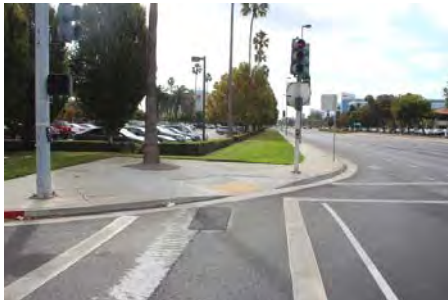
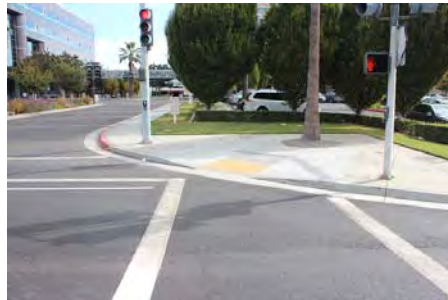
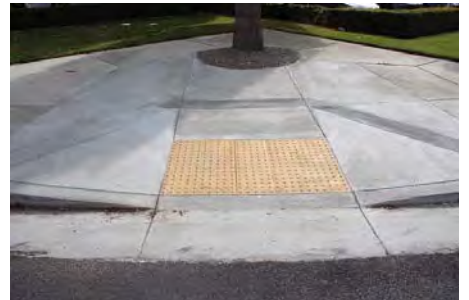
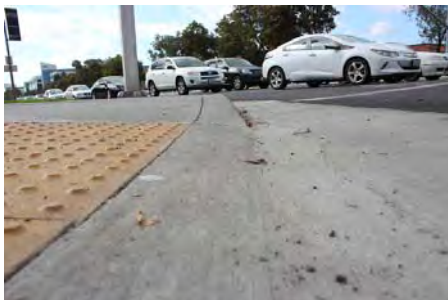
COD	CONDITION DESCRIPTION	ACTUAL
B03	Running slope of ramp is 1:12 (8.33%) max. (ADAS 405.2)	9.1% across curb face.
B14	Counter slopes of adjoining gutters and road surfaces immediately adjacent to and within 24 inches of the curb ramp are not steeper than 1:20 (5.0%). (ADAS 406.2)	5.8%

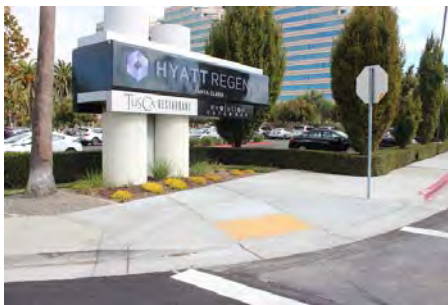
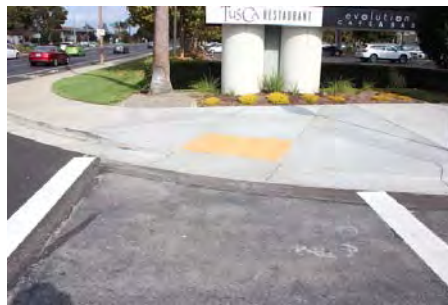
COD	CONDITION DESCRIPTION	ACTUAL
B03	Running slope of ramp is 1:12 (8.33%) max. (ADAS 405.2)	18.1% at btm. 2", 13.4% at btm. 2" to 6" portion.

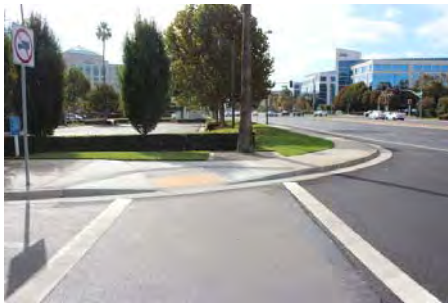
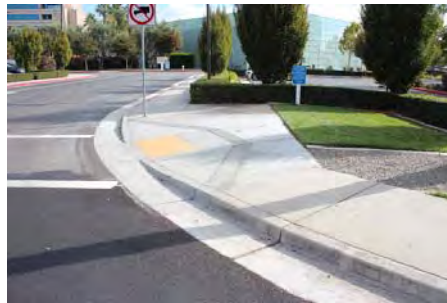
COD	CONDITION DESCRIPTION	ACTUAL
B03	Running slope of ramp is 1:12 (8.33%) max. (ADAS 405.2)	11.8% at btm. 6"

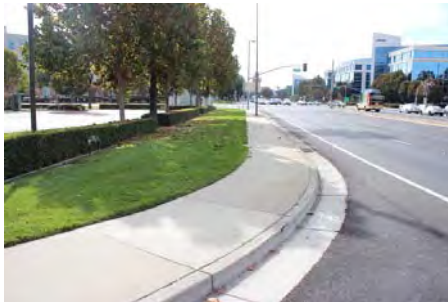
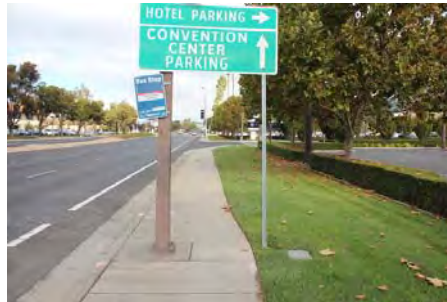
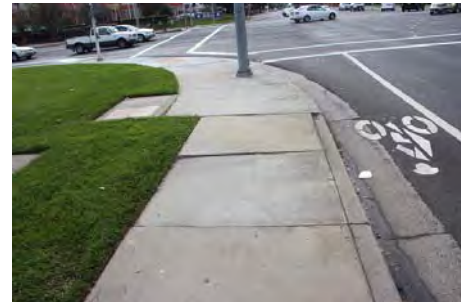
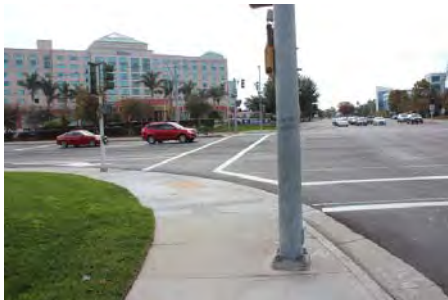
COD	CONDITION DESCRIPTION	ACTUAL
B15	No level changes greater than 1/2" (except by accessible ramp or other means). (ADAS 303.4)	2 3/4" high vertical edge at S end.
B16	Cross slope (perpendicular to direction of travel) is 1:48 (2.08%) max. (ADAS 403.3)	40' L is 2.6% to 3.0%

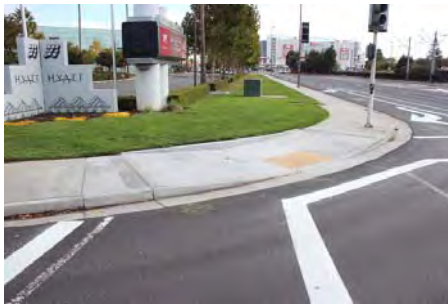
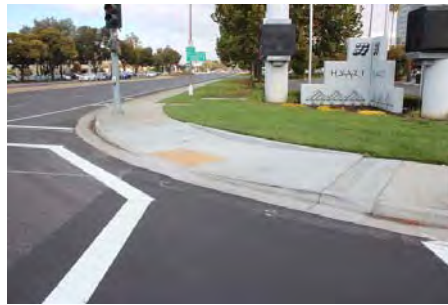
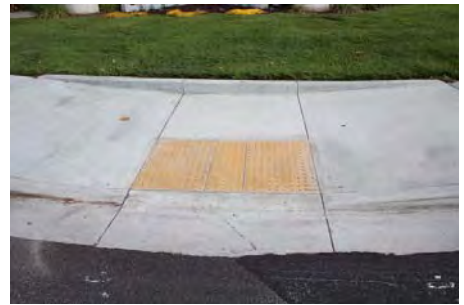
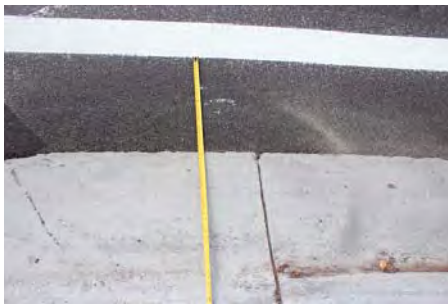
COD	CONDITION DESCRIPTION	ACTUAL
B13	Counter slopes of adjoining gutters and road surfaces immediately adjacent to and within 24 inches of the curb ramp are not steeper than 1:20 (5.0%). (ADAS 406.2)	9.0%

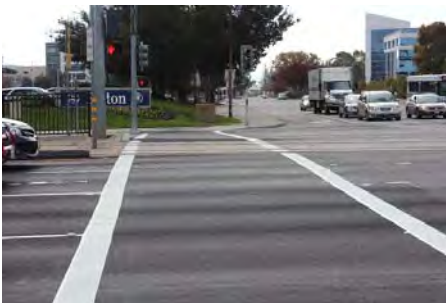
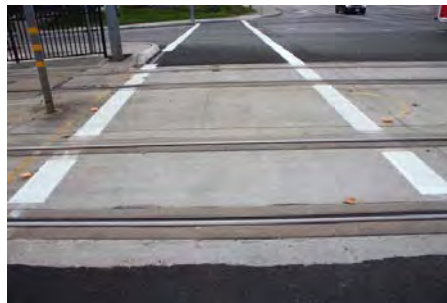
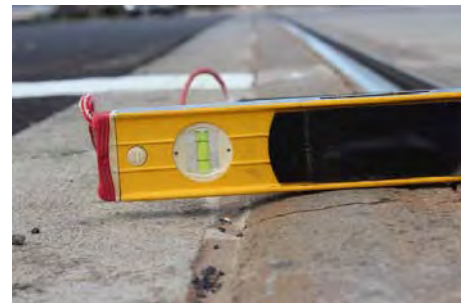
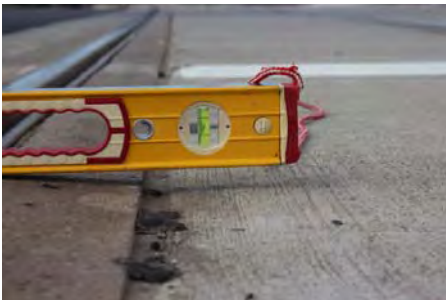
COD	CONDITION DESCRIPTION	ACTUAL
C40	Where pedestrian access routes cross rails: the route surface is flush with the outer edges of rails and the surface between rails is aligned with the top of the rail. (PROWAG R302.7.1)	1/2" to 3/4" elevation difference between route and rails (2 sets of 2 rails = 8 instances).

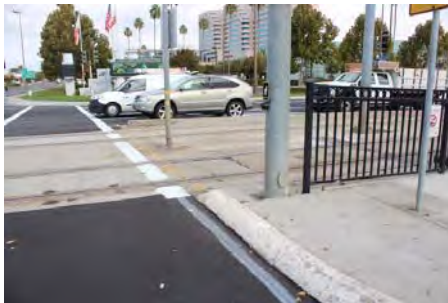
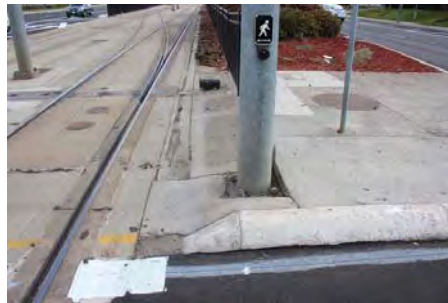
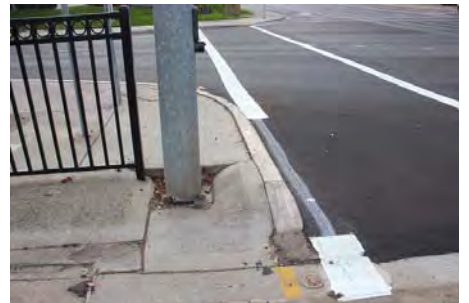
COD	CONDITION DESCRIPTION	ACTUAL
B41	Side reach over an obstruction greater than 10"d is max 46" AFF where the obstruction is max 34"AFF, and reach depth is no more than 24". (ADAS 308.3.2)	25" reach depth from clear space.

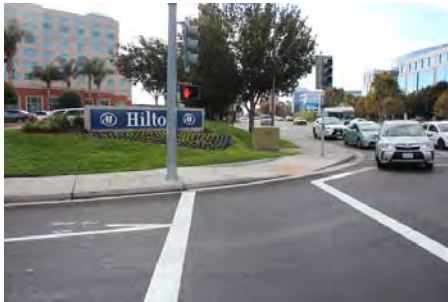
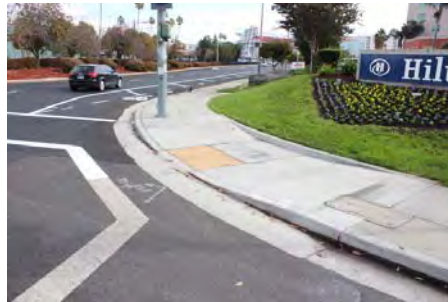
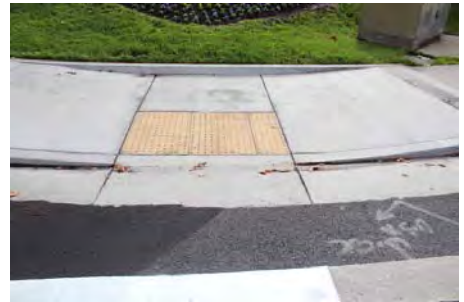
COD	CONDITION DESCRIPTION	ACTUAL
B03	Running slope of ramp is 1:12 (8.33%) max. (ADAS 405.2)	10.7% at btm. 6".
B14	Counter slopes of adjoining gutters and road surfaces immediately adjacent to and within 24 inches of the curb ramp are not steeper than 1:20 (5.0%). (ADAS 406.2)	7.6%

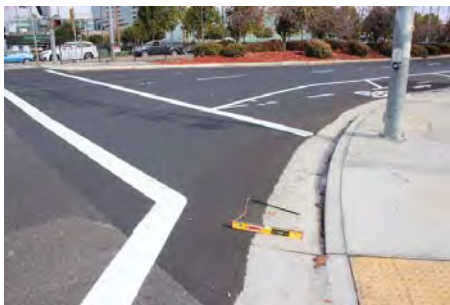
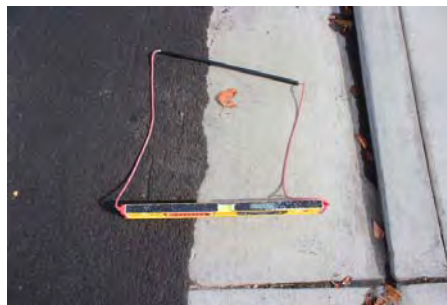
COD	CONDITION DESCRIPTION	ACTUAL
B16	Cross slope (perpendicular to direction of travel) is 1:48 (2.08%) max. (ADAS 403.3)	11.1%

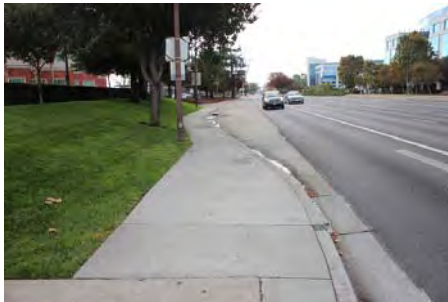
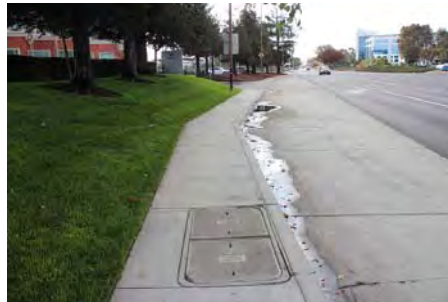
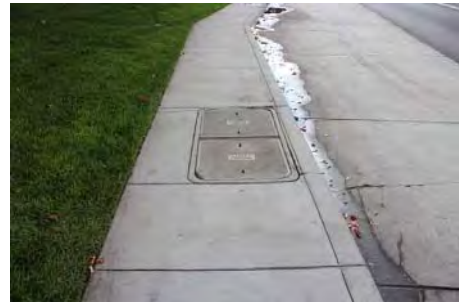
COD	CONDITION DESCRIPTION	ACTUAL
B12	Gaps/openings in ground or floor surfaces do not allow the passage of a sphere more than 1/2" in diameter. (ADAS 302.3)	3 gaps at utility cover, up to 1 1/2" W.
B16	Cross slope (perpendicular to direction of travel) is 1:48 (2.08%) max. (ADAS 403.3)	Approx. 10' L is 2.8%.

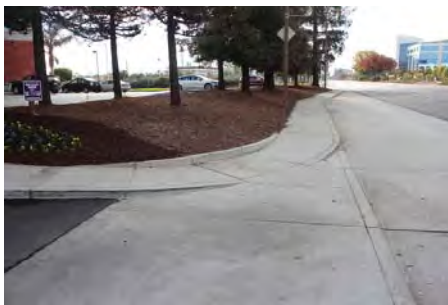
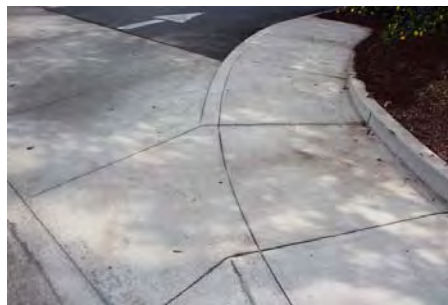
COD	CONDITION DESCRIPTION	ACTUAL
B03	Running slope of ramp is 1:12 (8.33%) max. (ADAS 405.2)	9.9% at btm. 6".

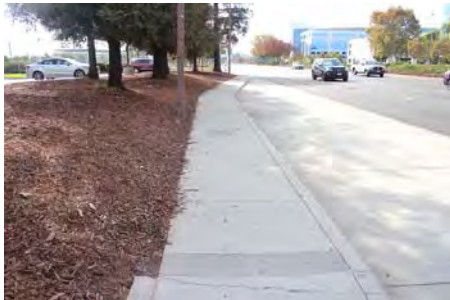
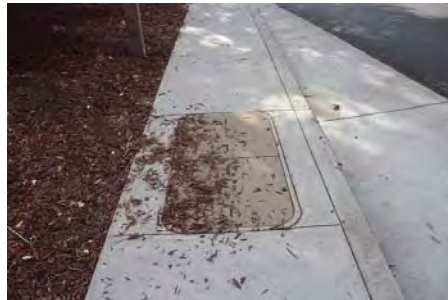
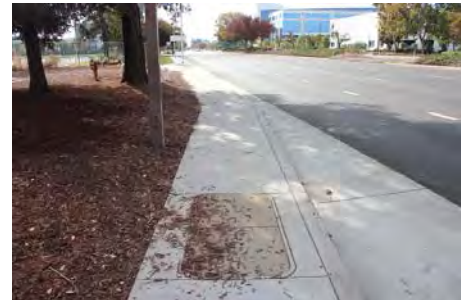
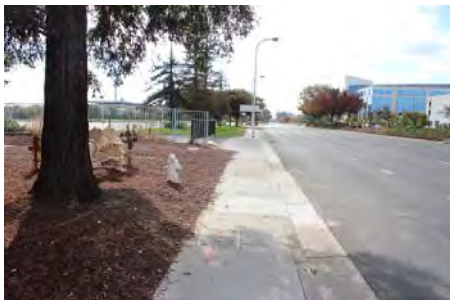
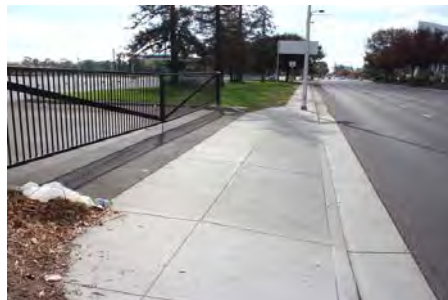
COD	CONDITION DESCRIPTION	ACTUAL
B14	1/4" to 1/2" level changes are beveled at max 1:2 (vert:horiz) slope. (ADAS 303.3)	Two 1/2" vertical edges at utility cover.
B16	Cross slope (perpendicular to direction of travel) is 1:48 (2.08%) max. (ADAS 403.3)	Approx. 20' L is 3.2% to 3.3%.

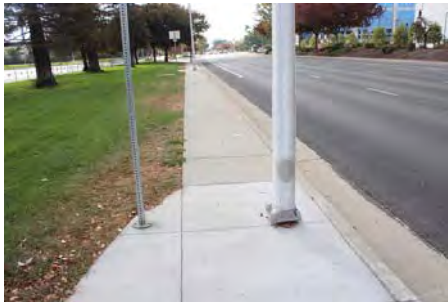
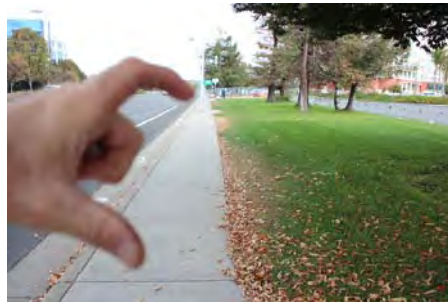
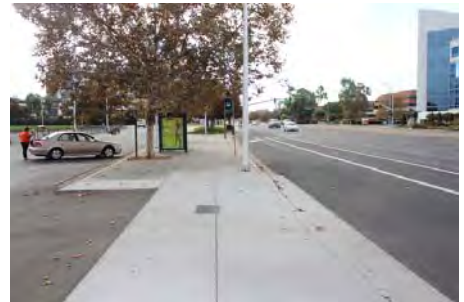
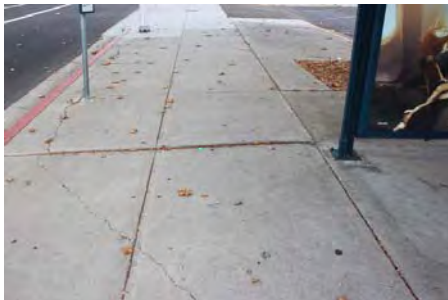
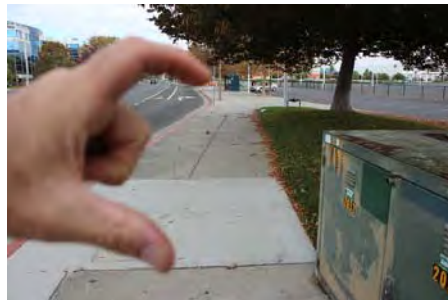
COD	CONDITION DESCRIPTION	ACTUAL
B15	No level changes greater than 1/2" (except by accessible ramp or other means). (ADAS 303.4)	Three vertical edges 5/8" to 1 1/4" S of bus stop.
B16	Cross slope (perpendicular to direction of travel) is 1:48 (2.08%) max. (ADAS 403.3)	Approx. 270' L is 2.7% to 4.2%.

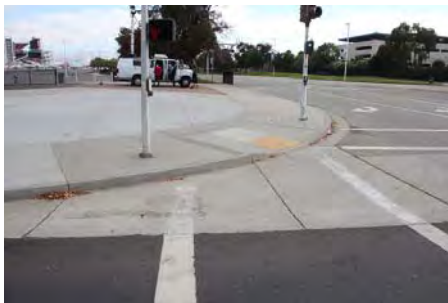
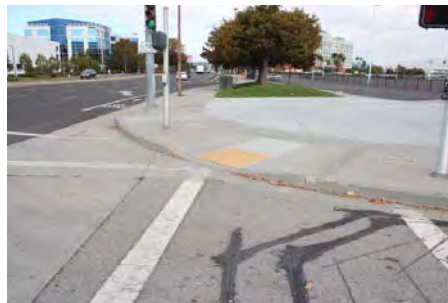
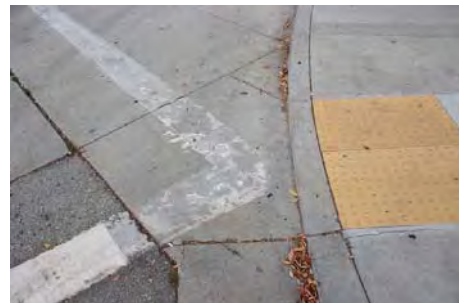
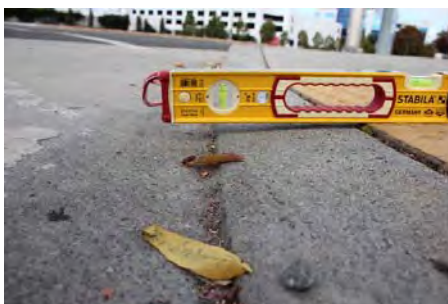
COD	CONDITION DESCRIPTION	ACTUAL
B03	Running slope of ramp is 1:12 (8.33%) max. (ADAS 405.2)	9.5% generally, 15.2% across curb face.
B06	Transition to walk, gutter or street is flush and free of abrupt changes. (ADAS 406.2)	1/2" high vertical edge.
B16	Maximum slope of flared sides is 1:10 (10.0%). (ADAS 406.2)	11.7% at right side.
B19	DIAGONAL: If curb ramp is located at marked crossing, 48" min. clear space is provided within the markings. (ADAS 406.6)	0" to CW markings (no landing in CW).

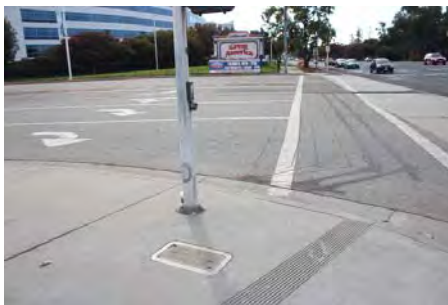
COD	CONDITION DESCRIPTION	ACTUAL
B11	The clear floor space is without changes in level except for slopes up to 1:48 (2.08%). (ADAS 305.2)	3.8%

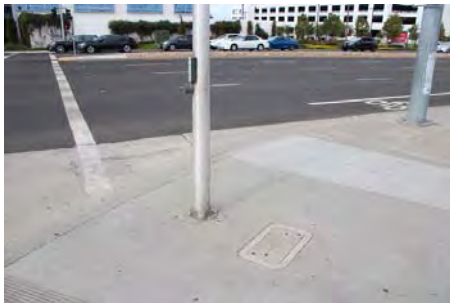
COD	CONDITION DESCRIPTION	ACTUAL
B11	The clear floor space is without changes in level except for slopes up to 1:48 (2.08%). (ADAS 305.2)	3.5%

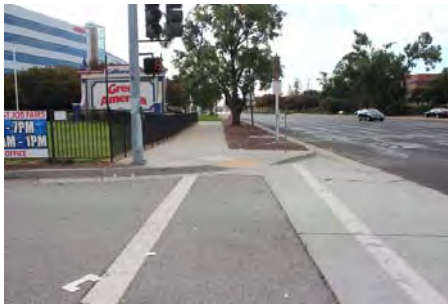
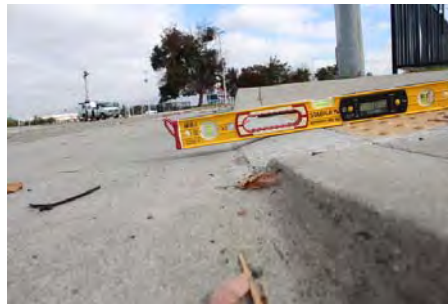
COD	CONDITION DESCRIPTION	ACTUAL
B06	Transition to walk, gutter or street is flush and free of abrupt changes. (ADAS 406.2)	5/8" elevation difference in approx. 2" btm. Portion.

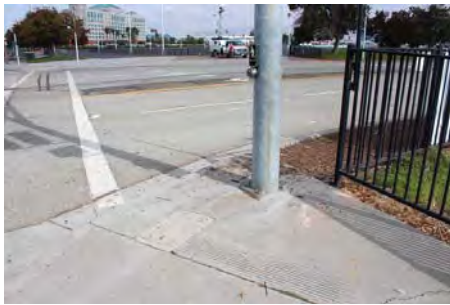
COD	CONDITION DESCRIPTION	ACTUAL
B11	The clear floor space is without changes in level except for slopes up to 1:48 (2.08%). (ADAS 305.2)	3.4%

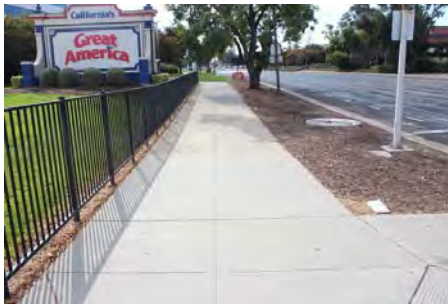
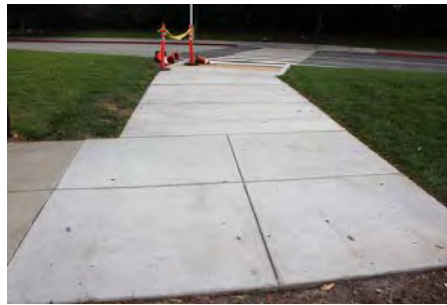
COD	CONDITION DESCRIPTION	ACTUAL
B16	Cross slope (perpendicular to direction of travel) is 1:48 (2.08%) max. (ADAS 403.3)	Approx. 40' L is 3.9% to 4.5%.

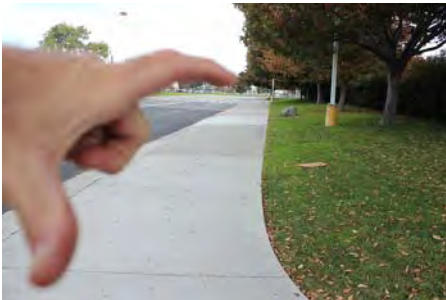
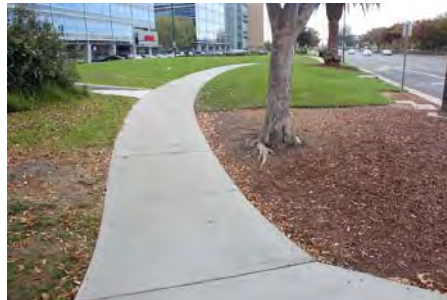
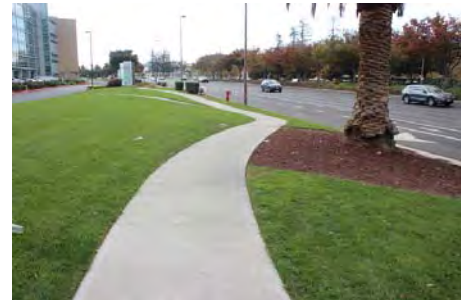
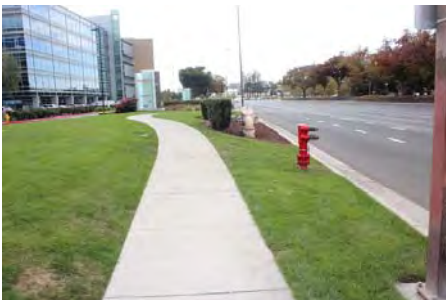
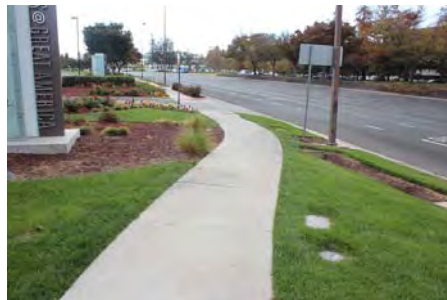
COD	CONDITION DESCRIPTION	ACTUAL
B16	Cross slope (perpendicular to direction of travel) is 1:48 (2.08%) max. (ADAS 403.3)	Approx. 110' L is 2.5% to 4.3%.
B17	Running slope (parallel to direction of travel) is 1:20 (5.0%) max. (ADAS 403.3)	2 hills comprising approx. 55' L running slope up to 6.8%.

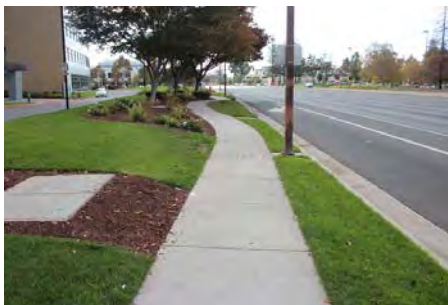
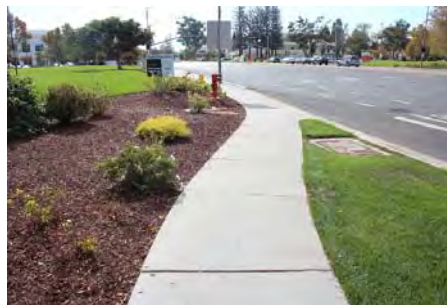
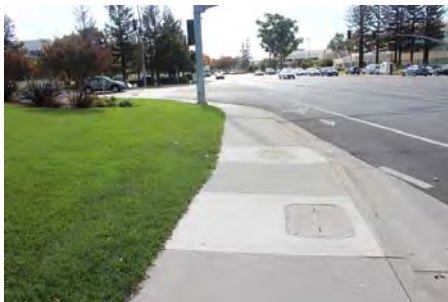
COD	CONDITION DESCRIPTION	ACTUAL
B16	Cross slope (perpendicular to direction of travel) is 1:48 (2.08%) max. (ADAS 403.3)	Approx. 320' L is 2.5% to 5.1%.

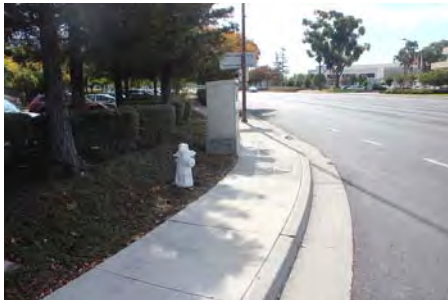
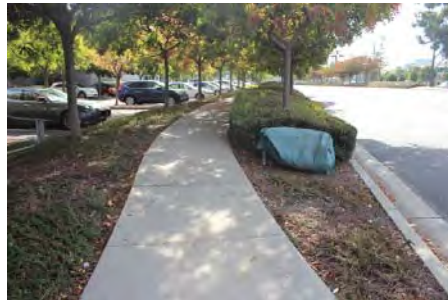
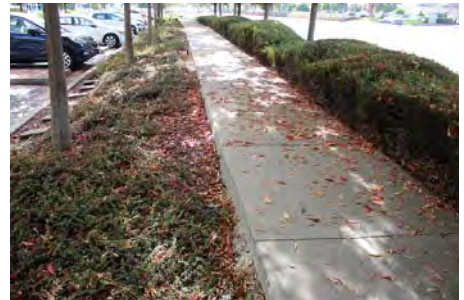
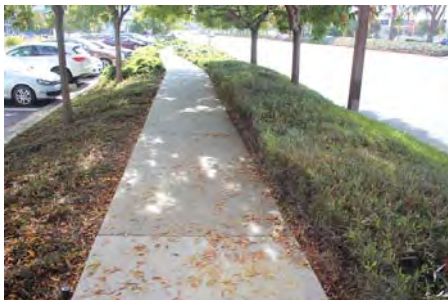
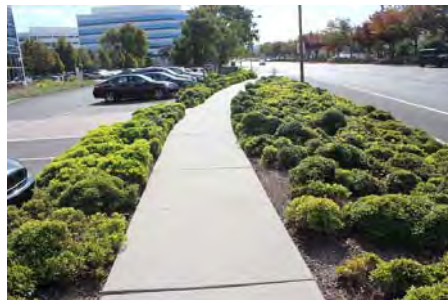
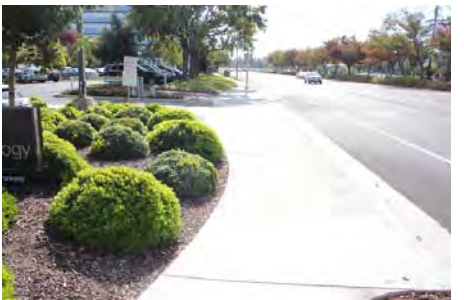
COD	CONDITION DESCRIPTION	ACTUAL
B16	Cross slope (perpendicular to direction of travel) is 1:48 (2.08%) max. (ADAS 403.3)	Approx. 90' L is 2.6% to 4.8%.
B17	Running slope (parallel to direction of travel) is 1:20 (5.0%) max. (ADAS 403.3)	Up to 6.9% for approx. 10' L at hill.

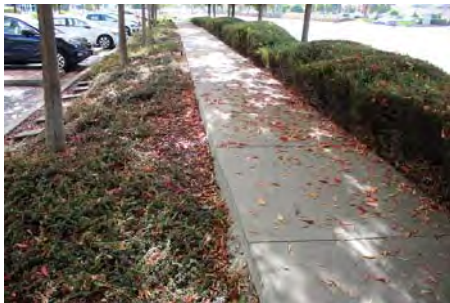
COD	CONDITION DESCRIPTION	ACTUAL
B11	Abrupt changes in level over 4" high are identified either by a curb or guide rail. (28 CFR 35.130(a), ADAS 405.9, CBC 11B-303.5)	Over 4" drop off, approx. 20' L at one side.

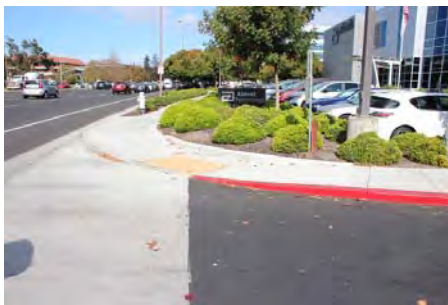
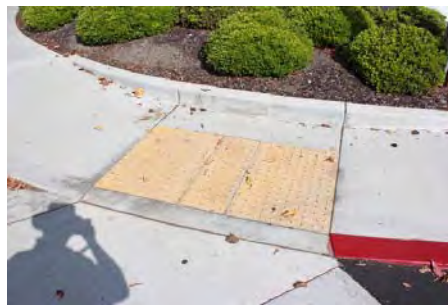
COD	CONDITION DESCRIPTION	ACTUAL
B03	Running slope is 1:12 (8.33%) max. (ADAS 405.2)	9.5% at btm. 6".

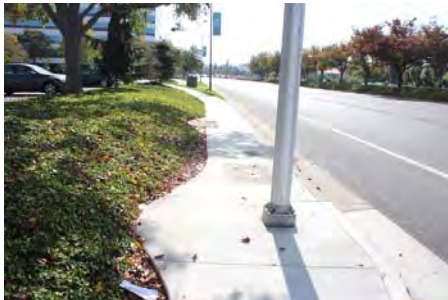
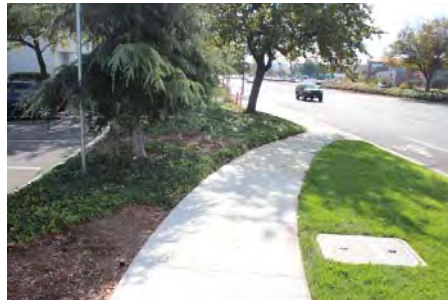
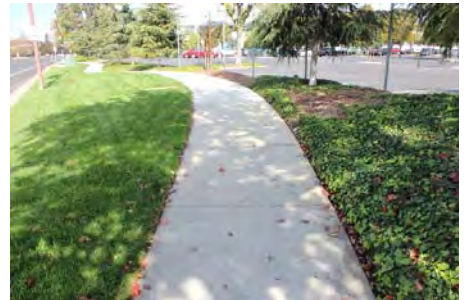
COD	CONDITION DESCRIPTION	ACTUAL
B16	Cross slope (perpendicular to direction of travel) is 1:48 (2.08%) max. (ADAS 403.3)	Approx. 60' L is 2.6% to 5.1%.
B17	Running slope (parallel to direction of travel) is 1:20 (5.0%) max. (ADAS 403.3)	Up to 6.1% at hill.

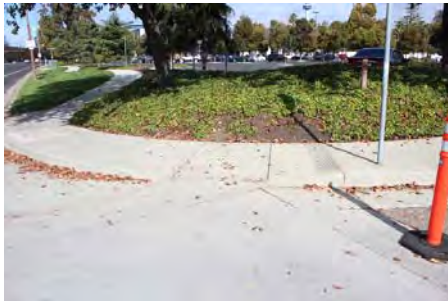
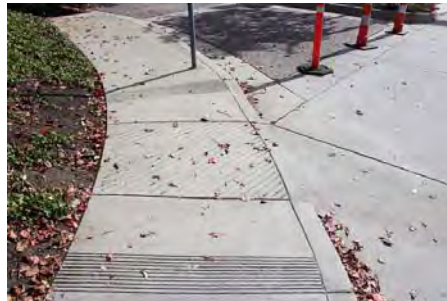
COD	CONDITION DESCRIPTION	ACTUAL
B03	Running slope of ramp is 1:12 (8.33%) max. (ADAS 405.2)	12.0%
B04	Cross slope of ramp is 1:48 (2.08%). (ADAS 405.3)	4.6%
B11	Top landing is as wide as the ramp and 36" min. in length. (ADAS 406.4)	None
A17	Where no top landing is provided at an existing ramp, side flare slopes are 8.33% max. (ADAS 406.4)	15.6% left side, 15.9% right side.

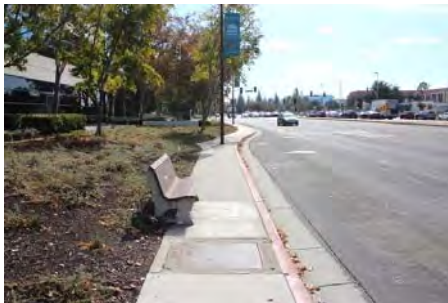
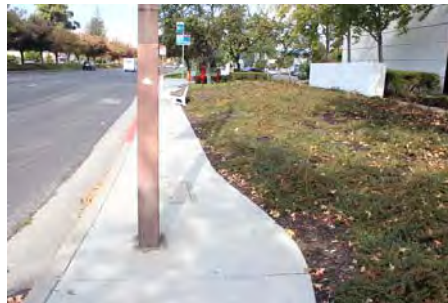
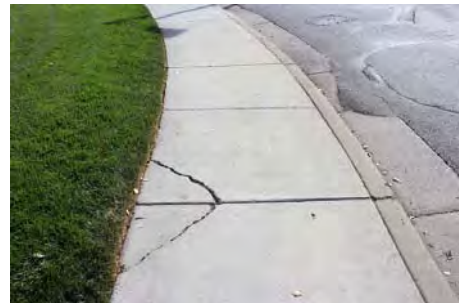
COD	CONDITION DESCRIPTION	ACTUAL
B16	Cross slope (perpendicular to direction of travel) is 1:48 (2.08%) max. (ADAS 403.3)	Approx. 250' L is 2.5% to 8.0%.

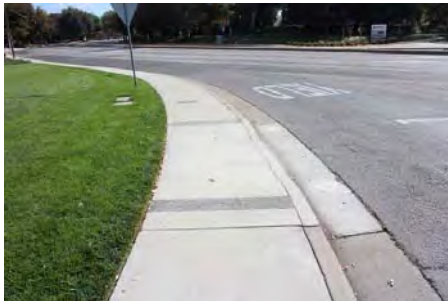
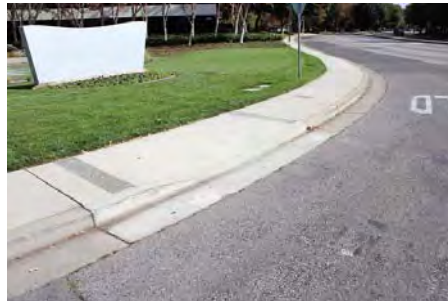
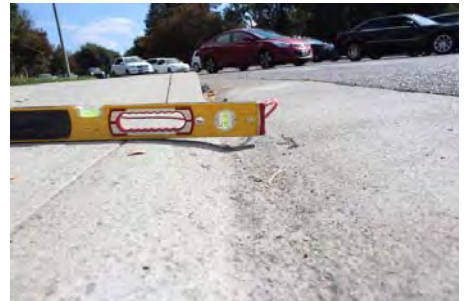
COD	CONDITION DESCRIPTION	ACTUAL
B03	Running slope of ramp is 1:12 (8.33%) max. (ADAS 405.2)	11.6% w/ 32.2% at btm. 1" and 19.9% at btm. 1" to 6".
B11	Top landing is as wide as the ramp and 36" min. in length. (ADAS 406.4)	None
B14	Counter slopes of adjoining gutters and road surfaces immediately adjacent to and within 24 inches of the curb ramp are not steeper than 1:20 (5.0%). (ADAS 406.2)	10.1%
A17	Where no top landing is provided at an existing ramp, side flare slopes are 8.33% max. (ADAS 406.4)	13.9% at right side, 12.3% at left side.

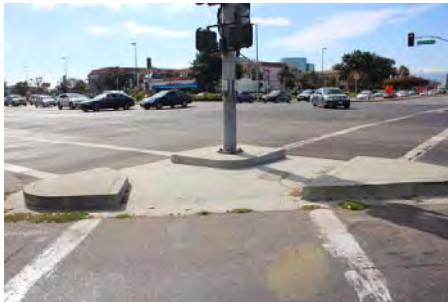
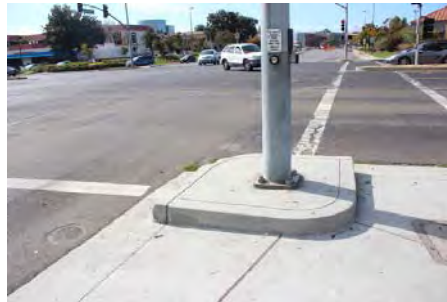
COD	CONDITION DESCRIPTION	ACTUAL
B11	The clear floor space is without changes in level except for slopes up to 1:48 (2.08%). (ADAS 305.2)	3.2%
B41	Side reach over an obstruction greater than 10"d is max 46" AFF where the obstruction is max 34" AFF, and reach depth is no more than 24". (ADAS 308.3.2)	Approx. 52" H, 21" from clear space.

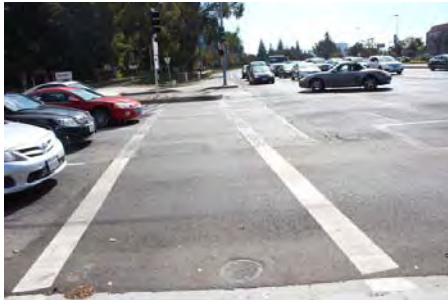
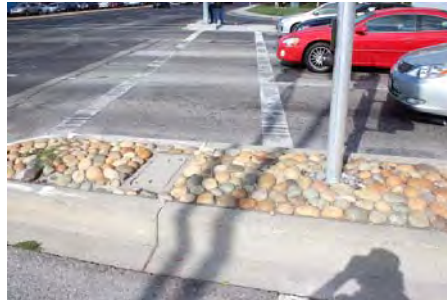
COD	CONDITION DESCRIPTION	ACTUAL
B02	36" min. clear width of exterior walkway. (ADAS 403.5.1)	Obstructed by mid-crossing island to 0" wide.
B15	No level changes greater than 1/2" (except by accessible ramp or other means). (ADAS 303.4)	Sign indicates to push button and wait for walk signal, however, user who cannot step up the curb must wait in traffic lanes.

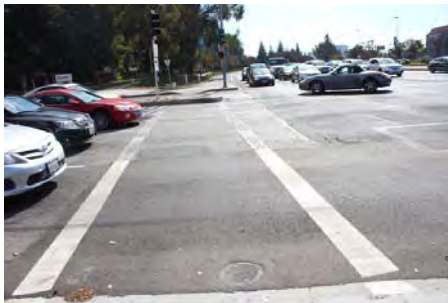
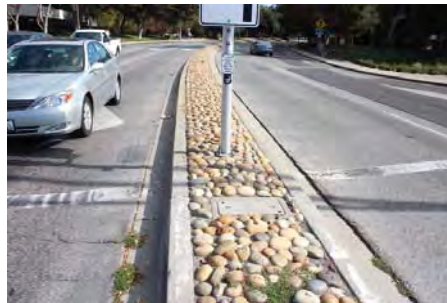
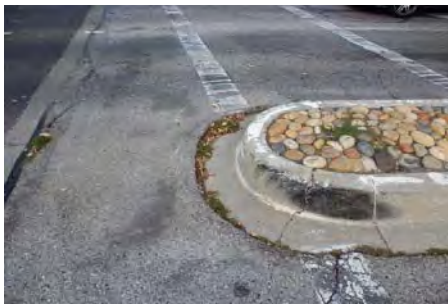
COD	CONDITION DESCRIPTION	ACTUAL
B41	Side reach over an obstruction greater than 10"d is max 46" AFF where the obstruction is max 34" AFF, and reach depth is no more than 24". (ADAS 308.3.2)	Over 24" from clear space in crossing.

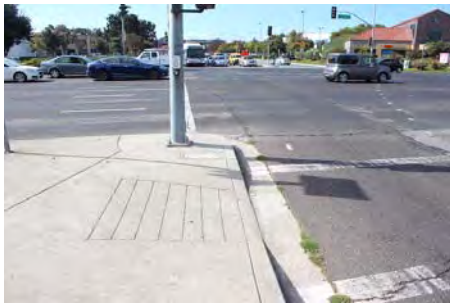
COD	CONDITION DESCRIPTION	ACTUAL
B03	Running slope of ramp is 1:12 (8.33%) max. (ADAS 405.2)	8.7% and 14.2% across curb face.
B06	Transition to walk, gutter or street is flush and free of abrupt changes. (ADAS 406.2)	1/2" high vertical edge.
B16	Maximum slope of flared sides is 1:10 (10.0%). (ADAS 406.2)	18.0% right side, 15.8% left side.
