Case No. 5:16-cv-07013-LHK (SVK)

**DECLARATION OF JEFFREY SCOTT  
MASTIN IN SUPPORT OF PLAINTIFFS'  
MOTION FOR CLASS CERTIFICATION**

NEVAREZ V 49ERS - ACCESSIBILITY ASSESSMENT

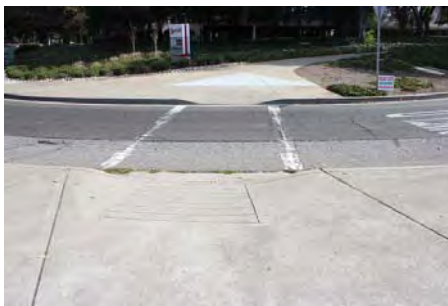
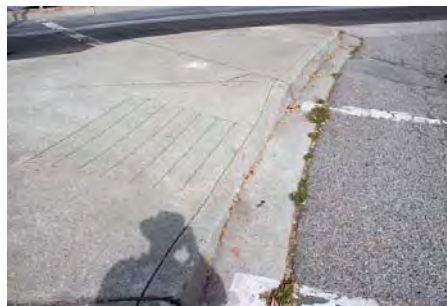
COD	CONDITION DESCRIPTION	ACTUAL
B03	Running slope of ramp is 1:12 (8.33%) max. (ADAS 405.2)	16.4% and 23.2% across curb face.
B05	Surface of ramp and landings complies with requirements for an accessible path of travel (stable, firm, slip-resistant, without gaps over 1/2" wide or edges over 1/4" high). (ADAS 302.1, 403.2, 403.3, 403.4)	3/4" gap at asphalt transition.
B06	Transition to walk, gutter or street is flush and free of abrupt changes. (ADAS 406.2)	1/2" high vertical edge.
B16	Maximum slope of flared sides is 1:10 (10.0%). (ADAS 406.2)	18.0% right side, 15.8% left side.

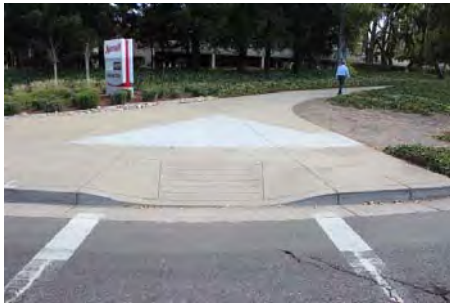
COD	CONDITION DESCRIPTION	ACTUAL
B03	Running slope of ramp is 1:12 (8.33%) max. (ADAS 405.2)	12.9%
B06	Transition to walk, gutter or street is flush and free of abrupt changes. (ADAS 406.2)	1/2" high vertical edge.
B14	Counter slopes of adjoining gutters and road surfaces immediately adjacent to and within 24 inches of the curb ramp are not steeper than 1:20 (5.0%). (ADAS 406.2)	8.2%
B16	Maximum slope of flared sides is 1:10 (10.0%). (ADAS 406.2)	17.3% left side, 14.7% right side.

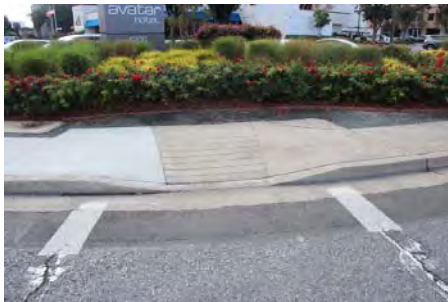
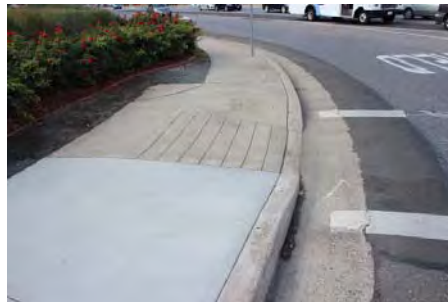
COD	CONDITION DESCRIPTION	ACTUAL
B03	Running slope of ramp is 1:12 (8.33%) max. (ADAS 405.2)	11.6% and 12.6% across curb face.
B06	Transition to walk, gutter or street is flush and free of abrupt changes. (ADAS 406.2)	3/8" high vertical edge.
B11	Top landing is as wide as the ramp and 36" min. in length. (ADAS 406.4)	34" L.
B14	Counter slopes of adjoining gutters and road surfaces immediately adjacent to and within 24 inches of the curb ramp are not steeper than 1:20 (5.0%). (ADAS 406.2)	9.0%
A17	Where no top landing is provided at an existing ramp, side flare slopes are 8.33% max. (ADAS 406.4)	13.3% left side, 12.6% right side.

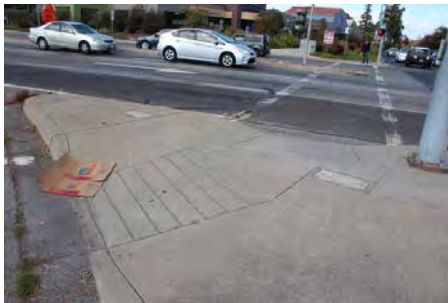
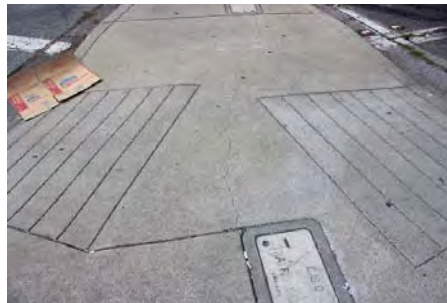
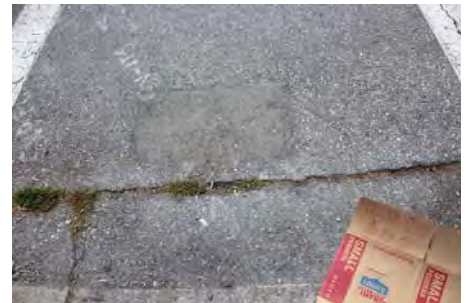
COD	CONDITION DESCRIPTION	ACTUAL
B03	Running slope of ramp is 1:12 (8.33%) max. (ADAS 405.2)	15.0% to 17.3%
B05	Surface of ramp and landings complies with requirements for an accessible path of travel (stable, firm, slip-resistant, without gaps over 1/2" wide or edges over 1/4" high). (ADAS 302.1, 403.2, 403.3, 403.4)	2" W gap at btm. Landing.
A17	Where no top landing is provided at an existing ramp, side flare slopes are 8.33% max. (ADAS 406.4)	25.0% left side, 25.9% right side
B21	Islands - each curb ramp has a min. 48" long x 36" wide level landing at the top of the curb ramp, with the 48" length in the direction of the running slope of the curb ramp it serves. (ADAS 406.7)	18" L to adjacent curb ramp.

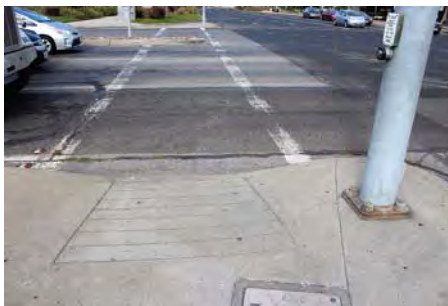
COD	CONDITION DESCRIPTION	ACTUAL
B03	Running slope of ramp is 1:12 (8.33%) max. (ADAS 405.2)	9.8% to 11.0%
B14	Counter slopes of adjoining gutters and road surfaces immediately adjacent to and within 24 inches of the curb ramp are not steeper than 1:20 (5.0%). (ADAS 406.2)	7.9%
A17	Where no top landing is provided at an existing ramp, side flare slopes are 8.33% max. (ADAS 406.4)	29.8% left side, 16.1% right side.
B21	Islands - each curb ramp has a min. 48" long x 36" wide level landing at the top of the curb ramp, with the 48" length in the direction of the running slope of the curb ramp it serves. (ADAS 406.7)	18" to adjacent curb ramp.

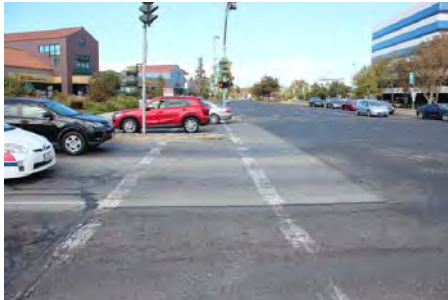
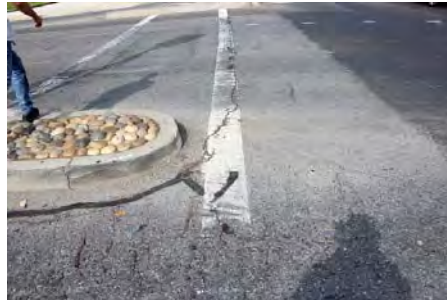
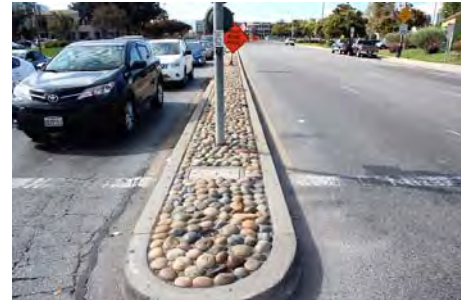
COD	CONDITION DESCRIPTION	ACTUAL
B02	36" min. clear width of exterior walkway. (ADAS 403.5.1)	Obstructed by mid crossing island to 6" W.
B15	No level changes greater than 1/2" (except by accessible ramp or other means). (ADAS 303.4)	Sign indicates to push button and wait for walk signal, however user who cannot step up the curb must wait in traffic lanes.

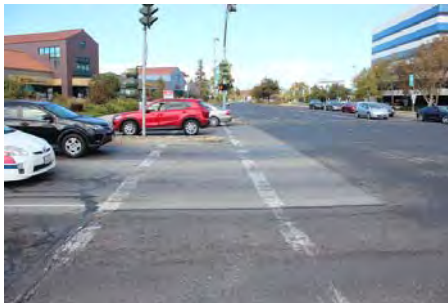
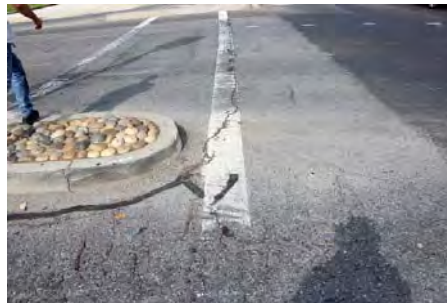
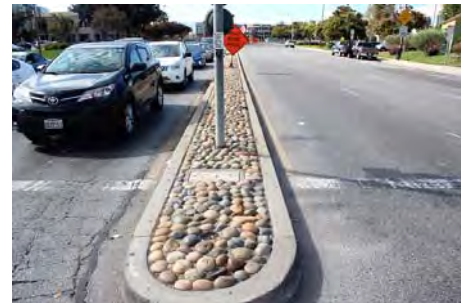
COD	CONDITION DESCRIPTION	ACTUAL
B41	Side reach over an obstruction greater than 10"d is max 46" AFF where the obstruction is max 34" AFF, and reach depth is no more than 24". (ADAS 308.3.2)	Over 24" from clear space in crossing.

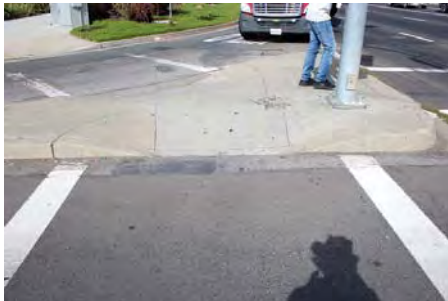
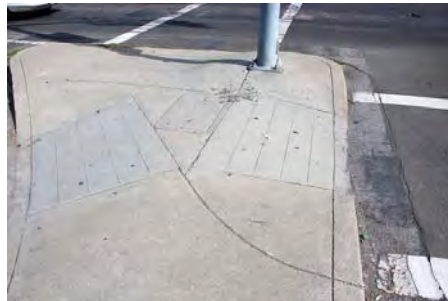
COD	CONDITION DESCRIPTION	ACTUAL
B03	Running slope of ramp is 1:12 (8.33%) max. (ADAS 405.2)	13.6% to 14.3%
A17	Where no top landing is provided at an existing ramp, side flare slopes are 8.33% max. (ADAS 406.4)	17.3% left side, 22.4% right side.
B21	Islands - each curb ramp has a min. 48" long x 36" wide level landing at the top of the curb ramp, with the 48" length in the direction of the running slope of the curb ramp it serves. (ADAS 406.7)	3" to adjacent curb ramp.

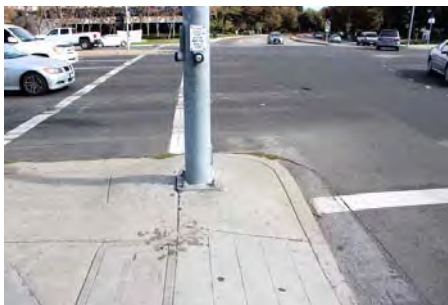
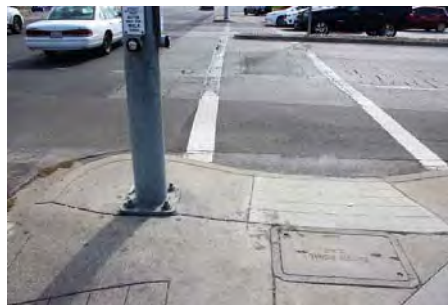
COD	CONDITION DESCRIPTION	ACTUAL
B11	The clear floor space is without changes in level except for slopes up to 1:48 (2.08%). (ADAS 305.2)	18.9%

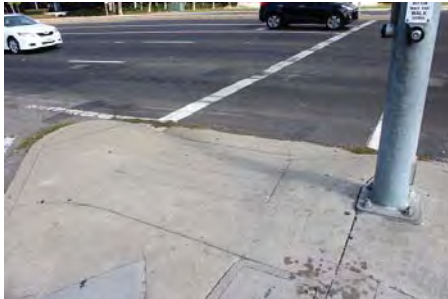
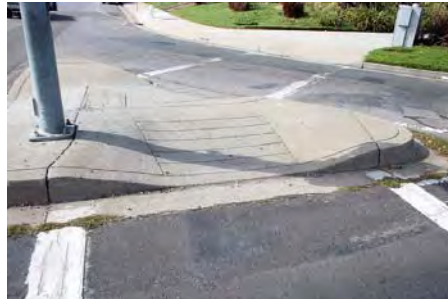
COD	CONDITION DESCRIPTION	ACTUAL
B03	Running slope of ramp is 1:12 (8.33%) max. (ADAS 405.2)	11.4%
B05	Surface of ramp and landings complies with requirements for an accessible path of travel (stable, firm, slip-resistant, without gaps over 1/2" wide or edges over 1/4" high). (ADAS 302.1, 403.2, 403.3, 403.4)	5.8% running slope at top landing.
B06	Transition to walk, gutter or street is flush and free of abrupt changes. (ADAS 406.2)	3/8" high vertical edge.
B14	Counter slopes of adjoining gutters and road surfaces immediately adjacent to and within 24 inches of the curb ramp are not steeper than 1:20 (5.0%). (ADAS 406.2)	8.0%
A17	Where no top landing is provided at an existing ramp, side flare slopes are 8.33% max. (ADAS 406.4)	15.1% left side, 15.7% right side.
B21	Islands - each curb ramp has a min. 48" long x 36" wide level landing at the top of the curb ramp, with the 48" length in the direction of the running slope of the curb ramp it serves. (ADAS 406.7)	33" to one adjacent curb ramp, 31" to a second adjacent curb ramp.

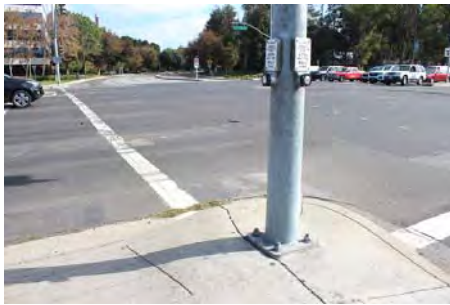
COD	CONDITION DESCRIPTION	ACTUAL
B11	The clear floor space is without changes in level except for slopes up to 1:48 (2.08%). (ADAS 305.2)	21.7%

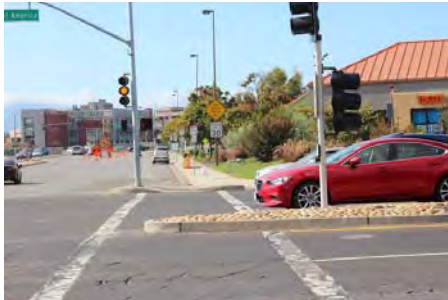
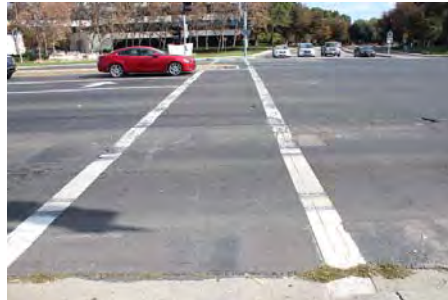
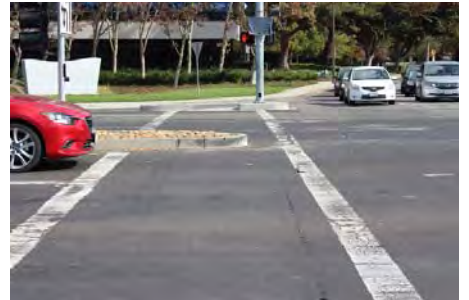
COD	CONDITION DESCRIPTION	ACTUAL
B02	36" min. clear width of exterior walkway. (ADAS 403.5.1)	Obstructed by mid crossing island to approx. 12" W.
B15	No level changes greater than 1/2" (except by accessible ramp or other means). (ADAS 303.4)	Sign indicates to push button and wait for walk signal, however user who cannot step up the curb must wait in traffic lanes.

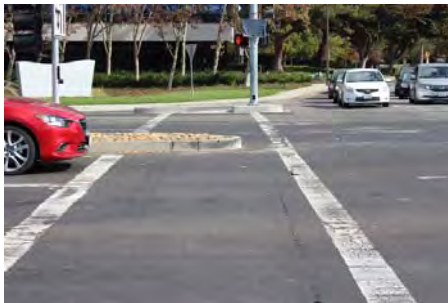
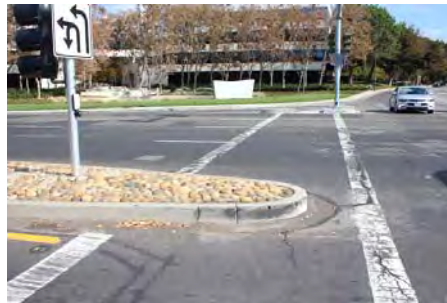
COD	CONDITION DESCRIPTION	ACTUAL
B41	Side reach over an obstruction greater than 10"d is max 46" AFF where the obstruction is max 34"AFF, and reach depth is no more than 24". (ADAS 308.3.2)	Over 24" away from clear space in crossing.

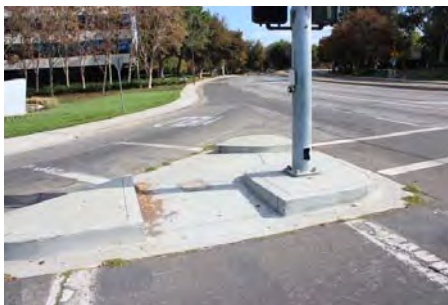
COD	CONDITION DESCRIPTION	ACTUAL
B41	Side reach over an obstruction greater than 10"d is max 46" AFF where the obstruction is max 34" AFF, and reach depth is no more than 24". (ADAS 308.3.2)	Approx. 52" AFF with reach of 21" over curb from clear space.

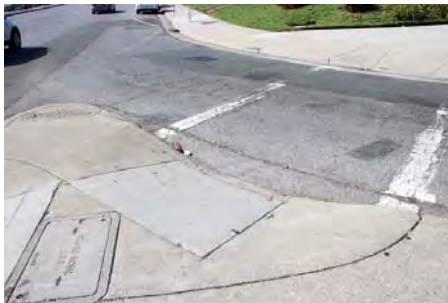
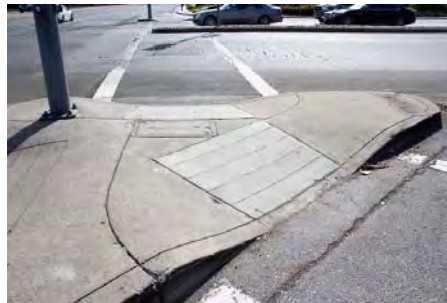
COD	CONDITION DESCRIPTION	ACTUAL
B03	Running slope of ramp is 1:12 (8.33%) max. (ADAS 405.2)	19.7% to 20.8%.
B05	Surface of ramp and landings complies with requirements for an accessible path of travel (stable, firm, slip-resistant, without gaps over 1/2" wide or edges over 1/4" high). (ADAS 302.1, 403.2, 403.3, 403.4)	1 3/4" gap at btm. Landing.
A17	Where no top landing is provided at an existing ramp, side flare slopes are 8.33% max. (ADAS 406.4)	26.9% left side, 16.0% right side.
B21	Islands - each curb ramp has a min. 48" long x 36" wide level landing at the top of the curb ramp, with the 48" length in the direction of the running slope of the curb ramp it serves. (ADAS 406.7)	3" to one adjacent curb ramp, 33" to a second adjacent curb ramp.

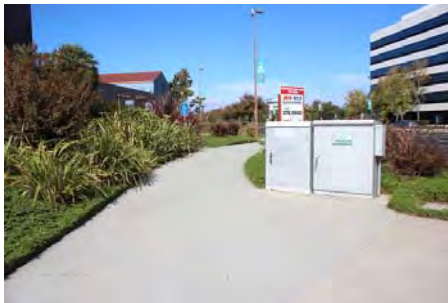
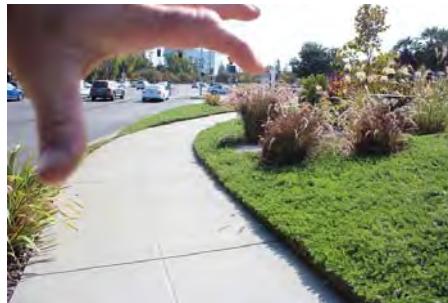
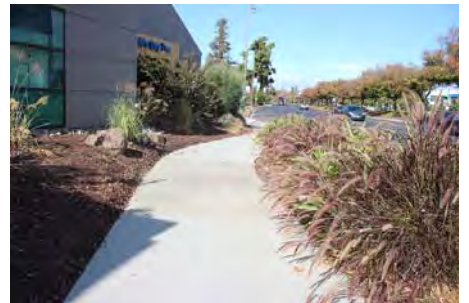
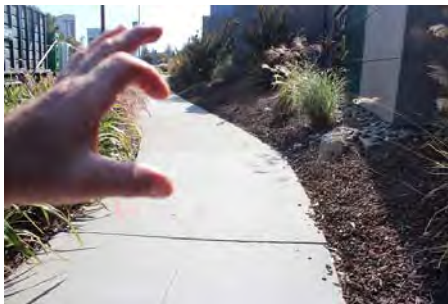
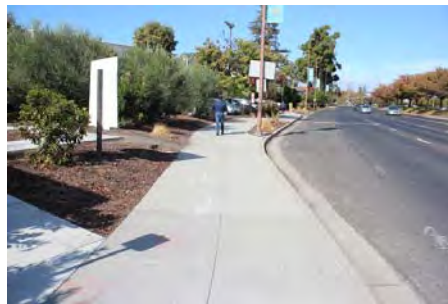
COD	CONDITION DESCRIPTION	ACTUAL
B16	Cross slope (perpendicular to direction of travel) is 1:48 (2.08%) max. (ADAS 403.3)	Approx. 240' L is 2.5% to 4.7%.

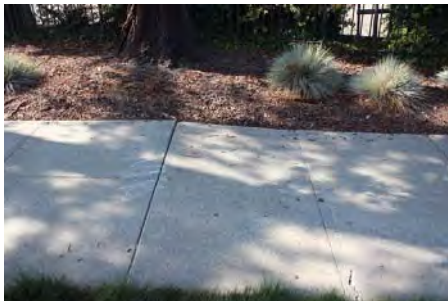
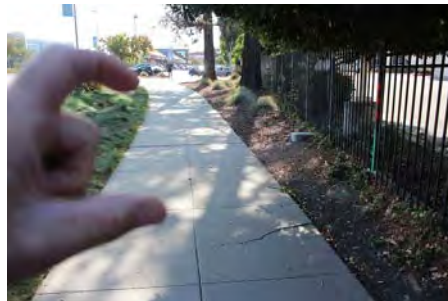
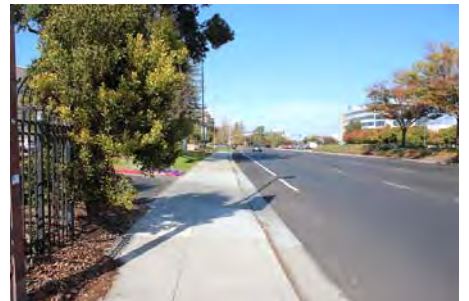
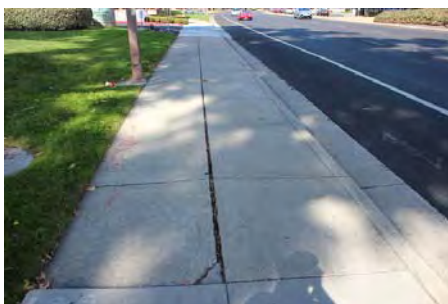
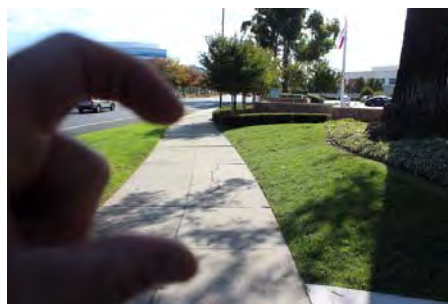
COD	CONDITION DESCRIPTION	ACTUAL
B12	Gaps/openings in ground or floor surfaces do not allow the passage of a sphere more than 1/2" in diameter. (ADAS 302.3)	Up to 2" W gap approx. 45' L.
B13	Gaps/openings are oriented perpendicular to dominant direction of travel. (ADAS 302.3)	Approx. 45' L gap in direction of travel.
B16	Cross slope (perpendicular to direction of travel) is 1:48 (2.08%) max. (ADAS 403.3)	Approx. 50' L is 2.7% to 3.0%.
B17	Running slope (parallel to direction of travel) is 1:20 (5.0%) max. (ADAS 403.3)	Approx. 10' L is up to 10.0%.

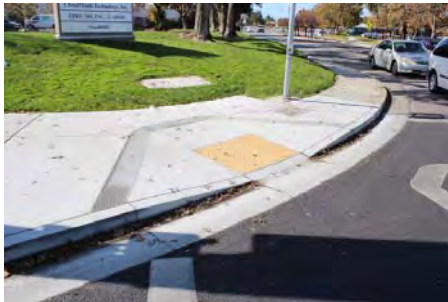
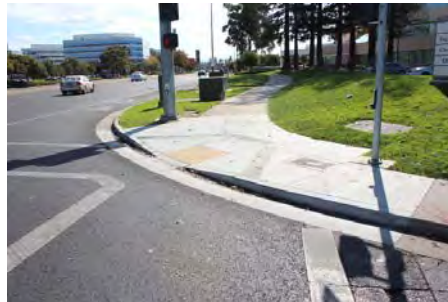
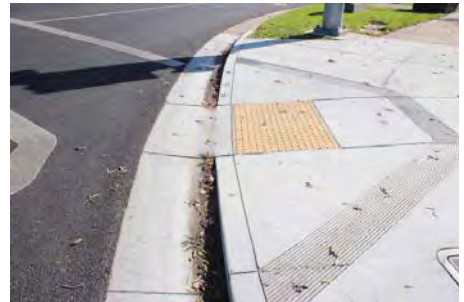
COD	CONDITION DESCRIPTION	ACTUAL
B03	Running slope of ramp is 1:12 (8.33%) max. (ADAS 405.2)	20.0% at btm. 2", 13.1% at btm. 2" to 6" (otherwise 7.4%).
B14	Counter slopes of adjoining gutters and road surfaces immediately adjacent to and within 24 inches of the curb ramp are not steeper than 1:20 (5.0%). (ADAS 406.2)	10.3%

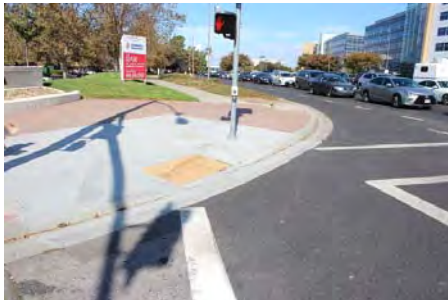
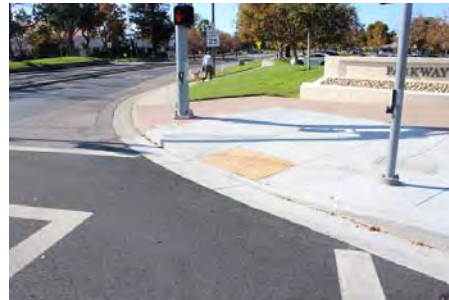
COD	CONDITION DESCRIPTION	ACTUAL
B03	Running slope of ramp is 1:12 (8.33%) max. (ADAS 405.2)	9.2% at btm. 6".
B14	Counter slopes of adjoining gutters and road surfaces immediately adjacent to and within 24 inches of the curb ramp are not steeper than 1:20 (5.0%). (ADAS 406.2)	9.4%

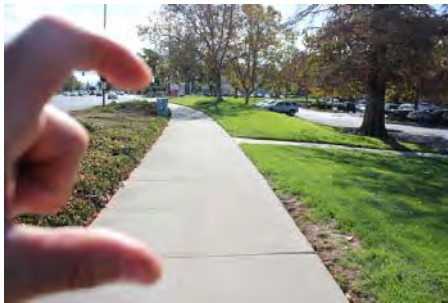
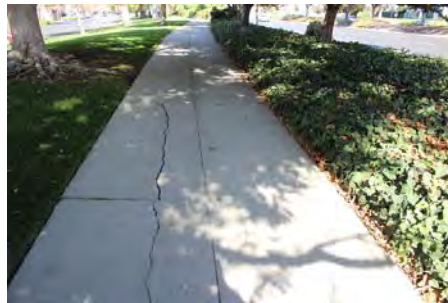
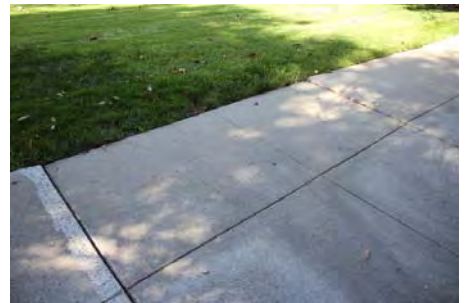
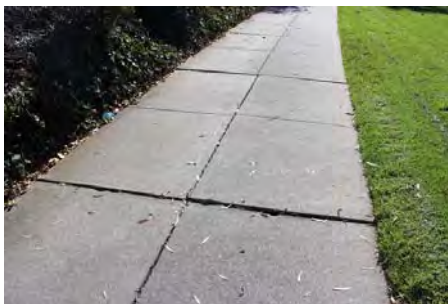
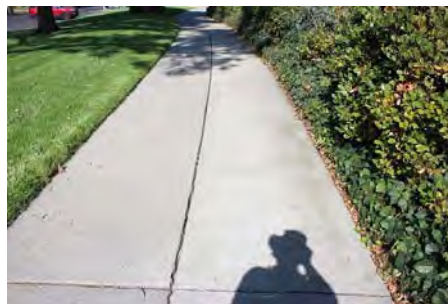
COD	CONDITION DESCRIPTION	ACTUAL
B12	Gaps/openings in ground or floor surfaces do not allow the passage of a sphere more than 1/2" in diameter. (ADAS 302.3)	Approx. 80' L gap exceeding 1/2" W in direction of travel.
B13	Gaps/openings are oriented perpendicular to dominant direction of travel. (ADAS 302.3)	Approx. 80' L gap exceeding 1/2" W in direction of travel.
B15	No level changes greater than 1/2" (except by accessible ramp or other means). (ADAS 303.4)	1" and 1 1/2" high vertical edge.
B16	Cross slope (perpendicular to direction of travel) is 1:48 (2.08%) max. (ADAS 403.3)	Approx. 770' L is 2.5% to 5.7%.

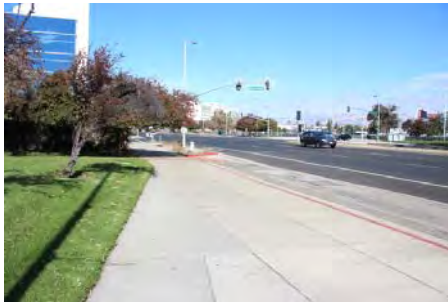
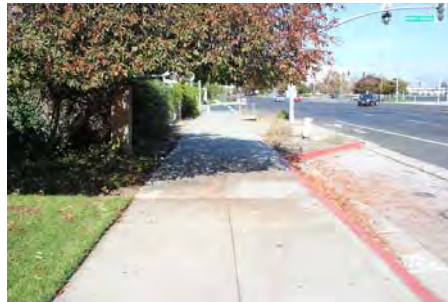
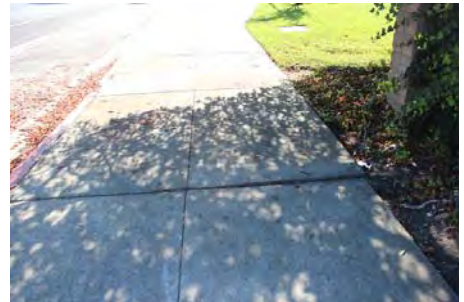
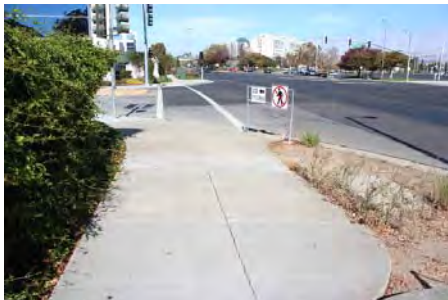
COD	CONDITION DESCRIPTION	ACTUAL
B15	No level changes greater than 1/2" (except by accessible ramp or other means). (ADAS 303.4)	1 1/2" high vertical edge.
B16	Cross slope (perpendicular to direction of travel) is 1:48 (2.08%) max. (ADAS 403.3)	Appox. 50' L is 2.7% to 6.0%.

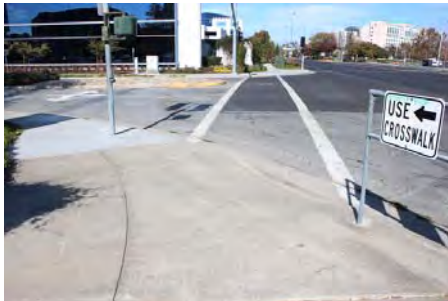
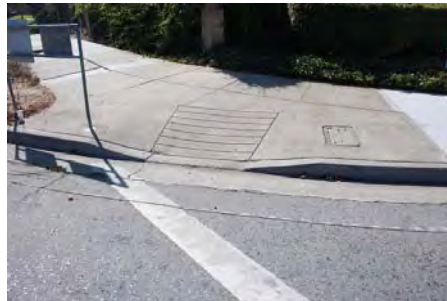
COD	CONDITION DESCRIPTION	ACTUAL
B03	Running slope of ramp is 1:12 (8.33%) max. (ADAS 405.2)	15.0%
B06	Transition to walk, gutter or street is flush and free of abrupt changes. (ADAS 406.2)	1/2" high vertical edge.
B14	Counter slopes of adjoining gutters and road surfaces immediately adjacent to and within 24 inches of the curb ramp are not steeper than 1:20 (5.0%). (ADAS 406.2)	10.5%
B16	Maximum slope of flared sides is 1:10 (10.0%). (ADAS 406.2)	14.4% right side, 14.5% left side.

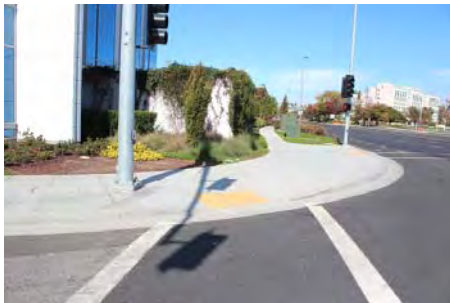
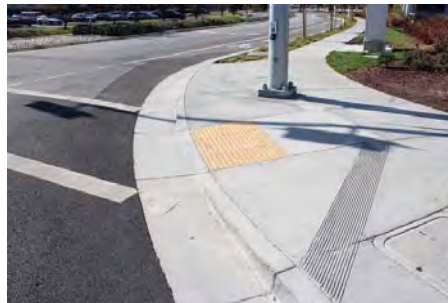
COD	CONDITION DESCRIPTION	ACTUAL
B14	Counter slopes of adjoining gutters and road surfaces immediately adjacent to and within 24 inches of the curb ramp are not steeper than 1:20 (5.0%). (ADAS 406.2)	10.0%

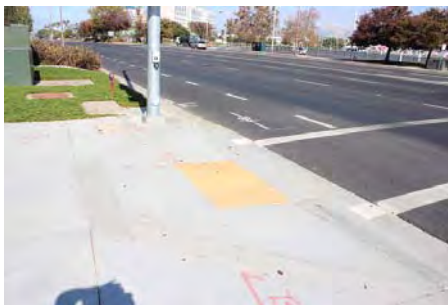
COD	CONDITION DESCRIPTION	ACTUAL
B14	Counter slopes of adjoining gutters and road surfaces immediately adjacent to and within 24 inches of the curb ramp are not steeper than 1:20 (5.0%). (ADAS 406.2)	6.9%

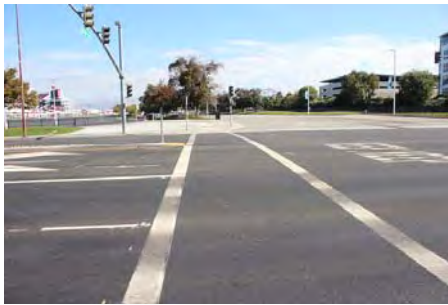
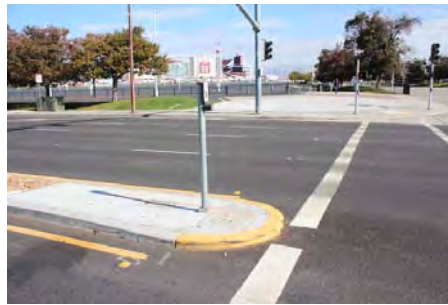
COD	CONDITION DESCRIPTION	ACTUAL
B15	No level changes greater than 1/2" (except by accessible ramp or other means). (ADAS 303.4)	User who cannot step up the curb must wait in traffic lanes.

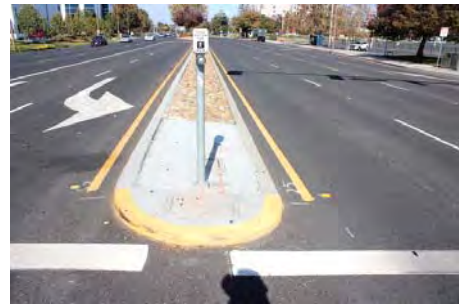
COD	CONDITION DESCRIPTION	ACTUAL
B41	Side reach over an obstruction greater than 10"d is max 46" AFF where the obstruction is max 34"AFF, and reach depth is no more than 24". (ADAS 308.3.2)	Over 28" from clear space and approx. 49" AFF.

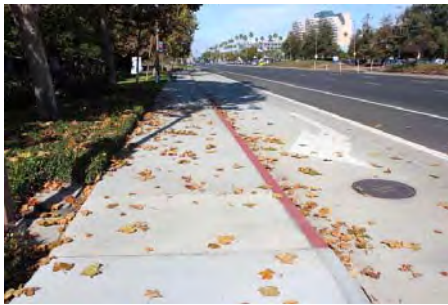
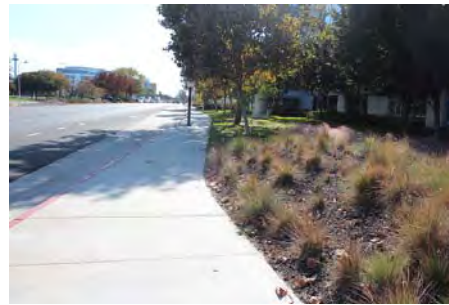
COD	CONDITION DESCRIPTION	ACTUAL
B16	Cross slope (perpendicular to direction of travel) is 1:48 (2.08%) max. (ADAS 403.3)	Approx. 280' L is 2.7% to 6.1%

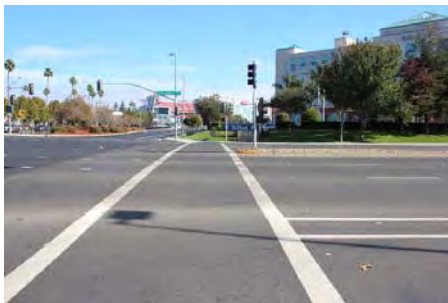
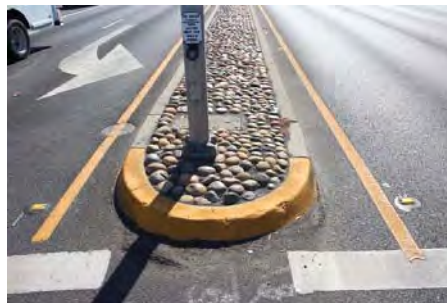
COD	CONDITION DESCRIPTION	ACTUAL
B15	No level changes greater than 1/2" (except by accessible ramp or other means). (ADAS 303.4)	Sign indicates to push button and wait for walk signal, however, user who cannot step up the curb must wait in traffic lanes.

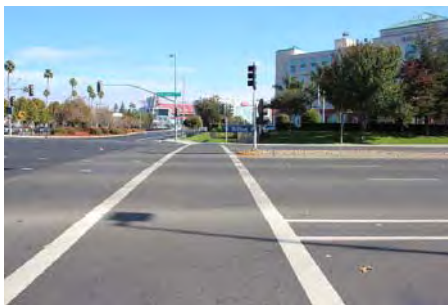
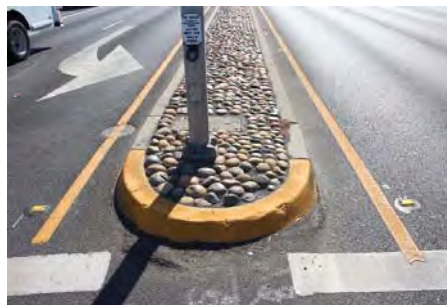
COD	CONDITION DESCRIPTION	ACTUAL
B41	Side reach over an obstruction greater than 10"d is max 46" AFF where the obstruction is max 34" AFF, and reach depth is no more than 24". (ADAS 308.3.2)	27" away from clear space.

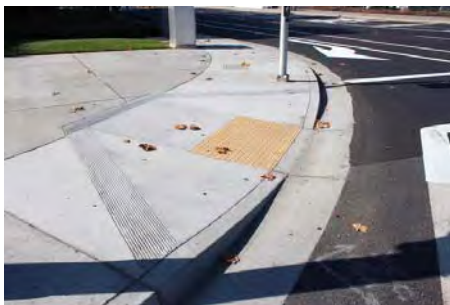
COD	CONDITION DESCRIPTION	ACTUAL
B14	Counter slopes of adjoining gutters and road surfaces immediately adjacent to and within 24 inches of the curb ramp are not steeper than 1:20 (5.0%). (ADAS 406.2)	9.5%

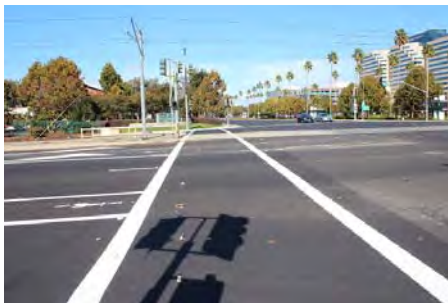
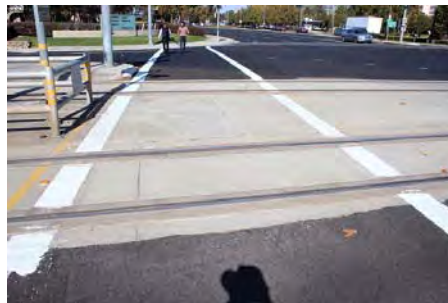
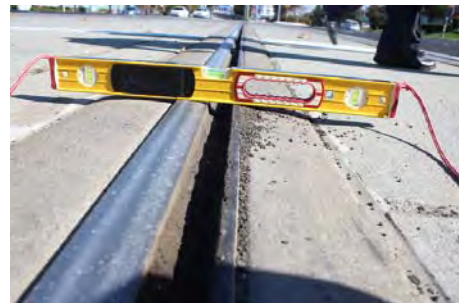
COD	CONDITION DESCRIPTION	ACTUAL
C40	Where pedestrian access routes cross rails: the route surface is flush with the outer edges of rails and the surface between rails is aligned with the top of the rail. (PROWAG R302.7.1)	Up to 1" H mounds at all 4 rails.

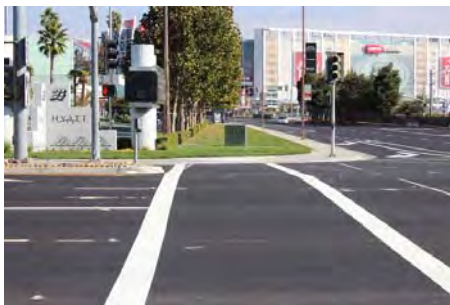
COD	CONDITION DESCRIPTION	ACTUAL
B15	No level changes greater than 1/2" (except by accessible ramp or other means). (ADAS 303.4)	User who cannot step up the curb must wait in traffic lanes.

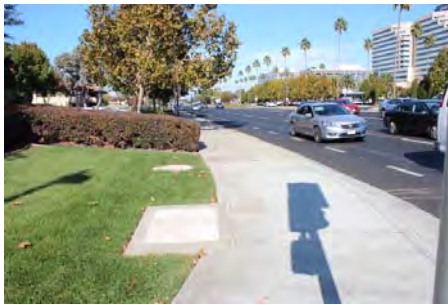
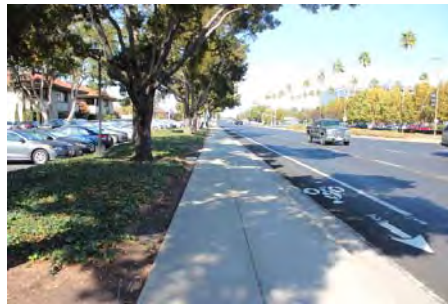
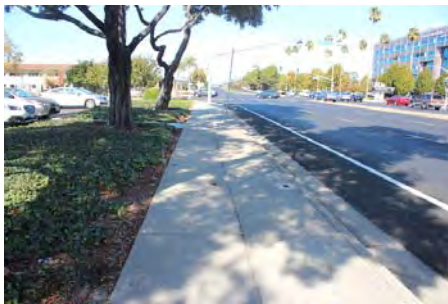
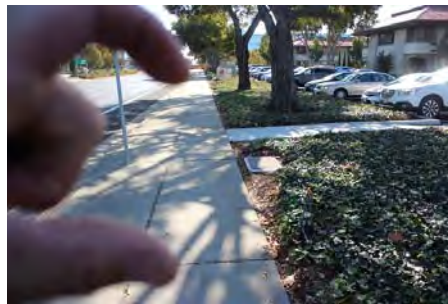
COD	CONDITION DESCRIPTION	ACTUAL
B16	Cross slope (perpendicular to direction of travel) is 1:48 (2.08%) max. (ADAS 403.3)	Approx. 80' L is 2.7% to 4.0%

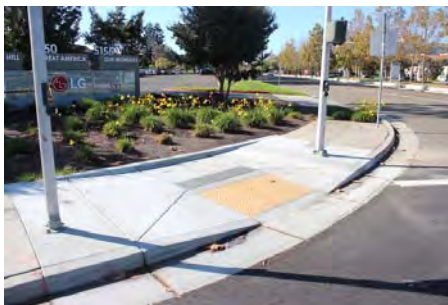
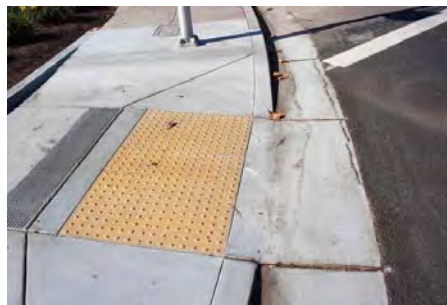
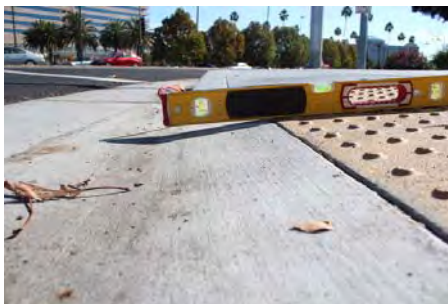
COD	CONDITION DESCRIPTION	ACTUAL
B03	Running slope of ramp is 1:12 (8.33%) max. (ADAS 405.2)	16.4% Across curb face.

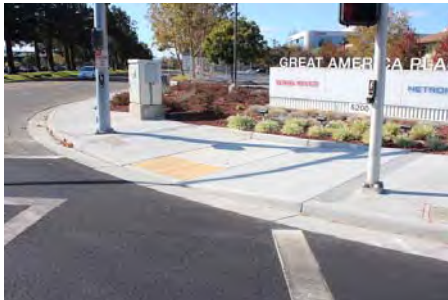
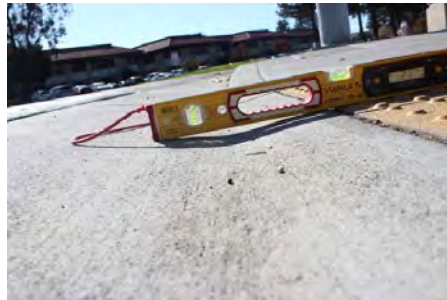
COD	CONDITION DESCRIPTION	ACTUAL
B06	Transition to walk, gutter or street is flush and free of abrupt changes. (ADAS 406.2)	13.1% gutter meets opposite slope of 10.5% for combined slope of 23.6%.
C11	Min. 48" x 48" turning space is provided at bottom of curb ramp. (ADAS 403.3)	10.5% Across curb face.

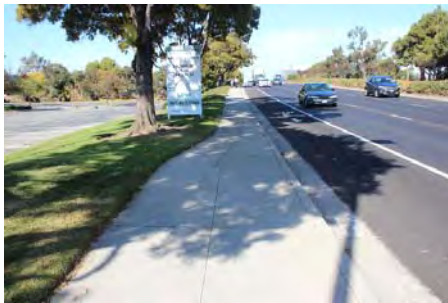
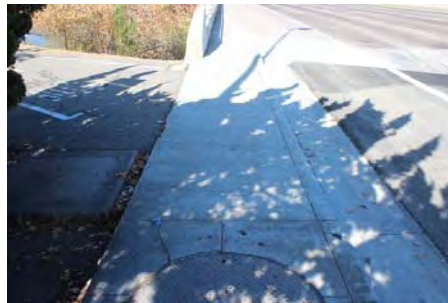
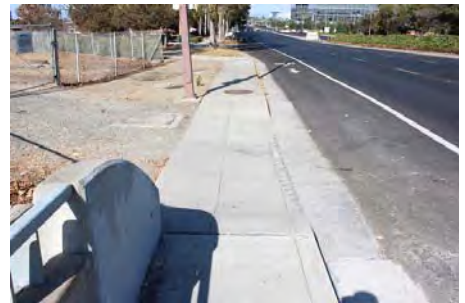
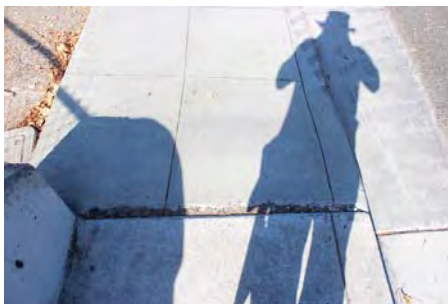
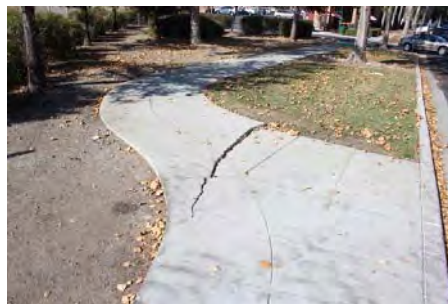
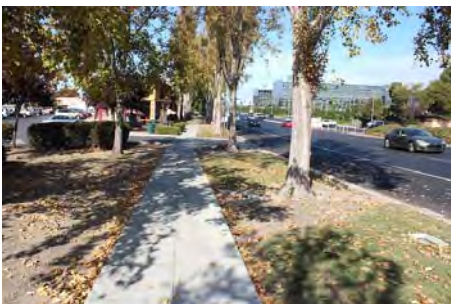
COD	CONDITION DESCRIPTION	ACTUAL
B12	Gaps/openings in ground or floor surfaces do not allow the passage of a sphere more than 1/2" in diameter. (ADAS 302.3)	2" gap at transition to bridge and 1" gap at raised crack.
B15	No level changes greater than 1/2" (except by accessible ramp or other means). (ADAS 303.4)	1 1/2" high vertical edge.
B16	Cross slope (perpendicular to direction of travel) is 1:48 (2.08%) max. (ADAS 403.3)	Approx. 40' L is 2.6% to 3.6% and 7.5% to 8.3% at 2 driveway aprons at each side of the bridge.
B17	Running slope (parallel to direction of travel) is 1:20 (5.0%) max. (ADAS 403.3)	14.8% and 27.0% at 2 driveway aprons at each side of bridge.

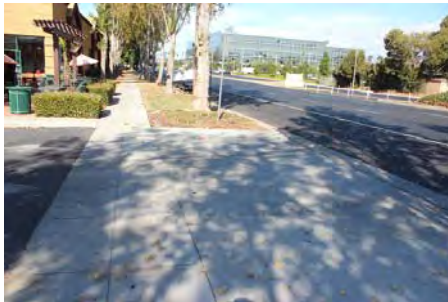
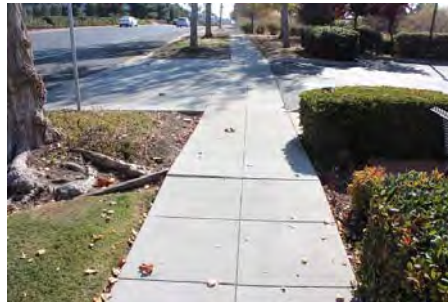
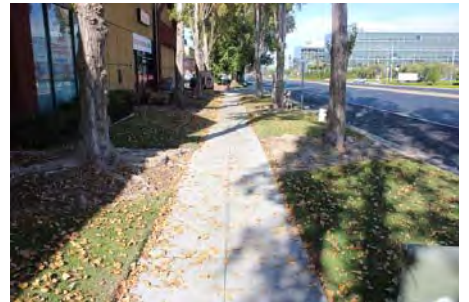
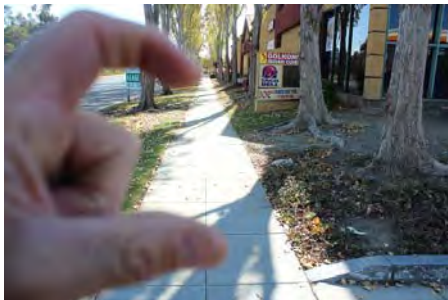
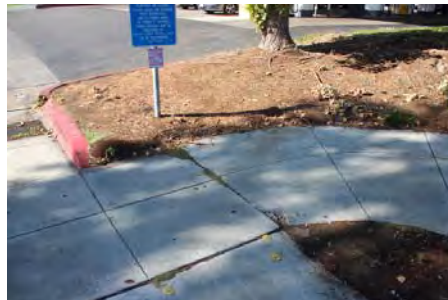
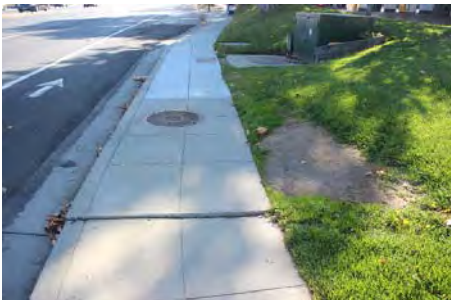
COD	CONDITION DESCRIPTION	ACTUAL
B15	No level changes greater than 1/2" (except by accessible ramp or other means). (ADAS 303.4)	3/4" and 7/8" high vertical edge.
B16	Cross slope (perpendicular to direction of travel) is 1:48 (2.08%) max. (ADAS 403.3)	Approx. 240' L is 2.6% to 7.5%.

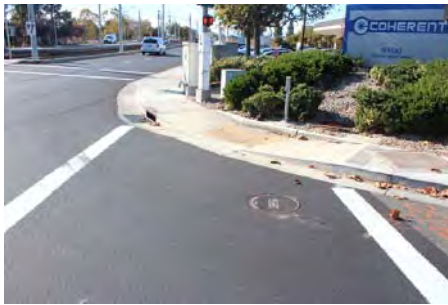
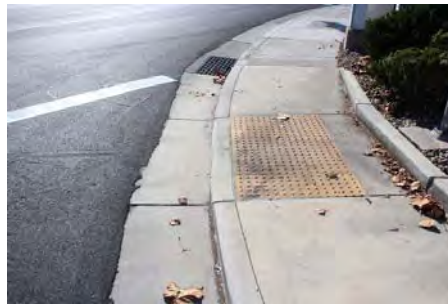
CODE	CONDITION DESCRIPTION	ACTUAL
B06 406.2)	Transition to walk, gutter or street is flush and free of abrupt changes. (ADAS 406.2)	1/2" high vertical edge.

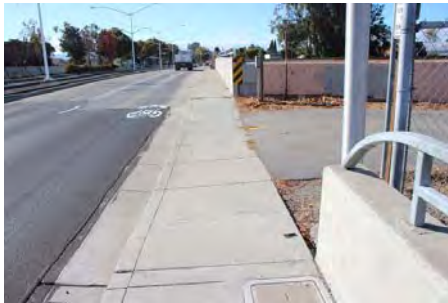
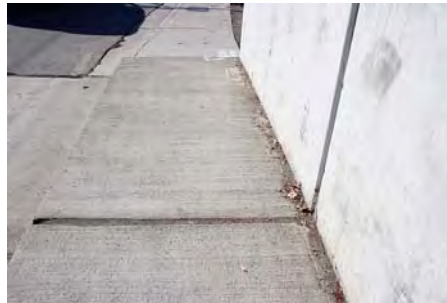
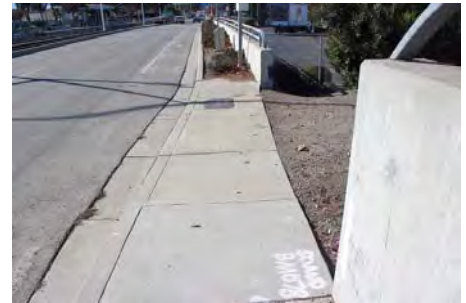
CODE	CONDITION DESCRIPTION	ACTUAL
B11	Surface is firm, stable and slip-resistant. (ADAS 302.1)	Sidewalk ends near Calabasas Creek trail.
B12	Gaps/openings in ground or floor surfaces do not allow the passage of a sphere more than 1/2" in diameter. (ADAS 302.3)	1 3/4" W at expansion joint
B16	Cross slope (perpendicular to direction of travel) is 1:48 (2.08%) max. (ADAS 403.3)	Up to 4.9% at driveway aprons.
B17	Running slope (parallel to direction of travel) is 1:20 (5.0%) max. (ADAS 403.3)	9.6% and 11.5% at 2 driveway aprons.

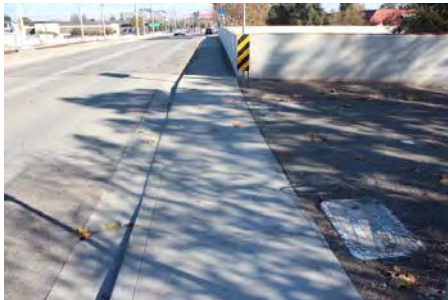
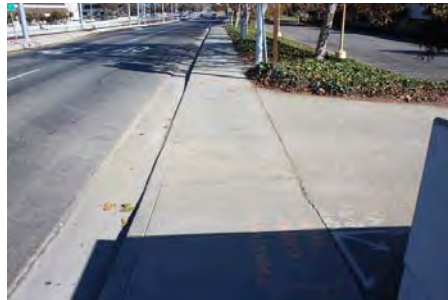
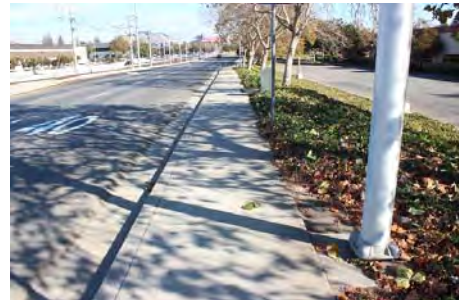
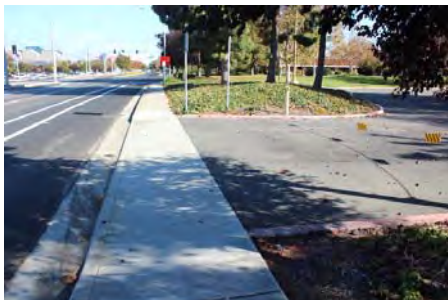
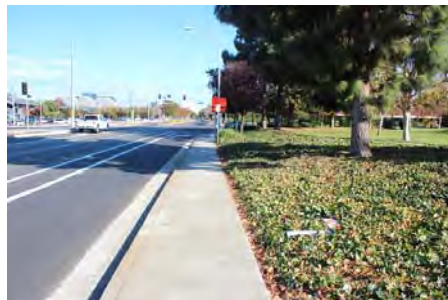
CODE	CONDITION DESCRIPTION	ACTUAL
B16	Cross slope (perpendicular to direction of travel) is 1:48 (2.08%) max. (ADAS 403.3)	Approx. 160' L is 2.5% to 4.9% and up to 11.1% at Driveway apron.
B17	Running slope (parallel to direction of travel) is 1:20 (5.0%) max. (ADAS 403.3)	14.7% and 14.6% at drive aisle.

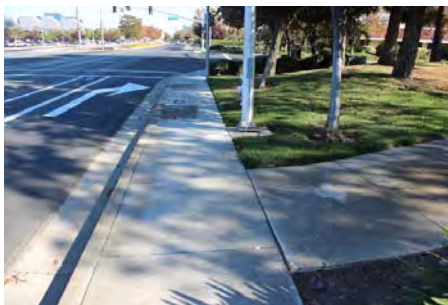
CODE	CONDITION DESCRIPTION	ACTUAL
B16	Cross slope (perpendicular to direction of travel) is 1:48 (2.08%) max. (ADAS 403.3)	Approx. 30' L is 3.2% to 3.7%.

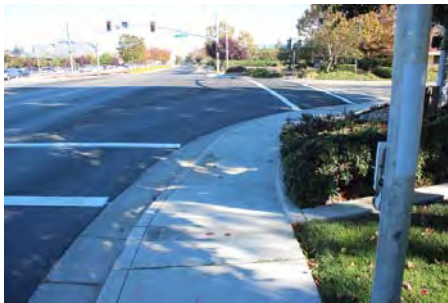
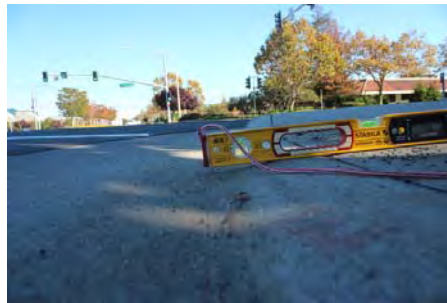
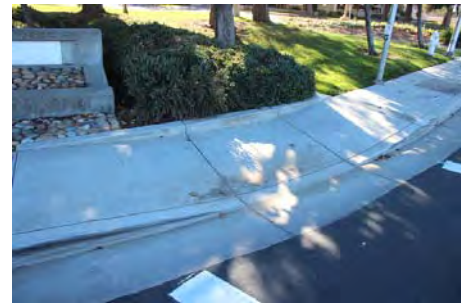
CODE	CONDITION DESCRIPTION	ACTUAL
B04	Cross slope is 1:48 (2.08%) max. (ADAS 405.3)	3.0% at W side ramp.
B06	Transition to walk, gutter or street is flush and free of abrupt changes. (ADAS 406.2)	17.7% for 2" L at gutter.
C12	Turning space at bottom of curb ramp slopes 1:48 (2.08%) max. in any direction (ADAS 403.3)	3.2% to 3.6%
B13	Counter slopes of adjoining gutters and road surfaces immediately adjacent to and within 24 inches of the curb ramp are not steeper than 1:20 (5.0%). (ADAS 406.2)	8.7%

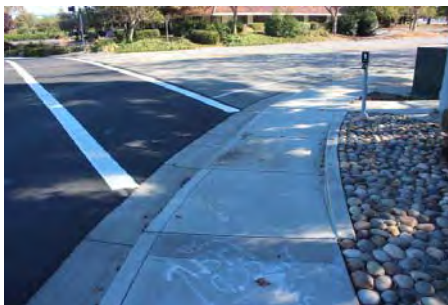
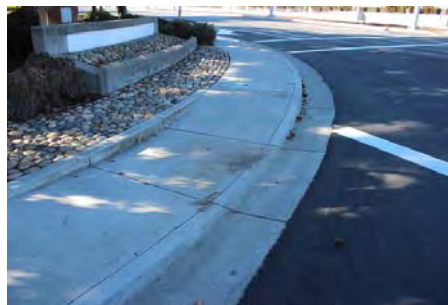
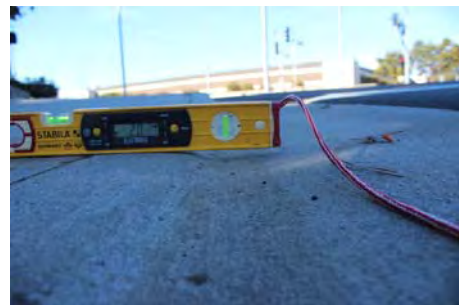
CODE	CONDITION DESCRIPTION	ACTUAL
B13	Counter slopes of adjoining gutters and road surfaces immediately adjacent to and within 24 inches of the curb ramp are not steeper than 1:20 (5.0%). (ADAS 406.2)	7.0% generally and 25.0% for 1" L.

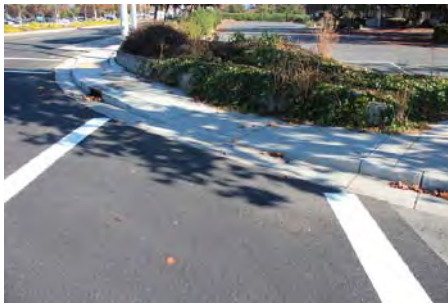
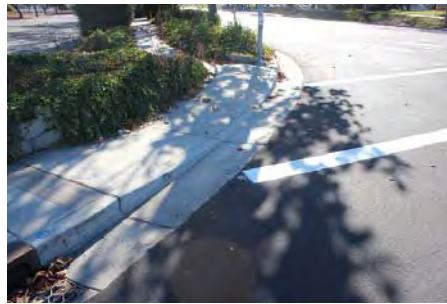
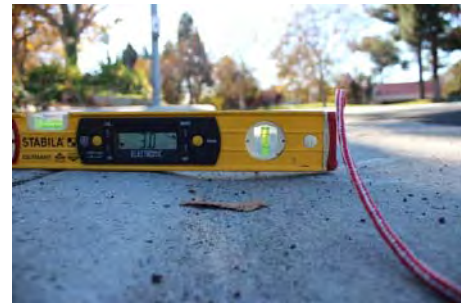
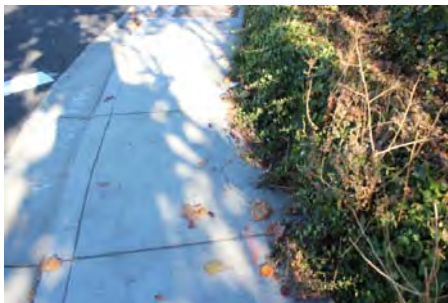
CODE	CONDITION DESCRIPTION	ACTUAL
B02	The width of curb ramp is 36" min. (ADAS 405.5)	Partially obstructed by landscaping.
B06	Transition to walk, gutter or street is flush and free of abrupt changes. (ADAS 406.2)	1/2" high vertical edge
C12	Turning space at bottom of curb ramp slopes 1:48 (2.08%) max. in any direction (ADAS 403.3)	2.5% to 3.2%

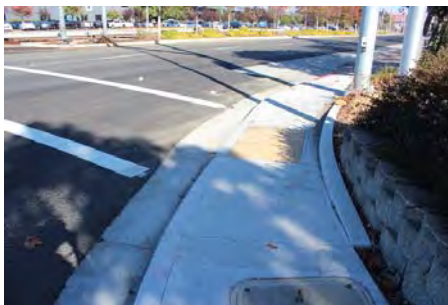
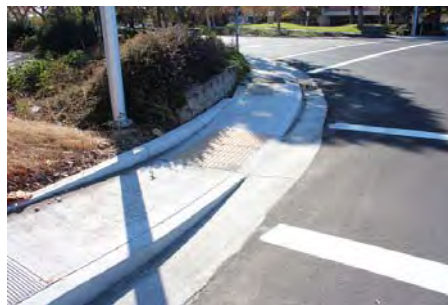
CODE	CONDITION DESCRIPTION	ACTUAL
B13	Counter slopes of adjoining gutters and road surfaces immediately adjacent to and within 24 inches of the curb ramp are not steeper than 1:20 (5.0%). (ADAS 406.2)	9.6% for 2" L.

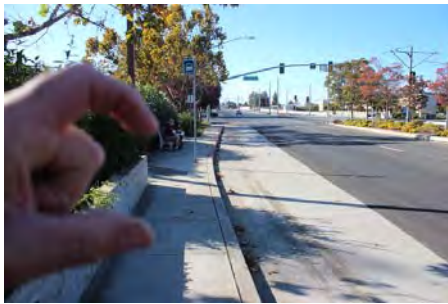
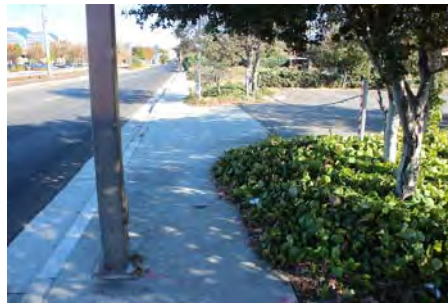
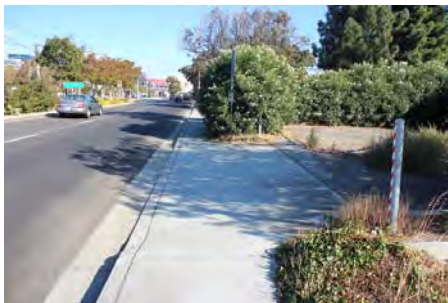
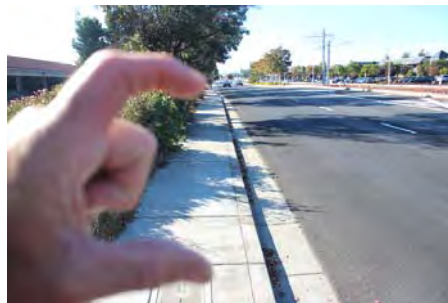
CODE	CONDITION DESCRIPTION	ACTUAL
B02	36" min. clear width of exterior walkway. (ADAS 403.5.1)	Landscape reduces width to 33" W at light post and 34" W near Ironsides drive.
B16	Cross slope (perpendicular to direction of travel) is 1:48 (2.08%) max. (ADAS 403.3)	Approx. 220' L is 2.6% to 4.5% and 5 drive aisles causing slopes from 4.5% to 10.8%.
B17	Running slope (parallel to direction of travel) is 1:20 (5.0%) max. (ADAS 403.3)	5 drive aisles causing slopes in 10 sections from 12.2% to 19.8%.

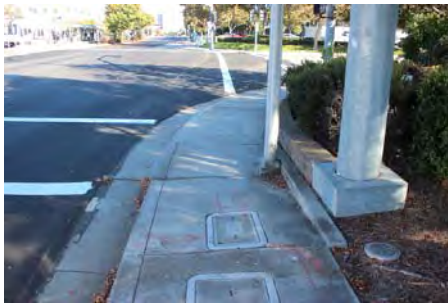
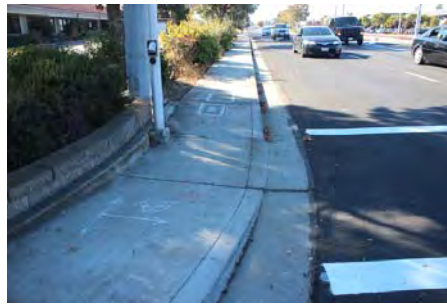
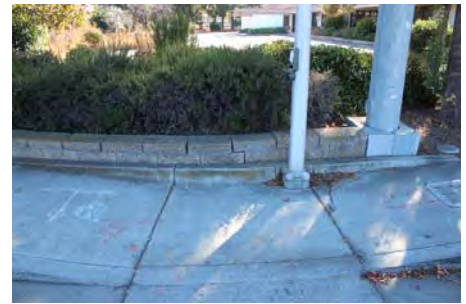
CODE	CONDITION DESCRIPTION	ACTUAL
B04	Cross slope is 1:48 (2.08%) max. (ADAS 405.3)	3.4% at W side ramp.
B06	Transition to walk, gutter or street is flush and free of abrupt changes. (ADAS 406.2)	3/8" high vertical edge.
C12	Turning space at bottom of curb ramp slopes 1:48 (2.08%) max. in any direction (ADAS 403.3)	Up to 3.3%.

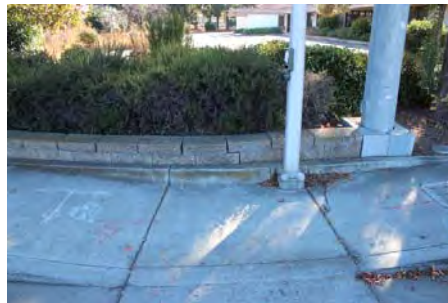
CODE	CONDITION DESCRIPTION	ACTUAL
B11	The clear floor space is without changes in level except for slopes up to 1:48 (2.08%). (ADAS 305.2)	3.3% at cross walk button.

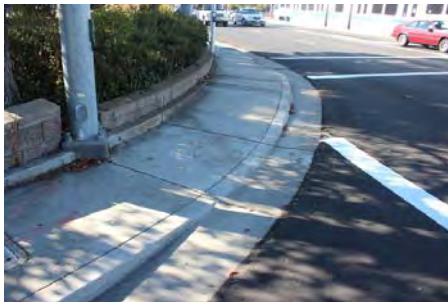
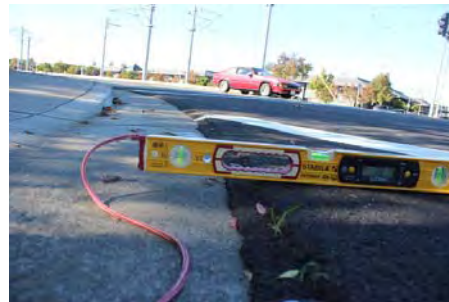
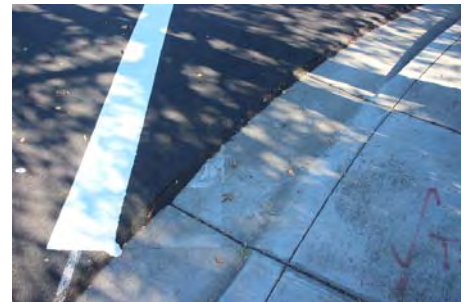
CODE	CONDITION DESCRIPTION	ACTUAL
B05	Surface of ramp and landings complies with requirements for an accessible path of travel (stable, firm, slip-resistant, without gaps over 1/2" wide or edges over 1/4" high). (ADAS 405.4)	1 1/8" high vertical edge at asphalt transition.
C12	Turning space at bottom of curb ramp slopes 1:48 (2.08%) max. in any direction (ADAS 403.3)	3.1%

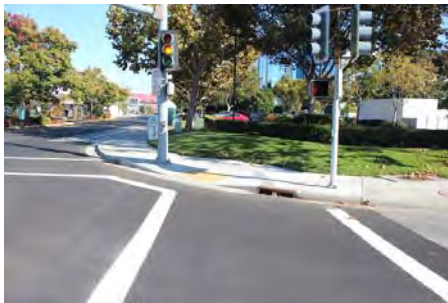
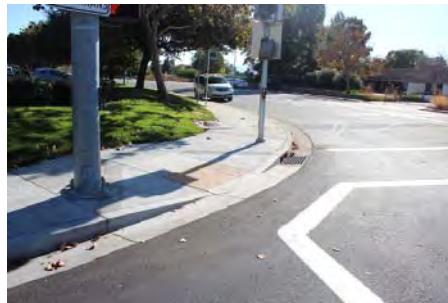
CODE	CONDITION DESCRIPTION	ACTUAL
B14	1/4" to 1/2" level changes are beveled at max 1:2 (vert:horiz) slope. (ADAS 303.3)	7.0%
