Case No. 5:16-cv-07013-LHK (SVK)

**DECLARATION OF JEFFREY SCOTT  
MASTIN IN SUPPORT OF PLAINTIFFS'  
MOTION FOR CLASS CERTIFICATION**

NEVAREZ V 49ERS - ACCESSIBILITY ASSESSMENT

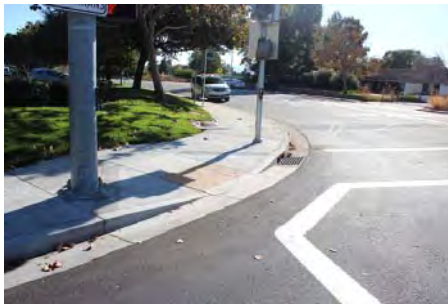
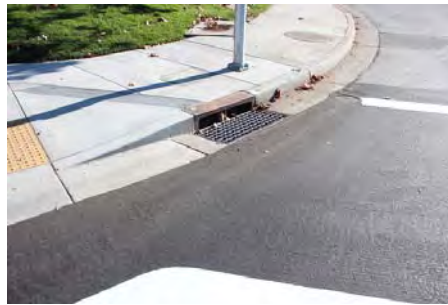
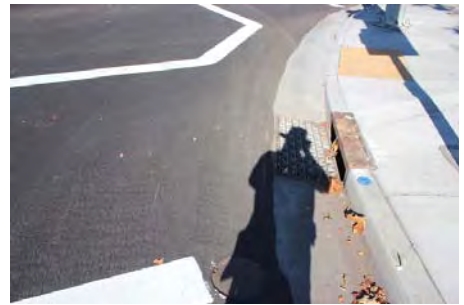
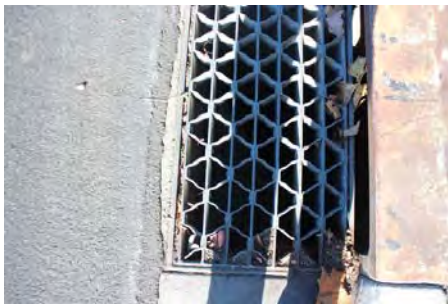
CODE	CONDITION DESCRIPTION	ACTUAL
B12	Gaps/openings in ground or floor surfaces do not allow the passage of a sphere more than 1/2" in diameter. (ADAS 302.3)	2" openings at grate near SE corner.

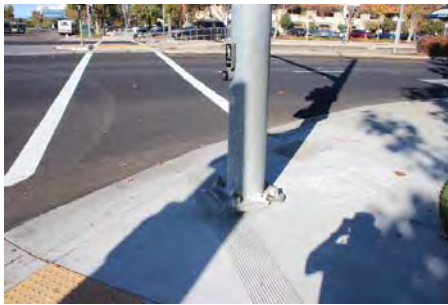
CODE	CONDITION DESCRIPTION	ACTUAL
B11	The clear floor space is without changes in level except for slopes up to 1:48 (2.08%). (ADAS 305.2)	13.1% at cross walk button.

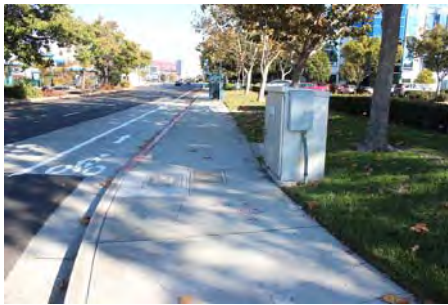
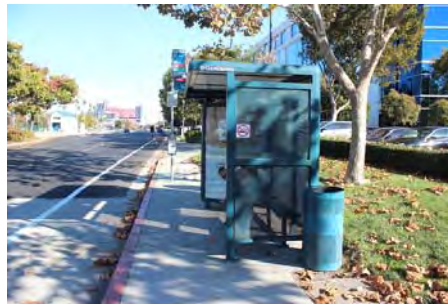
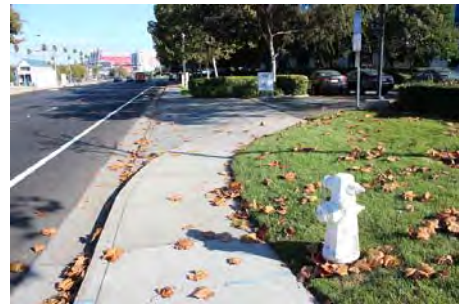
CODE	CONDITION DESCRIPTION	ACTUAL
B16	Cross slope (perpendicular to direction of travel) is 1:48 (2.08%) max. (ADAS 403.3)	Approx. 100' L is 2.6% to 5.1%.

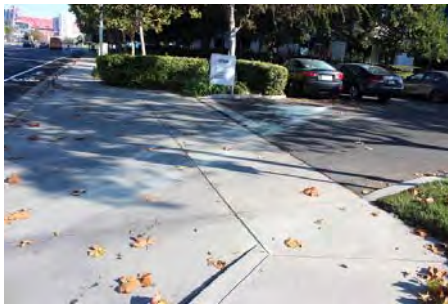
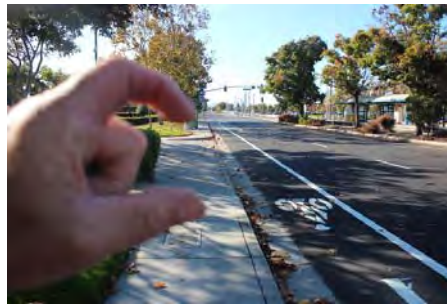
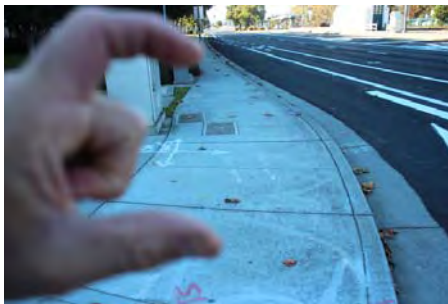
CODE	CONDITION DESCRIPTION	ACTUAL
B16	Cross slope (perpendicular to direction of travel) is 1:48 (2.08%) max. (ADAS 403.3)	Approx. 100' L is 2.7% to 4.1%.

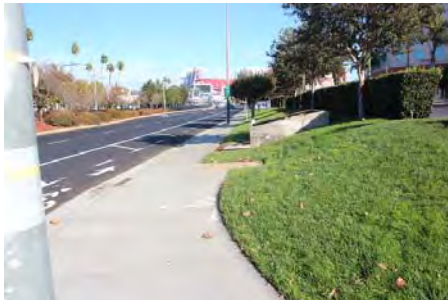
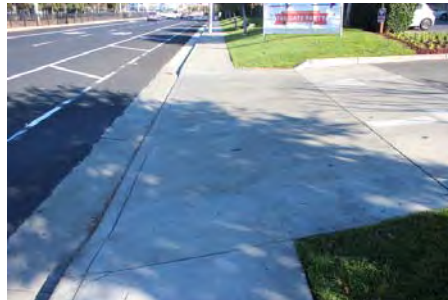
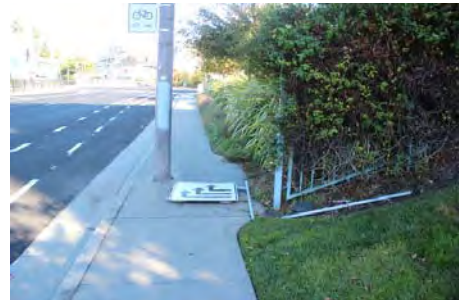
CODE	CONDITION DESCRIPTION	ACTUAL
B16	Cross slope (perpendicular to direction of travel) is 1:48 (2.08%) max. (ADAS 403.3)	Approx. 340' L is 2.5% to 5.0% and 6.9% across Hilton drive aisle.
B17	Running slope (parallel to direction of travel) is 1:20 (5.0%) max. (ADAS 403.3)	15.2% and 21.4% at Hilton drive aisle.

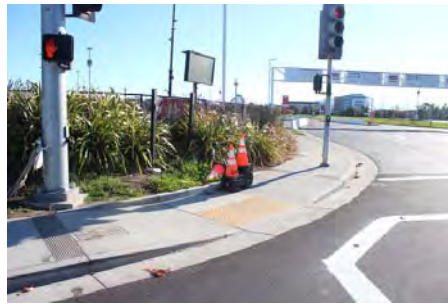
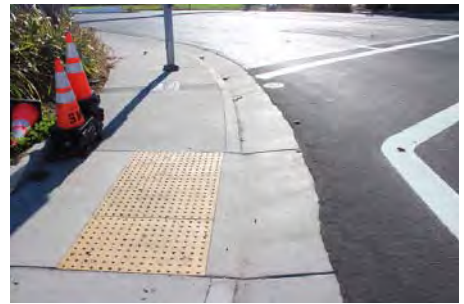
CODE	CONDITION DESCRIPTION	ACTUAL
B02	The width of curb ramp is 36" min. (ADAS 405.5)	Obstructed by traffic cones.
C12	Turning space at bottom of curb ramp slopes 1:48 (2.08%) max. in any direction (ADAS 403.3)	2.4% to 3.0% and 4.9% across curb face.
B13	Counter slopes of adjoining gutters and road surfaces immediately adjacent to and within 24 inches of the curb ramp are not steeper than 1:20 (5.0%). (ADAS 406.2)	8.7%

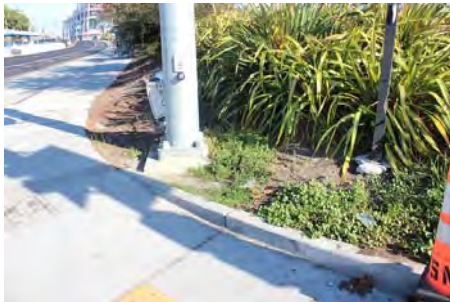
CODE	CONDITION DESCRIPTION	ACTUAL
B11	The clear floor space is without changes in level except for slopes up to 1:48 (2.08%). (ADAS 305.2)	4.1% at cross walk button.
B41	Side reach over an obstruction greater than 10"d is max 46" AFF where the obstruction is max 34" AFF, and reach depth is no more than 24". (ADAS 308.3.2)	25" reach over curb to cross walk button.

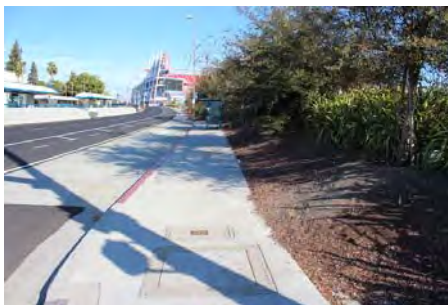
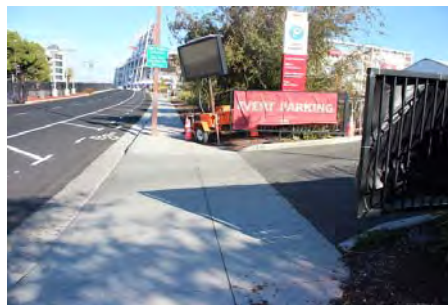
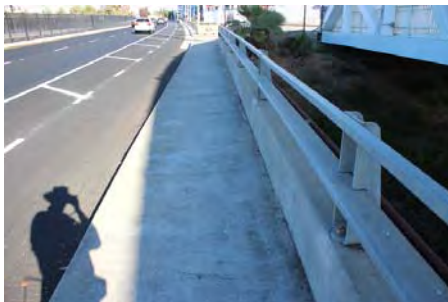
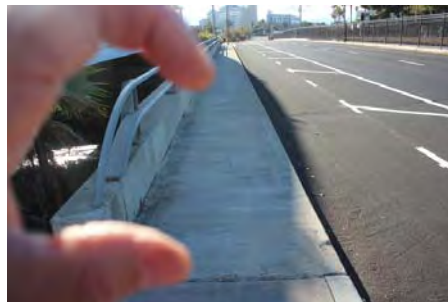
CODE	CONDITION DESCRIPTION	ACTUAL
B16	Cross slope (perpendicular to direction of travel) is 1:48 (2.08%) max. (ADAS 403.3)	Approx. 120' L is 2.8% to 3.5% and 2.7% across drive aisle.

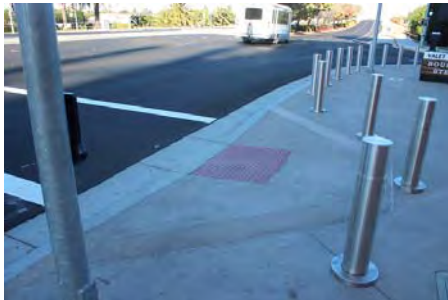
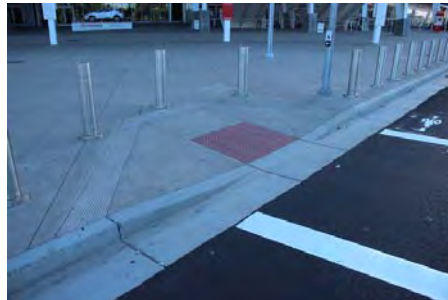
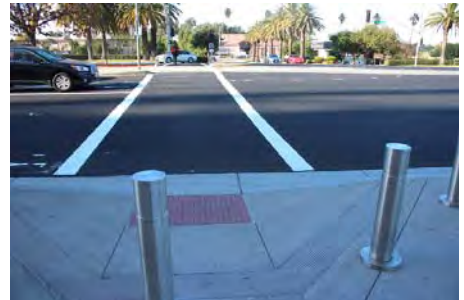
CODE	CONDITION DESCRIPTION	ACTUAL
B02	The width of curb ramp is 36" min. (ADAS 405.5)	Obstructed by bollard.
B03	Running slope of ramp is 1:12 (8.33%) max. (ADAS 405.2)	Up to 8.6%.

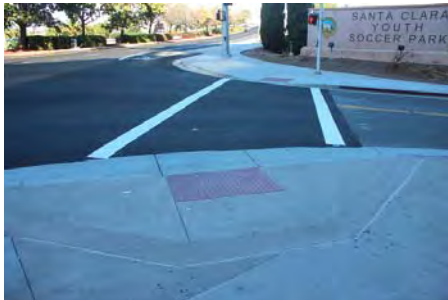
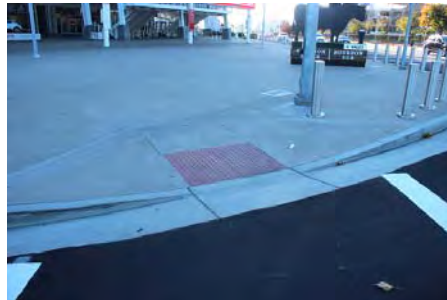
CODE	CONDITION DESCRIPTION	ACTUAL
B03	Running slope of ramp is 1:12 (8.33%) max. (ADAS 405.2)	Up to 9.2%.
B14	Counter slopes of adjoining gutters and road surfaces immediately adjacent to and within 24 inches of the curb ramp are not steeper than 1:20 (5.0%). (ADAS 406.2)	7.6%

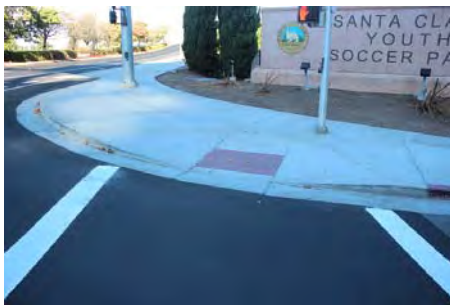
CODE	CONDITION DESCRIPTION	ACTUAL
B16	Cross slope (perpendicular to direction of travel) is 1:48 (2.08%) max. (ADAS 403.3)	2.8% to 3.8%.

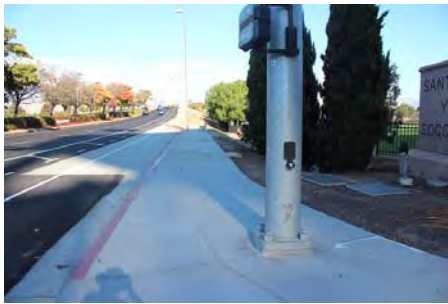
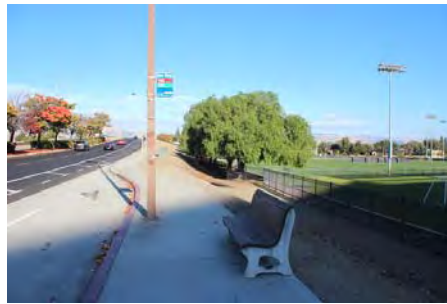
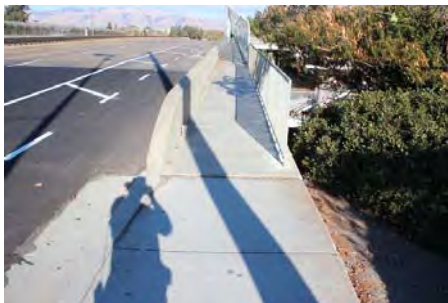
CODE	CONDITION DESCRIPTION	ACTUAL
B13	Gaps/openings are oriented perpendicular to dominant direction of travel. (ADAS 302.3)	2" W at bridge.
B15	No level changes greater than 1/2" (except by accessible ramp or other means). (ADAS 303.4)	1" high vertical edge at bridge.
B17	Running slope (parallel to direction of travel) is 1:20 (5.0%) max. (ADAS 403.3)	Long unbroken length of excessive running slope generally 4.5% and up to 6.3% at bridge.

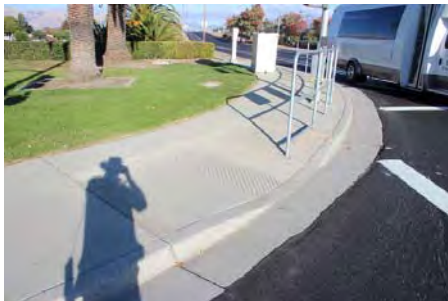
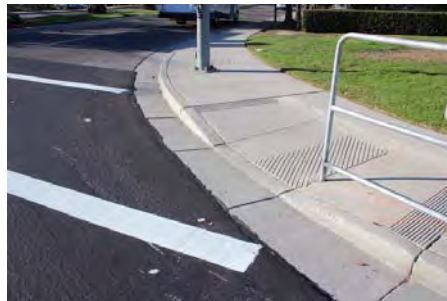
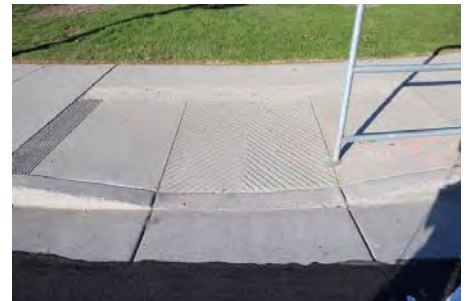
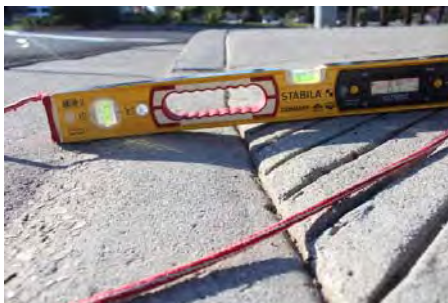
CODE	CONDITION DESCRIPTION	ACTUAL
B05	Surface of ramp and landings complies with requirements for an accessible path of travel (stable, firm, slip-resistant, without gaps over 1/2" wide or edges over 1/4" high). (ADAS 302.1, 403.2, 403.3, 403.4)	8.3% cross slope at top landing and 1/2" high vertical edge at asphalt transition at btm. Landing.
B06	Transition to walk, gutter or street is flush and free of abrupt changes. (ADAS 406.2)	2 edges, one at each side of curb line.
B14	Counter slopes of adjoining gutters and road surfaces immediately adjacent to and within 24 inches of the curb ramp are not steeper than 1:20 (5.0%). (ADAS 406.2)	11.2%

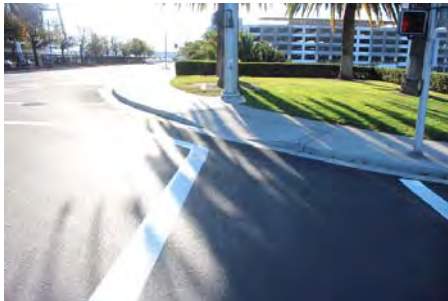
CODE	CONDITION DESCRIPTION	ACTUAL
B05	Surface of ramp and landings complies with requirements for an accessible path of travel (stable, firm, slip-resistant, without gaps over 1/2" wide or edges over 1/4" high). (ADAS 302.1, 403.2, 403.3, 403.4)	7.3% cross slope at top landing.
B14	Counter slopes of adjoining gutters and road surfaces immediately adjacent to and within 24 inches of the curb ramp are not steeper than 1:20 (5.0%). (ADAS 406.2)	11.9%
B16	Maximum slope of flared sides is 1:10 (10.0%). (ADAS 406.2)	19.8% left side.

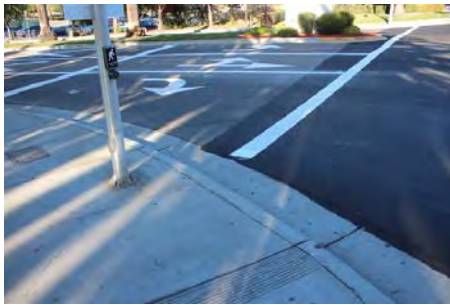
CODE	CONDITION DESCRIPTION	ACTUAL
B11	The clear floor space is without changes in level except for slopes up to 1:48 (2.08%). (ADAS 305.2)	7.1% at cross walk button.

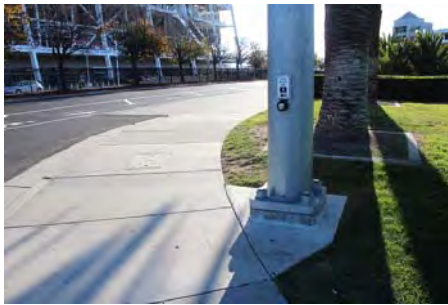
CODE	CONDITION DESCRIPTION	ACTUAL
B11	The clear floor space is without changes in level except for slopes up to 1:48 (2.08%). (ADAS 305.2)	5.4% at cross walk button.

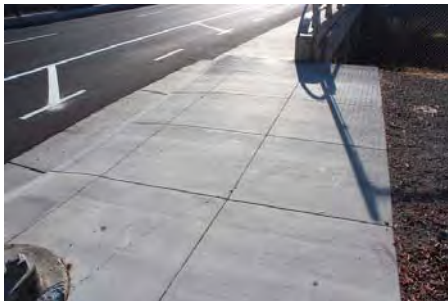
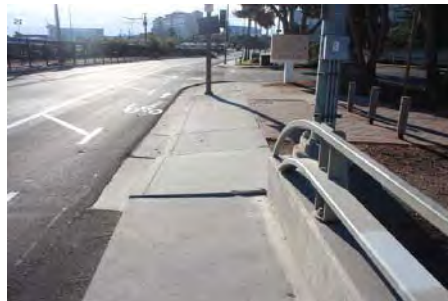
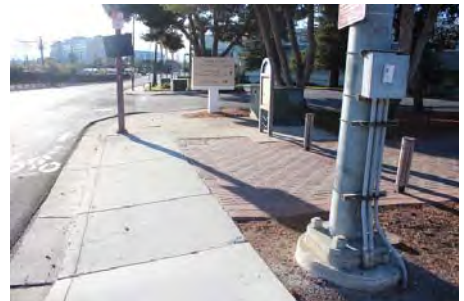
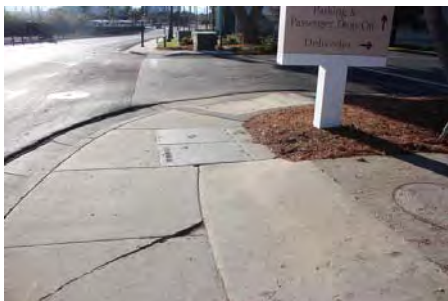
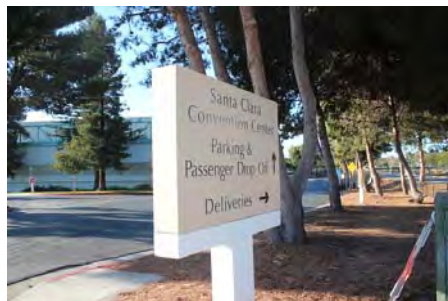
CODE	CONDITION DESCRIPTION	ACTUAL
B15	No level changes greater than 1/2" (except by accessible ramp or other means). (ADAS 303.4)	1" high vertical edge at W side of bridge.
B16	Cross slope (perpendicular to direction of travel) is 1:48 (2.08%) max. (ADAS 403.3)	9.8% at drive aisle at W side of bridge.
B17	Running slope (parallel to direction of travel) is 1:20 (5.0%) max. (ADAS 403.3)	7.8% at drive aisle at E side of bridge that appears recently constructed, 11.2% and 26.4% at drive aisle at W side.

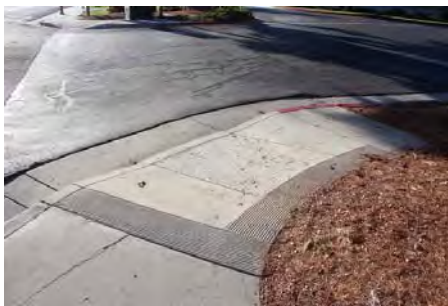
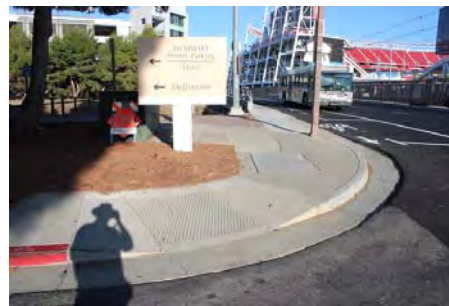
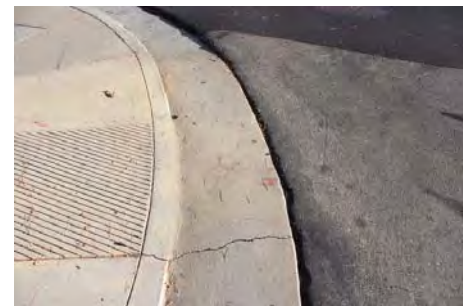
CODE	CONDITION DESCRIPTION	ACTUAL
B03	Running slope of ramp is 1:12 (8.33%) max. (ADAS 405.2)	10.8% to 12.0%
B05	Surface of ramp and landings complies with requirements for an accessible path of travel (stable, firm, slip-resistant, without gaps over 1/2" wide or edges over 1/4" high). (ADAS 302.1, 403.2, 403.3, 403.4)	1 1/2" gap and 3/4" high vertical edge at asphalt transition at btm. Landing.
B11	Top landing is as wide as the ramp and 36" min. in length. (ADAS 406.4)	None
A17	Where no top landing is provided at an existing ramp, side flare slopes are 8.33% max. (ADAS 406.4)	19.6% right side, 15.8% left side.

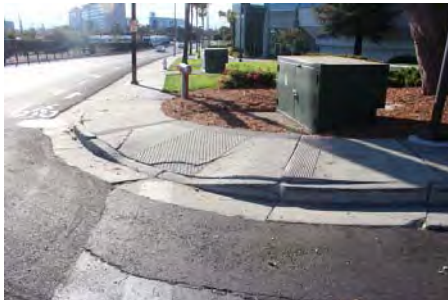
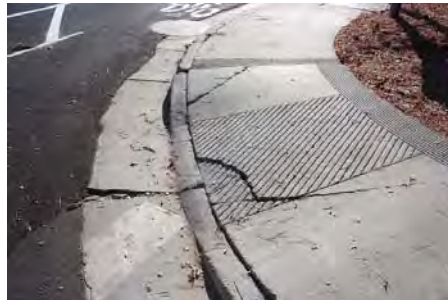
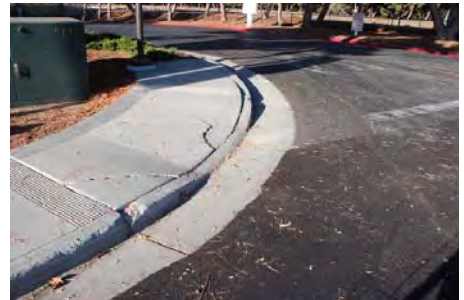
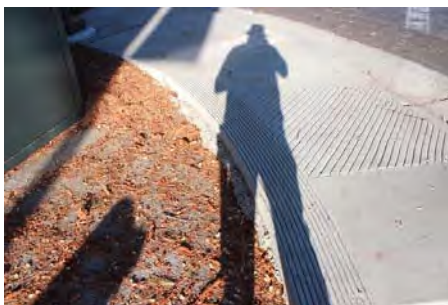
CODE	CONDITION DESCRIPTION	ACTUAL
B03	Running slope of ramp is 1:12 (8.33%) max. (ADAS 405.2)	11.1% to 12.4% and 25.6% at bottom 6".
B05	Surface of ramp and landings complies with requirements for an accessible path of travel (stable, firm, slip-resistant, without gaps over 1/2" wide or edges over 1/4" high). (ADAS 302.1, 403.2, 403.3, 403.4)	1 1/2" W gap on bottom landing and gap, and 3/4 high vertical edge on ramp (broken concrete).
B11	Top landing is as wide as the ramp and 36" min. in length. (ADAS 406.4)	None
B14	Counter slopes of adjoining gutters and road surfaces immediately adjacent to and within 24 inches of the curb ramp are not steeper than 1:20 (5.0%). (ADAS 406.2)	12.5%
A17	Where no top landing is provided at an existing ramp, side flare slopes are 8.33% max. (ADAS 406.4)	23.9% right side, 11.4% left side.

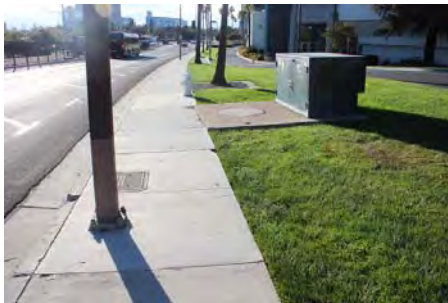
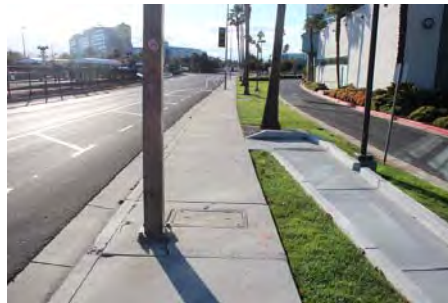
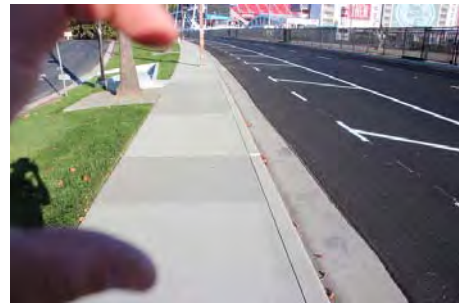
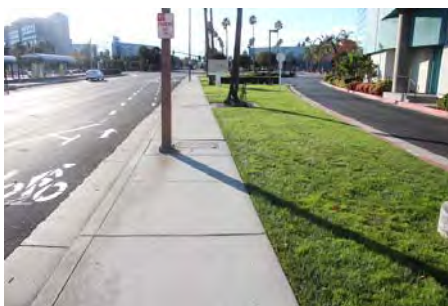
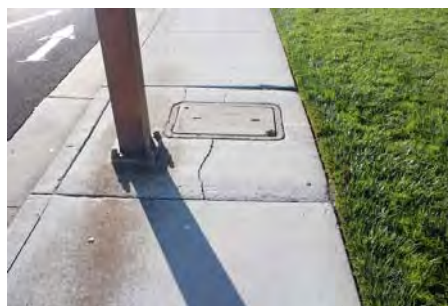
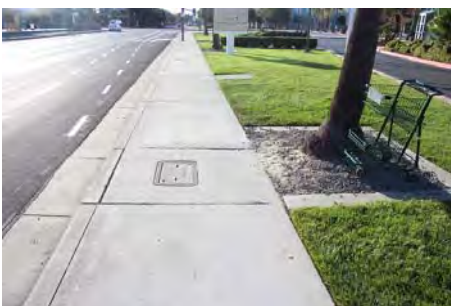
CODE	CONDITION DESCRIPTION	ACTUAL
B11	Surface is firm, stable and slip-resistant. (ADAS 302.1)	CSC LOW VOLTAGE utility cover is not secured and shifts under load.
B12	Gaps/openings in ground or floor surfaces do not allow the passage of a sphere more than 1/2" in diameter. (ADAS 302.3)	3" x 3" gap at street light utility cover.
B15	No level changes greater than 1/2" (except by accessible ramp or other means). (ADAS 303.4)	Over 1/2" high vertical edge at unsecured CST LOW VOLTAGE utility cover.
B16	Cross slope (perpendicular to direction of travel) is 1:48 (2.08%) max. (ADAS 403.3)	Approx. 50 L is 2.7% to 4.6%.

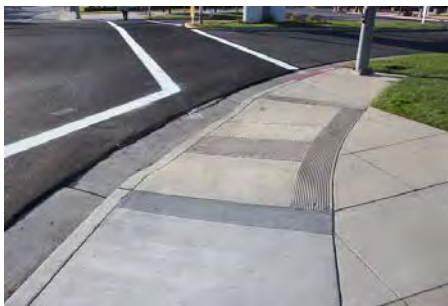
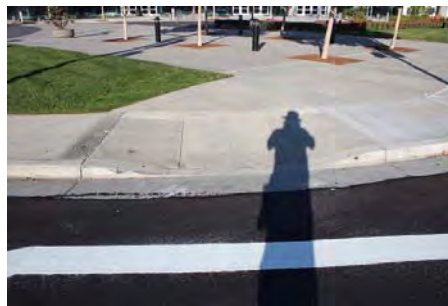
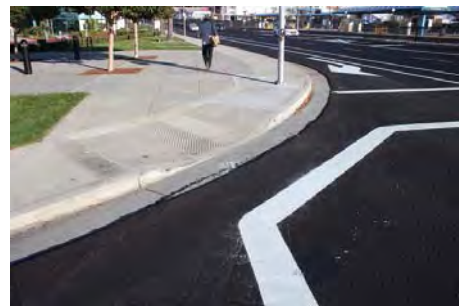
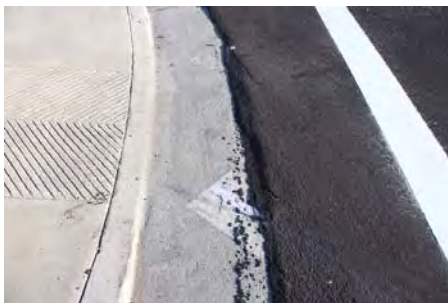
CODE	CONDITION DESCRIPTION	ACTUAL
B03	Running slope of ramp is 1:12 (8.33%) max. (ADAS 405.2)	10.8% at btm. 6", generally 10.6% to 11.5%.
B05	Surface of ramp and landings complies with requirements for an accessible path of travel (stable, firm, slip-resistant, without gaps over 1/2" wide or edges over 1/4" high). (ADAS 302.1, 403.2, 403.3, 403.4)	9.1% running slope at top landing and 3/4" high vertical edge at btm. Landing.
B14	Counter slopes of adjoining gutters and road surfaces immediately adjacent to and within 24 inches of the curb ramp are not steeper than 1:20 (5.0%). (ADAS 406.2)	7.9%
B16	Maximum slope of flared sides is 1:10 (10.0%). (ADAS 406.2)	18.2% right side, 14.6% left side.

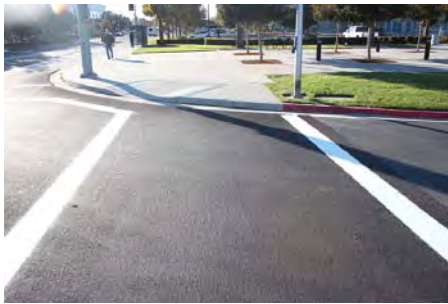
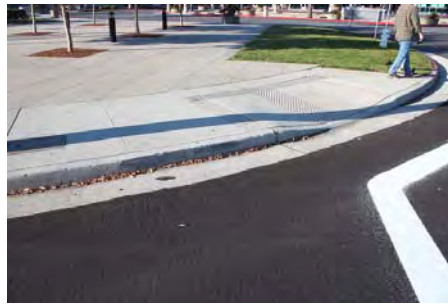
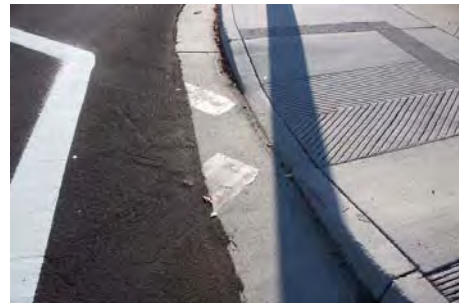
CODE	CONDITION DESCRIPTION	ACTUAL
B03	Running slope of ramp is 1:12 (8.33%) max. (ADAS 405.2)	21.2% at btm 6".
B14	Counter slopes of adjoining gutters and road surfaces immediately adjacent to and within 24 inches of the curb ramp are not steeper than 1:20 (5.0%). (ADAS 406.2)	9.3%
B16	Maximum slope of flared sides is 1:10 (10.0%). (ADAS 406.2)	13.1% left side, 15.1% right side.

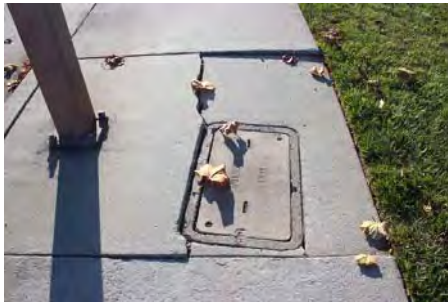
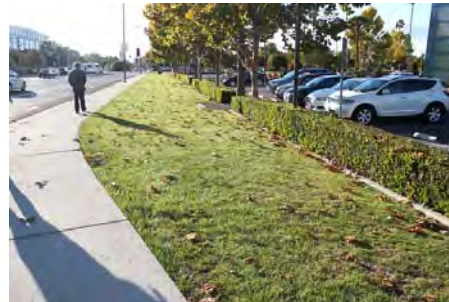
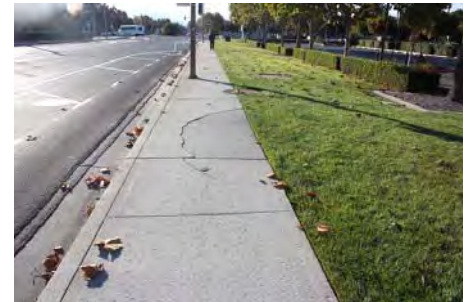
CODE	CONDITION DESCRIPTION	ACTUAL
B15	No level changes greater than 1/2" (except by accessible ramp or other means). (ADAS 303.4)	1" high vertical edge.
B16	Cross slope (perpendicular to direction of travel) is 1:48 (2.08%) max. (ADAS 403.3)	Approx. 300' L is 2.6% to 5.0%.

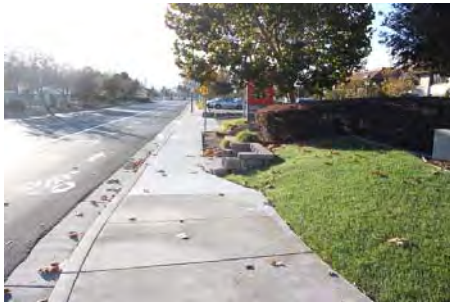
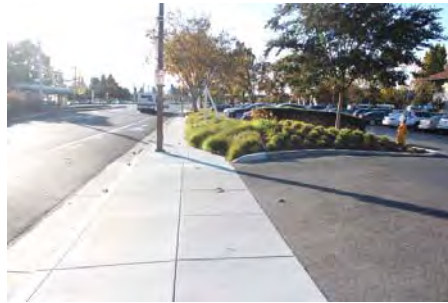
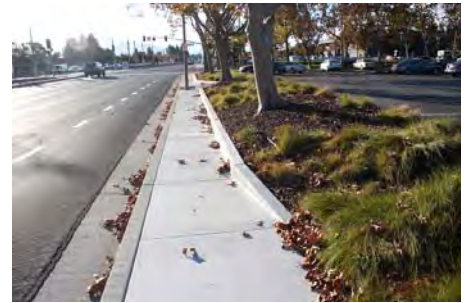
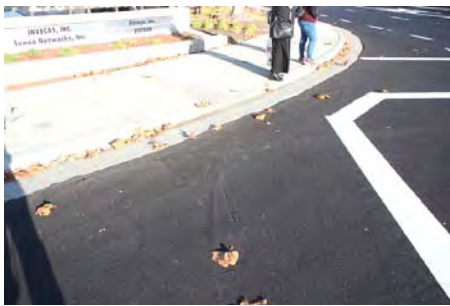
Reduces sidewalk to 42" W for approx. 90' L at planters. Conforms to standards used

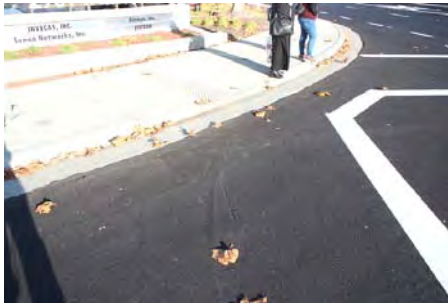
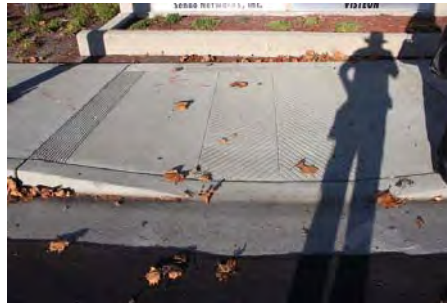
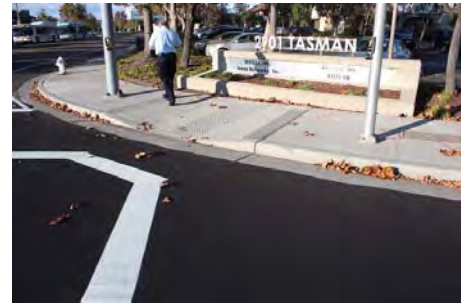
CODE	CONDITION DESCRIPTION	ACTUAL
B03	Running slope of ramp is 1:12 (8.33%) max. (ADAS 405.2)	Up to 9.1% and 13.6% at btm. 6".
B11	Top landing is as wide as the ramp and 36" min. in length. (ADAS 406.4)	None
B14	Counter slopes of adjoining gutters and road surfaces immediately adjacent to and within 24 inches of the curb ramp are not steeper than 1:20 (5.0%). (ADAS 406.2)	7.3%
A17	Where no top landing is provided at an existing ramp, side flare slopes are 8.33% max. (ADAS 406.4)	11.3% right side, 11.1% left side.

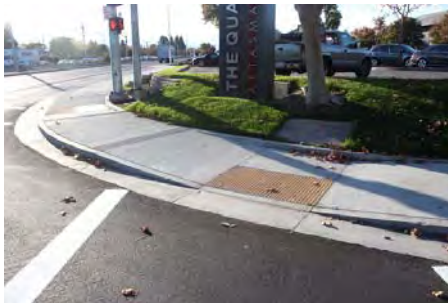
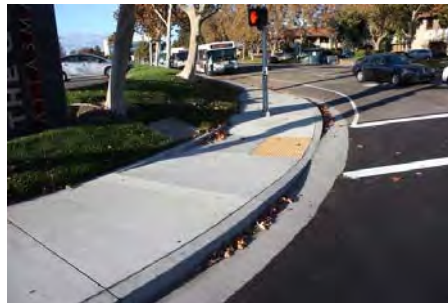
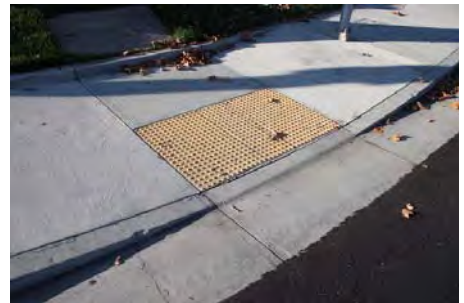
CODE	CONDITION DESCRIPTION	ACTUAL
B06	Transition to walk, gutter or street is flush and free of abrupt changes. (ADAS 406.2)	2 edges at btm. 3/8" high vertical edge at truncated domes, 3/8" high vertical edge at curb.

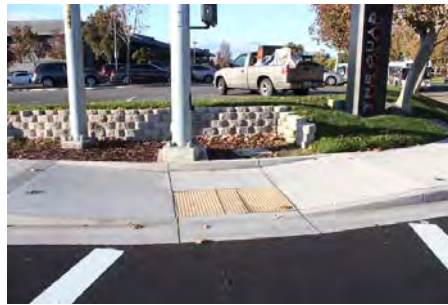
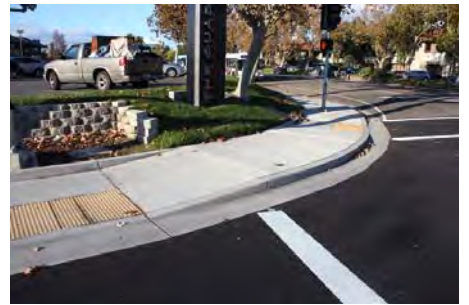
CODE	CONDITION DESCRIPTION	ACTUAL
B06 406.2)	Transition to walk, gutter or street is flush and free of abrupt changes. (ADAS	3/8" high vertical edge.

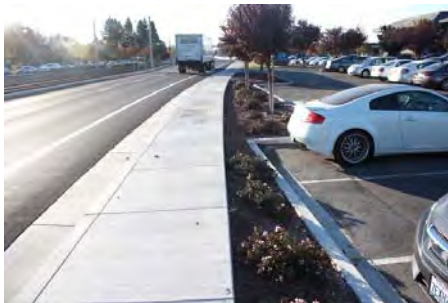
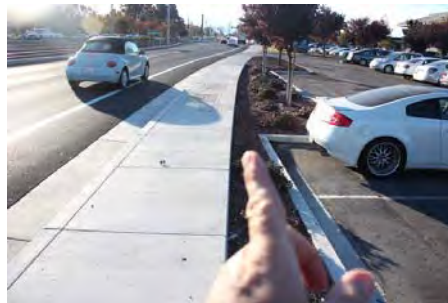
**FEATURE:** #11.1 HAZARDS

CODE	CONDITION DESCRIPTION	ACTUAL
B11	Abrupt changes in level over 4" high are identified either by a curb or guide rail. (28 CFR 35.130(a), ADAS 405.9, CBC 11B-303.5)	Approx. 6" high drop off at one side for approx. 20' L at new concrete sidewalk.

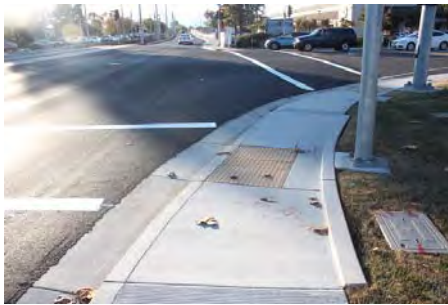
CODE	CONDITION DESCRIPTION	ACTUAL
C12	Turning space at bottom of curb ramp slopes 1:48 (2.08%) max. in any direction (ADAS 403.3)	7.6% across curb face.

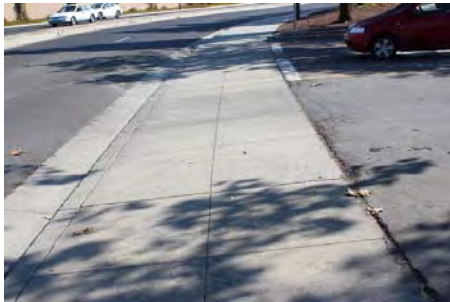
<b>COD</b>	<b>CONDITION DESCRIPTION</b>	<b>ACTUAL</b>
B16	Cross slope (perpendicular to direction of travel) is 1:48 (2.08%) max. (ADAS 403.3)	8.7%
B17	Running slope (parallel to direction of travel) is 1:20 (5.0%) max. (ADAS 403.3)	16.8% and 10.1%

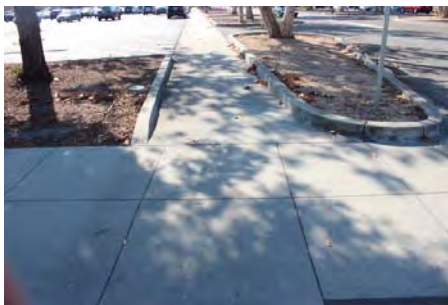
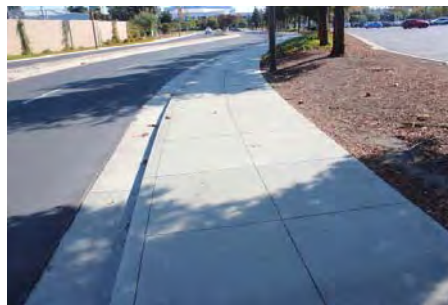
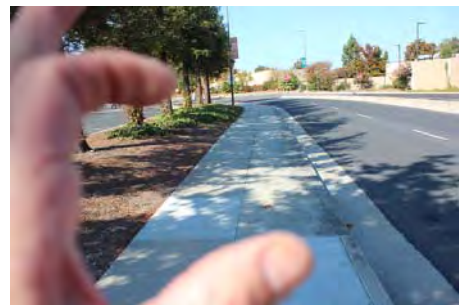
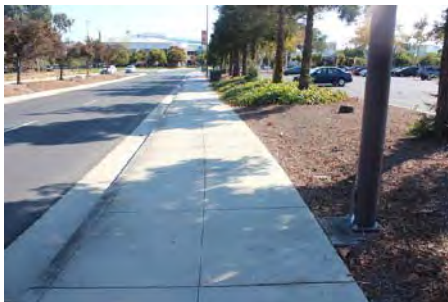
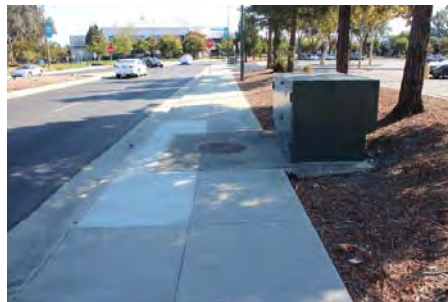
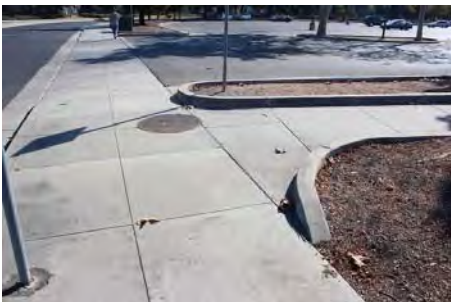
COD	CONDITION DESCRIPTION	ACTUAL
B16	Cross slope (perpendicular to direction of travel) is 1:48 (2.08%) max. (ADAS 403.3)	Approx. 180' L is 2.8% to 3.9%.

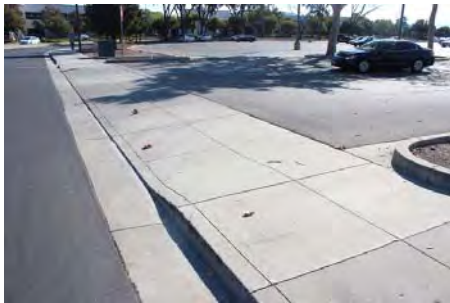
<b>COD</b>	<b>CONDITION DESCRIPTION</b>	<b>ACTUAL</b>
B17	Running slope (parallel to direction of travel) is 1:20 (5.0%) max. (ADAS 403.3)	Exceeds 8.3% at sides of drive apron

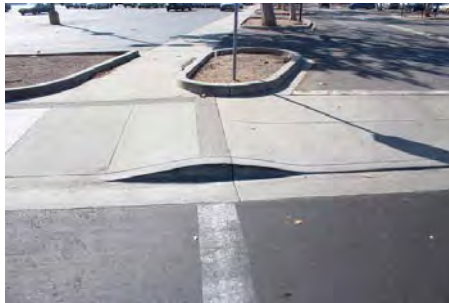
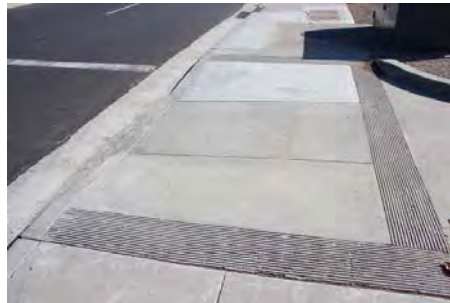
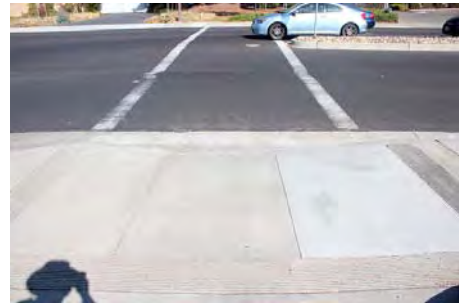
COD	CONDITION DESCRIPTION	ACTUAL
B03	Running slope of ramp is 1:12 (8.33%) max. (ADAS 405.2)	Up to 9.3%.
B11	Top landing is as wide as the ramp and 36" min. in length. (ADAS 406.4)	Configuration unnecessarily precludes use of top landing from either side, effectively making this a curb ramp without a top landing.
A17	Where no top landing is provided at an existing ramp, side flare slopes are 8.33% max. (ADAS 406.4)	11.0% left side, 15.4% right side.

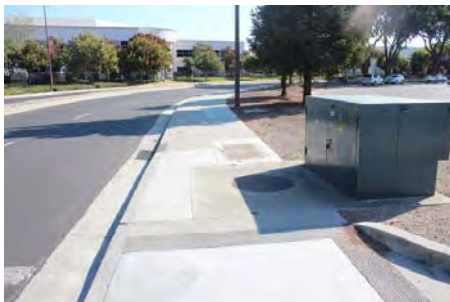
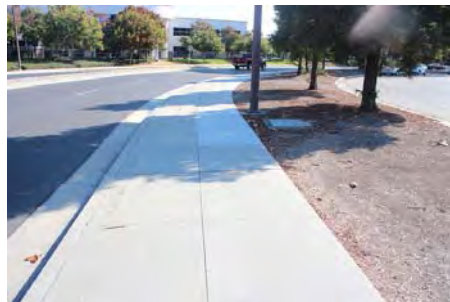
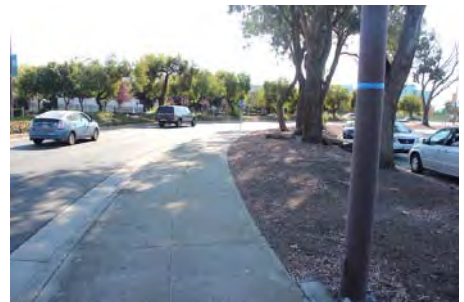
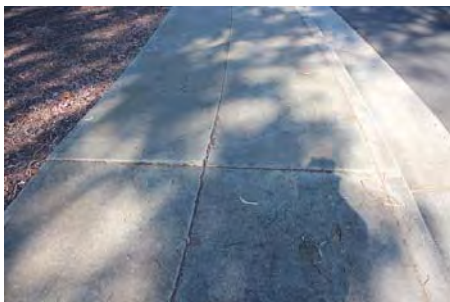
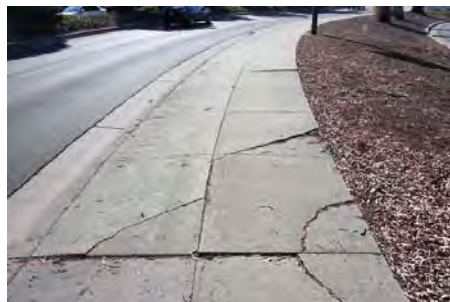
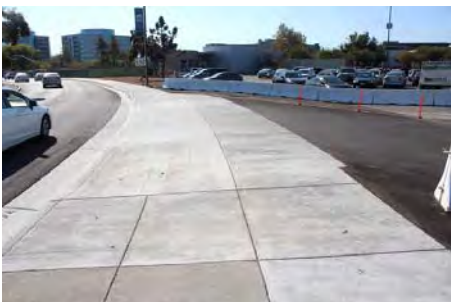
COD	CONDITION DESCRIPTION	ACTUAL
B15	No level changes greater than 1/2" (except by accessible ramp or other means). (ADAS 303.4)	2 vertical edges, 1" and 1 1/4" H.
B16	Cross slope (perpendicular to direction of travel) is 1:48 (2.08%) max. (ADAS 403.3)	Approx. 460' L is to 9.8%.

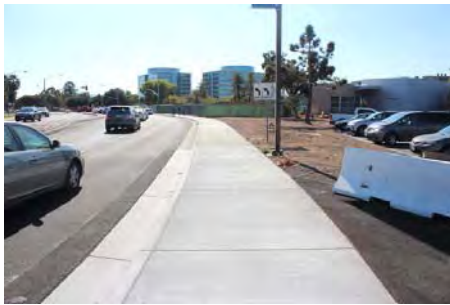
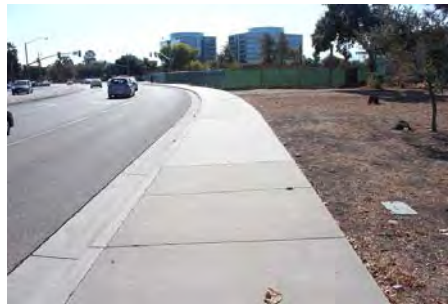
<b>COD</b>	<b>CONDITION DESCRIPTION</b>	<b>ACTUAL</b>
B16	Cross slope (perpendicular to direction of travel) is 1:48 (2.08%) max. (ADAS 403.3)	Approx. 80' L is 2.8% to 3.7%.

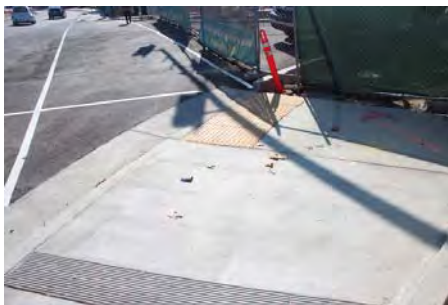
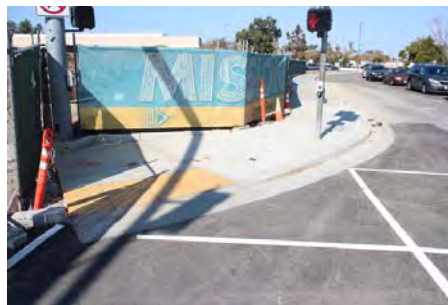
COD	CONDITION DESCRIPTION	ACTUAL
B13	Counter slopes of adjoining gutters and road surfaces immediately adjacent to and within 24 inches of the curb ramp are not steeper than 1:20 (5.0%). (ADAS 406.2)	7.7%

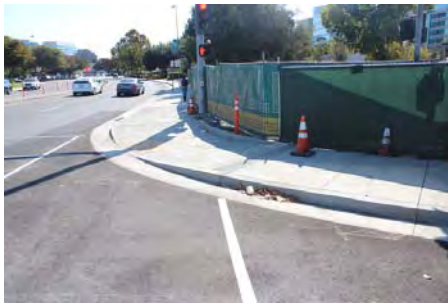
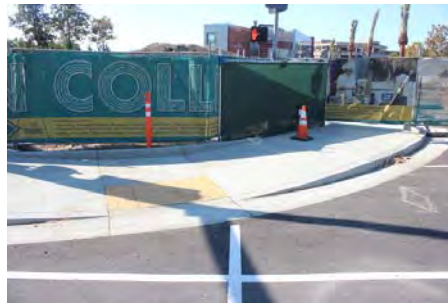
COD	CONDITION DESCRIPTION	ACTUAL
C12	Turning space at bottom of curb ramp slopes 1:48 (2.08%) max. in any direction (ADAS 403.3)	Up to 2.7%.
B13	Counter slopes of adjoining gutters and road surfaces immediately adjacent to and within 24 inches of the curb ramp are not steeper than 1:20 (5.0%). (ADAS 406.2)	5.5%
B14	If curb ramp is located at marked crossing, the transition is wholly contained within the markings. (ADAS 406.5)	W crosswalk is approx. 15' away from the curb ramp.

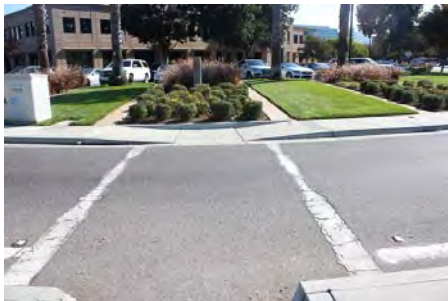
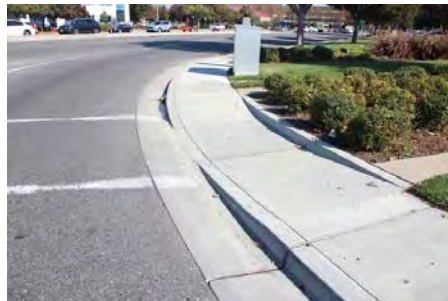
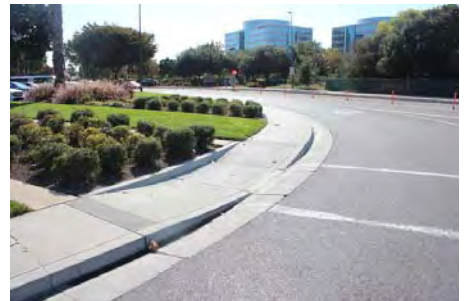
COD	CONDITION DESCRIPTION	ACTUAL
B05	Surface of ramp and landings complies with requirements for an accessible path of travel (stable, firm, slip-resistant, without gaps over 1/2" wide or edges over 1/4" high). (ADAS 405.4)	1/2" high vertical edge at one side on ramp surface.
C12	Turning space at bottom of curb ramp slopes 1:48 (2.08%) max. in any direction (ADAS 403.3)	8.9% for 3" L across curb face.
B13	Counter slopes of adjoining gutters and road surfaces immediately adjacent to and within 24 inches of the curb ramp are not steeper than 1:20 (5.0%). (ADAS 406.2)	11.1%

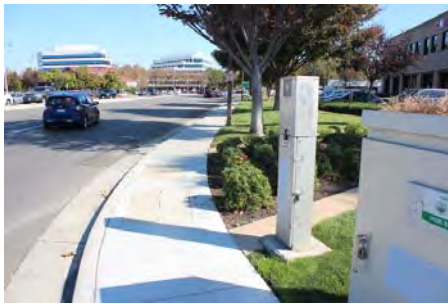
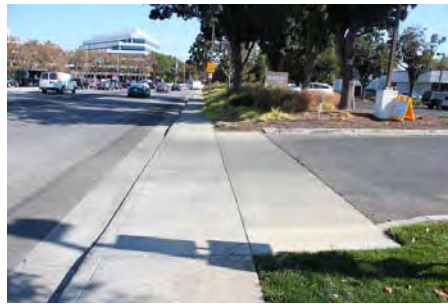
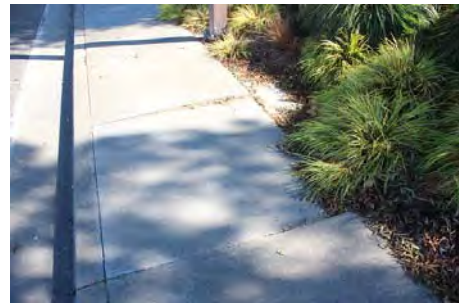
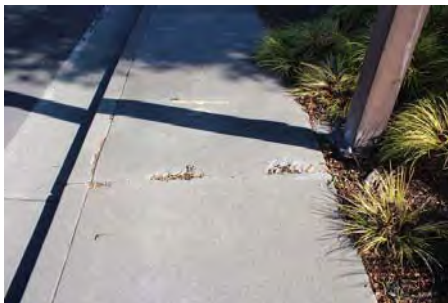
COD	CONDITION DESCRIPTION	ACTUAL
B15	No level changes greater than 1/2" (except by accessible ramp or other means). (ADAS 303.4)	Two vertical edges, 1" and 1 1/4" H.
B16	Cross slope (perpendicular to direction of travel) is 1:48 (2.08%) max. (ADAS 403.3)	Approx. 110' L is 2.7% to 3.7% and 5.9% at drive aisle.
B17	Running slope (parallel to direction of travel) is 1:20 (5.0%) max. (ADAS 403.3)	11.5% and 8.3% at drive aisle.

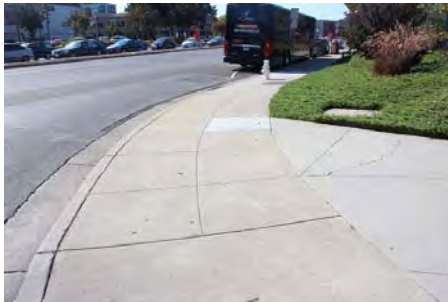
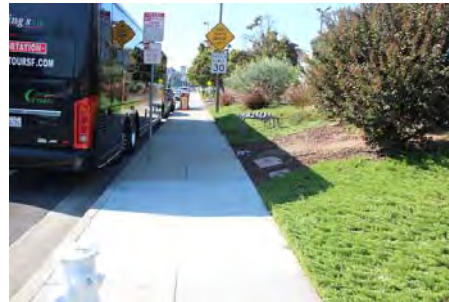
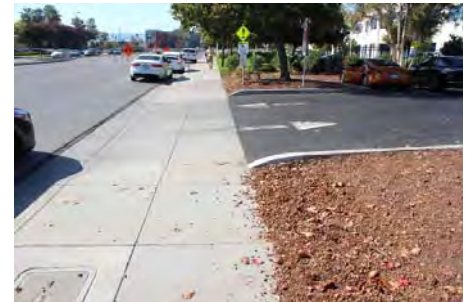
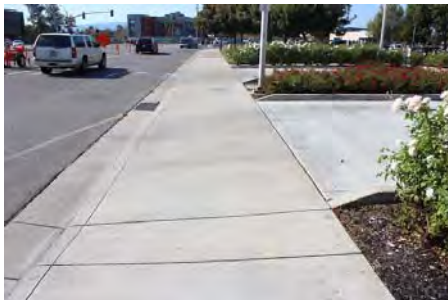
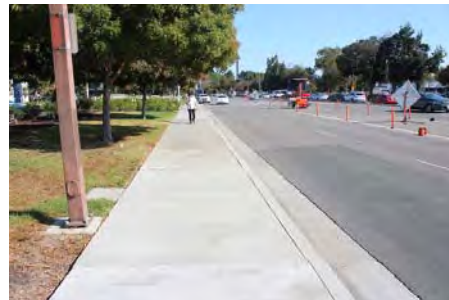
COD	CONDITION DESCRIPTION	ACTUAL
B16	Cross slope (perpendicular to direction of travel) is 1:48 (2.08%) max. (ADAS 403.3)	Approx. 200' L is 2.6% to 5.2% and 6.6% to 7.9% across three drive aisles.
B17	Running slope (parallel to direction of travel) is 1:20 (5.0%) max. (ADAS 403.3)	9.6% to 13.4% at each side of three drive aisles (6 places).

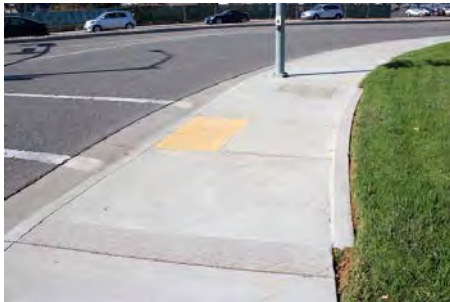
COD	CONDITION DESCRIPTION	ACTUAL
C12	Turning space at bottom of curb ramp slopes 1:48 (2.08%) max. in any direction (ADAS 403.3)	10.4%
B13	Counter slopes of adjoining gutters and road surfaces immediately adjacent to and within 24 inches of the curb ramp are not steeper than 1:20 (5.0%). (ADAS 406.2)	9.8% and 10.4% across curb face.

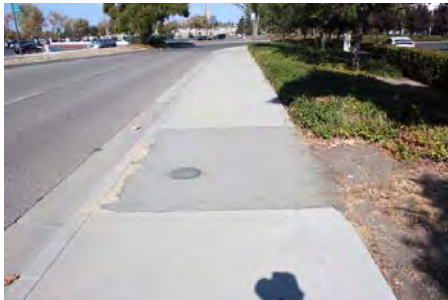
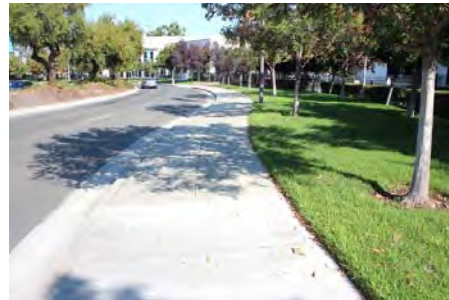
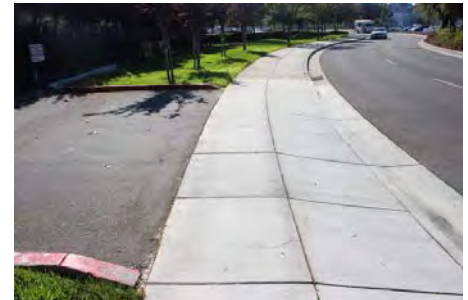
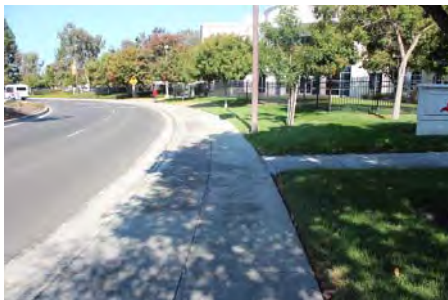
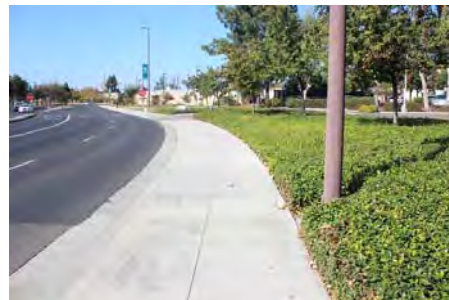
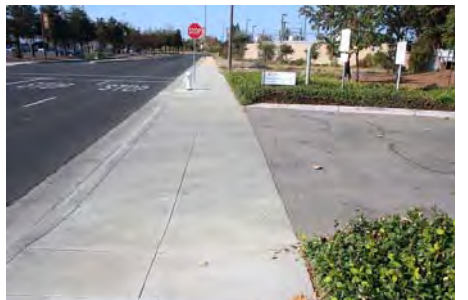
COD	CONDITION DESCRIPTION	ACTUAL
B16	Cross slope (perpendicular to direction of travel) is 1:48 (2.08%) max. (ADAS 403.3)	Approx. 470' L is 2.7% to 6.6% and 7.2% across drive aisle.
B17	Running slope (parallel to direction of travel) is 1:20 (5.0%) max. (ADAS 403.3)	8.3% and 10.4% at drive aisle.

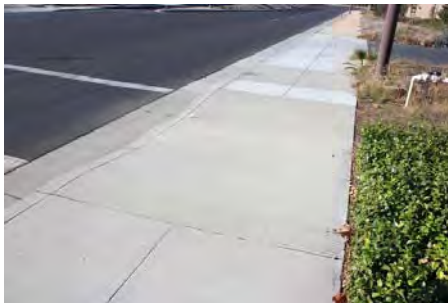
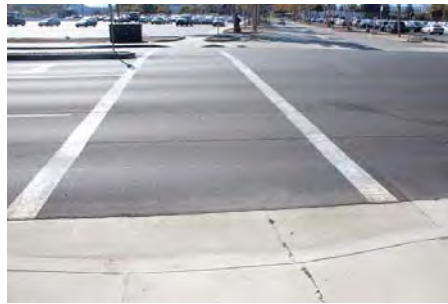
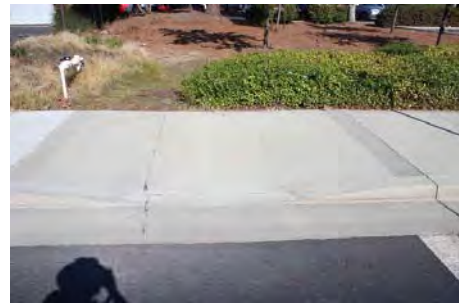
COD	CONDITION DESCRIPTION	ACTUAL
B11	Top landing is as wide as the ramp and 36" min. in length. (ADAS 406.4)	None
B14	Counter slopes of adjoining gutters and road surfaces immediately adjacent to and within 24 inches of the curb ramp are not steeper than 1:20 (5.0%). (ADAS 406.2)	6.0%
A17	Where no top landing is provided at an existing ramp, side flare slopes are 8.33% max. (ADAS 406.4)	13.3% left side, 12.0% right side.

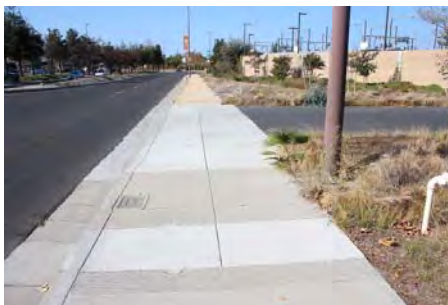
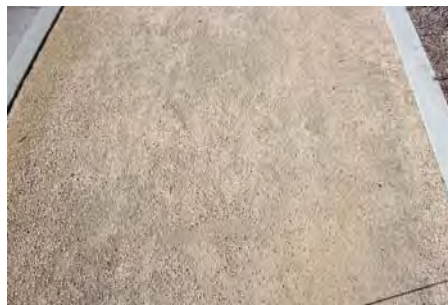
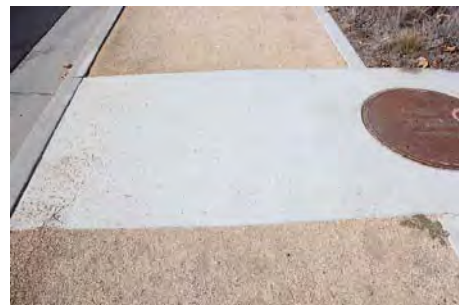
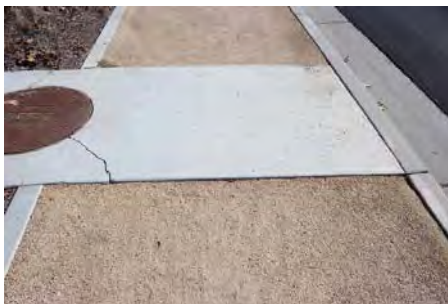
COD	CONDITION DESCRIPTION	ACTUAL
B11	Surface is firm, stable and slip-resistant. (ADAS 302.1)	Sidewalk dead ends into dirt.

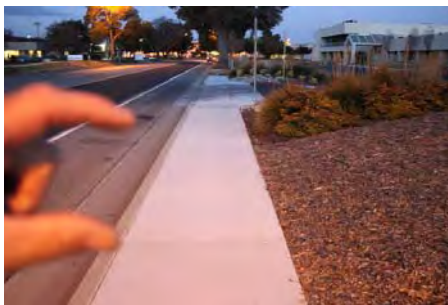
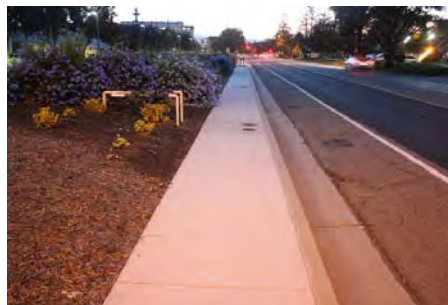
COD	CONDITION DESCRIPTION	ACTUAL
B16	Cross slope (perpendicular to direction of travel) is 1:48 (2.08%) max. (ADAS 403.3)	Approx. 20' L is 2.7%.

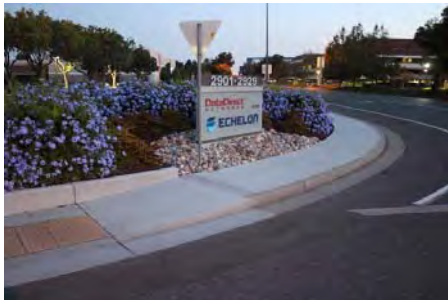
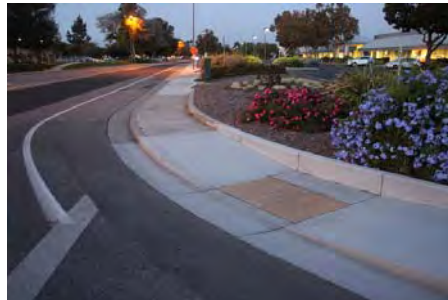
COD	CONDITION DESCRIPTION	ACTUAL
C12	Turning space at bottom of curb ramp slopes 1:48 (2.08%) max. in any direction (ADAS 403.3)	7.6% for 3" L across curb face.
B13	Counter slopes of adjoining gutters and road surfaces immediately adjacent to and within 24 inches of the curb ramp are not steeper than 1:20 (5.0%). (ADAS 406.2)	7.8%

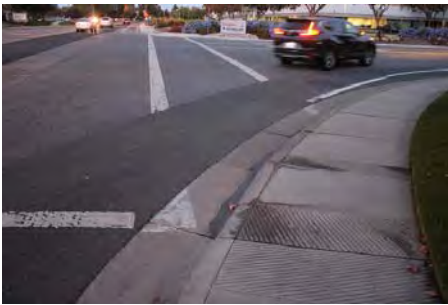
<b>COD</b>	<b>CONDITION DESCRIPTION</b>	<b>ACTUAL</b>
B16	Cross slope (perpendicular to direction of travel) is 1:48 (2.08%) max. (ADAS 403.3)	6.2% for portion between crosswalk and curb ramp at NE corner.
