Case No. 5:16-cv-07013-LHK (SVK)

**DECLARATION OF JEFFREY SCOTT  
MASTIN IN SUPPORT OF PLAINTIFFS'  
MOTION FOR CLASS CERTIFICATION**

NEVAREZ V 49ERS - ACCESSIBILITY ASSESSMENT

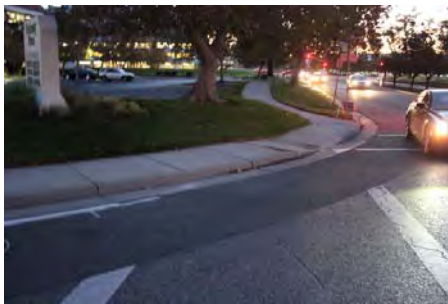
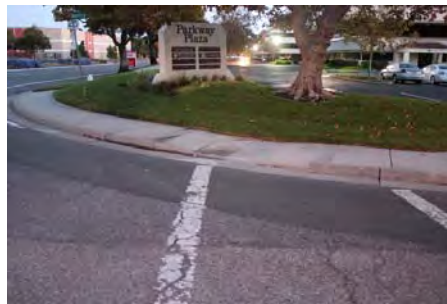
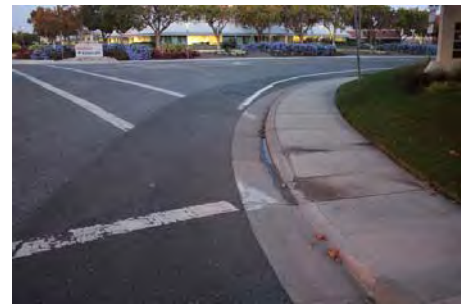
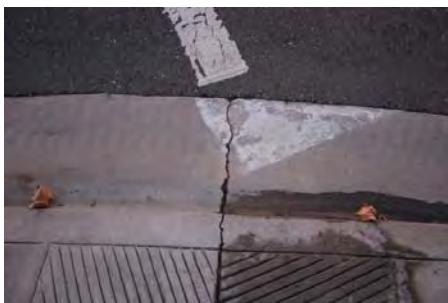
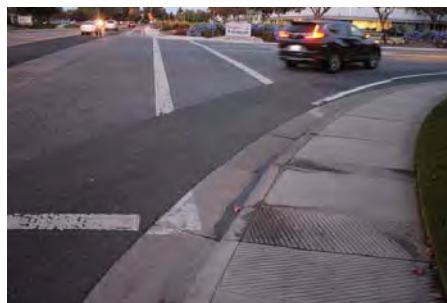
COD	CONDITION DESCRIPTION	ACTUAL
B03	Running slope of ramp is 1:12 (8.33%) max. (ADAS 405.2)	12.5% for 6" across curb face.
B06	Transition to walk, gutter or street is flush and free of abrupt changes. (ADAS 406.2)	1/2" high vertical edge.
B11	Top landing is as wide as the ramp and 36" min. in length. (ADAS 406.4)	None
B14	Counter slopes of adjoining gutters and road surfaces immediately adjacent to and within 24 inches of the curb ramp are not steeper than 1:20 (5.0%). (ADAS 406.2)	8.9%
A17	Where no top landing is provided at an existing ramp, side flare slopes are 8.33% max. (ADAS 406.4)	10.5% right side, 10.9% left side.
B19	DIAGONAL: If curb ramp is located at marked crossing, 48" min. clear space is provided within the markings. (ADAS 406.6)	7" clear to lines.

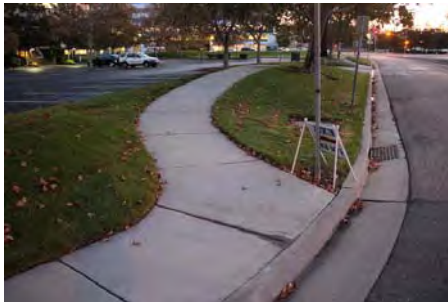
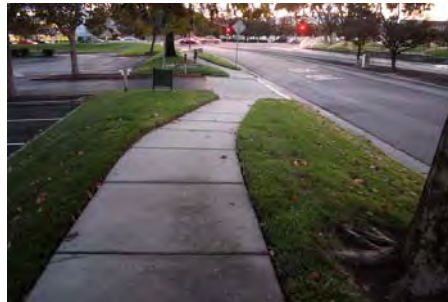
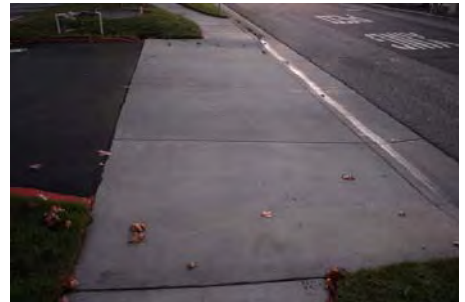
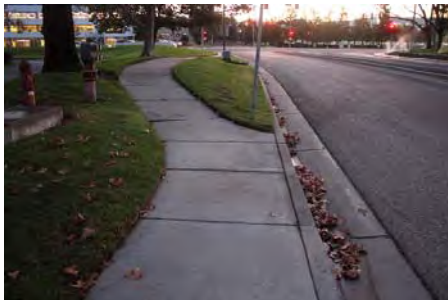
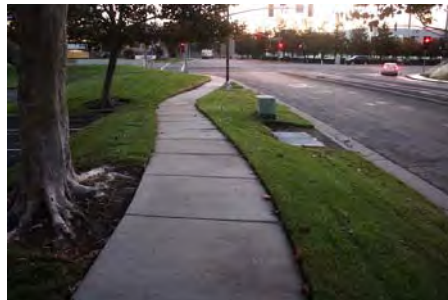
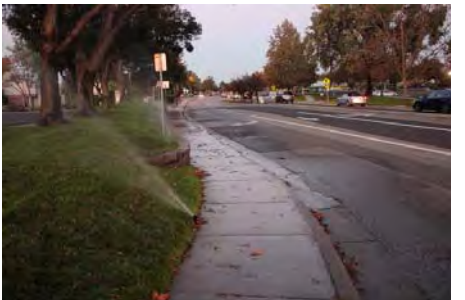
COD	CONDITION DESCRIPTION	ACTUAL
B16	Cross slope (perpendicular to direction of travel) is 1:48 (2.08%) max. (ADAS 403.3)	Approx. 110' L is 2.7% to 6.3%, and up to 8.2% at driveway apron.
B17	Running slope (parallel to direction of travel) is 1:20 (5.0%) max. (ADAS 403.3)	Approx. 100' L is 5.4% to 10.4% and up to 16.1% at driveway apron.

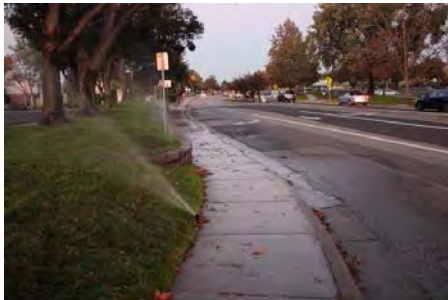
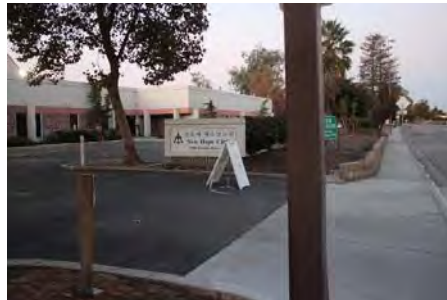
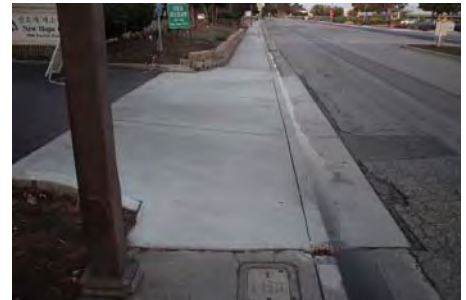
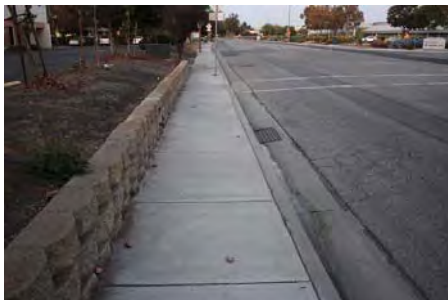
COD	CONDITION DESCRIPTION	ACTUAL
B16	Cross slope (perpendicular to direction of travel) is 1:48 (2.08%) max. (ADAS 403.3)	Approx. 50' L is 2.5% o 3.9% and up to 5.8% at driveway apron.
B17	Running slope (parallel to direction of travel) is 1:20 (5.0%) max. (ADAS 403.3)	13.7% and 18.4% at driveway apron.

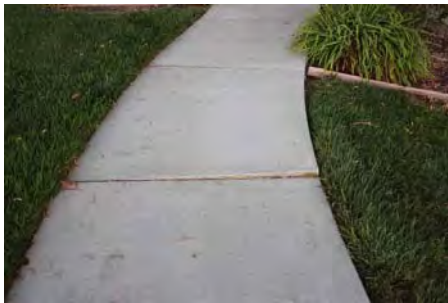
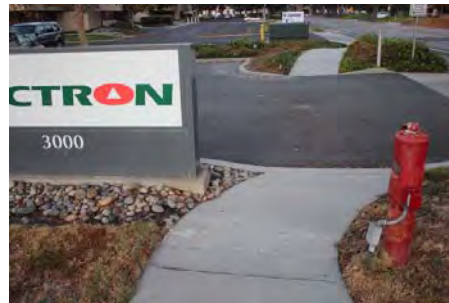
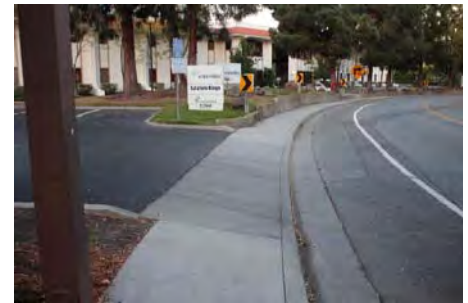
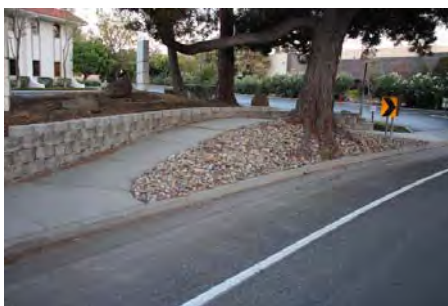
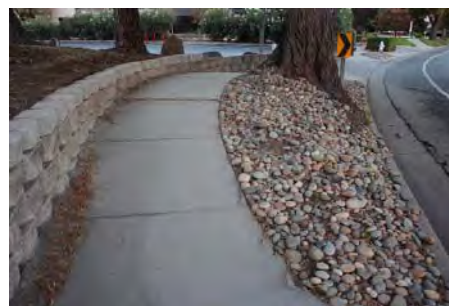
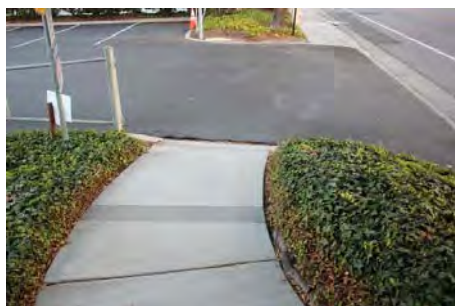
COD	CONDITION DESCRIPTION	ACTUAL
B12	Gaps/openings in ground or floor surfaces do not allow the passage of a sphere more than 1/2" in diameter. (ADAS 302.3)	6" wide gap at address 3000 driveway apron.
B15	No level changes greater than 1/2" (except by accessible ramp or other means). (ADAS 303.4)	3/4" to 1" high vertical edges at 5 places.
B16	Cross slope (perpendicular to direction of travel) is 1:48 (2.08%) max. (ADAS 403.3)	Approx. 520' L is 2.6% to 10.5%, including 10 drive aprons and 6 hills.
B17	Running slope (parallel to direction of travel) is 1:20 (5.0%) max. (ADAS 403.3)	10.3% to 18.8% at 14 sides of drive aprons, 10.0% to 13.6% at 10 sides of hills.

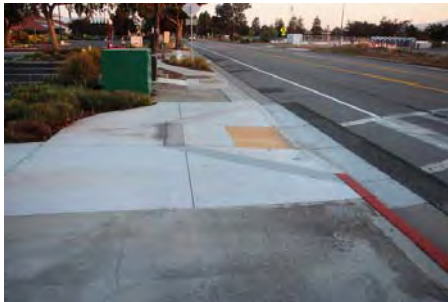
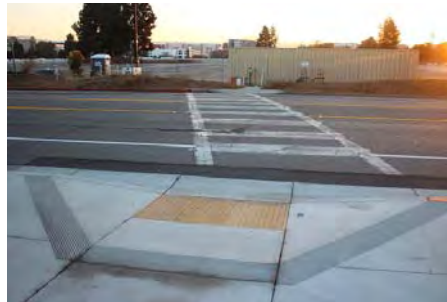
COD	CONDITION DESCRIPTION	ACTUAL
B14	Counter slopes of adjoining gutters and road surfaces immediately adjacent to and within 24 inches of the curb ramp are not steeper than 1:20 (5.0%). (ADAS 406.2)	6.3%
B18	If curb ramp is located at marked crossing, the transition is wholly contained within the markings. (ADAS 406.5)	Approx. half of transition is not within markings.

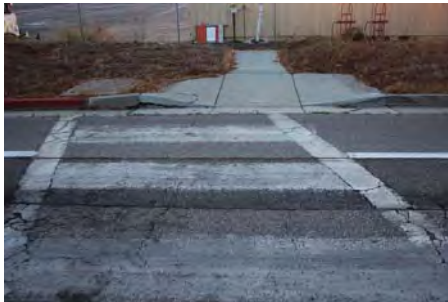
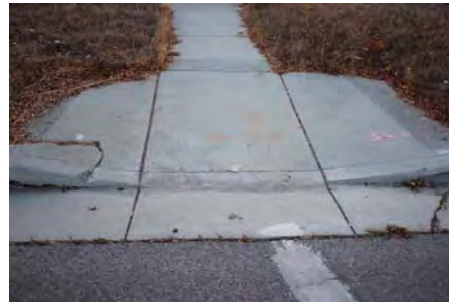
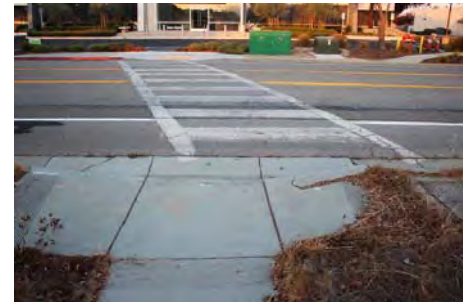
COD	CONDITION DESCRIPTION	ACTUAL
B14	Counter slopes of adjoining gutters and road surfaces immediately adjacent to and within 24 inches of the curb ramp are not steeper than 1:20 (5.0%). (ADAS 406.2)	13.4%
B18	If curb ramp is located at marked crossing, the transition is wholly contained within the markings. (ADAS 406.5)	Approx. half of transition is not within markings.

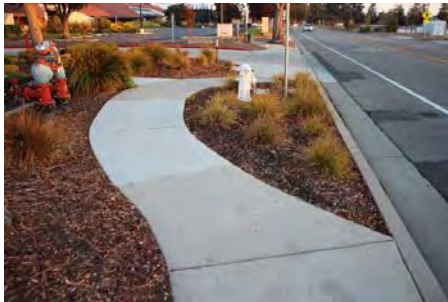
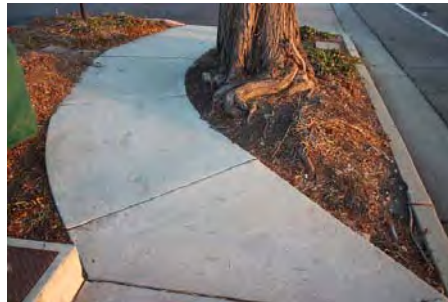
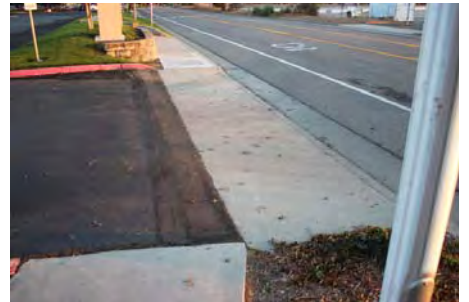
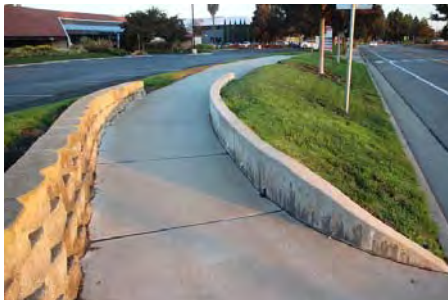
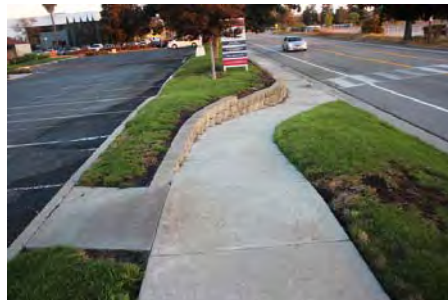
COD	CONDITION DESCRIPTION	ACTUAL
B16	Cross slope (perpendicular to direction of travel) is 1:48 (2.08%) max. (ADAS 403.3)	Approx. 40' L is 3.5% to 5.8% at 1 hill and drive apron.
B17	Running slope (parallel to direction of travel) is 1:20 (5.0%) max. (ADAS 403.3)	Approx. 120' L is 6.3% to 10.4% at sides of 3 hills and 1 drive apron.

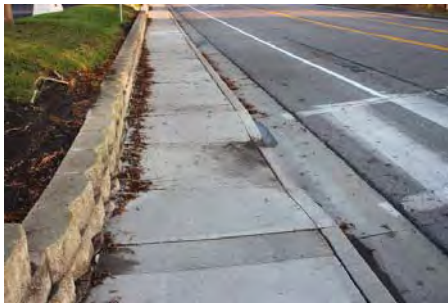
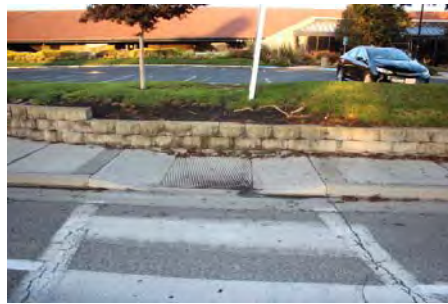
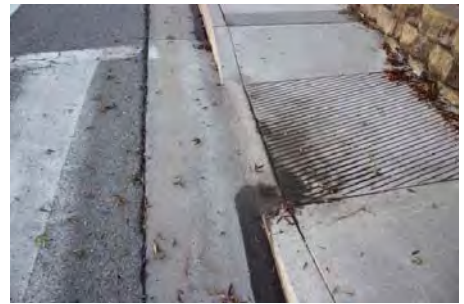
COD	CONDITION DESCRIPTION	ACTUAL
B11	Top landing is as wide as the ramp and 36" min. in length. (ADAS 406.4)	None
B14	Counter slopes of adjoining gutters and road surfaces immediately adjacent to and within 24 inches of the curb ramp are not steeper than 1:20 (5.0%). (ADAS 406.2)	7.9%
A17	Where no top landing is provided at an existing ramp, side flare slopes are 8.33% max. (ADAS 406.4)	16.8% left side, 14.2% right side.

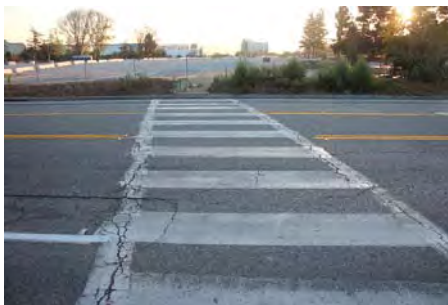
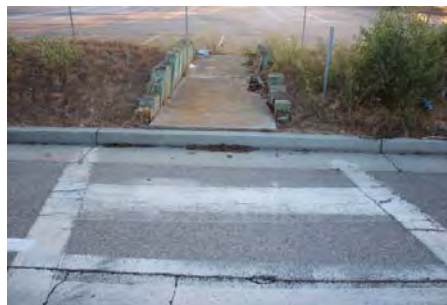
COD	CONDITION DESCRIPTION	ACTUAL
B15	No level changes greater than 1/2" (except by accessible ramp or other means). (ADAS 303.4)	6" high vertical edge at curb and 2" high vertical edge at walkway leading to Blue Lot #1.

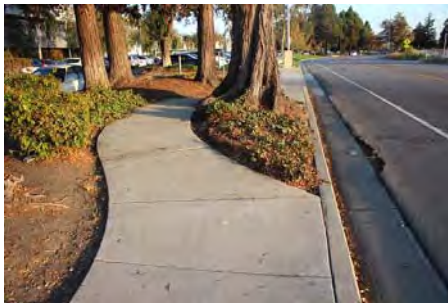
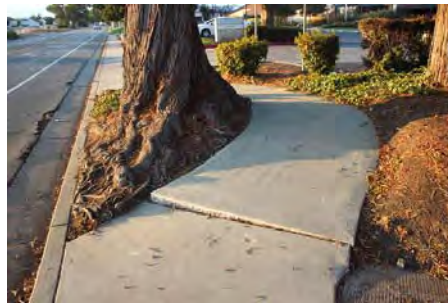
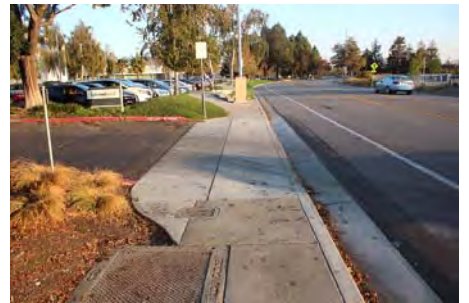
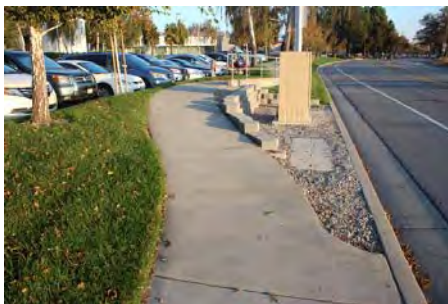
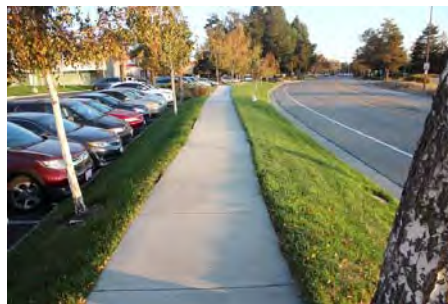
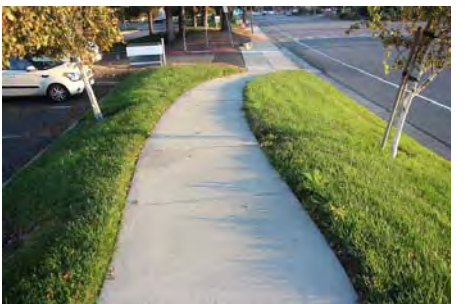
COD	CONDITION DESCRIPTION	ACTUAL
B12	Gaps/openings in ground or floor surfaces do not allow the passage of a sphere more than 1/2" in diameter. (ADAS 302.3)	2 3/4" W gap.
B15	No level changes greater than 1/2" (except by accessible ramp or other means). (ADAS 303.4)	3" high vertical edge.
B16	Cross slope (perpendicular to direction of travel) is 1:48 (2.08%) max. (ADAS 403.3)	Approx. 60' L is 3.5% to 9.7%.
B17	Running slope (parallel to direction of travel) is 1:20 (5.0%) max. (ADAS 403.3)	5.9% to 15.0% at 6 sides of hills and 1 driveway apron.

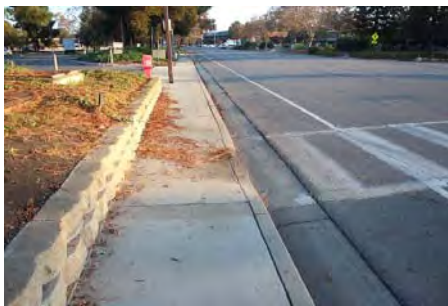
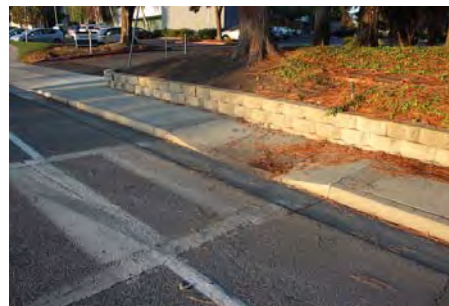
COD	CONDITION DESCRIPTION	ACTUAL
B05	Surface of ramp and landings complies with requirements for an accessible path of travel (stable, firm, slip-resistant, without gaps over 1/2" wide or edges over 1/4" high). (ADAS 302.1, 403.2, 403.3, 403.4)	Covered with plant debris.
B11	Top landing is as wide as the ramp and 36" min. in length. (ADAS 406.4)	None
B14	Counter slopes of adjoining gutters and road surfaces immediately adjacent to and within 24 inches of the curb ramp are not steeper than 1:20 (5.0%). (ADAS 406.2)	8.6%
A17	Where no top landing is provided at an existing ramp, side flare slopes are 8.33% max. (ADAS 406.4)	13.0% left side, 15.0% right side.

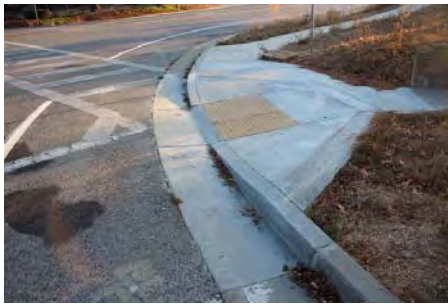
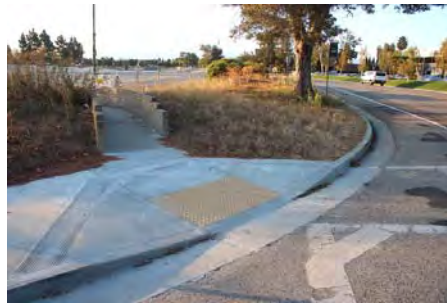
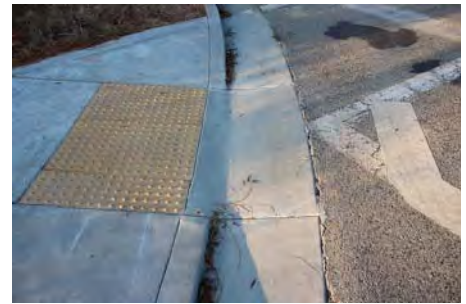
COD	CONDITION DESCRIPTION	ACTUAL
B03	Running slope of ramp is 1:12 (8.33%) max. (ADAS 405.2)	16.8% across curb face and up to 8.8% general slope.
B14	Counter slopes of adjoining gutters and road surfaces immediately adjacent to and within 24 inches of the curb ramp are not steeper than 1:20 (5.0%). (ADAS 406.2)	10.1%
B19	DIAGONAL: If curb ramp is located at marked crossing, 48" min. clear space is provided within the markings. (ADAS 406.6)	22" clear to markings.

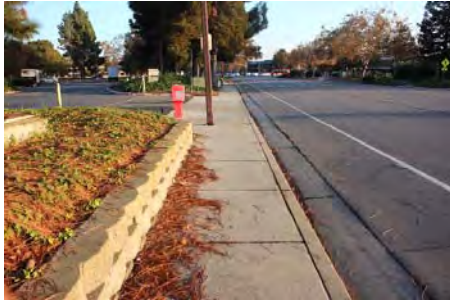
COD	CONDITION DESCRIPTION	ACTUAL
B16	Cross slope (perpendicular to direction of travel) is 1:48 (2.08%) max. (ADAS 403.3)	5.7% at driveway apron.
B17	Running slope (parallel to direction of travel) is 1:20 (5.0%) max. (ADAS 403.3)	13.0% and 14.1% at driveway apron.

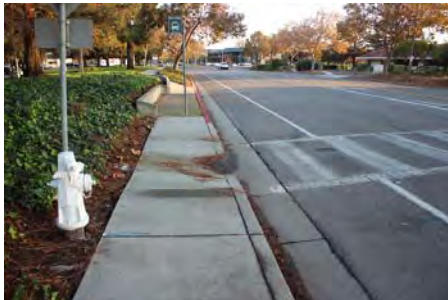
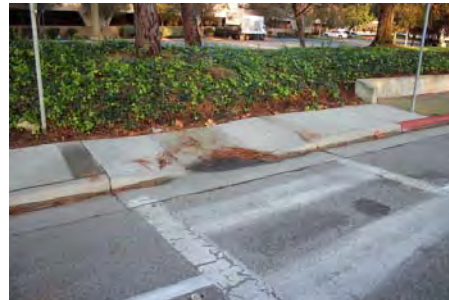
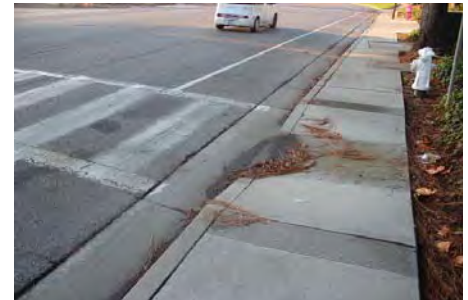
COD	CONDITION DESCRIPTION	ACTUAL
B03	Running slope of ramp is 1:12 (8.33%) max. (ADAS 405.2)	12.4% across curb face.
B05	Surface of ramp and landings complies with requirements for an accessible path of travel (stable, firm, slip-resistant, without gaps over 1/2" wide or edges over 1/4" high). (ADAS 302.1, 403.2, 403.3, 403.4)	1 1/2" W gap at asphalt transition at btm. landing and ramp covered by plant debris.
B11	Top landing is as wide as the ramp and 36" min. in length. (ADAS 406.4)	None
B14	Counter slopes of adjoining gutters and road surfaces immediately adjacent to and within 24 inches of the curb ramp are not steeper than 1:20 (5.0%). (ADAS 406.2)	10.1%
A17	Where no top landing is provided at an existing ramp, side flare slopes are 8.33% max. (ADAS 406.4)	15.1% right side, 16.2% left side.

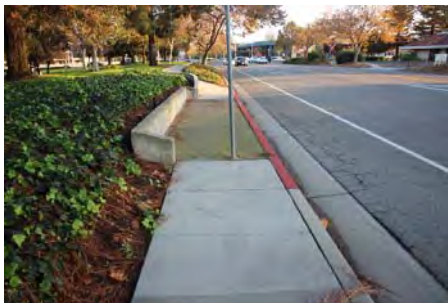
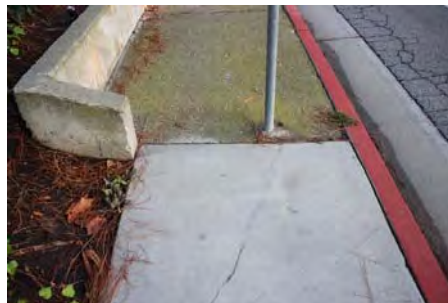
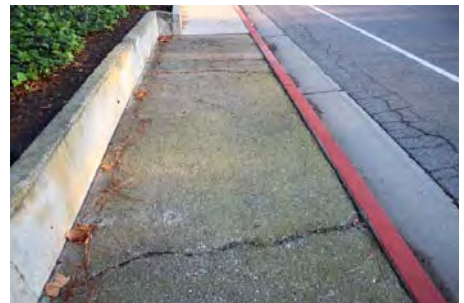
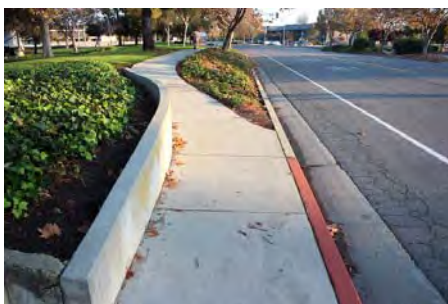
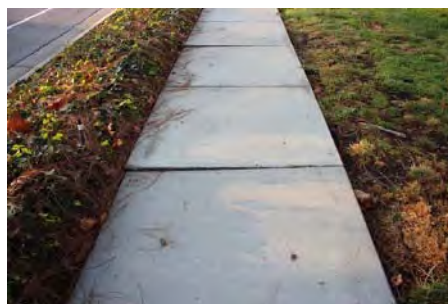
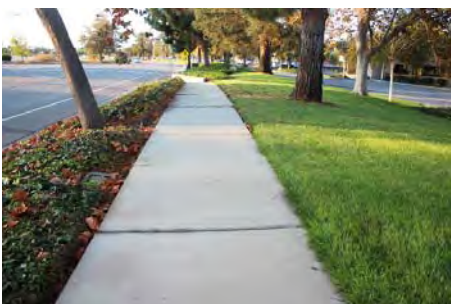
COD	CONDITION DESCRIPTION	ACTUAL
B02	36" min. clear width of exterior walkway. (ADAS 403.5.1)	33" clear at bus sign post.
B15	No level changes greater than 1/2" (except by accessible ramp or other means). (ADAS 303.4)	3/4" to 2" high vertical edges at 4 places.
B16	Cross slope (perpendicular to direction of travel) is 1:48 (2.08%) max. (ADAS 403.3)	Approx. 180' L is 3.6% to 7.0%.
B17	Running slope (parallel to direction of travel) is 1:20 (5.0%) max. (ADAS 403.3)	9.0% at hill.

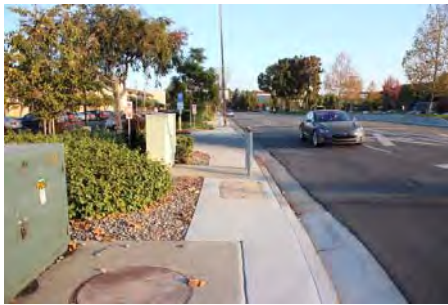
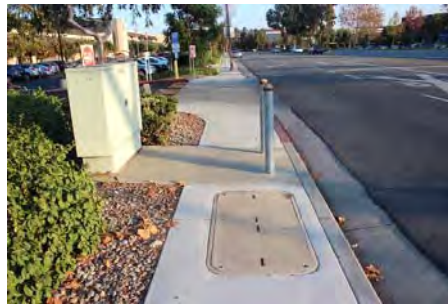
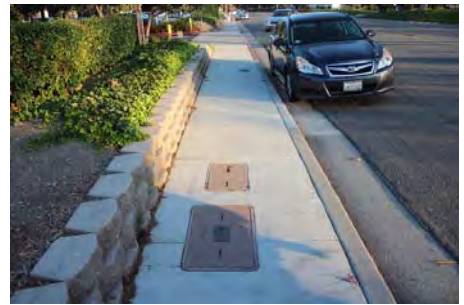
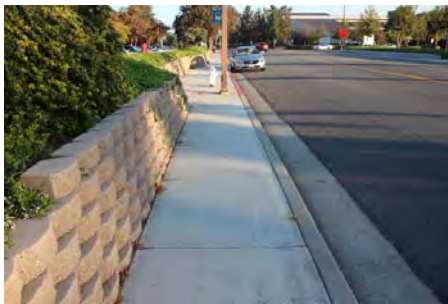
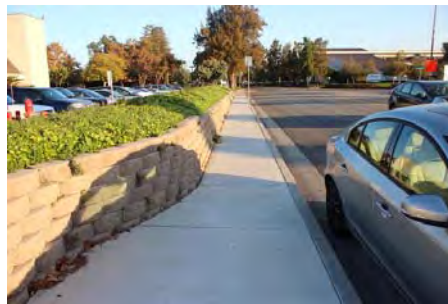
**FACILITY/SITE:** 4. Patrick Henry Dr.  
**FEATURE:** #11 ACC ROUTE OF TRAVEL

COD	CONDITION DESCRIPTION	ACTUAL
B16	Cross slope (perpendicular to direction of travel) is 1:48 (2.08%) max. (ADAS 403.3)	Approx. 150' L is 2.8% to 4.3%.

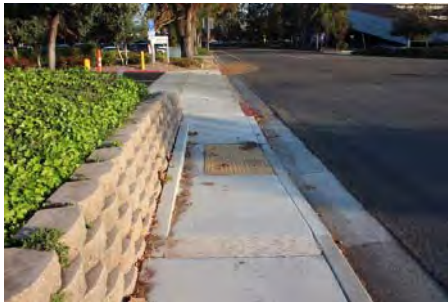
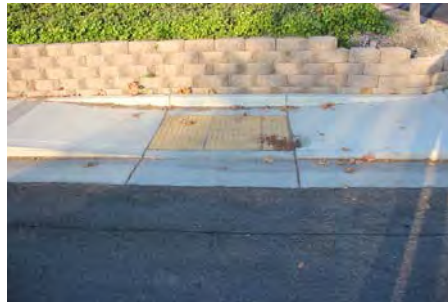
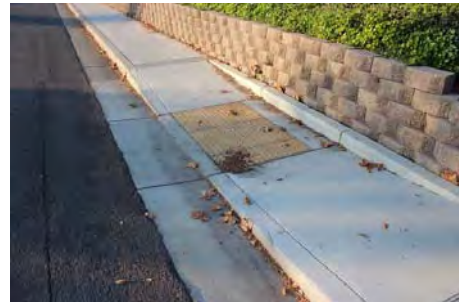
COD	CONDITION DESCRIPTION	ACTUAL
B06	Transition to walk, gutter or street is flush and free of abrupt changes. (ADAS 406.2)	3/8" high vertical edge
B13	Counter slopes of adjoining gutters and road surfaces immediately adjacent to and within 24 inches of the curb ramp are not steeper than 1:20 (5.0%). (ADAS 406.2)	6.2%

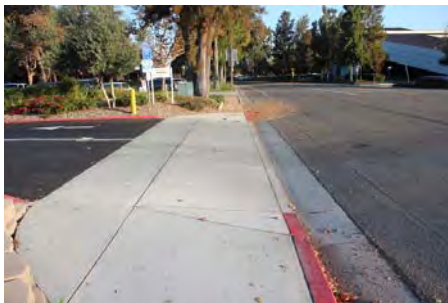
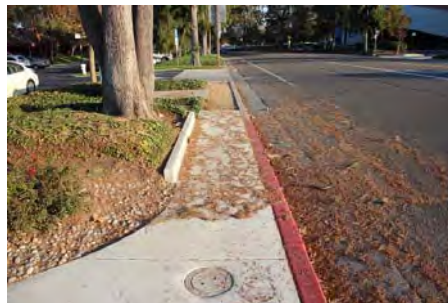
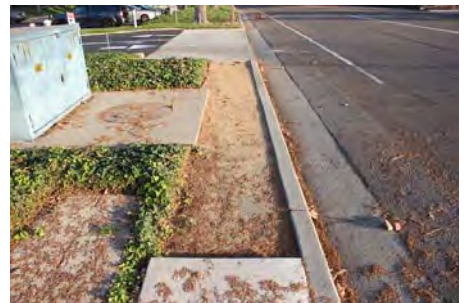
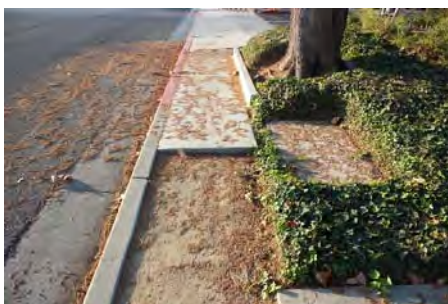
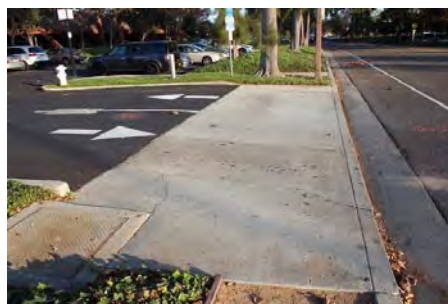
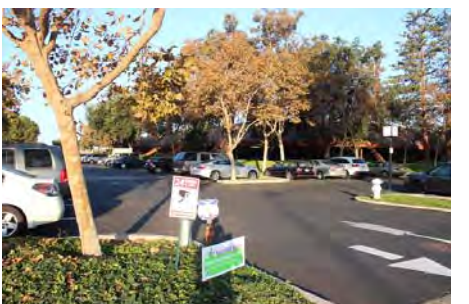
**FACILITY/SITE:** 4. Patrick Henry Dr.  
**FEATURE:** #11 ACC ROUTE OF TRAVEL

COD	CONDITION DESCRIPTION	ACTUAL
B02	36" min. clear width of exterior walkway. (ADAS 403.5.1)	32 1/2" W at dirt portion.
B11	Surface is firm, stable and slip-resistant. (ADAS 302.1)	Dirt surface for approx. 20' L.
B15	No level changes greater than 1/2" (except by accessible ramp or other means). (ADAS 303.4)	2 1/2" high vertical edge at end of concrete.
B16	Cross slope (perpendicular to direction of travel) is 1:48 (2.08%) max. (ADAS 403.3)	Portion of concrete is 3.2%.

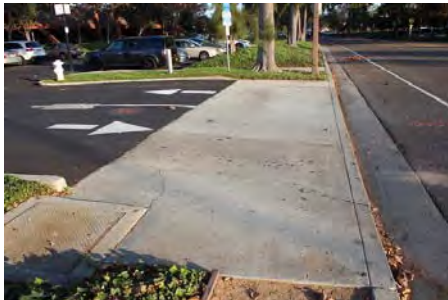
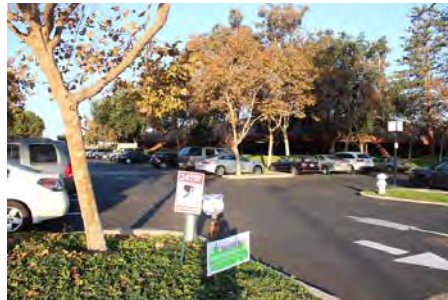
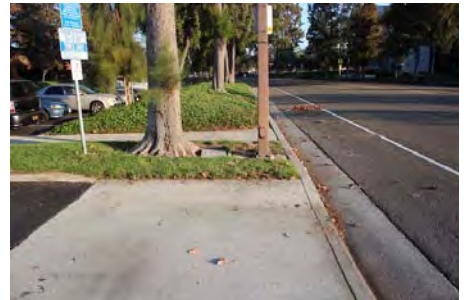
COD	CONDITION DESCRIPTION	ACTUAL
B02	36" min. clear width of exterior walkway. (ADAS 403.5.1)	Obstructed by 2 sign posts utility cover and tree.
B11	Surface is firm, stable and slip-resistant. (ADAS 302.1)	Grass surface.

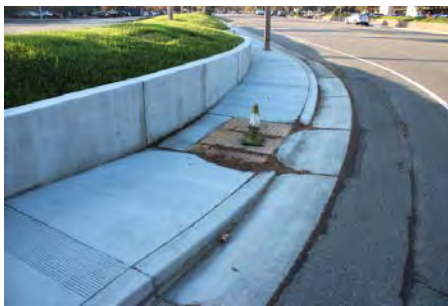
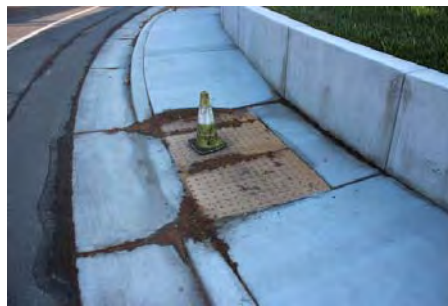
COD	CONDITION DESCRIPTION	ACTUAL
B02	The width of curb ramp is 36" min. (ADAS 405.5)	Obstructed by traffic cone.
B03	Running slope is 1:12 (8.33%) max. (ADAS 405.2)	8.6% and 1" at btm. is 18.2%.
B05	Surface of ramp and landings complies with requirements for an accessible path of travel (stable, firm, slip-resistant, without gaps over 1/2" wide or edges over 1/4" high). (ADAS 405.4)	Partially covered with debris.
B13	Counter slopes of adjoining gutters and road surfaces immediately adjacent to and within 24 inches of the curb ramp are not steeper than 1:20 (5.0%). (ADAS 406.2)	6.8%

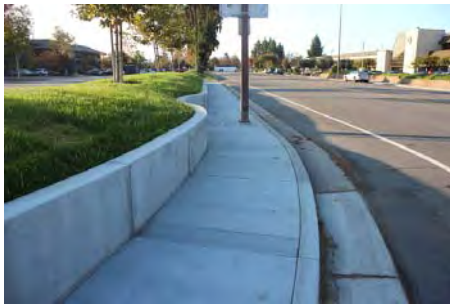
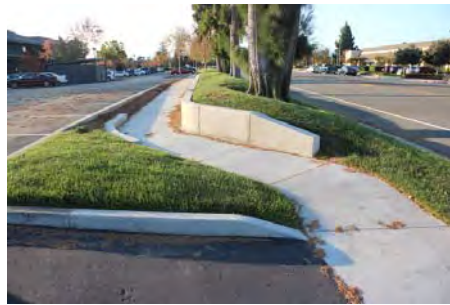
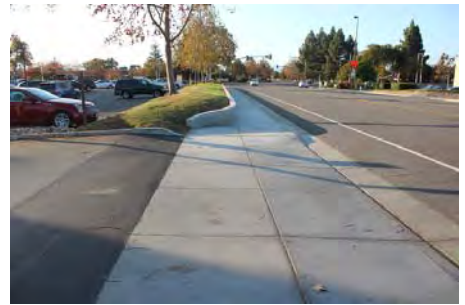
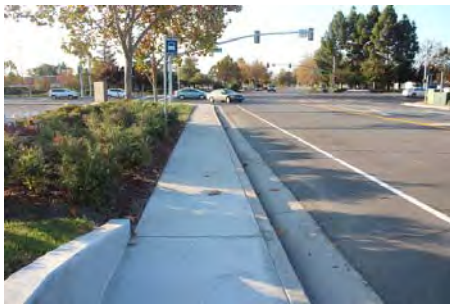
**FACILITY/SITE:** 4. Patrick Henry Dr.  
**FEATURE:** #11 ACC ROUTE OF TRAVEL

COD	CONDITION DESCRIPTION	ACTUAL
B16	Cross slope (perpendicular to direction of travel) is 1:48 (2.08%) max. (ADAS 403.3)	Approx. 120' L is 2.6% to 3.8%.

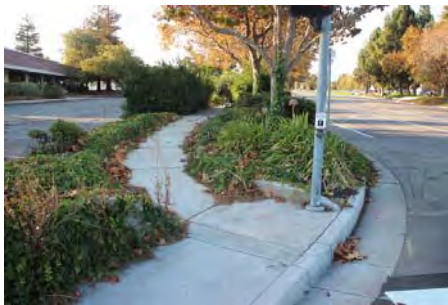
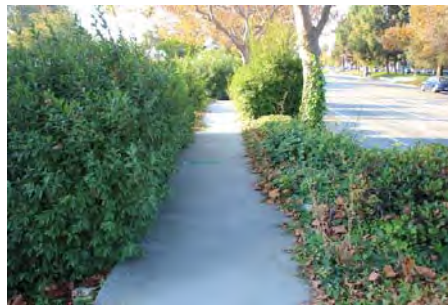
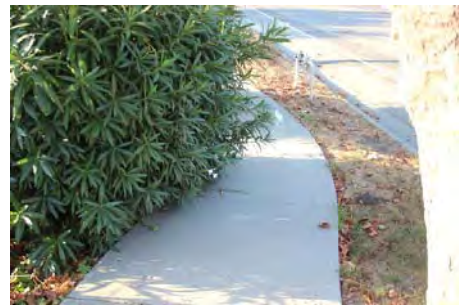
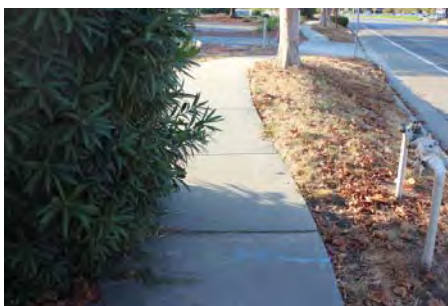
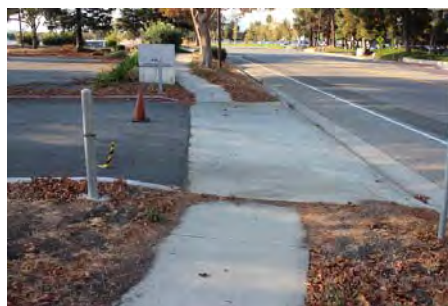
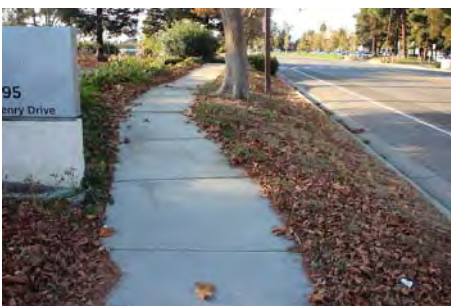
**FACILITY/SITE:** 4. Patrick Henry Dr.  
**FEATURE:** #11 ACC ROUTE OF TRAVEL

COD	CONDITION DESCRIPTION	ACTUAL
B02	36" min. clear width of exterior walkway. (ADAS 403.5.1)	Obstructed by plants.
B15	No level changes greater than 1/2" (except by accessible ramp or other means). (ADAS 303.4)	1 1/4" high vertical edge.
B16	Cross slope (perpendicular to direction of travel) is 1:48 (2.08%) max. (ADAS 403.3)	Approx. 120' L is 2.8% to 8.2%.
B17	Running slope (parallel to direction of travel) is 1:20 (5.0%) max. (ADAS 403.3)	5.6% to 10.2% at 5 sides of hills.

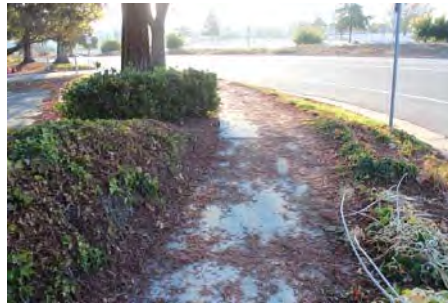
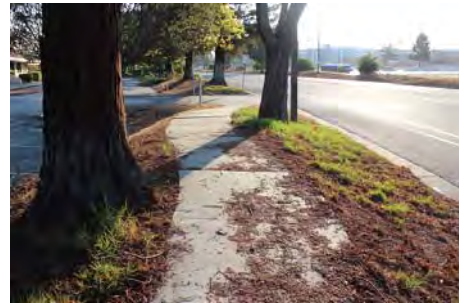
COD	CONDITION DESCRIPTION	ACTUAL
B11	Surface is firm, stable and slip-resistant. (ADAS 302.1)	Covered with Pine needles and sidewalk dead ends.
B15	No level changes greater than 1/2" (except by accessible ramp or other means). (ADAS 303.4)	1" and 1 1/2" high vertical edges.
B16	Cross slope (perpendicular to direction of travel) is 1:48 (2.08%) max. (ADAS 403.3)	Approx. 40' L is 3.5% to 6.1%.
B17	Running slope (parallel to direction of travel) is 1:20 (5.0%) max. (ADAS 403.3)	Approx. 40' L is 5.3% to 12.8%.

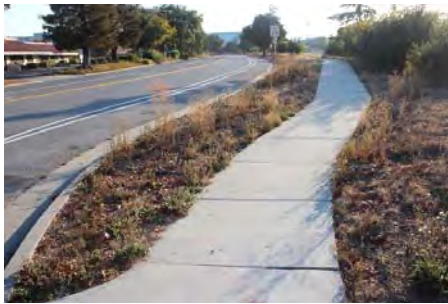
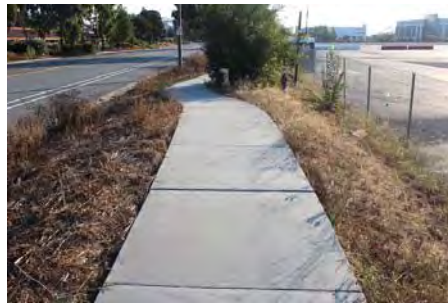
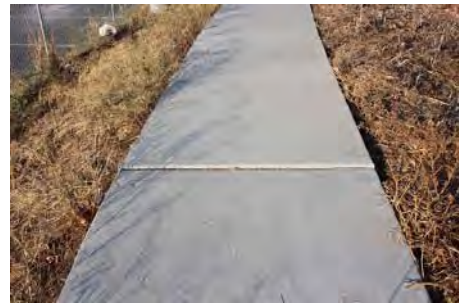
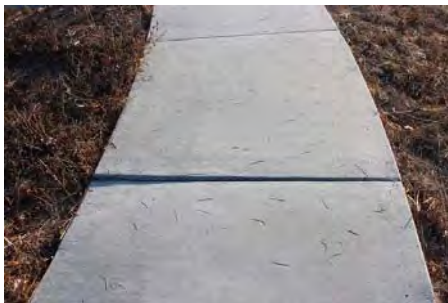
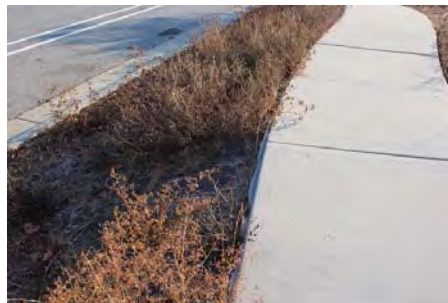
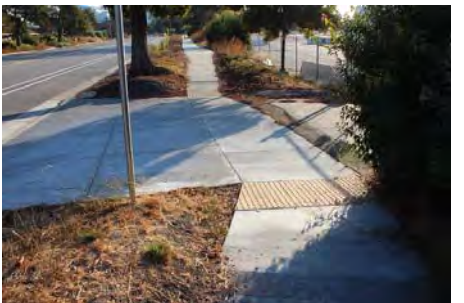
COD	CONDITION DESCRIPTION	ACTUAL
B15	No level changes greater than 1/2" (except by accessible ramp or other means). (ADAS 303.4)	1" high vertical edge.
B16	Cross slope (perpendicular to direction of travel) is 1:48 (2.08%) max. (ADAS 403.3)	Approx. 100' L is 2.6% to 4.7%.
B17	Running slope (parallel to direction of travel) is 1:20 (5.0%) max. (ADAS 403.3)	Apporx. 60' L is 5.8% to 7.2%.

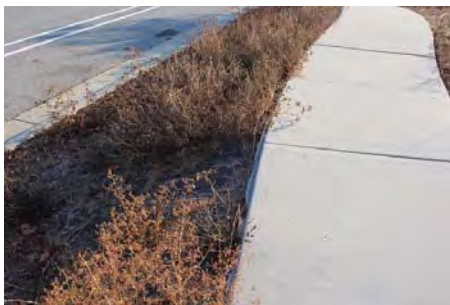
**FEATURE:** #11.1 HAZARDS

COD	CONDITION DESCRIPTION	ACTUAL
B11	Abrupt changes in level over 4" high are identified either by a curb or guide rail. (28 CFR 35.130(a), ADAS 405.9, CBC 11B-303.5)	Drop off at one side exceeds 4" H near top of hill.

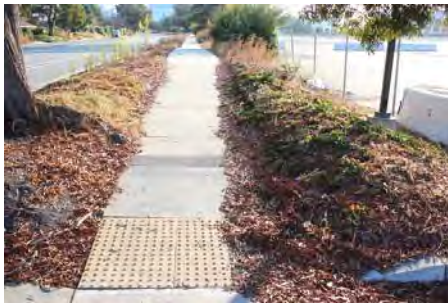
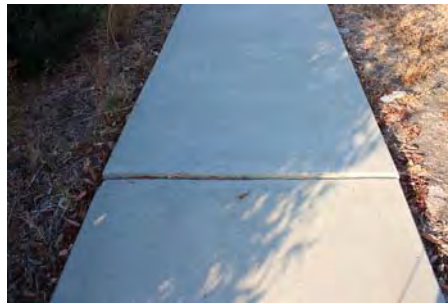
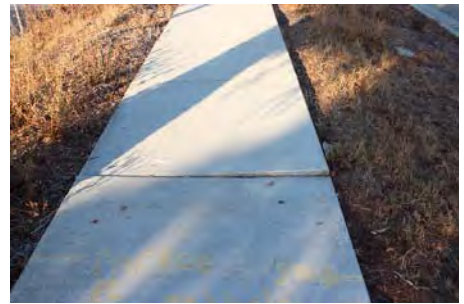
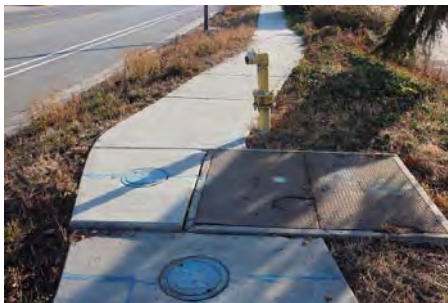
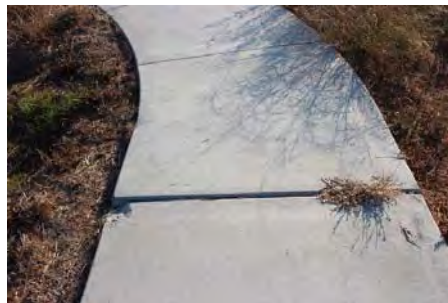
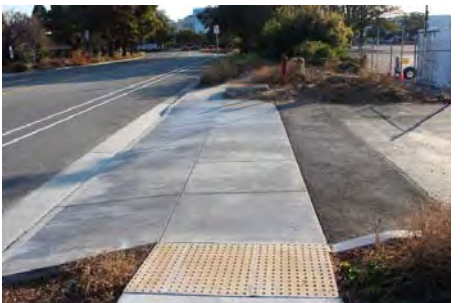
COD	CONDITION DESCRIPTION	ACTUAL
B15	No level changes greater than 1/2" (except by accessible ramp or other means). (ADAS 303.4)	3/4" to 2" high vertical edges at 8 places.
B16	Cross slope (perpendicular to direction of travel) is 1:48 (2.08%) max. (ADAS 403.3)	Approx. 220' L is 2.6% to 4.5%.
B17	Running slope (parallel to direction of travel) is 1:20 (5.0%) max. (ADAS 403.3)	Approx. 10' L is up to 8.9%.

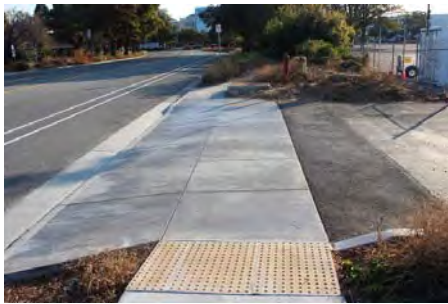
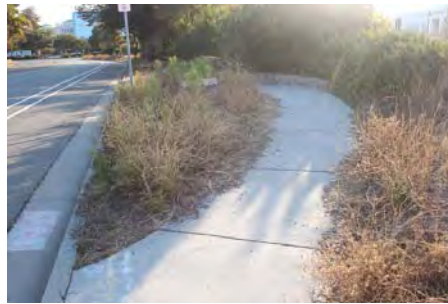
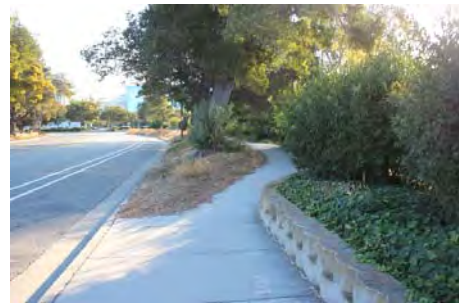
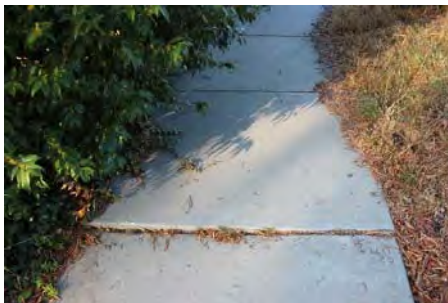
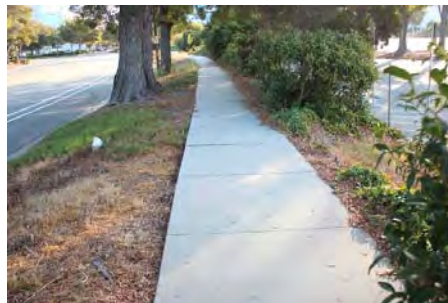
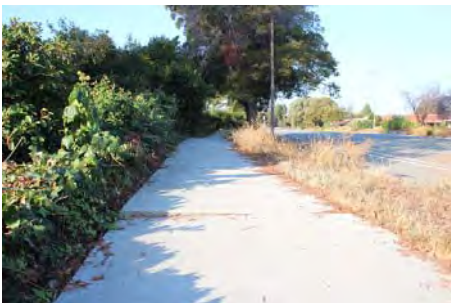
COD	CONDITION DESCRIPTION	ACTUAL
B15	No level changes greater than 1/2" (except by accessible ramp or other means). (ADAS 303.4)	1" to 1 1/4" high vertical edges at 4 places.
B16	Cross slope (perpendicular to direction of travel) is 1:48 (2.08%) max. (ADAS 403.3)	Approx. 200' L is 2.6% to 6.8%.
B17	Running slope (parallel to direction of travel) is 1:20 (5.0%) max. (ADAS 403.3)	Up to 7.8% at 2 hills and approx. 20' L is 7.8% to 10.3%.

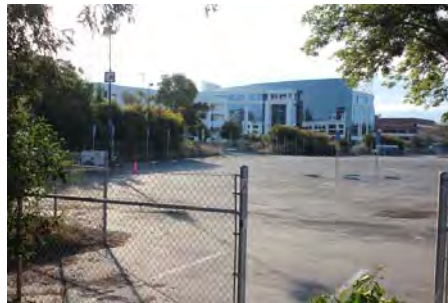
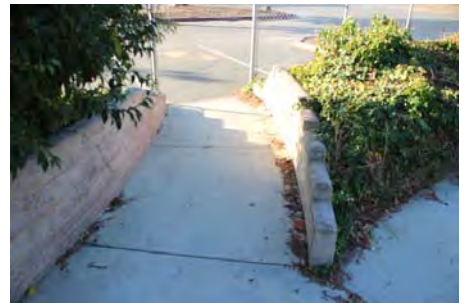
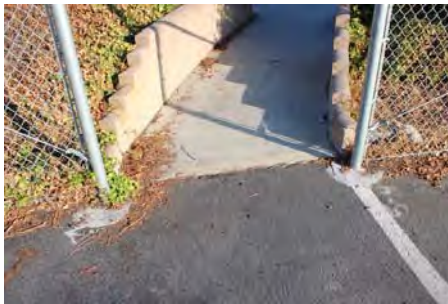
COD	CONDITION DESCRIPTION	ACTUAL
B17	Running slope (parallel to direction of travel) is 1:20 (5.0%) max. (ADAS 403.3)	Entire length is 5.7% to 11.2%.

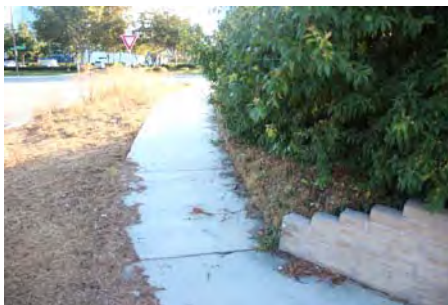
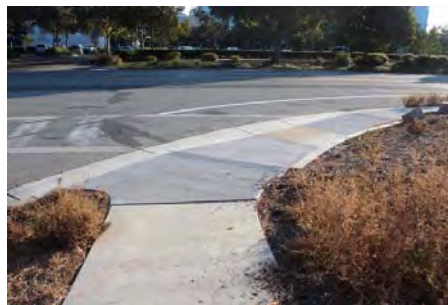
COD	CONDITION DESCRIPTION	ACTUAL
B16	Cross slope (perpendicular to direction of travel) is 1:48 (2.08%) max. (ADAS 403.3)	Apporx. 10' L is 2.9%.

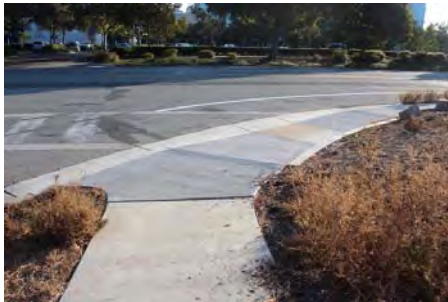
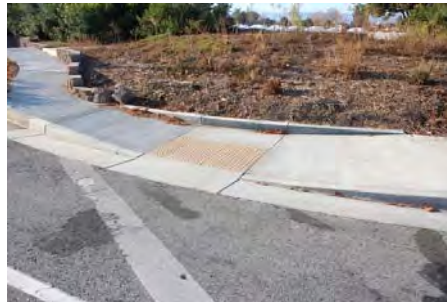
COD	CONDITION DESCRIPTION	ACTUAL
C12	Turning space at bottom of curb ramp slopes 1:48 (2.08%) max. in any direction (ADAS 403.3)	9.2% across curb face.
B13	Counter slopes of adjoining gutters and road surfaces immediately adjacent to and within 24 inches of the curb ramp are not steeper than 1:20 (5.0%). (ADAS 406.2)	10.2%

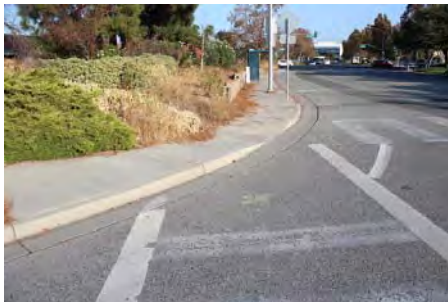
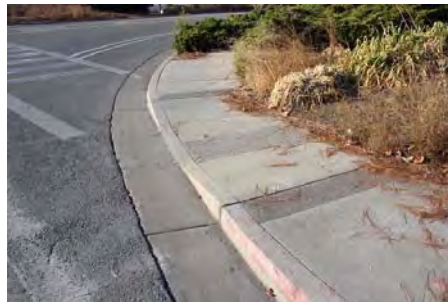
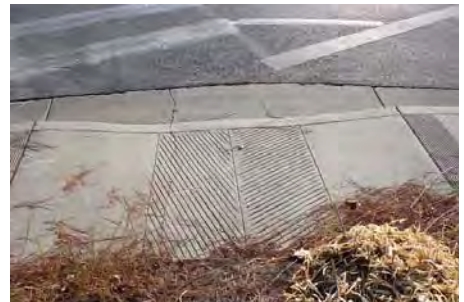
COD	CONDITION DESCRIPTION	ACTUAL
B03	Running slope of ramp is 1:12 (8.33%) max. (ADAS 405.2)	14.7% across curb face.
B11	Top landing is as wide as the ramp and 36" min. in length. (ADAS 406.4)	None
B14	Counter slopes of adjoining gutters and road surfaces immediately adjacent to and within 24 inches of the curb ramp are not steeper than 1:20 (5.0%). (ADAS 406.2)	10.4%
A17	Where no top landing is provided at an existing ramp, side flare slopes are 8.33% max. (ADAS 406.4)	13.2% right side, 12.0% left side.
B19	DIAGONAL: If curb ramp is located at marked crossing, 48" min. clear space is provided within the markings. (ADAS 406.6)	35" clear within markings.

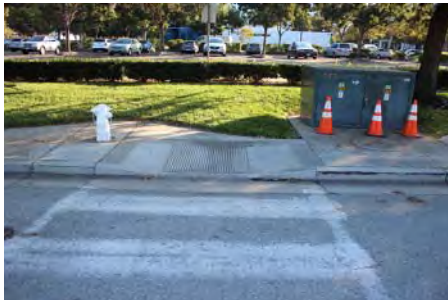
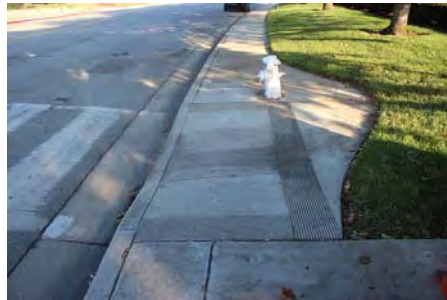
COD	CONDITION DESCRIPTION	ACTUAL
B03	Running slope of ramp is 1:12 (8.33%) max. (ADAS 405.2)	16.8% across curb face.
B05	Surface of ramp and landings complies with requirements for an accessible path of travel (stable, firm, slip-resistant, without gaps over 1/2" wide or edges over 1/4" high). (ADAS 302.1, 403.2, 403.3, 403.4)	3.5% cross slope at top landing.
B11	Top landing is as wide as the ramp and 36" min. in length. (ADAS 406.4)	24" L.
B14	Counter slopes of adjoining gutters and road surfaces immediately adjacent to and within 24 inches of the curb ramp are not steeper than 1:20 (5.0%). (ADAS 406.2)	9.9%
A17	Where no top landing is provided at an existing ramp, side flare slopes are 8.33% max. (ADAS 406.4)	13.6% left side, 13.7% right side.

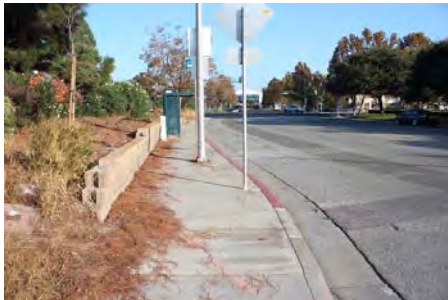
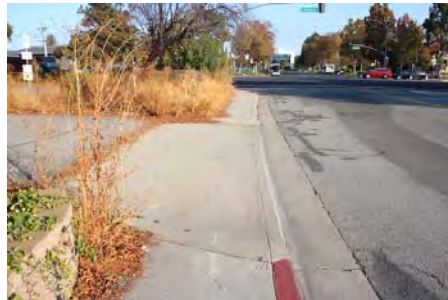
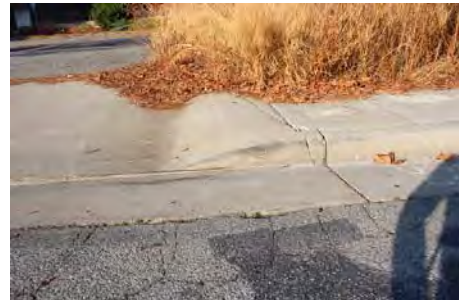
COD	CONDITION DESCRIPTION	ACTUAL
B16	Cross slope (perpendicular to direction of travel) is 1:48 (2.08%) max. (ADAS 403.3)	7.6% for approx. 20' L at driveway apron.
B17	Running slope (parallel to direction of travel) is 1:20 (5.0%) max. (ADAS 403.3)	20.8% and 25.6% at sides of driveway apron.

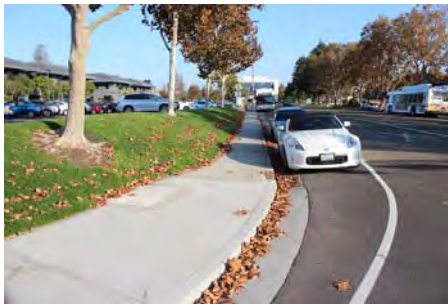
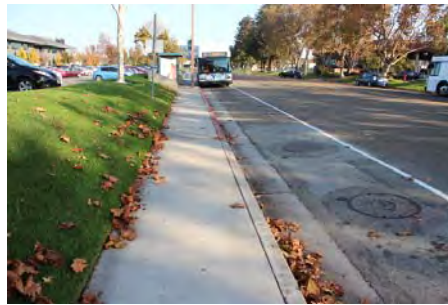
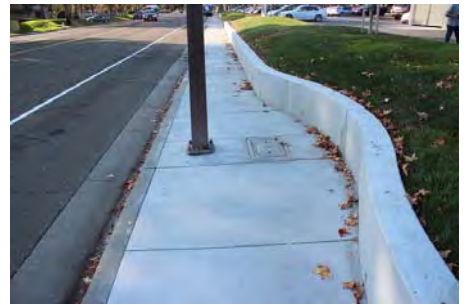
COD	CONDITION DESCRIPTION	ACTUAL
B16	Cross slope (perpendicular to direction of travel) is 1:48 (2.08%) max. (ADAS 403.3)	Approx. 70' L is 2.8% to 3.9%.

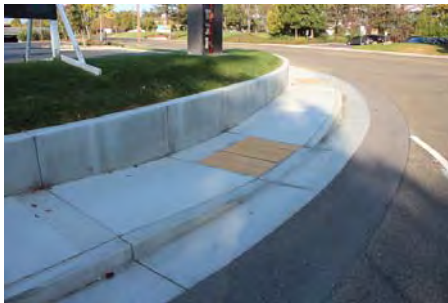
COD	CONDITION DESCRIPTION	ACTUAL
B13	Counter slopes of adjoining gutters and road surfaces immediately adjacent to and within 24 inches of the curb ramp are not steeper than 1:20 (5.0%). (ADAS 406.2)	6.8%

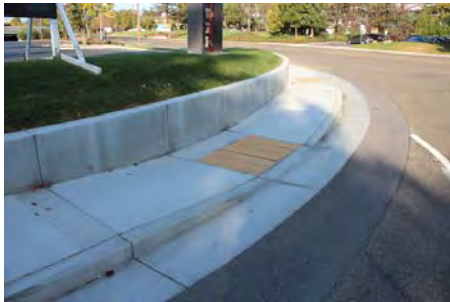
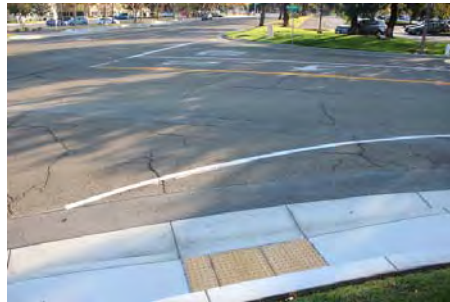
<b>COD</b>	<b>CONDITION DESCRIPTION</b>	<b>ACTUAL</b>
B11	Surface is firm, stable and slip-resistant. (ADAS 302.1)	No sidewalk.
B15	No level changes greater than 1/2" (except by accessible ramp or other means). (ADAS 303.4)	No curb access.

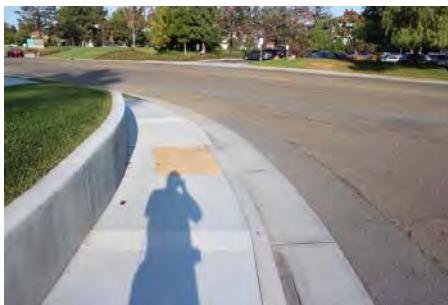
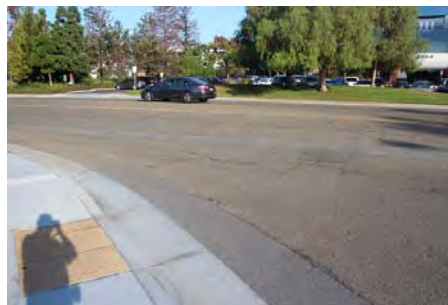
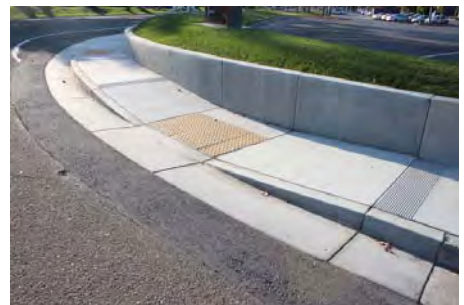
COD	CONDITION DESCRIPTION	ACTUAL
B13	Counter slopes of adjoining gutters and road surfaces immediately adjacent to and within 24 inches of the curb ramp are not steeper than 1:20 (5.0%). (ADAS 406.2)	7.4%

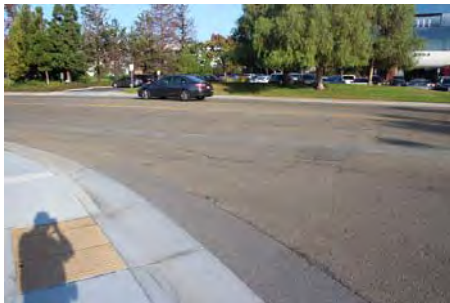
COD	CONDITION DESCRIPTION	ACTUAL
B15	No level changes greater than 1/2" (except by accessible ramp or other means). (ADAS 303.4)	No curb ramp.

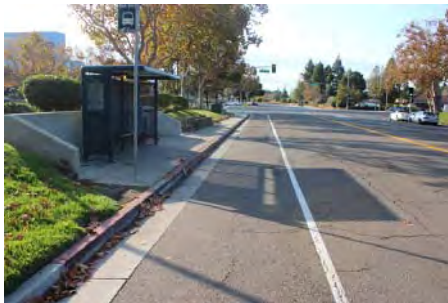
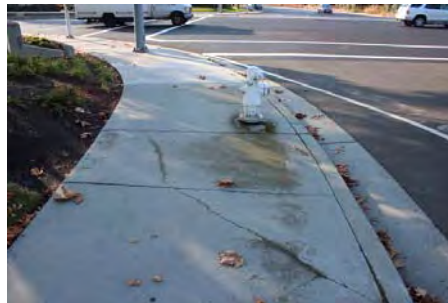
COD	CONDITION DESCRIPTION	ACTUAL
B16	Cross slope (perpendicular to direction of travel) is 1:48 (2.08%) max. (ADAS 403.3)	Approx. 10' L is up to 4.7% near Tasman Drive.
