Case No. 5:16-cv-07013-LHK (SVK)

**DECLARATION OF JEFFREY SCOTT  
MASTIN IN SUPPORT OF PLAINTIFFS'  
MOTION FOR CLASS CERTIFICATION**

NEVAREZ V 49ERS - ACCESSIBILITY ASSESSMENT

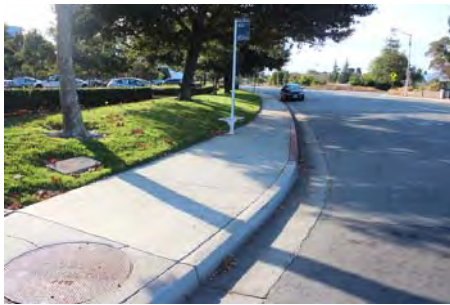
COD	CONDITION DESCRIPTION	ACTUAL
B16	Cross slope (perpendicular to direction of travel) is 1:48 (2.08%) max. (ADAS 403.3)	Approx. 120' L is 2.7% to 4.4%.

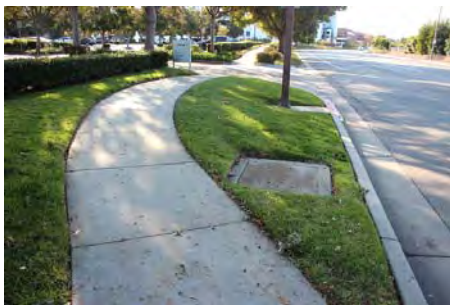
COD	CONDITION DESCRIPTION	ACTUAL
B17	Running slope (parallel to direction of travel) is 1:20 (5.0%) max. (ADAS 403.3)	7.5% at one side of hill.

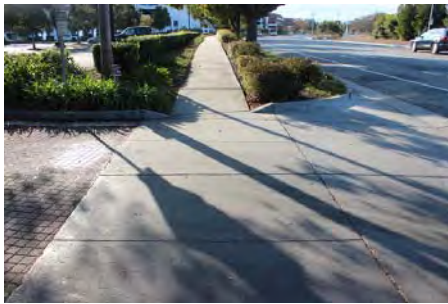
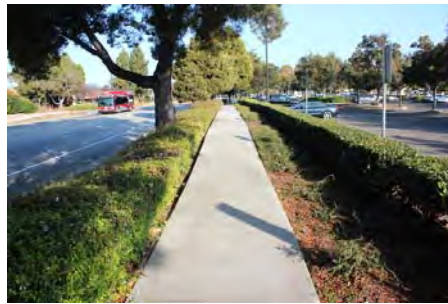
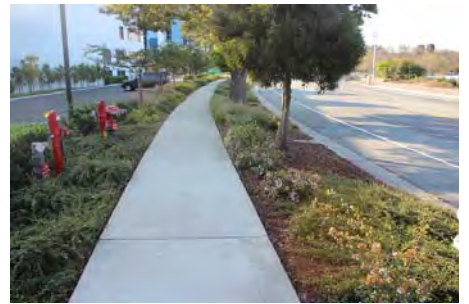
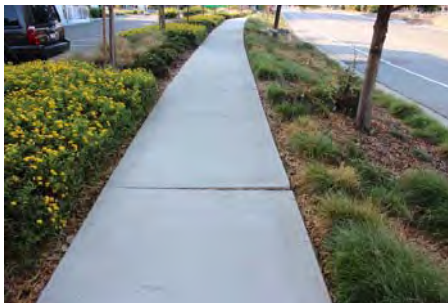
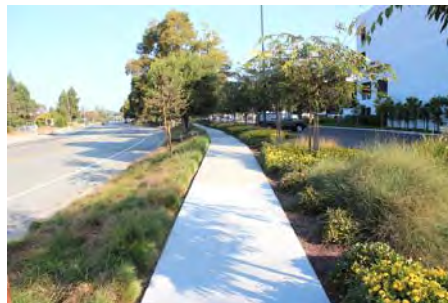
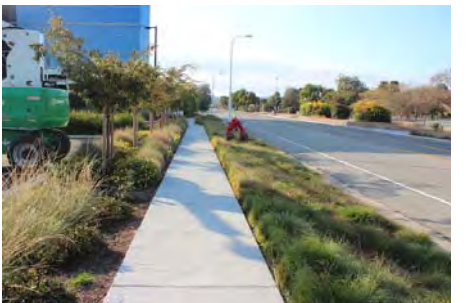
COD	CONDITION DESCRIPTION	ACTUAL
B15	No level changes greater than 1/2" (except by accessible ramp or other means). (ADAS 303.4)	1" high vertical edge.
B16	Cross slope (perpendicular to direction of travel) is 1:48 (2.08%) max. (ADAS 403.3)	Approx. 260' L is 3.1% to 5.6%.
B17	Running slope (parallel to direction of travel) is 1:20 (5.0%) max. (ADAS 403.3)	6.0% at one side of hill.

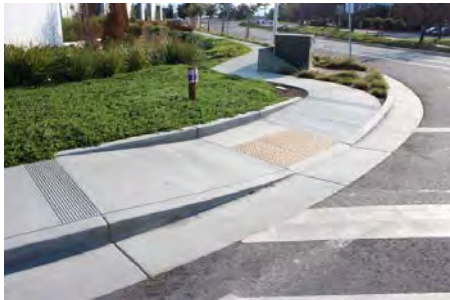
COD	CONDITION DESCRIPTION	ACTUAL
C12	Turning space at bottom of curb ramp slopes 1:48 (2.08%) max. in any direction (ADAS 403.3)	9.6% across curb face.
B13	Counter slopes of adjoining gutters and road surfaces immediately adjacent to and within 24 inches of the curb ramp are not steeper than 1:20 (5.0%). (ADAS 406.2)	10.7%

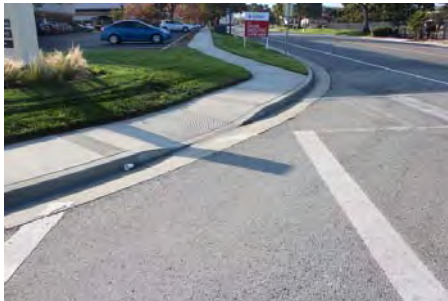
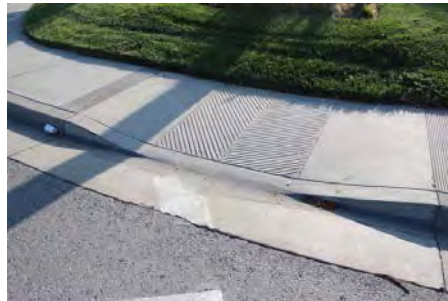
COD	CONDITION DESCRIPTION	ACTUAL
B03	Running slope of ramp is 1:12 (8.33%) max. (ADAS 405.2)	14.3% for 3" L at btm.
B11	Top landing is as wide as the ramp and 36" min. in length. (ADAS 406.4)	None
B14	Counter slopes of adjoining gutters and road surfaces immediately adjacent to and within 24 inches of the curb ramp are not steeper than 1:20 (5.0%). (ADAS 406.2)	10.4%
A17	Where no top landing is provided at an existing ramp, side flare slopes are 8.33% max. (ADAS 406.4)	13.6% left side, 13.8% right side.

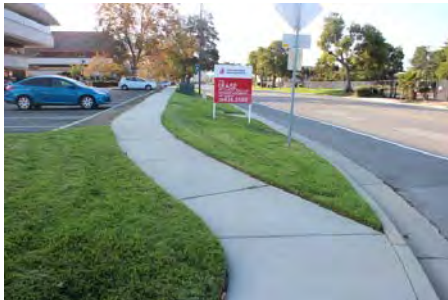
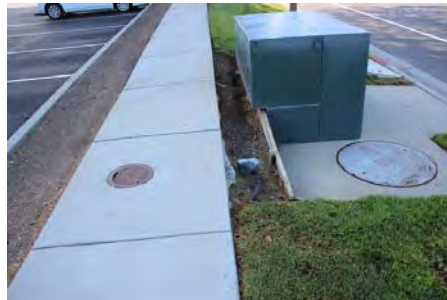
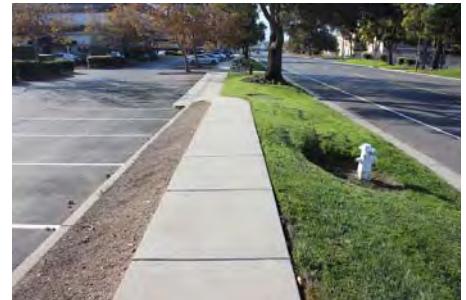
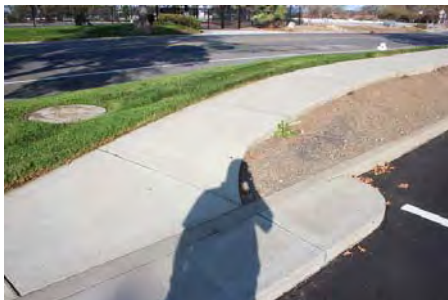
COD	CONDITION DESCRIPTION	ACTUAL
B16	Cross slope (perpendicular to direction of travel) is 1:48 (2.08%) max. (ADAS 403.3)	Approx. 50' L is 2.7% to 6.8%.
B17	Running slope (parallel to direction of travel) is 1:20 (5.0%) max. (ADAS 403.3)	9.1% and 17.7% at 2 sides of hills.

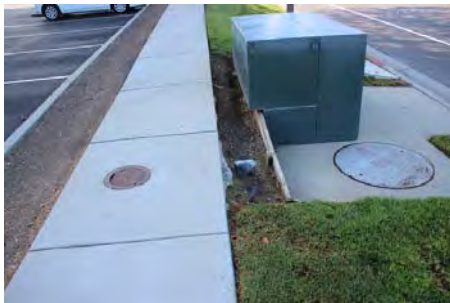
COD	CONDITION DESCRIPTION	ACTUAL
B11	Abrupt changes in level over 4" high are identified either by a curb or guide rail. (28 CFR 35.130(a), ADAS 405.9, CBC 11B-303.5)	Approx. 10' L has 9" high drop off at one side.

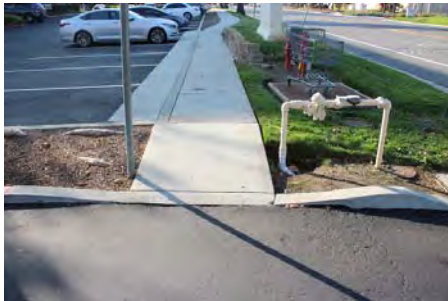
COD	CONDITION DESCRIPTION	ACTUAL
B03	Running slope of ramp is 1:12 (8.33%) max. (ADAS 405.2)	10.4%
B04	Cross slope of ramp is 1:48 (2.08%). (ADAS 405.3)	3.6%
B06	Transition to walk, gutter or street is flush and free of abrupt changes. (ADAS 406.2)	3/4 high vertical edge and 1" W gap.
B16	Maximum slope of flared sides is 1:10 (10.0%). (ADAS 406.2)	None provided and up to 4" drop off.

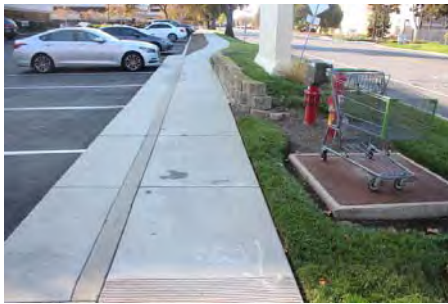
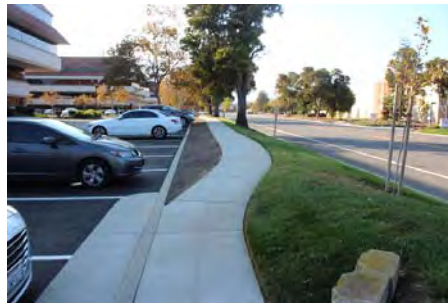
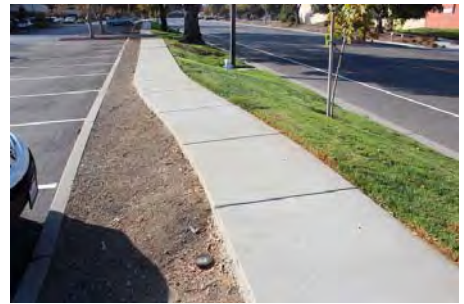
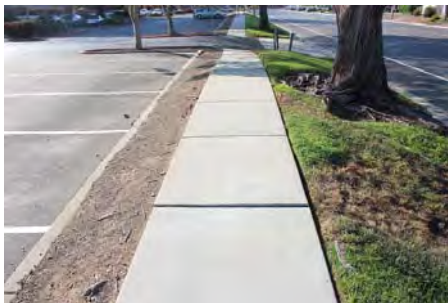
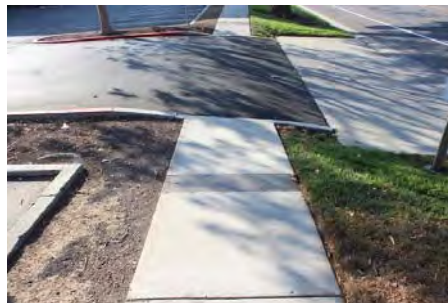
COD	CONDITION DESCRIPTION	ACTUAL
B15	No level changes greater than 1/2" (except by accessible ramp or other means). (ADAS 303.4)	3/4" high vertical edge.
B16	Cross slope (perpendicular to direction of travel) is 1:48 (2.08%) max. (ADAS 403.3)	Approx. 160' L is 2.7% to 4.8%.
B17	Running slope (parallel to direction of travel) is 1:20 (5.0%) max. (ADAS 403.3)	8.8% at side of one hill.

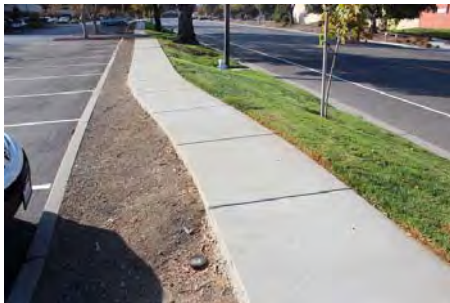
COD	CONDITION DESCRIPTION	ACTUAL
B11	Abrupt changes in level over 4" high are identified either by a curb or guide rail. (28 CFR 35.130(a), ADAS 405.9, CBC 11B-303.5)	6" drop off along portion of one side approx. 20' L.

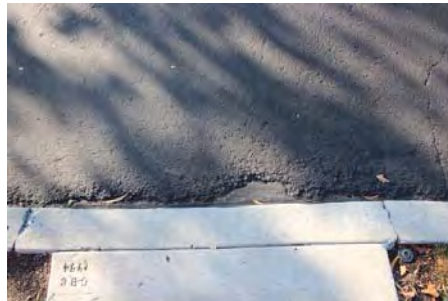
COD	CONDITION DESCRIPTION	ACTUAL
B04	Cross slope of ramp is 1:48 (2.08%). (ADAS 405.3)	6.4%
B05	Surface of ramp and landings complies with requirements for an accessible path of travel (stable, firm, slip-resistant, without gaps over 1/2" wide or edges over 1/4" high). (ADAS 302.1, 403.2, 403.3, 403.4)	6.1% running slope at top landing, 8.6% cross slope at btm. landing.
B06	Transition to walk, gutter or street is flush and free of abrupt changes. (ADAS 406.2)	3/4" high vertical edge and 1" W gap.

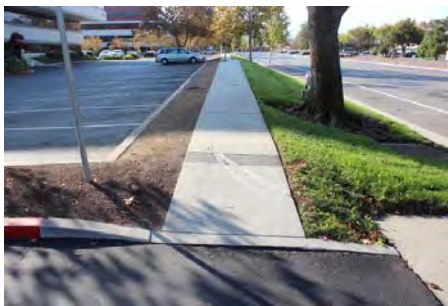
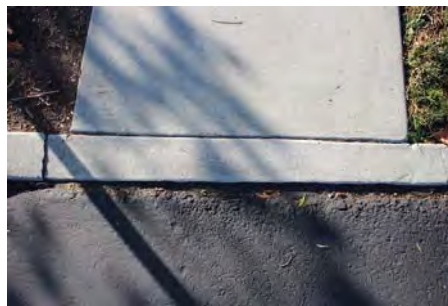
COD	CONDITION DESCRIPTION	ACTUAL
B03	Running slope of ramp is 1:12 (8.33%) max. (ADAS 405.2)	12.3%
B04	Cross slope of ramp is 1:48 (2.08%). (ADAS 405.3)	4.0%
B05	Surface of ramp and landings complies with requirements for an accessible path of travel (stable, firm, slip-resistant, without gaps over 1/2" wide or edges over 1/4" high). (ADAS 302.1, 403.2, 403.3, 403.4)	12.2% running slope at top landing, 6.9% cross slope at btm. landing.
B06	Transition to walk, gutter or street is flush and free of abrupt changes. (ADAS 406.2)	3/4" high vertical edge and 2" W gap.

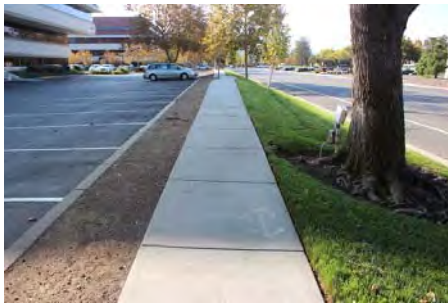
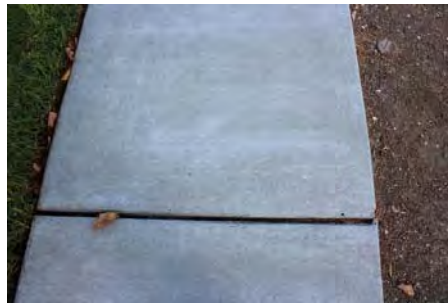
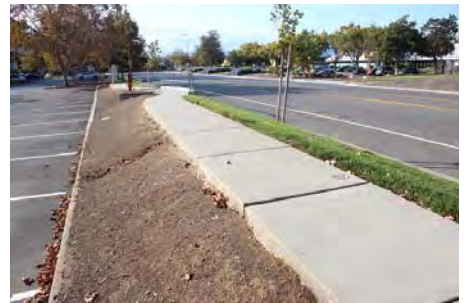
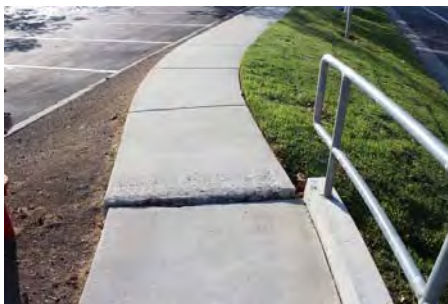
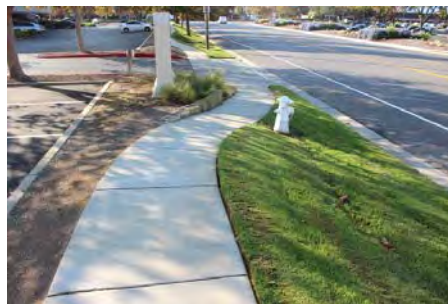
COD	CONDITION DESCRIPTION	ACTUAL
B12	Gaps/openings in ground or floor surfaces do not allow the passage of a sphere more than 1/2" in diameter. (ADAS 302.3)	3/4" W gaps at 2 places.
B15	No level changes greater than 1/2" (except by accessible ramp or other means). (ADAS 303.4)	2" high vertical edge
B16	Cross slope (perpendicular to direction of travel) is 1:48 (2.08%) max. (ADAS 403.3)	Approx. 200' L is 2.9% to 5.4%.
B17	Running slope (parallel to direction of travel) is 1:20 (5.0%) max. (ADAS 403.3)	11.1% at side of one hill.

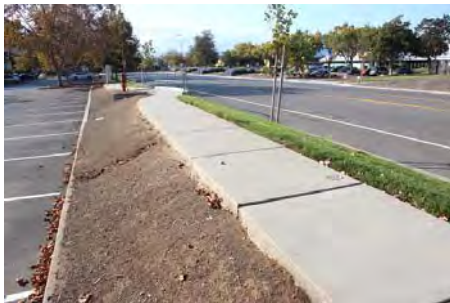
COD	CONDITION DESCRIPTION	ACTUAL
B11	Abrupt changes in level over 4" high are identified either by a curb or guide rail. (28 CFR 35.130(a), ADAS 405.9, CBC 11B-303.5)	Approx. 30' L drops off up to 9" high at one side.

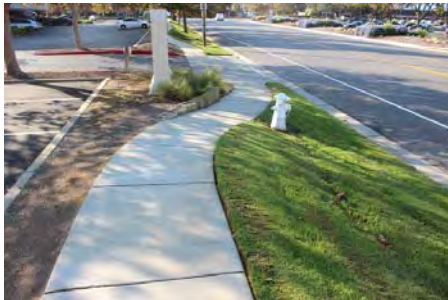
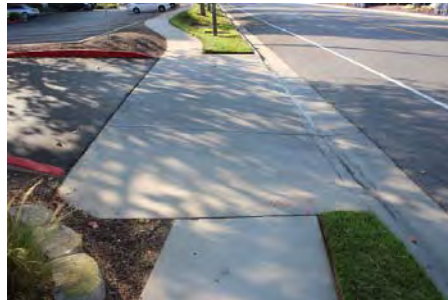
COD	CONDITION DESCRIPTION	ACTUAL
B16	Cross slope (perpendicular to direction of travel) is 1:48 (2.08%) max. (ADAS 403.3)	7.2%
B17	Running slope (parallel to direction of travel) is 1:20 (5.0%) max. (ADAS 403.3)	Up to 14.5%.

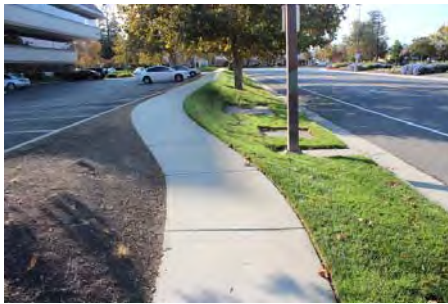
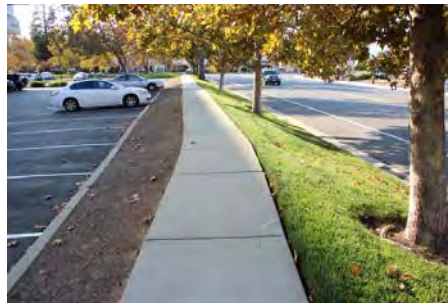
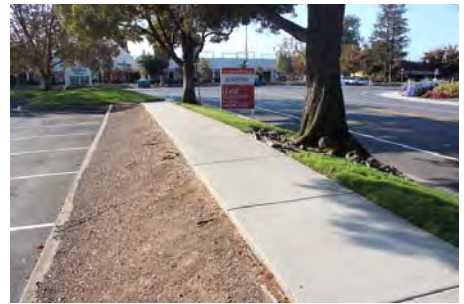
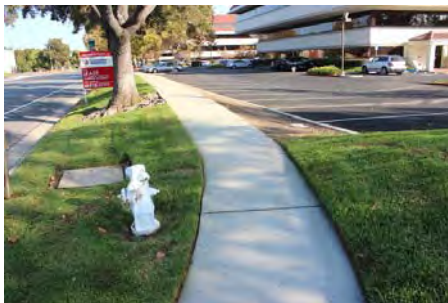
COD	CONDITION DESCRIPTION	ACTUAL
B15	No level changes greater than 1/2" (except by accessible ramp or other means). (ADAS 303.4)	3/4" high vertical edge.
B16	Cross slope (perpendicular to direction of travel) is 1:48 (2.08%) max. (ADAS 403.3)	Approx. 220' L is 2.7% to 6.5%.
B17	Running slope (parallel to direction of travel) is 1:20 (5.0%) max. (ADAS 403.3)	7.9% and 7.1% at 2 sides of hills.

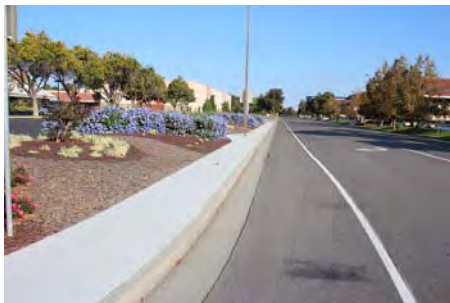
COD	CONDITION DESCRIPTION	ACTUAL
B11	Surface is firm, stable and slip-resistant. (ADAS 302.1)	Approximate 700' long dead end with no indication at intersection of Patrick Henry Drive that the route is not accessible.

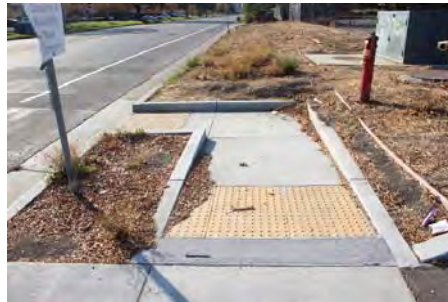
COD	CONDITION DESCRIPTION	ACTUAL
B06	Transition to walk, gutter or street is flush and free of abrupt changes. (ADAS 406.2)	3/8" high vertical edge.
B13	Counter slopes of adjoining gutters and road surfaces immediately adjacent to and within 24 inches of the curb ramp are not steeper than 1:20 (5.0%). (ADAS 406.2)	10.3%

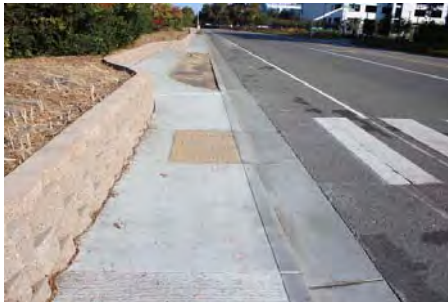
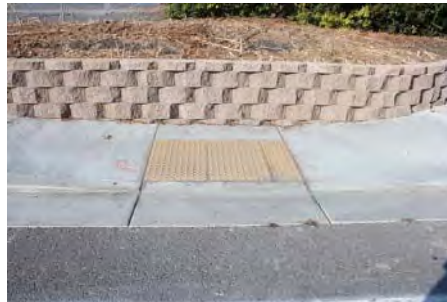
COD	CONDITION DESCRIPTION	ACTUAL
C12	Turning space at bottom of curb ramp slopes 1:48 (2.08%) max. in any direction (ADAS 403.3)	10.7% across curb face.
B13	Counter slopes of adjoining gutters and road surfaces immediately adjacent to and within 24 inches of the curb ramp are not steeper than 1:20 (5.0%). (ADAS 406.2)	13.8%

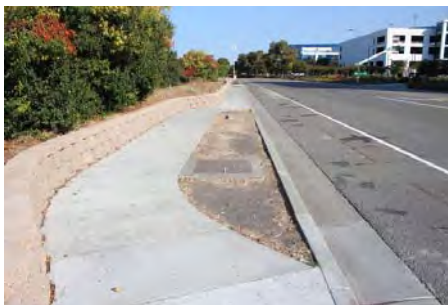
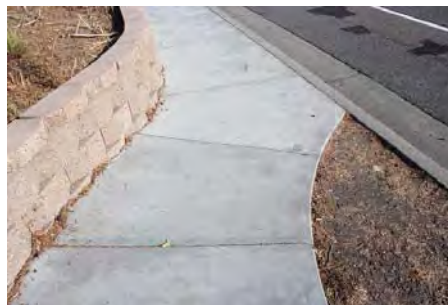
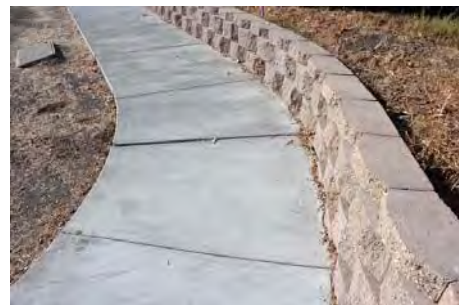
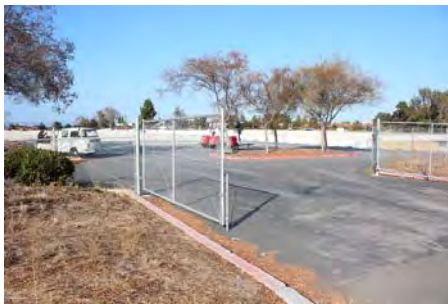
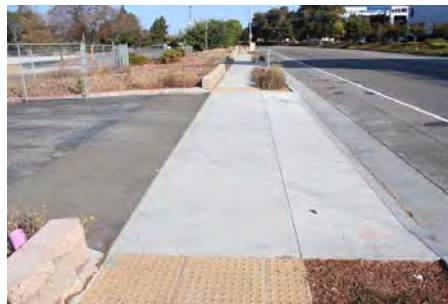
COD	CONDITION DESCRIPTION	ACTUAL
B16	Cross slope (perpendicular to direction of travel) is 1:48 (2.08%) max. (ADAS 403.3)	5' L is 5.3%.

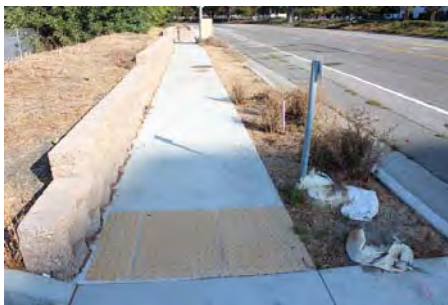
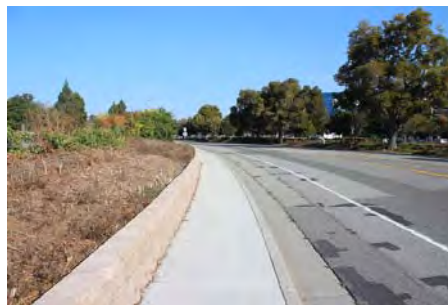
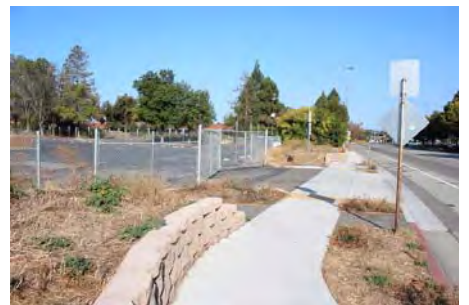
COD	CONDITION DESCRIPTION	ACTUAL
B16	Cross slope (perpendicular to direction of travel) is 1:48 (2.08%) max. (ADAS 403.3)	Approx. 40' L is 2.7% to 3.5%.

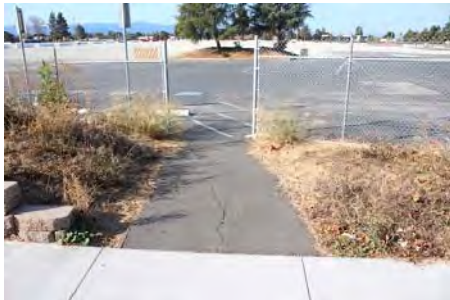
COD	CONDITION DESCRIPTION	ACTUAL
B16	Cross slope (perpendicular to direction of travel) is 1:48 (2.08%) max. (ADAS 403.3)	Up to 3.7%.
B17	Running slope (parallel to direction of travel) is 1:20 (5.0%) max. (ADAS 403.3)	Up to 7.4%.

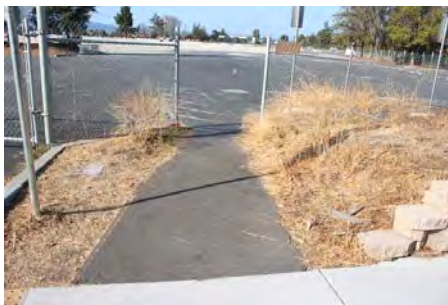
COD	CONDITION DESCRIPTION	ACTUAL
B17	Running slope (parallel to direction of travel) is 1:20 (5.0%) max. (ADAS 403.3)	Up to 5.8%.

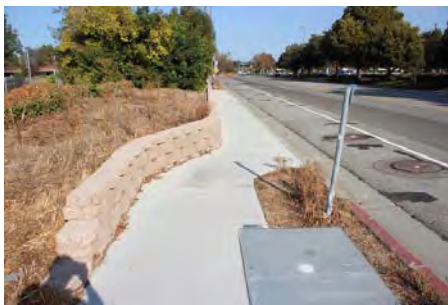
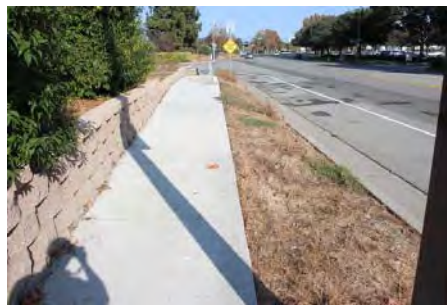
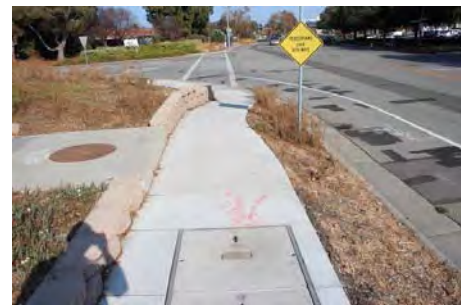
COD	CONDITION DESCRIPTION	ACTUAL
B17	Running slope (parallel to direction of travel) is 1:20 (5.0%) max. (ADAS 403.3)	5.9% at one side of hill.

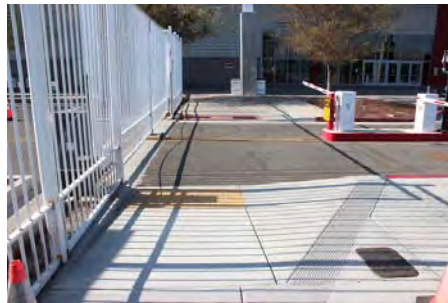
CODE	CONDITION DESCRIPTION	ACTUAL
B16	Maximum slope of flared sides is 1:10 (10.0%). (ADAS 406.2)	10.8% right side.

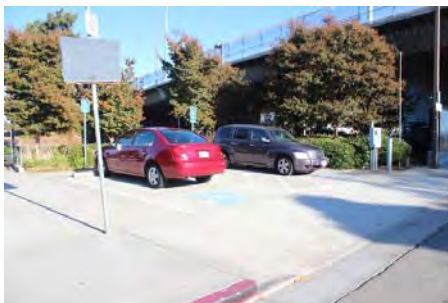
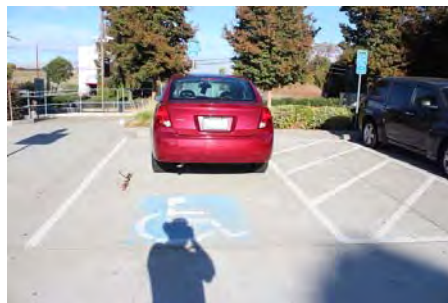
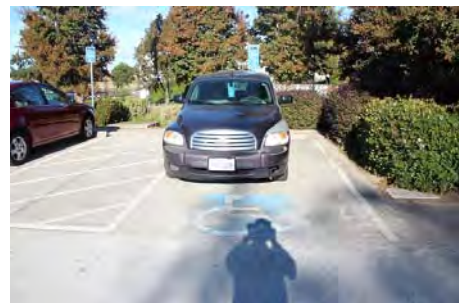
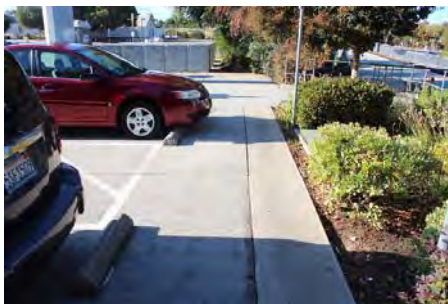
COD	CONDITION DESCRIPTION	ACTUAL
B31	Slopes do not exceed 1:48 (2.08%)	Up to 3.0% at portions of both spaces and access aisle.

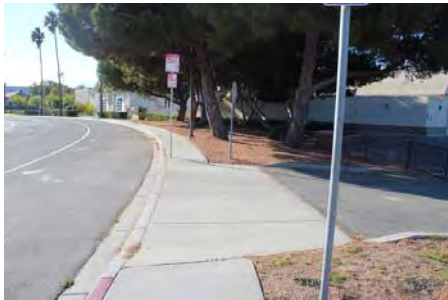
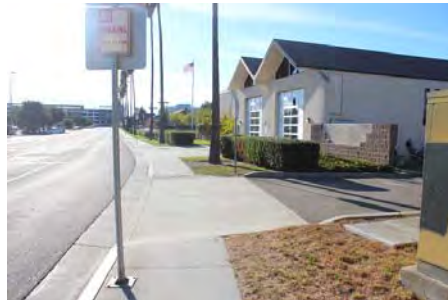
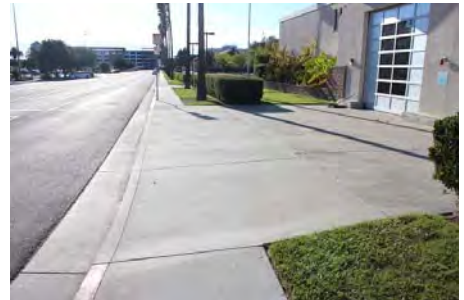
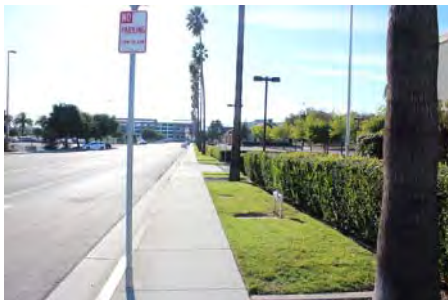
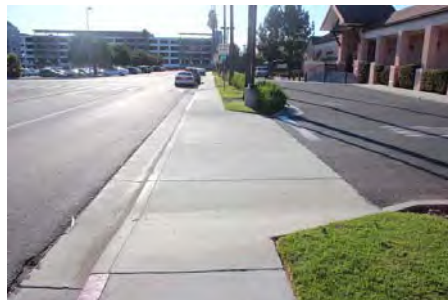
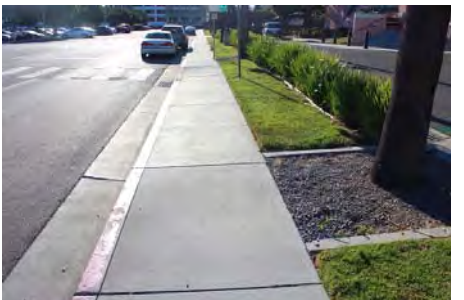
COD	CONDITION DESCRIPTION	ACTUAL
B16	Cross slope (perpendicular to direction of travel) is 1:48 (2.08%) max. (ADAS 403.3)	Approx. 120' L is 2.7% to 5.6%.
B17	Running slope (parallel to direction of travel) is 1:20 (5.0%) max. (ADAS 403.3)	11.1% to 16.7% at 10 sides of driveway aprons.

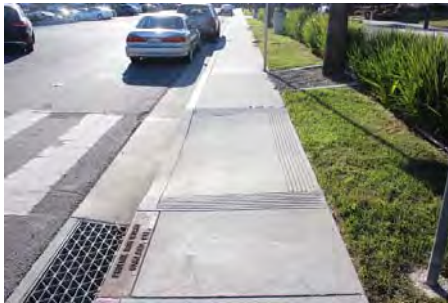
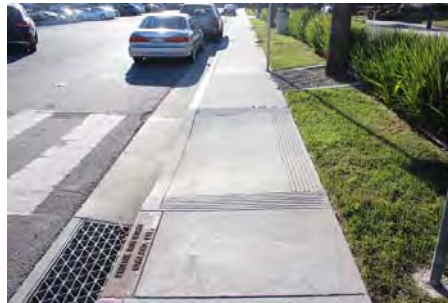
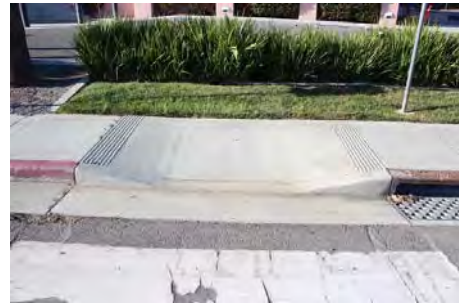
COD	CONDITION DESCRIPTION	ACTUAL
B03	Running slope of ramp is 1:12 (8.33%) max. (ADAS 405.2)	12.2% to 13.3%.
B11	Top landing is as wide as the ramp and 36" min. in length. (ADAS 406.4)	None
B14	Counter slopes of adjoining gutters and road surfaces immediately adjacent to and within 24 inches of the curb ramp are not steeper than 1:20 (5.0%). (ADAS 406.2)	7.8%
A17	Where no top landing is provided at an existing ramp, side flare slopes are 8.33% max. (ADAS 406.4)	16.7% right side, 15.3% left side.

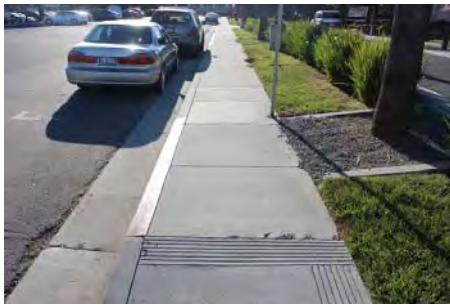
<b>FACILITY/SITE:</b> 8. Stars and Stripes Dr.	<b>SEQ. #</b>	<b>804</b>
<b>FEATURE:</b> #11 ACC ROUTE OF TRAVEL

<b>COD</b>	<b>CONDITION DESCRIPTION</b>	<b>ACTUAL</b>
B16	Cross slope (perpendicular to direction of travel) is 1:48 (2.08%) max. (ADAS 403.3)	Approx. 70' L is 3.5% to 4.1%.

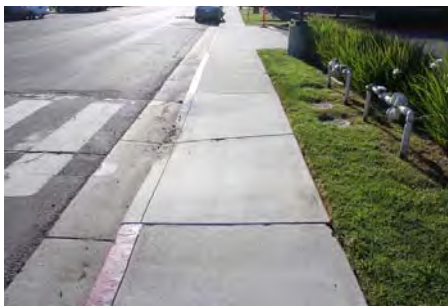
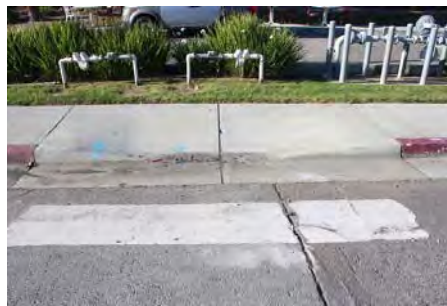
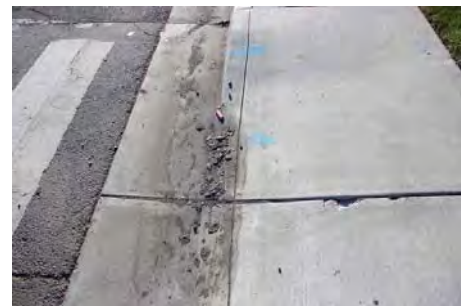
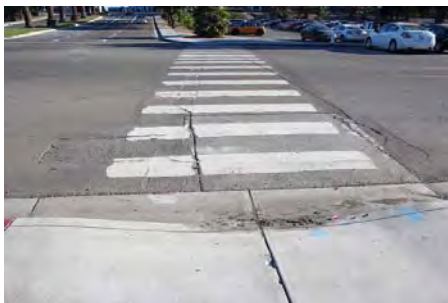
COD	CONDITION DESCRIPTION	ACTUAL
B03	Running slope of ramp is 1:12 (8.33%) max. (ADAS 405.2)	11.5% to 13.0%.
B05	Surface of ramp and landings complies with requirements for an accessible path of travel (stable, firm, slip-resistant, without gaps over 1/2" wide or edges over 1/4" high). (ADAS 302.1, 403.2, 403.3, 403.4)	Debris on btm. Landing.
B11	Top landing is as wide as the ramp and 36" min. in length. (ADAS 406.4)	None
A17	Where no top landing is provided at an existing ramp, side flare slopes are 8.33% max. (ADAS 406.4)	11.7% right side, 14.4% left side.

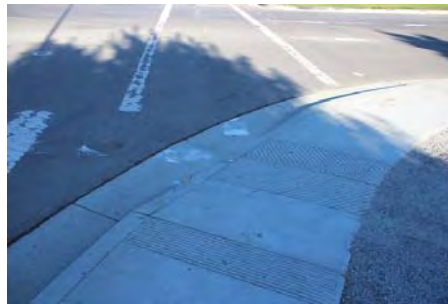
COD	CONDITION DESCRIPTION	ACTUAL
B03	Running slope of ramp is 1:12 (8.33%) max. (ADAS 405.2)	9.1% to 12.6%.
B05	Surface of ramp and landings complies with requirements for an accessible path of travel (stable, firm, slip-resistant, without gaps over 1/2" wide or edges over 1/4" high). (ADAS 302.1, 403.2, 403.3, 403.4)	1/2" high vertical edges on ramp and btm. Landing.
B11	Top landing is as wide as the ramp and 36" min. in length. (ADAS 406.4)	None
A17	Where no top landing is provided at an existing ramp, side flare slopes are 8.33% max. (ADAS 406.4)	18.6% right side, 14.1% left side.

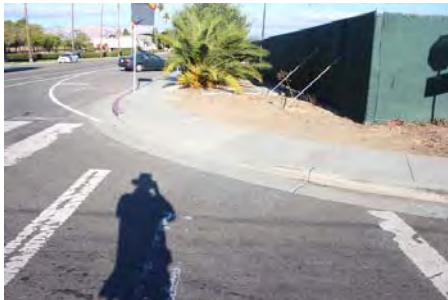
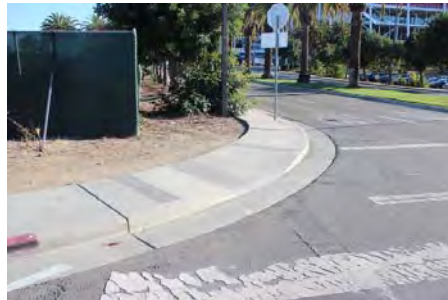
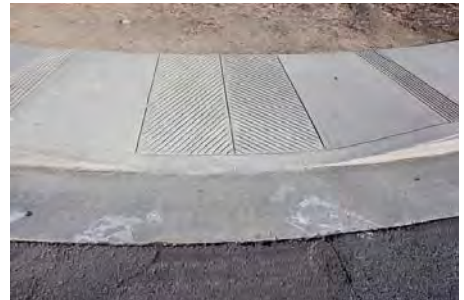
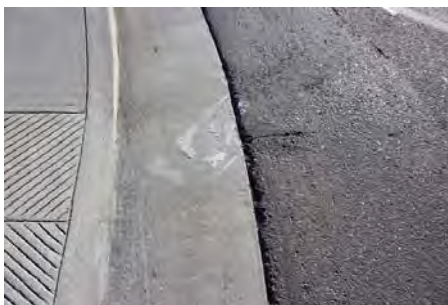
COD	CONDITION DESCRIPTION	ACTUAL
B03	Running slope of ramp is 1:12 (8.33%) max. (ADAS 405.2)	8.5% to 11.3%.
B05	Surface of ramp and landings complies with requirements for an accessible path of travel (stable, firm, slip-resistant, without gaps over 1/2" wide or edges over 1/4" high). (ADAS 302.1, 403.2, 403.3, 403.4)	1 1/2" high vertical edge at asphalt transition at btm. landing.
B11	Top landing is as wide as the ramp and 36" min. in length. (ADAS 406.4)	None
B14	Counter slopes of adjoining gutters and road surfaces immediately adjacent to and within 24 inches of the curb ramp are not steeper than 1:20 (5.0%). (ADAS 406.2)	9.1%
A17	Where no top landing is provided at an existing ramp, side flare slopes are 8.33% max. (ADAS 406.4)	13.9% left side, 12.5% right side.

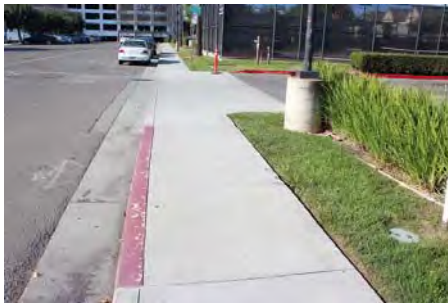
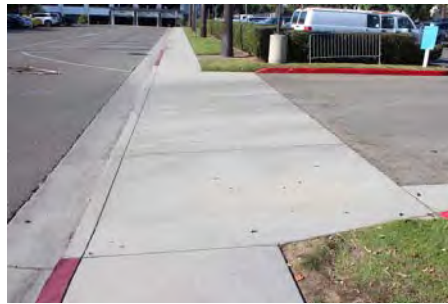
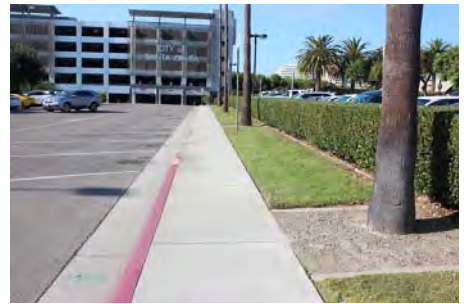
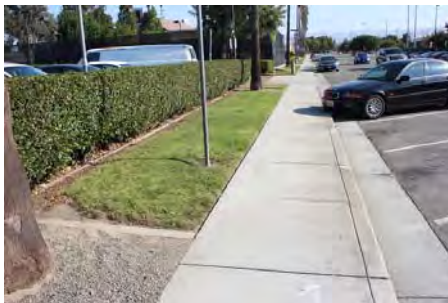
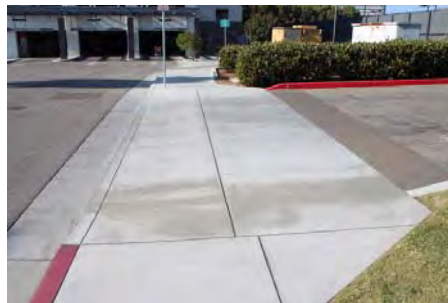
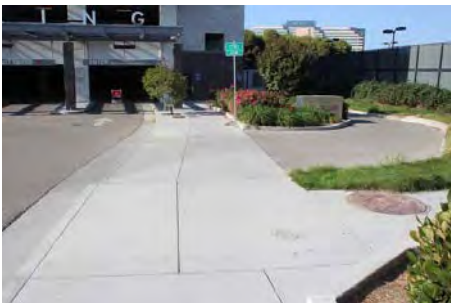
COD	CONDITION DESCRIPTION	ACTUAL
B02	36" min. clear width of exterior walkway. (ADAS 403.5.1)	30" car overhang potentially reduces 60" wide sidewalk to 30" clear width at 14 parking spaces.
B16	Cross slope (perpendicular to direction of travel) is 1:48 (2.08%) max. (ADAS 403.3)	Approx. 300' L is 2.6% to 7.8%.
B17	Running slope (parallel to direction of travel) is 1:20 (5.0%) max. (ADAS 403.3)	11.9% to 16.6% at 4 sides of driveway apron.

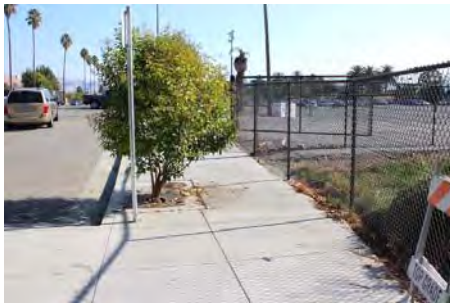
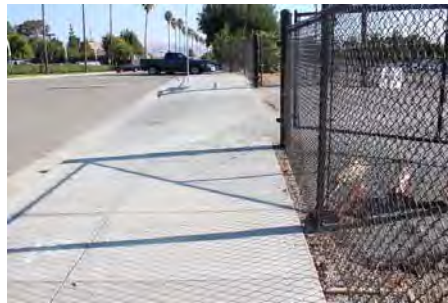
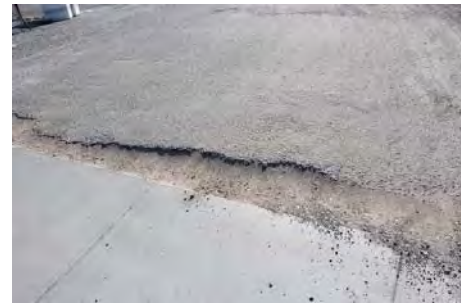
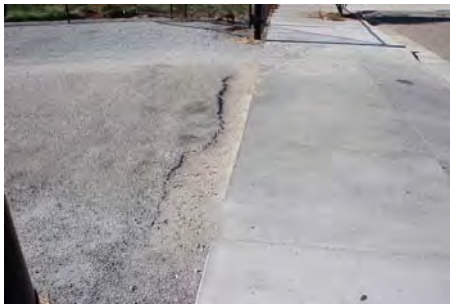
COD	CONDITION DESCRIPTION	ACTUAL
B11	Surface is firm, stable and slip-resistant. (ADAS 302.1)	Partially covered with gravel at drive entrance.

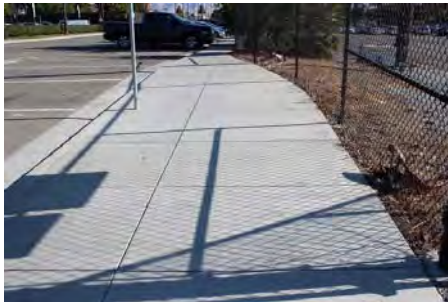
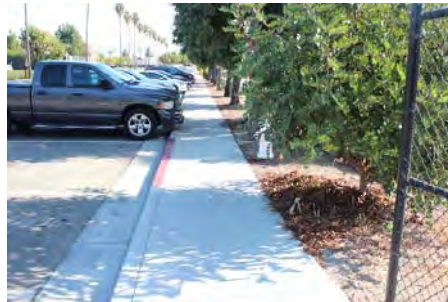
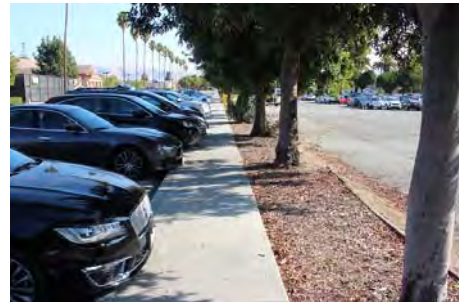
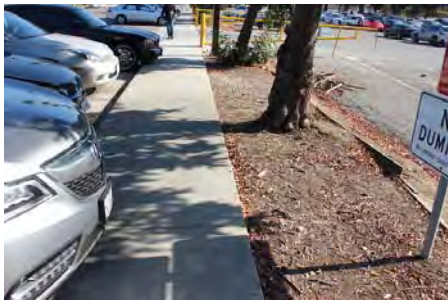
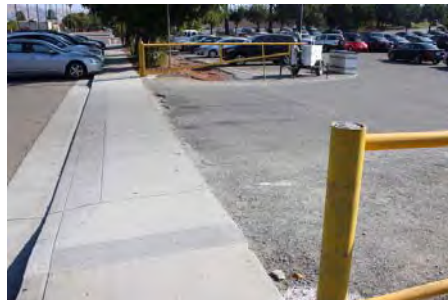
COD	CONDITION DESCRIPTION	ACTUAL
B02	36" min. clear width of exterior walkway. (ADAS 403.5.1)	30" car overhang potentially reduces 60" wide sidewalk to 30" clear width at 23 parking spaces.
B16	Cross slope (perpendicular to direction of travel) is 1:48 (2.08%) max. (ADAS 403.3)	10' L is 3.0%.

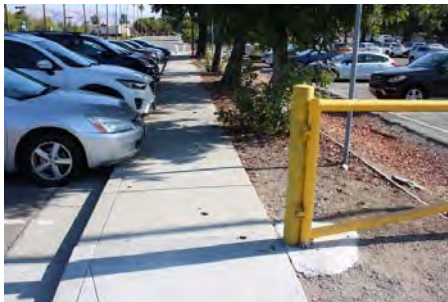
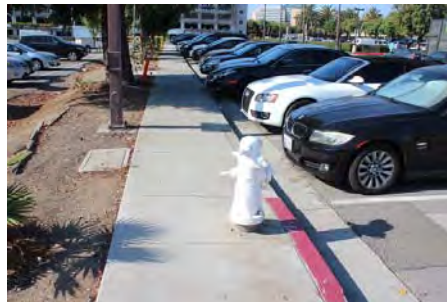
COD	CONDITION DESCRIPTION	ACTUAL
B02	36" min. clear width of exterior walkway. (ADAS 403.5.1)	30" car overhang potentially reduces 60" wide sidewalk to 30" clear width at 13 parking spaces and 33" clear at fire hydrant.
B16	Cross slope (perpendicular to direction of travel) is 1:48 (2.08%) max. (ADAS 403.3)	Approx. 20' L is 2.6% to 3.1%.

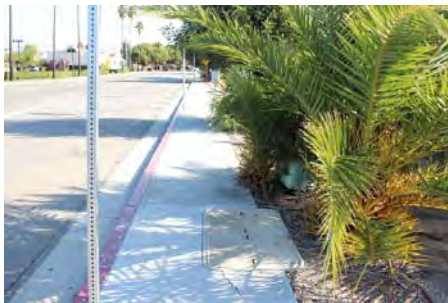
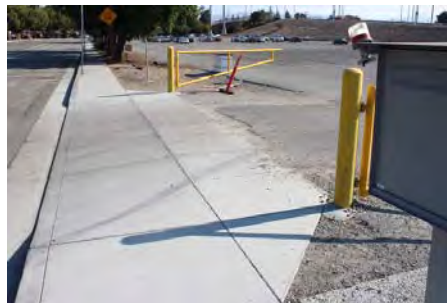
COD	CONDITION DESCRIPTION	ACTUAL
B02	36" min. clear width of exterior walkway. (ADAS 403.5.1)	30" car overhang potentially reduces 60" wide sidewalk to 30" clear width at 4 parking stalls and partially obstructed by plants.

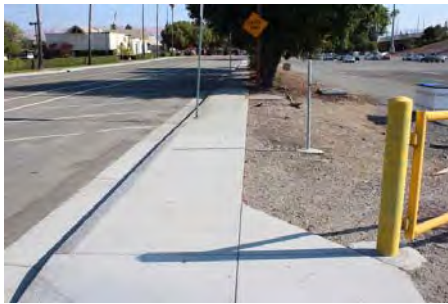
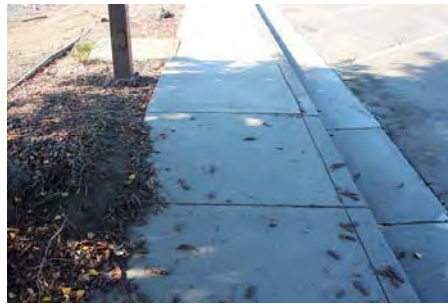
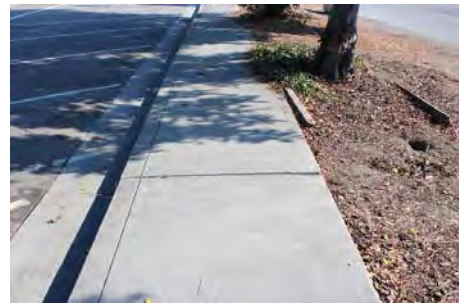
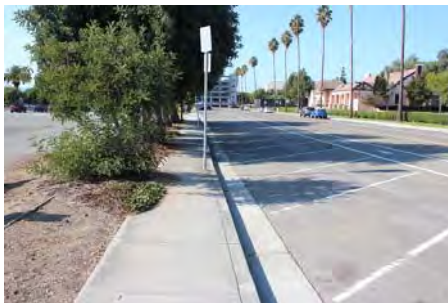
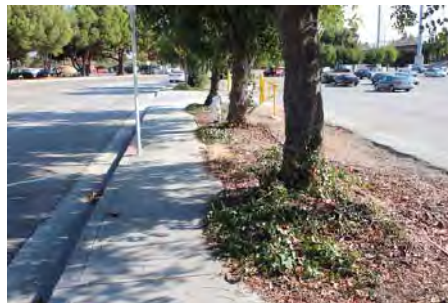
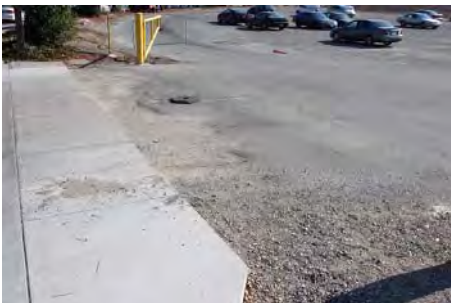
COD	CONDITION DESCRIPTION	ACTUAL
B02	36" min. clear width of exterior walkway. (ADAS 403.5.1)	30" car overhang potentially reduces 60" wide sidewalk to 30" clear width at 27 parking spaces.
B15	No level changes greater than 1/2" (except by accessible ramp or other means). (ADAS 303.4)	3/4" high vertical edge at tree.
B16	Cross slope (perpendicular to direction of travel) is 1:48 (2.08%) max. (ADAS 403.3)	3.1% at tree.

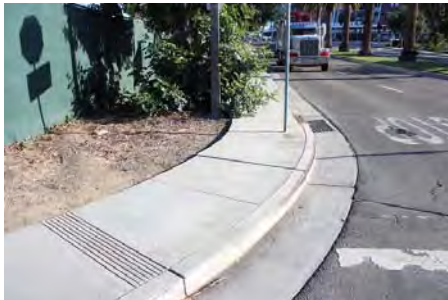
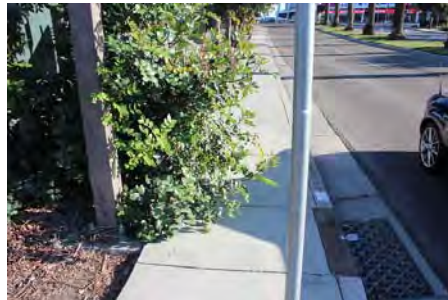
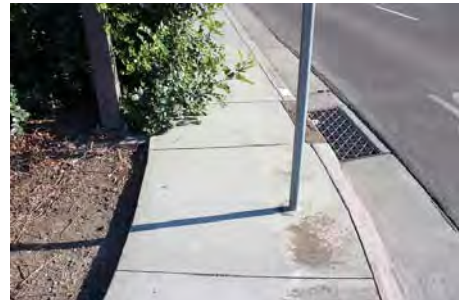
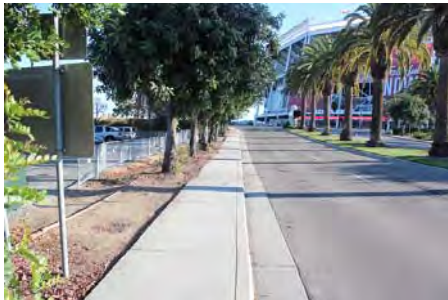
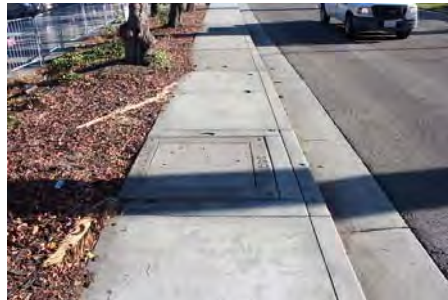
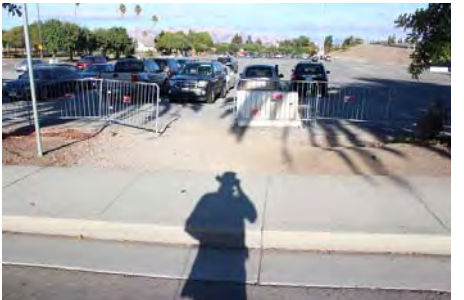
COD	CONDITION DESCRIPTION	ACTUAL
B02	36" min. clear width of exterior walkway. (ADAS 403.5.1)	Obstructed by plants at N end.
B15	No level changes greater than 1/2" (except by accessible ramp or other means). (ADAS 303.4)	5/8" and 3/4" high vertical edges.

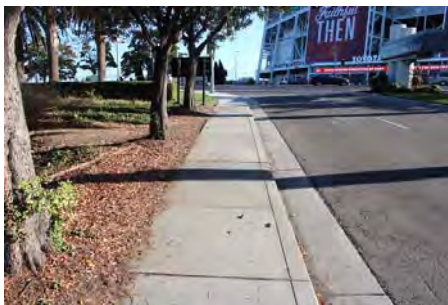
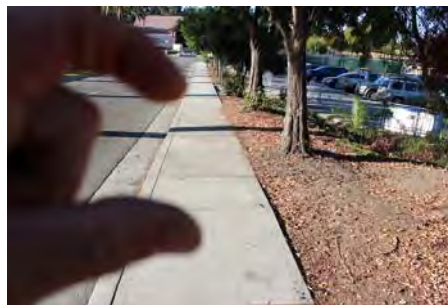
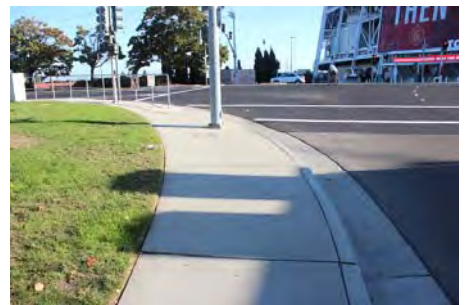
COD	CONDITION DESCRIPTION	ACTUAL
B16	Cross slope (perpendicular to direction of travel) is 1:48 (2.08%) max. (ADAS 403.3)	Approx. 40' L is 3.0% to 4.4%.

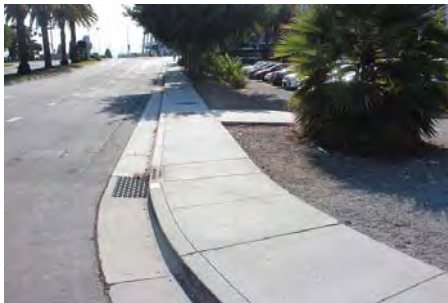
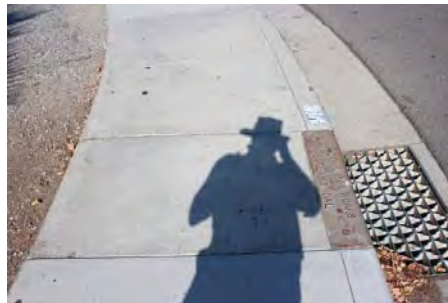
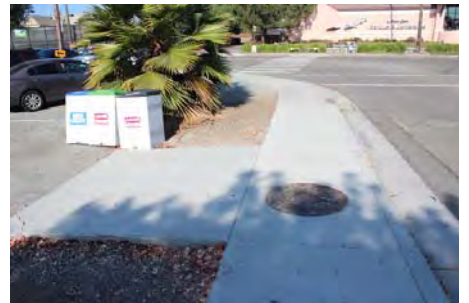
COD	CONDITION DESCRIPTION	ACTUAL
B16	Cross slope (perpendicular to direction of travel) is 1:48 (2.08%) max. (ADAS 403.3)	5' L is 3.8%.

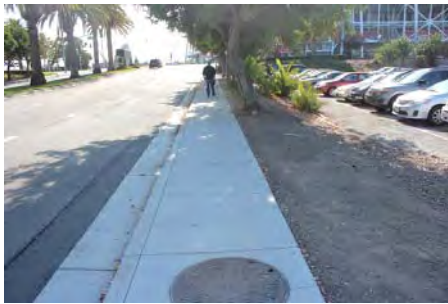
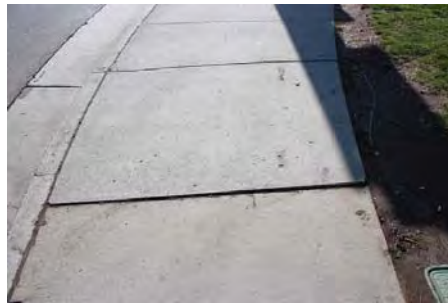
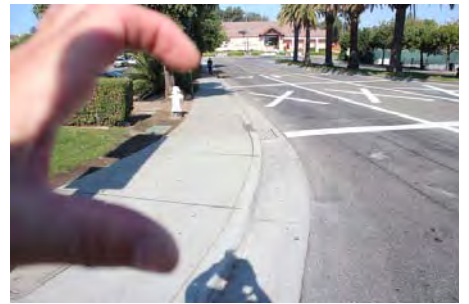
COD	CONDITION DESCRIPTION	ACTUAL
B15	No level changes greater than 1/2" (except by accessible ramp or other means). (ADAS 303.4)	5/8" high vertical edge.
B16	Cross slope (perpendicular to direction of travel) is 1:48 (2.08%) max. (ADAS 403.3)	Approx. 110' L is 2.6% to 4.0%.
B17	Running slope (parallel to direction of travel) is 1:20 (5.0%) max. (ADAS 403.3)	Up to 5.8%, generally matching street slope.

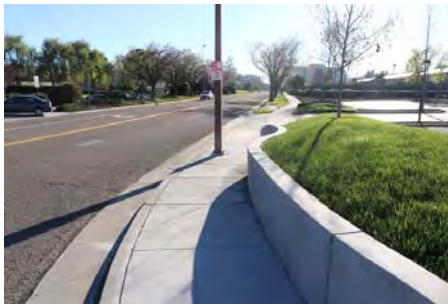
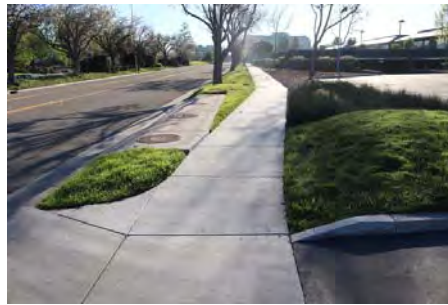
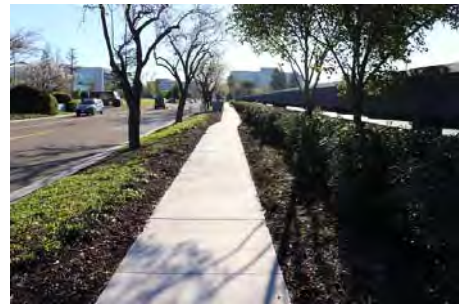
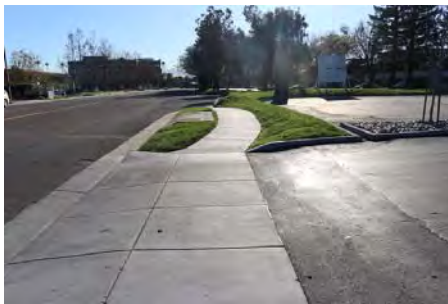
COD	CONDITION DESCRIPTION	ACTUAL
B17	Running slope (parallel to direction of travel) is 1:20 (5.0%) max. (ADAS 403.3)	At drive aisle near Patrick Henry Dr. up to 6.2% for approx. 8'.

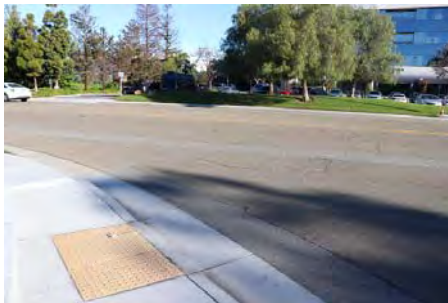
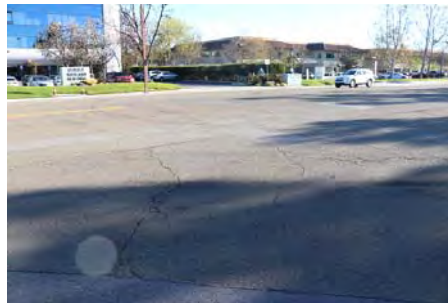
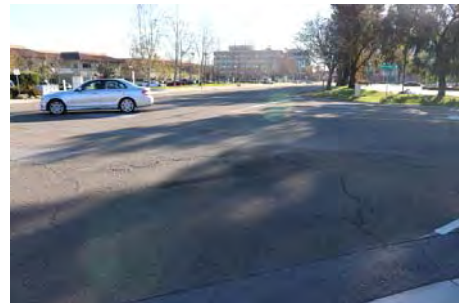
COD	CONDITION DESCRIPTION	ACTUAL
B15	No level changes greater than 1/2" (except by accessible ramp or other means). (ADAS 303.4)	No curb ramp at N side of street.

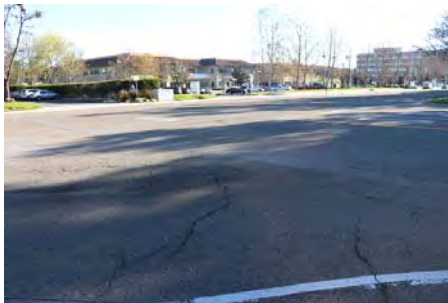
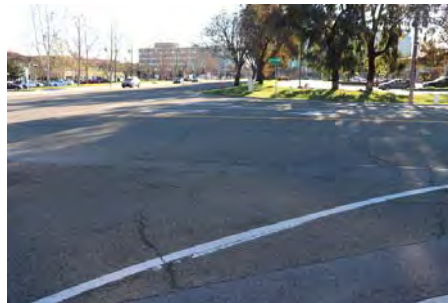
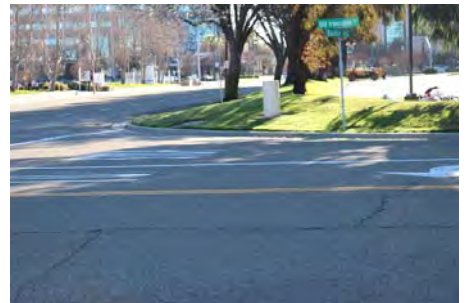
COD	CONDITION DESCRIPTION	ACTUAL
B15	No level changes greater than 1/2" (except by accessible ramp or other means). (ADAS 303.4)	No curb ramp access at SE corner or N side of the street.

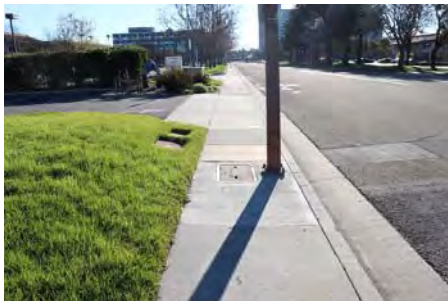
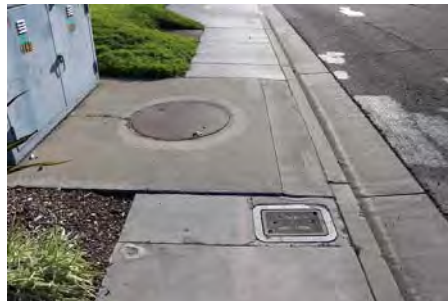
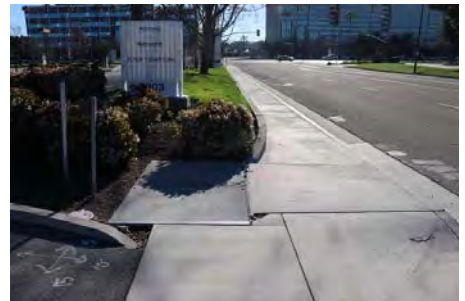
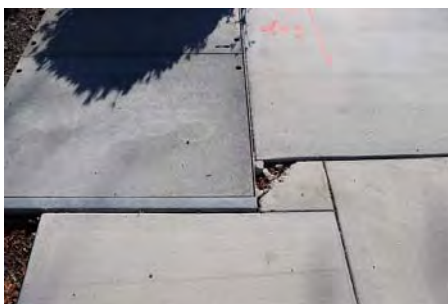
COD	CONDITION DESCRIPTION	ACTUAL
B12	Gaps/openings in ground or floor surfaces do not allow the passage of a sphere more than 1/2" in diameter. (ADAS 302.3)	Pothole, 4" wide x 9" L x 1 1/2" deep.
B15	No level changes greater than 1/2" (except by accessible ramp or other means). (ADAS 303.4)	3/4" high vertical edge.
B16	Cross slope (perpendicular to direction of travel) is 1:48 (2.08%) max. (ADAS 403.3)	Approx. 30' L is 2.5% to 3.6% and 7.0% at drive aisle.
B17	Running slope (parallel to direction of travel) is 1:20 (5.0%) max. (ADAS 403.3)	11.3% and 11.3% at drive aisle.
