Case No. 5:16-cv-07013-LHK (SVK)

**DECLARATION OF JEFFREY SCOTT
MASTIN IN SUPPORT OF PLAINTIFFS'
MOTION FOR CLASS CERTIFICATION**

NEVAREZ V 49ERS - ACCESSIBILITY ASSESSMENT

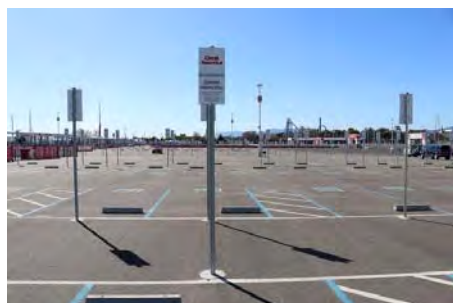
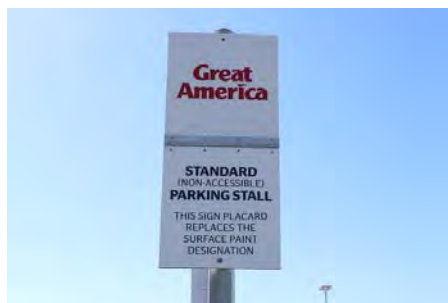
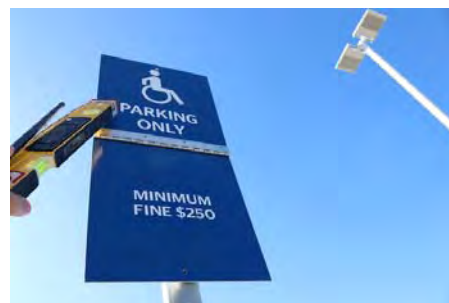
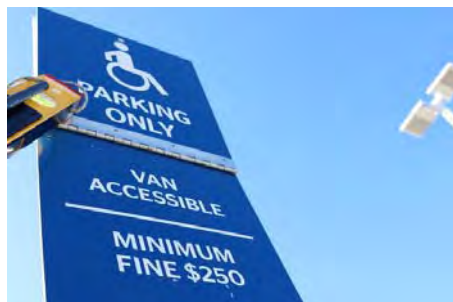
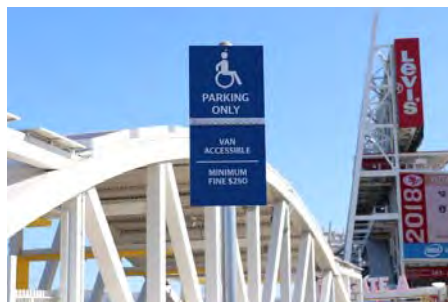
COD	CONDITION DESCRIPTION	ACTUAL
B02	I.D. sign with contrasting ISA (White on blue background per CVC 22511.7(b)(1)) is provided and located with bottom at min. 60" high. (ADAS 502.6)	ISA is not the standard symbol.
C03	I.D. sign is min. 70" square in size and reflectorized. (2013 CBC 11B-502.6.1)	Signs are not reflectorized.

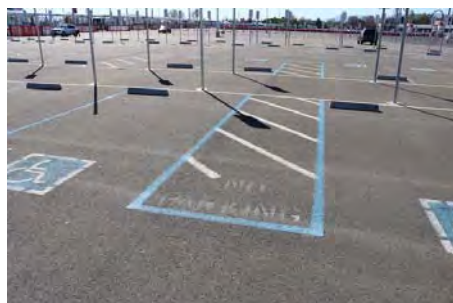
COD	CONDITION DESCRIPTION	ACTUAL
B23	Access aisle is marked to discourage parking -in California: with "NO PARKING" in white with min. 12" high letters located at tail end of access aisle. (ADAS 502.3.3)	Access aisle markings are faded (NO PARKING).

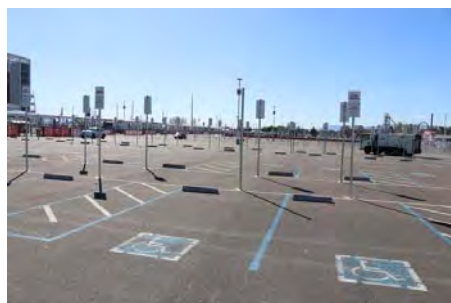
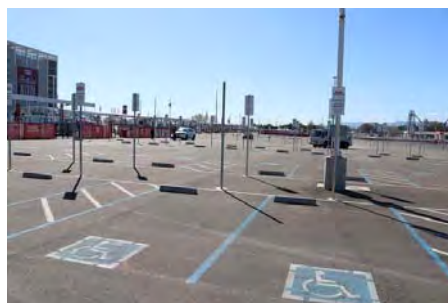
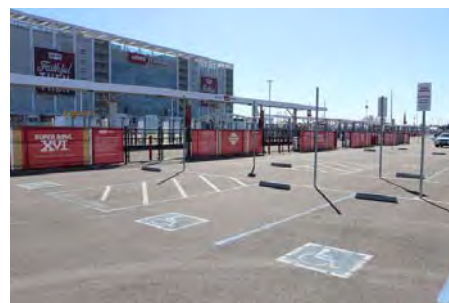
NEVAREZ V 49ERS - ACCESSIBILITY ASSESSMENT**FACILITY/SITE: 10. Parking: Red Lot 1****SEQ.
#****1003****FEATURE: #5 PARKING STALL****LOCATION: 64 DAS at gate A.****MEMO: Stalls A16, A15, A11, A7****Notes:**

COD	CONDITION DESCRIPTION	ACTUAL
B02	I.D. sign with contrasting ISA (White on blue background per CVC 22511.7(b)(1)) is provided and located with bottom at min. 60" high. (ADAS 502.6)	None

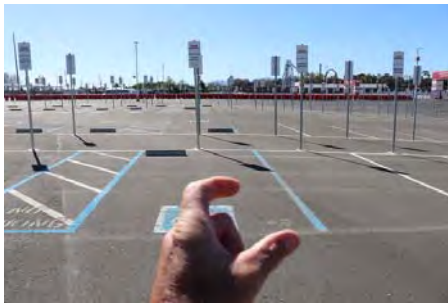
COD	CONDITION DESCRIPTION	ACTUAL
B31	Slopes do not exceed 1:48 (2.08%). (ADAS 502.4)	Up to 2.7%.

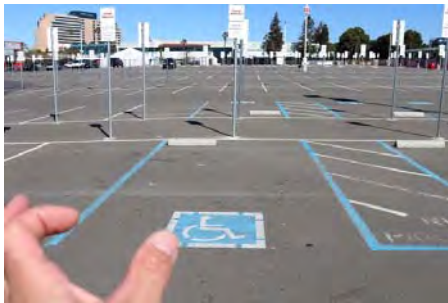
COD	CONDITION DESCRIPTION	ACTUAL
B31	Slopes do not exceed 1:48 (2.08%). (ADAS 502.4)	Up to 4.2%

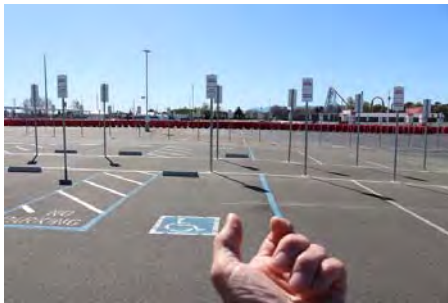
COD	CONDITION DESCRIPTION	ACTUAL
B31	Slopes do not exceed 1:48 (2.08%). (ADAS 502.4)	Up to 5.4%

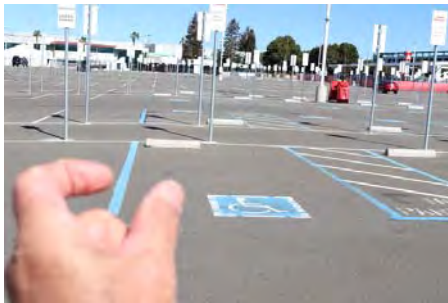
COD	CONDITION DESCRIPTION	ACTUAL
B31	Slopes do not exceed 1:48 (2.08%). (ADAS 502.4)	Up to 5.9%

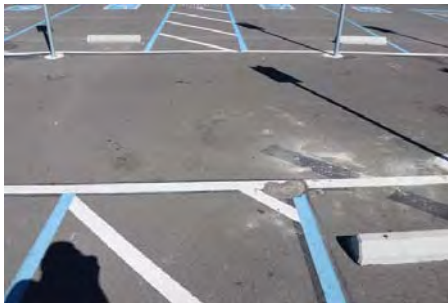
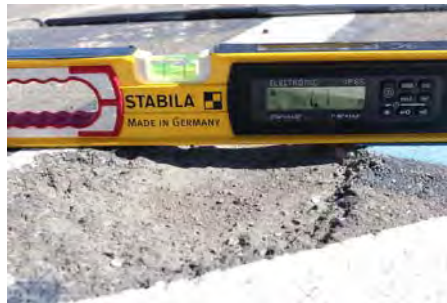
NEVAREZ V 49ERS - ACCESSIBILITY ASSESSMENT**FACILITY/SITE: 10. Parking: Red Lot 1****SEQ.
#****1008****FEATURE: #5 PARKING STALL****LOCATION: 56 DAS at gate B.****MEMO: DAS H3/H4****Notes:**

COD	CONDITION DESCRIPTION	ACTUAL
B32	Stall & access aisle has no gaps or changes in level and is firm, stable and slip resistant. (ADAS 502.4)	Pothole in access aisle serving both DAS that is 3/4" deep by 6" wide by 7" long.

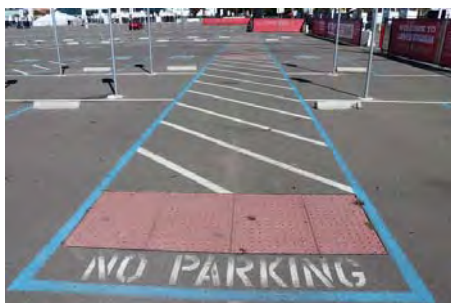
COD	CONDITION DESCRIPTION	ACTUAL
B32	Stall & access aisle has no gaps or changes in level and is firm, stable and slip resistant. (ADAS 502.4)	Detectable warnings are unnecessary and obstruct the access aisle for all 8 DAS.

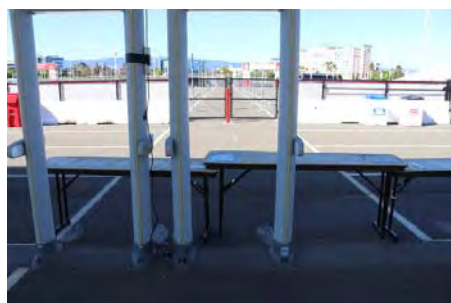
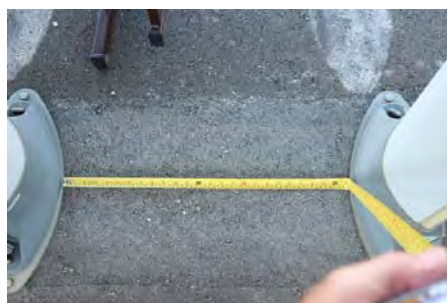
COD	CONDITION DESCRIPTION	ACTUAL
B03	If clear width is less than 36", it is min. 32" clear for 24" long max. and reduced width segments are separated by min. 48" long by 36" wide segments. (ADAS 403.5.1)	25" wide at the btm., 28" wide at the top at all security devices.

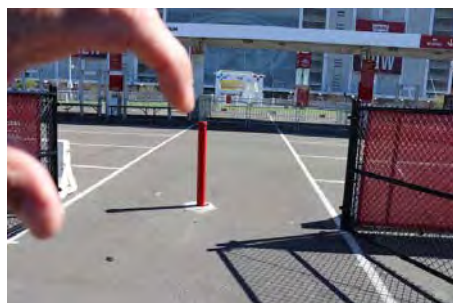
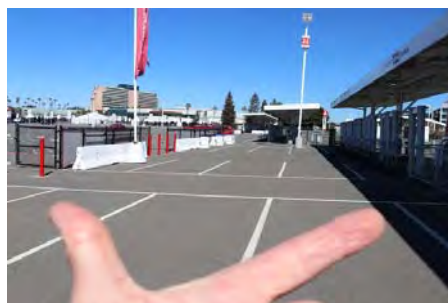
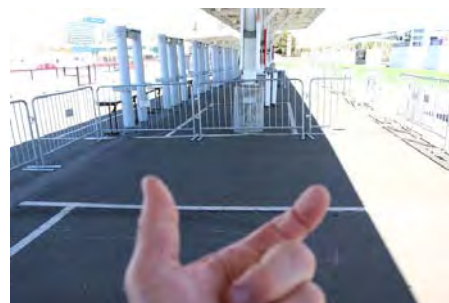
COD	CONDITION DESCRIPTION	ACTUAL
B17	Running slope (parallel to direction of travel) is 1:20 (5.0%) max. (ADAS 403.3)	5.0% to 5.7% for 40' L between DAS and security device, up to 5.8% just East of security device.

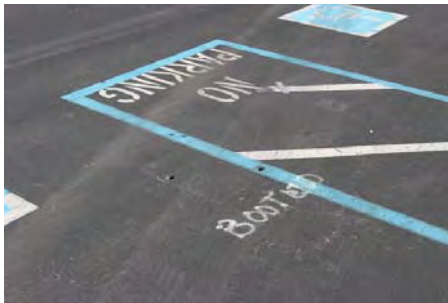
COD	CONDITION DESCRIPTION	ACTUAL
B32	Stall & access aisle has no gaps or changes in level and is firm, stable and slip resistant. (ADAS 502.4)	Two holes 1" in diameter.

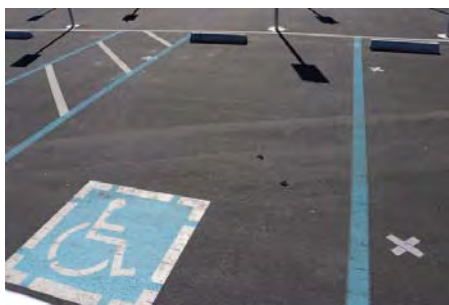
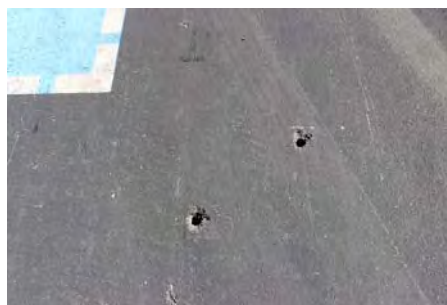
COD	CONDITION DESCRIPTION	ACTUAL
B32	Stall & access aisle has no gaps or changes in level and is firm, stable and slip resistant. (ADAS 502.4)	Two holes 1" in diameter.

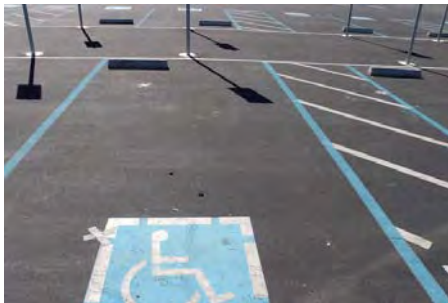
COD	CONDITION DESCRIPTION	ACTUAL
B32	Stall & access aisle has no gaps or changes in level and is firm, stable and slip resistant. (ADAS 502.4)	Two holes 1" in diameter.

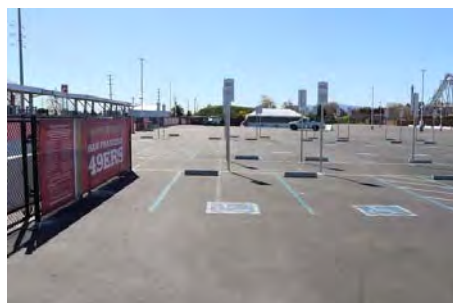
COD	CONDITION DESCRIPTION	ACTUAL
B12	Access aisle is marked to define a width of min. 5' wide. (ADAS 502..3.1)	No access are provided, stall is 9' wide.

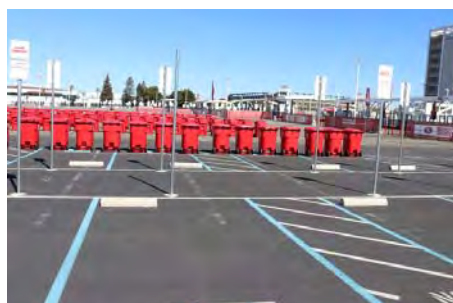
COD	CONDITION DESCRIPTION	ACTUAL
C06	Signs are positioned with bottom min. 60" above surface of parking space, and are visible from, and located at projected width at head end, or are immediately adjacent to parking space.	None

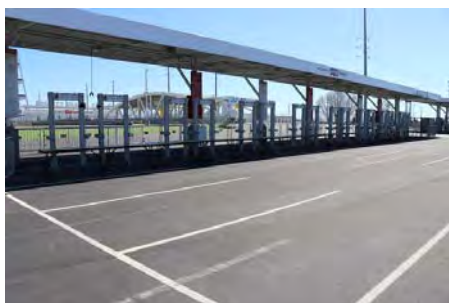
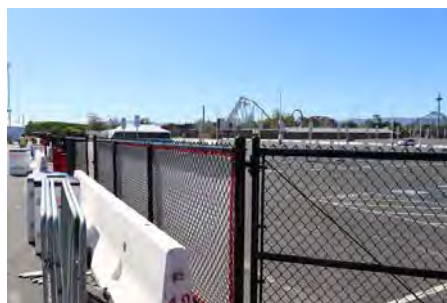
COD	CONDITION DESCRIPTION	ACTUAL
B41	Stall is located as close as practical to entrance. (ADAS 208.3.1)	Many other standard parking spaces are closer to the bridge to gate C.

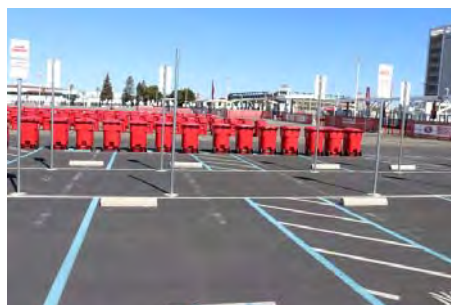
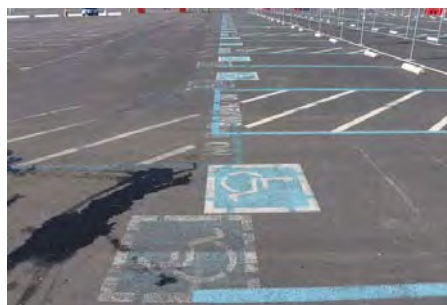
COD	CONDITION DESCRIPTION	ACTUAL
B11	Parking space is marked to define a width of min.8' wide (9' CBC). (ADAS 502.2)	New surface markings are painted over old markings and determining extent of DAS is difficult.

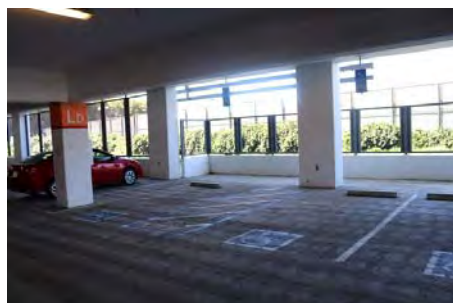
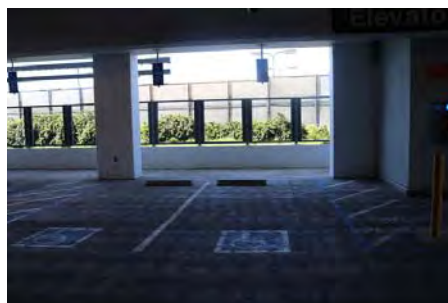
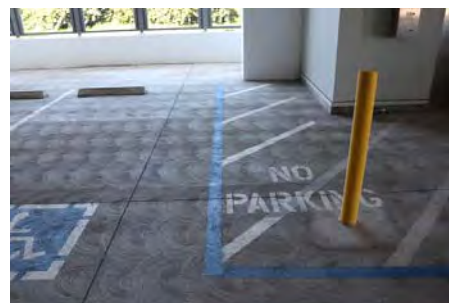
COD	CONDITION DESCRIPTION	ACTUAL
B15	Access aisle extends the full length of the parking space. (ADAS 502.3.2)	Access aisle is obstructed by 38" to bollard at East DAS.
C42	Accessible route from stall does not pass behind other parked cars. (2013 CBC 11B-502.7.1).	For middle and West stalls must pass behind other vehicles.

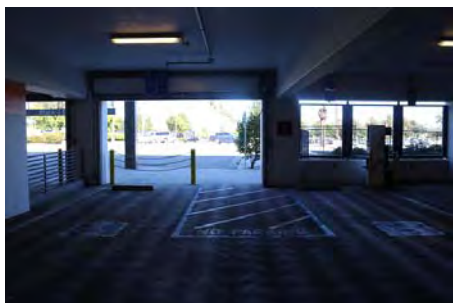
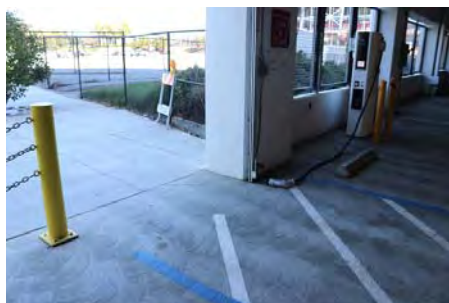
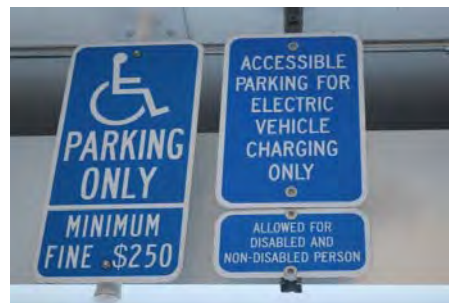
North space is signed for electrical vehicle charging only, however the charging cable for 2 DAS does not reach, and if it did it would obstruct the pedestrian accessible route to Stars and Stripes Blvd.

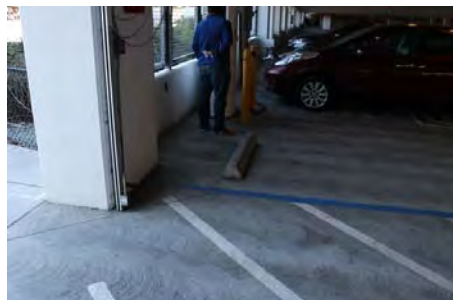
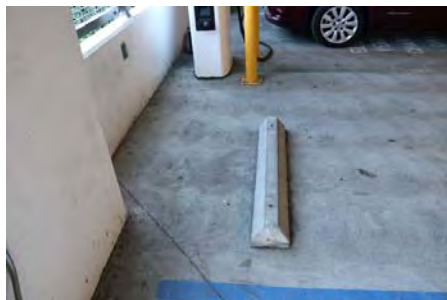
COD	CONDITION DESCRIPTION	ACTUAL
B02	36" min. clear width of exterior walkway. (ADAS 403.5.1)	If vehicle is parked in adjacent stall to S, the route is completely obstructed by the vehicle.
B03	If clear width is less than 36", it is min. 32" clear for 24" long max. and reduced width segments are separated by min. 48" long by 36" wide segments. (ADAS 403.5.1)	20" to wheel stop if no vehicle park to the South.

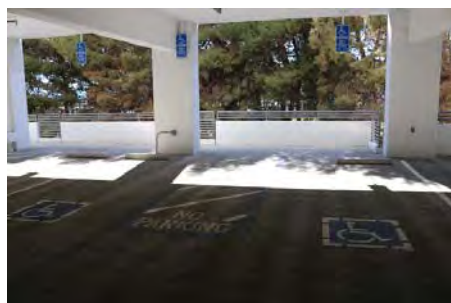
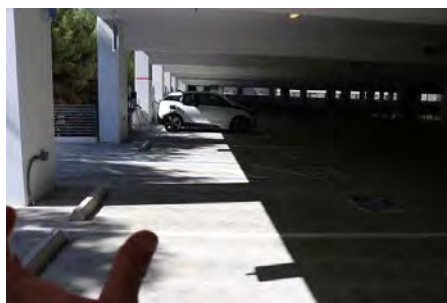
COD	CONDITION DESCRIPTION	ACTUAL
B31	Slopes do not exceed 1:48 (2.08%). (ADAS 502.4)	Up to 3.1% at head end of stalls and access aisle.

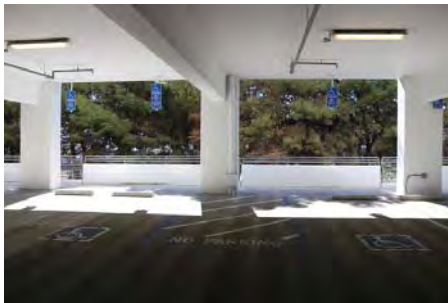
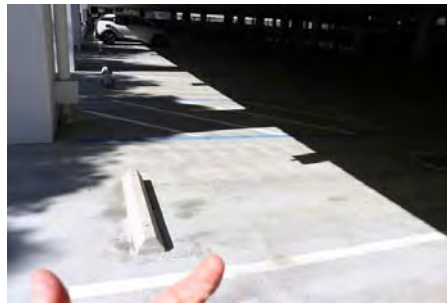
COD	CONDITION DESCRIPTION	ACTUAL
B31	Slopes do not exceed 1:48 (2.08%). (ADAS 502.4)	Up to 2.8% at head end of stalls and access aisle.

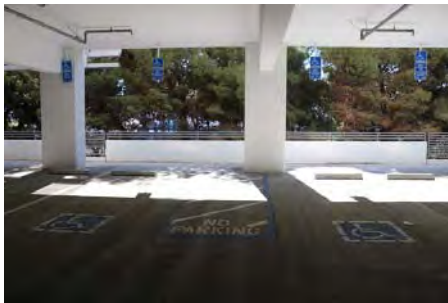
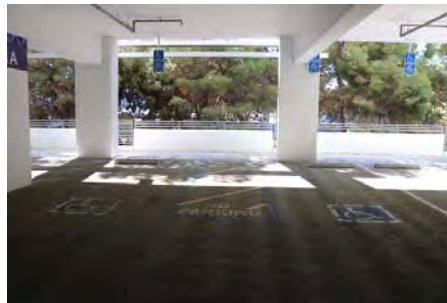
COD	CONDITION DESCRIPTION	ACTUAL
B31	Slopes do not exceed 1:48 (2.08%). (ADAS 502.4)	Up to 3.1% at head end of North stall and access aisle.

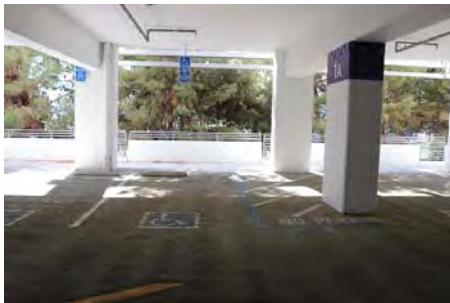
COD	CONDITION DESCRIPTION	ACTUAL
B13	Van parking space is marked to define a width of 11' wide (12' CBC) with 5' wide access aisle or 8' wide (9' CBC) with 8' wide access aisle. (ADAS 502.2, 502.3.1)	Access aisle obstructed by column (50" to column). Overall 13' wide to column stall portion is 9' wide.

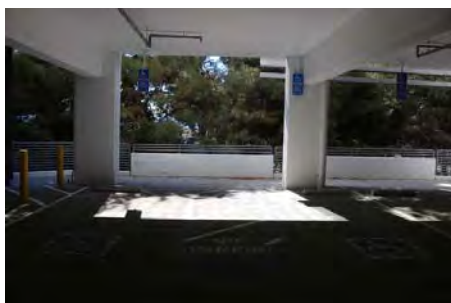
COD	CONDITION DESCRIPTION	ACTUAL
B31	Slopes do not exceed 1:48 (2.08%). (ADAS 502.4)	Up to 2.8% at North stall.

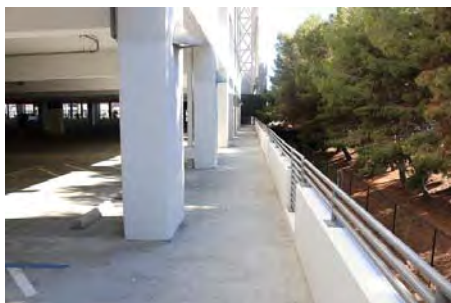
COD	CONDITION DESCRIPTION	ACTUAL
C42	Accessible routes coincide with or are located in the same area as general circulation paths. Where circulation paths are interior, required accessible routes are also interior (ADAS 206.3)	Route is exterior and exposed to weather whereas the route for the general public is interior and not exposed to weather.

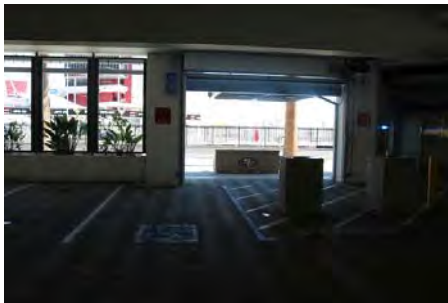
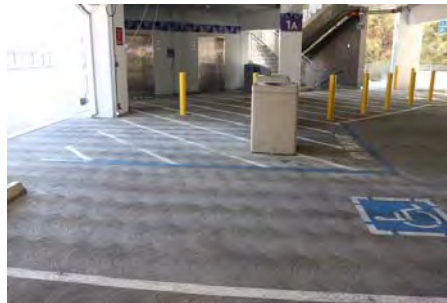
COD	CONDITION DESCRIPTION	ACTUAL
B12	Access aisle is marked to define a width of min. 5' wide. (ADAS 502..3.1)	Access aisle obstructed by concrete waste receptacle (28" to waste receptacle).

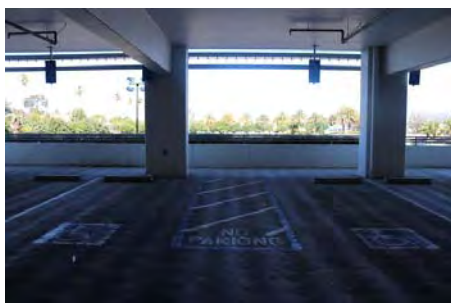
COD	CONDITION DESCRIPTION	ACTUAL
B31	Slopes do not exceed 1:48 (2.08%). (ADAS 502.4)	Up tp 3.5% in stalls and access aisle.

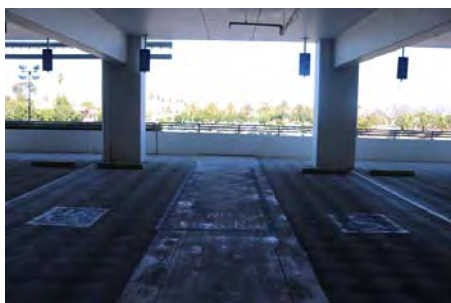
COD	CONDITION DESCRIPTION	ACTUAL
B31	Slopes do not exceed 1:48 (2.08%). (ADAS 502.4)	Up to 3.5% in stalls and access aisles.

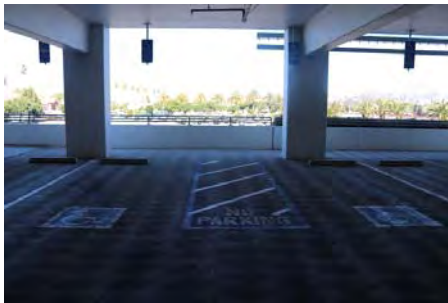
COD	CONDITION DESCRIPTION	ACTUAL
B31	Slopes do not exceed 1:48 (2.08%). (ADAS 502.4)	Up to 3.0% at North stall and access aisle.

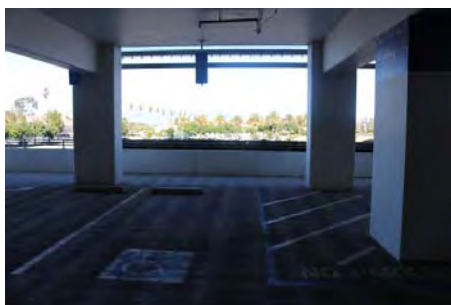
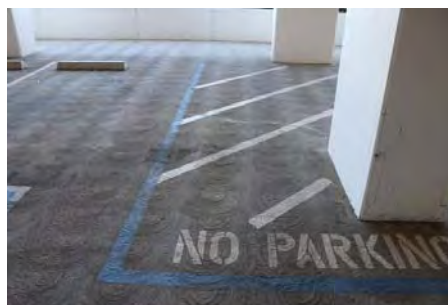
COD	CONDITION DESCRIPTION	ACTUAL
B13	Van parking space is marked to define a width of 11' wide (12' CBC) with 5' wide access aisle or 8' wide (9' CBC) with 8' wide access aisle. (ADAS 502.2, 502.3.1)	Access aisle obstructed by column (5' to column). Stall is 9' wide.

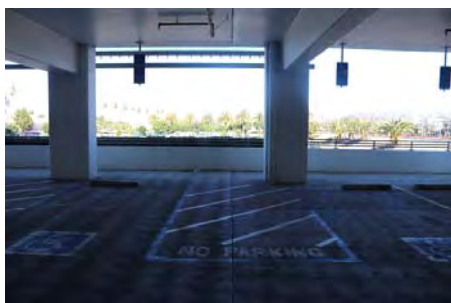
COD	CONDITION DESCRIPTION	ACTUAL
B31	Slopes do not exceed 1:48 (2.08%). (ADAS 502.4)	Up to 2.5% at South stall and access aisle.

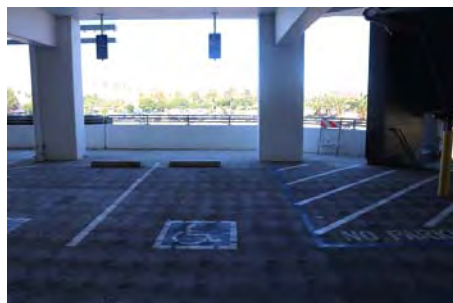
FACILITY/SITE: 11. Parking: Yellow Lot 1 Parking Structure**SEQ.
#****1118****FEATURE: #5 PARKING STALL****LOCATION: 12 DAS at 1D at SE corner.****MEMO: Southern DAS.****Notes:**

Conforms to standards used.

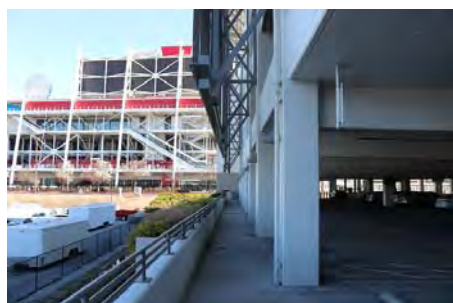
COD	CONDITION DESCRIPTION	ACTUAL
C42	Accessible routes coincide with or are located in the same area as general circulation paths. Where circulation paths are interior, required accessible routes are also interior (ADAS 206.3)	Route is exterior and exposed to weather whereas the route for the general public is interior and not exposed to weather.

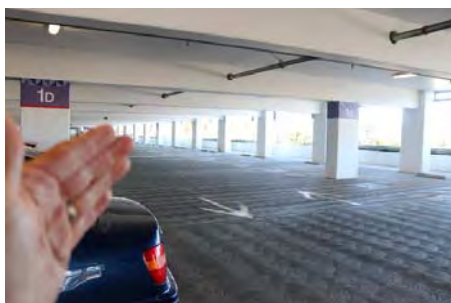
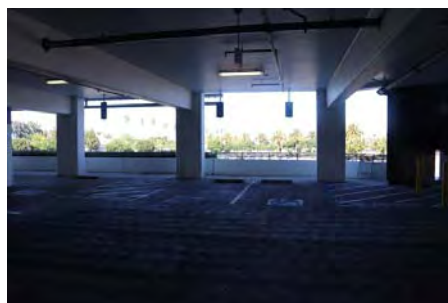
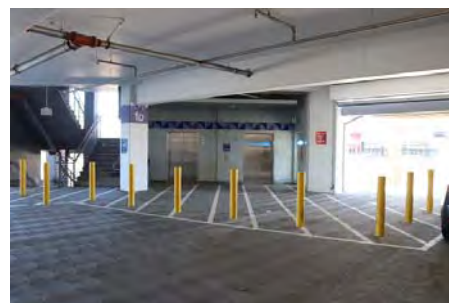
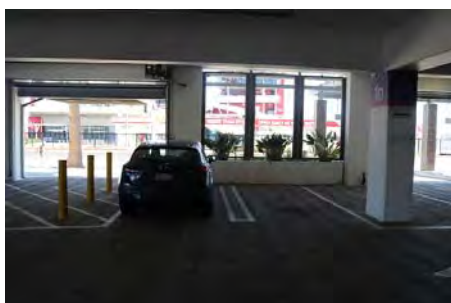
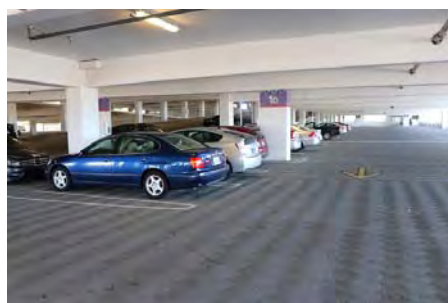
COD	CONDITION DESCRIPTION	ACTUAL
B41	Stall is located as close as practical to entrance. (ADAS 208.3.1)	There are standard stalls that are closer to the SE entrance than are these 12 DAS.

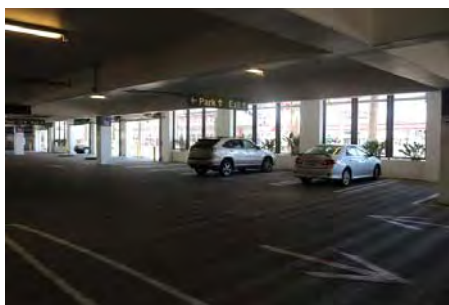
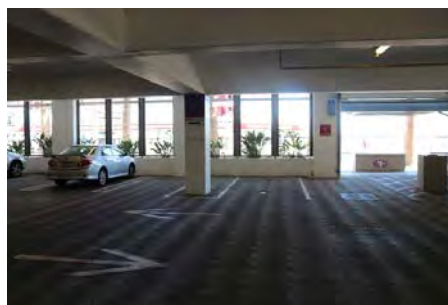
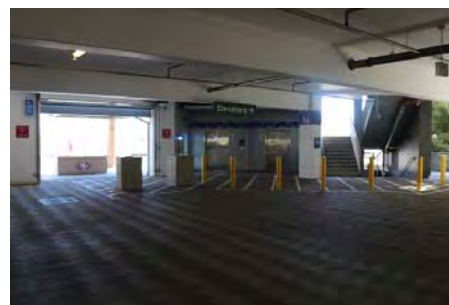
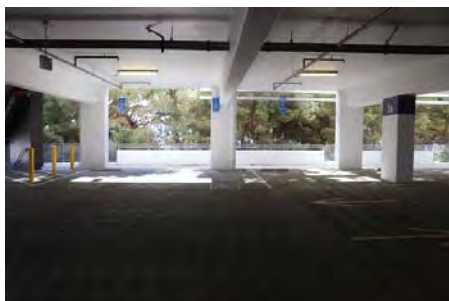
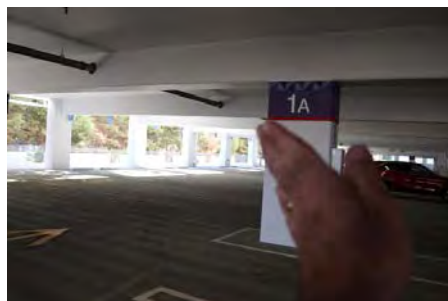
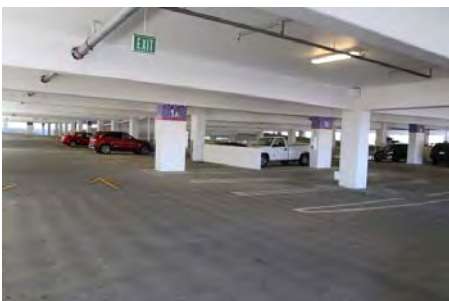
COD	CONDITION DESCRIPTION	ACTUAL
B41	Stall is located as close as practical to entrance. (ADAS 208.3.1)	There are standard stalls that are closer to the SW entrance than are 10 of these DAS.

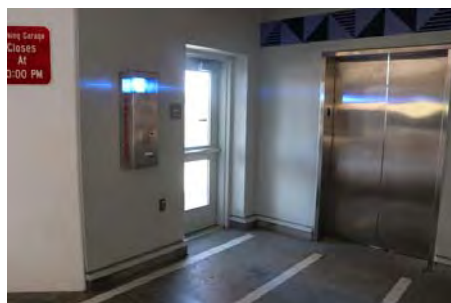
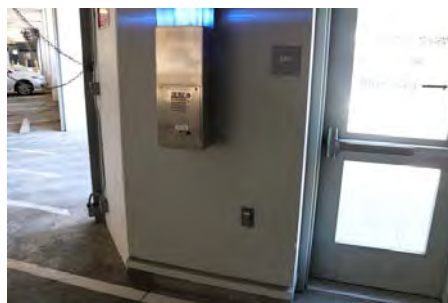
COD	CONDITION DESCRIPTION	ACTUAL
B21	Unobstructed forward or side approach reach range is min 15" to max 48" AFF. (ADAS 308.2.1, 308.3.1)	Help button is 52" AFF.

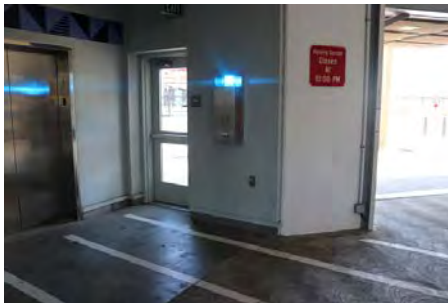
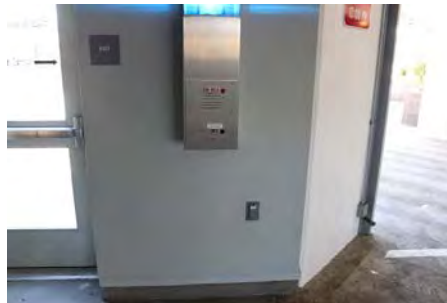
COD	CONDITION DESCRIPTION	ACTUAL
B21	Unobstructed forward or side approach reach range is min 15" to max 48" AFF. (ADAS 308.2.1, 308.3.1)	Help button is 52 1/2" AFF.

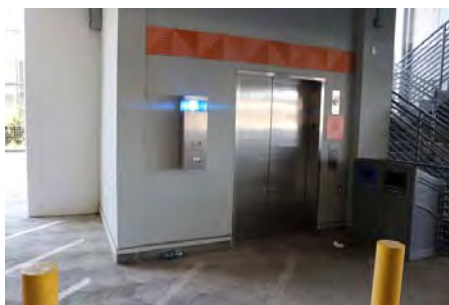
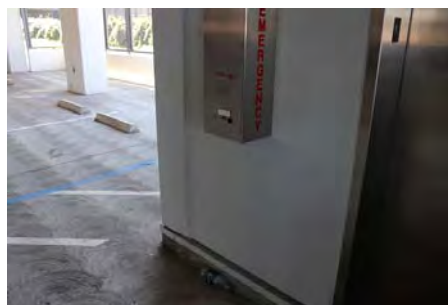
COD	CONDITION DESCRIPTION	ACTUAL
B21	Unobstructed forward or side approach reach range is min 15" to max 48" AFF. (ADAS 308.2.1, 308.3.1)	Help button is 52" AFF.

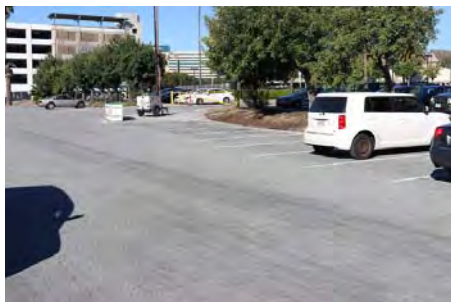
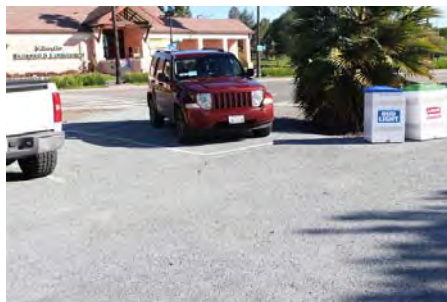
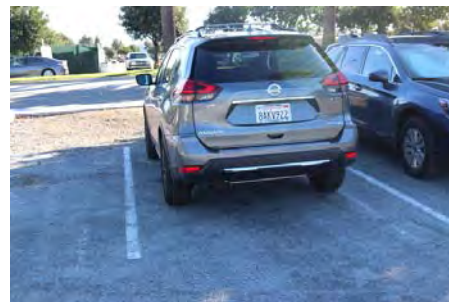
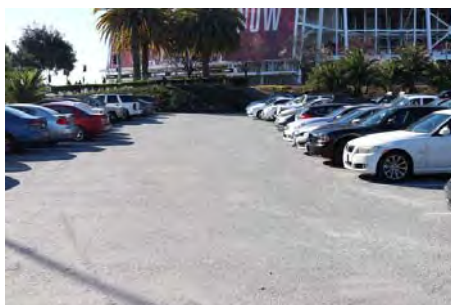
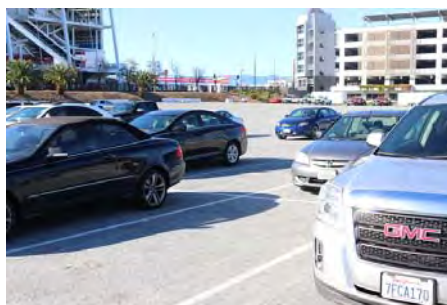
NEVAREZ V 49ERS - ACCESSIBILITY ASSESSMENT**FACILITY/SITE: 13. Yellow Lot 2****SEQ.
#****1301****FEATURE: #2 PARKING LOT****LOCATION: Lot with 304 spaces.****MEMO:****Notes:****CONDITIONS THAT DO NOT CONFORM TO NEW CONSTRUCTION STANDARDS**

COD	CONDITION DESCRIPTION	ACTUAL
C10	Required number of acc stalls are provided as follows: 1-25=1, 26-50=2, 51-75=3, 76-100=4, 101-150=5, 151-200=6, 201-300=7, 301-400=8, 401-500=9, 501-1000=2% of total, 1001+=20+1 for each 100 over 1000. (ADAS 208.2)	8 required none provided
A12	1 van stall provided for every 6 required acc stalls. (ADAS 208.2.4)	2 required none provided

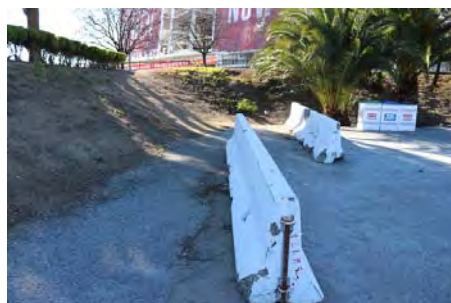
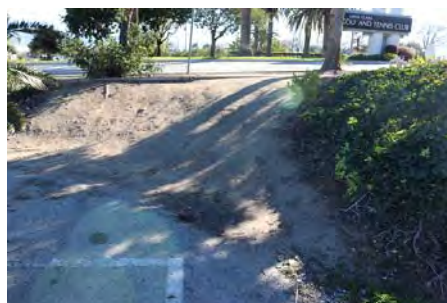
NEVAREZ V 49ERS - ACCESSIBILITY ASSESSMENT**FACILITY/SITE: 13. Yellow Lot 2****SEQ.
#****1302****FEATURE: #11 ACC ROUTE OF TRAVEL****LOCATION: Access to public right of way.****MEMO: To dirt pass at SE corner of lot.****Notes:**

These lead to NW corner of Tasman Dr. and Centennial Blvd.

COD	CONDITION DESCRIPTION	ACTUAL
B11	Surface is firm, stable and slip-resistant. (ADAS 302.1)	Dirt surface.
B15	No level changes greater than 1/2" (except by accessible ramp or other means). (ADAS 303.4)	Multiple edges over 1 1/2" high.
B17	Running slope (parallel to direction of travel) is 1:20 (5.0%) max. (ADAS 403.3)	Steep uphill routes.

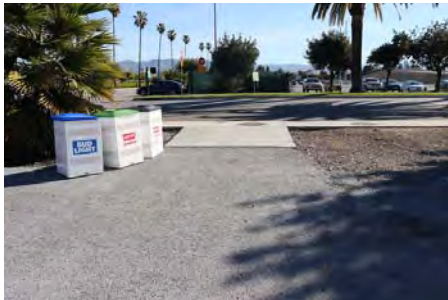
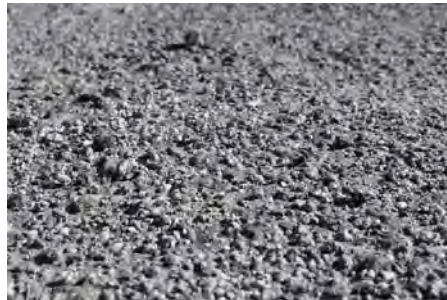
NEVAREZ V 49ERS - ACCESSIBILITY ASSESSMENT**FACILITY/SITE: 13. Yellow Lot 2****SEQ.
#****1303****FEATURE: #11 ACC ROUTE OF TRAVEL****LOCATION: Access to public right of way.****MEMO: Asphalt and concrete path at NE corner of lot leads to SW corner of Stars and Stripes Dr. and Centennial Blvd.****Notes:****CONDITIONS THAT DO NOT CONFORM TO NEW CONSTRUCTION STANDARDS**

COD	CONDITION DESCRIPTION	ACTUAL
B11	Surface is firm, stable and slip-resistant. (ADAS 302.1)	loose rocks, sand and gravel.
B15	No level changes greater than 1/2" (except by accessible ramp or other means). (ADAS 303.4)	3/4 high vertical edge.

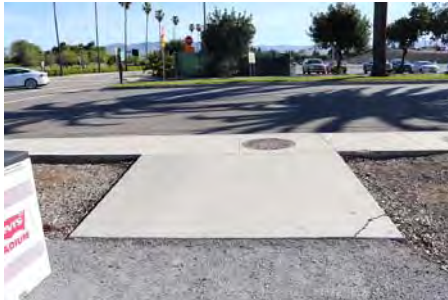
NEVAREZ V 49ERS - ACCESSIBILITY ASSESSMENT**FACILITY/SITE: 13. Yellow Lot 2****SEQ.
#****1304****FEATURE: #12 RAMP****LOCATION: Access to public right of way.****MEMO: Asphalt and concrete path at NE corner of lot leads to SW corner of Stars and Stripes Dr. and Centennial Blvd.****Notes:**

Concrete portion is approx. 7' long and up to 6.5% running slope.

COD	CONDITION DESCRIPTION	ACTUAL
B12	Landings are sloped 1:48 (2.08%) max. and are firm, stable and slip resistant without gaps or edges. (ADAS 405.7.1)	Btm. landing up to 4.8% and loose gravel, sand and rocks.
B31	Handrails are provided at both sides (ADA: except at ramp with max 6" rise / 72" run) (CBC: except adjacent to assembly seating, or at door landing ramp with max 6" rise / 72" run). (ADAS 405.8)	Overall height is over 6" and longer than 72".

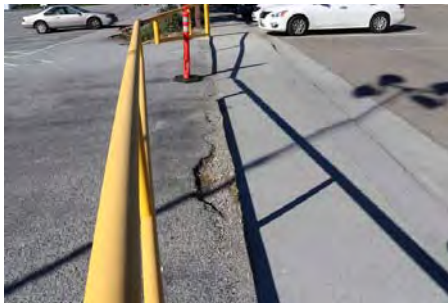
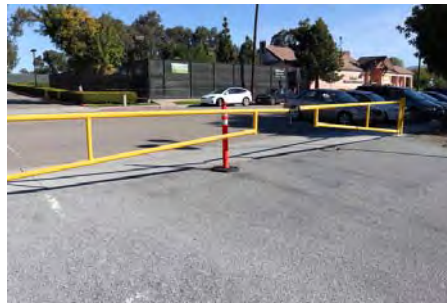
NEVAREZ V 49ERS - ACCESSIBILITY ASSESSMENT**FACILITY/SITE: 13. Yellow Lot 2****SEQ.
#****1305****FEATURE: #11 ACC ROUTE OF TRAVEL****LOCATION: Access to public right of way.****MEMO: Middle drive entrance at the N side of the lot.****Notes:****CONDITIONS THAT DO NOT CONFORM TO NEW CONSTRUCTION STANDARDS**

COD	CONDITION DESCRIPTION	ACTUAL
B11	Surface is firm, stable and slip-resistant. (ADAS 302.1)	Loose rocks.
B12	Gaps/openings in ground or floor surfaces do not allow the passage of a sphere more than 1/2" in diameter. (ADAS 302.3)	Large gaps over 2" deep x 12" wide along transition to concrete.
B15	No level changes greater than 1/2" (except by accessible ramp or other means). (ADAS 303.4)	Up to 2 1/2" high vertical edge at transition of concrete.

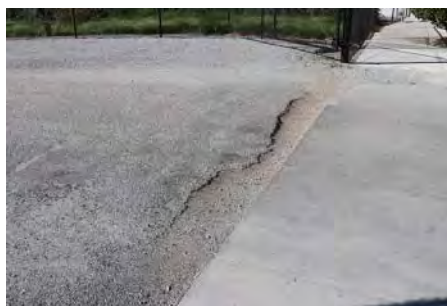
NEVAREZ V 49ERS - ACCESSIBILITY ASSESSMENT**FACILITY/SITE: 13. Yellow Lot 2****SEQ.
#****1306****FEATURE: #11 ACC ROUTE OF TRAVEL****LOCATION: Access to public right of way.****MEMO: Vehicular entrance at NW corner of lot.****Notes:****CONDITIONS THAT DO NOT CONFORM TO NEW CONSTRUCTION STANDARDS**

COD	CONDITION DESCRIPTION	ACTUAL
B11	Surface is firm, stable and slip-resistant. (ADAS 302.1)	Loose rocks, gravel and sand.
B12	Gaps/openings in ground or floor surfaces do not allow the passage of a sphere more than 1/2" in diameter. (ADAS 302.3)	Up to 2" deep gaps over 12" wide along transition to concrete.
B15	No level changes greater than 1/2" (except by accessible ramp or other means). (ADAS 303.4)	Up to 1" high vertical edge.

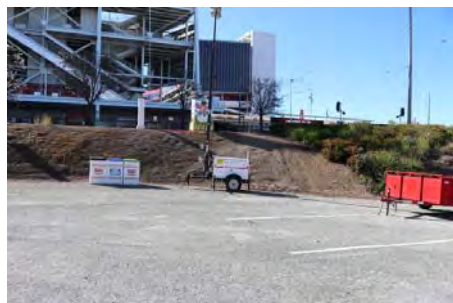
NEVAREZ V 49ERS - ACCESSIBILITY ASSESSMENT**FACILITY/SITE: 13. Yellow Lot 2****SEQ.
#****1307****FEATURE: #11 ACC ROUTE OF TRAVEL****LOCATION: Access to public right of way.****MEMO: Dirt pedestrian path at SW corner of lot.****Notes:**

Leads to N side of Tasman Dr.

COD	CONDITION DESCRIPTION	ACTUAL
B11	Surface is firm, stable and slip-resistant. (ADAS 302.1)	Loose rocks, gravel and sand.
B12	Gaps/openings in ground or floor surfaces do not allow the passage of a sphere more than 1/2" in diameter. (ADAS 302.3)	Multiples gaps.
B15	No level changes greater than 1/2" (except by accessible ramp or other means). (ADAS 303.4)	Multiple vertical edges over 1/2" high.
B17	Running slope (parallel to direction of travel) is 1:20 (5.0%) max. (ADAS 403.3)	Steep hillside.

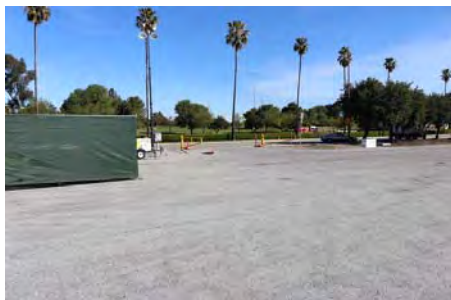
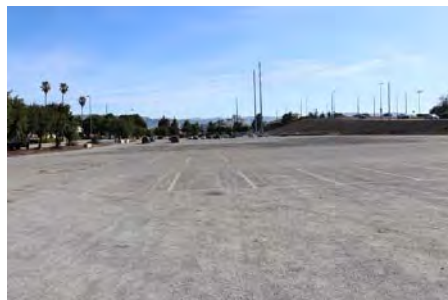
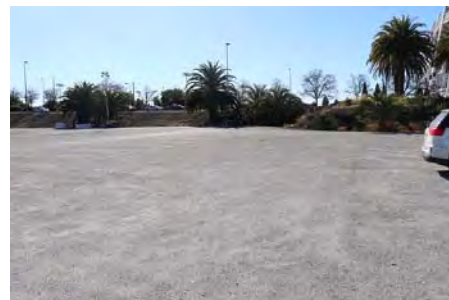
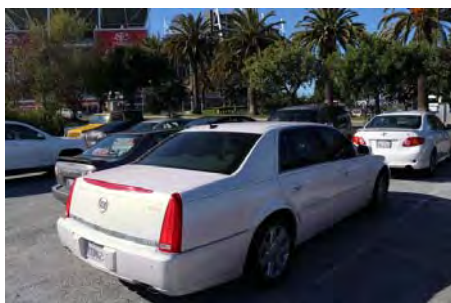
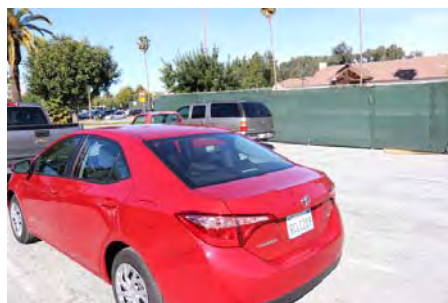
COD	CONDITION DESCRIPTION	ACTUAL
C10	Required number of acc stalls are provided as follows: 1-25=1, 26-50=2, 51-75=3, 76-100=4, 101-150=5, 151-200=6, 201-300=7, 301-400=8, 401-500=9, 501-1000=2% of total, 1001+=20+1 for each 100 over 1000. (ADAS 208.2)	None provided, 9 required.
A12	1 van stall provided for every 6 required acc stalls. (ADAS 208.2.4)	None provided, 2 required.

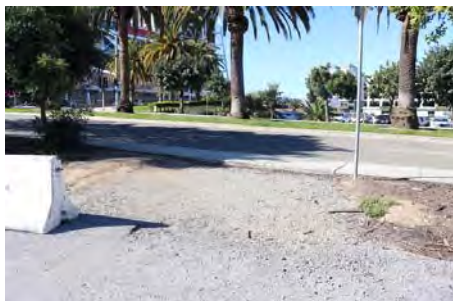
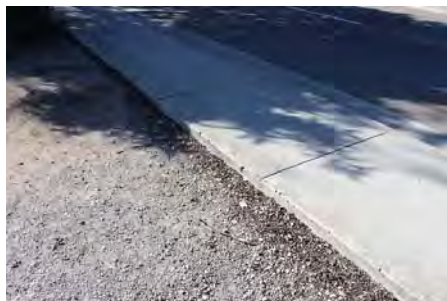
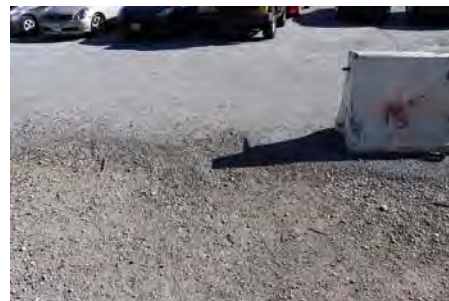
NEVAREZ V 49ERS - ACCESSIBILITY ASSESSMENT**FACILITY/SITE: 14. Yellow Lot 3****SEQ.
#****1402****FEATURE: #11 ACC ROUTE OF TRAVEL****LOCATION: Pedestrian walkway to public right of way.****MEMO: Dirt pathway at middle of W side of lot.****Notes:**

Asphalt and dirt leading to E side of Centennial Blvd.

COD	CONDITION DESCRIPTION	ACTUAL
B11	Surface is firm, stable and slip-resistant. (ADAS 302.1)	Dirt, rocks, gravel and sand.
B12	Gaps/openings in ground or floor surfaces do not allow the passage of a sphere more than 1/2" in diameter. (ADAS 302.3)	Multiples gaps at asphalt to dirt transition.
B15	No level changes greater than 1/2" (except by accessible ramp or other means). (ADAS 303.4)	4" high vertical edge at concrete.
B17	Running slope (parallel to direction of travel) is 1:20 (5.0%) max. (ADAS 403.3)	Running slope 17.7% for approx. 12" at asphalt to dirt transition.

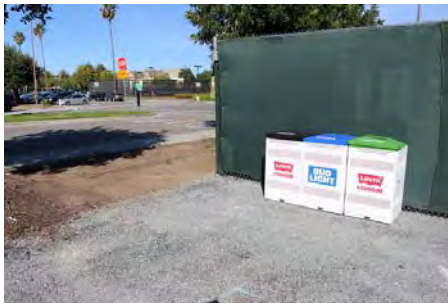
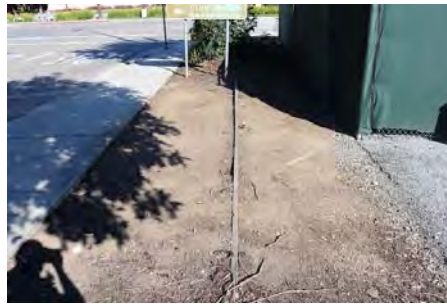
NEVAREZ V 49ERS - ACCESSIBILITY ASSESSMENT**FACILITY/SITE: 14. Yellow Lot 3****SEQ.
#****1403****FEATURE: #11 ACC ROUTE OF TRAVEL****LOCATION: Pedestrian walkway to public right of way.****MEMO: Dirt pedestrian path at NW corner of lot.****Notes:**

Leads to SE corner of Stars and Stripes Dr. and Centennial Blvd.

COD	CONDITION DESCRIPTION	ACTUAL
B11	Surface is firm, stable and slip-resistant. (ADAS 302.1)	Dirt, gravel, sand and rocks.
B15	No level changes greater than 1/2" (except by accessible ramp or other means). (ADAS 303.4)	3" high vertical edge at concrete to dirt, 3" at wood planting strip, and 1" at asphalt to dirt.
B17	Running slope (parallel to direction of travel) is 1:20 (5.0%) max. (ADAS 403.3)	19.7% at asphalt to dirt, 16.9% at dirt.

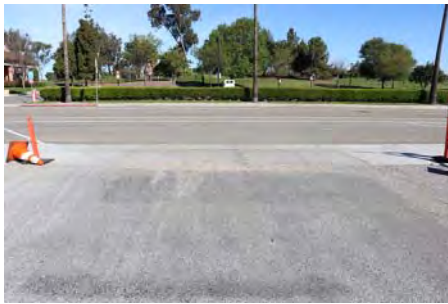
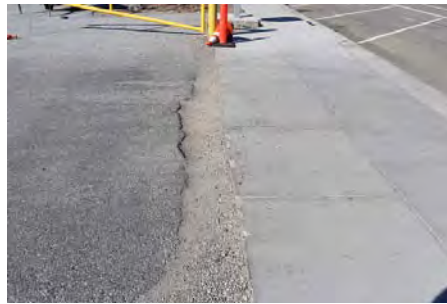
NEVAREZ V 49ERS - ACCESSIBILITY ASSESSMENT**FACILITY/SITE: 14. Yellow Lot 3****SEQ.
#****1404****FEATURE: #11 ACC ROUTE OF TRAVEL****LOCATION: Pedestrian walkway to public right of way.****MEMO: Vehicular drive by near NW corner.****Notes:**

Leads to S side of Stars and Stripes Dr.

COD	CONDITION DESCRIPTION	ACTUAL
B11	Surface is firm, stable and slip-resistant. (ADAS 302.1)	Rocks, sand, gravel and dirt.
B12	Gaps/openings in ground or floor surfaces do not allow the passage of a sphere more than 1/2" in diameter. (ADAS 302.3)	1 1/2" deep gap over 12" wide along transition to concrete.
B15	No level changes greater than 1/2" (except by accessible ramp or other means). (ADAS 303.4)	Multiples edges up to 1 1/2".

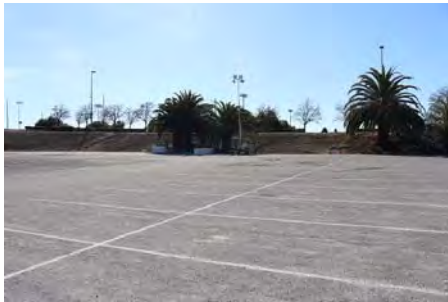
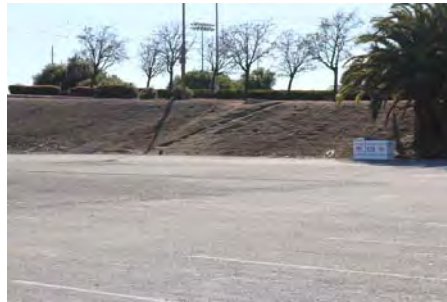
NEVAREZ V 49ERS - ACCESSIBILITY ASSESSMENT**FACILITY/SITE: 14. Yellow Lot 3****SEQ.
#****1405****FEATURE: #11 ACC ROUTE OF TRAVEL****LOCATION: Pedestrian walkway to public right of way.****MEMO: To dirt path at S side of lot.****Notes:**

Leads to N side of Tasman Dr.

COD	CONDITION DESCRIPTION	ACTUAL
B11	Surface is firm, stable and slip-resistant. (ADAS 302.1)	Dirt
B17	Running slope (parallel to direction of travel) is 1:20 (5.0%) max. (ADAS 403.3)	Steep hillside.

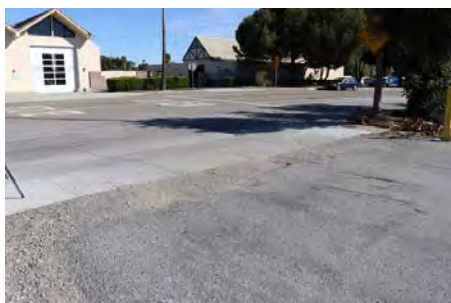
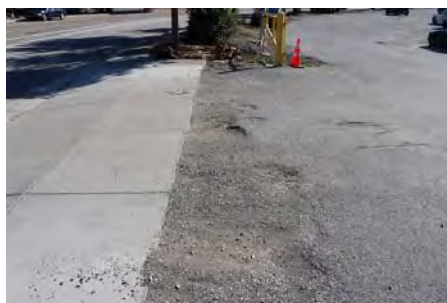
NEVAREZ V 49ERS - ACCESSIBILITY ASSESSMENT**FACILITY/SITE: 14. Yellow Lot 3****SEQ.
#****1406****FEATURE: #11 ACC ROUTE OF TRAVEL****LOCATION: Pedestrian walkway to public right of way.****MEMO: East vehicular drive.****Notes:**

Leads to S side of Stars and Stripes Dr.

COD	CONDITION DESCRIPTION	ACTUAL
B11	Surface is firm, stable and slip-resistant. (ADAS 302.1)	Rocks, gravel, sand and dirt.
B12	Gaps/openings in ground or floor surfaces do not allow the passage of a sphere more than 1/2" in diameter. (ADAS 302.3)	Up to 2 1/2" deep gap over 18" wide along transition to concrete.
B15	No level changes greater than 1/2" (except by accessible ramp or other means). (ADAS 303.4)	Multiple edges up to 1 1/2".

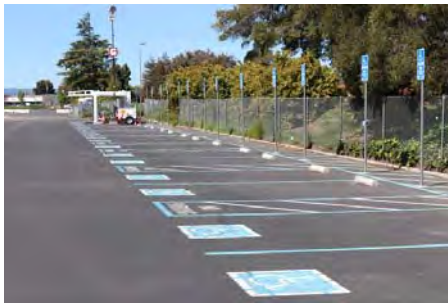
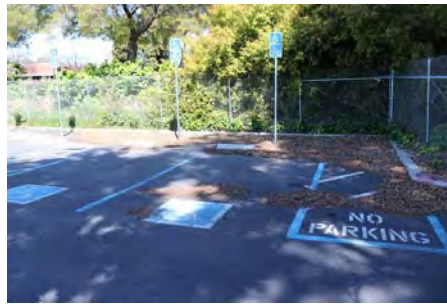
NEVAREZ V 49ERS - ACCESSIBILITY ASSESSMENT**FACILITY/SITE: 15. Blue Lot 1****SEQ.
#****1501****FEATURE: #5 PARKING STALL****LOCATION: 19 stalls at the N side of the lot at Democracy Wy.****MEMO:****Notes:****CONDITIONS THAT DO NOT CONFORM TO NEW CONSTRUCTION STANDARDS**

COD	CONDITION DESCRIPTION	ACTUAL
B11	Parking space is marked to define a width of min.8' wide (9' CBC). (ADAS 502.2)	West to stalls are obstructed by shelter.
B12	Access aisle is marked to define a width of min. 5' wide. (ADAS 502..3.1)	8 of the 11 access aisles are 58" to 59" wide.
B32	Stall & access aisle has no gaps or changes in level and is firm, stable and slip resistant. (ADAS 502.4)	Stalls and access aisles at eastern 3 stalls are partially covered by leaves and dirt.

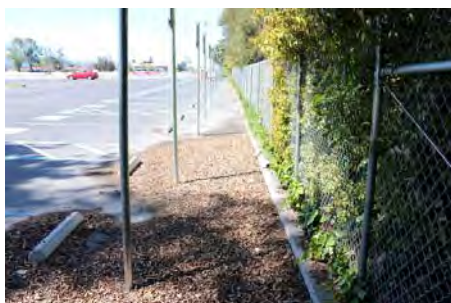
COD	CONDITION DESCRIPTION	ACTUAL
B11	Surface is firm, stable and slip-resistant. (ADAS 302.1)	Partially covered by leaves and dirt.

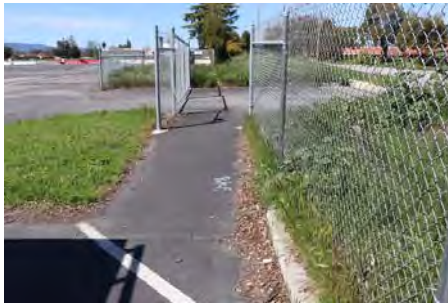
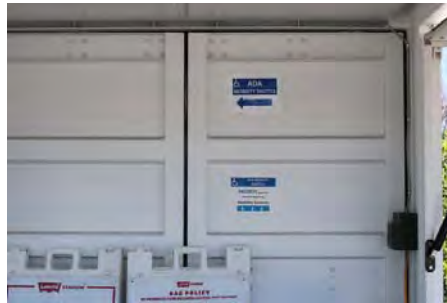
NEVAREZ V 49ERS - ACCESSIBILITY ASSESSMENT**FACILITY/SITE: 15. Blue Lot 1****SEQ.
#****1503****FEATURE: #12 RAMP****LOCATION: 19 stalls at the N side of the lot at Democracy Wy.****MEMO: Asphalt ramp at W end of walkway at N side of DAS.****Notes:**

Approx. 12' long from 4.0% to 6.5% slope. Route to the ADA mobility shuttle.

COD	CONDITION DESCRIPTION	ACTUAL
B04	Cross slope of ramp is 1:48 (2.08%) max. (ADAS 405.3)	2.6% to 4.0%.
B12	Landings are sloped 1:48 (2.08%) max. and are firm, stable and slip resistant without gaps or edges. (ADAS 405.7.1)	Top landing up to 3.2%.
B31	Handrails are provided at both sides (ADA: except at ramp with max 6" rise / 72" run) (CBC: except adjacent to assembly seating, or at door landing ramp with max 6" rise / 72" run). (ADAS 405.8)	None. Approx. 12' long.

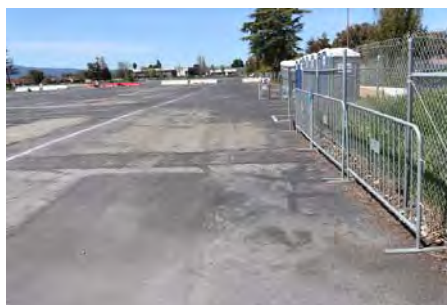
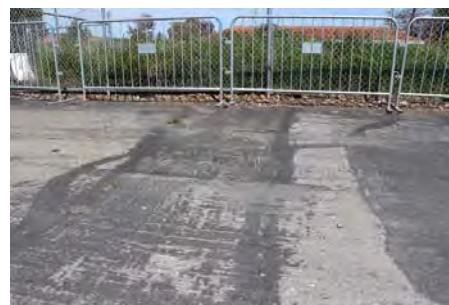
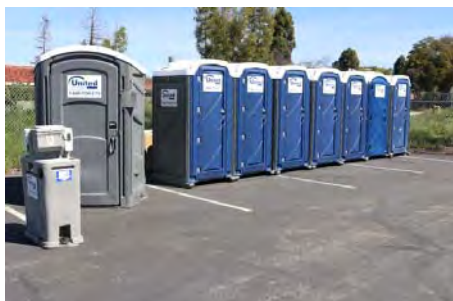
COD	CONDITION DESCRIPTION	ACTUAL
B15	No level changes greater than 1/2" (except by accessible ramp or other means). (ADAS 303.4)	Multiple raised edges 1" high.

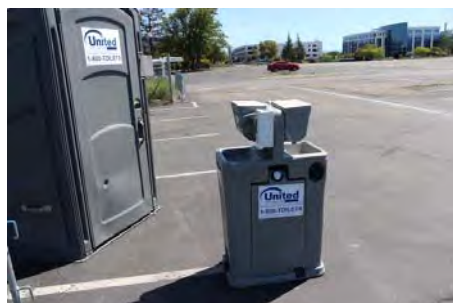
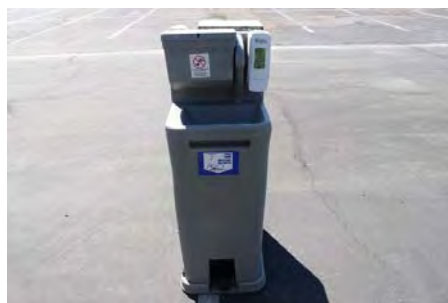
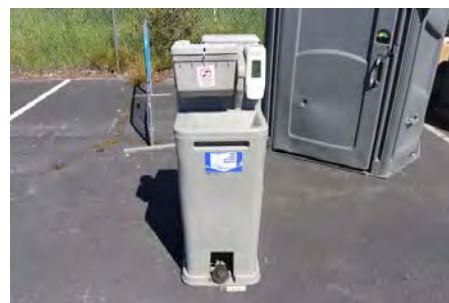
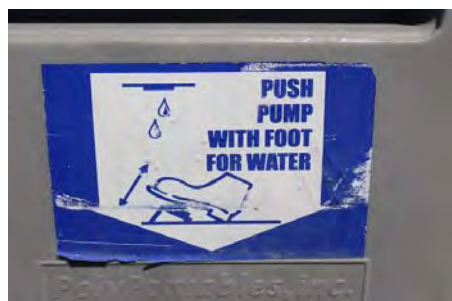
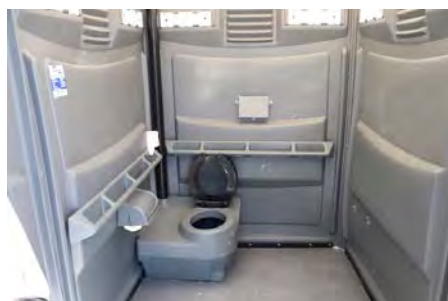
COD	CONDITION DESCRIPTION	ACTUAL
B02	Operable parts are operable with one hand, using max 5lbs force, and not requiring tight grasping, pinching, or twisting of the wrist. (ADAS 309.4)	Water is foot operated, not hand operated.

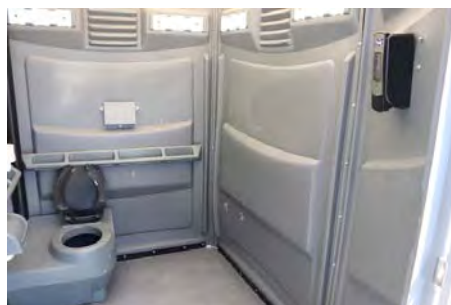
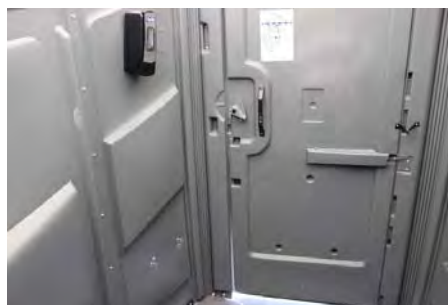
COD	CONDITION DESCRIPTION	ACTUAL
B21	Unobstructed forward or side approach reach range is min 15" to max 48" AFF. (ADAS 308.2.1, 308.3.1)	Hand sanitizer 54" high.

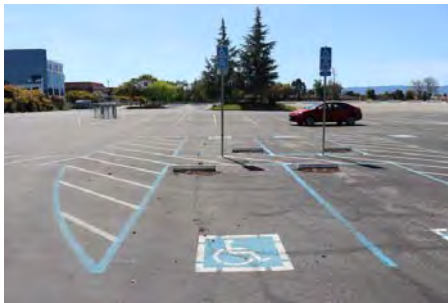
NEVAREZ V 49ERS - ACCESSIBILITY ASSESSMENT**FACILITY/SITE: 15. Blue Lot 1****SEQ.
#****1507****FEATURE: #5 PARKING STALL****LOCATION: 26 DAS at NE corner.****MEMO: NE DAS at center island.****Notes:****CONDITIONS THAT DO NOT CONFORM TO NEW CONSTRUCTION STANDARDS**

COD	CONDITION DESCRIPTION	ACTUAL
B12	Access aisle is marked to define a width of min. 5' wide. (ADAS 502..3.1)	Varies from 0" to 94".

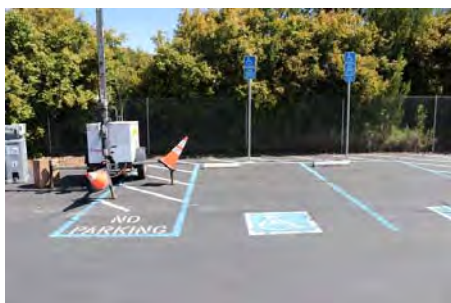
NEVAREZ V 49ERS - ACCESSIBILITY ASSESSMENT**FACILITY/SITE: 15. Blue Lot 1****SEQ.
#****1508****FEATURE: #5 PARKING STALL****LOCATION: 26 DAS at NE corner.****MEMO: NE corner DAS at N end of row of DAS at E side.****Notes:****CONDITIONS THAT DO NOT CONFORM TO NEW CONSTRUCTION STANDARDS**

COD	CONDITION DESCRIPTION	ACTUAL
B12	Access aisle is marked to define a width of min. 5' wide. (ADAS 502..3.1)	Obstructed by equipment.
