Case No. 5:16-cv-07013-LHK (SVK)

**DECLARATION OF JEFFREY SCOTT
MASTIN IN SUPPORT OF PLAINTIFFS'
MOTION FOR CLASS CERTIFICATION**

NEVAREZ V 49ERS - ACCESSIBILITY ASSESSMENT

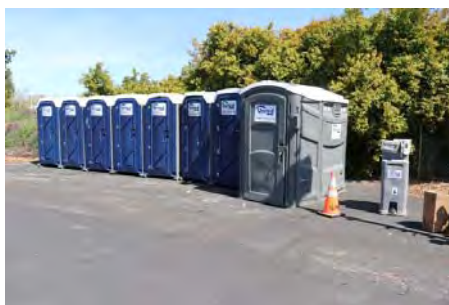
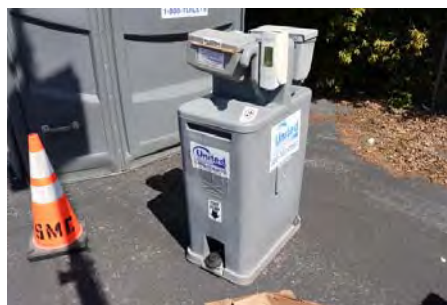
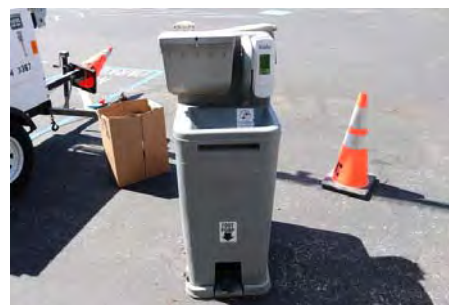
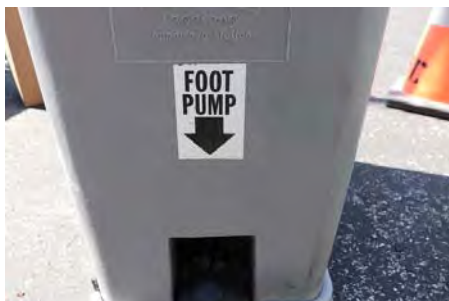
COD	CONDITION DESCRIPTION	ACTUAL
B02	Operable parts are operable with one hand, using max 5lbs force, and not requiring tight grasping, pinching, or twisting of the wrist. (ADAS 309.4)	Water operated by foot pump.

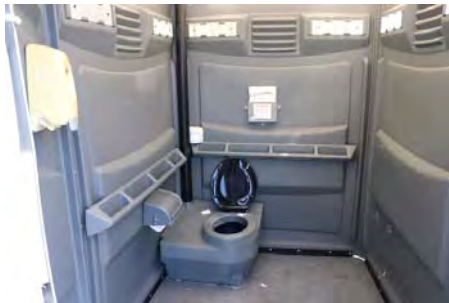
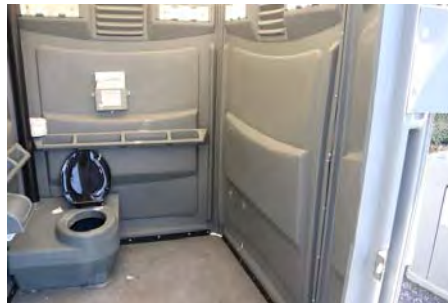
NEVAREZ V 49ERS - ACCESSIBILITY ASSESSMENT**FACILITY/SITE: 15. Blue Lot 1****SEQ.
#****1510****FEATURE: #54 REACH RANGE & OPERATING MECHANISMS****LOCATION: 26 DAS at NE corner.****MEMO: Accessible portable toilet.****Notes:****CONDITIONS THAT DO NOT CONFORM TO NEW CONSTRUCTION STANDARDS**

COD	CONDITION DESCRIPTION	ACTUAL
B21	Unobstructed forward or side approach reach range is min 15" to max 48" AFF. (ADAS 308.2.1, 308.3.1)	51 3/4" to hand sanitizer.

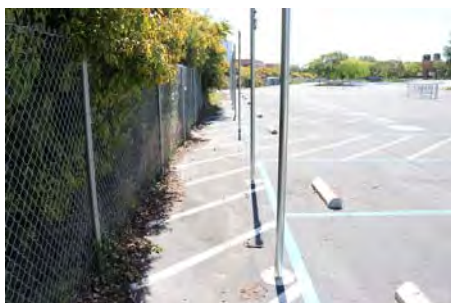
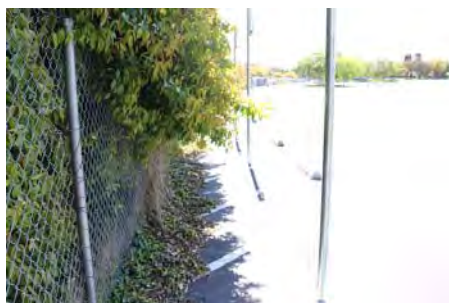
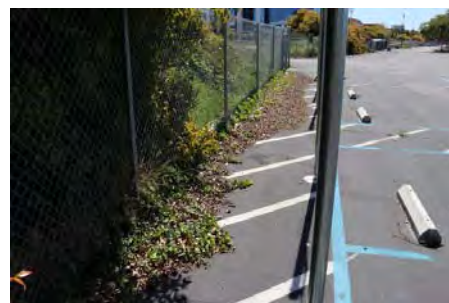
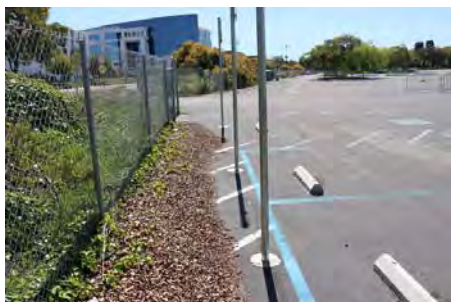
CONDITIONS THAT DO NOT CONFORM TO NEW CONSTRUCTION STANDARDS

COD	CONDITION DESCRIPTION	ACTUAL
B02	36" min. clear width of exterior walkway. (ADAS 403.5.1)	Obstructed by trees and plants.
B11	Surface is firm, stable and slip-resistant. (ADAS 302.1)	Surface obstructed by leaves, dirt and debris.

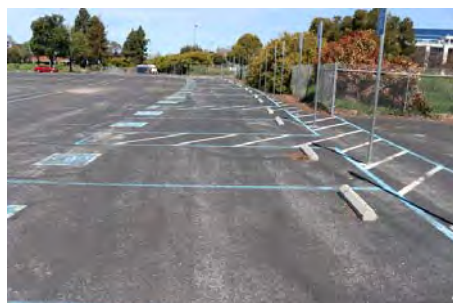
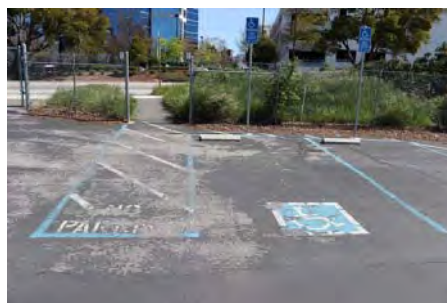
NEVAREZ V 49ERS - ACCESSIBILITY ASSESSMENT**FACILITY/SITE: 15. Blue Lot 1****SEQ.
#****1513****FEATURE: #5 PARKING STALL****LOCATION: 14 DAS at E side of parking lot.****MEMO:****Notes:****CONDITIONS THAT DO NOT CONFORM TO NEW CONSTRUCTION STANDARDS**

COD	CONDITION DESCRIPTION	ACTUAL
B23	Access aisle is marked to discourage parking -in California: with "NO PARKING" in white with min. 12" high letters located at tail end of access aisle. (ADAS 502.3.3)	North stall markings are worn away.
B31	Slopes do not exceed 1:48 (2.08%). (ADAS 502.4)	Slopes at the southern 8 stalls and access aisles are excessive up to 4.6%.

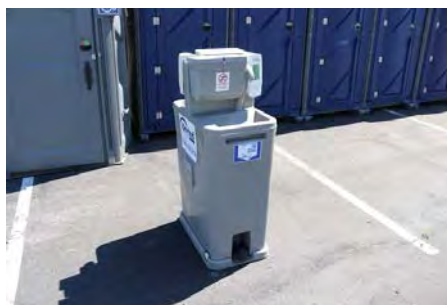
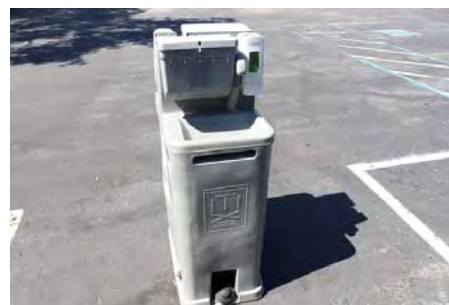
CONDITIONS THAT DO NOT CONFORM TO NEW CONSTRUCTION STANDARDS

COD	CONDITION DESCRIPTION	ACTUAL
B02	Operable parts are operable with one hand, using max 5lbs force, and not requiring tight grasping, pinching, or twisting of the wrist. (ADAS 309.4)	Water operation by foot pedal.

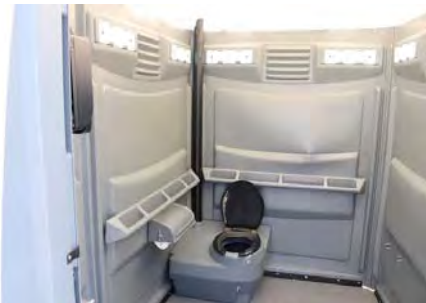
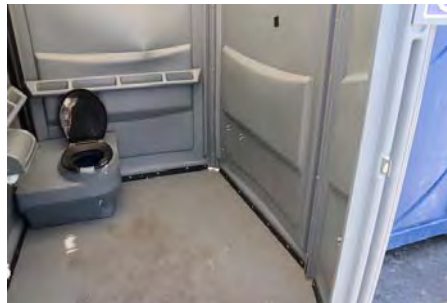
COD	CONDITION DESCRIPTION	ACTUAL
B21	Unobstructed forward or side approach reach range is min 15" to max 48" AFF. (ADAS 308.2.1, 308.3.1)	55" to hand sanitizer.

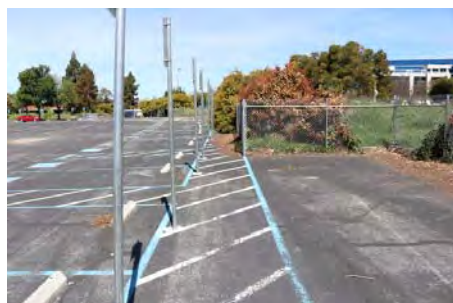
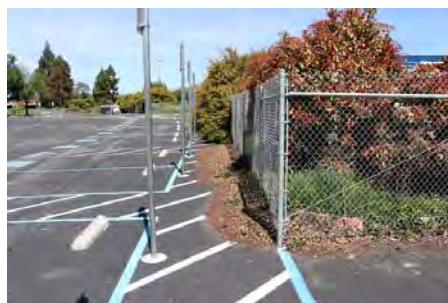
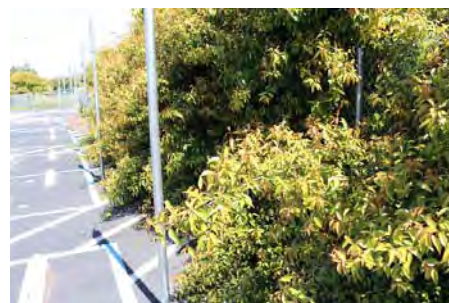
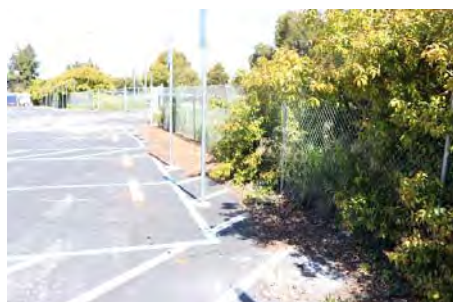
COD	CONDITION DESCRIPTION	ACTUAL
B02	36" min. clear width of exterior walkway. (ADAS 403.5.1)	Completely obstructed by bushes and trees.
B11	Surface is firm, stable and slip-resistant. (ADAS 302.1)	Covered by leaves, dirt and debris.

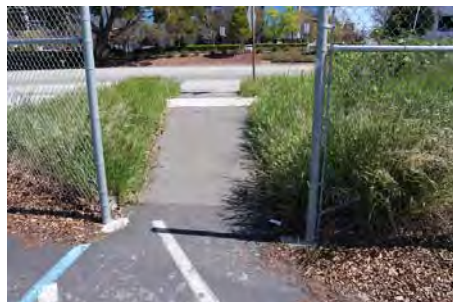
NEVAREZ V 49ERS - ACCESSIBILITY ASSESSMENT**FACILITY/SITE: 15. Blue Lot 1****SEQ.
#****1517****FEATURE: #12 RAMP****LOCATION: 14 DAS at E side of parking lot.****MEMO: Asphalt walkway to public right of way at Old Ironsides.****Notes:**

Approx. 12' long with running slope from 4.7% to 9.0%.

COD	CONDITION DESCRIPTION	ACTUAL
B03	Running slope is 1:12 (8.33%) max. (ADAS 405.2)	Up to 9.0%, running slope undulates from high to low and surface is not planar.
B31	Handrails are provided at both sides (ADA: except at ramp with max 6" rise / 72" run) (CBC: except adjacent to assembly seating, or at door landing ramp with max 6" rise / 72" run). (ADAS 405.8)	None, approx. 12' long.

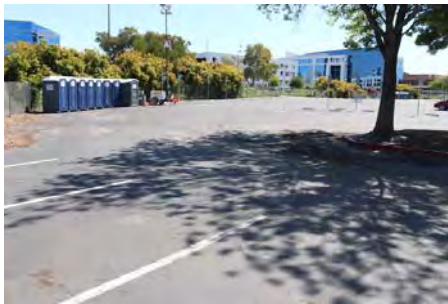
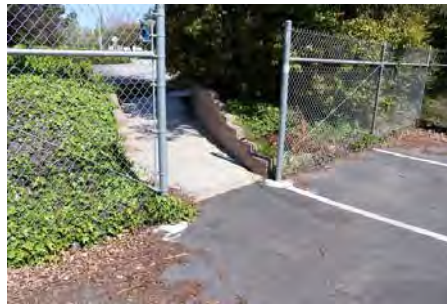
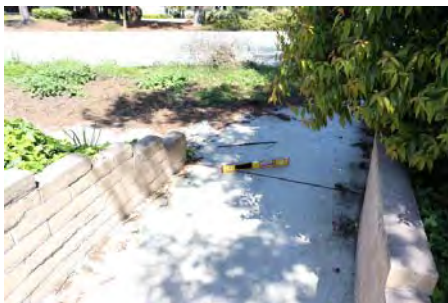
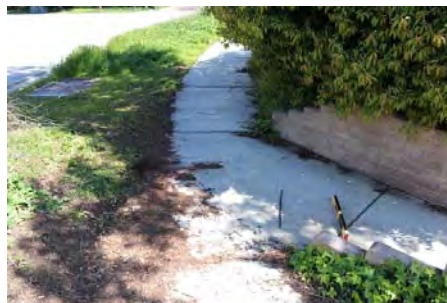
NEVAREZ V 49ERS - ACCESSIBILITY ASSESSMENT**FACILITY/SITE: 15. Blue Lot 1****SEQ.
#****1518****FEATURE: #12 RAMP****LOCATION: 26 DAS at NE corner.****MEMO: Concrete walkway to Democracy Wy.****Notes:**

Not the indicated accessible route to the public right of way. Approx. 12' long with running slope from 2.4% to 8.0%.

COD	CONDITION DESCRIPTION	ACTUAL
B04	Cross slope of ramp is 1:48 (2.08%) max. (ADAS 405.3)	Cross slope is 4.0% at the top.
B12	Landings are sloped 1:48 (2.08%) max. and are firm, stable and slip resistant without gaps or edges. (ADAS 405.7.1)	Btm. Landing is 3.9%, top landing is 5.0% and top landing partially covered by debris.
B14	Top landing is min. 60" long. (ADAS 405.7.3)	Top landing is 48".
B31	Handrails are provided at both sides (ADA: except at ramp with max 6" rise / 72" run) (CBC: except adjacent to assembly seating, or at door landing ramp with max 6" rise / 72" run). (ADAS 405.8)	None, approx. 12' long.

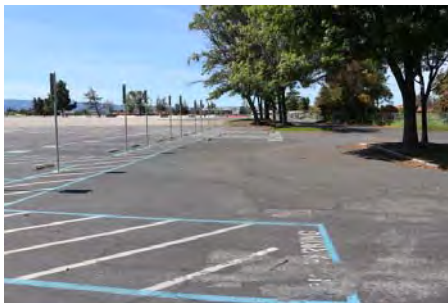
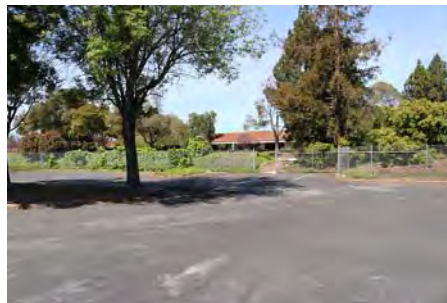
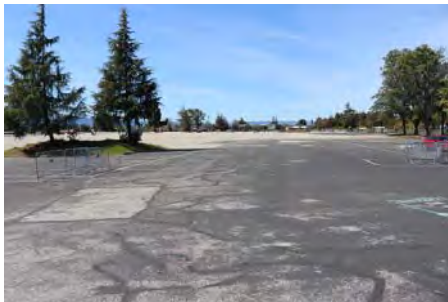
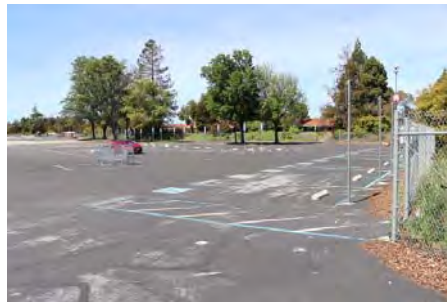
NEVAREZ V 49ERS - ACCESSIBILITY ASSESSMENT**FACILITY/SITE: 15. Blue Lot 1****SEQ.
#****1519****FEATURE: #2 PARKING LOT****LOCATION: 26 DAS at NE corner.****MEMO:****Notes:****CONDITIONS THAT DO NOT CONFORM TO NEW CONSTRUCTION STANDARDS**

COD	CONDITION DESCRIPTION	ACTUAL
A5	Acc parking stalls are located on the shortest ACC route from parking to ACC entrance. (ADAS 208.3.1)	Many standard stalls are closer to both walkways to the public right of way, at the E side and the N side, than are some of the DAS.

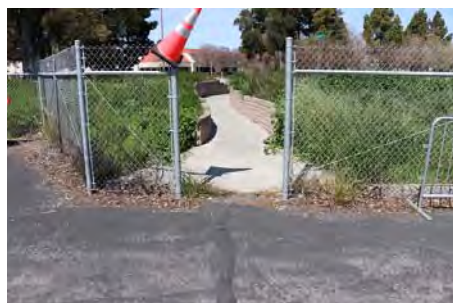
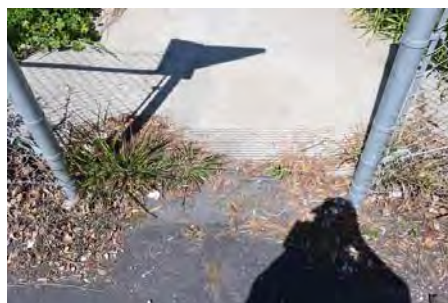
COD	CONDITION DESCRIPTION	ACTUAL
B03	Running slope is 1:12 (8.33%) max. (ADAS 405.2)	Up to 11.1%.
B12	Landings are sloped 1:48 (2.08%) max. and are firm, stable and slip resistant without gaps or edges. (ADAS 405.7.1)	Vegetation at the btm. transition. Top landing 3.1%.

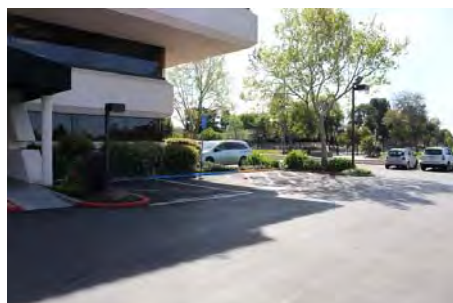
NEVAREZ V 49ERS - ACCESSIBILITY ASSESSMENT**FACILITY/SITE: 16. Green Lot 3****SEQ.
#****1601****FEATURE: #5 PARKING STALL****LOCATION: N side of building 4899****MEMO: Single DAS****Notes:****CONDITIONS THAT DO NOT CONFORM TO NEW CONSTRUCTION STANDARDS**

COD	CONDITION DESCRIPTION	ACTUAL
B41	Stall is located as close as practical to entrance. (ADAS 208.3.1)	Many other standard stalls closer to routes to the public right of way.
C42	Accessible route from stall does not pass behind other parked cars. (2013 CBC 11B-502.7.1).	Must pass behind other vehicles.

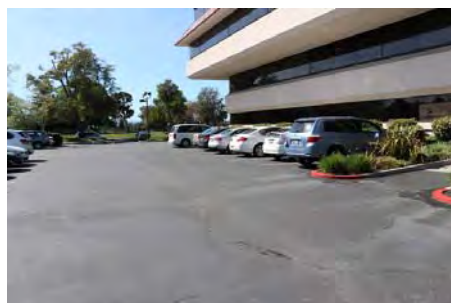
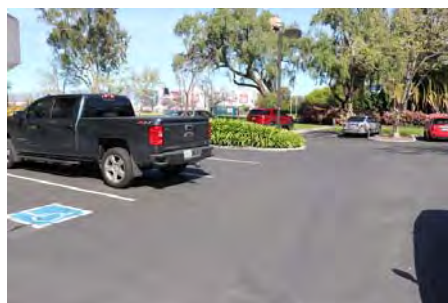
NEVAREZ V 49ERS - ACCESSIBILITY ASSESSMENT**FACILITY/SITE: 16. Green Lot 3****SEQ.
#****1602****FEATURE: #5 PARKING STALL****LOCATION: S side of building 4899.****MEMO: Double DAS.****Notes:****CONDITIONS THAT DO NOT CONFORM TO NEW CONSTRUCTION STANDARDS**

COD	CONDITION DESCRIPTION	ACTUAL
B41	Stall is located as close as practical to entrance. (ADAS 208.3.1)	Many other standard stalls closer to routes to the public right of way.
C42	Accessible route from stall does not pass behind other parked cars. (2013 CBC 11B-502.7.1).	Must pass behind other vehicles.

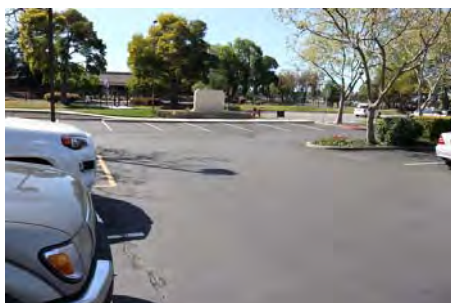
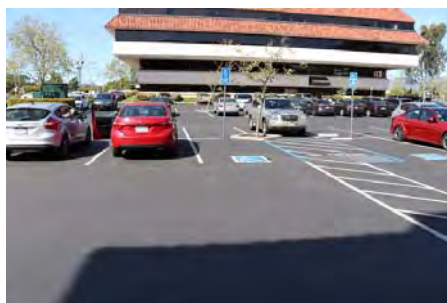
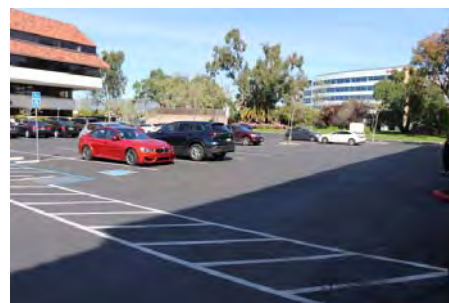
NEVAREZ V 49ERS - ACCESSIBILITY ASSESSMENT**FACILITY/SITE: 16. Green Lot 3****SEQ.
#****1603****FEATURE: #5 PARKING STALL****LOCATION: N side of building 4667.****MEMO: Double DAS, W side designated van.****Notes:****CONDITIONS THAT DO NOT CONFORM TO NEW CONSTRUCTION STANDARDS**

COD	CONDITION DESCRIPTION	ACTUAL
B41	Stall is located as close as practical to entrance. (ADAS 208.3.1)	Many other standard stalls closer to routes to the public right of way.
C42	Accessible route from stall does not pass behind other parked cars. (2013 CBC 11B-502.7.1).	Must pass behind other vehicles.

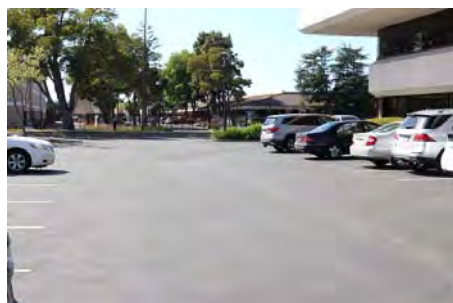
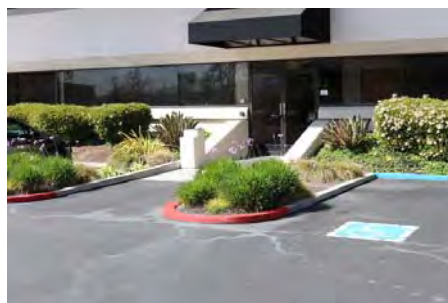
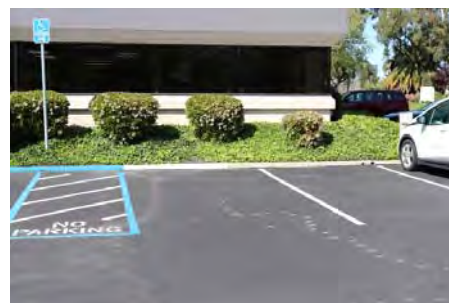
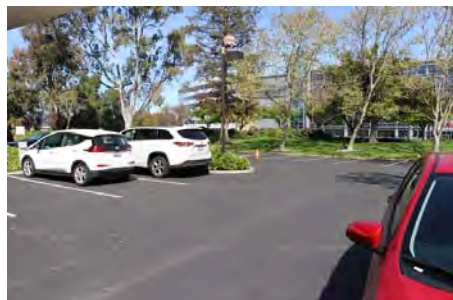
NEVAREZ V 49ERS - ACCESSIBILITY ASSESSMENT**FACILITY/SITE: 16. Green Lot 3****SEQ.
#****1604****FEATURE: #5 PARKING STALL****LOCATION: S side of building 4667.****MEMO: Single DAS****Notes:****CONDITIONS THAT DO NOT CONFORM TO NEW CONSTRUCTION STANDARDS**

COD	CONDITION DESCRIPTION	ACTUAL
B41	Stall is located as close as practical to entrance. (ADAS 208.3.1)	Many other standard stalls closer to routes to the public right of way.
C42	Accessible route from stall does not pass behind other parked cars. (2013 CBC 11B-502.7.1).	Must pass behind other vehicles.

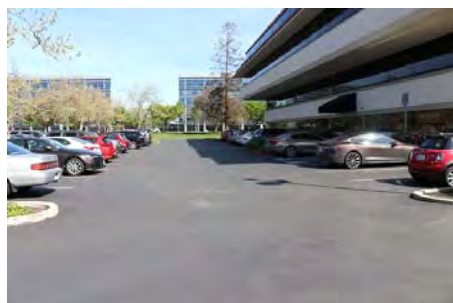
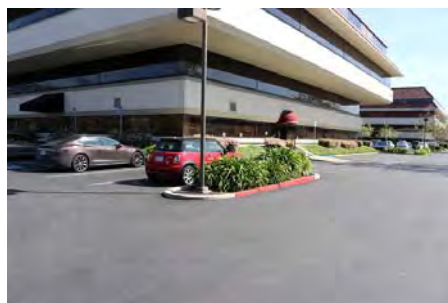
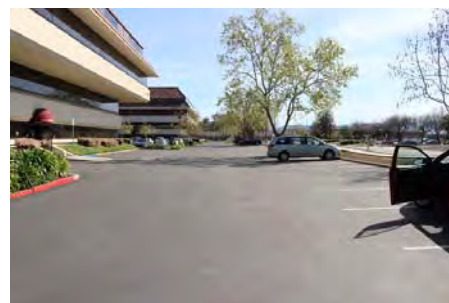
NEVAREZ V 49ERS - ACCESSIBILITY ASSESSMENT**FACILITY/SITE: 16. Green Lot 3****SEQ.
#****1605****FEATURE: #5 PARKING STALL****LOCATION: N side of building 4655.****MEMO: Double DAS****Notes:****CONDITIONS THAT DO NOT CONFORM TO NEW CONSTRUCTION STANDARDS**

COD	CONDITION DESCRIPTION	ACTUAL
B41	Stall is located as close as practical to entrance. (ADAS 208.3.1)	Many other standard stalls closer to routes to the public right of way.
C42	Accessible route from stall does not pass behind other parked cars. (2013 CBC 11B-502.7.1).	Must pass behind other vehicles.

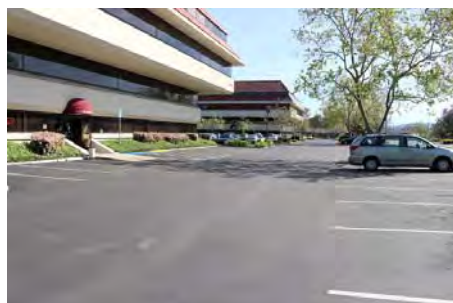
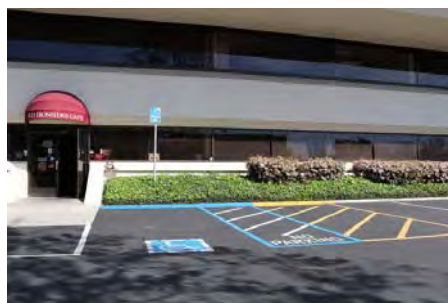
NEVAREZ V 49ERS - ACCESSIBILITY ASSESSMENT**FACILITY/SITE: 16. Green Lot 3****SEQ.
#****1606****FEATURE: #5 PARKING STALL****LOCATION: W side of building 4655.****MEMO: Single DAS.****Notes:****CONDITIONS THAT DO NOT CONFORM TO NEW CONSTRUCTION STANDARDS**

COD	CONDITION DESCRIPTION	ACTUAL
B41	Stall is located as close as practical to entrance. (ADAS 208.3.1)	Many other standard stalls closer to routes to the public right of way.
C42	Accessible route from stall does not pass behind other parked cars. (2013 CBC 11B-502.7.1).	Must pass behind other vehicles.

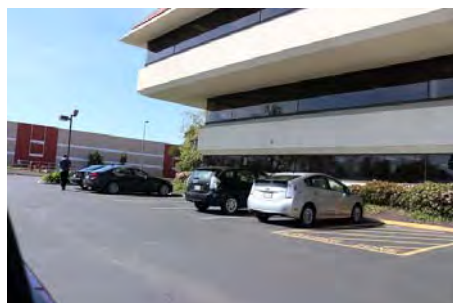
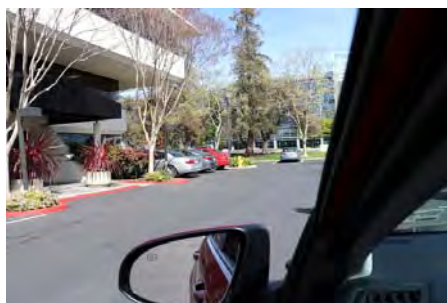
NEVAREZ V 49ERS - ACCESSIBILITY ASSESSMENT**FACILITY/SITE: 16. Green Lot 3****SEQ.
#****1607****FEATURE: #5 PARKING STALL****LOCATION: S side of building 4655.****MEMO: Single van DAS.****Notes:****CONDITIONS THAT DO NOT CONFORM TO NEW CONSTRUCTION STANDARDS**

COD	CONDITION DESCRIPTION	ACTUAL
B41	Stall is located as close as practical to entrance. (ADAS 208.3.1)	Many other standard stalls closer to routes to the public right of way.
C42	Accessible route from stall does not pass behind other parked cars. (2013 CBC 11B-502.7.1).	Must pass behind other vehicles.

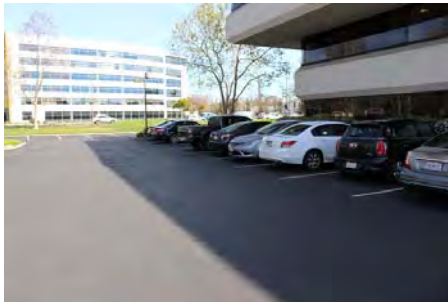
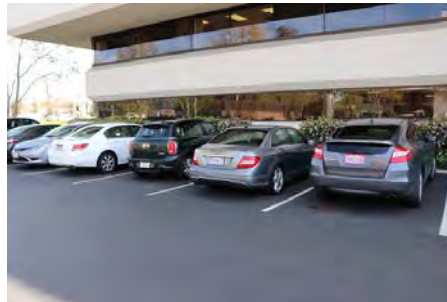
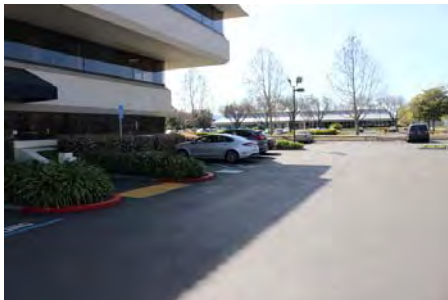
NEVAREZ V 49ERS - ACCESSIBILITY ASSESSMENT**FACILITY/SITE: 16. Green Lot 3****SEQ.
#****1608****FEATURE: #5 PARKING STALL****LOCATION: N side of building 4633.****MEMO: 2 DAS, E side designated van.****Notes:****CONDITIONS THAT DO NOT CONFORM TO NEW CONSTRUCTION STANDARDS**

COD	CONDITION DESCRIPTION	ACTUAL
B41	Stall is located as close as practical to entrance. (ADAS 208.3.1)	Many other standard stalls closer to routes to the public right of way.
C42	Accessible route from stall does not pass behind other parked cars. (2013 CBC 11B-502.7.1).	Must pass behind other vehicles.

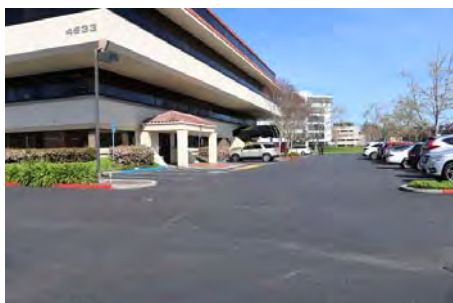
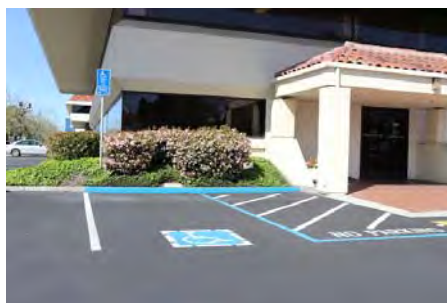
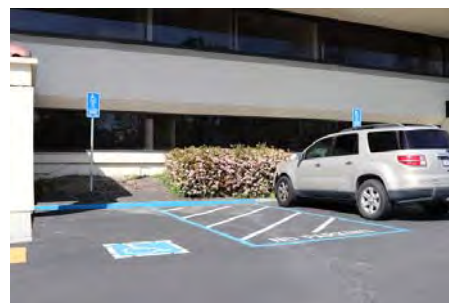
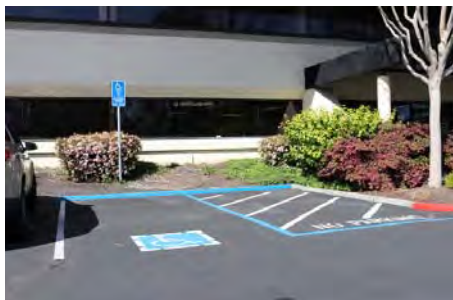
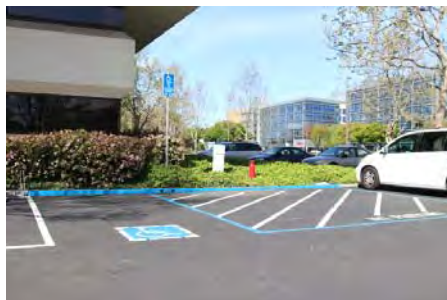
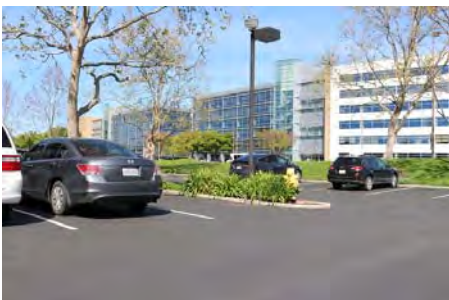
NEVAREZ V 49ERS - ACCESSIBILITY ASSESSMENT**FACILITY/SITE: 16. Green Lot 3****SEQ.
#****1609****FEATURE: #5 PARKING STALL****LOCATION: S side of building 4633.****MEMO: 1 double and 2 single van DAS.****Notes:****CONDITIONS THAT DO NOT CONFORM TO NEW CONSTRUCTION STANDARDS**

COD	CONDITION DESCRIPTION	ACTUAL
B41	Stall is located as close as practical to entrance. (ADAS 208.3.1)	Many other standard stalls closer to routes to the public right of way.
C42	Accessible route from stall does not pass behind other parked cars. (2013 CBC 11B-502.7.1).	Must pass behind other vehicles.

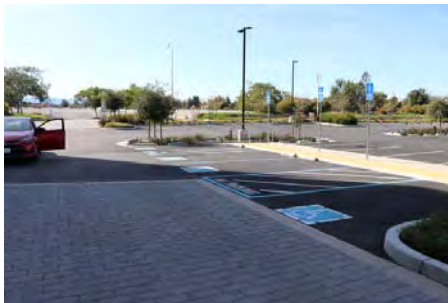
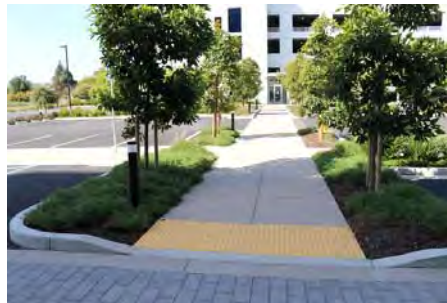
COD	CONDITION DESCRIPTION	ACTUAL
B41	Stall is located as close as practical to entrance. (ADAS 208.3.1)	Many standard spaces are closer to the public right of way.

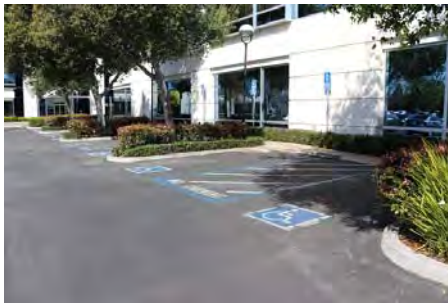
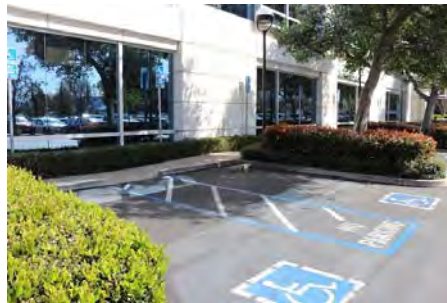
NEVAREZ V 49ERS - ACCESSIBILITY ASSESSMENT**FACILITY/SITE: 17. Green Lot 2****SEQ.
#****1703****FEATURE: #5 PARKING STALL****LOCATION: W side of Citrix building.****MEMO: 8 DAS including one designated van.****Notes:****CONDITIONS THAT DO NOT CONFORM TO NEW CONSTRUCTION STANDARDS**

COD	CONDITION DESCRIPTION	ACTUAL
B41	Stall is located as close as practical to entrance. (ADAS 208.3.1)	Many spaces are closer to the public right of way.

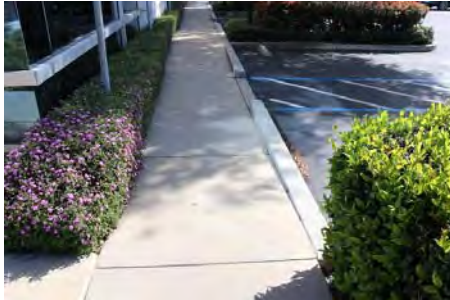
NEVAREZ V 49ERS - ACCESSIBILITY ASSESSMENT**FACILITY/SITE: 17. Green Lot 2****SEQ.
#****1704****FEATURE: #9 PARALLEL CURB RAMP****LOCATION: Walkway in front row of DAS at W side of Citrix building.****MEMO: Curb ramp at N pair of DAS.****Notes:****CONDITIONS THAT DO NOT CONFORM TO NEW CONSTRUCTION STANDARDS**

COD	CONDITION DESCRIPTION	ACTUAL
B04	Cross slope is 1:48 (2.08%) max. (ADAS 405.3)	3.5%
C12	Turning space at bottom of curb ramp slopes 1:48 (2.08%) max. in any direction (ADAS 403.3)	3.1%

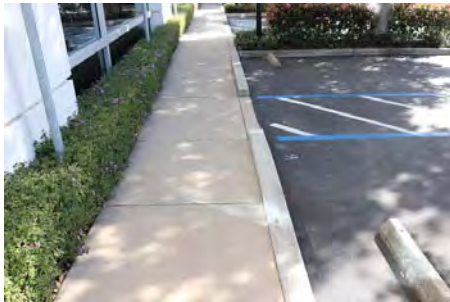
NEVAREZ V 49ERS - ACCESSIBILITY ASSESSMENT**FACILITY/SITE: 17. Green Lot 2****SEQ.
#****1705****FEATURE: #9 PARALLEL CURB RAMP****LOCATION: Walkway in front row of DAS at W side of Citrix building.****MEMO: Curb ramp at DAS pair second from N.****Notes:****CONDITIONS THAT DO NOT CONFORM TO NEW CONSTRUCTION STANDARDS**

COD	CONDITION DESCRIPTION	ACTUAL
B04	Cross slope is 1:48 (2.08%) max. (ADAS 405.3)	3.2% at N ramp, 2.8% at S ramp.
C12	Turning space at bottom of curb ramp slopes 1:48 (2.08%) max. in any direction (ADAS 403.3)	3.0%

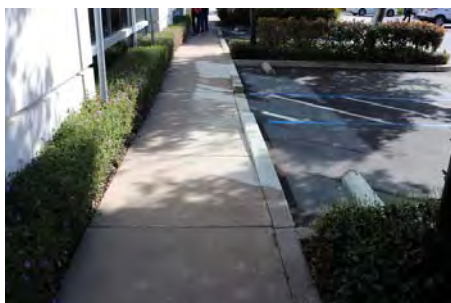
COD	CONDITION DESCRIPTION	ACTUAL
B04	Cross slope is 1:48 (2.08%) max. (ADAS 405.3)	3.0% at S ramp.

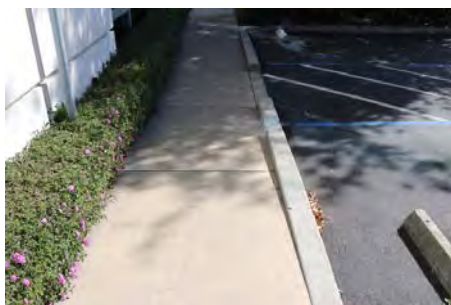
COD	CONDITION DESCRIPTION	ACTUAL
C12	Turning space at bottom of curb ramp slopes 1:48 (2.08%) max. in any direction (ADAS 403.3)	3.2%

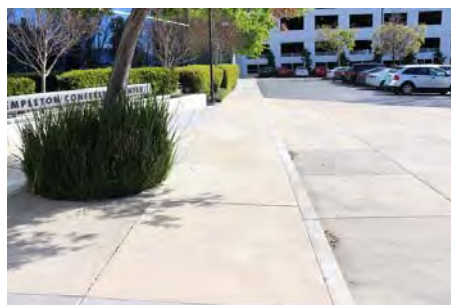
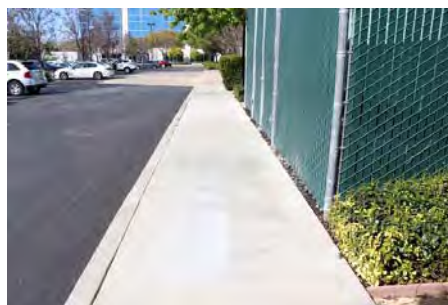
NEVAREZ V 49ERS - ACCESSIBILITY ASSESSMENT**FACILITY/SITE: 17. Green Lot 2****SEQ.
#****1708****FEATURE: #11 ACC ROUTE OF TRAVEL****LOCATION: Route from 8 DAS at W side of Citrix to PROW at Great America Pky.****MEMO: Between DAS and SW corner of building.****Notes:****CONDITIONS THAT DO NOT CONFORM TO NEW CONSTRUCTION STANDARDS**

COD	CONDITION DESCRIPTION	ACTUAL
B16	Cross slope (perpendicular to direction of travel) is 1:48 (2.08%) max. (ADAS 403.3)	Approx. 120' L is 3.5% to 5.4%.

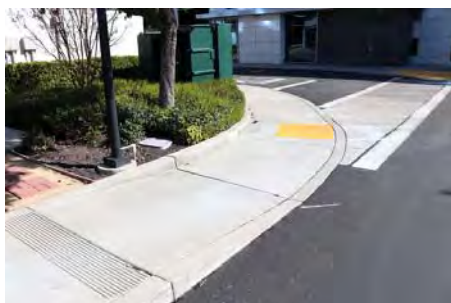
NEVAREZ V 49ERS - ACCESSIBILITY ASSESSMENT**FACILITY/SITE: 17. Green Lot 2****SEQ.
#****1709****FEATURE: #9 PARALLEL CURB RAMP****LOCATION: Route from 8 DAS at W side of Citrix to PROW at Great America Pky.****MEMO: At SW corner of building.****Notes:**

Curb ramp must be used as part of sidewalk.

COD	CONDITION DESCRIPTION	ACTUAL
B04	Cross slope is 1:48 (2.08%) max. (ADAS 405.3)	3.0% at N ramp.
C12	Turning space at bottom of curb ramp slopes 1:48 (2.08%) max. in any direction (ADAS 403.3)	3.2%.

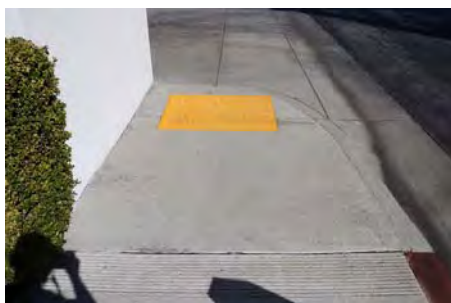
COD	CONDITION DESCRIPTION	ACTUAL
B04	Cross slope of ramp is 1:48 (2.08%). (ADAS 405.3)	3.8%

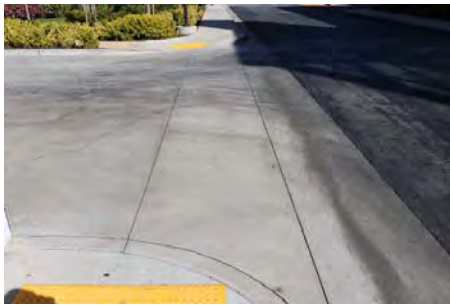
NEVAREZ V 49ERS - ACCESSIBILITY ASSESSMENT**FACILITY/SITE: 17. Green Lot 2****SEQ.
#****1711****FEATURE: #11 ACC ROUTE OF TRAVEL****LOCATION: Route from 8 DAS at W side of Citrix to PROW at Great America Pky.****MEMO: S side of Citrix building across service drive.****Notes:****CONDITIONS THAT DO NOT CONFORM TO NEW CONSTRUCTION STANDARDS**

COD	CONDITION DESCRIPTION	ACTUAL
B16	Cross slope (perpendicular to direction of travel) is 1:48 (2.08%) max. (ADAS 403.3)	Approx. 20' L is 3.1% to 4.4%.

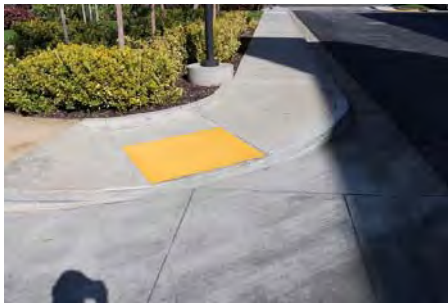
NEVAREZ V 49ERS - ACCESSIBILITY ASSESSMENT**FACILITY/SITE: 17. Green Lot 2****SEQ.
#****1712****FEATURE: #9 PARALLEL CURB RAMP****LOCATION: Route from 8 DAS at W side of Citrix to PROW at Great America Pky.****MEMO: S side of Citrix building, E side of service drive.****Notes:****CONDITIONS THAT DO NOT CONFORM TO NEW CONSTRUCTION STANDARDS**

COD	CONDITION DESCRIPTION	ACTUAL
B03	Running slope is 1:12 (8.33%) max. (ADAS 405.2)	16.1% at N ramp.

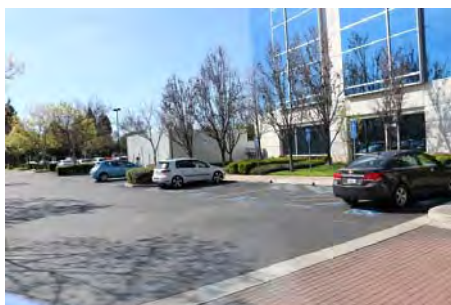
NEVAREZ V 49ERS - ACCESSIBILITY ASSESSMENT**FACILITY/SITE: 17. Green Lot 2****SEQ.
#****1713****FEATURE: #5 PARKING STALL****LOCATION: 7 DAS at S side of N Citrix building.****MEMO: Including one designated van.****Notes:****CONDITIONS THAT DO NOT CONFORM TO NEW CONSTRUCTION STANDARDS**

COD	CONDITION DESCRIPTION	ACTUAL
B41	Stall is located as close as practical to entrance. (ADAS 208.3.1)	Many standard spaces are closer to the public right of way.

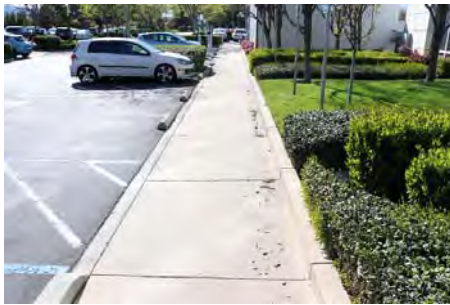
NEVAREZ V 49ERS - ACCESSIBILITY ASSESSMENT**FACILITY/SITE: 17. Green Lot 2****SEQ.
#****1714****FEATURE: #11 ACC ROUTE OF TRAVEL****LOCATION: Route between 7 DAS at S side of N Citrix building and PROW at Tasman Dr.****MEMO: Along front of row of DAS.****Notes:****CONDITIONS THAT DO NOT CONFORM TO NEW CONSTRUCTION STANDARDS**

COD	CONDITION DESCRIPTION	ACTUAL
B16	Cross slope (perpendicular to direction of travel) is 1:48 (2.08%) max. (ADAS 403.3)	Approx. 80' L is 2.6% to 3.8%.

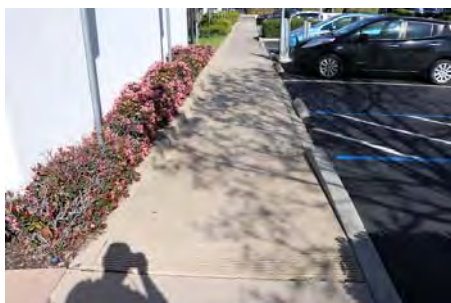
NEVAREZ V 49ERS - ACCESSIBILITY ASSESSMENT**FACILITY/SITE: 17. Green Lot 2****SEQ.
#****1715****FEATURE: #10 CURB RAMP****LOCATION: Route between 7 DAS at S side of N Citrix building and PROW at Tasman Dr.****MEMO: At SW corner of N Citrix building.****Notes:****CONDITIONS THAT DO NOT CONFORM TO NEW CONSTRUCTION STANDARDS**

COD	CONDITION DESCRIPTION	ACTUAL
B04	Cross slope of ramp is 1:48 (2.08%). (ADAS 405.3)	2.6% to 3.7%.

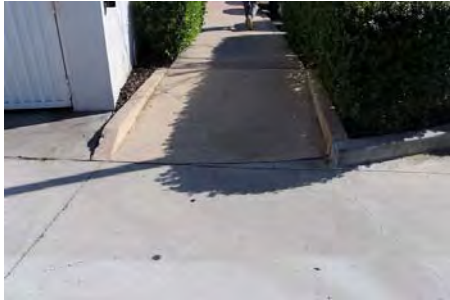
NEVAREZ V 49ERS - ACCESSIBILITY ASSESSMENT**FACILITY/SITE: 17. Green Lot 2****SEQ.
#****1716****FEATURE: #10 CURB RAMP****LOCATION: Route between 7 DAS at S side of N Citrix building and PROW at Tasman Dr.****MEMO: At S side of service drive.****Notes:****CONDITIONS THAT DO NOT CONFORM TO NEW CONSTRUCTION STANDARDS**

COD	CONDITION DESCRIPTION	ACTUAL
B03	Running slope of ramp is 1:12 (8.33%) max. (ADAS 405.2)	8.8% to 10.4%.
B04	Cross slope of ramp is 1:48 (2.08%). (ADAS 405.3)	3.1%

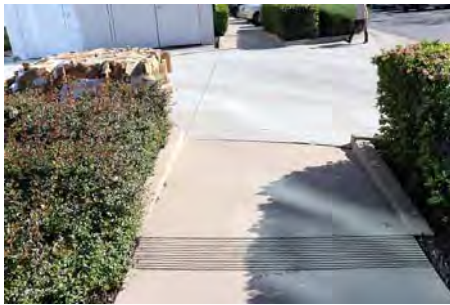
NEVAREZ V 49ERS - ACCESSIBILITY ASSESSMENT**FACILITY/SITE: 17. Green Lot 2****SEQ.
#****1717****FEATURE: #11 ACC ROUTE OF TRAVEL****LOCATION: Route between 7 DAS at S side of N Citrix building and PROW at Tasman Dr.****MEMO: Across service drive.****Notes:****CONDITIONS THAT DO NOT CONFORM TO NEW CONSTRUCTION STANDARDS**

COD	CONDITION DESCRIPTION	ACTUAL
B16	Cross slope (perpendicular to direction of travel) is 1:48 (2.08%) max. (ADAS 403.3)	4.0%.

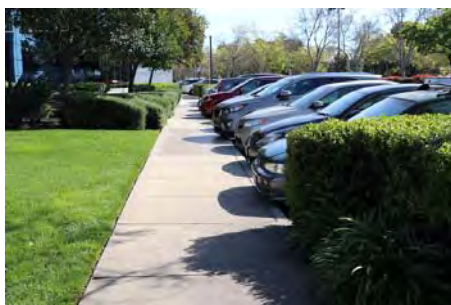
NEVAREZ V 49ERS - ACCESSIBILITY ASSESSMENT**FACILITY/SITE: 17. Green Lot 2****SEQ.
#****1718****FEATURE: #11 ACC ROUTE OF TRAVEL****LOCATION: Route between 7 DAS at S side of N Citrix building and PROW at Tasman Dr.****MEMO: Between service drive and PROW at Tasman Dr.****Notes:****CONDITIONS THAT DO NOT CONFORM TO NEW CONSTRUCTION STANDARDS**

COD	CONDITION DESCRIPTION	ACTUAL
B16	Cross slope (perpendicular to direction of travel) is 1:48 (2.08%) max. (ADAS 403.3)	Approx. 100' L is 2.6% to 4.0%.

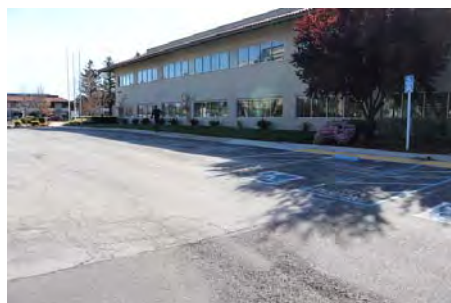
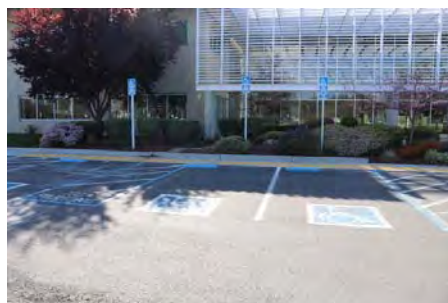
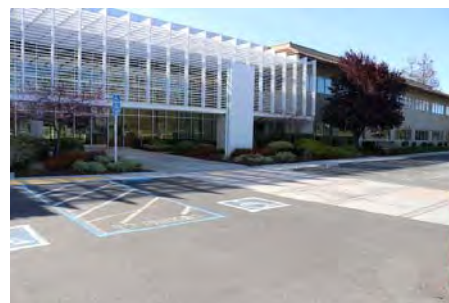
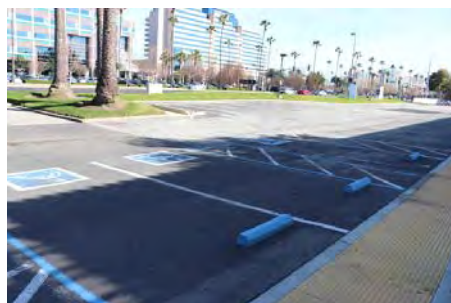
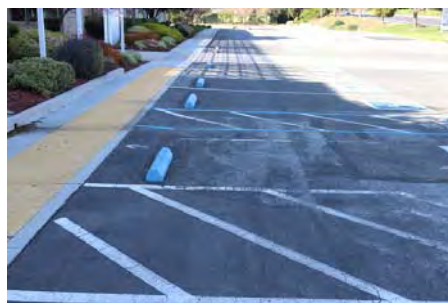
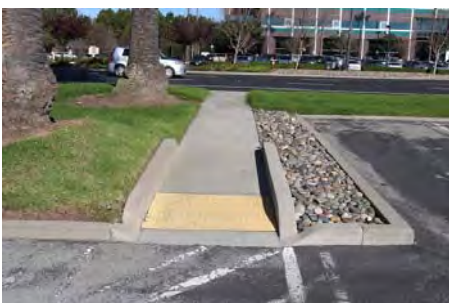
COD	CONDITION DESCRIPTION	ACTUAL
B31	Slopes do not exceed 1:48 (2.08%). (ADAS 502.4)	3.8% to 4.1% at head end of stalls and access aisle.

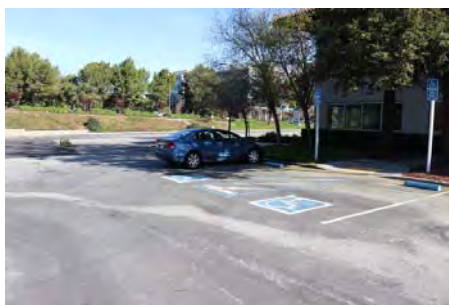
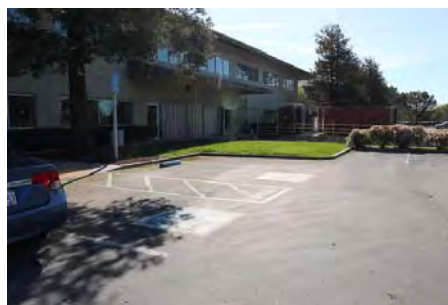
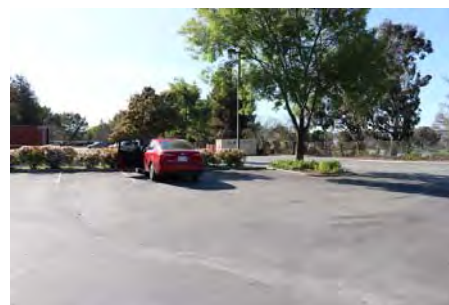
NEVAREZ V 49ERS - ACCESSIBILITY ASSESSMENT**FACILITY/SITE: 18. Red Lot 3****SEQ.
#****1803****FEATURE: #5 PARKING STALL****LOCATION: N side of E building.****MEMO: Double DAS.****Notes:****CONDITIONS THAT DO NOT CONFORM TO NEW CONSTRUCTION STANDARDS**

COD	CONDITION DESCRIPTION	ACTUAL
B41	Stall is located as close as practical to entrance. (ADAS 208.3.1)	Many other standard stalls are closer to routes to the public right of way.

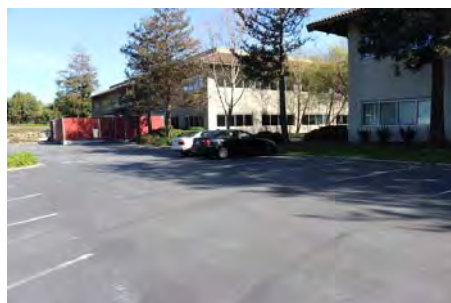
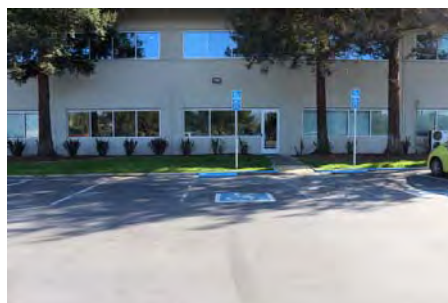
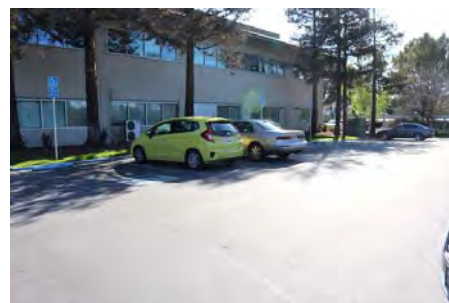
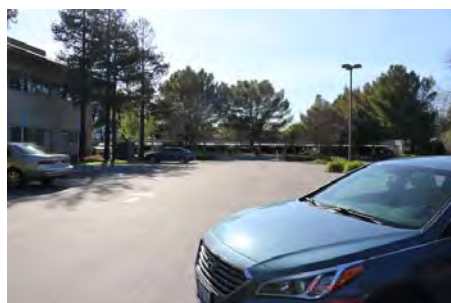
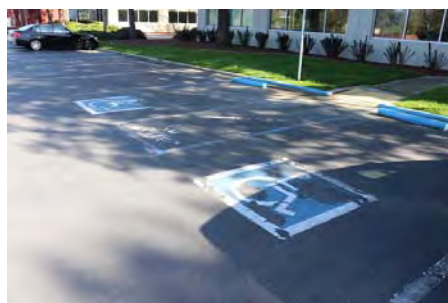
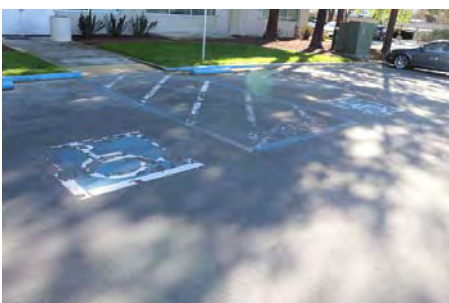
NEVAREZ V 49ERS - ACCESSIBILITY ASSESSMENT**FACILITY/SITE: 18. Red Lot 3****SEQ.
#****1804****FEATURE: #5 PARKING STALL****LOCATION: N side of NW building.****MEMO: 4 DAS including one designated van.****Notes:****CONDITIONS THAT DO NOT CONFORM TO NEW CONSTRUCTION STANDARDS**

COD	CONDITION DESCRIPTION	ACTUAL
B41	Stall is located as close as practical to entrance. (ADAS 208.3.1)	Many other standard stalls are closer to routes to the public right of way.

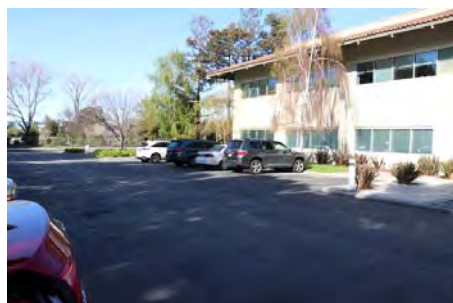
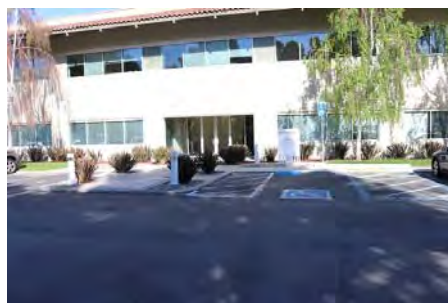
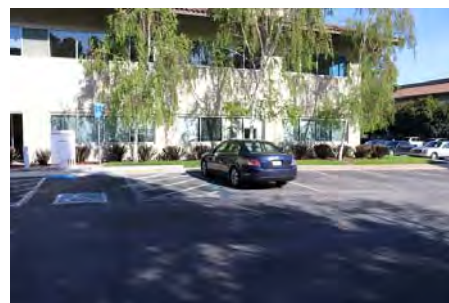
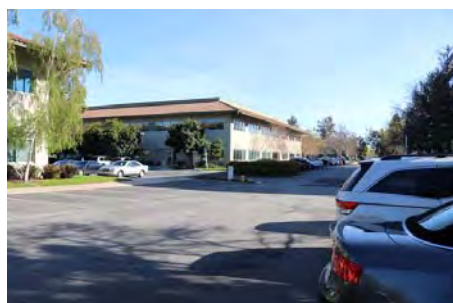
NEVAREZ V 49ERS - ACCESSIBILITY ASSESSMENT**FACILITY/SITE: 18. Red Lot 3****SEQ.
#****1805****FEATURE: #5 PARKING STALL****LOCATION: W side of NW building.****MEMO: Single van DAS.****Notes:****CONDITIONS THAT DO NOT CONFORM TO NEW CONSTRUCTION STANDARDS**

COD	CONDITION DESCRIPTION	ACTUAL
B41	Stall is located as close as practical to entrance. (ADAS 208.3.1)	Many other standard stalls are closer to routes to the public right of way.

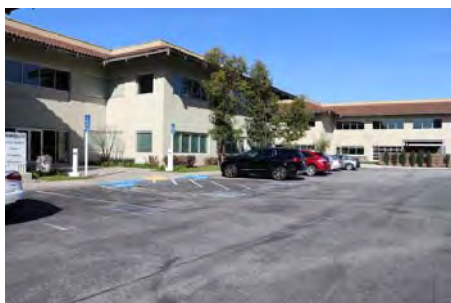
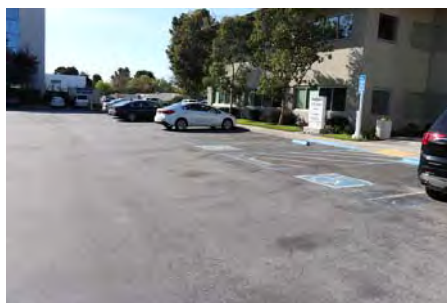
NEVAREZ V 49ERS - ACCESSIBILITY ASSESSMENT**FACILITY/SITE: 18. Red Lot 3****SEQ.
#****1806****FEATURE: #5 PARKING STALL****LOCATION: S side of NW building.****MEMO: Double DAS, W stall designated van.****Notes:****CONDITIONS THAT DO NOT CONFORM TO NEW CONSTRUCTION STANDARDS**

COD	CONDITION DESCRIPTION	ACTUAL
B41	Stall is located as close as practical to entrance. (ADAS 208.3.1)	Many other standard stalls are closer to routes to the public right of way.

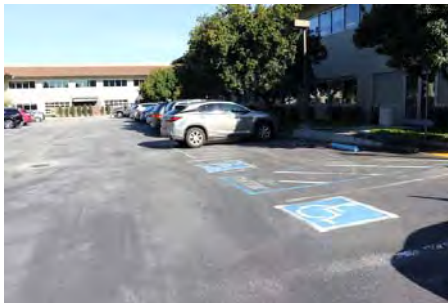
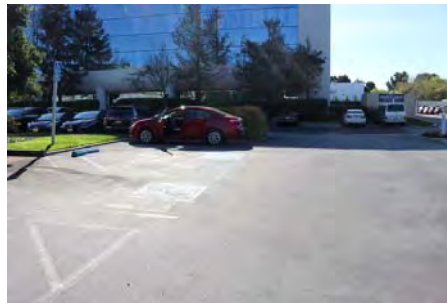
CONDITIONS THAT DO NOT CONFORM TO NEW CONSTRUCTION STANDARDS

COD	CONDITION DESCRIPTION	ACTUAL
B41	Stall is located as close as practical to entrance. (ADAS 208.3.1)	Many other standard stalls are closer to routes to the public right of way.

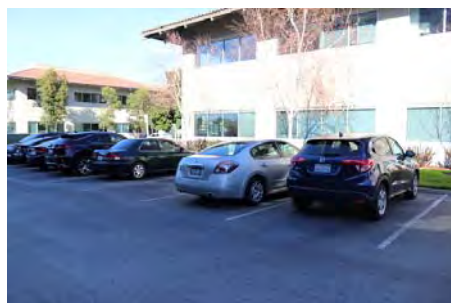
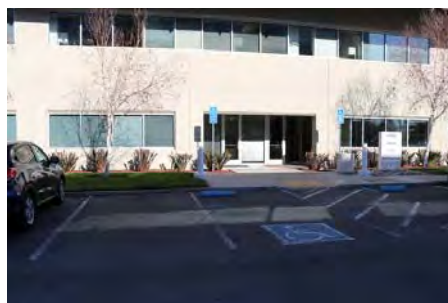
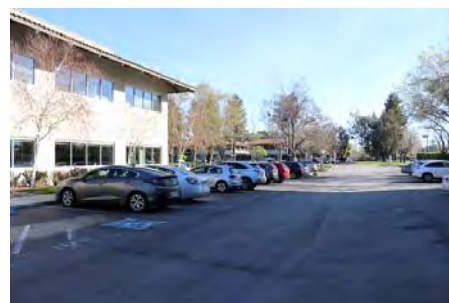
NEVAREZ V 49ERS - ACCESSIBILITY ASSESSMENT**FACILITY/SITE: 18. Red Lot 3****SEQ.
#****1808****FEATURE: #5 PARKING STALL****LOCATION: W side of SW building.****MEMO: Double DAS, N designated as van.****Notes:****CONDITIONS THAT DO NOT CONFORM TO NEW CONSTRUCTION STANDARDS**

COD	CONDITION DESCRIPTION	ACTUAL
B41	Stall is located as close as practical to entrance. (ADAS 208.3.1)	Many other standard stalls are closer to routes to the public right of way.

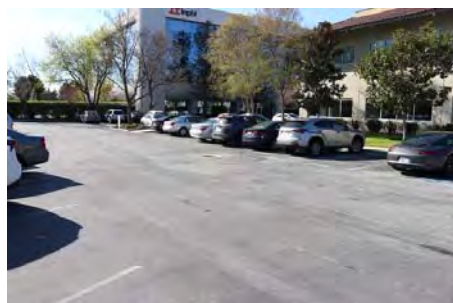
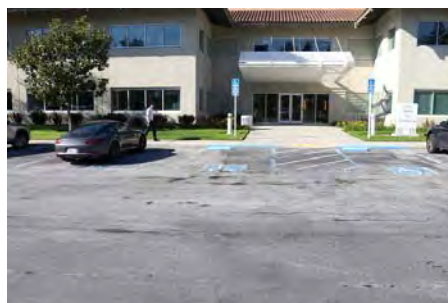
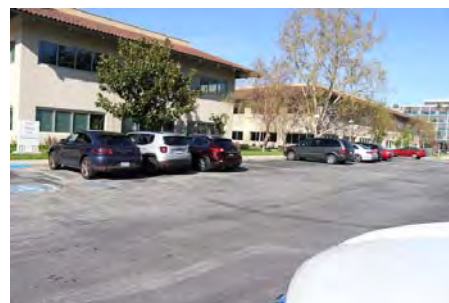
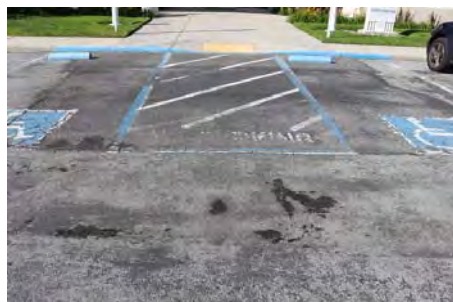
NEVAREZ V 49ERS - ACCESSIBILITY ASSESSMENT**FACILITY/SITE: 18. Red Lot 3****SEQ.
#****1809****FEATURE: #5 PARKING STALL****LOCATION: S side of SW building.****MEMO: Double DAS, W designated as van.****Notes:****CONDITIONS THAT DO NOT CONFORM TO NEW CONSTRUCTION STANDARDS**

COD	CONDITION DESCRIPTION	ACTUAL
B11	Parking space is marked to define a width of min.8' wide (9' CBC). (ADAS 502.2)	Markings worn and faded.
B41	Stall is located as close as practical to entrance. (ADAS 208.3.1)	Many other standard stalls are closer to routes to the public right of way.

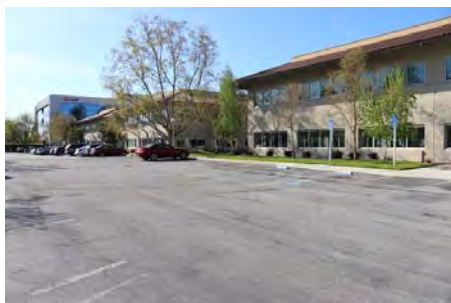
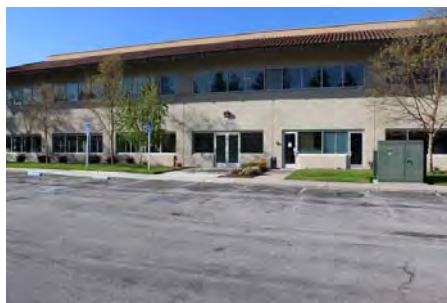
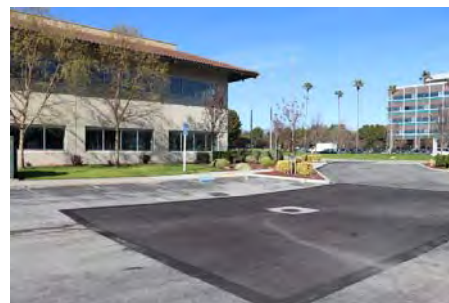
NEVAREZ V 49ERS - ACCESSIBILITY ASSESSMENT**FACILITY/SITE: 18. Red Lot 3****SEQ.
#****1810****FEATURE: #5 PARKING STALL****LOCATION: 3 DAS at S side of E building.****MEMO: Double DAS.****Notes:****CONDITIONS THAT DO NOT CONFORM TO NEW CONSTRUCTION STANDARDS**

COD	CONDITION DESCRIPTION	ACTUAL
B11	Parking space is marked to define a width of min.8' wide (9' CBC). (ADAS 502.2)	Markings worn and faded.
B23	Access aisle is marked to discourage parking -in California: with "NO PARKING" in white with min. 12" high letters located at tail end of access aisle. (ADAS 502.3.3)	Markings worn and faded.
B31	Slopes do not exceed 1:48 (2.08%). (ADAS 502.4)	3.3% at access aisle.
B41	Stall is located as close as practical to entrance. (ADAS 208.3.1)	Many other standard stalls are closer to routes to the public right of way.

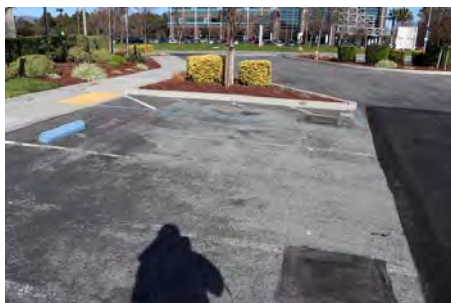
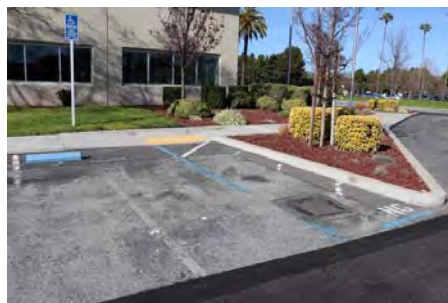
NEVAREZ V 49ERS - ACCESSIBILITY ASSESSMENT**FACILITY/SITE: 18. Red Lot 3****SEQ.
#****1811****FEATURE: #5 PARKING STALL****LOCATION: 3 DAS at S side of E building.****MEMO: Single DAS.****Notes:****CONDITIONS THAT DO NOT CONFORM TO NEW CONSTRUCTION STANDARDS**

COD	CONDITION DESCRIPTION	ACTUAL
B11	Parking space is marked to define a width of min.8' wide (9' CBC). (ADAS 502.2)	Markings worn and faded.
B23	Access aisle is marked to discourage parking -in California: with "NO PARKING" in white with min. 12" high letters located at tail end of access aisle. (ADAS 502.3.3)	Markings worn and faded.
B31	Slopes do not exceed 1:48 (2.08%). (ADAS 502.4)	5.5%
B41	Stall is located as close as practical to entrance. (ADAS 208.3.1)	Many other standard stalls are closer to routes to the public right of way.

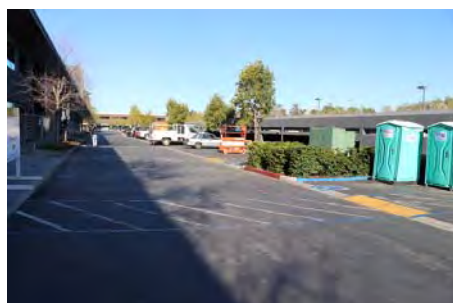
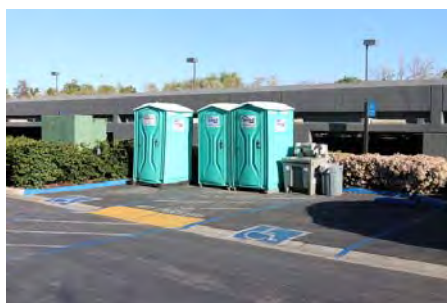
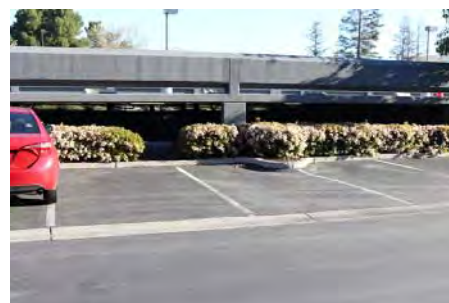
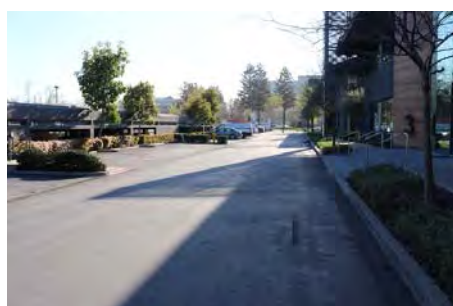
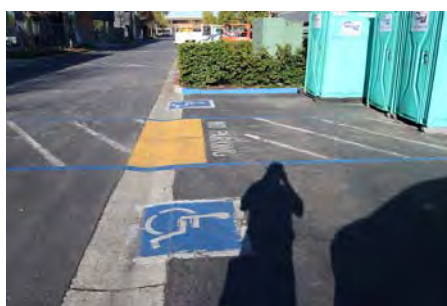
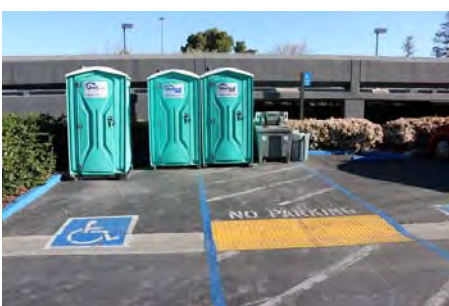
NEVAREZ V 49ERS - ACCESSIBILITY ASSESSMENT**FACILITY/SITE: 19. Red Lot 4****SEQ.
#****1901****FEATURE: #5 PARKING STALL****LOCATION: N side of building 3.****MEMO: Double DAS, W side designated as van.****Notes:****CONDITIONS THAT DO NOT CONFORM TO NEW CONSTRUCTION STANDARDS**

COD	CONDITION DESCRIPTION	ACTUAL
B11	Parking space is marked to define a width of min.8' wide (9' CBC). (ADAS 502.2)	Obstructed by portable toilet.
B12	Access aisle is marked to define a width of min. 5' wide. (ADAS 502..3.1)	Obstructed by portable toilet.
B31	Slopes do not exceed 1:48 (2.08%). (ADAS 502.4)	18.5% at tail end of stalls and access aisles at swale.
B32	Stall & access aisle has no gaps or changes in level and is firm, stable and slip resistant. (ADAS 502.4)	Detectable warnings placed in the access aisle which are unnecessary.
B41	Stall is located as close as practical to entrance. (ADAS 208.3.1)	Many other standard stalls are closer to routes to the public right of way.
C42	Accessible route from stall does not pass behind other parked cars. (2013 CBC 11B-502.7.1).	Must pass behind other vehicles en route to the public right of way.
