Case No. 5:16-cv-07013-LHK (SVK)

**DECLARATION OF JEFFREY SCOTT
MASTIN IN SUPPORT OF PLAINTIFFS'
MOTION FOR CLASS CERTIFICATION**

NEVAREZ V 49ERS - ACCESSIBILITY ASSESSMENT

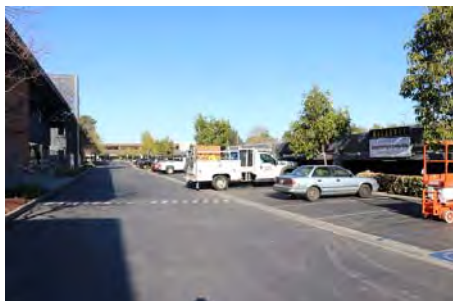
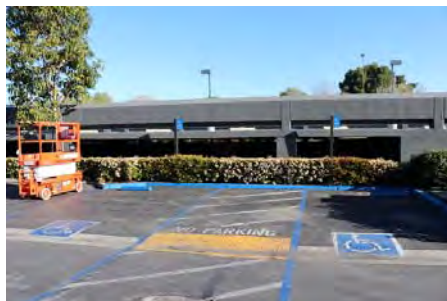
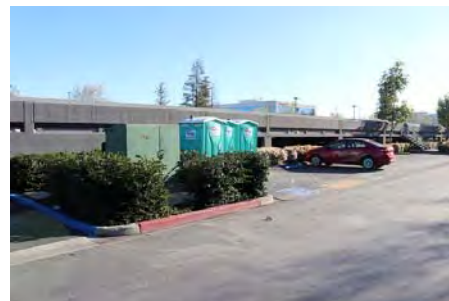
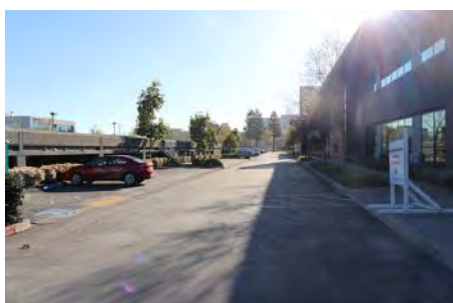
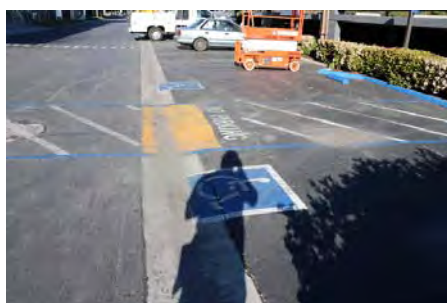
NEVAREZ V 49ERS - ACCESSIBILITY ASSESSMENT**FACILITY/SITE: 19. Red Lot 4****SEQ.
#****1902****FEATURE: #5 PARKING STALL****LOCATION: N side of building 2.****MEMO: Double DAS.****Notes:****CONDITIONS THAT DO NOT CONFORM TO NEW CONSTRUCTION STANDARDS**

COD	CONDITION DESCRIPTION	ACTUAL
B31	Slopes do not exceed 1:48 (2.08%). (ADAS 502.4)	15.4% at tail end of stalls and access aisles at swale.
B32	Stall & access aisle has no gaps or changes in level and is firm, stable and slip resistant. (ADAS 502.4)	Detectable warnings placed in the access aisle which are unnecessary.
B41	Stall is located as close as practical to entrance. (ADAS 208.3.1)	Many other standard stalls are closer to routes to the public right of way.
C42	Accessible route from stall does not pass behind other parked cars. (2013 CBC 11B-502.7.1).	Must pass behind other vehicles en route to the public right of way.

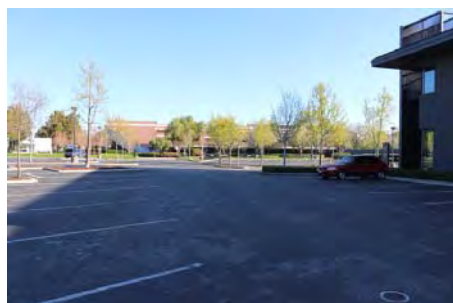
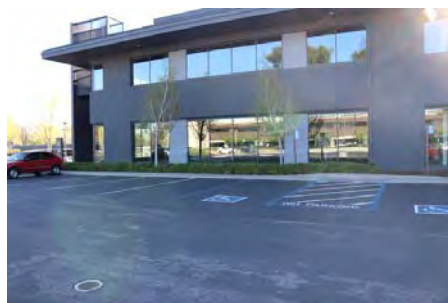
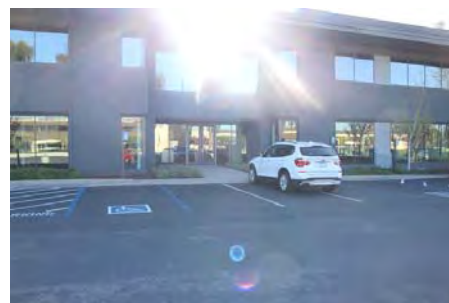
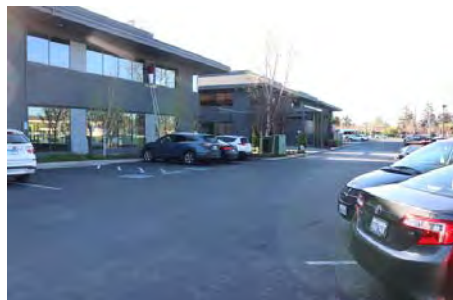
NEVAREZ V 49ERS - ACCESSIBILITY ASSESSMENT**FACILITY/SITE: 19. Red Lot 4****SEQ.
#****1903****FEATURE: #5 PARKING STALL****LOCATION: 4 DAS at W side of building 1****MEMO: Northern pair, N designated as van.****Notes:****CONDITIONS THAT DO NOT CONFORM TO NEW CONSTRUCTION STANDARDS**

COD	CONDITION DESCRIPTION	ACTUAL
B41	Stall is located as close as practical to entrance. (ADAS 208.3.1)	Many other standard stalls are closer to routes to the public right of way.
C42	Accessible route from stall does not pass behind other parked cars. (2013 CBC 11B-502.7.1).	Must pass behind other vehicles en route to the public right of way.

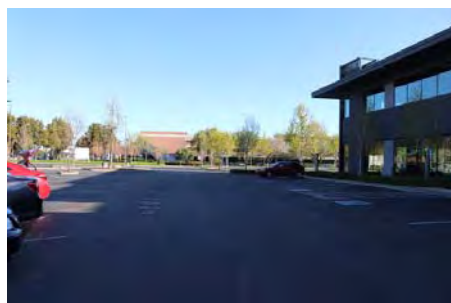
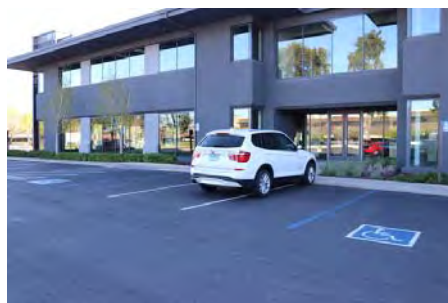
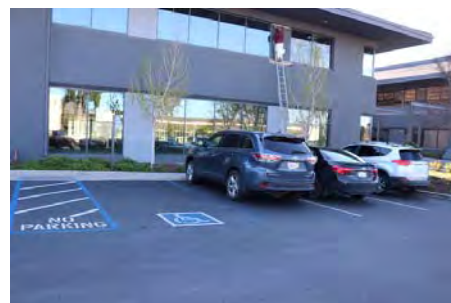
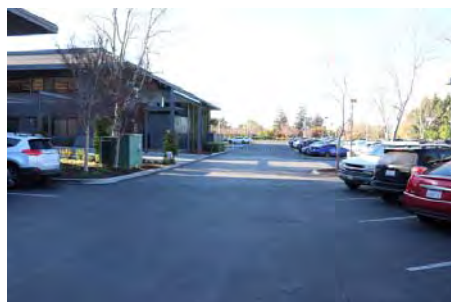
NEVAREZ V 49ERS - ACCESSIBILITY ASSESSMENT**FACILITY/SITE: 19. Red Lot 4****SEQ.
#****1904****FEATURE: #5 PARKING STALL****LOCATION: 4 DAS at W side of building 1****MEMO: Southern pair.****Notes:****CONDITIONS THAT DO NOT CONFORM TO NEW CONSTRUCTION STANDARDS**

COD	CONDITION DESCRIPTION	ACTUAL
B41	Stall is located as close as practical to entrance. (ADAS 208.3.1)	Many other standard stalls are closer to routes to the public right of way.
C42	Accessible route from stall does not pass behind other parked cars. (2013 CBC 11B-502.7.1).	Must pass behind other vehicles en route to the public right of way.

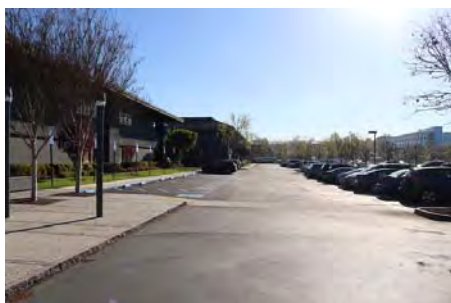
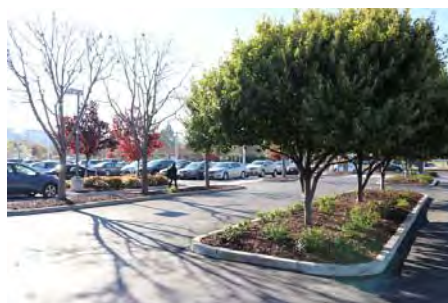
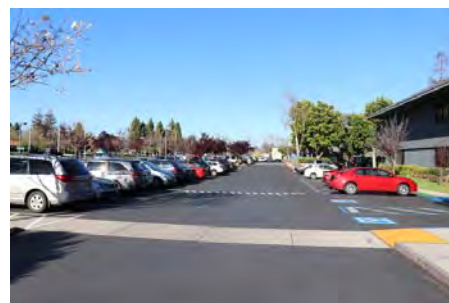
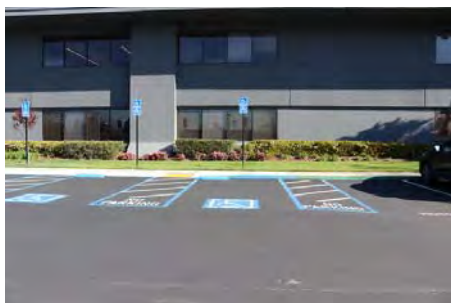
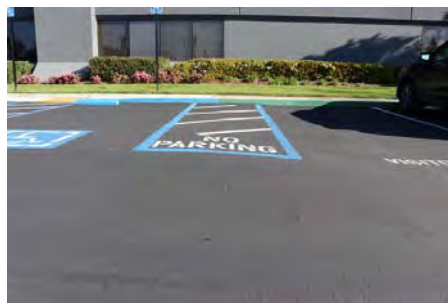
NEVAREZ V 49ERS - ACCESSIBILITY ASSESSMENT**FACILITY/SITE: 19. Red Lot 4****SEQ.
#****1905****FEATURE: #5 PARKING STALL****LOCATION: 4 DAS at W side of building 1****MEMO: Single DAS, farthest E from entrance.****Notes:**

Appears recently constructed.

COD	CONDITION DESCRIPTION	ACTUAL
B31	Slopes do not exceed 1:48 (2.08%). (ADAS 502.4)	6.7% at access aisle.
B41	Stall is located as close as practical to entrance. (ADAS 208.3.1)	Many other standard stalls are closer to routes to the public right of way.
C42	Accessible route from stall does not pass behind other parked cars. (2013 CBC 11B-502.7.1).	Must pass behind other vehicles en route to the public right of way.

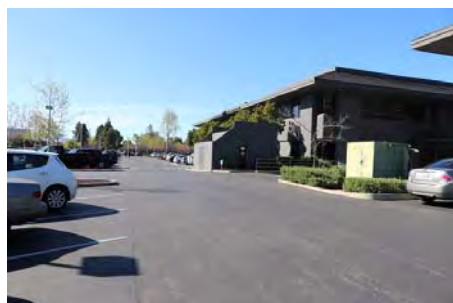
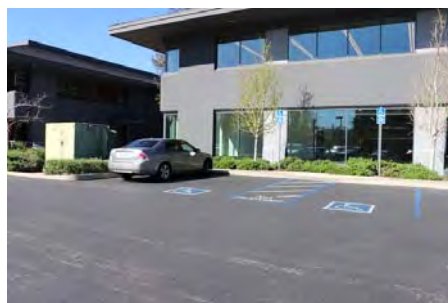
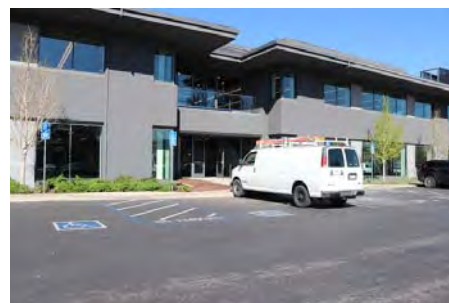
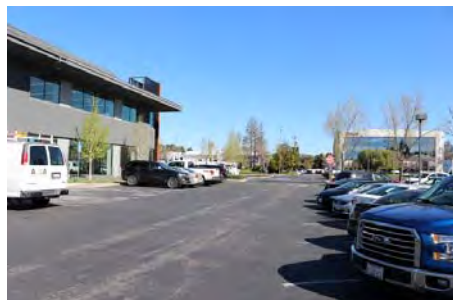
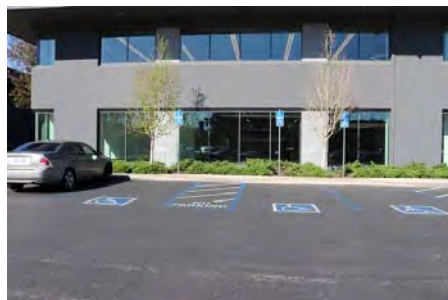
NEVAREZ V 49ERS - ACCESSIBILITY ASSESSMENT**FACILITY/SITE: 19. Red Lot 4****SEQ.
#****1906****FEATURE: #5 PARKING STALL****LOCATION: 6 DAS at the E side of building 4.****MEMO: Southern pair.****Notes:**

Appears recently constructed.

COD	CONDITION DESCRIPTION	ACTUAL
B41	Stall is located as close as practical to entrance. (ADAS 208.3.1)	Many other standard stalls are closer to routes to the public right of way.
C42	Accessible route from stall does not pass behind other parked cars. (2013 CBC 11B-502.7.1).	Must pass behind other vehicles en route to the public right of way.

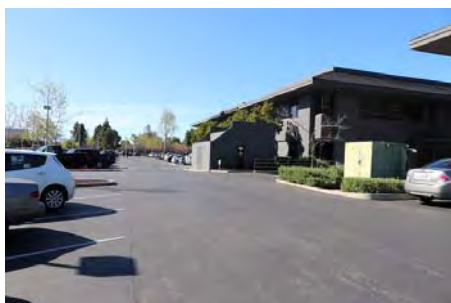
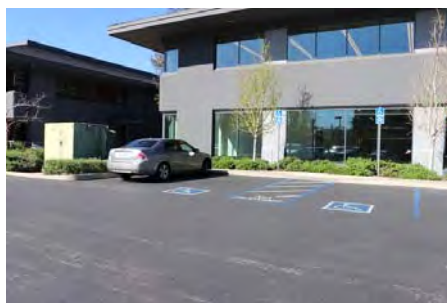
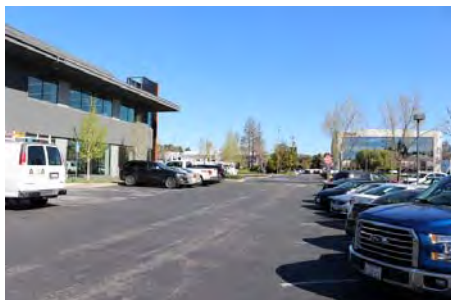
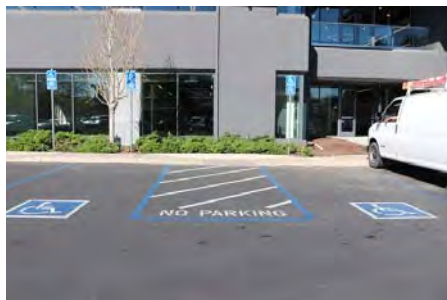
NEVAREZ V 49ERS - ACCESSIBILITY ASSESSMENT**FACILITY/SITE: 19. Red Lot 4****SEQ.
#****1907****FEATURE: #5 PARKING STALL****LOCATION: 6 DAS at the E side of building 4.****MEMO: Middle double DAS, S desginted as van.****Notes:**

Appears recently constructed.

COD	CONDITION DESCRIPTION	ACTUAL
B41	Stall is located as close as practical to entrance. (ADAS 208.3.1)	Many other standard stalls are closer to routes to the public right of way.
C42	Accessible route from stall does not pass behind other parked cars. (2013 CBC 11B-502.7.1).	Must pass behind other vehicles en route to the public right of way.

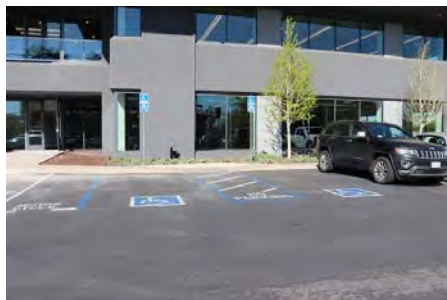
NEVAREZ V 49ERS - ACCESSIBILITY ASSESSMENT**FACILITY/SITE: 19. Red Lot 4****SEQ.
#****1908****FEATURE: #5 PARKING STALL****LOCATION: 6 DAS at the E side of building 4.****MEMO: Northern double DAS.****Notes:**

Appears recently constructed.

COD	CONDITION DESCRIPTION	ACTUAL
B41	Stall is located as close as practical to entrance. (ADAS 208.3.1)	Many other standard stalls are closer to routes to the public right of way.
C42	Accessible route from stall does not pass behind other parked cars. (2013 CBC 11B-502.7.1).	Must pass behind other vehicles en route to the public right of way.

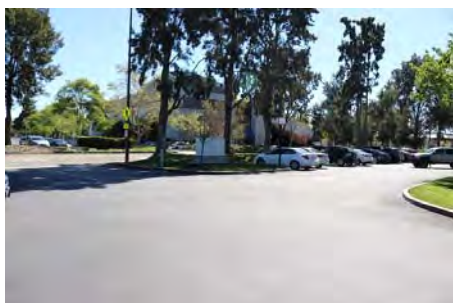
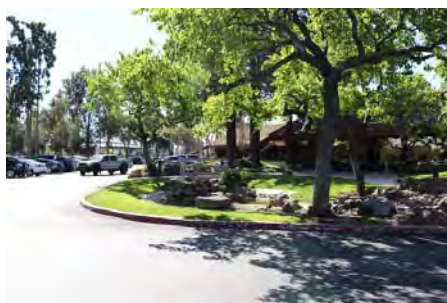
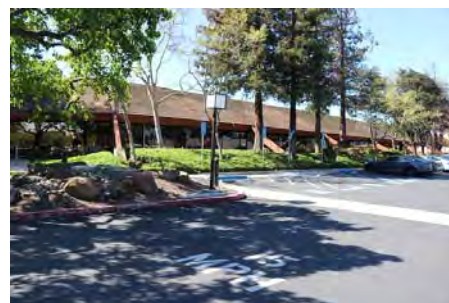
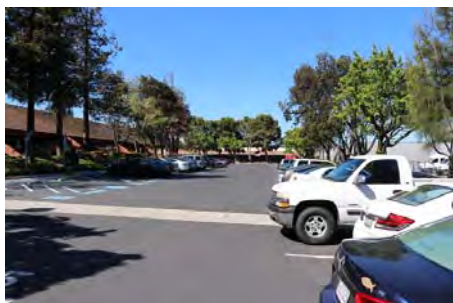
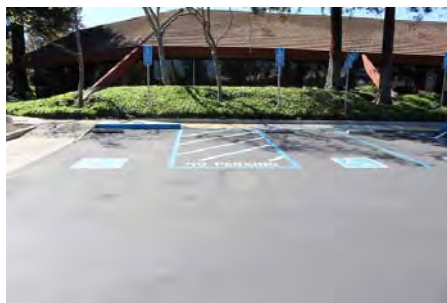
COD	CONDITION DESCRIPTION	ACTUAL
B31	Slopes do not exceed 1:48 (2.08%). (ADAS 502.4)	Up to 5.0% at E stall.
B41	Stall is located as close as practical to entrance. (ADAS 208.3.1)	Many other standard stalls are closer to routes to the public right of way.
C42	Accessible route from stall does not pass behind other parked cars. (2013 CBC 11B-502.7.1).	Must pass behind other vehicles en route to the public right of way.

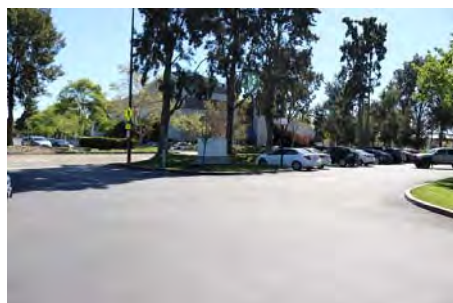
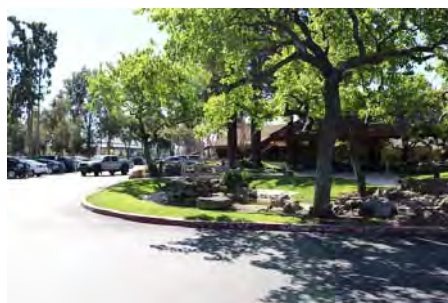
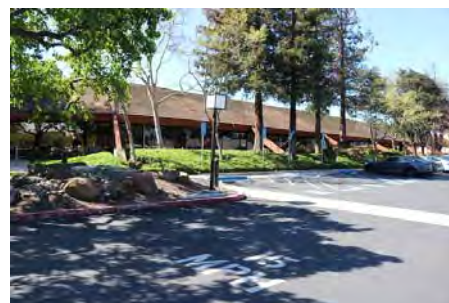
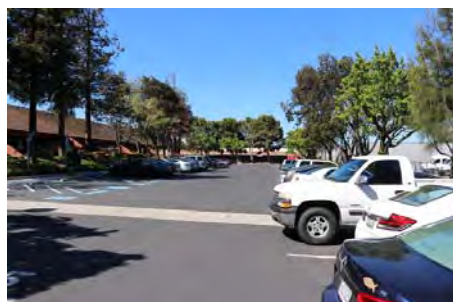
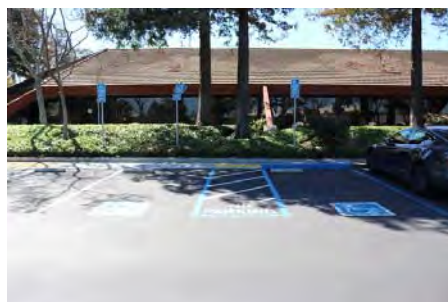
COD	CONDITION DESCRIPTION	ACTUAL
B41	Stall is located as close as practical to entrance. (ADAS 208.3.1)	Many other standard stalls are closer to routes to the public right of way.
C42	Accessible route from stall does not pass behind other parked cars. (2013 CBC 11B-502.7.1).	Must pass behind other vehicles en route to the public right of way.

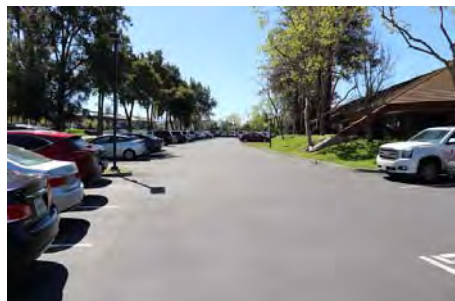
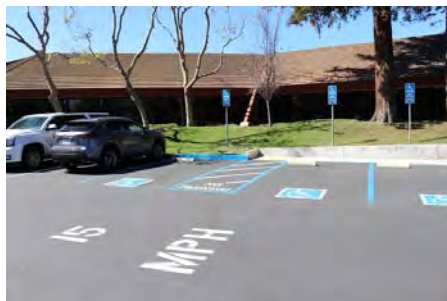
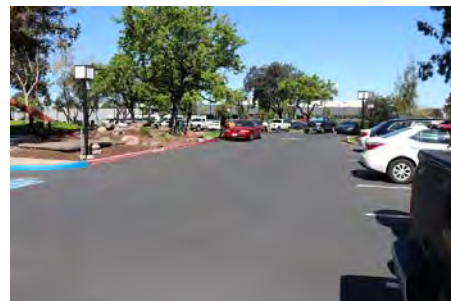
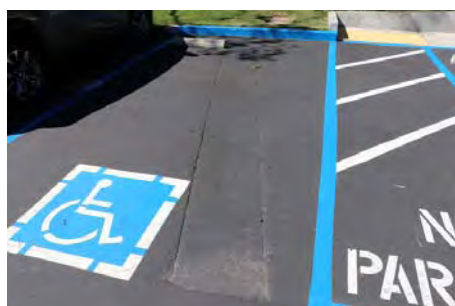
COD	CONDITION DESCRIPTION	ACTUAL
B31	Slopes do not exceed 1:48 (2.08%). (ADAS 502.4)	Asphalt patch along entire length of S stall creates slopes up to 8.2%.
B32	Stall & access aisle has no gaps or changes in level and is firm, stable and slip resistant. (ADAS 502.4)	Asphalt patch across entire length of S stall creates depression over 1 1/2" deep.
B41	Stall is located as close as practical to entrance. (ADAS 208.3.1)	Many other standard stalls are closer to routes to the public right of way.
C42	Accessible route from stall does not pass behind other parked cars. (2013 CBC 11B-502.7.1).	Must pass behind other vehicles en route to the public right of way.

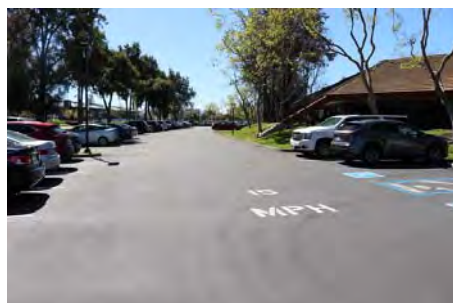
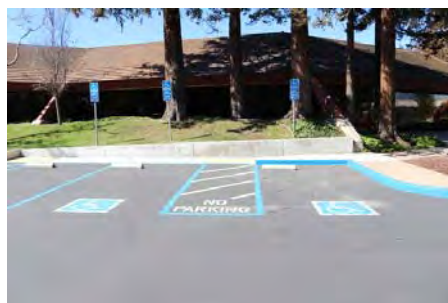
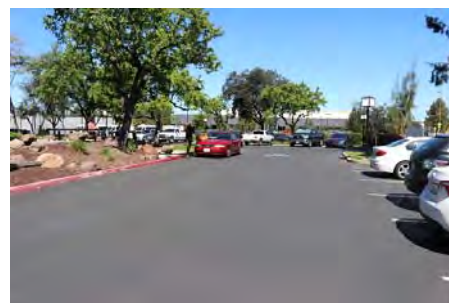
NEVAREZ V 49ERS - ACCESSIBILITY ASSESSMENT**FACILITY/SITE: 20. Red Lot 5****SEQ.
#****2004****FEATURE: #5 PARKING STALL****LOCATION: 4 DAS at E side of N building. Near N end.****MEMO: Northern pair.****Notes:**

Appears recently constructed. There is no public right of way sidewalk at the drive aisle.

COD	CONDITION DESCRIPTION	ACTUAL
B41	Stall is located as close as practical to entrance. (ADAS 208.3.1)	Many other standard stalls are closer to routes to the public right of way.
C42	Accessible route from stall does not pass behind other parked cars. (2013 CBC 11B-502.7.1).	Must pass behind other vehicles en route to the public right of way.

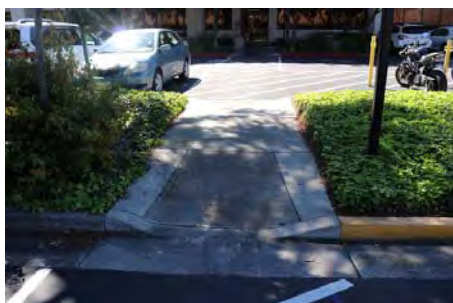
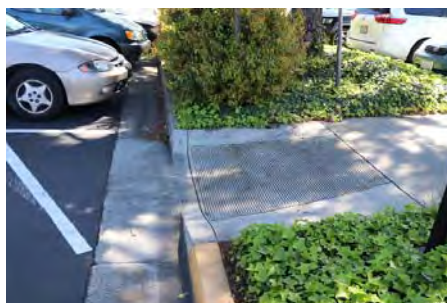
COD	CONDITION DESCRIPTION	ACTUAL
B03	Running slope of ramp is 1:12 (8.33%) max. (ADAS 405.2)	Running slope 12.6% to 14.2%.
B14	Counter slopes of adjoining gutters and road surfaces immediately adjacent to and within 24 inches of the curb ramp are not steeper than 1:20 (5.0%). (ADAS 406.2)	8.7%.
B16	Maximum slope of flared sides is 1:10 (10.0%). (ADAS 406.2)	Left side 46.3%, right side 25.8%.

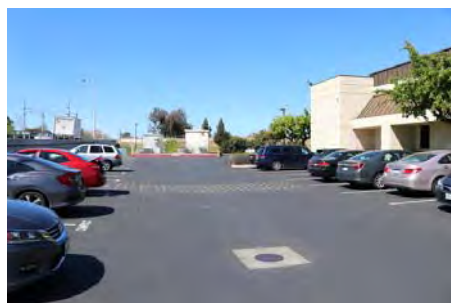
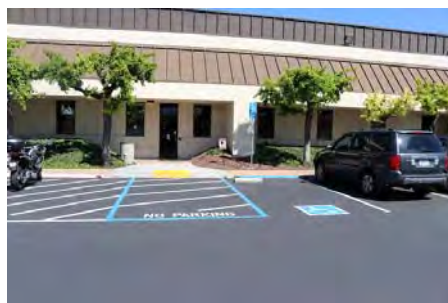
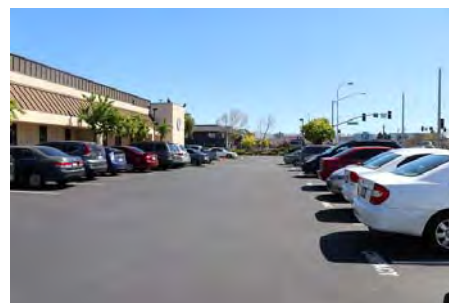
CONDITIONS THAT DO NOT CONFORM TO NEW CONSTRUCTION STANDARDS

COD	CONDITION DESCRIPTION	ACTUAL
B41	Stall is located as close as practical to entrance. (ADAS 208.3.1)	Many other standard stalls are closer to routes to the public right of way.
C42	Accessible route from stall does not pass behind other parked cars. (2013 CBC 11B-502.7.1).	Must pass behind other vehicles en route to the public right of way.

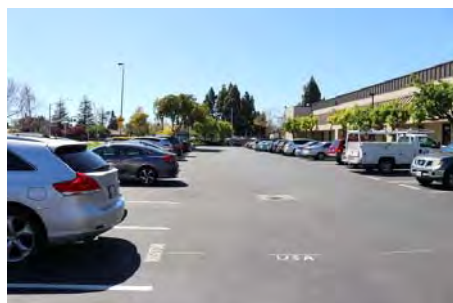
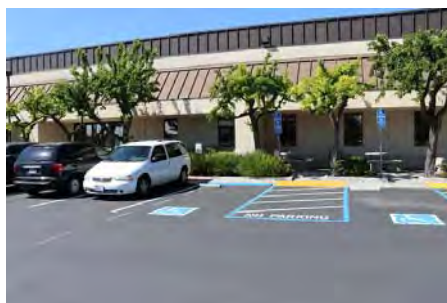
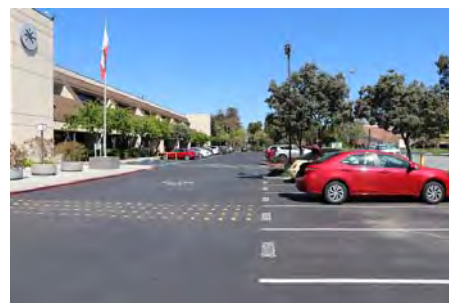
NEVAREZ V 49ERS - ACCESSIBILITY ASSESSMENT**FACILITY/SITE: 20. Red Lot 5****SEQ.
#****2008****FEATURE: #5 PARKING STALL****LOCATION: 3 DAS S of entrance at E side of S building.****MEMO: Single van stall.****Notes:**

Appears recently constructed.

COD	CONDITION DESCRIPTION	ACTUAL
B41	Stall is located as close as practical to entrance. (ADAS 208.3.1)	Many other standard stalls are closer to routes to the public right of way.
C42	Accessible route from stall does not pass behind other parked cars. (2013 CBC 11B-502.7.1).	Must pass behind other vehicles en route to the public right of way.

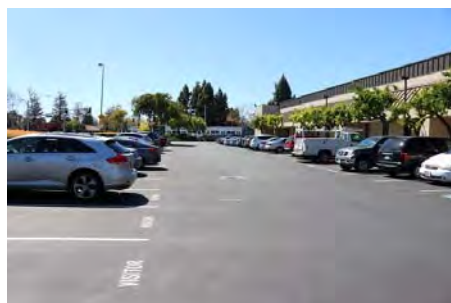
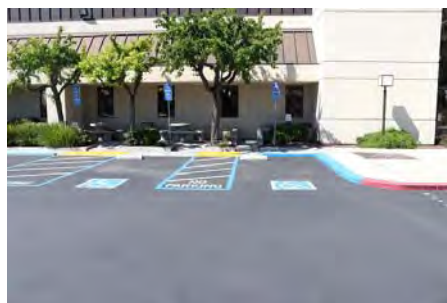
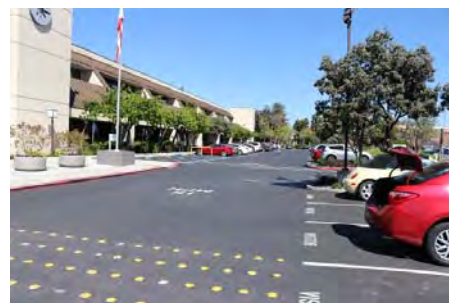
NEVAREZ V 49ERS - ACCESSIBILITY ASSESSMENT**FACILITY/SITE: 20. Red Lot 5****SEQ.
#****2009****FEATURE: #5 PARKING STALL****LOCATION: 3 DAS S of entrance at E side of S building.****MEMO: Double DAS.****Notes:**

Appears recently constructed.

COD	CONDITION DESCRIPTION	ACTUAL
B31	Slopes do not exceed 1:48 (2.08%). (ADAS 502.4)	Up to 7.8% at N stall.
B41	Stall is located as close as practical to entrance. (ADAS 208.3.1)	Many other standard stalls are closer to routes to the public right of way.
C42	Accessible route from stall does not pass behind other parked cars. (2013 CBC 11B-502.7.1).	Must pass behind other vehicles en route to the public right of way.

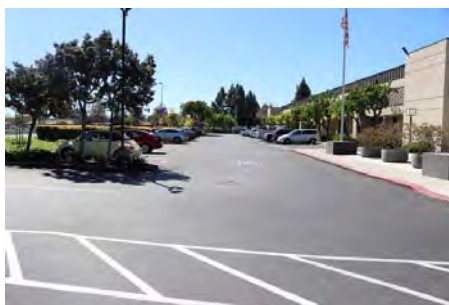
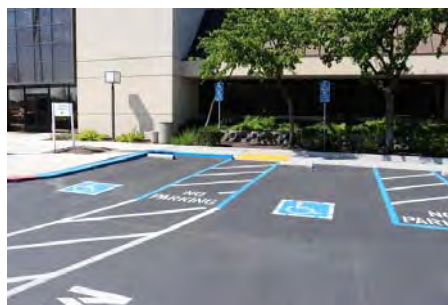
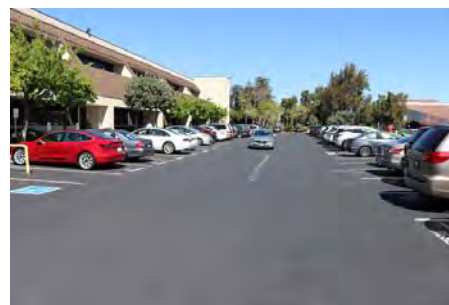
COD	CONDITION DESCRIPTION	ACTUAL
B41	Stall is located as close as practical to entrance. (ADAS 208.3.1)	Many other standard stalls are closer to routes to the public right of way.

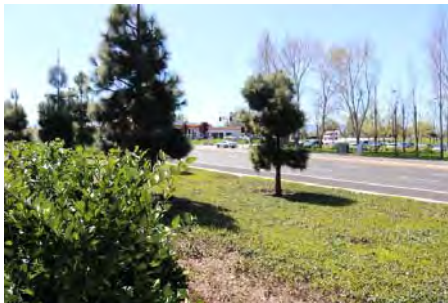
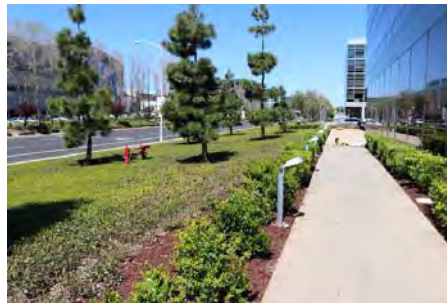
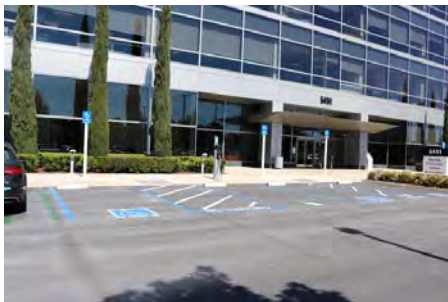
NEVAREZ V 49ERS - ACCESSIBILITY ASSESSMENT**FACILITY/SITE: 21. Red Lot 7****SEQ.
#****2100****FEATURE: #5 PARKING STALL****LOCATION: 3 DAS at W side of S entrance to 5451 building.****MEMO: Single van stall.****Notes:****CONDITIONS THAT DO NOT CONFORM TO NEW CONSTRUCTION STANDARDS**

COD	CONDITION DESCRIPTION	ACTUAL
B41	Stall is located as close as practical to entrance. (ADAS 208.3.1)	Many other standard stalls are closer to routes to the public right of way.

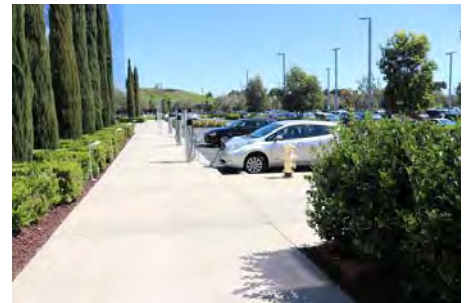
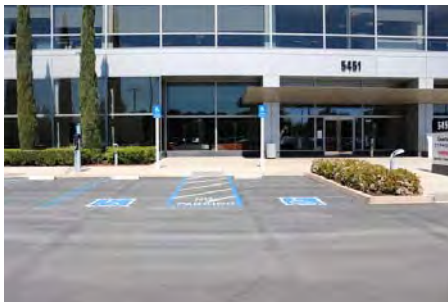
NEVAREZ V 49ERS - ACCESSIBILITY ASSESSMENT**FACILITY/SITE: 21. Red Lot 7****SEQ.
#****2101****FEATURE: #5 PARKING STALL****LOCATION: 3 DAS at W side of S entrance to 5451 building.****MEMO: Double DAS.****Notes:****CONDITIONS THAT DO NOT CONFORM TO NEW CONSTRUCTION STANDARDS**

COD	CONDITION DESCRIPTION	ACTUAL
B41	Stall is located as close as practical to entrance. (ADAS 208.3.1)	Many other standard stalls are closer to routes to the public right of way.

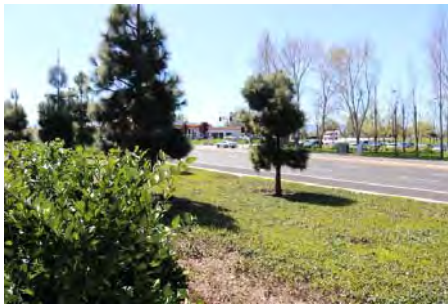
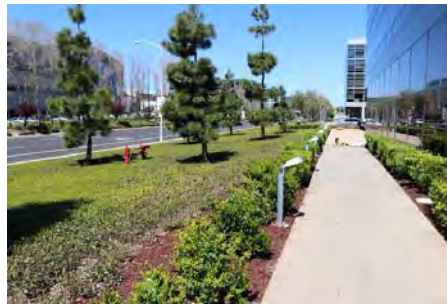
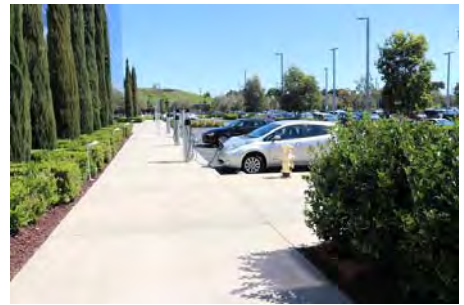
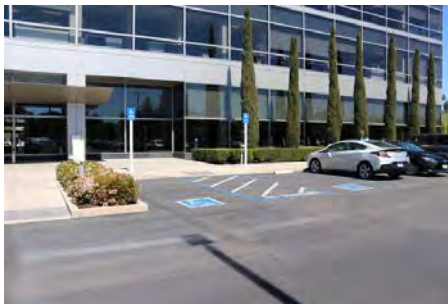
NEVAREZ V 49ERS - ACCESSIBILITY ASSESSMENT**FACILITY/SITE: 21. Red Lot 7****SEQ.
#****2102****FEATURE: #5 PARKING STALL****LOCATION: 2 DAS at E side of S entrance to 5451 building.****MEMO: Double DAS, W designated van.****Notes:****CONDITIONS THAT DO NOT CONFORM TO NEW CONSTRUCTION STANDARDS**

COD	CONDITION DESCRIPTION	ACTUAL
B41	Stall is located as close as practical to entrance. (ADAS 208.3.1)	Many other standard stalls are closer to routes to the public right of way.

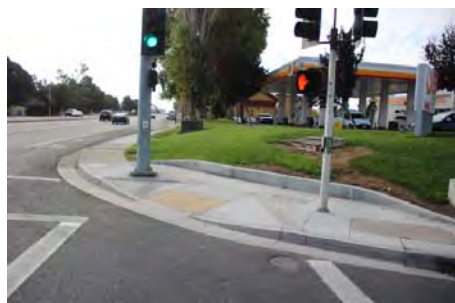
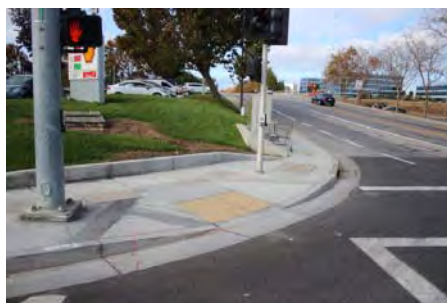
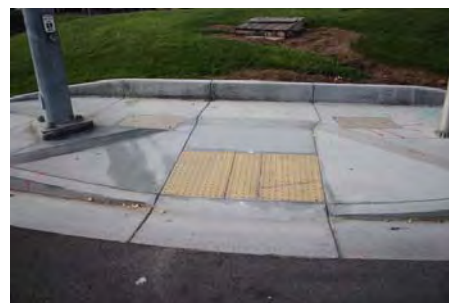
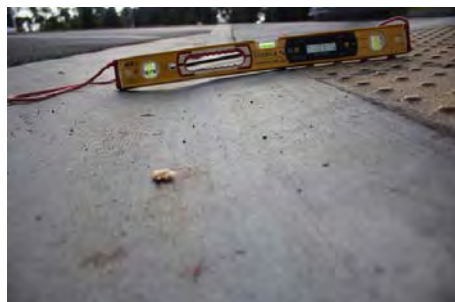
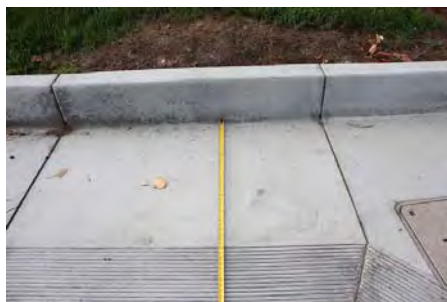
COD	CONDITION DESCRIPTION	ACTUAL
B03	Running slope of ramp is 1:12 (8.33%) max. (ADAS 405.2)	16.8% at btm. 3", 11.9% at btm. 3" to 8" portion.
B14	Counter slopes of adjoining gutters and road surfaces immediately adjacent to and within 24 inches of the curb ramp are not steeper than 1:20 (5.0%). (ADAS 406.2)	8.0%

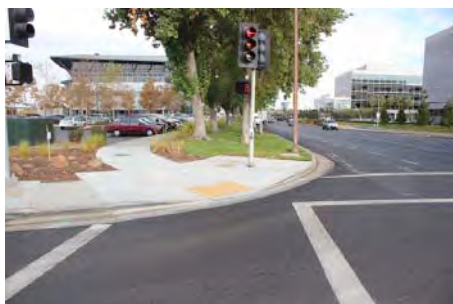
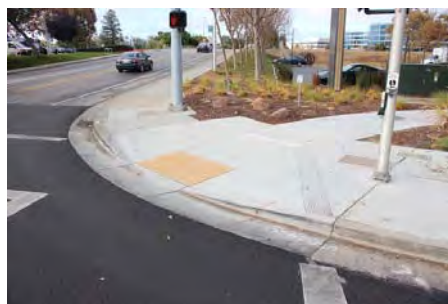
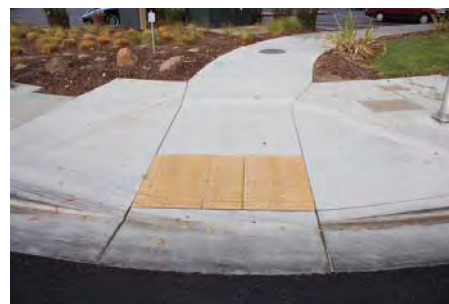
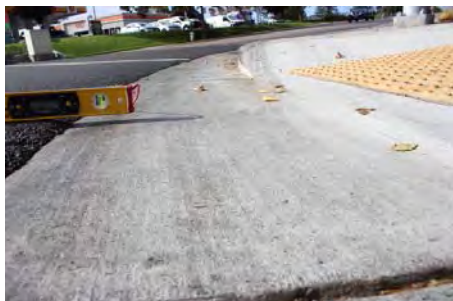
NEVAREZ V 49ERS - ACCESSIBILITY ASSESSMENT**FACILITY/SITE: 1. Great America Pky.****SEQ.
#****2****FEATURE: #10 CURB RAMP****LOCATION: Into Old Mountain View.****MEMO: NW corner diagonal type.****Notes:****CONDITIONS THAT DO NOT CONFORM TO NEW CONSTRUCTION STANDARDS**

COD	CONDITION DESCRIPTION	ACTUAL
B03	Running slope of ramp is 1:12 (8.33%) max. (ADAS 405.2)	11.7% at btm. 2", 8.8% at top 24" portion.
B05	Surface of ramp and landings complies with requirements for an accessible path of travel (stable, firm, slip-resistant, without gaps over 1/2" wide or edges over 1/4" high). (ADAS 302.1, 403.2, 403.3, 403.4)	3/4" high vertical edge at asphalt transition.
B14	Counter slopes of adjoining gutters and road surfaces immediately adjacent to and within 24 inches of the curb ramp are not steeper than 1:20 (5.0%). (ADAS 406.2)	6.0%

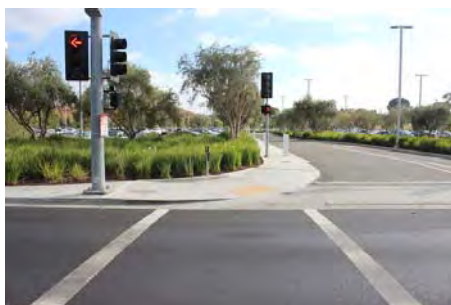
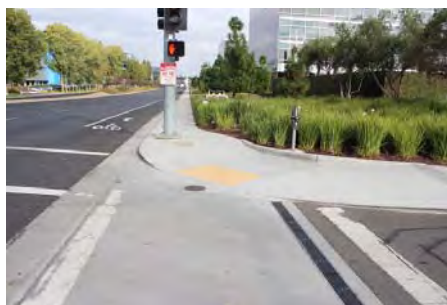
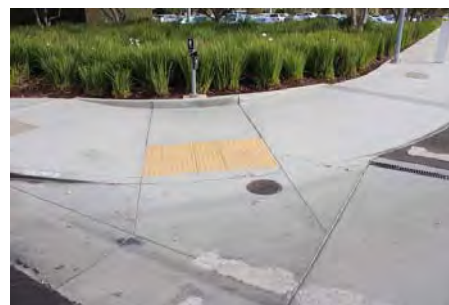
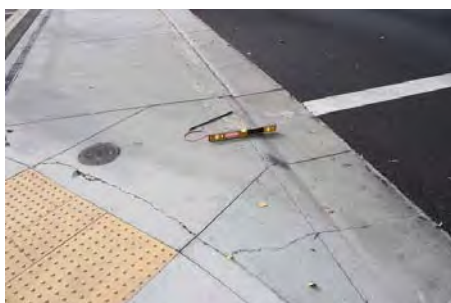
COD	CONDITION DESCRIPTION	ACTUAL
C11	Min. 48" x 48" turning space is provided at bottom of curb ramp. (ADAS 403.3)	19.0% for 3" L (approx. 5/8" H difference) 43" from btm. of curb ramp.

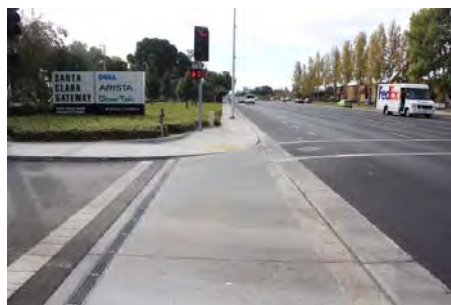
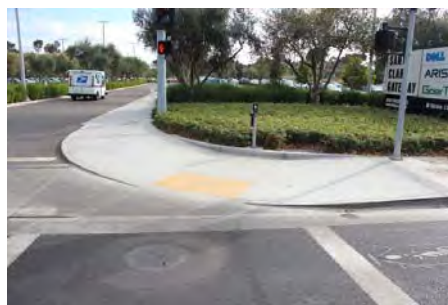
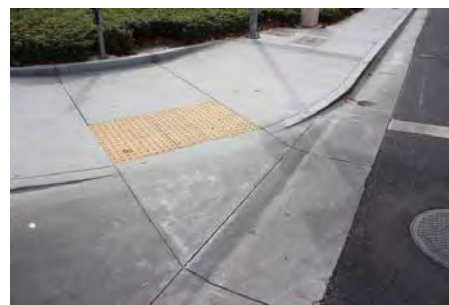
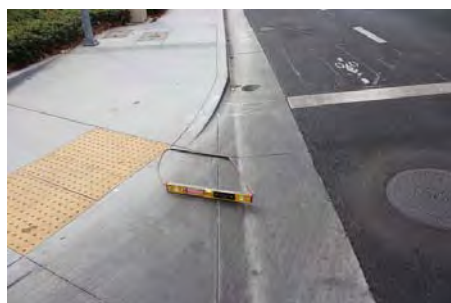
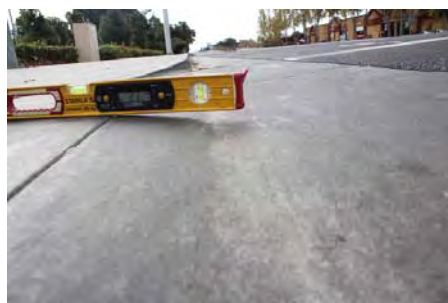
COD	CONDITION DESCRIPTION	ACTUAL
C12	Turning space at bottom of curb ramp slopes 1:48 (2.08%) max. in any direction (ADAS 403.3)	16.0% for 2" (approx. 7/8" H difference).

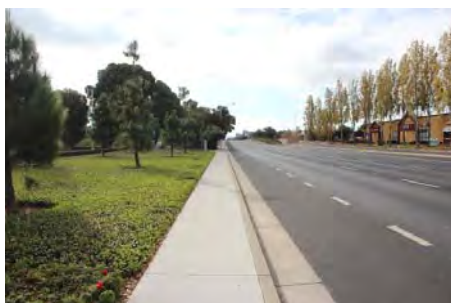
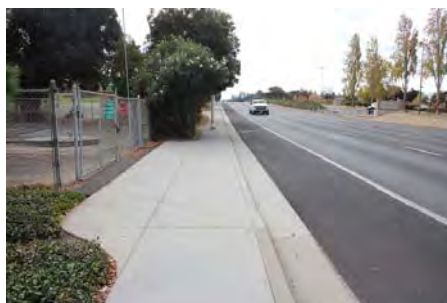
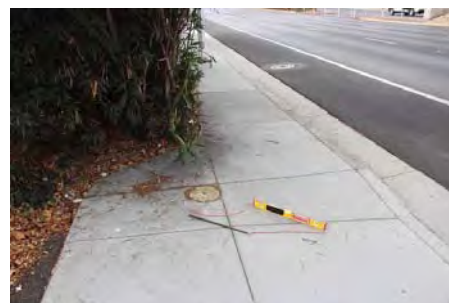
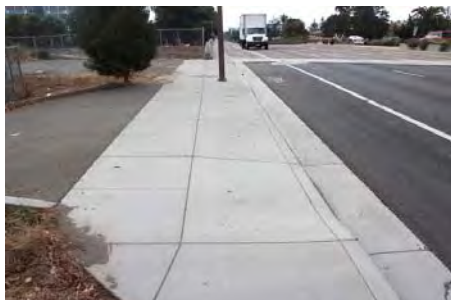
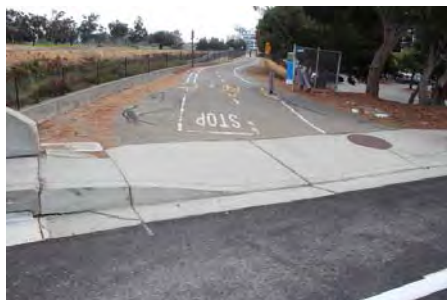
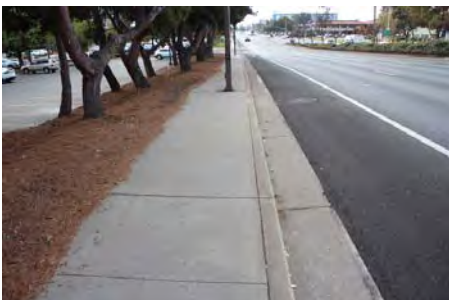
COD	CONDITION DESCRIPTION	ACTUAL
B16	Cross slope (perpendicular to direction of travel) is 1:48 (2.08%) max. (ADAS 403.3)	Approx. 130' L is 2.5% to 5.0% and 3.2% at sign post.
B17	Running slope (parallel to direction of travel) is 1:20 (5.0%) max. (ADAS 403.3)	10.8% and 12.2% at drive apron sides at S side of bridge.

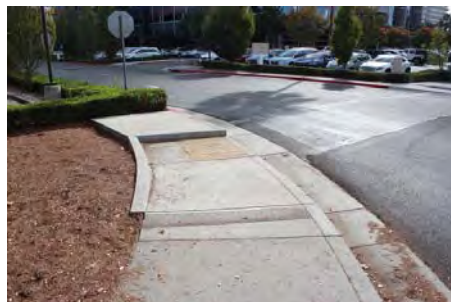
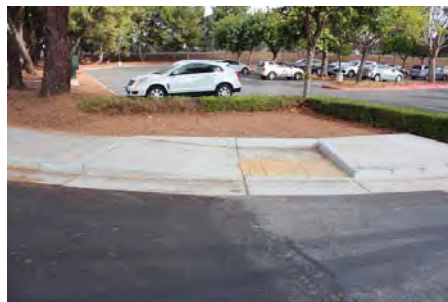
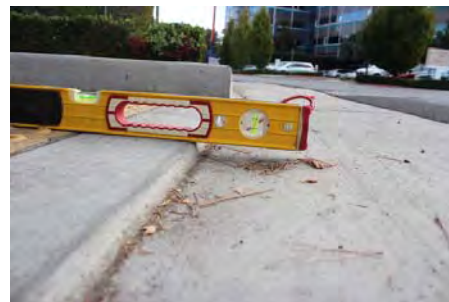
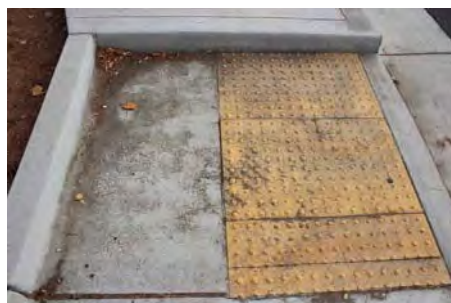
COD	CONDITION DESCRIPTION	ACTUAL
B05	Surface of ramp and landings complies with requirements for an accessible path of travel (stable, firm, slip-resistant, without gaps over 1/2" wide or edges over 1/4" high). (ADAS 405.4)	sand and debris
B06	Transition to walk, gutter or street is flush and free of abrupt changes. (ADAS 406.2)	1 1/8" high vertical edge

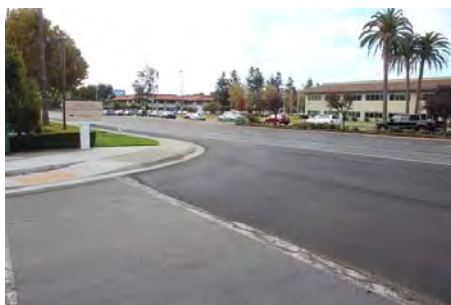
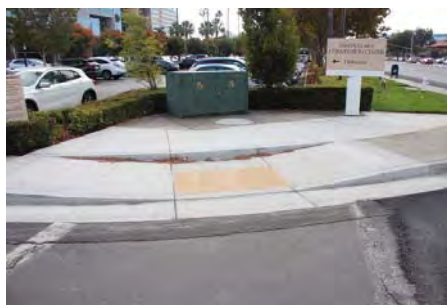
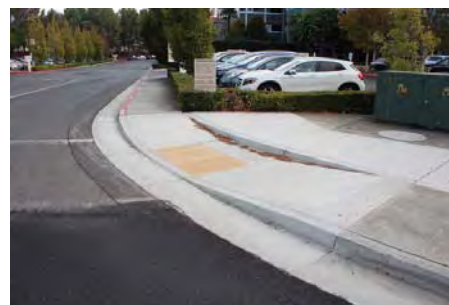
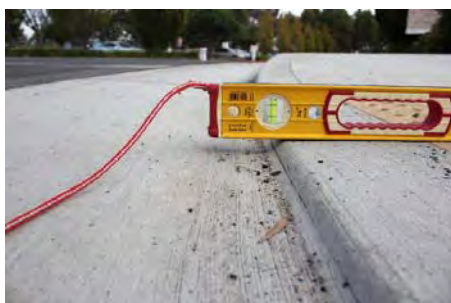
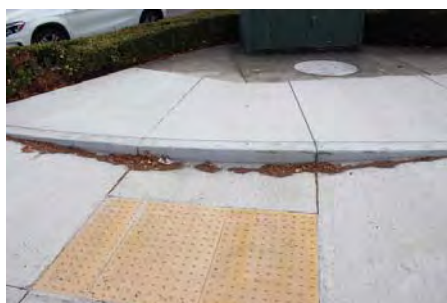
Appears recently constructed and in repave zone.

COD	CONDITION DESCRIPTION	ACTUAL
B06 406.2)	Transition to walk, gutter or street is flush and free of abrupt changes. (ADAS	3/4" high vertical edge

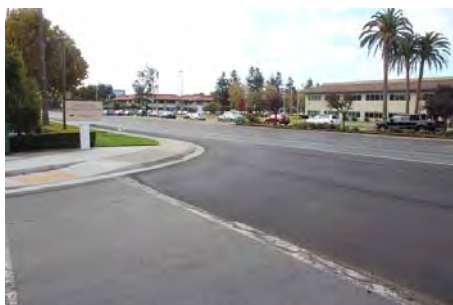
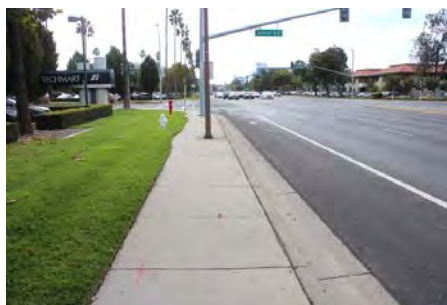
COD	CONDITION DESCRIPTION	ACTUAL
B16	Cross slope (perpendicular to direction of travel) is 1:48 (2.08%) max. (ADAS 403.3)	Approx. 40' L is 2.5% to 4.0%

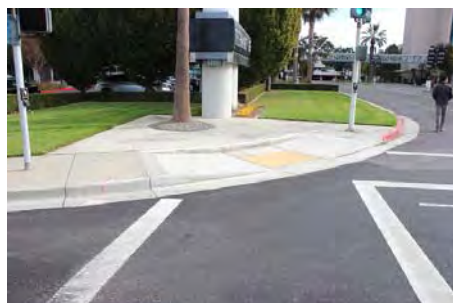
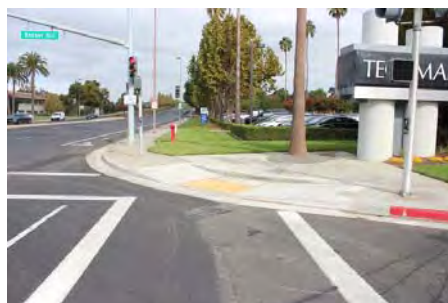
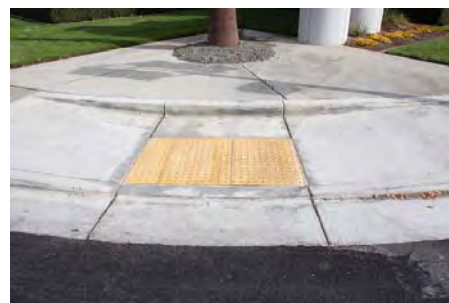
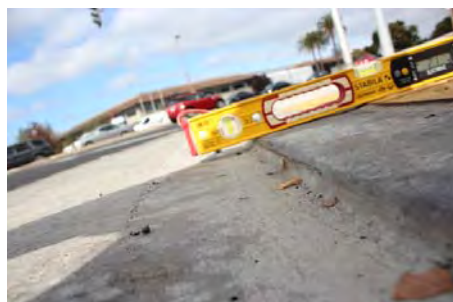
COD	CONDITION DESCRIPTION	ACTUAL
B06	Transition to walk, gutter or street is flush and free of abrupt changes. (ADAS 406.2)	5/8" vertical edge
B13	Counter slopes of adjoining gutters and road surfaces immediately adjacent to and within 24 inches of the curb ramp are not steeper than 1:20 (5.0%). (ADAS 406.2)	8.3%

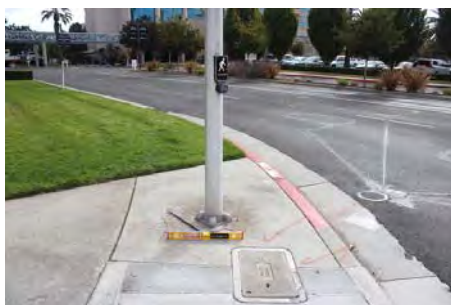
COD	CONDITION DESCRIPTION	ACTUAL
B11	The clear floor space is without changes in level except for slopes up to 1:48 (2.08%). (ADAS 305.2)	3.8% back side, 4.6% front side.

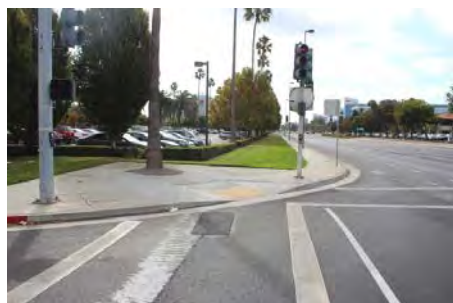
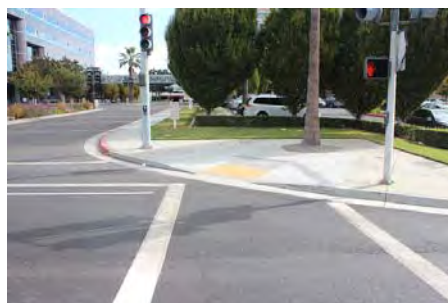
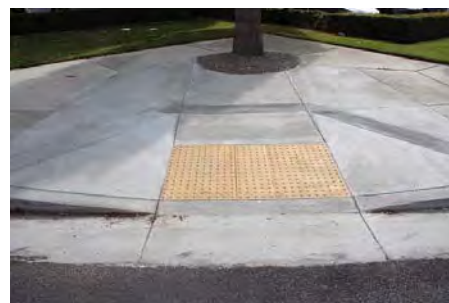
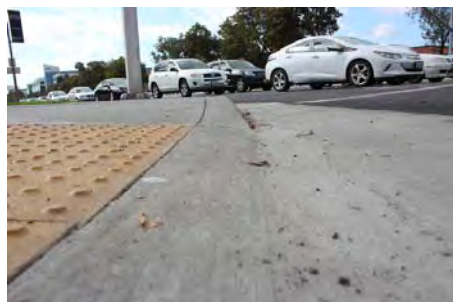
COD	CONDITION DESCRIPTION	ACTUAL
B03	Running slope of ramp is 1:12 (8.33%) max. (ADAS 405.2)	9.1% across curb face.
B14	Counter slopes of adjoining gutters and road surfaces immediately adjacent to and within 24 inches of the curb ramp are not steeper than 1:20 (5.0%). (ADAS 406.2)	5.8%

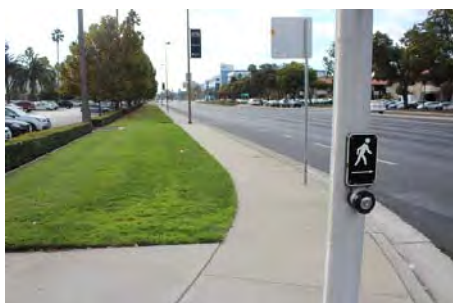
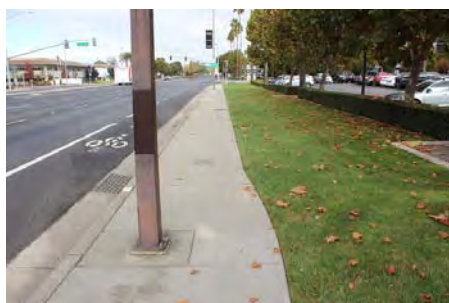
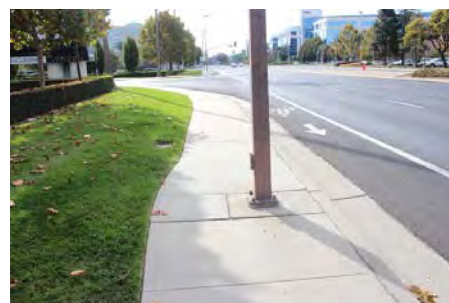
Conforms to standards used.

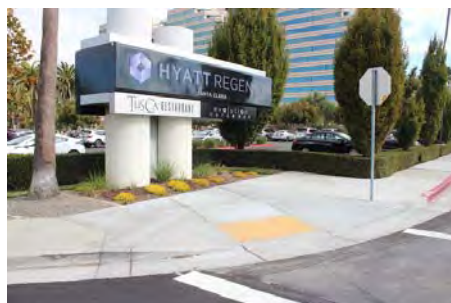
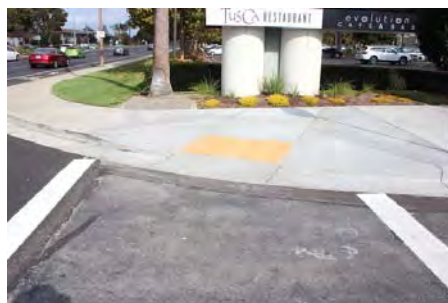
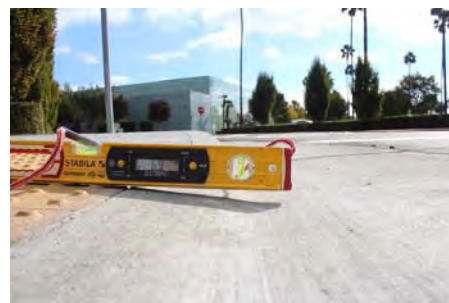
COD	CONDITION DESCRIPTION	ACTUAL
B03	Running slope of ramp is 1:12 (8.33%) max. (ADAS 405.2)	18.1% at btm. 2", 13.4% at btm. 2" to 6" portion.

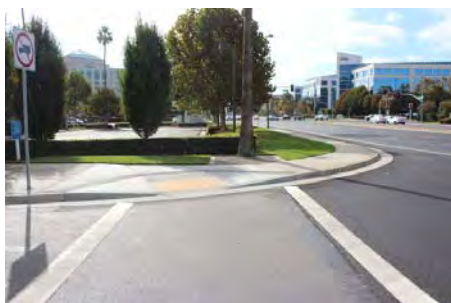
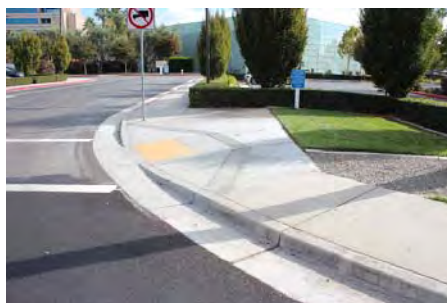
COD	CONDITION DESCRIPTION	ACTUAL
B03	Running slope of ramp is 1:12 (8.33%) max. (ADAS 405.2)	11.8% at btm. 6"

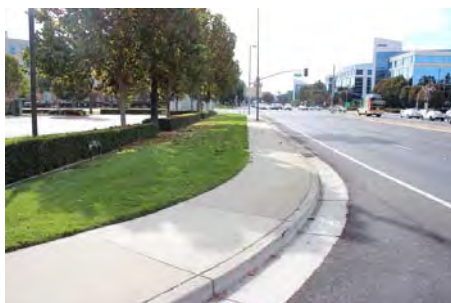
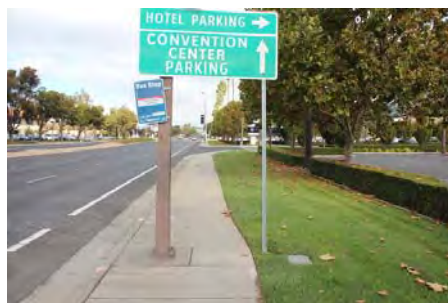
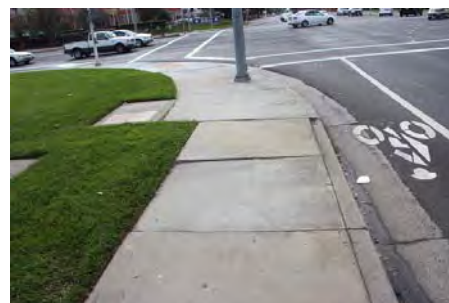
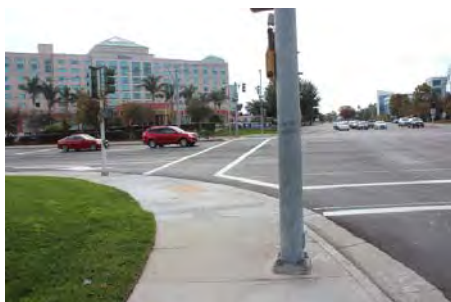
COD	CONDITION DESCRIPTION	ACTUAL
B15	No level changes greater than 1/2" (except by accessible ramp or other means). (ADAS 303.4)	2 3/4" high vertical edge at S end.
B16	Cross slope (perpendicular to direction of travel) is 1:48 (2.08%) max. (ADAS 403.3)	40' L is 2.6% to 3.0%

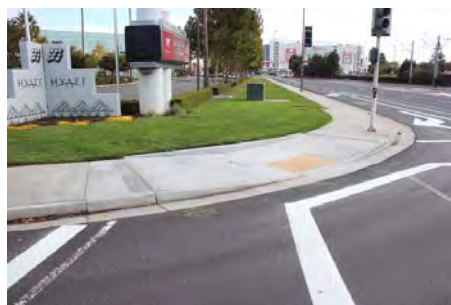
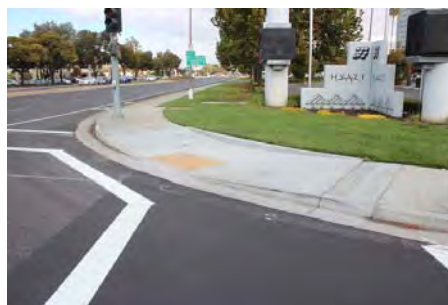
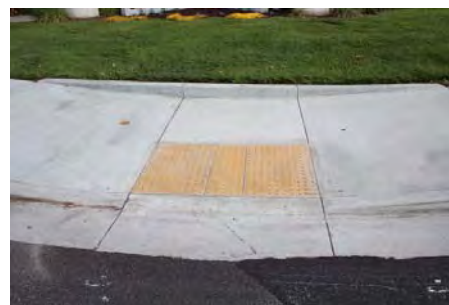
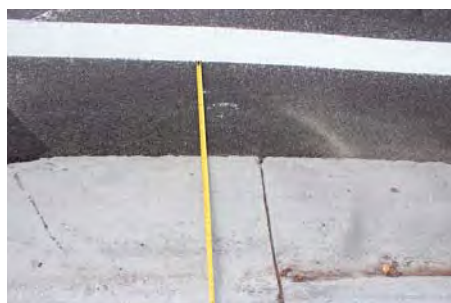
COD	CONDITION DESCRIPTION	ACTUAL
B13	Counter slopes of adjoining gutters and road surfaces immediately adjacent to and within 24 inches of the curb ramp are not steeper than 1:20 (5.0%). (ADAS 406.2)	9.0%

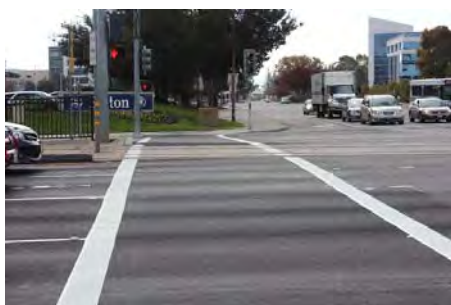
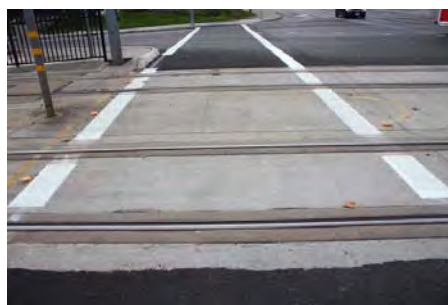
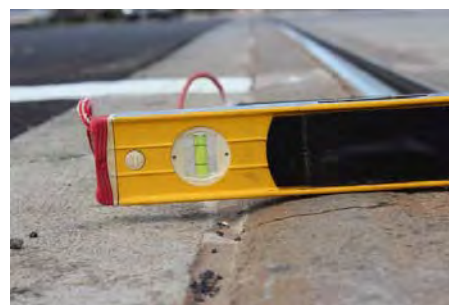
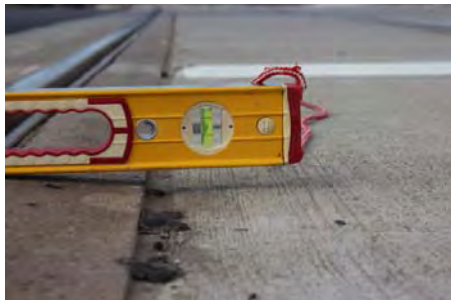
COD	CONDITION DESCRIPTION	ACTUAL
C40	Where pedestrian access routes cross rails: the route surface is flush with the outer edges of rails and the surface between rails is aligned with the top of the rail. (PROWAG R302.7.1)	1/2" to 3/4" elevation difference between route and rails (2 sets of 2 rails = 8 instances).

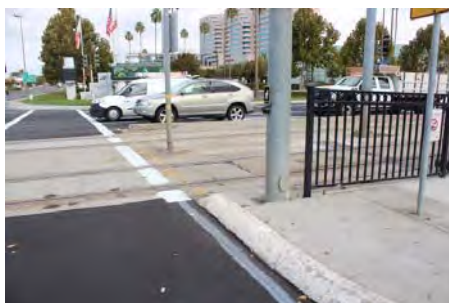
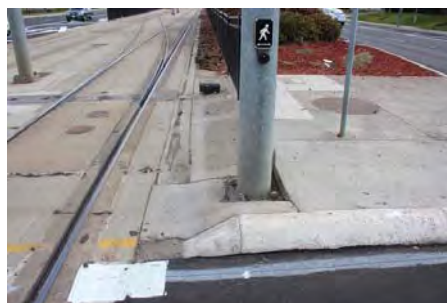
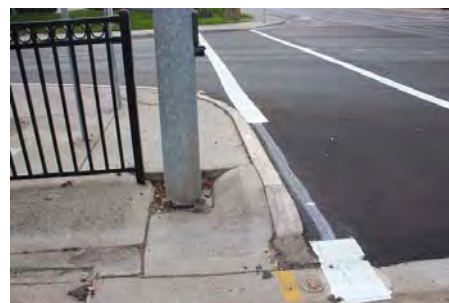
COD	CONDITION DESCRIPTION	ACTUAL
B41	Side reach over an obstruction greater than 10"d is max 46" AFF where the obstruction is max 34"AFF, and reach depth is no more than 24". (ADAS 308.3.2)	25" reach depth from clear space.
