Case No. 5:16-cv-07013-LHK (SVK)

**DECLARATION OF JEFFREY SCOTT
MASTIN IN SUPPORT OF PLAINTIFFS'
MOTION FOR CLASS CERTIFICATION**

NEVAREZ V 49ERS - ACCESSIBILITY ASSESSMENT

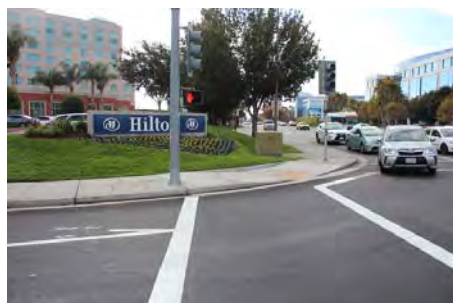
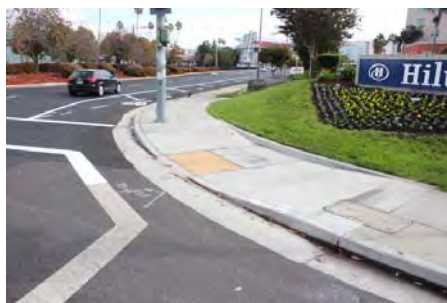
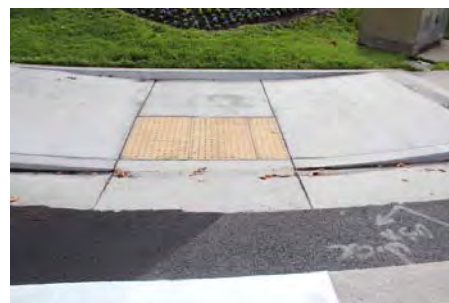
COD	CONDITION DESCRIPTION	ACTUAL
B03	Running slope of ramp is 1:12 (8.33%) max. (ADAS 405.2)	10.7% at btm. 6".
B14	Counter slopes of adjoining gutters and road surfaces immediately adjacent to and within 24 inches of the curb ramp are not steeper than 1:20 (5.0%). (ADAS 406.2)	7.6%

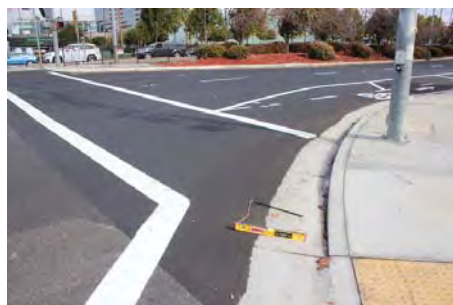
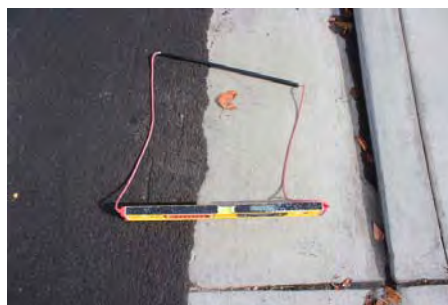
COD	CONDITION DESCRIPTION	ACTUAL
B16	Cross slope (perpendicular to direction of travel) is 1:48 (2.08%) max. (ADAS 403.3)	11.1%

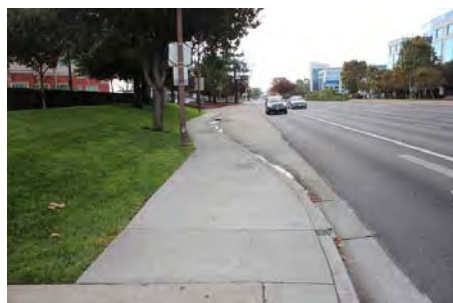
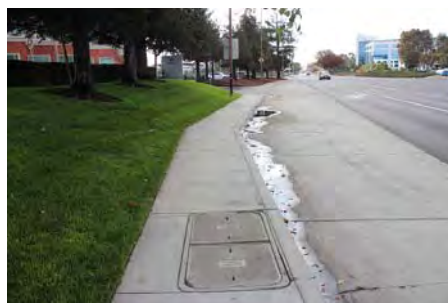
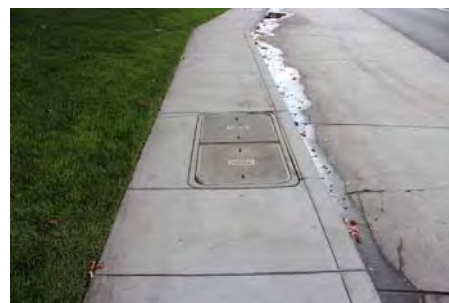
COD	CONDITION DESCRIPTION	ACTUAL
B12	Gaps/openings in ground or floor surfaces do not allow the passage of a sphere more than 1/2" in diameter. (ADAS 302.3)	3 gaps at utility cover, up to 1 1/2" W.
B16	Cross slope (perpendicular to direction of travel) is 1:48 (2.08%) max. (ADAS 403.3)	Approx. 10' L is 2.8%.

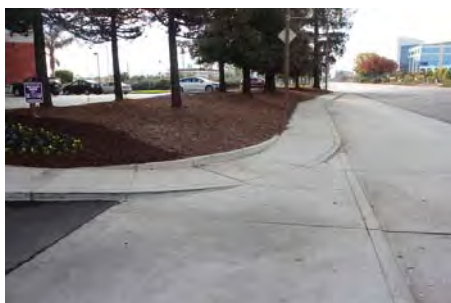
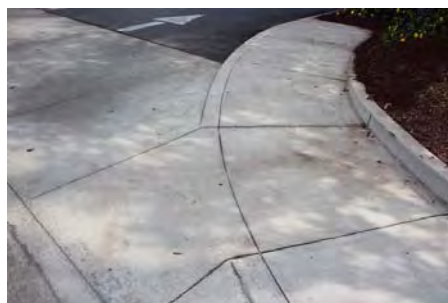
COD	CONDITION DESCRIPTION	ACTUAL
B03	Running slope of ramp is 1:12 (8.33%) max. (ADAS 405.2)	9.9% at btm. 6".

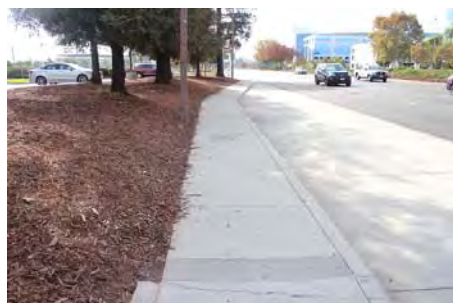
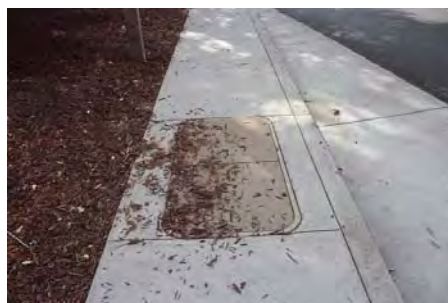
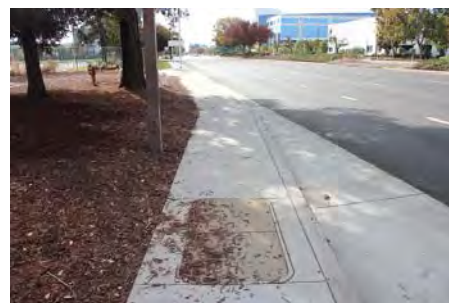
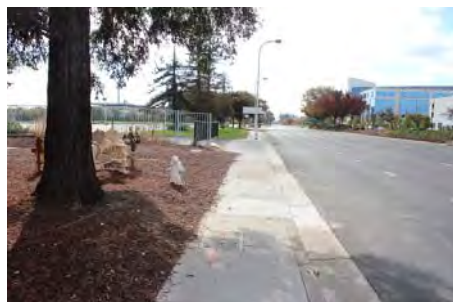
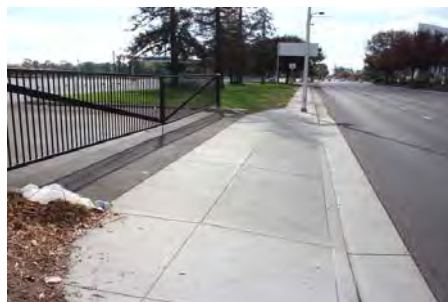
COD	CONDITION DESCRIPTION	ACTUAL
B14	1/4" to 1/2" level changes are beveled at max 1:2 (vert:horiz) slope. (ADAS 303.3)	Two 1/2" vertical edges at utility cover.
B16	Cross slope (perpendicular to direction of travel) is 1:48 (2.08%) max. (ADAS 403.3)	Approx. 20' L is 3.2% to 3.3%.

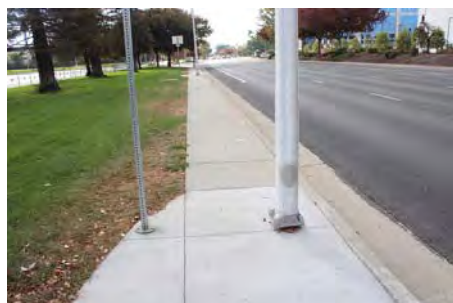
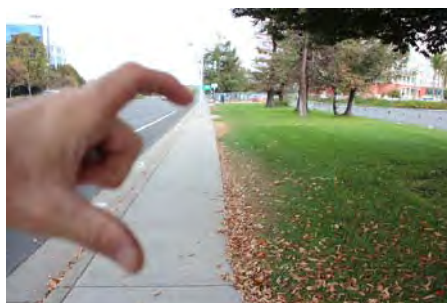
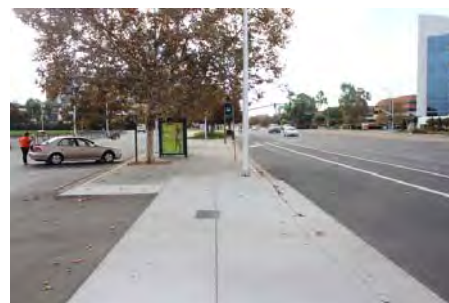
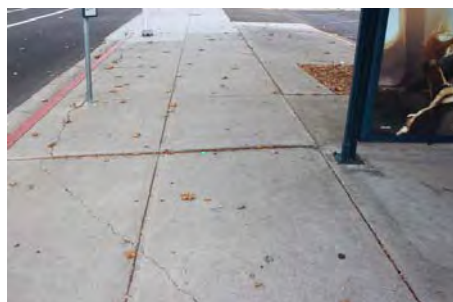
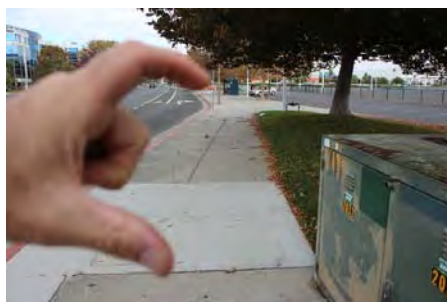
COD	CONDITION DESCRIPTION	ACTUAL
B15	No level changes greater than 1/2" (except by accessible ramp or other means). (ADAS 303.4)	Three vertical edges 5/8" to 1 1/4" S of bus stop.
B16	Cross slope (perpendicular to direction of travel) is 1:48 (2.08%) max. (ADAS 403.3)	Approx. 270' L is 2.7% to 4.2%.

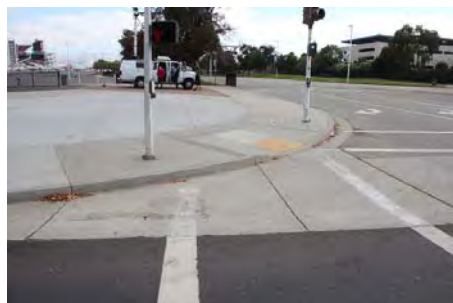
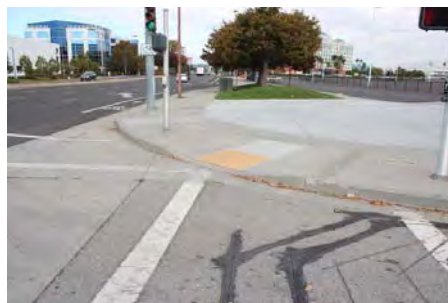
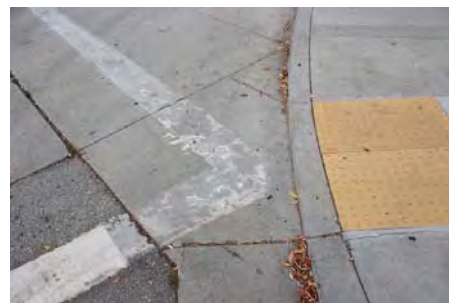
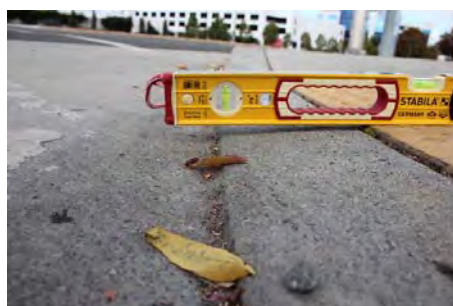
COD	CONDITION DESCRIPTION	ACTUAL
B03	Running slope of ramp is 1:12 (8.33%) max. (ADAS 405.2)	9.5% generally, 15.2% across curb face.
B06	Transition to walk, gutter or street is flush and free of abrupt changes. (ADAS 406.2)	1/2" high vertical edge.
B16	Maximum slope of flared sides is 1:10 (10.0%). (ADAS 406.2)	11.7% at right side.
B19	DIAGONAL: If curb ramp is located at marked crossing, 48" min. clear space is provided within the markings. (ADAS 406.6)	0" to CW markings (no landing in CW).

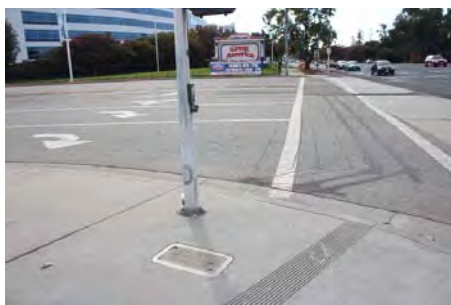
COD	CONDITION DESCRIPTION	ACTUAL
B11	The clear floor space is without changes in level except for slopes up to 1:48 (2.08%). (ADAS 305.2)	3.8%

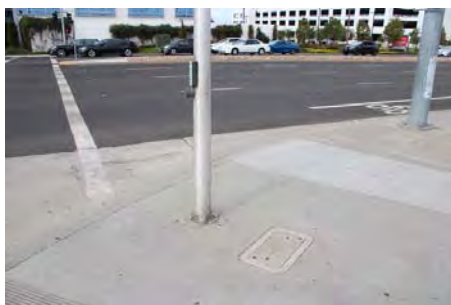
COD	CONDITION DESCRIPTION	ACTUAL
B11	The clear floor space is without changes in level except for slopes up to 1:48 (2.08%). (ADAS 305.2)	3.5%

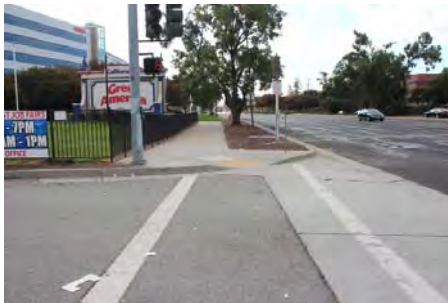
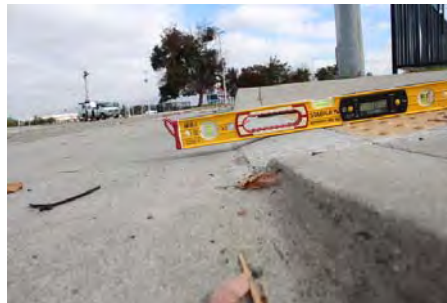
COD	CONDITION DESCRIPTION	ACTUAL
B06	Transition to walk, gutter or street is flush and free of abrupt changes. (ADAS 406.2)	5/8" elevation difference in approx. 2" btm. Portion.

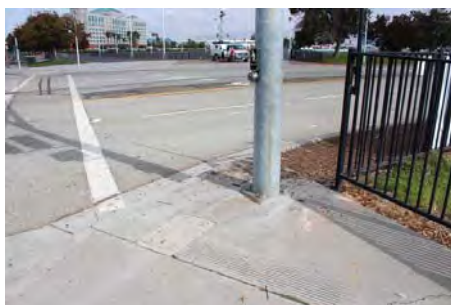
COD	CONDITION DESCRIPTION	ACTUAL
B11	The clear floor space is without changes in level except for slopes up to 1:48 (2.08%). (ADAS 305.2)	3.4%

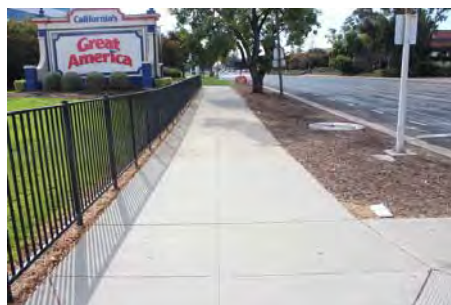
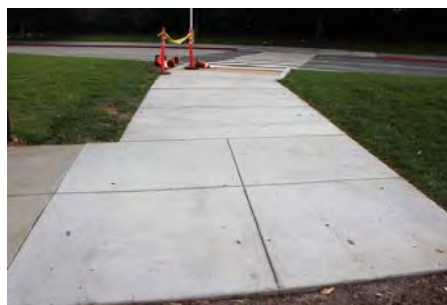
COD	CONDITION DESCRIPTION	ACTUAL
B16	Cross slope (perpendicular to direction of travel) is 1:48 (2.08%) max. (ADAS 403.3)	Approx. 40' L is 3.9% to 4.5%.

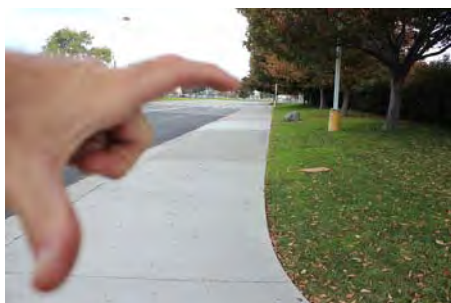
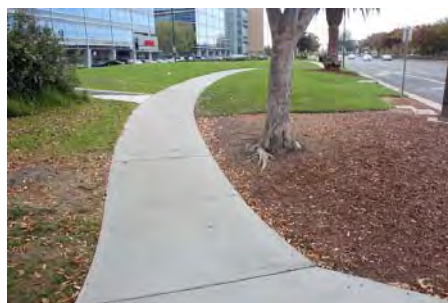
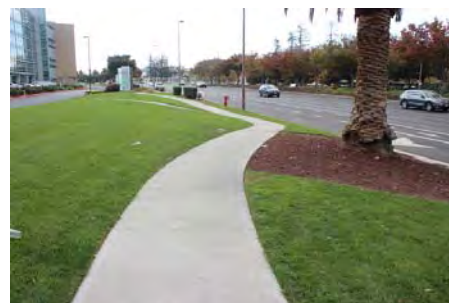
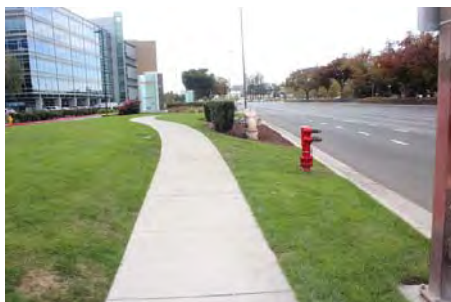
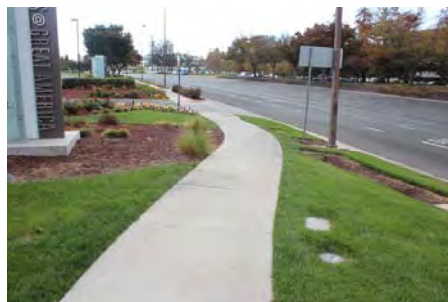
COD	CONDITION DESCRIPTION	ACTUAL
B16	Cross slope (perpendicular to direction of travel) is 1:48 (2.08%) max. (ADAS 403.3)	Approx. 110' L is 2.5% to 4.3%.
B17	Running slope (parallel to direction of travel) is 1:20 (5.0%) max. (ADAS 403.3)	2 hills comprising approx. 55' L running slope up to 6.8%.

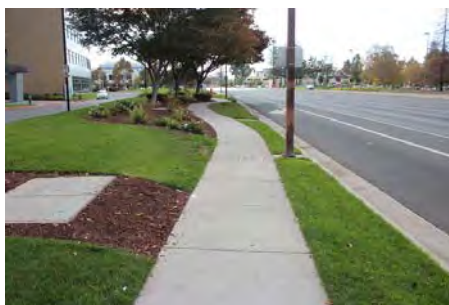
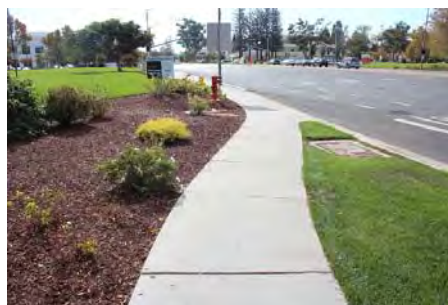
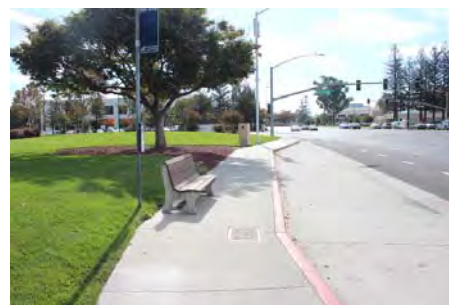
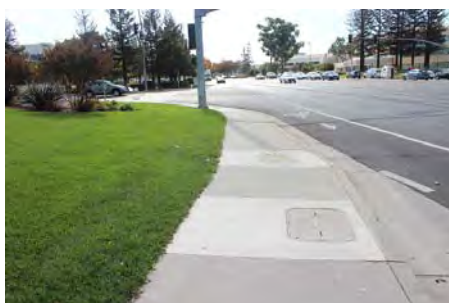
COD	CONDITION DESCRIPTION	ACTUAL
B16	Cross slope (perpendicular to direction of travel) is 1:48 (2.08%) max. (ADAS 403.3)	Approx. 320' L is 2.5% to 5.1%.

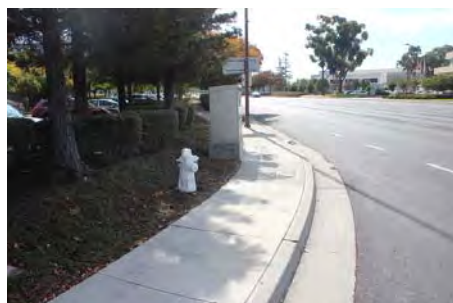
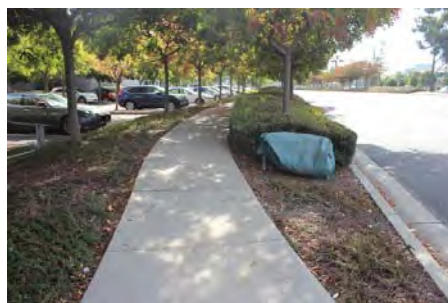
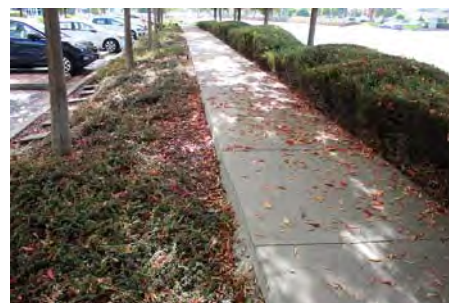
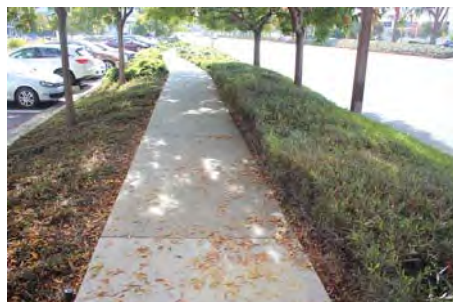
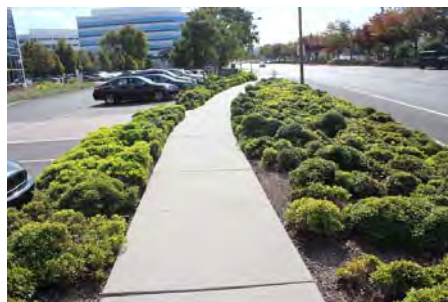
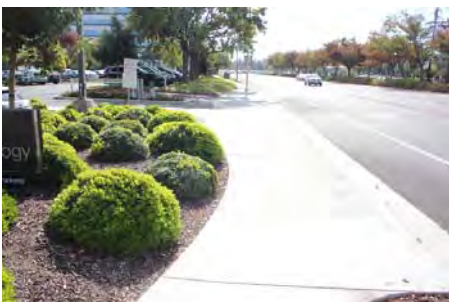
COD	CONDITION DESCRIPTION	ACTUAL
B16	Cross slope (perpendicular to direction of travel) is 1:48 (2.08%) max. (ADAS 403.3)	Approx. 90' L is 2.6% to 4.8%.
B17	Running slope (parallel to direction of travel) is 1:20 (5.0%) max. (ADAS 403.3)	Up to 6.9% for approx. 10' L at hill.

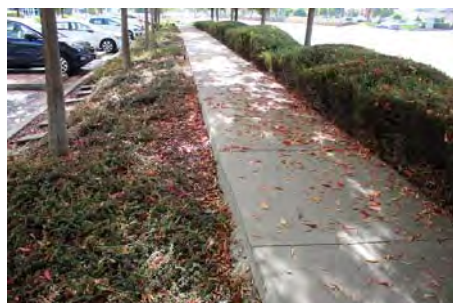
COD	CONDITION DESCRIPTION	ACTUAL
B11	Abrupt changes in level over 4" high are identified either by a curb or guide rail. (28 CFR 35.130(a), ADAS 405.9, CBC 11B-303.5)	Over 4" drop off, approx. 20' L at one side.

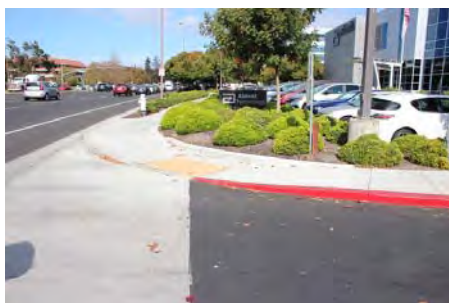
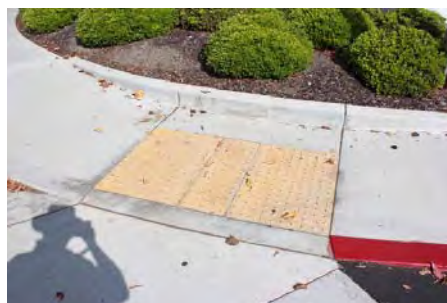
COD	CONDITION DESCRIPTION	ACTUAL
B03	Running slope is 1:12 (8.33%) max. (ADAS 405.2)	9.5% at btm. 6".

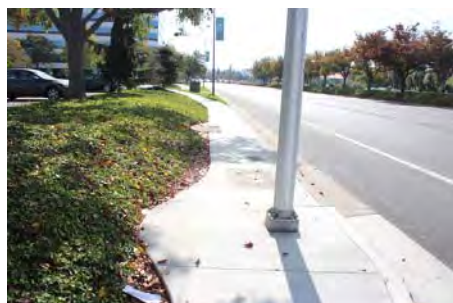
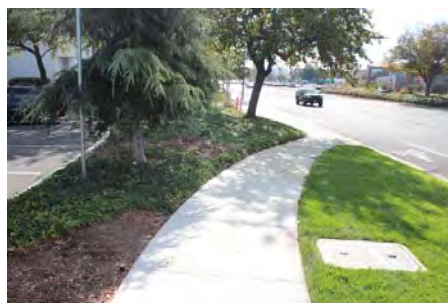
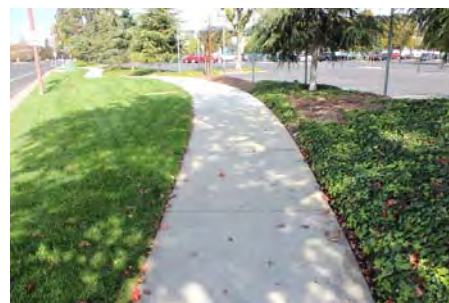
COD	CONDITION DESCRIPTION	ACTUAL
B16	Cross slope (perpendicular to direction of travel) is 1:48 (2.08%) max. (ADAS 403.3)	Approx. 60' L is 2.6% to 5.1%.
B17	Running slope (parallel to direction of travel) is 1:20 (5.0%) max. (ADAS 403.3)	Up to 6.1% at hill.

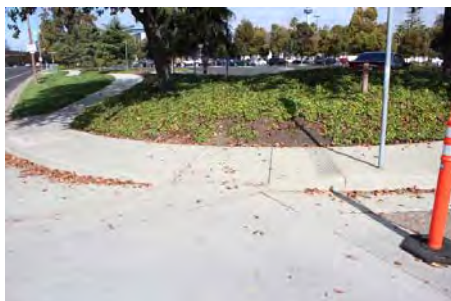
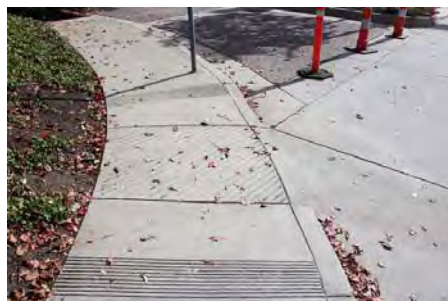
COD	CONDITION DESCRIPTION	ACTUAL
B03	Running slope of ramp is 1:12 (8.33%) max. (ADAS 405.2)	12.0%
B04	Cross slope of ramp is 1:48 (2.08%). (ADAS 405.3)	4.6%
B11	Top landing is as wide as the ramp and 36" min. in length. (ADAS 406.4)	None
A17	Where no top landing is provided at an existing ramp, side flare slopes are 8.33% max. (ADAS 406.4)	15.6% left side, 15.9% right side.

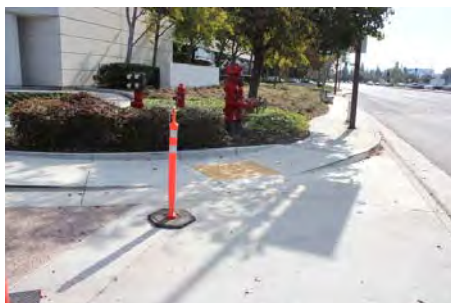
Conforms to standards used.

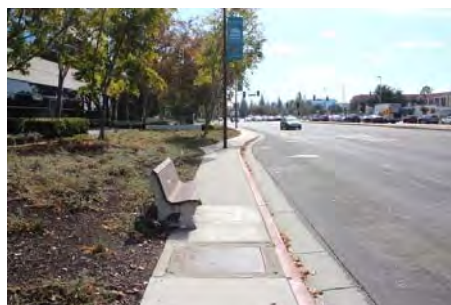
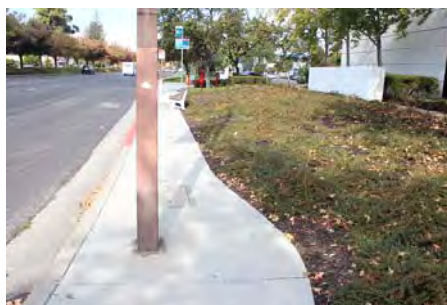
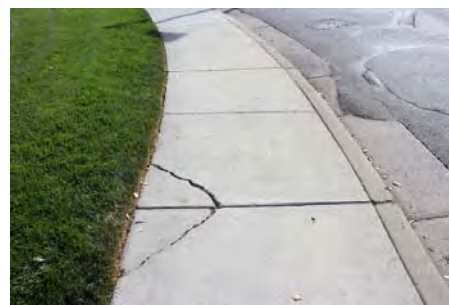
COD	CONDITION DESCRIPTION	ACTUAL
B16	Cross slope (perpendicular to direction of travel) is 1:48 (2.08%) max. (ADAS 403.3)	Approx. 250' L is 2.5% to 8.0%.

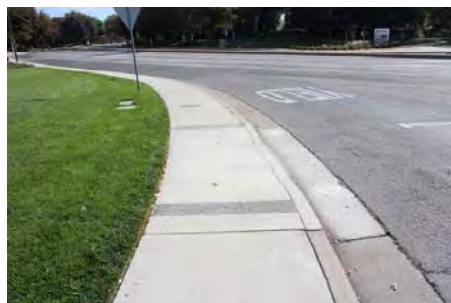
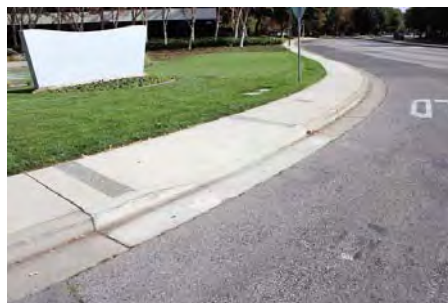
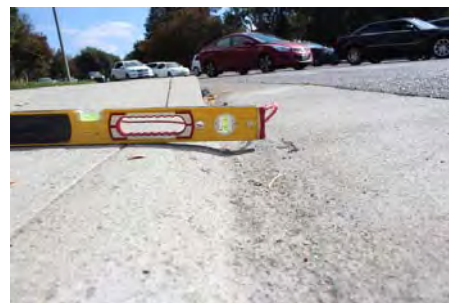
COD	CONDITION DESCRIPTION	ACTUAL
B03	Running slope of ramp is 1:12 (8.33%) max. (ADAS 405.2)	11.6% w/ 32.2% at btm. 1" and 19.9% at btm. 1" to 6".
B11	Top landing is as wide as the ramp and 36" min. in length. (ADAS 406.4)	None
B14	Counter slopes of adjoining gutters and road surfaces immediately adjacent to and within 24 inches of the curb ramp are not steeper than 1:20 (5.0%). (ADAS 406.2)	10.1%
A17	Where no top landing is provided at an existing ramp, side flare slopes are 8.33% max. (ADAS 406.4)	13.9% at right side, 12.3% at left side.

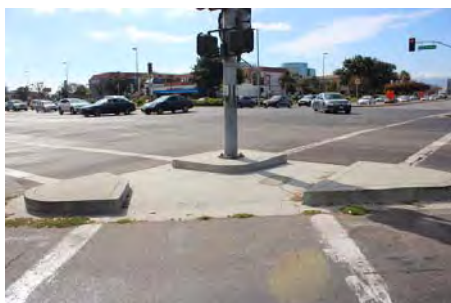
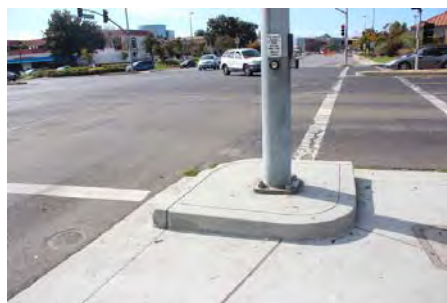
COD	CONDITION DESCRIPTION	ACTUAL
B11	The clear floor space is without changes in level except for slopes up to 1:48 (2.08%). (ADAS 305.2)	3.2%
B41	Side reach over an obstruction greater than 10"d is max 46" AFF where the obstruction is max 34"AFF, and reach depth is no more than 24". (ADAS 308.3.2)	Approx. 52" H, 21" from clear space.

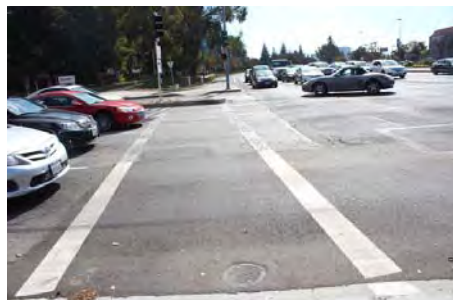
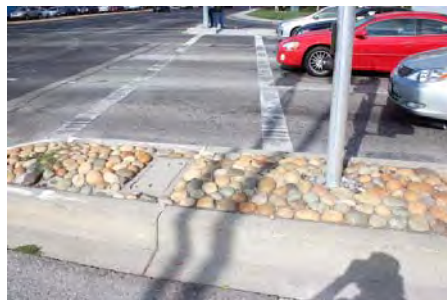
COD	CONDITION DESCRIPTION	ACTUAL
B02	36" min. clear width of exterior walkway. (ADAS 403.5.1)	Obstructed by mid-crossing island to 0" wide.
B15	No level changes greater than 1/2" (except by accessible ramp or other means). (ADAS 303.4)	Sign indicates to push button and wait for walk signal, however, user who cannot step up the curb must wait in traffic lanes.

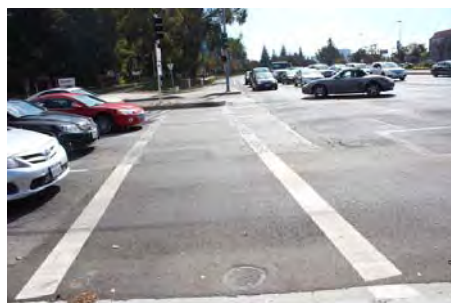
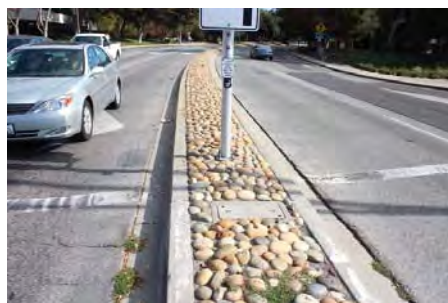
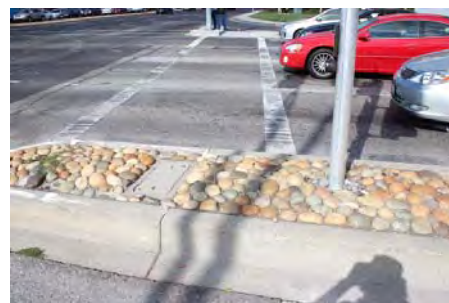
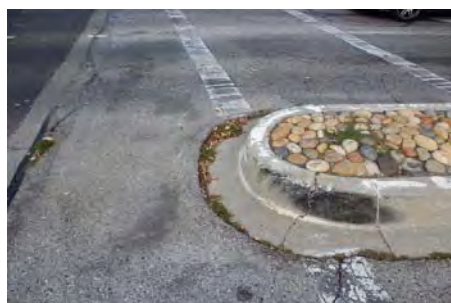
COD	CONDITION DESCRIPTION	ACTUAL
B41	Side reach over an obstruction greater than 10"d is max 46" AFF where the obstruction is max 34"AFF, and reach depth is no more than 24". (ADAS 308.3.2)	Over 24" from clear space in crossing.

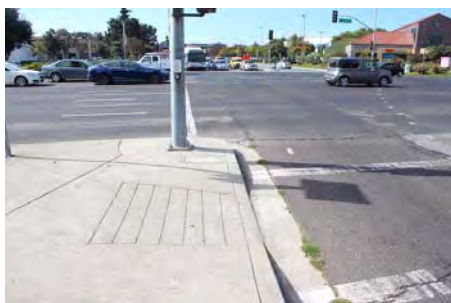
COD	CONDITION DESCRIPTION	ACTUAL
B03	Running slope of ramp is 1:12 (8.33%) max. (ADAS 405.2)	8.7% and 14.2% across curb face.
B06	Transition to walk, gutter or street is flush and free of abrupt changes. (ADAS 406.2)	1/2" high vertical edge.
B16	Maximum slope of flared sides is 1:10 (10.0%). (ADAS 406.2)	18.0% right side, 15.8% left side.

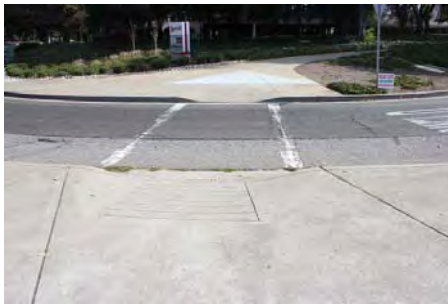
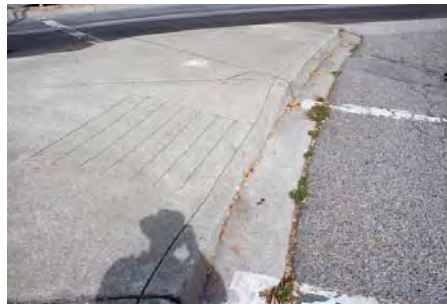
COD	CONDITION DESCRIPTION	ACTUAL
B03	Running slope of ramp is 1:12 (8.33%) max. (ADAS 405.2)	16.4% and 23.2% across curb face.
B05	Surface of ramp and landings complies with requirements for an accessible path of travel (stable, firm, slip-resistant, without gaps over 1/2" wide or edges over 1/4" high). (ADAS 302.1, 403.2, 403.3, 403.4)	3/4" gap at asphalt transition.
B06	Transition to walk, gutter or street is flush and free of abrupt changes. (ADAS 406.2)	1/2" high vertical edge.
B16	Maximum slope of flared sides is 1:10 (10.0%). (ADAS 406.2)	18.0% right side, 15.8% left side.

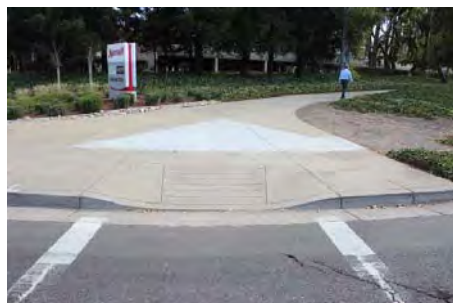
COD	CONDITION DESCRIPTION	ACTUAL
B03	Running slope of ramp is 1:12 (8.33%) max. (ADAS 405.2)	12.9%
B06	Transition to walk, gutter or street is flush and free of abrupt changes. (ADAS 406.2)	1/2" high vertical edge.
B14	Counter slopes of adjoining gutters and road surfaces immediately adjacent to and within 24 inches of the curb ramp are not steeper than 1:20 (5.0%). (ADAS 406.2)	8.2%
B16	Maximum slope of flared sides is 1:10 (10.0%). (ADAS 406.2)	17.3% left side, 14.7% right side.

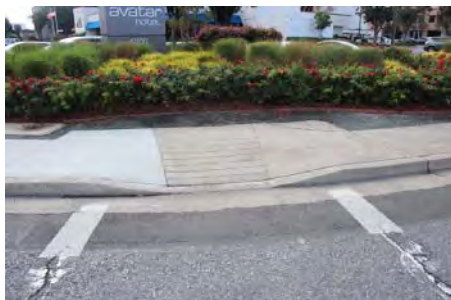
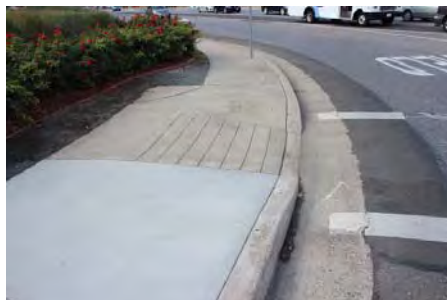
COD	CONDITION DESCRIPTION	ACTUAL
B03	Running slope of ramp is 1:12 (8.33%) max. (ADAS 405.2)	11.6% and 12.6% across curb face.
B06	Transition to walk, gutter or street is flush and free of abrupt changes. (ADAS 406.2)	3/8" high vertical edge.
B11	Top landing is as wide as the ramp and 36" min. in length. (ADAS 406.4)	34" L.
B14	Counter slopes of adjoining gutters and road surfaces immediately adjacent to and within 24 inches of the curb ramp are not steeper than 1:20 (5.0%). (ADAS 406.2)	9.0%
A17	Where no top landing is provided at an existing ramp, side flare slopes are 8.33% max. (ADAS 406.4)	13.3% left side, 12.6% right side.

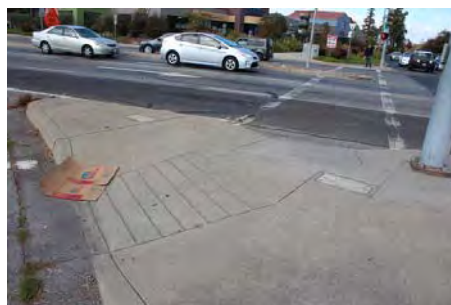
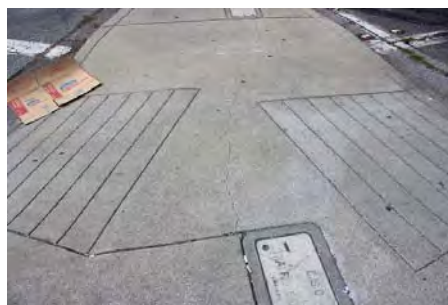
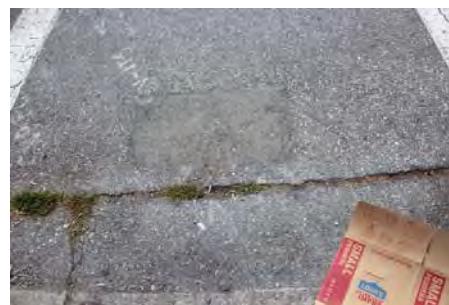
COD	CONDITION DESCRIPTION	ACTUAL
B03	Running slope of ramp is 1:12 (8.33%) max. (ADAS 405.2)	15.0% to 17.3%
B05	Surface of ramp and landings complies with requirements for an accessible path of travel (stable, firm, slip-resistant, without gaps over 1/2" wide or edges over 1/4" high). (ADAS 302.1, 403.2, 403.3, 403.4)	2" W gap at btm. Landing.
A17	Where no top landing is provided at an existing ramp, side flare slopes are 8.33% max. (ADAS 406.4)	25.0% left side, 25.9% right side
B21	Islands - each curb ramp has a min. 48" long x 36" wide level landing at the top of the curb ramp, with the 48" length in the direction of the running slope of the curb ramp it serves. (ADAS 406.7)	18" L to adjacent curb ramp.

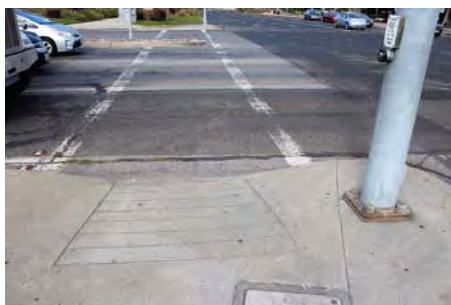
COD	CONDITION DESCRIPTION	ACTUAL
B03	Running slope of ramp is 1:12 (8.33%) max. (ADAS 405.2)	9.8% to 11.0%
B14	Counter slopes of adjoining gutters and road surfaces immediately adjacent to and within 24 inches of the curb ramp are not steeper than 1:20 (5.0%). (ADAS 406.2)	7.9%
A17	Where no top landing is provided at an existing ramp, side flare slopes are 8.33% max. (ADAS 406.4)	29.8% left side, 16.1% right side.
B21	Islands - each curb ramp has a min. 48" long x 36" wide level landing at the top of the curb ramp, with the 48" length in the direction of the running slope of the curb ramp it serves. (ADAS 406.7)	18" to adjacent curb ramp.

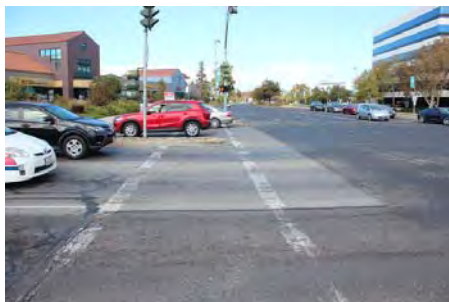
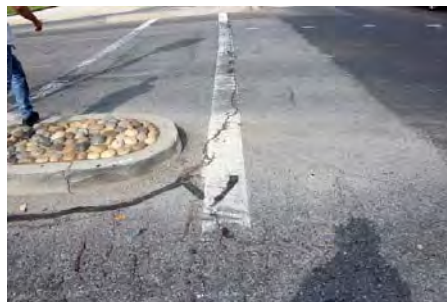
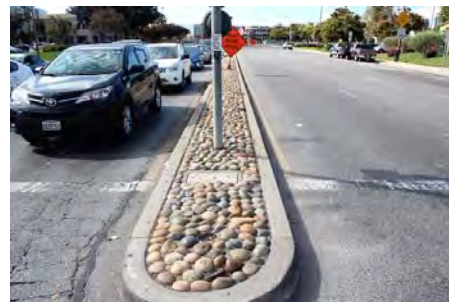
COD	CONDITION DESCRIPTION	ACTUAL
B02	36" min. clear width of exterior walkway. (ADAS 403.5.1)	Obstructed by mid crossing island to 6" W.
B15	No level changes greater than 1/2" (except by accessible ramp or other means). (ADAS 303.4)	Sign indicates to push button and wait for walk signal, however user who cannot step up the curb must wait in traffic lanes.

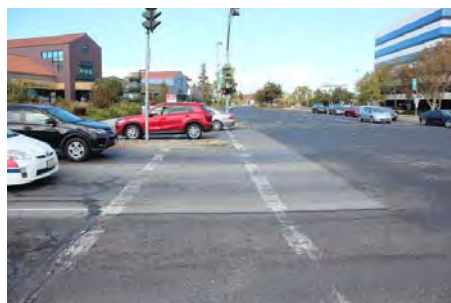
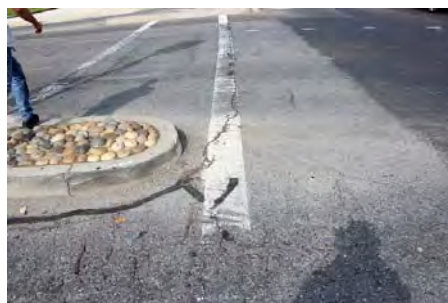
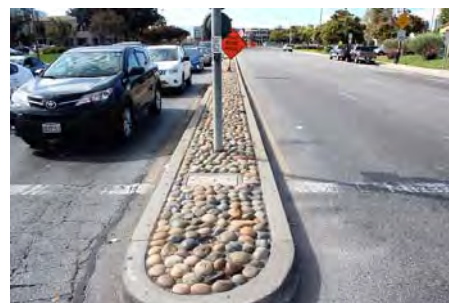
COD	CONDITION DESCRIPTION	ACTUAL
B41	Side reach over an obstruction greater than 10"d is max 46" AFF where the obstruction is max 34"AFF, and reach depth is no more than 24". (ADAS 308.3.2)	Over 24" from clear space in crossing.

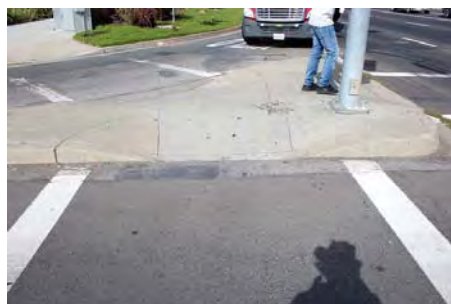
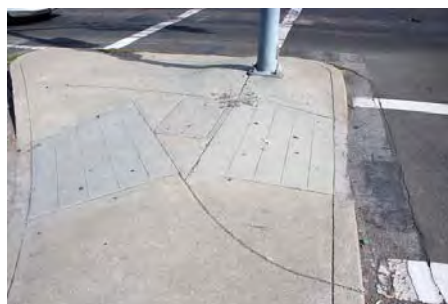
COD	CONDITION DESCRIPTION	ACTUAL
B03	Running slope of ramp is 1:12 (8.33%) max. (ADAS 405.2)	13.6% to 14.3%
A17	Where no top landing is provided at an existing ramp, side flare slopes are 8.33% max. (ADAS 406.4)	17.3% left side, 22.4% right side.
B21	Islands - each curb ramp has a min. 48" long x 36" wide level landing at the top of the curb ramp, with the 48" length in the direction of the running slope of the curb ramp it serves. (ADAS 406.7)	3" to adjacent curb ramp.

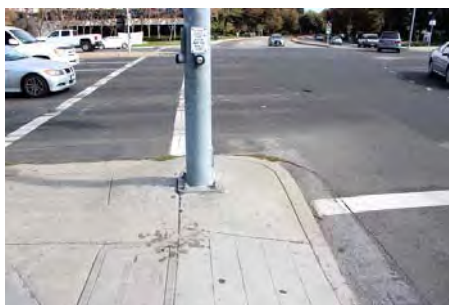
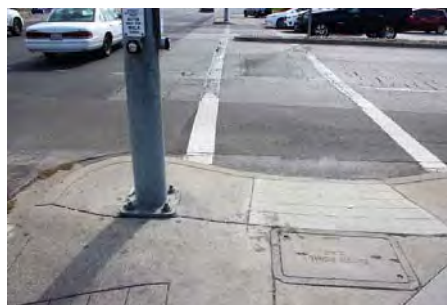
COD	CONDITION DESCRIPTION	ACTUAL
B11	The clear floor space is without changes in level except for slopes up to 1:48 (2.08%). (ADAS 305.2)	18.9%

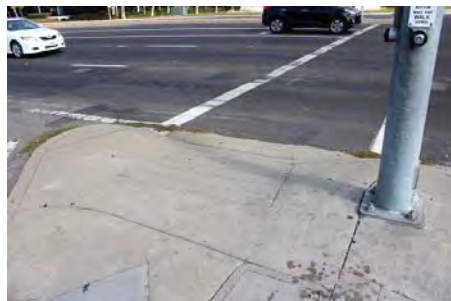
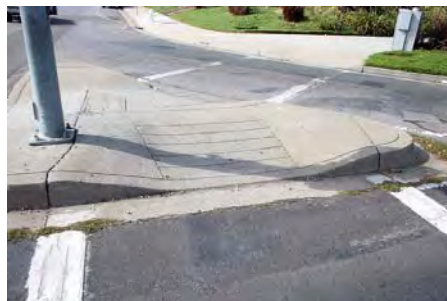
COD	CONDITION DESCRIPTION	ACTUAL
B03	Running slope of ramp is 1:12 (8.33%) max. (ADAS 405.2)	11.4%
B05	Surface of ramp and landings complies with requirements for an accessible path of travel (stable, firm, slip-resistant, without gaps over 1/2" wide or edges over 1/4" high). (ADAS 302.1, 403.2, 403.3, 403.4)	5.8% running slope at top landing.
B06	Transition to walk, gutter or street is flush and free of abrupt changes. (ADAS 406.2)	3/8" high vertical edge.
B14	Counter slopes of adjoining gutters and road surfaces immediately adjacent to and within 24 inches of the curb ramp are not steeper than 1:20 (5.0%). (ADAS 406.2)	8.0%
A17	Where no top landing is provided at an existing ramp, side flare slopes are 8.33% max. (ADAS 406.4)	15.1% left side, 15.7% right side.
B21	Islands - each curb ramp has a min. 48" long x 36" wide level landing at the top of the curb ramp, with the 48" length in the direction of the running slope of the curb ramp it serves. (ADAS 406.7)	33" to one adjacent curb ramp, 31" to a second adjacent curb ramp.

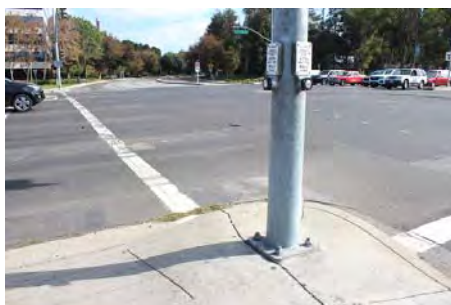
COD	CONDITION DESCRIPTION	ACTUAL
B11	The clear floor space is without changes in level except for slopes up to 1:48 (2.08%). (ADAS 305.2)	21.7%

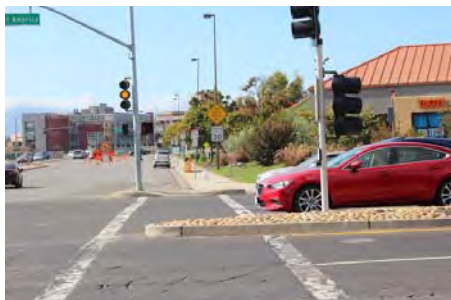
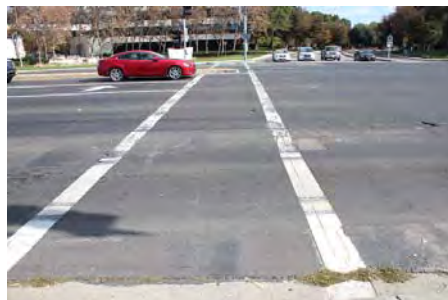
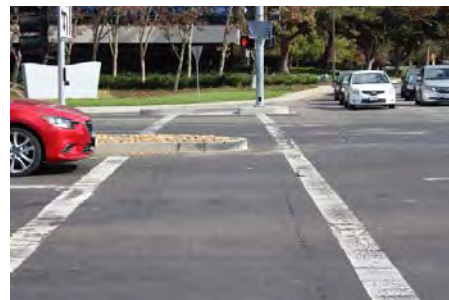
COD	CONDITION DESCRIPTION	ACTUAL
B02	36" min. clear width of exterior walkway. (ADAS 403.5.1)	Obstructed by mid crossing island to approx. 12" W.
B15	No level changes greater than 1/2" (except by accessible ramp or other means). (ADAS 303.4)	Sign indicates to push button and wait for walk signal, however user who cannot step up the curb must wait in traffic lanes.

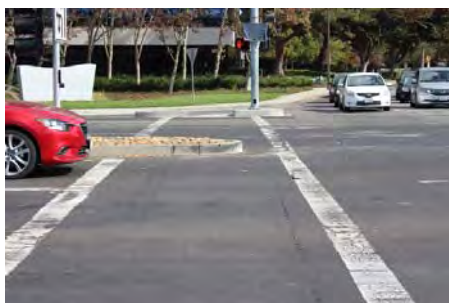
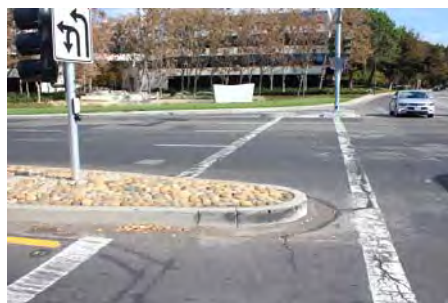
COD	CONDITION DESCRIPTION	ACTUAL
B41	Side reach over an obstruction greater than 10"d is max 46" AFF where the obstruction is max 34"AFF, and reach depth is no more than 24". (ADAS 308.3.2)	Over 24" away from clear space in crossing.

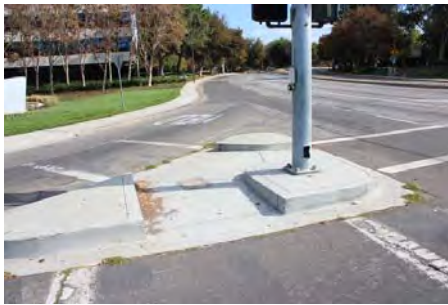
COD	CONDITION DESCRIPTION	ACTUAL
B41	Side reach over an obstruction greater than 10"d is max 46" AFF where the obstruction is max 34"AFF, and reach depth is no more than 24". (ADAS 308.3.2)	Approx. 52" AFF with reach of 21" over curb from clear space.

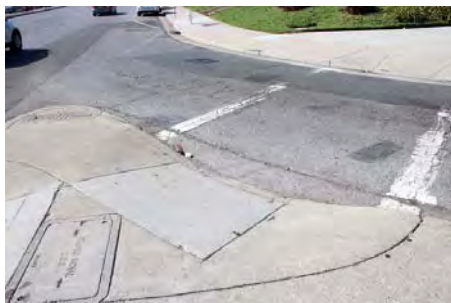
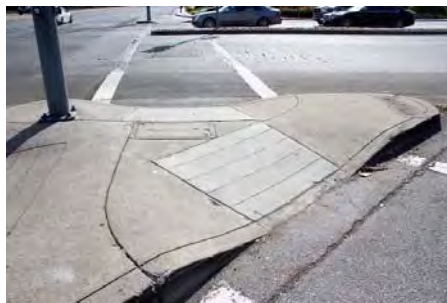
COD	CONDITION DESCRIPTION	ACTUAL
B03	Running slope of ramp is 1:12 (8.33%) max. (ADAS 405.2)	19.7% to 20.8%.
B05	Surface of ramp and landings complies with requirements for an accessible path of travel (stable, firm, slip-resistant, without gaps over 1/2" wide or edges over 1/4" high). (ADAS 302.1, 403.2, 403.3, 403.4)	1 3/4" gap at btm. Landing.
A17	Where no top landing is provided at an existing ramp, side flare slopes are 8.33% max. (ADAS 406.4)	26.9% left side, 16.0% right side.
B21	Islands - each curb ramp has a min. 48" long x 36" wide level landing at the top of the curb ramp, with the 48" length in the direction of the running slope of the curb ramp it serves. (ADAS 406.7)	3" to one adjacent curb ramp, 33" to a second adjacent curb ramp.

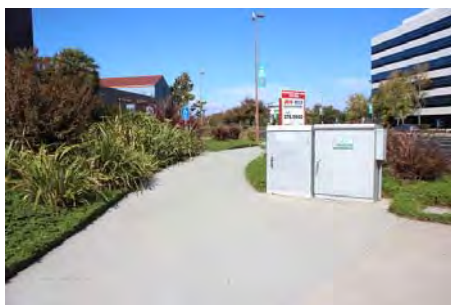
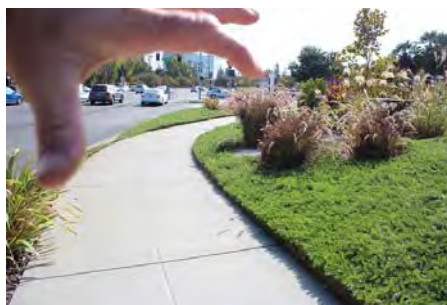
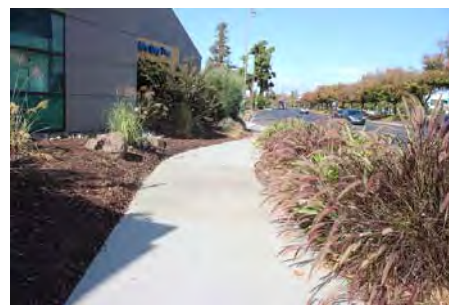
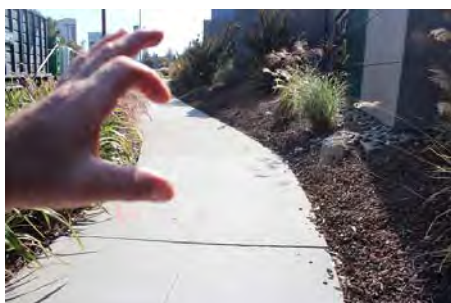
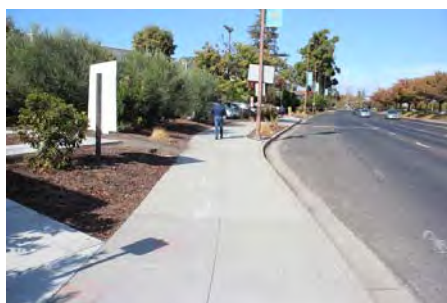
COD	CONDITION DESCRIPTION	ACTUAL
B16	Cross slope (perpendicular to direction of travel) is 1:48 (2.08%) max. (ADAS 403.3)	Approx. 240' L is 2.5% to 4.7%.

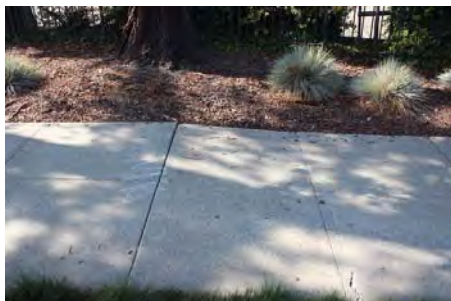
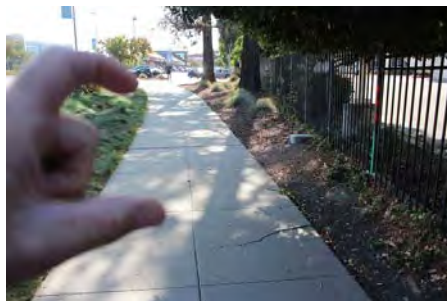
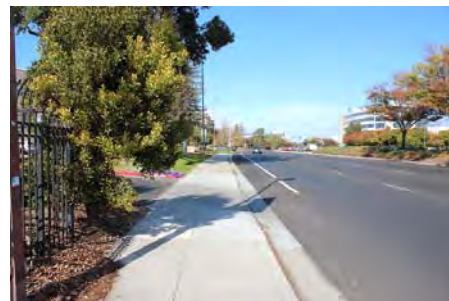
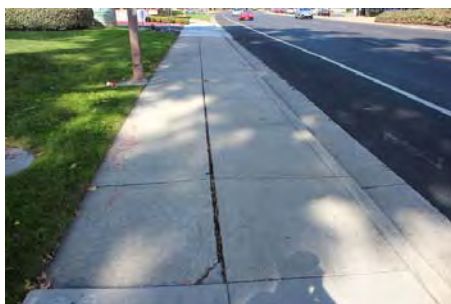
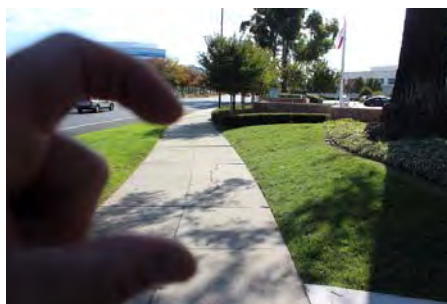
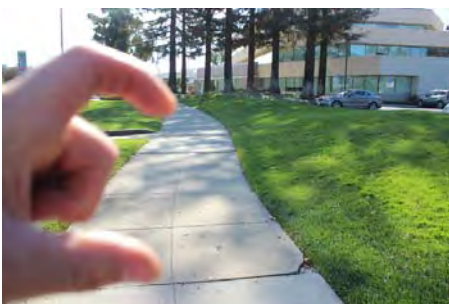
COD	CONDITION DESCRIPTION	ACTUAL
B12	Gaps/openings in ground or floor surfaces do not allow the passage of a sphere more than 1/2" in diameter. (ADAS 302.3)	Up to 2" W gap approx. 45' L.
B13	Gaps/openings are oriented perpendicular to dominant direction of travel. (ADAS 302.3)	Approx. 45' L gap in direction of travel.
B16	Cross slope (perpendicular to direction of travel) is 1:48 (2.08%) max. (ADAS 403.3)	Approx. 50' L is 2.7% to 3.0%.
B17	Running slope (parallel to direction of travel) is 1:20 (5.0%) max. (ADAS 403.3)	Approx. 10' L is up to 10.0%.

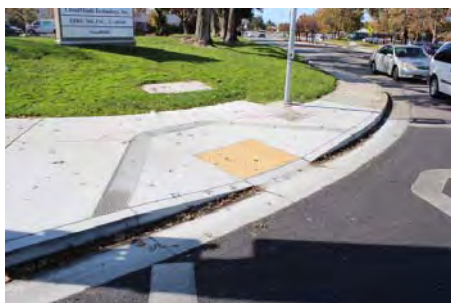
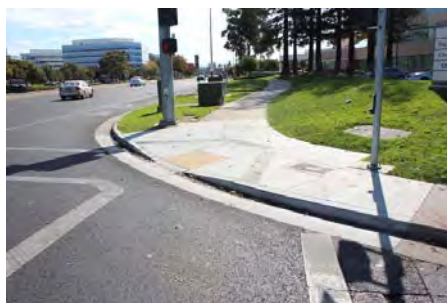
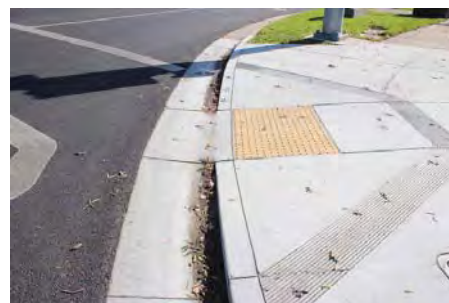
COD	CONDITION DESCRIPTION	ACTUAL
B03	Running slope of ramp is 1:12 (8.33%) max. (ADAS 405.2)	20.0% at btm. 2", 13.1% at btm. 2" to 6" (otherwise 7.4%).
B14	Counter slopes of adjoining gutters and road surfaces immediately adjacent to and within 24 inches of the curb ramp are not steeper than 1:20 (5.0%). (ADAS 406.2)	10.3%

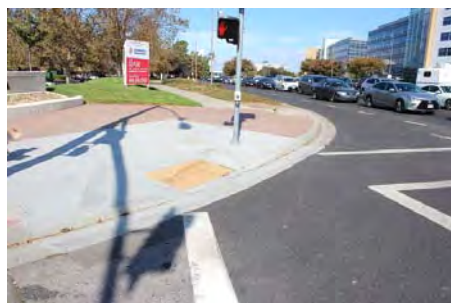
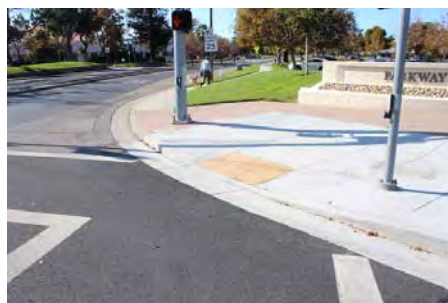
COD	CONDITION DESCRIPTION	ACTUAL
B03	Running slope of ramp is 1:12 (8.33%) max. (ADAS 405.2)	9.2% at btm. 6".
B14	Counter slopes of adjoining gutters and road surfaces immediately adjacent to and within 24 inches of the curb ramp are not steeper than 1:20 (5.0%). (ADAS 406.2)	9.4%

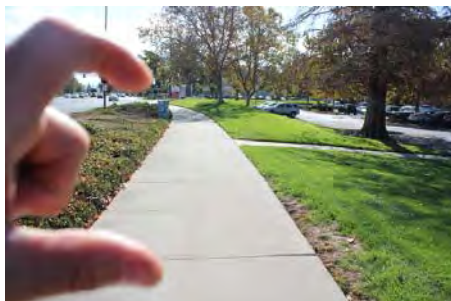
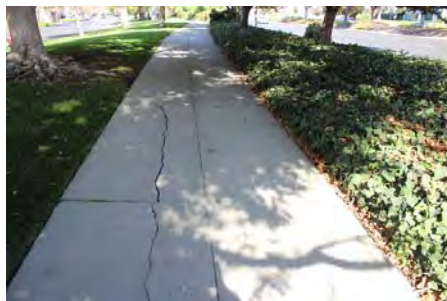
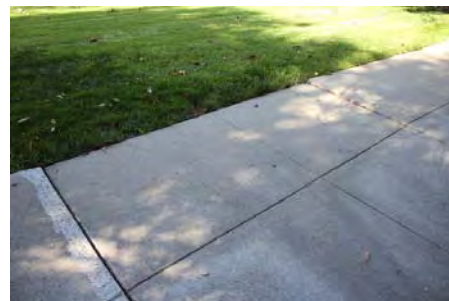
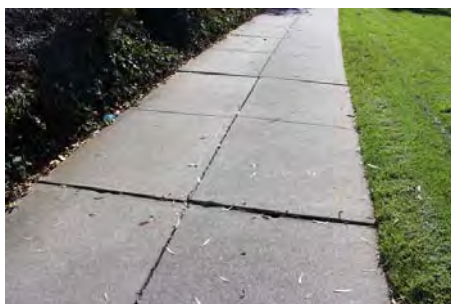
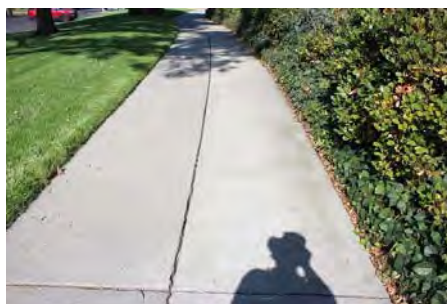
COD	CONDITION DESCRIPTION	ACTUAL
B12	Gaps/openings in ground or floor surfaces do not allow the passage of a sphere more than 1/2" in diameter. (ADAS 302.3)	Approx. 80' L gap exceeding 1/2" W in direction of travel.
B13	Gaps/openings are oriented perpendicular to dominant direction of travel. (ADAS 302.3)	Approx. 80' L gap exceeding 1/2" W in direction of travel.
B15	No level changes greater than 1/2" (except by accessible ramp or other means). (ADAS 303.4)	1" and 1 1/2" high vertical edge.
B16	Cross slope (perpendicular to direction of travel) is 1:48 (2.08%) max. (ADAS 403.3)	Approx. 770' L is 2.5% to 5.7%.

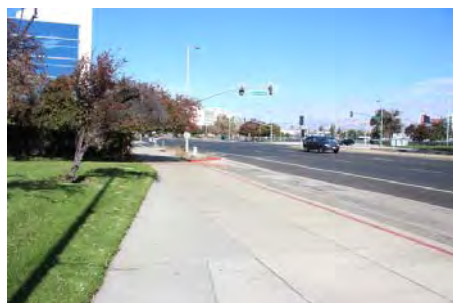
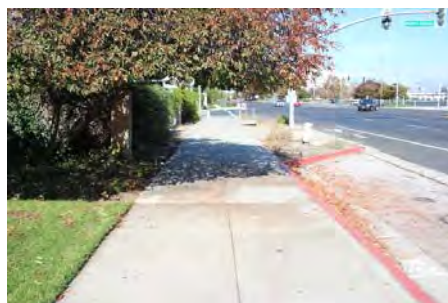
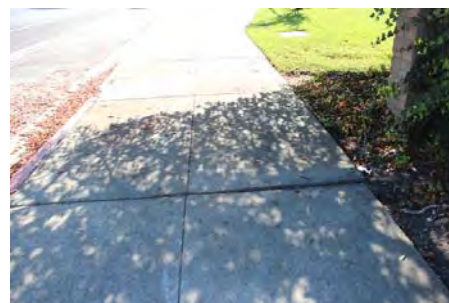
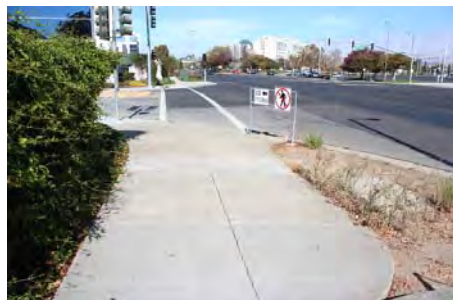
COD	CONDITION DESCRIPTION	ACTUAL
B15	No level changes greater than 1/2" (except by accessible ramp or other means). (ADAS 303.4)	1 1/2" high vertical edge.
B16	Cross slope (perpendicular to direction of travel) is 1:48 (2.08%) max. (ADAS 403.3)	Appox. 50' L is 2.7% to 6.0%.

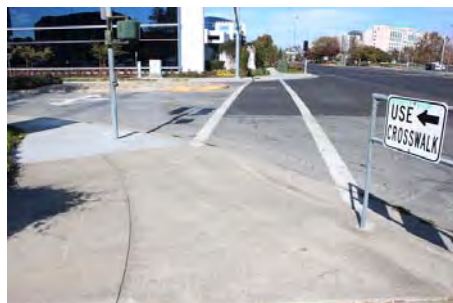
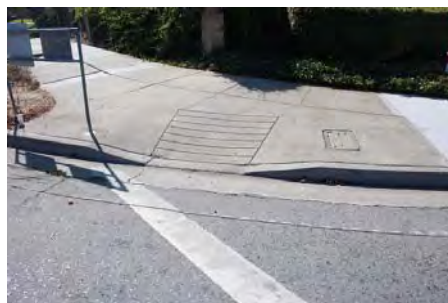
COD	CONDITION DESCRIPTION	ACTUAL
B03	Running slope of ramp is 1:12 (8.33%) max. (ADAS 405.2)	15.0%
B06	Transition to walk, gutter or street is flush and free of abrupt changes. (ADAS 406.2)	1/2" high vertical edge.
B14	Counter slopes of adjoining gutters and road surfaces immediately adjacent to and within 24 inches of the curb ramp are not steeper than 1:20 (5.0%). (ADAS 406.2)	10.5%
B16	Maximum slope of flared sides is 1:10 (10.0%). (ADAS 406.2)	14.4% right side, 14.5% left side.

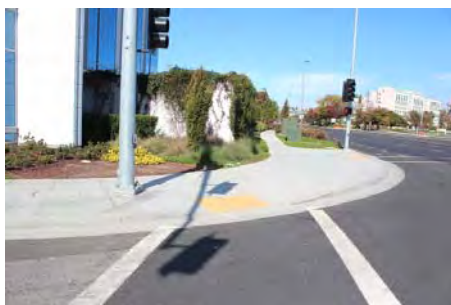
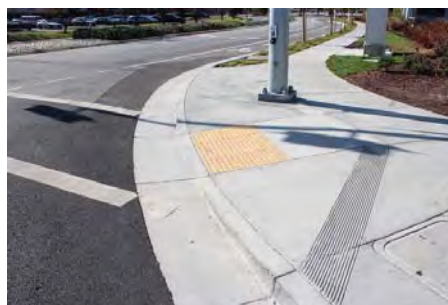
COD	CONDITION DESCRIPTION	ACTUAL
B14	Counter slopes of adjoining gutters and road surfaces immediately adjacent to and within 24 inches of the curb ramp are not steeper than 1:20 (5.0%). (ADAS 406.2)	10.0%

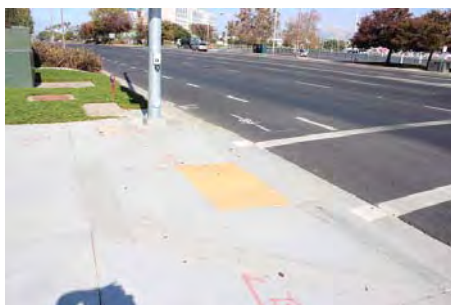
COD	CONDITION DESCRIPTION	ACTUAL
B14	Counter slopes of adjoining gutters and road surfaces immediately adjacent to and within 24 inches of the curb ramp are not steeper than 1:20 (5.0%). (ADAS 406.2)	6.9%
