Case No. 5:16-cv-07013-LHK (SVK)

**DECLARATION OF JEFFREY SCOTT
MASTIN IN SUPPORT OF PLAINTIFFS'
MOTION FOR CLASS CERTIFICATION**

NEVAREZ V 49ERS - ACCESSIBILITY ASSESSMENT

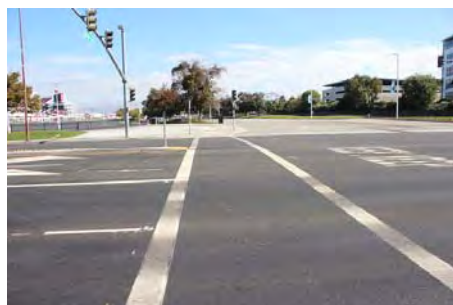
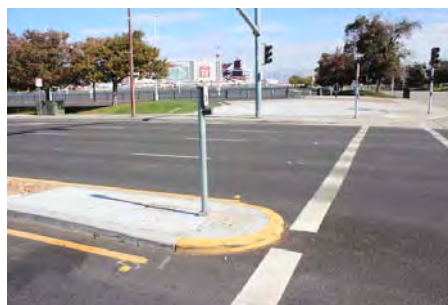
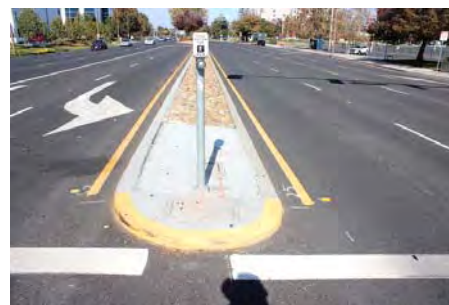
COD	CONDITION DESCRIPTION	ACTUAL
B15	No level changes greater than 1/2" (except by accessible ramp or other means). (ADAS 303.4)	User who cannot step up the curb must wait in traffic lanes.

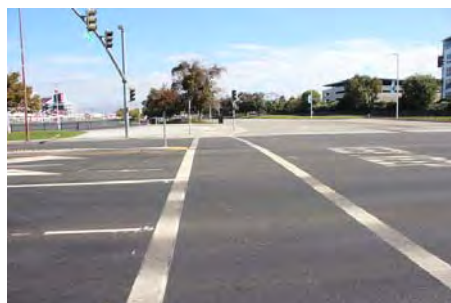
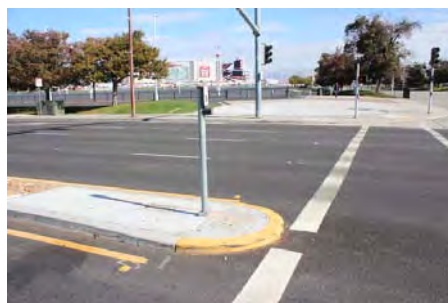
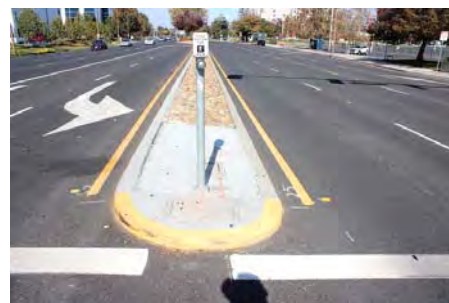
COD	CONDITION DESCRIPTION	ACTUAL
B41	Side reach over an obstruction greater than 10"d is max 46" AFF where the obstruction is max 34"AFF, and reach depth is no more than 24". (ADAS 308.3.2)	Over 28" from clear space and approx. 49" AFF.

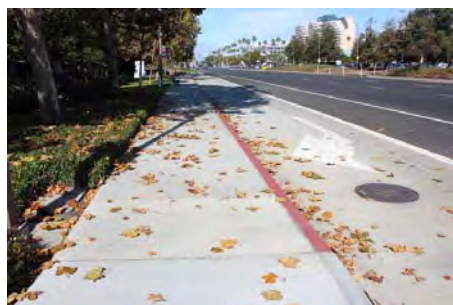
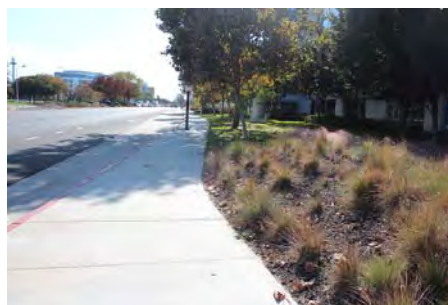
COD	CONDITION DESCRIPTION	ACTUAL
B16	Cross slope (perpendicular to direction of travel) is 1:48 (2.08%) max. (ADAS 403.3)	Approx. 280' L is 2.7% to 6.1%

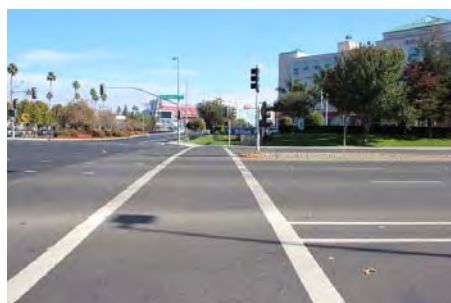
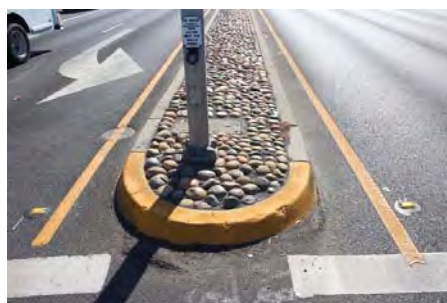
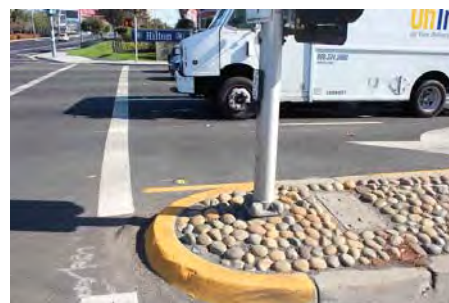
COD	CONDITION DESCRIPTION	ACTUAL
B15	No level changes greater than 1/2" (except by accessible ramp or other means). (ADAS 303.4)	Sign indicates to push button and wait for walk signal, however, user who cannot step up the curb must wait in traffic lanes.

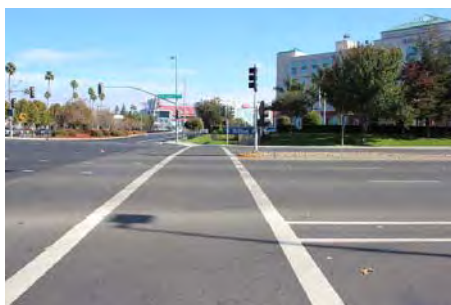
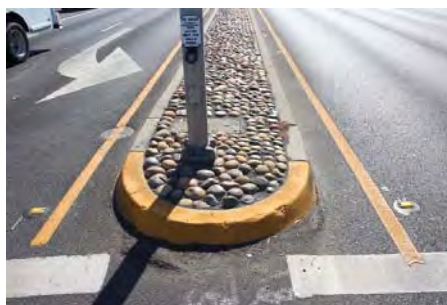
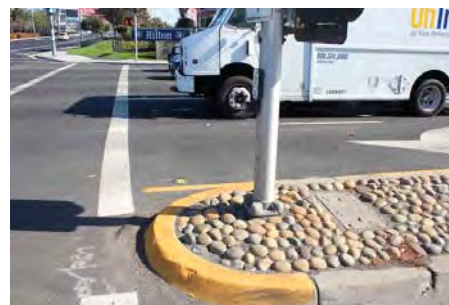
COD	CONDITION DESCRIPTION	ACTUAL
B41	Side reach over an obstruction greater than 10"d is max 46" AFF where the obstruction is max 34"AFF, and reach depth is no more than 24". (ADAS 308.3.2)	27" away from clear space.

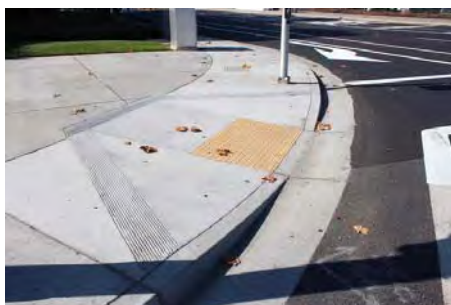
COD	CONDITION DESCRIPTION	ACTUAL
B14	Counter slopes of adjoining gutters and road surfaces immediately adjacent to and within 24 inches of the curb ramp are not steeper than 1:20 (5.0%). (ADAS 406.2)	9.5%

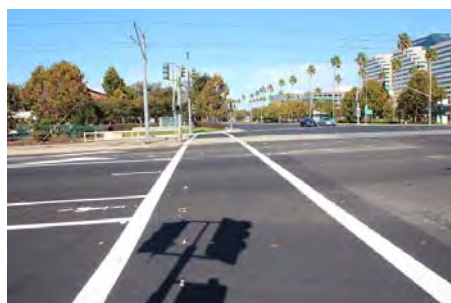
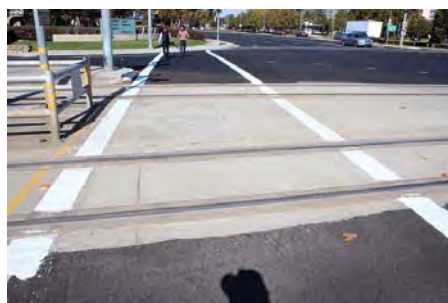
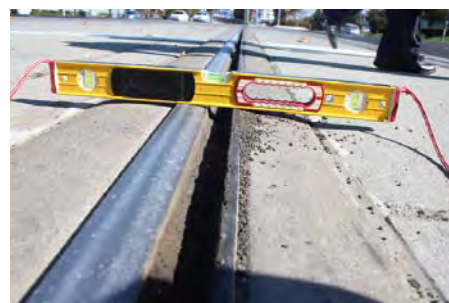
COD	CONDITION DESCRIPTION	ACTUAL
C40	Where pedestrian access routes cross rails: the route surface is flush with the outer edges of rails and the surface between rails is aligned with the top of the rail. (PROWAG R302.7.1)	Up to 1" H mounds at all 4 rails.

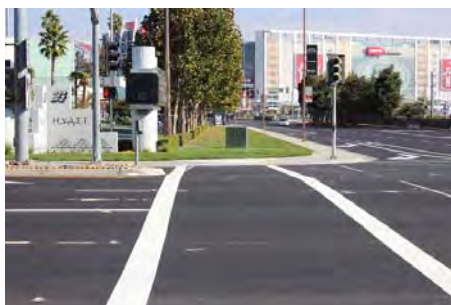
COD	CONDITION DESCRIPTION	ACTUAL
B15	No level changes greater than 1/2" (except by accessible ramp or other means). (ADAS 303.4)	User who cannot step up the curb must wait in traffic lanes.

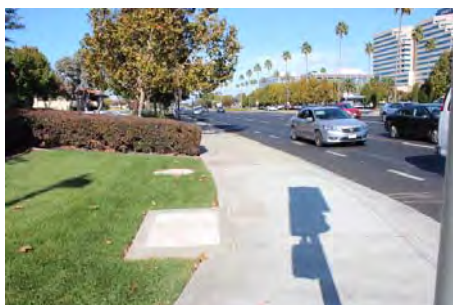
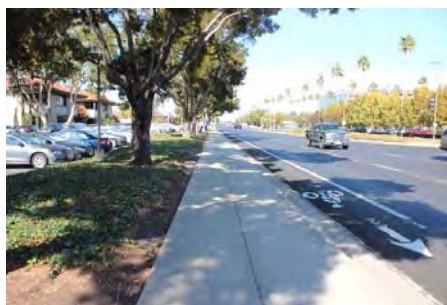
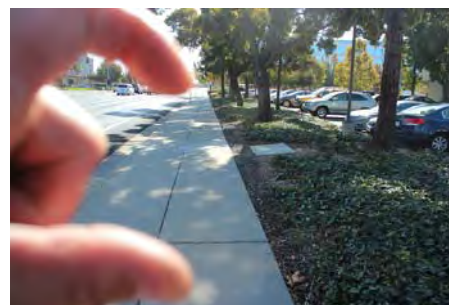
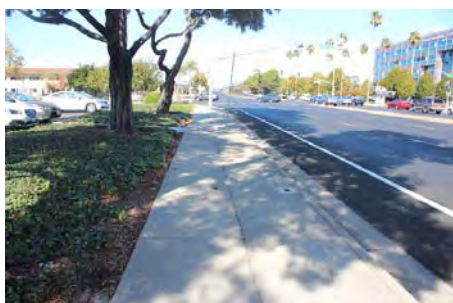
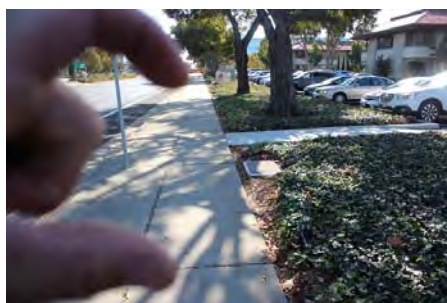
COD	CONDITION DESCRIPTION	ACTUAL
B16	Cross slope (perpendicular to direction of travel) is 1:48 (2.08%) max. (ADAS 403.3)	Approx. 80' L is 2.7% to 4.0%

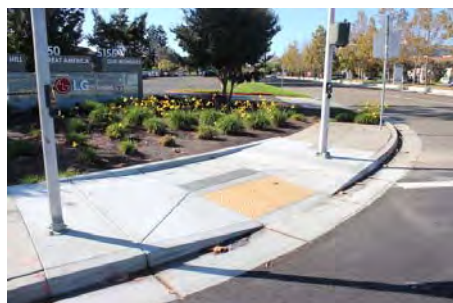
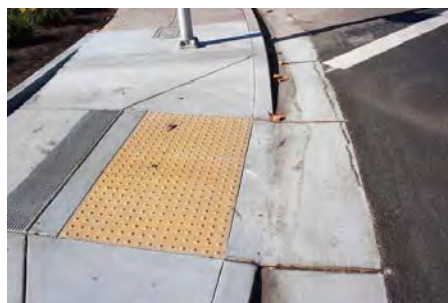
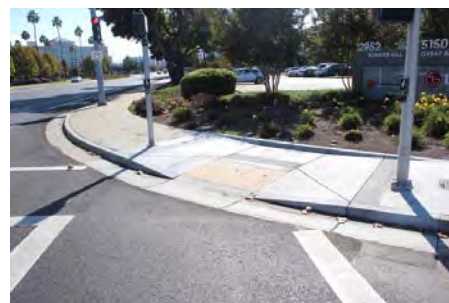
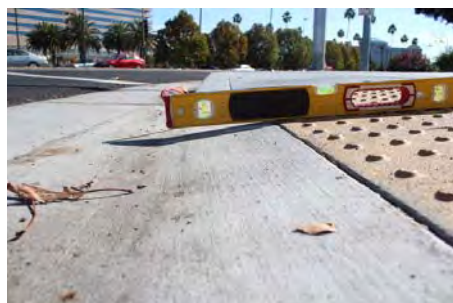
COD	CONDITION DESCRIPTION	ACTUAL
B03	Running slope of ramp is 1:12 (8.33%) max. (ADAS 405.2)	16.4% Across curb face.

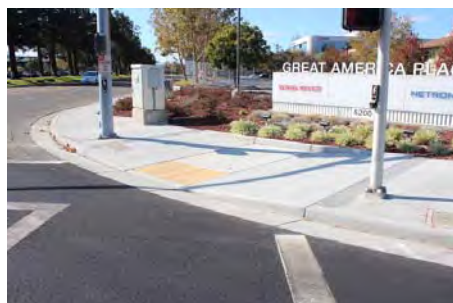
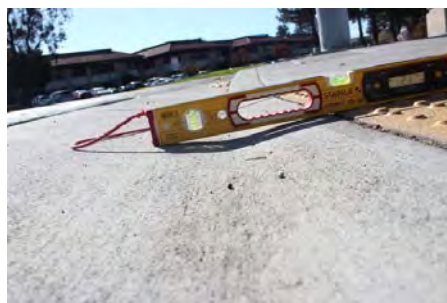
COD	CONDITION DESCRIPTION	ACTUAL
B06	Transition to walk, gutter or street is flush and free of abrupt changes. (ADAS 406.2)	13.1% gutter meets opposite slope of 10.5% for combined slope of 23.6%.
C11	Min. 48" x 48" turning space is provided at bottom of curb ramp. (ADAS 403.3)	10.5% Across curb face.

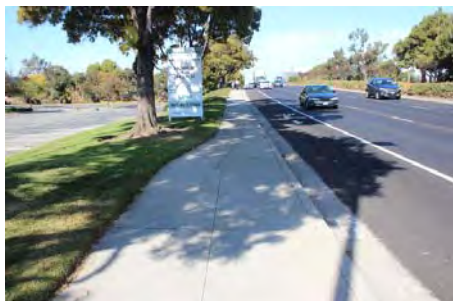
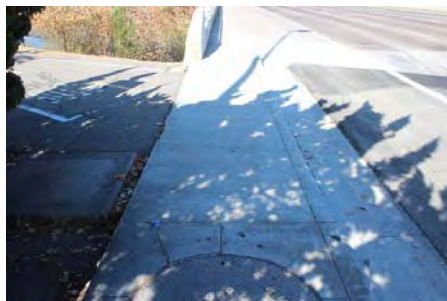
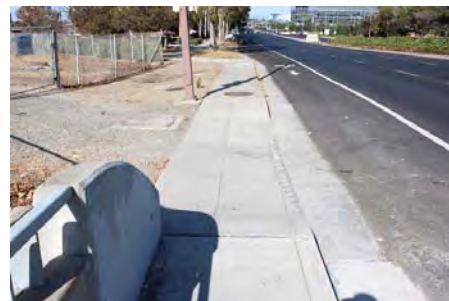
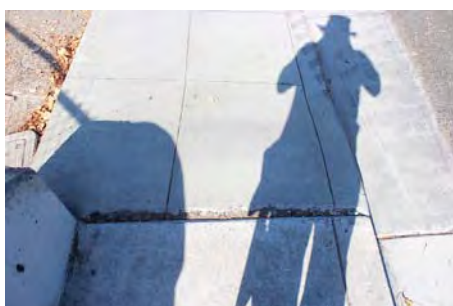
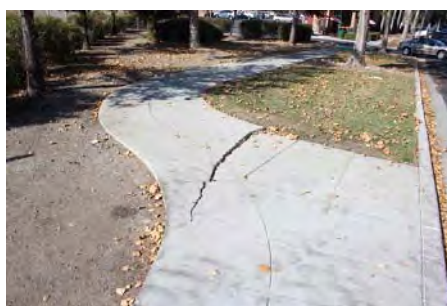
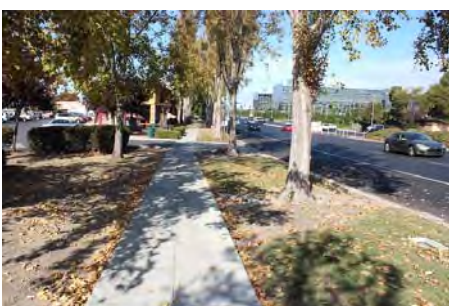
NEVAREZ V 49ERS - ACCESSIBILITY ASSESSMENT**FACILITY/SITE: 1. Great America Pky.****SEQ.
#****88****FEATURE: #11 ACC ROUTE OF TRAVEL****LOCATION: W side of the street.****MEMO: Between Bunker Hill Lane and southern retail entrance drive S of Old Mountain View Rd.****Notes:****CONDITIONS THAT DO NOT CONFORM TO NEW CONSTRUCTION STANDARDS**

COD	CONDITION DESCRIPTION	ACTUAL
B12	Gaps/openings in ground or floor surfaces do not allow the passage of a sphere more than 1/2" in diameter. (ADAS 302.3)	2" gap at transition to bridge and 1" gap at raised crack.
B15	No level changes greater than 1/2" (except by accessible ramp or other means). (ADAS 303.4)	1 1/2" high vertical edge.
B16	Cross slope (perpendicular to direction of travel) is 1:48 (2.08%) max. (ADAS 403.3)	Approx. 40' L is 2.6% to 3.6% and 7.5% to 8.3% at 2 driveway aprons at each side of the bridge.
B17	Running slope (parallel to direction of travel) is 1:20 (5.0%) max. (ADAS 403.3)	14.8% and 27.0% at 2 driveway aprons at each side of bridge.

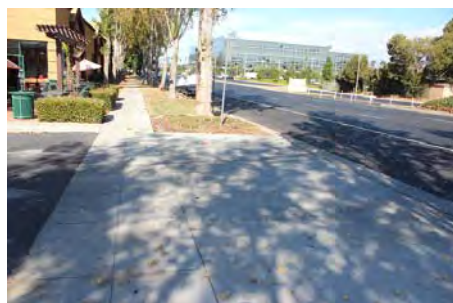
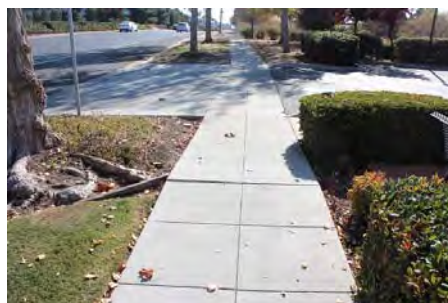
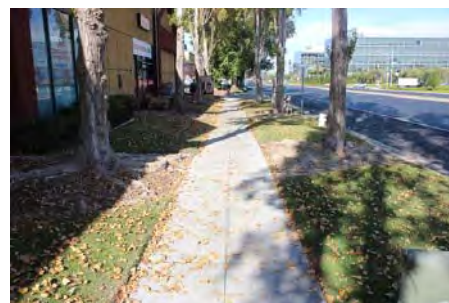
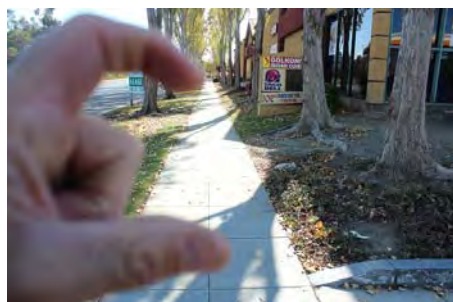
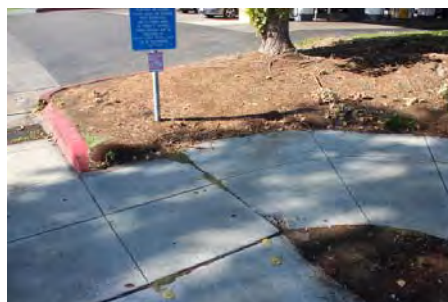
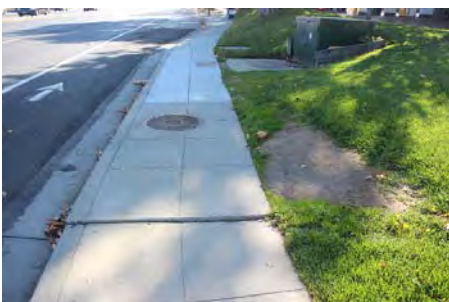
CONDITIONS THAT DO NOT CONFORM TO NEW CONSTRUCTION STANDARDS

COD	CONDITION DESCRIPTION	ACTUAL
B15	No level changes greater than 1/2" (except by accessible ramp or other means). (ADAS 303.4)	3/4" and 7/8" high vertical edge.
B16	Cross slope (perpendicular to direction of travel) is 1:48 (2.08%) max. (ADAS 403.3)	Approx. 240' L is 2.6% to 7.5%.

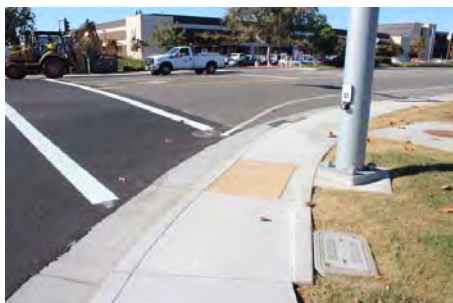
FACILITY/SITE: 2. Tasman Dr.**SEQ.
#****201****FEATURE: #9 PARALLEL CURB RAMP****LOCATION: Int. of Patrick Henry Drive.****MEMO: NE corner serving N crossing of Patrick Henry drive.****Notes:**

Appears recently constructed and in repave zone.

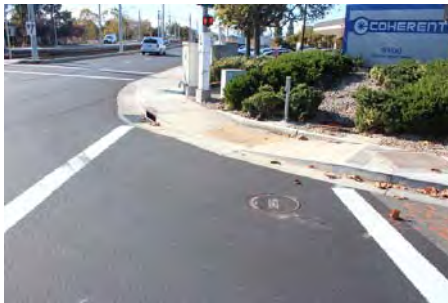
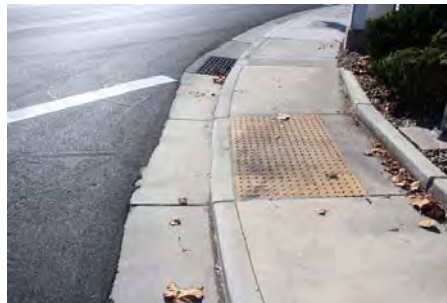
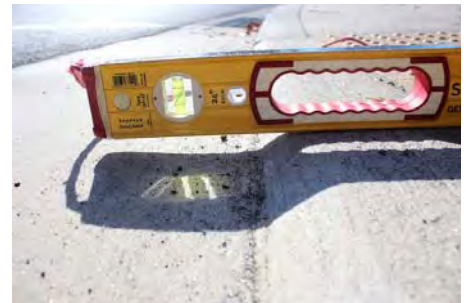
CONDITIONS THAT DO NOT CONFORM TO NEW CONSTRUCTION STANDARDS

CODE	CONDITION DESCRIPTION	ACTUAL
B06 406.2)	Transition to walk, gutter or street is flush and free of abrupt changes. (ADAS	1/2" high vertical edge.

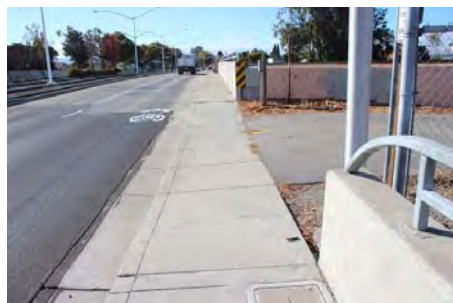
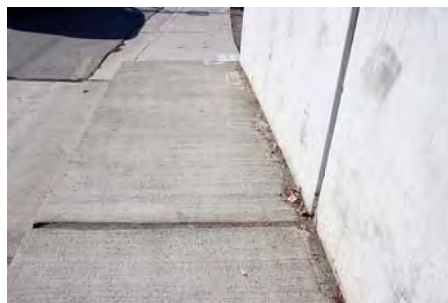
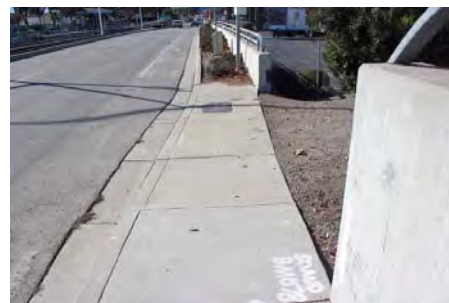
CONDITIONS THAT DO NOT CONFORM TO NEW CONSTRUCTION STANDARDS

CODE	CONDITION DESCRIPTION	ACTUAL
B11	Surface is firm, stable and slip-resistant. (ADAS 302.1)	Sidewalk ends near Calabasas Creek trail.
B12	Gaps/openings in ground or floor surfaces do not allow the passage of a sphere more than 1/2" in diameter. (ADAS 302.3)	1 3/4" W at expansion joint
B16	Cross slope (perpendicular to direction of travel) is 1:48 (2.08%) max. (ADAS 403.3)	Up to 4.9% at driveway aprons.
B17	Running slope (parallel to direction of travel) is 1:20 (5.0%) max. (ADAS 403.3)	9.6% and 11.5% at 2 driveway aprons.

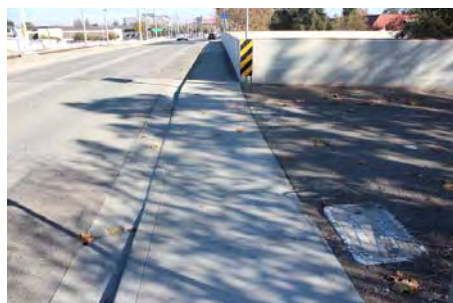
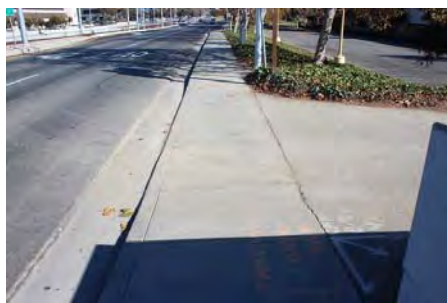
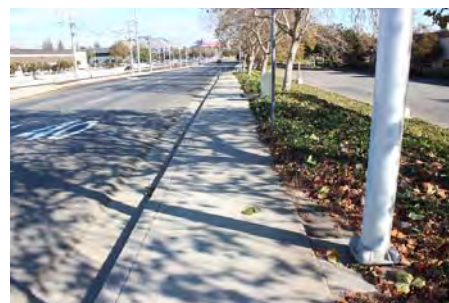
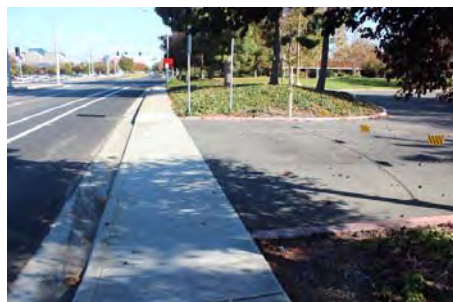
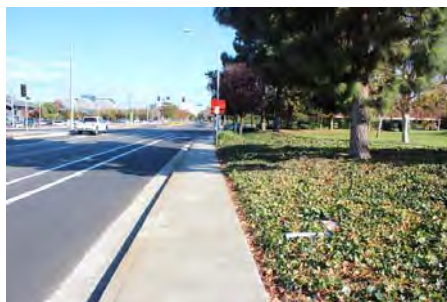
NEVAREZ V 49ERS - ACCESSIBILITY ASSESSMENT**FACILITY/SITE: 2. Tasman Dr.****SEQ.
#****205****FEATURE: #11 ACC ROUTE OF TRAVEL****LOCATION: S side of the street.****MEMO: Between Calabasas Creek Trail and lateral walkway to Blue Lot #3.****Notes:****CONDITIONS THAT DO NOT CONFORM TO NEW CONSTRUCTION STANDARDS**

CODE	CONDITION DESCRIPTION	ACTUAL
B16	Cross slope (perpendicular to direction of travel) is 1:48 (2.08%) max. (ADAS 403.3)	Approx. 160' L is 2.5% to 4.9% and up to 11.1% at Driveway apron.
B17	Running slope (parallel to direction of travel) is 1:20 (5.0%) max. (ADAS 403.3)	14.7% and 14.6% at drive aisle.

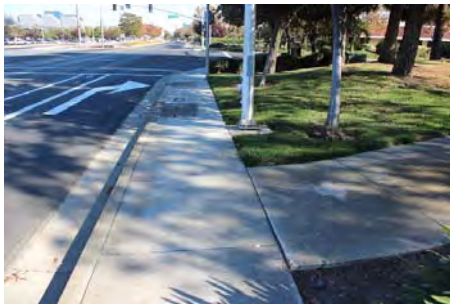
NEVAREZ V 49ERS - ACCESSIBILITY ASSESSMENT**FACILITY/SITE: 2. Tasman Dr.****SEQ.
#****206****FEATURE: #11 ACC ROUTE OF TRAVEL****LOCATION: S side of the street.****MEMO: Between lateral walkway to Blue Lot #3 and Patrick Henry Drive.****Notes:****CONDITIONS THAT DO NOT CONFORM TO NEW CONSTRUCTION STANDARDS**

CODE	CONDITION DESCRIPTION	ACTUAL
B16	Cross slope (perpendicular to direction of travel) is 1:48 (2.08%) max. (ADAS 403.3)	Approx. 30' L is 3.2% to 3.7%.

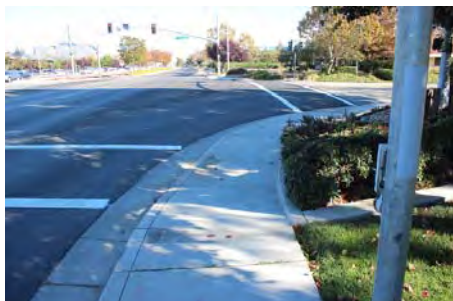
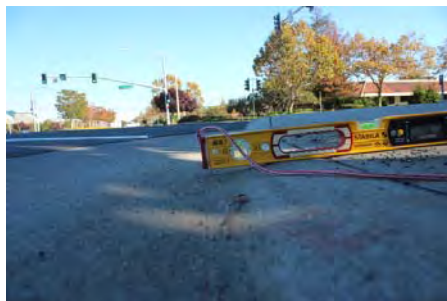
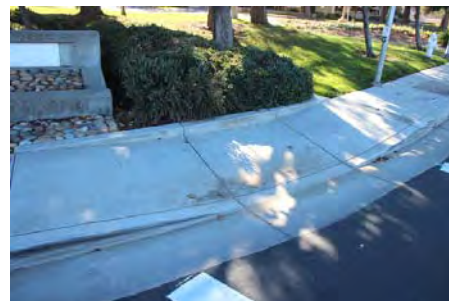
CONDITIONS THAT DO NOT CONFORM TO NEW CONSTRUCTION STANDARDS

CODE	CONDITION DESCRIPTION	ACTUAL
B04	Cross slope is 1:48 (2.08%) max. (ADAS 405.3)	3.0% at W side ramp.
B06	Transition to walk, gutter or street is flush and free of abrupt changes. (ADAS 406.2)	17.7% for 2" L at gutter.
C12	Turning space at bottom of curb ramp slopes 1:48 (2.08%) max. in any direction (ADAS 403.3)	3.2% to 3.6%
B13	Counter slopes of adjoining gutters and road surfaces immediately adjacent to and within 24 inches of the curb ramp are not steeper than 1:20 (5.0%). (ADAS 406.2)	8.7%

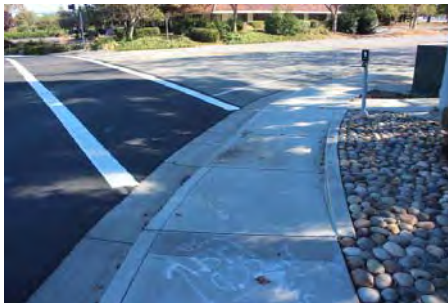
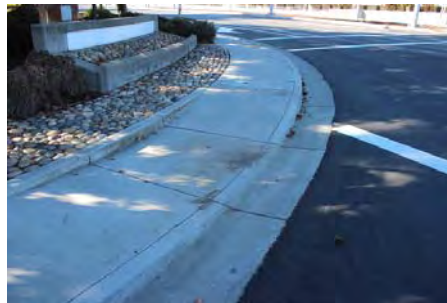
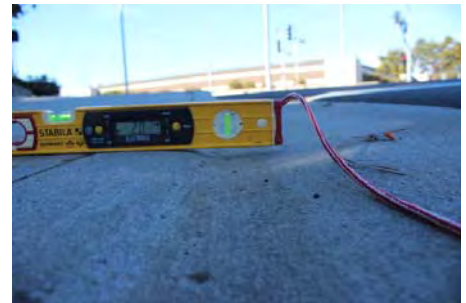
NEVAREZ V 49ERS - ACCESSIBILITY ASSESSMENT**FACILITY/SITE: 2. Tasman Dr.****SEQ.
#****208****FEATURE: #9 PARALLEL CURB RAMP****LOCATION: Int. of Patrick Henry Drive.****MEMO: SW corner serving S crossing of Patrick Henry Drive.****Notes:**

CODE	CONDITION DESCRIPTION	ACTUAL
B13	Counter slopes of adjoining gutters and road surfaces immediately adjacent to and within 24 inches of the curb ramp are not steeper than 1:20 (5.0%). (ADAS 406.2)	7.0% generally and 25.0% for 1" L.

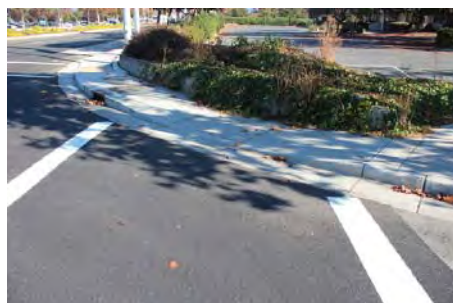
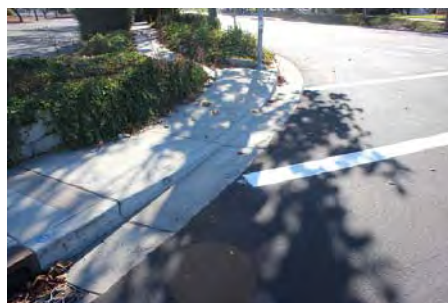
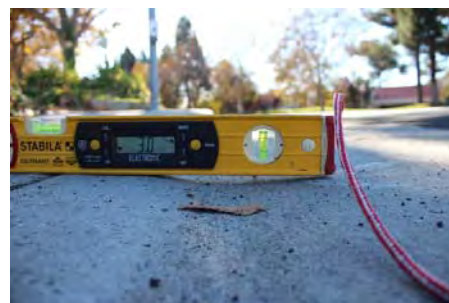
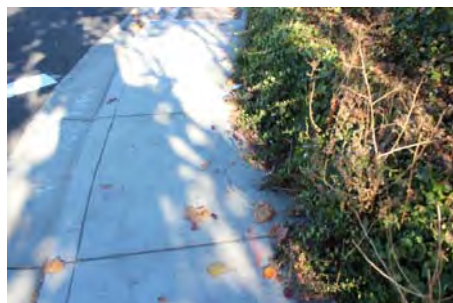
NEVAREZ V 49ERS - ACCESSIBILITY ASSESSMENT**FACILITY/SITE: 2. Tasman Dr.****SEQ.
#****209****FEATURE: #9 PARALLEL CURB RAMP****LOCATION: Int. of Patrick Henry Drive.****MEMO: SE corner serving S crossing of Patrick Henry Drive.****Notes:**

CODE	CONDITION DESCRIPTION	ACTUAL
B02	The width of curb ramp is 36" min. (ADAS 405.5)	Partially obstructed by landscaping.
B06	Transition to walk, gutter or street is flush and free of abrupt changes. (ADAS 406.2)	1/2" high vertical edge
C12	Turning space at bottom of curb ramp slopes 1:48 (2.08%) max. in any direction (ADAS 403.3)	2.5% to 3.2%

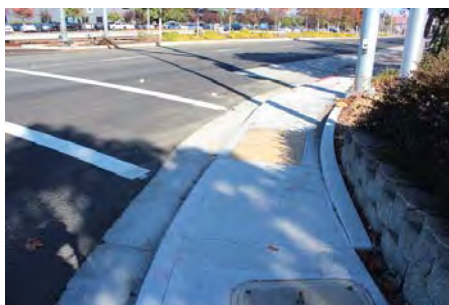
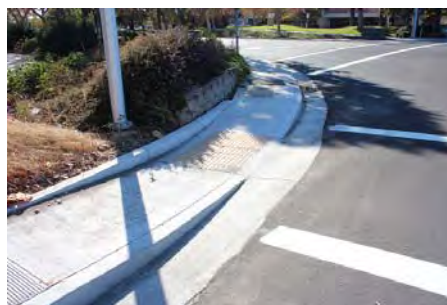
CONDITIONS THAT DO NOT CONFORM TO NEW CONSTRUCTION STANDARDS

CODE	CONDITION DESCRIPTION	ACTUAL
B13	Counter slopes of adjoining gutters and road surfaces immediately adjacent to and within 24 inches of the curb ramp are not steeper than 1:20 (5.0%). (ADAS 406.2)	9.6% for 2" L.

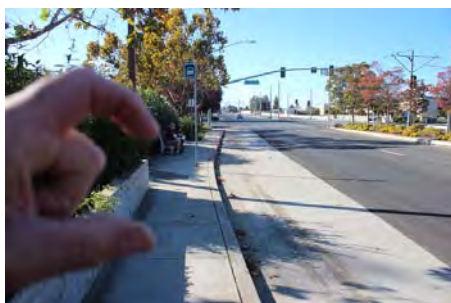
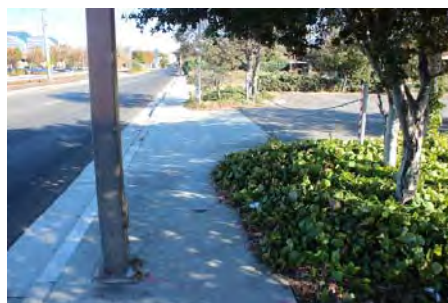
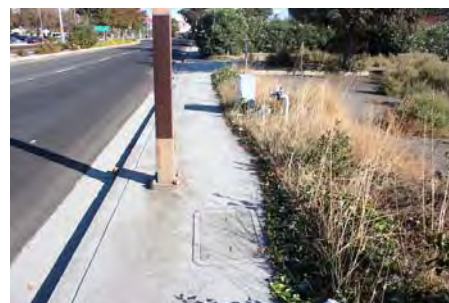
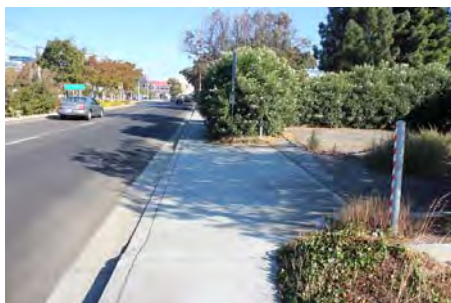
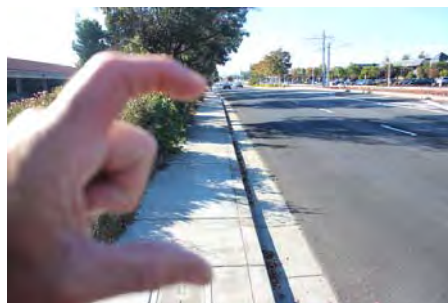
NEVAREZ V 49ERS - ACCESSIBILITY ASSESSMENT**FACILITY/SITE: 2. Tasman Dr.****SEQ.
#****211****FEATURE: #11 ACC ROUTE OF TRAVEL****LOCATION: S side of the street.****MEMO: Between Patrick Henry drive and Old Ironsides Drive.****Notes:****CONDITIONS THAT DO NOT CONFORM TO NEW CONSTRUCTION STANDARDS**

CODE	CONDITION DESCRIPTION	ACTUAL
B02	36" min. clear width of exterior walkway. (ADAS 403.5.1)	Landscape reduces width to 33" W at light post and 34" W near Ironsides drive.
B16	Cross slope (perpendicular to direction of travel) is 1:48 (2.08%) max. (ADAS 403.3)	Approx. 220' L is 2.6% to 4.5% and 5 drive aisles causing slopes from 4.5% to 10.8%.
B17	Running slope (parallel to direction of travel) is 1:20 (5.0%) max. (ADAS 403.3)	5 drive aisles causing slopes in 10 sections from 12.2% to 19.8%.

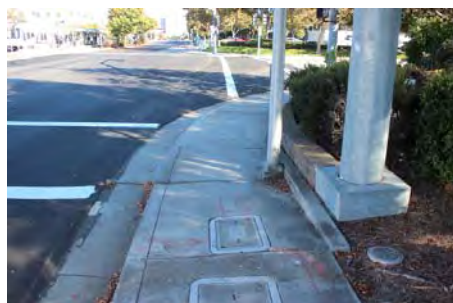
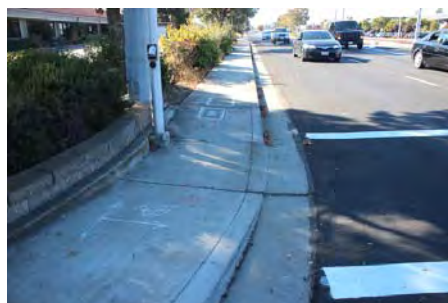
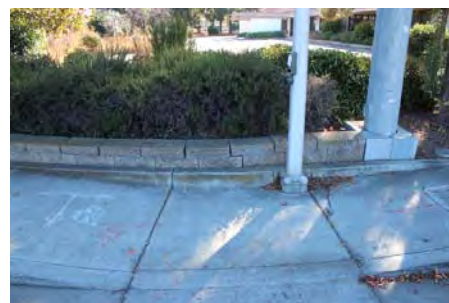
CODE	CONDITION DESCRIPTION	ACTUAL
B04	Cross slope is 1:48 (2.08%) max. (ADAS 405.3)	3.4% at W side ramp.
B06	Transition to walk, gutter or street is flush and free of abrupt changes. (ADAS 406.2)	3/8" high vertical edge.
C12	Turning space at bottom of curb ramp slopes 1:48 (2.08%) max. in any direction (ADAS 403.3)	Up to 3.3%.

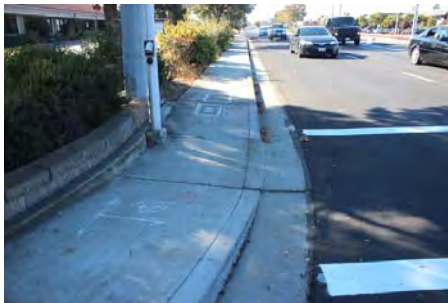
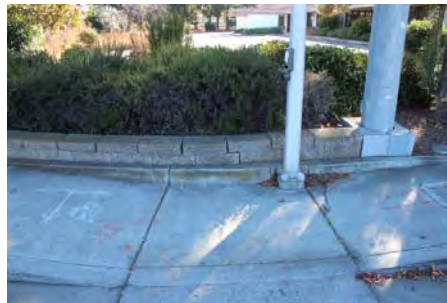
CODE	CONDITION DESCRIPTION	ACTUAL
B11	The clear floor space is without changes in level except for slopes up to 1:48 (2.08%). (ADAS 305.2)	3.3% at cross walk button.

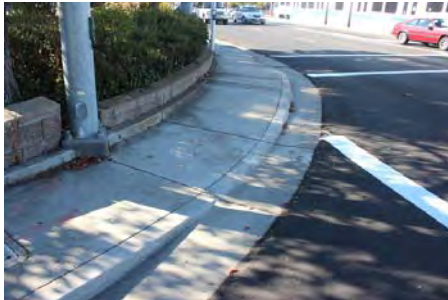
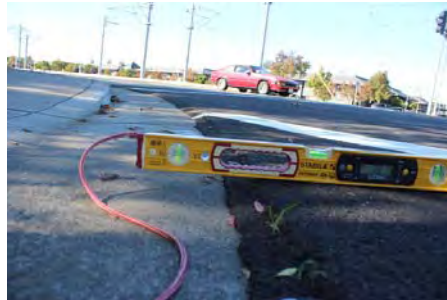
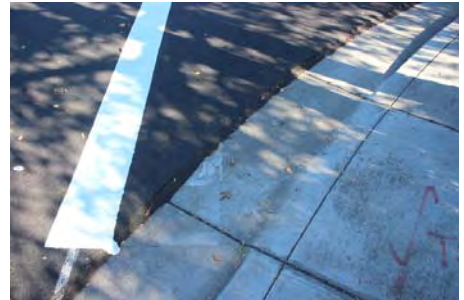
CODE	CONDITION DESCRIPTION	ACTUAL
B05	Surface of ramp and landings complies with requirements for an accessible path of travel (stable, firm, slip-resistant, without gaps over 1/2" wide or edges over 1/4" high). (ADAS 405.4)	1 1/8" high vertical edge at asphalt transition.
C12	Turning space at bottom of curb ramp slopes 1:48 (2.08%) max. in any direction (ADAS 403.3)	3.1%

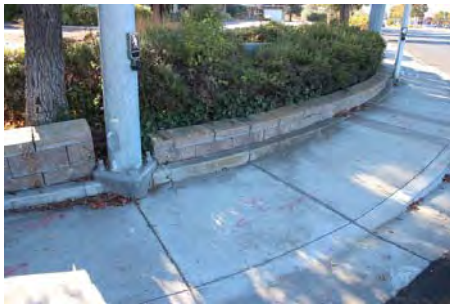
CODE	CONDITION DESCRIPTION	ACTUAL
B11	The clear floor space is without changes in level except for slopes up to 1:48 (2.08%). (ADAS 305.2)	3.3% at cross walk button.

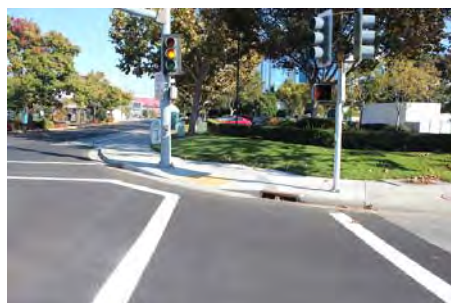
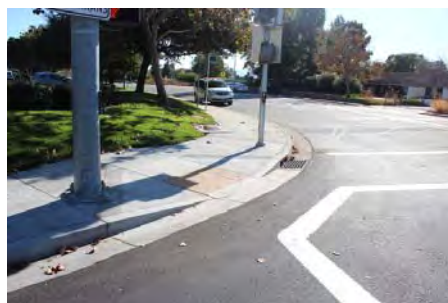
CODE	CONDITION DESCRIPTION	ACTUAL
B14	1/4" to 1/2" level changes are beveled at max 1:2 (vert:horiz) slope. (ADAS 303.3)	7.0%

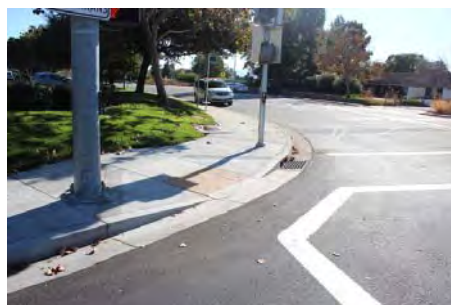
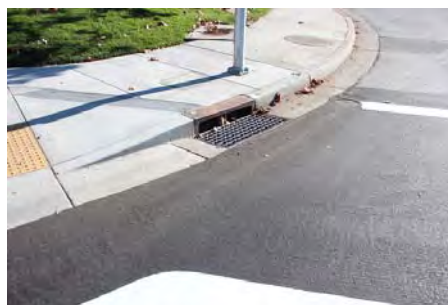
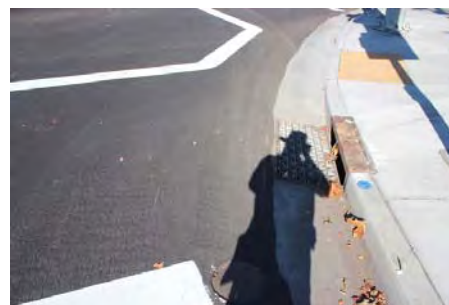
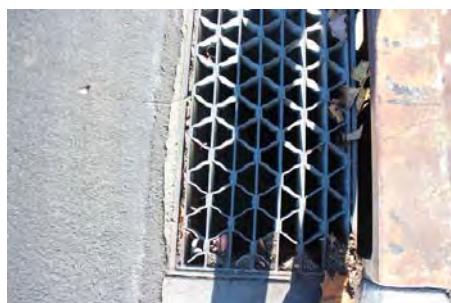
CODE	CONDITION DESCRIPTION	ACTUAL
B12	Gaps/openings in ground or floor surfaces do not allow the passage of a sphere more than 1/2" in diameter. (ADAS 302.3)	2" openings at grate near SE corner.

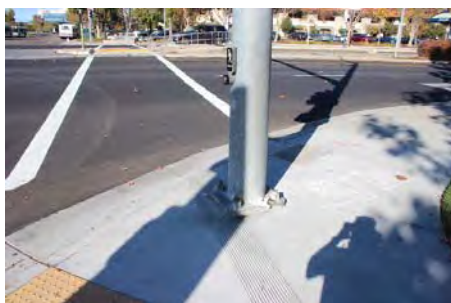
CODE	CONDITION DESCRIPTION	ACTUAL
B11	The clear floor space is without changes in level except for slopes up to 1:48 (2.08%). (ADAS 305.2)	13.1% at cross walk button.

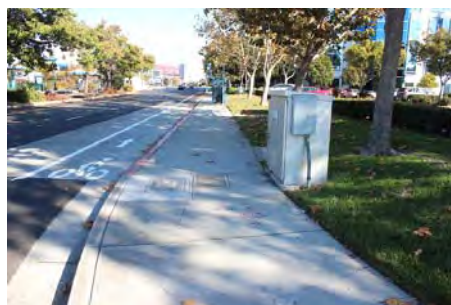
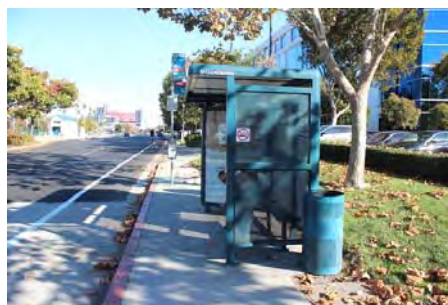
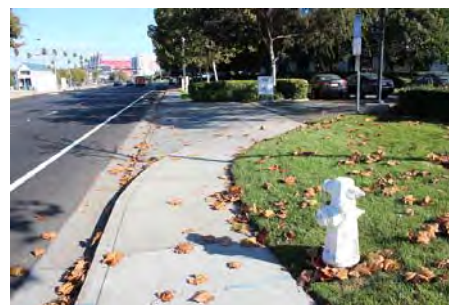
CODE	CONDITION DESCRIPTION	ACTUAL
B16	Cross slope (perpendicular to direction of travel) is 1:48 (2.08%) max. (ADAS 403.3)	Approx. 100' L is 2.6% to 5.1%.

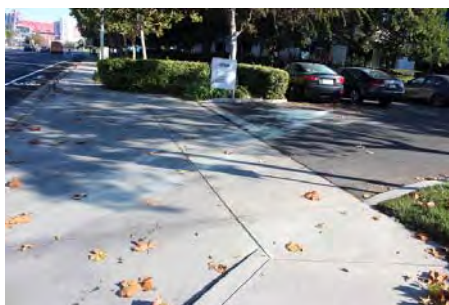
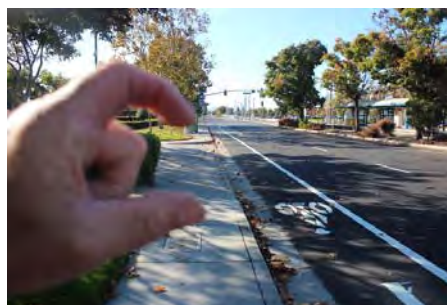
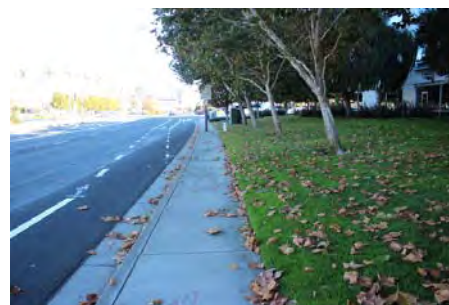
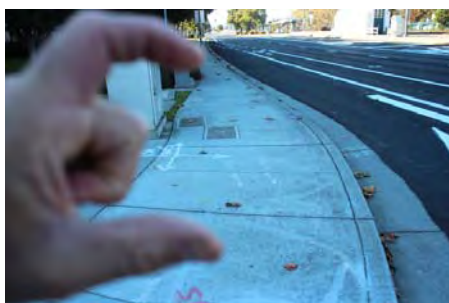
CODE	CONDITION DESCRIPTION	ACTUAL
B16	Cross slope (perpendicular to direction of travel) is 1:48 (2.08%) max. (ADAS 403.3)	Approx. 100' L is 2.7% to 4.1%.

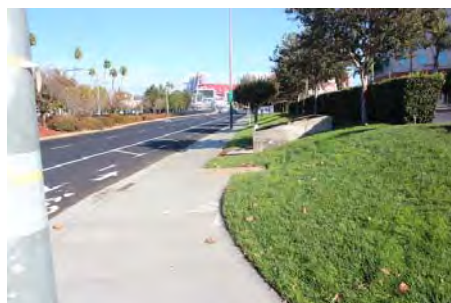
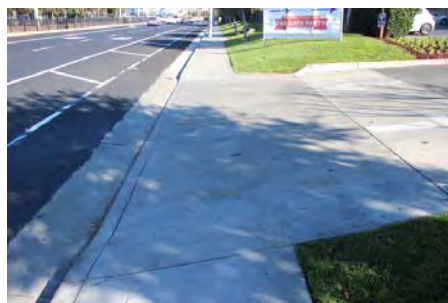
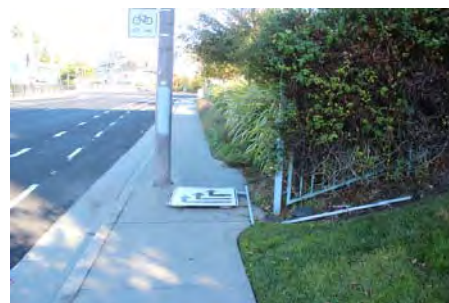
CODE	CONDITION DESCRIPTION	ACTUAL
B16	Cross slope (perpendicular to direction of travel) is 1:48 (2.08%) max. (ADAS 403.3)	Approx. 340' L is 2.5% to 5.0% and 6.9% across Hilton drive aisle.
B17	Running slope (parallel to direction of travel) is 1:20 (5.0%) max. (ADAS 403.3)	15.2% and 21.4% at Hilton drive aisle.

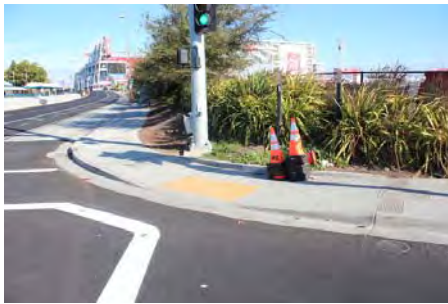
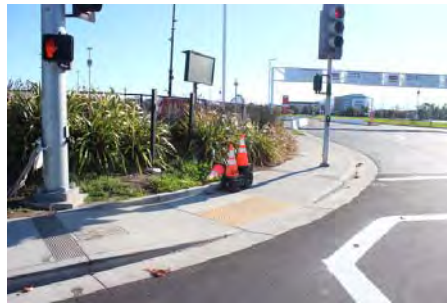
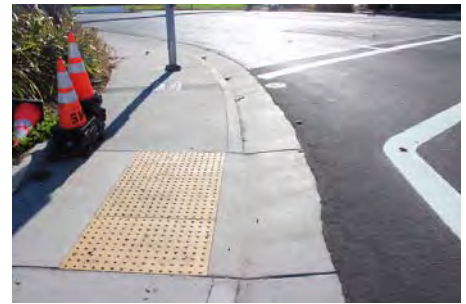
CODE	CONDITION DESCRIPTION	ACTUAL
B02	The width of curb ramp is 36" min. (ADAS 405.5)	Obstructed by traffic cones.
C12	Turning space at bottom of curb ramp slopes 1:48 (2.08%) max. in any direction (ADAS 403.3)	2.4% to 3.0% and 4.9% across curb face.
B13	Counter slopes of adjoining gutters and road surfaces immediately adjacent to and within 24 inches of the curb ramp are not steeper than 1:20 (5.0%). (ADAS 406.2)	8.7%

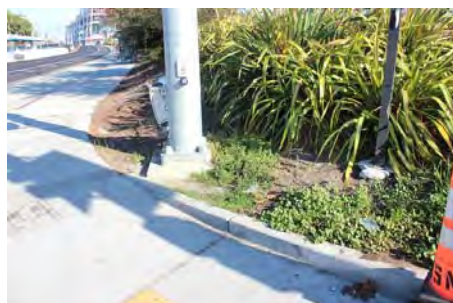
CODE	CONDITION DESCRIPTION	ACTUAL
B11	The clear floor space is without changes in level except for slopes up to 1:48 (2.08%). (ADAS 305.2)	4.1% at cross walk button.
B41	Side reach over an obstruction greater than 10"d is max 46" AFF where the obstruction is max 34"AFF, and reach depth is no more than 24". (ADAS 308.3.2)	25" reach over curb to cross walk button.

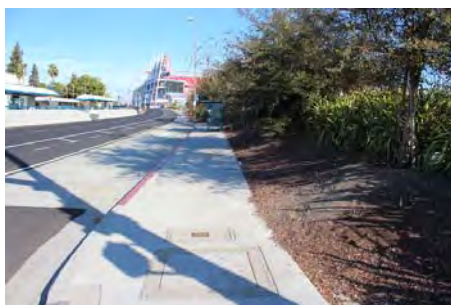
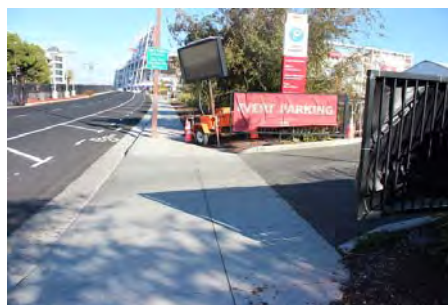
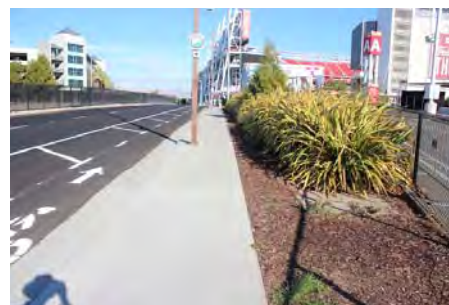
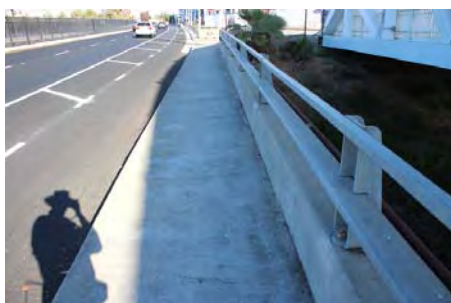
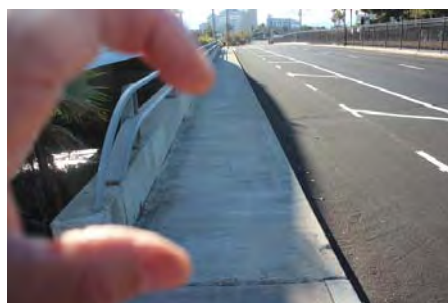
NEVAREZ V 49ERS - ACCESSIBILITY ASSESSMENT**FACILITY/SITE: 2. Tasman Dr.****SEQ.
#****225****FEATURE: #11 ACC ROUTE OF TRAVEL****LOCATION: S side of the street.****MEMO: Between Convention Center and Stadium entrance.****Notes:****CONDITIONS THAT DO NOT CONFORM TO NEW CONSTRUCTION STANDARDS**

CODE	CONDITION DESCRIPTION	ACTUAL
B16	Cross slope (perpendicular to direction of travel) is 1:48 (2.08%) max. (ADAS 403.3)	Approx. 120' L is 2.8% to 3.5% and 2.7% across drive aisle.

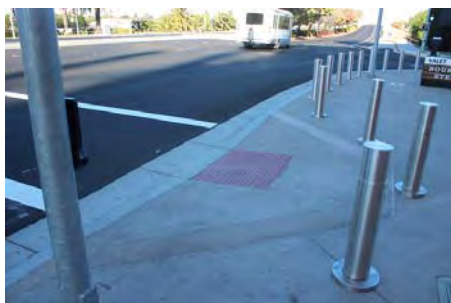
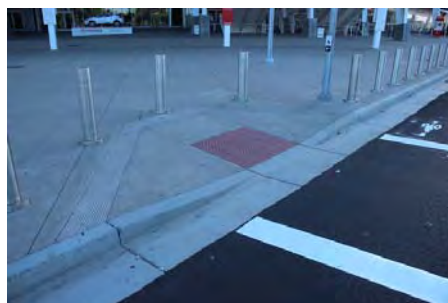
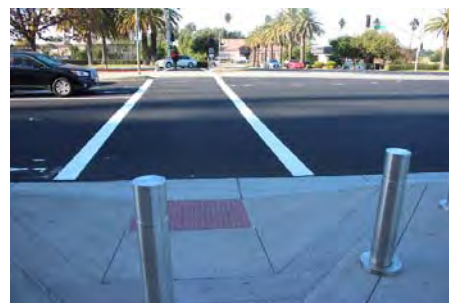
NEVAREZ V 49ERS - ACCESSIBILITY ASSESSMENT**FACILITY/SITE: 2. Tasman Dr.****SEQ.
#****226****FEATURE: #10 CURB RAMP****LOCATION: Int. of M.P. Bartolo Wy.****MEMO: SW corner serving W crossing of Tasman Drive.****Notes:**

Appears recently constructed and in repave zone.

CODE	CONDITION DESCRIPTION	ACTUAL
B02	The width of curb ramp is 36" min. (ADAS 405.5)	Obstructed by bollard.
B03	Running slope of ramp is 1:12 (8.33%) max. (ADAS 405.2)	Up to 8.6%.

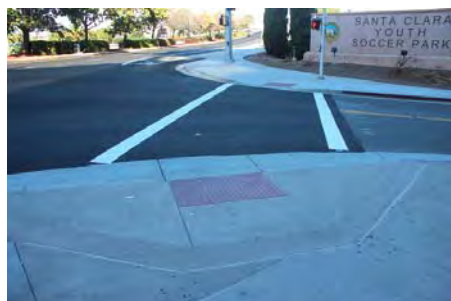
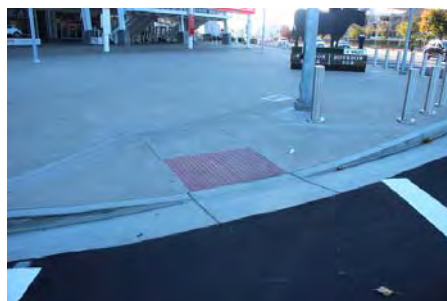
CODE	CONDITION DESCRIPTION	ACTUAL
B03	Running slope of ramp is 1:12 (8.33%) max. (ADAS 405.2)	Up to 9.2%.
B14	Counter slopes of adjoining gutters and road surfaces immediately adjacent to and within 24 inches of the curb ramp are not steeper than 1:20 (5.0%). (ADAS 406.2)	7.6%

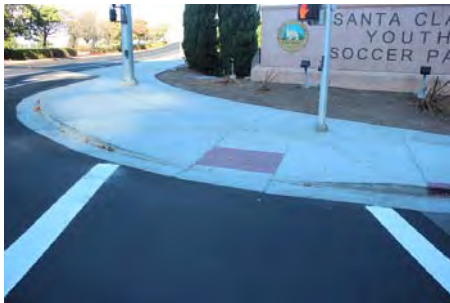
CODE	CONDITION DESCRIPTION	ACTUAL
B16	Cross slope (perpendicular to direction of travel) is 1:48 (2.08%) max. (ADAS 403.3)	2.8% to 3.8%.

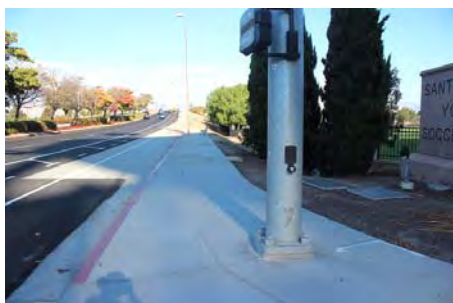
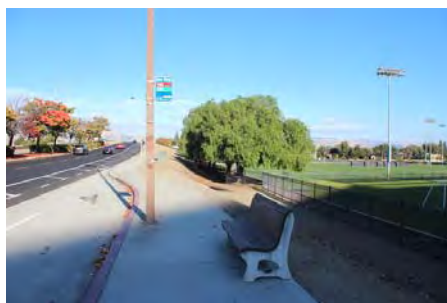
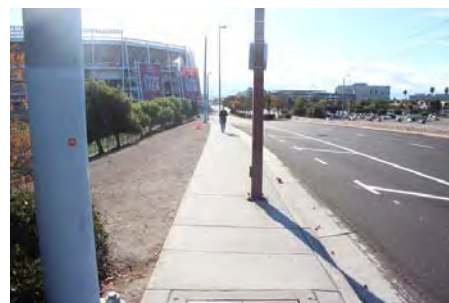
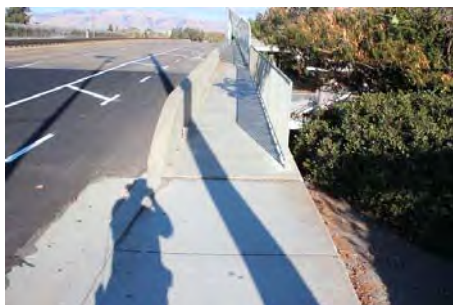
NEVAREZ V 49ERS - ACCESSIBILITY ASSESSMENT**FACILITY/SITE: 2. Tasman Dr.****SEQ.
#****229****FEATURE: #11 ACC ROUTE OF TRAVEL****LOCATION: S side of the street.****MEMO: Between M.P. Bartolo Wy. And stair to Metro rail at E.****Notes:****CONDITIONS THAT DO NOT CONFORM TO NEW CONSTRUCTION STANDARDS**

CODE	CONDITION DESCRIPTION	ACTUAL
B13	Gaps/openings are oriented perpendicular to dominant direction of travel. (ADAS 302.3)	2" W at bridge.
B15	No level changes greater than 1/2" (except by accessible ramp or other means). (ADAS 303.4)	1" high vertical edge at bridge.
B17	Running slope (parallel to direction of travel) is 1:20 (5.0%) max. (ADAS 403.3)	Long unbroken length of excessive running slope generally 4.5% and up to 6.3% at bridge.

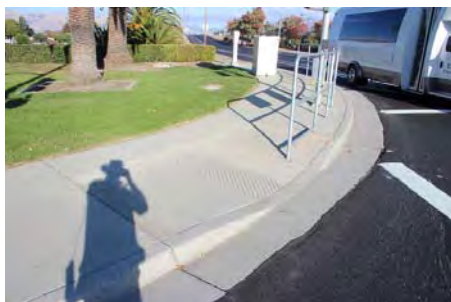
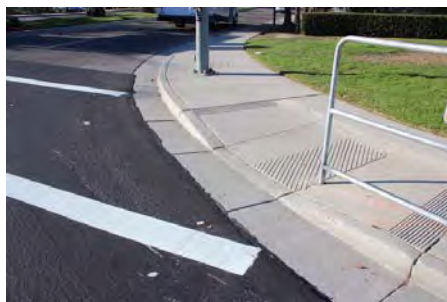
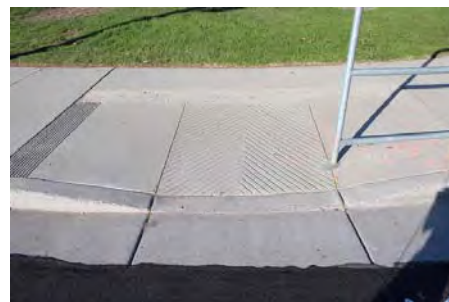
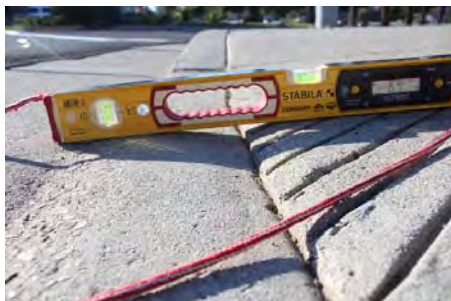
NEVAREZ V 49ERS - ACCESSIBILITY ASSESSMENT**FACILITY/SITE: 2. Tasman Dr.****SEQ.
#****230****FEATURE: #10 CURB RAMP****LOCATION: Int. of Centennial Blvd.****MEMO: NE corner serving N crossing of Centennial Blvd.****Notes:****CONDITIONS THAT DO NOT CONFORM TO NEW CONSTRUCTION STANDARDS**

CODE	CONDITION DESCRIPTION	ACTUAL
B05	Surface of ramp and landings complies with requirements for an accessible path of travel (stable, firm, slip-resistant, without gaps over 1/2" wide or edges over 1/4" high). (ADAS 302.1, 403.2, 403.3, 403.4)	8.3% cross slope at top landing and 1/2" high vertical edge at asphalt transition at btm. Landing.
B06	Transition to walk, gutter or street is flush and free of abrupt changes. (ADAS 406.2)	2 edges, one at each side of curb line.
B14	Counter slopes of adjoining gutters and road surfaces immediately adjacent to and within 24 inches of the curb ramp are not steeper than 1:20 (5.0%). (ADAS 406.2)	11.2%

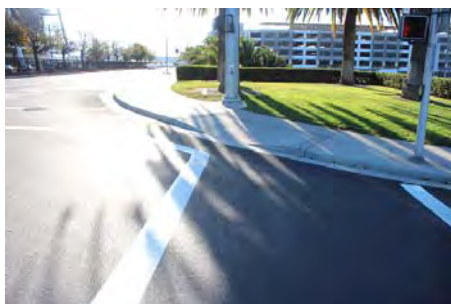
CODE	CONDITION DESCRIPTION	ACTUAL
B05	Surface of ramp and landings complies with requirements for an accessible path of travel (stable, firm, slip-resistant, without gaps over 1/2" wide or edges over 1/4" high). (ADAS 302.1, 403.2, 403.3, 403.4)	7.3% cross slope at top landing.
B14	Counter slopes of adjoining gutters and road surfaces immediately adjacent to and within 24 inches of the curb ramp are not steeper than 1:20 (5.0%). (ADAS 406.2)	11.9%
B16	Maximum slope of flared sides is 1:10 (10.0%). (ADAS 406.2)	19.8% left side.

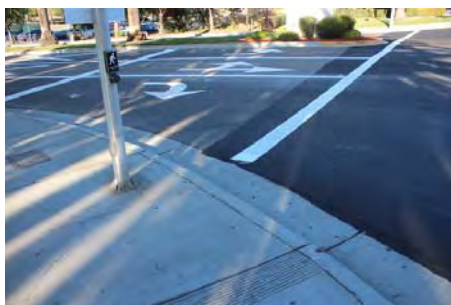
CODE	CONDITION DESCRIPTION	ACTUAL
B11	The clear floor space is without changes in level except for slopes up to 1:48 (2.08%). (ADAS 305.2)	7.1% at cross walk button.

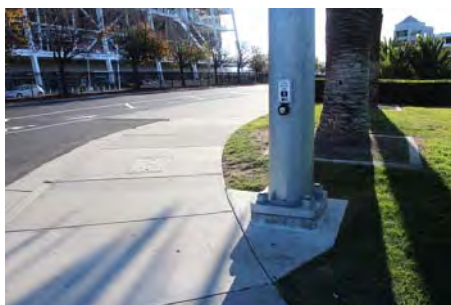
CODE	CONDITION DESCRIPTION	ACTUAL
B11	The clear floor space is without changes in level except for slopes up to 1:48 (2.08%). (ADAS 305.2)	5.4% at cross walk button.

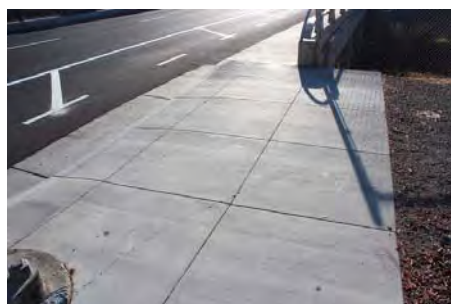
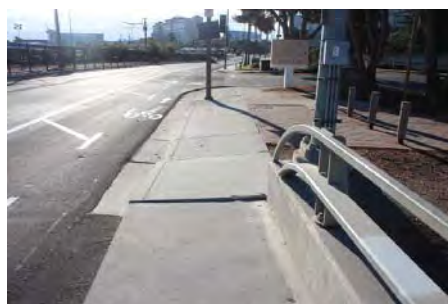
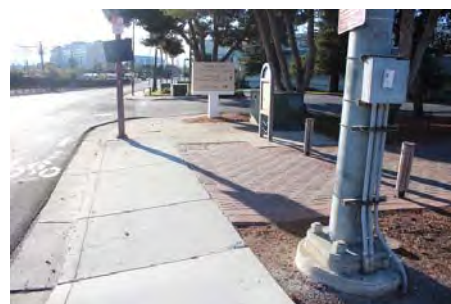
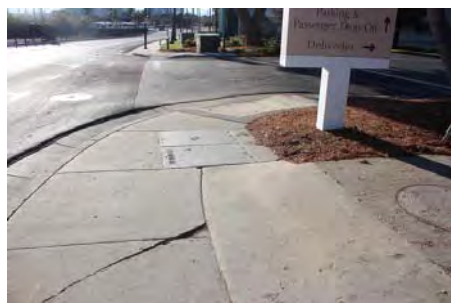
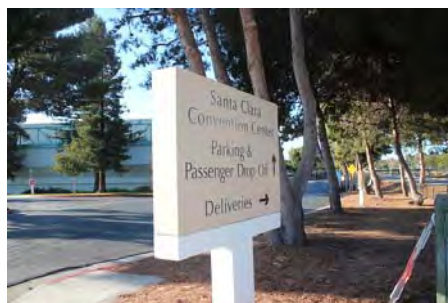
NEVAREZ V 49ERS - ACCESSIBILITY ASSESSMENT**FACILITY/SITE: 2. Tasman Dr.****SEQ.
#****234****FEATURE: #11 ACC ROUTE OF TRAVEL****LOCATION: N side of the street.****MEMO: Between Centennial Blvd. and Santa Clara Convention Center entrance Drive.****Notes:****CONDITIONS THAT DO NOT CONFORM TO NEW CONSTRUCTION STANDARDS**

CODE	CONDITION DESCRIPTION	ACTUAL
B15	No level changes greater than 1/2" (except by accessible ramp or other means). (ADAS 303.4)	1" high vertical edge at W side of bridge.
B16	Cross slope (perpendicular to direction of travel) is 1:48 (2.08%) max. (ADAS 403.3)	9.8% at drive aisle at W side of bridge.
B17	Running slope (parallel to direction of travel) is 1:20 (5.0%) max. (ADAS 403.3)	7.8% at drive aisle at E side of bridge that appears recently constructed, 11.2% and 26.4% at drive aisle at W side.
