Case No. 5:16-cv-07013-LHK (SVK)

**DECLARATION OF JEFFREY SCOTT
MASTIN IN SUPPORT OF PLAINTIFFS'
MOTION FOR CLASS CERTIFICATION**

NEVAREZ V 49ERS - ACCESSIBILITY ASSESSMENT

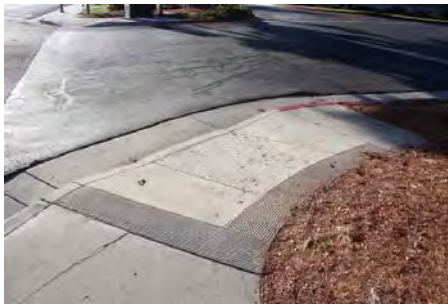
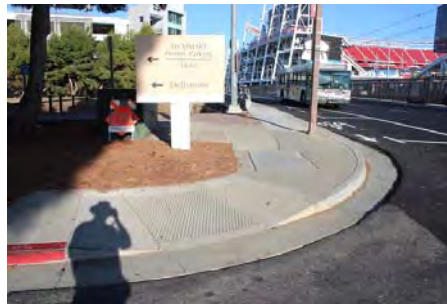
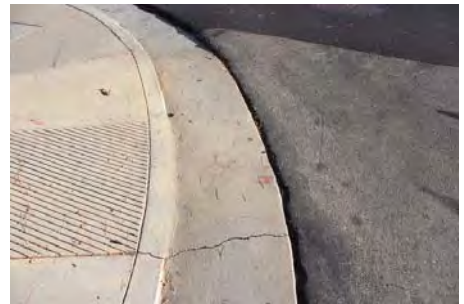
NEVAREZ V 49ERS - ACCESSIBILITY ASSESSMENT**FACILITY/SITE: 2. Tasman Dr.****SEQ.
#****235****FEATURE: #10 CURB RAMP****LOCATION: Int. of Santa Clara Convention Center entrance drive at N side of street.****MEMO: E side perpendicular type.****Notes:****CONDITIONS THAT DO NOT CONFORM TO NEW CONSTRUCTION STANDARDS**

CODE	CONDITION DESCRIPTION	ACTUAL
B03	Running slope of ramp is 1:12 (8.33%) max. (ADAS 405.2)	10.8% to 12.0%
B05	Surface of ramp and landings complies with requirements for an accessible path of travel (stable, firm, slip-resistant, without gaps over 1/2" wide or edges over 1/4" high). (ADAS 302.1, 403.2, 403.3, 403.4)	1 1/2" gap and 3/4" high vertical edge at asphalt transition at btm. Landing.
B11		None
A17	Where no top landing is provided at an existing ramp, side flare slopes are 8.33% max. (ADAS 406.4)	19.6% right side, 15.8% left side.

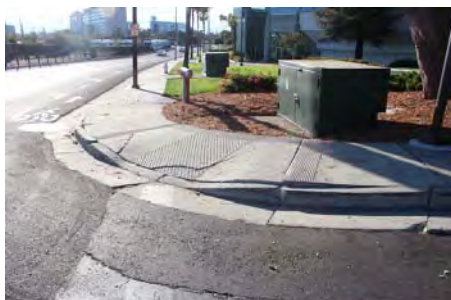
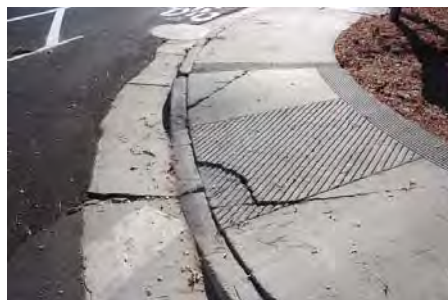
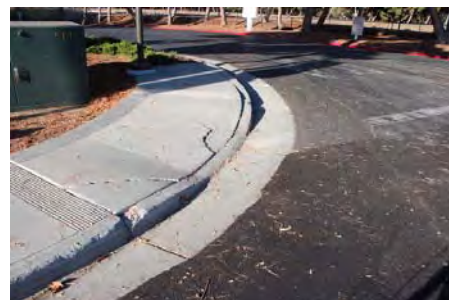
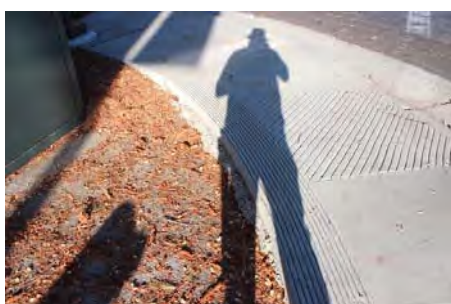
NEVAREZ V 49ERS - ACCESSIBILITY ASSESSMENT**FACILITY/SITE: 2. Tasman Dr.****SEQ.
#****236****FEATURE: #10 CURB RAMP****LOCATION: Int. of Santa Clara Convention Center entrance drive at N side of street.****MEMO: W side perpendicular type.****Notes:****CONDITIONS THAT DO NOT CONFORM TO NEW CONSTRUCTION STANDARDS**

CODE	CONDITION DESCRIPTION	ACTUAL
B03	Running slope of ramp is 1:12 (8.33%) max. (ADAS 405.2)	11.1% to 12.4% and 25.6% at bottom 6".
B05	Surface of ramp and landings complies with requirements for an accessible path of travel (stable, firm, slip-resistant, without gaps over 1/2" wide or edges over 1/4" high). (ADAS 302.1, 403.2, 403.3, 403.4)	1 1/2" W gap on bottom landing and gap, and 3/4 high vertical edge on ramp (broken concrete).
B11	Top landing is as wide as the ramp and 36" min. in length. (ADAS 406.4)	None
B14	Counter slopes of adjoining gutters and road surfaces immediately adjacent to and within 24 inches of the curb ramp are not steeper than 1:20 (5.0%). (ADAS 406.2)	12.5%
A17	Where no top landing is provided at an existing ramp, side flare slopes are 8.33% max. (ADAS 406.4)	23.9% right side, 11.4% left side.

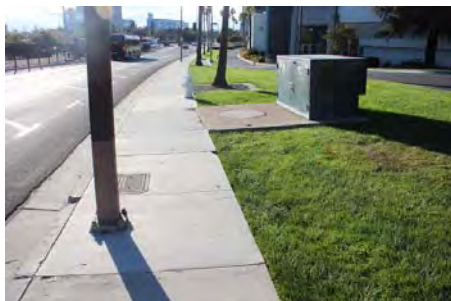
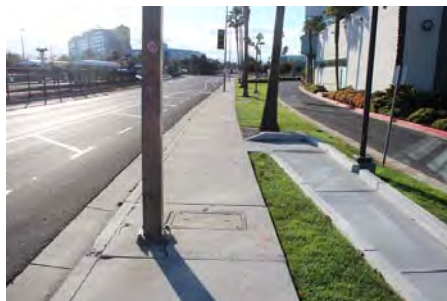
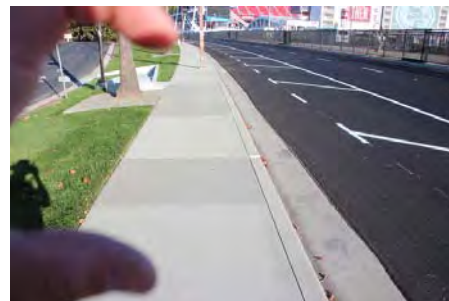
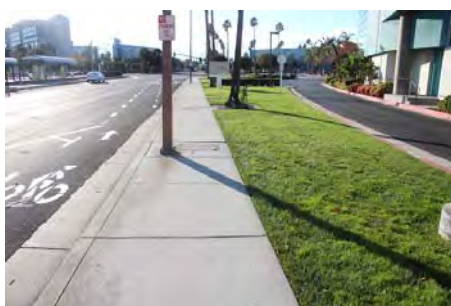
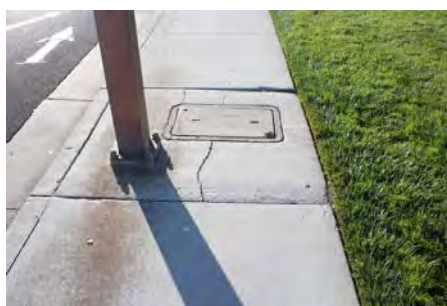
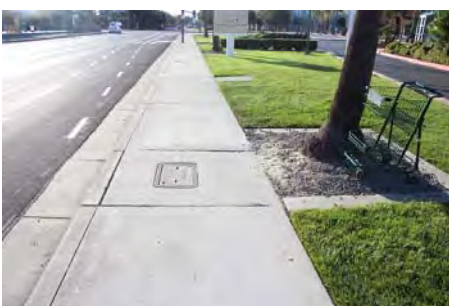
NEVAREZ V 49ERS - ACCESSIBILITY ASSESSMENT**FACILITY/SITE: 2. Tasman Dr.****SEQ.
#****237****FEATURE: #11 ACC ROUTE OF TRAVEL****LOCATION: N side of the street.****MEMO: Between Santa Clara Convention Center entrance drive and Convention Center.****Notes:****CONDITIONS THAT DO NOT CONFORM TO NEW CONSTRUCTION STANDARDS**

CODE	CONDITION DESCRIPTION	ACTUAL
B11	Surface is firm, stable and slip-resistant. (ADAS 302.1)	CSC LOW VOLTAGE utility cover is not secured and shifts under load.
B12	Gaps/openings in ground or floor surfaces do not allow the passage of a sphere more than 1/2" in diameter. (ADAS 302.3)	3" x 3" gap at street light utility cover.
B15	No level changes greater than 1/2" (except by accessible ramp or other means). (ADAS 303.4)	Over 1/2" high vertical edge at unsecured CST LOW VOLTAGE utility cover.
B16	Cross slope (perpendicular to direction of travel) is 1:48 (2.08%) max. (ADAS 403.3)	Approx. 50 L is 2.7% to 4.6%.

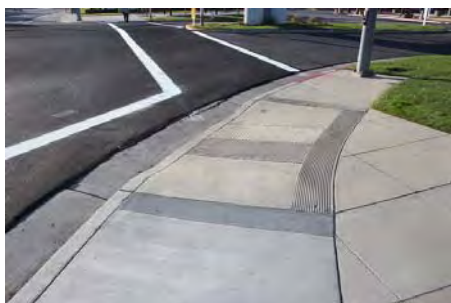
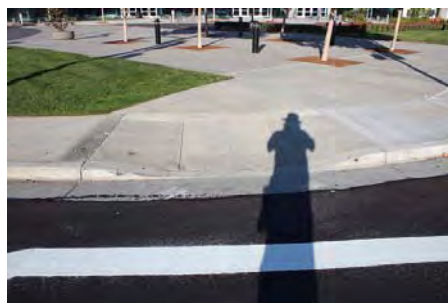
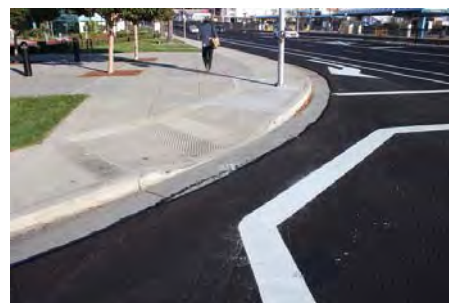
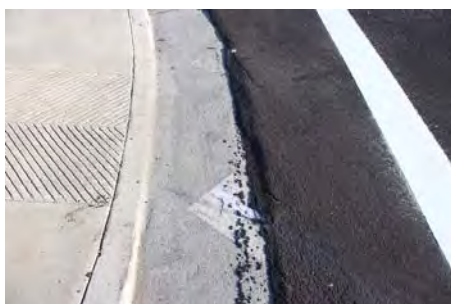
CODE	CONDITION DESCRIPTION	ACTUAL
B03	Running slope of ramp is 1:12 (8.33%) max. (ADAS 405.2)	10.8% at btm. 6", generally 10.6% to 11.5%.
B05	Surface of ramp and landings complies with requirements for an accessible path of travel (stable, firm, slip-resistant, without gaps over 1/2" wide or edges over 1/4" high). (ADAS 302.1, 403.2, 403.3, 403.4)	9.1% running slope at top landing and 3/4" high vertical edge at btm. Landing.
B14	Counter slopes of adjoining gutters and road surfaces immediately adjacent to and within 24 inches of the curb ramp are not steeper than 1:20 (5.0%). (ADAS 406.2)	7.9%
B16	Maximum slope of flared sides is 1:10 (10.0%). (ADAS 406.2)	18.2% right side, 14.6% left side.

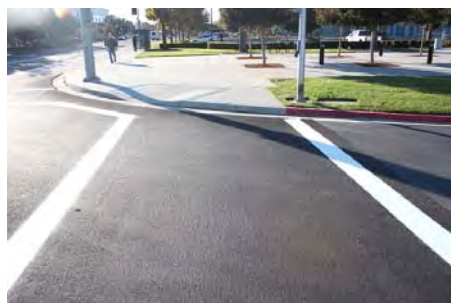
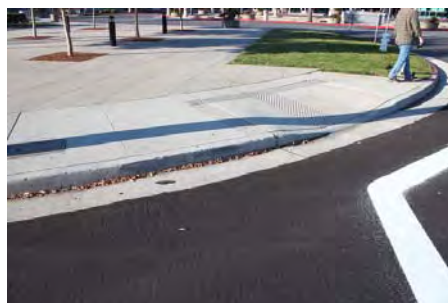
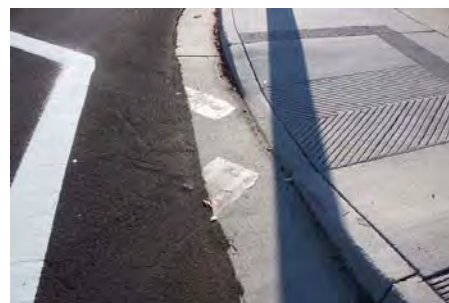
CODE	CONDITION DESCRIPTION	ACTUAL
B03	Running slope of ramp is 1:12 (8.33%) max. (ADAS 405.2)	21.2% at btm 6".
B14	Counter slopes of adjoining gutters and road surfaces immediately adjacent to and within 24 inches of the curb ramp are not steeper than 1:20 (5.0%). (ADAS 406.2)	9.3%
B16	Maximum slope of flared sides is 1:10 (10.0%). (ADAS 406.2)	13.1% left side, 15.1% right side.

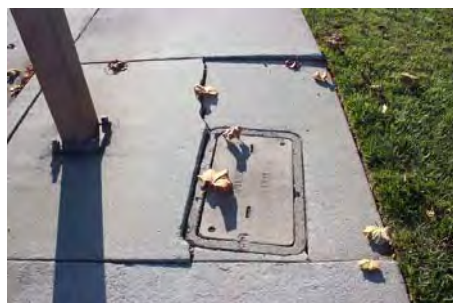
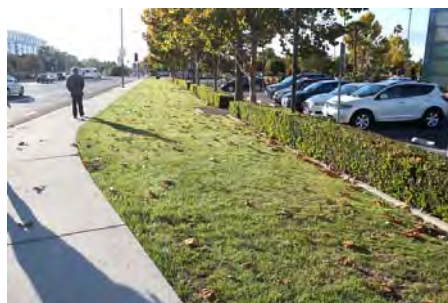
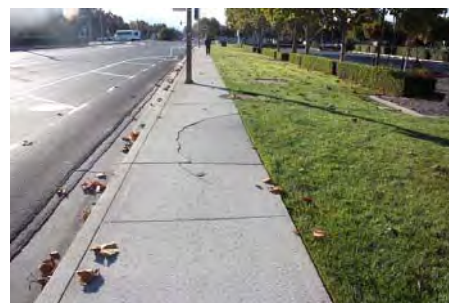
CODE	CONDITION DESCRIPTION	ACTUAL
B15	No level changes greater than 1/2" (except by accessible ramp or other means). (ADAS 303.4)	1" high vertical edge.
B16	Cross slope (perpendicular to direction of travel) is 1:48 (2.08%) max. (ADAS 403.3)	Approx. 300' L is 2.6% to 5.0%.

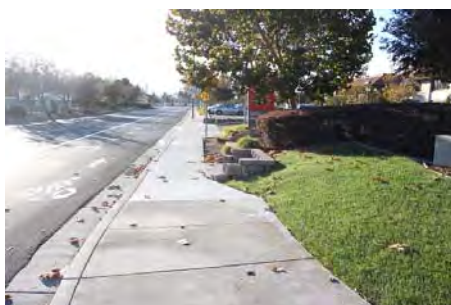
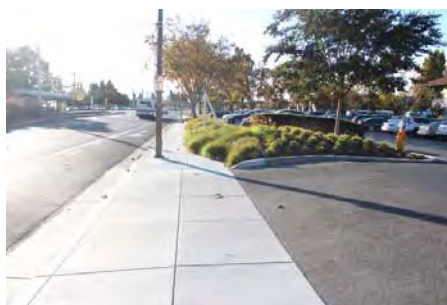
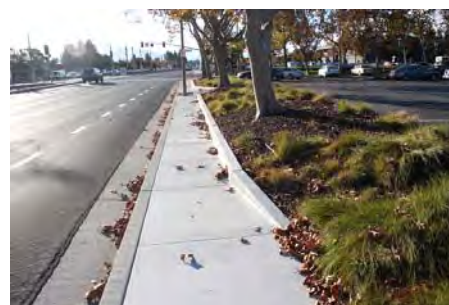
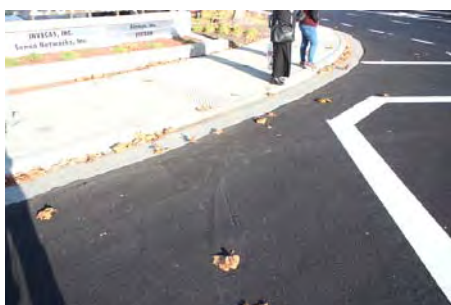
Reduces sidewalk to 42" W for approx. 90' L at planters. Conforms to standards used

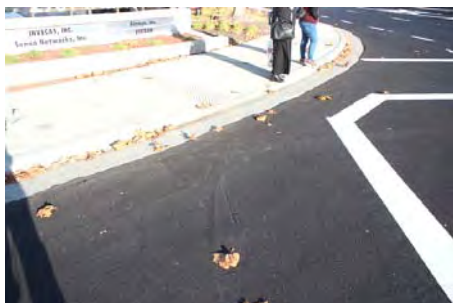
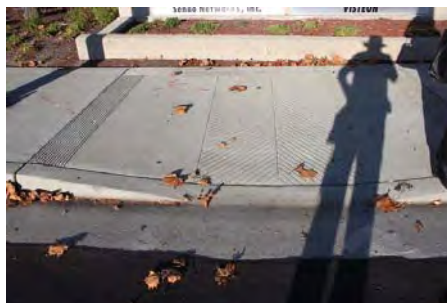
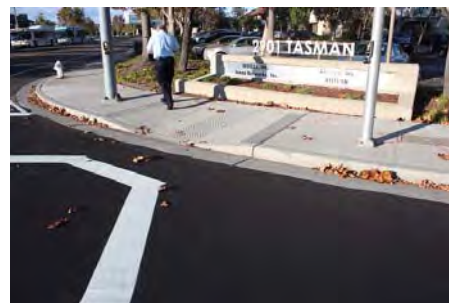
CODE	CONDITION DESCRIPTION	ACTUAL
B03	Running slope of ramp is 1:12 (8.33%) max. (ADAS 405.2)	Up to 9.1% and 13.6% at btm. 6".
B11	Top landing is as wide as the ramp and 36" min. in length. (ADAS 406.4)	None
B14	Counter slopes of adjoining gutters and road surfaces immediately adjacent to and within 24 inches of the curb ramp are not steeper than 1:20 (5.0%). (ADAS 406.2)	7.3%
A17	Where no top landing is provided at an existing ramp, side flare slopes are 8.33% max. (ADAS 406.4)	11.3% right side, 11.1% left side.

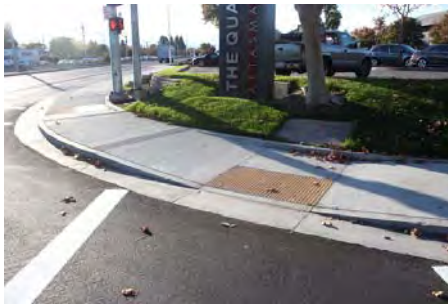
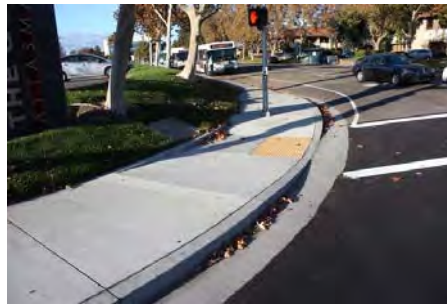
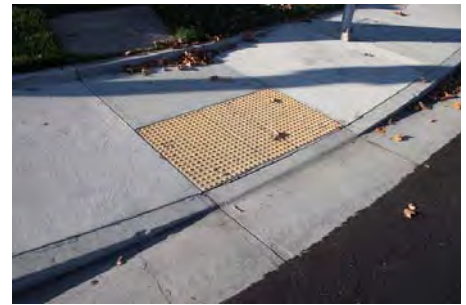
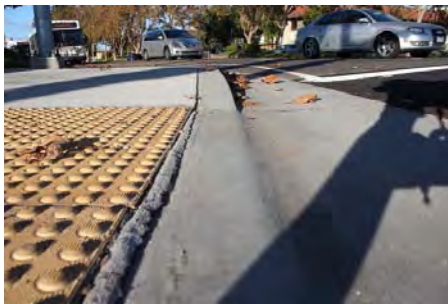
CODE	CONDITION DESCRIPTION	ACTUAL
B06	Transition to walk, gutter or street is flush and free of abrupt changes. (ADAS 406.2)	2 edges at btm. 3/8" high vertical edge at truncated domes, 3/8" high vertical edge at curb.

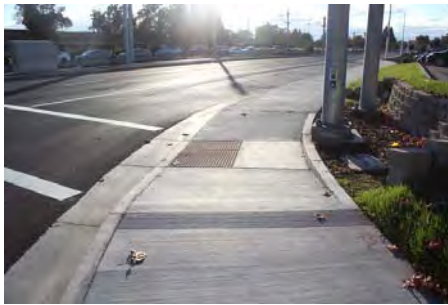
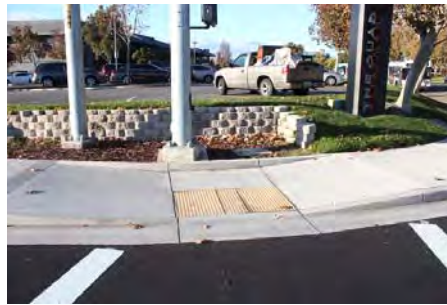
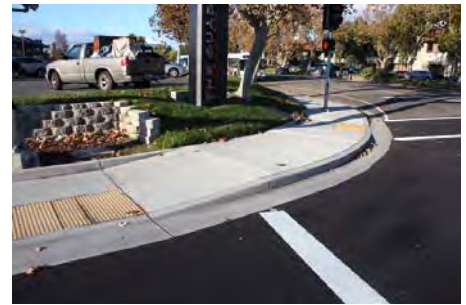
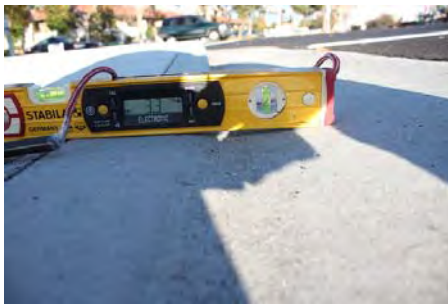
Appears recently constructed and in repave zone.

CODE	CONDITION DESCRIPTION	ACTUAL
B06 406.2)	Transition to walk, gutter or street is flush and free of abrupt changes. (ADAS	3/8" high vertical edge.

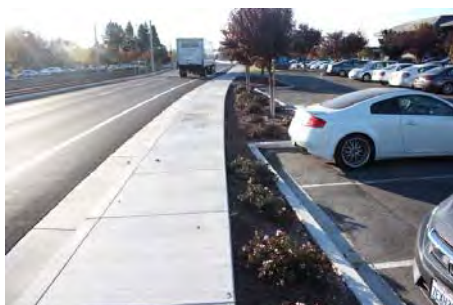
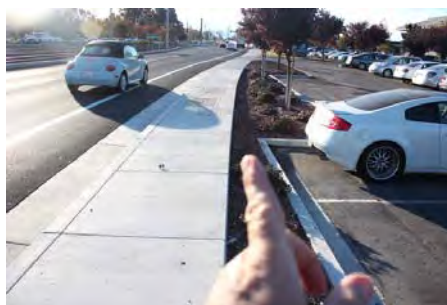
CODE	CONDITION DESCRIPTION	ACTUAL
B11	Abrupt changes in level over 4" high are identified either by a curb or guide rail. (28 CFR 35.130(a), ADAS 405.9, CBC 11B-303.5)	Approx. 6" high drop off at one side for approx. 20' L at new concrete sidewalk.

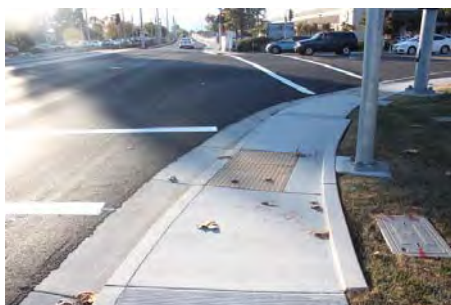
CODE	CONDITION DESCRIPTION	ACTUAL
C12	Turning space at bottom of curb ramp slopes 1:48 (2.08%) max. in any direction (ADAS 403.3)	7.6% across curb face.

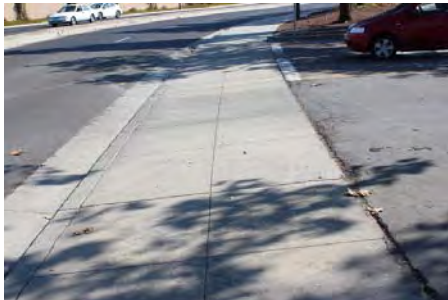
COD	CONDITION DESCRIPTION	ACTUAL
B16	Cross slope (perpendicular to direction of travel) is 1:48 (2.08%) max. (ADAS 403.3)	8.7%
B17	Running slope (parallel to direction of travel) is 1:20 (5.0%) max. (ADAS 403.3)	16.8% and 10.1%

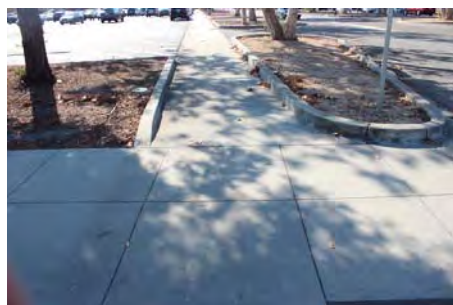
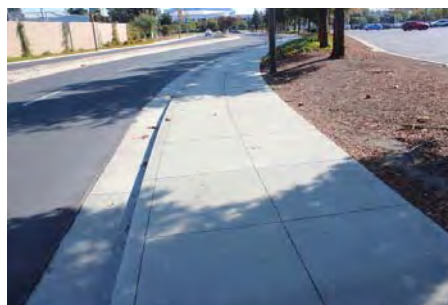
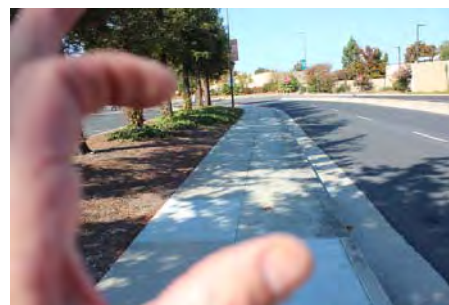
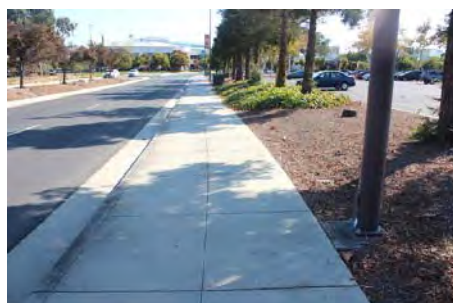
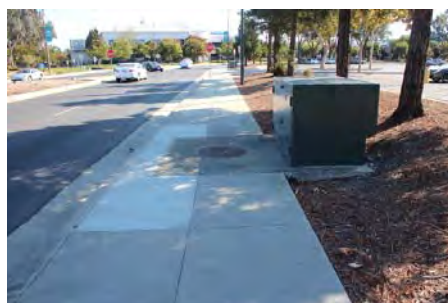
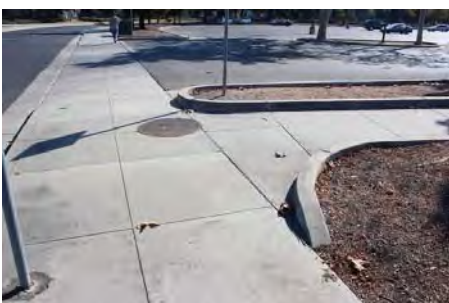
COD	CONDITION DESCRIPTION	ACTUAL
B16	Cross slope (perpendicular to direction of travel) is 1:48 (2.08%) max. (ADAS 403.3)	Approx. 180' L is 2.8% to 3.9%.

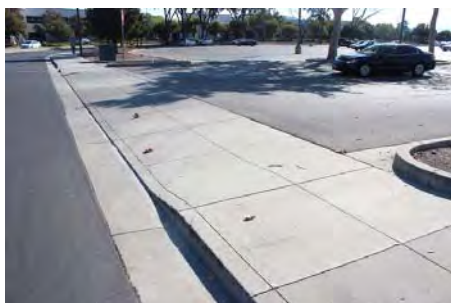
COD	CONDITION DESCRIPTION	ACTUAL
B17	Running slope (parallel to direction of travel) is 1:20 (5.0%) max. (ADAS 403.3)	Exceeds 8.3% at sides of drive apron

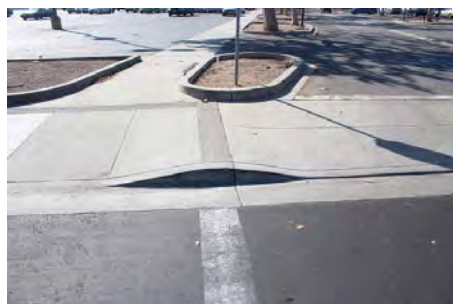
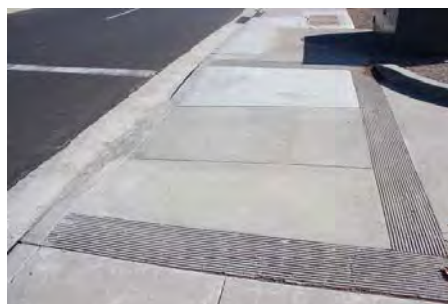
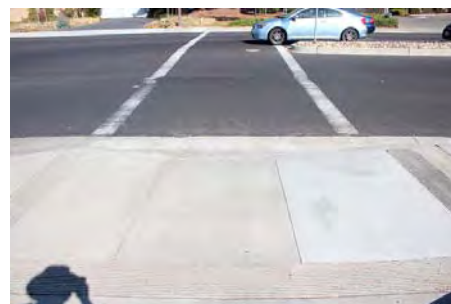
COD	CONDITION DESCRIPTION	ACTUAL
B03	Running slope of ramp is 1:12 (8.33%) max. (ADAS 405.2)	Up to 9.3%.
B11	Top landing is as wide as the ramp and 36" min. in length. (ADAS 406.4)	Configuration unnecessarily precludes use of top landing from either side, effectively making this a curb ramp without a top landing.
A17	Where no top landing is provided at an existing ramp, side flare slopes are 8.33% max. (ADAS 406.4)	11.0% left side, 15.4% right side.

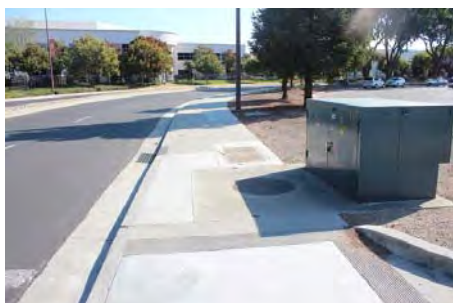
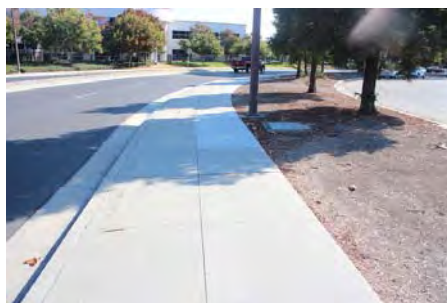
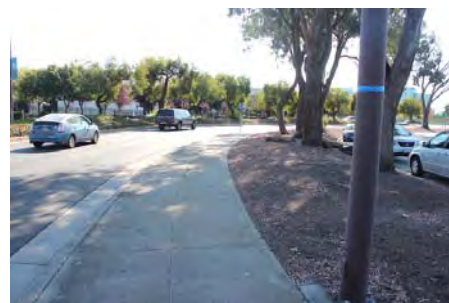
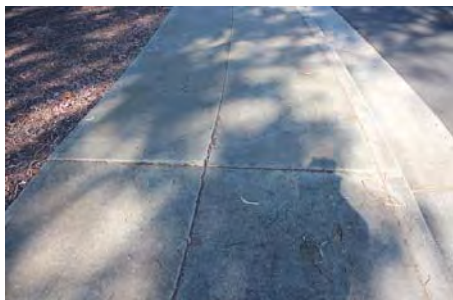
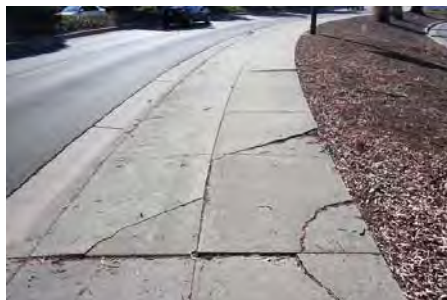
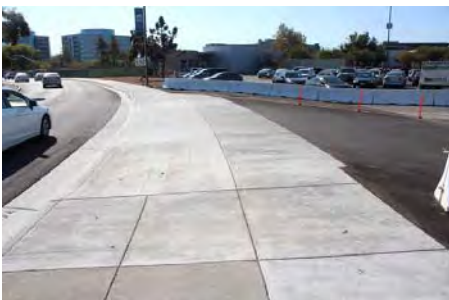
COD	CONDITION DESCRIPTION	ACTUAL
B15	No level changes greater than 1/2" (except by accessible ramp or other means). (ADAS 303.4)	2 vertical edges, 1" and 1 1/4" H.
B16	Cross slope (perpendicular to direction of travel) is 1:48 (2.08%) max. (ADAS 403.3)	Approx. 460' L is to 9.8%.

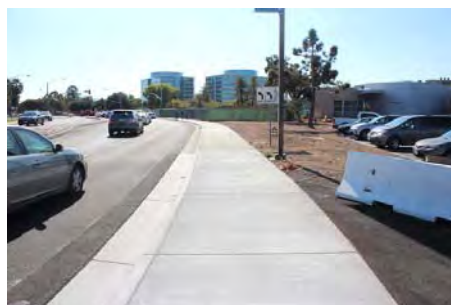
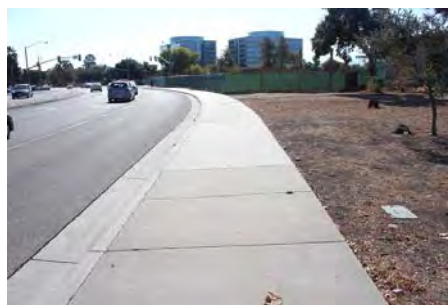
COD	CONDITION DESCRIPTION	ACTUAL
B16	Cross slope (perpendicular to direction of travel) is 1:48 (2.08%) max. (ADAS 403.3)	Approx. 80' L is 2.8% to 3.7%.

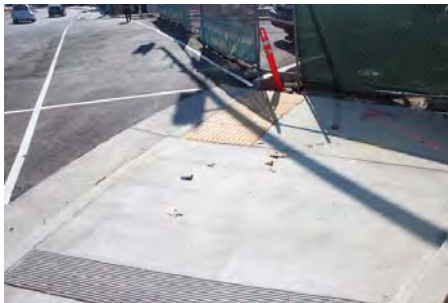
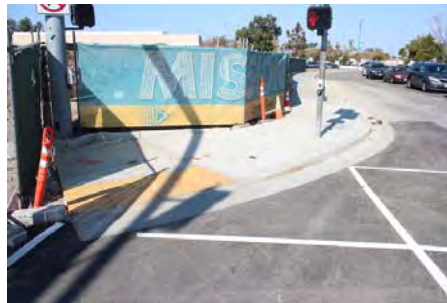
COD	CONDITION DESCRIPTION	ACTUAL
B13	Counter slopes of adjoining gutters and road surfaces immediately adjacent to and within 24 inches of the curb ramp are not steeper than 1:20 (5.0%). (ADAS 406.2)	7.7%

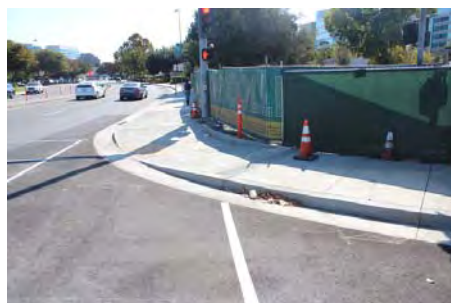
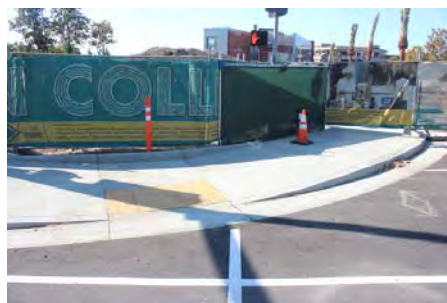
COD	CONDITION DESCRIPTION	ACTUAL
C12	Turning space at bottom of curb ramp slopes 1:48 (2.08%) max. in any direction (ADAS 403.3)	Up to 2.7%.
B13	Counter slopes of adjoining gutters and road surfaces immediately adjacent to and within 24 inches of the curb ramp are not steeper than 1:20 (5.0%). (ADAS 406.2)	5.5%
B14	If curb ramp is located at marked crossing, the transition is wholly contained within the markings. (ADAS 406.5)	W crosswalk is approx. 15' away from the curb ramp.

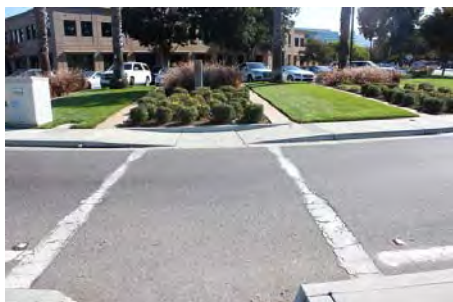
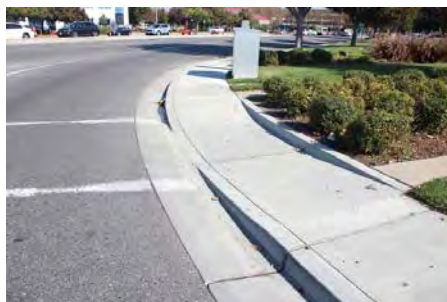
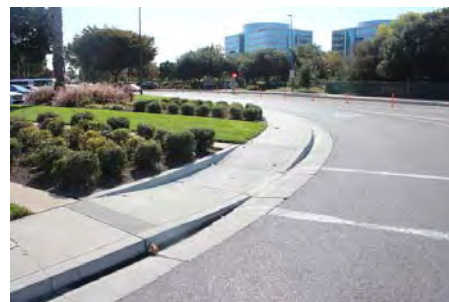
COD	CONDITION DESCRIPTION	ACTUAL
B05	Surface of ramp and landings complies with requirements for an accessible path of travel (stable, firm, slip-resistant, without gaps over 1/2" wide or edges over 1/4" high). (ADAS 405.4)	1/2" high vertical edge at one side on ramp surface.
C12	Turning space at bottom of curb ramp slopes 1:48 (2.08%) max. in any direction (ADAS 403.3)	8.9% for 3" L across curb face.
B13	Counter slopes of adjoining gutters and road surfaces immediately adjacent to and within 24 inches of the curb ramp are not steeper than 1:20 (5.0%). (ADAS 406.2)	11.1%

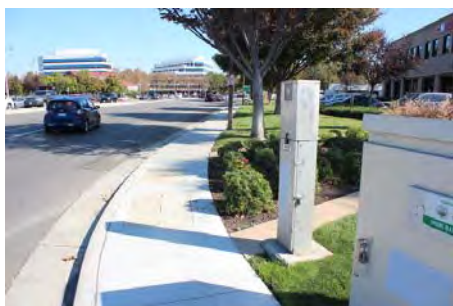
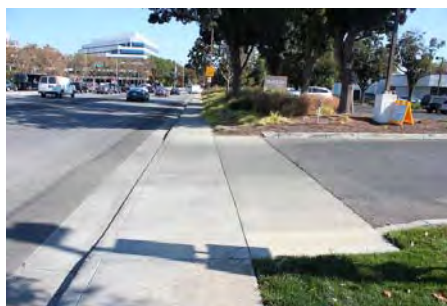
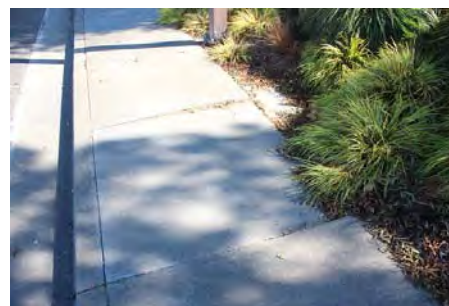
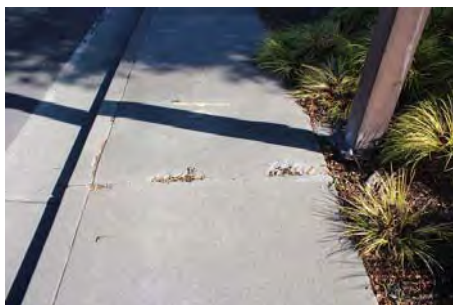
COD	CONDITION DESCRIPTION	ACTUAL
B15	No level changes greater than 1/2" (except by accessible ramp or other means). (ADAS 303.4)	Two vertical edges, 1" and 1 1/4" H.
B16	Cross slope (perpendicular to direction of travel) is 1:48 (2.08%) max. (ADAS 403.3)	Approx. 110' L is 2.7% to 3.7% and 5.9% at drive aisle.
B17	Running slope (parallel to direction of travel) is 1:20 (5.0%) max. (ADAS 403.3)	11.5% and 8.3% at drive aisle.

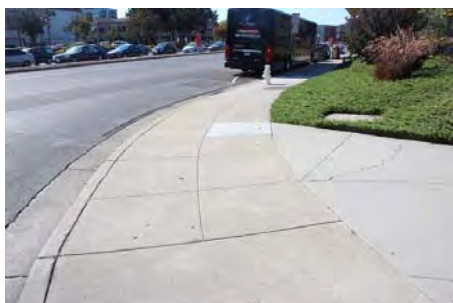
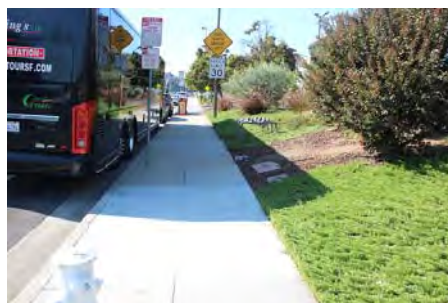
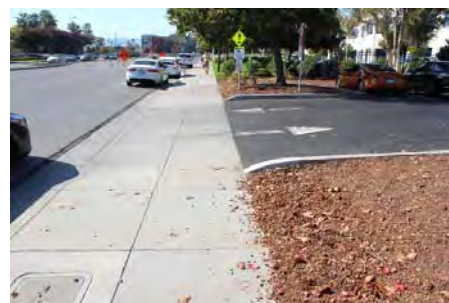
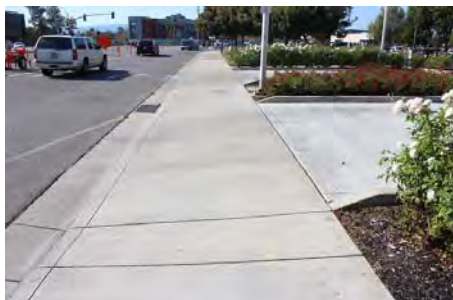
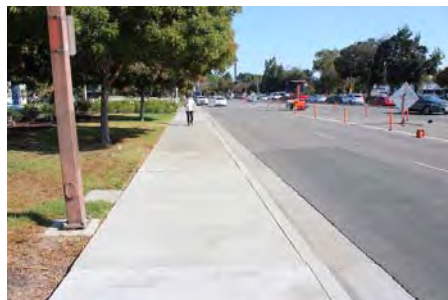
COD	CONDITION DESCRIPTION	ACTUAL
B16	Cross slope (perpendicular to direction of travel) is 1:48 (2.08%) max. (ADAS 403.3)	Approx. 200' L is 2.6% to 5.2% and 6.6% to 7.9% across three drive aisles.
B17	Running slope (parallel to direction of travel) is 1:20 (5.0%) max. (ADAS 403.3)	9.6% to 13.4% at each side of three drive aisles (6 places).

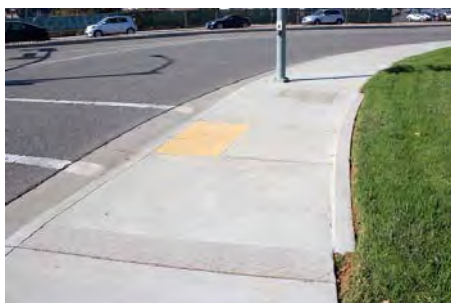
COD	CONDITION DESCRIPTION	ACTUAL
C12	Turning space at bottom of curb ramp slopes 1:48 (2.08%) max. in any direction (ADAS 403.3)	10.4%
B13	Counter slopes of adjoining gutters and road surfaces immediately adjacent to and within 24 inches of the curb ramp are not steeper than 1:20 (5.0%). (ADAS 406.2)	9.8% and 10.4% across curb face.

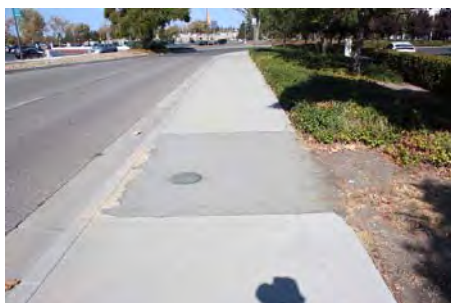
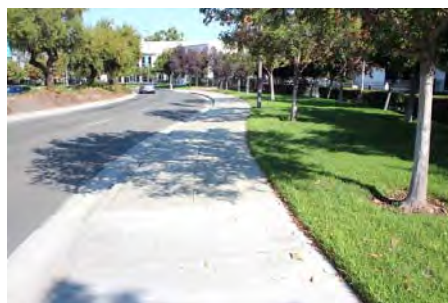
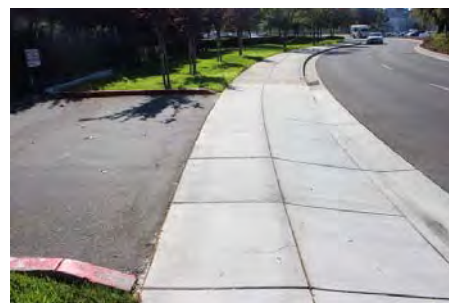
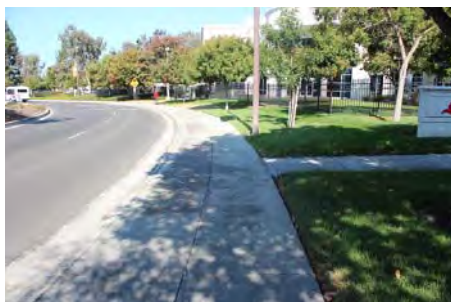
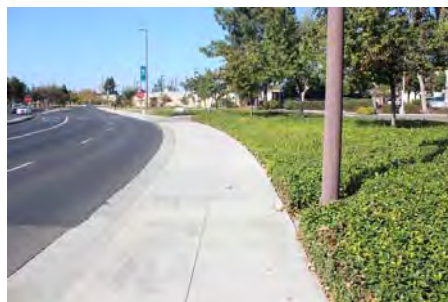
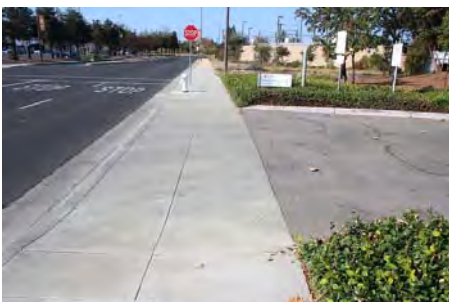
COD	CONDITION DESCRIPTION	ACTUAL
B16	Cross slope (perpendicular to direction of travel) is 1:48 (2.08%) max. (ADAS 403.3)	Approx. 470' L is 2.7% to 6.6% and 7.2% across drive aisle.
B17	Running slope (parallel to direction of travel) is 1:20 (5.0%) max. (ADAS 403.3)	8.3% and 10.4% at drive aisle.

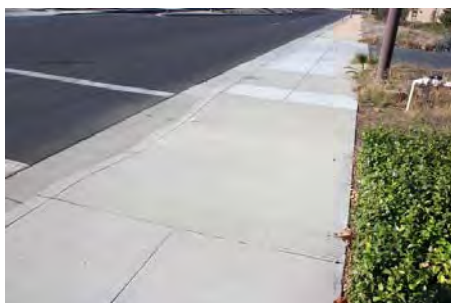
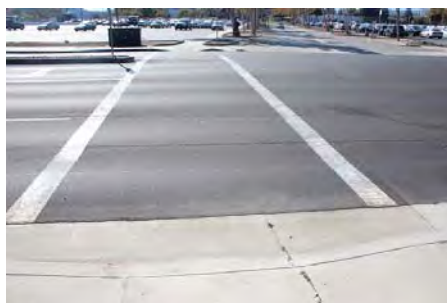
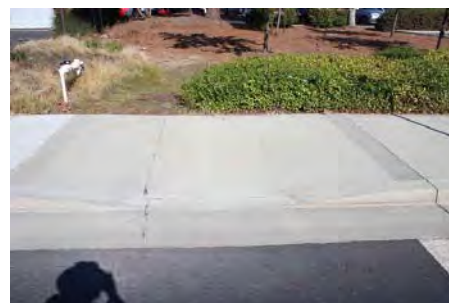
COD	CONDITION DESCRIPTION	ACTUAL
B11	Top landing is as wide as the ramp and 36" min. in length. (ADAS 406.4)	None
B14	Counter slopes of adjoining gutters and road surfaces immediately adjacent to and within 24 inches of the curb ramp are not steeper than 1:20 (5.0%). (ADAS 406.2)	6.0%
A17	Where no top landing is provided at an existing ramp, side flare slopes are 8.33% max. (ADAS 406.4)	13.3% left side, 12.0% right side.

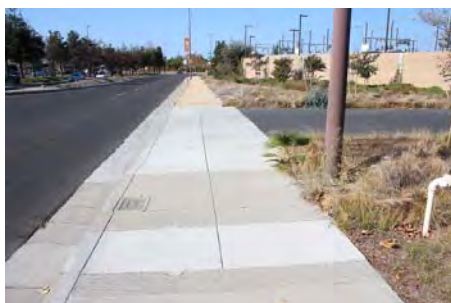
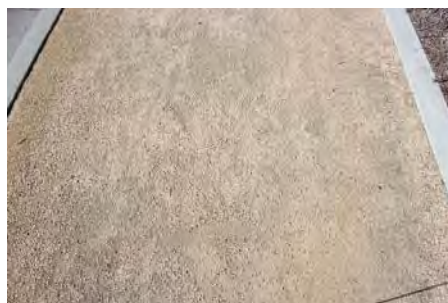
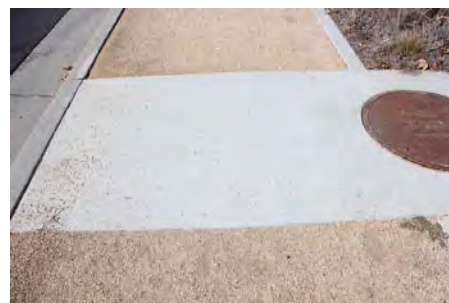
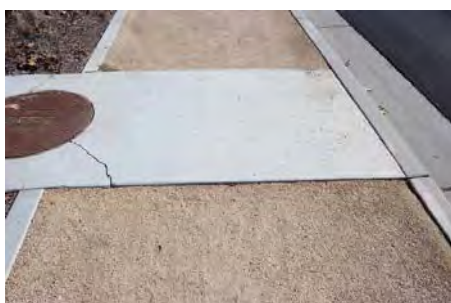
COD	CONDITION DESCRIPTION	ACTUAL
B11	Surface is firm, stable and slip-resistant. (ADAS 302.1)	Sidewalk dead ends into dirt.

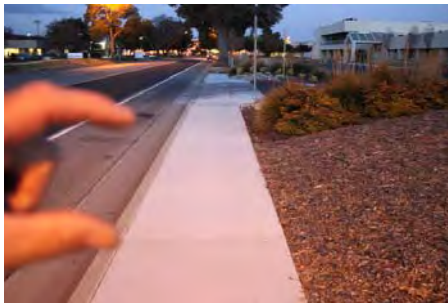
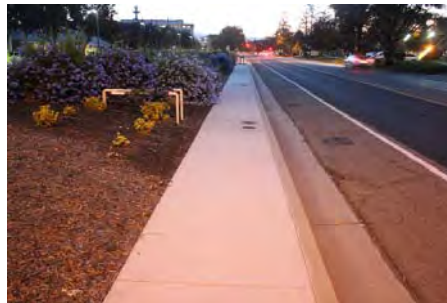
COD	CONDITION DESCRIPTION	ACTUAL
B16	Cross slope (perpendicular to direction of travel) is 1:48 (2.08%) max. (ADAS 403.3)	Approx. 20' L is 2.7%.

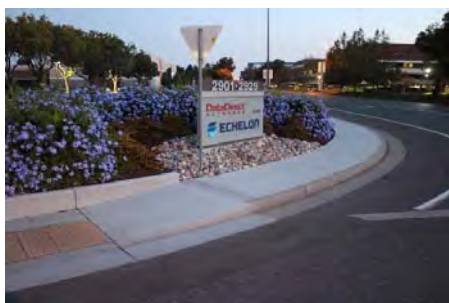
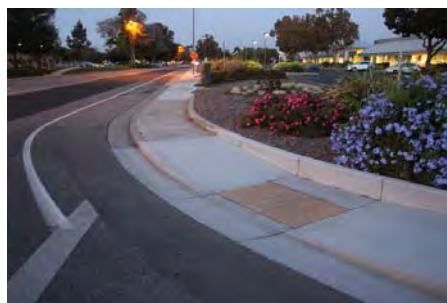
COD	CONDITION DESCRIPTION	ACTUAL
C12	Turning space at bottom of curb ramp slopes 1:48 (2.08%) max. in any direction (ADAS 403.3)	7.6% for 3" L across curb face.
B13	Counter slopes of adjoining gutters and road surfaces immediately adjacent to and within 24 inches of the curb ramp are not steeper than 1:20 (5.0%). (ADAS 406.2)	7.8%

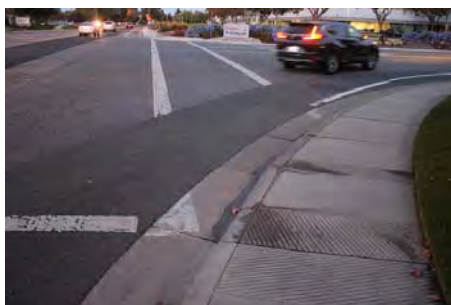
COD	CONDITION DESCRIPTION	ACTUAL
B16	Cross slope (perpendicular to direction of travel) is 1:48 (2.08%) max. (ADAS 403.3)	6.2% for portion between crosswalk and curb ramp at NE corner.

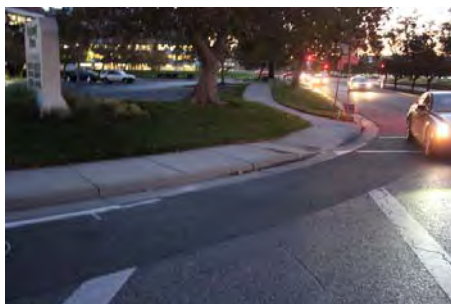
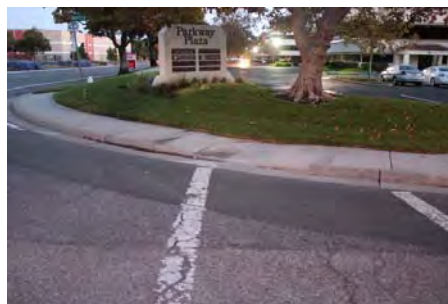
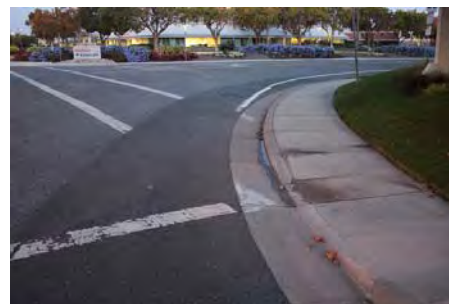
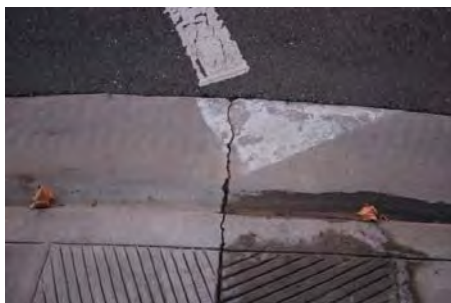
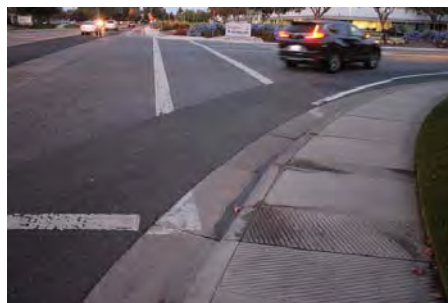
COD	CONDITION DESCRIPTION	ACTUAL
B03	Running slope of ramp is 1:12 (8.33%) max. (ADAS 405.2)	12.5% for 6" across curb face.
B06	Transition to walk, gutter or street is flush and free of abrupt changes. (ADAS 406.2)	1/2" high vertical edge.
B11	Top landing is as wide as the ramp and 36" min. in length. (ADAS 406.4)	None
B14	Counter slopes of adjoining gutters and road surfaces immediately adjacent to and within 24 inches of the curb ramp are not steeper than 1:20 (5.0%). (ADAS 406.2)	8.9%
A17	Where no top landing is provided at an existing ramp, side flare slopes are 8.33% max. (ADAS 406.4)	10.5% right side, 10.9% left side.
B19	DIAGONAL: If curb ramp is located at marked crossing, 48" min. clear space is provided within the markings. (ADAS 406.6)	7" clear to lines.

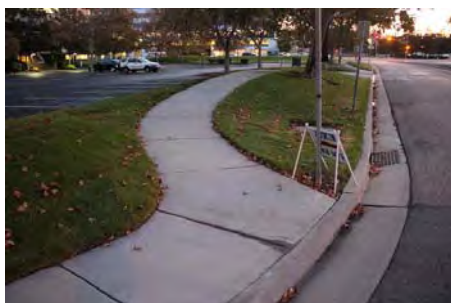
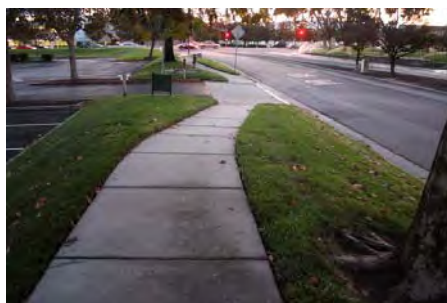
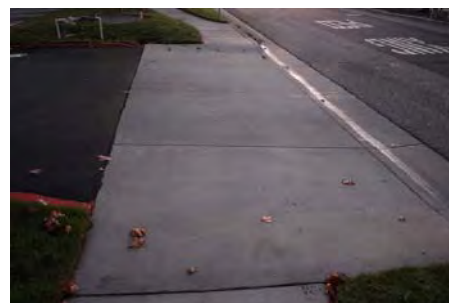
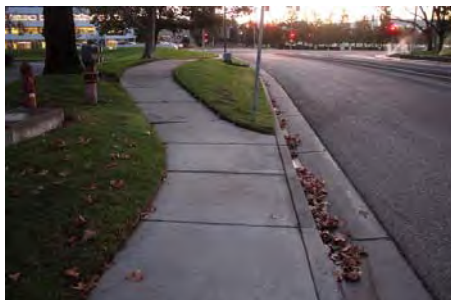
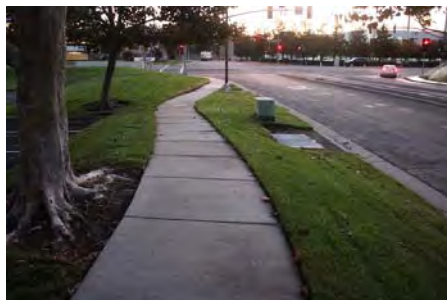
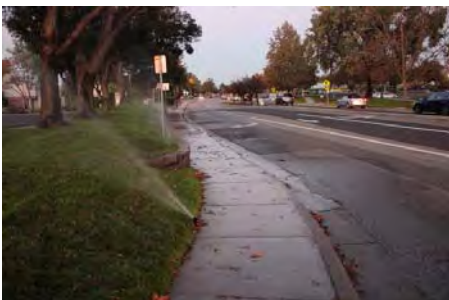
COD	CONDITION DESCRIPTION	ACTUAL
B16	Cross slope (perpendicular to direction of travel) is 1:48 (2.08%) max. (ADAS 403.3)	Approx. 110' L is 2.7% to 6.3%, and up to 8.2% at driveway apron.
B17	Running slope (parallel to direction of travel) is 1:20 (5.0%) max. (ADAS 403.3)	Approx. 100' L is 5.4% to 10.4% and up to 16.1% at driveway apron.

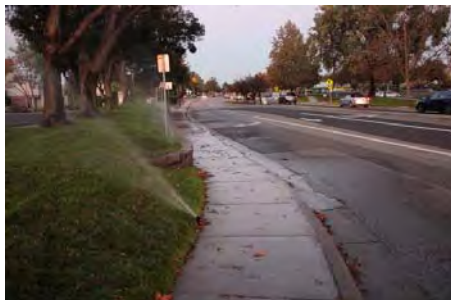
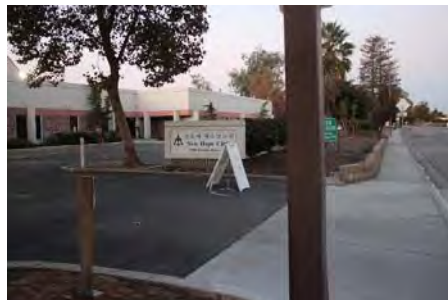
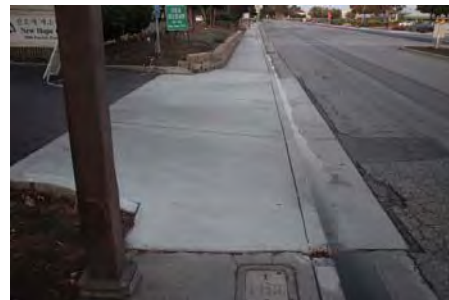
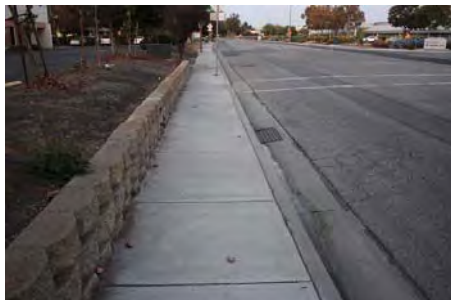
COD	CONDITION DESCRIPTION	ACTUAL
B16	Cross slope (perpendicular to direction of travel) is 1:48 (2.08%) max. (ADAS 403.3)	Approx. 50' L is 2.5% o 3.9% and up to 5.8% at driveway apron.
B17	Running slope (parallel to direction of travel) is 1:20 (5.0%) max. (ADAS 403.3)	13.7% and 18.4% at driveway apron.

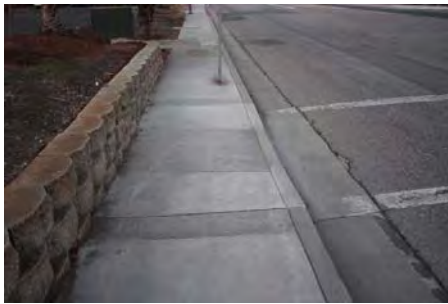
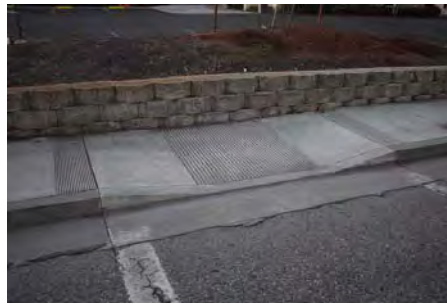
COD	CONDITION DESCRIPTION	ACTUAL
B06	Transition to walk, gutter or street is flush and free of abrupt changes. (ADAS 406.2)	1/2" high vertical edge.
B11	Top landing is as wide as the ramp and 36" min. in length. (ADAS 406.4)	None
A17	Where no top landing is provided at an existing ramp, side flare slopes are 8.33% max. (ADAS 406.4)	13.9% right side, 11.9% left side.

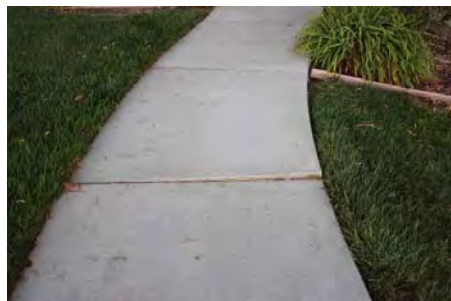
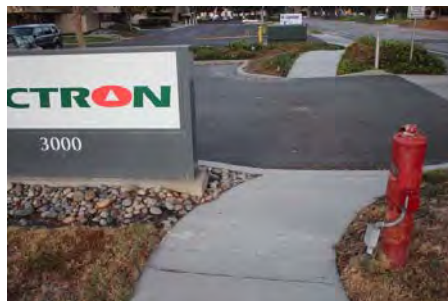
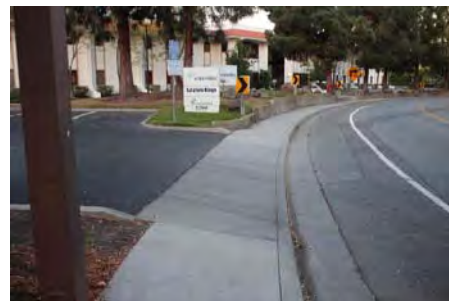
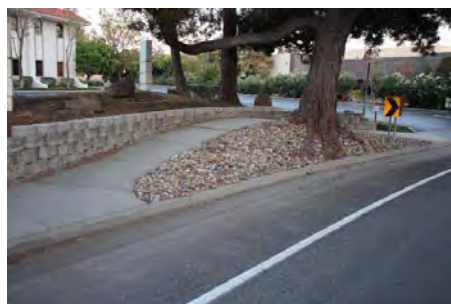
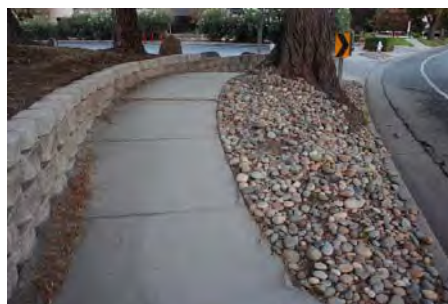
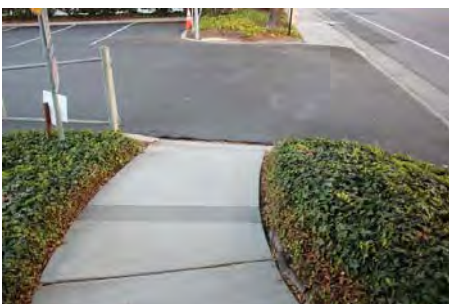
Sidewalk with artificial hills. Excessive cross/running slope occurs in conjunction.

COD	CONDITION DESCRIPTION	ACTUAL
B12	Gaps/openings in ground or floor surfaces do not allow the passage of a sphere more than 1/2" in diameter. (ADAS 302.3)	6" wide gap at address 3000 driveway apron.
B15	No level changes greater than 1/2" (except by accessible ramp or other means). (ADAS 303.4)	3/4" to 1" high vertical edges at 5 places.
B16	Cross slope (perpendicular to direction of travel) is 1:48 (2.08%) max. (ADAS 403.3)	Approx. 520' L is 2.6% to 10.5%, including 10 drive aprons and 6 hills.
B17	Running slope (parallel to direction of travel) is 1:20 (5.0%) max. (ADAS 403.3)	10.3% to 18.8% at 14 sides of drive aprons, 10.0% to 13.6% at 10 sides of hills.

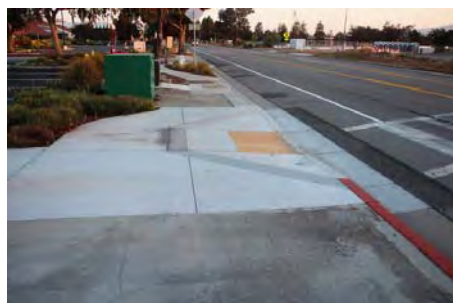
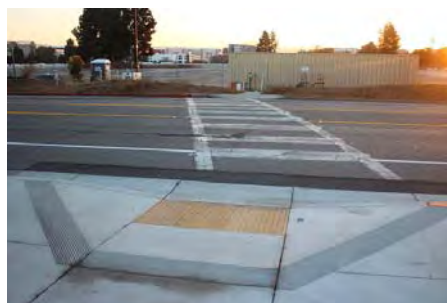
COD	CONDITION DESCRIPTION	ACTUAL
B14	Counter slopes of adjoining gutters and road surfaces immediately adjacent to and within 24 inches of the curb ramp are not steeper than 1:20 (5.0%). (ADAS 406.2)	6.3%
B18	If curb ramp is located at marked crossing, the transition is wholly contained within the markings. (ADAS 406.5)	Approx. half of transition is not within markings.

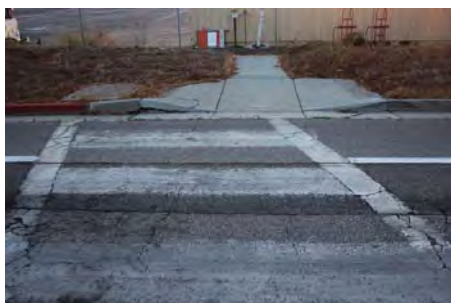
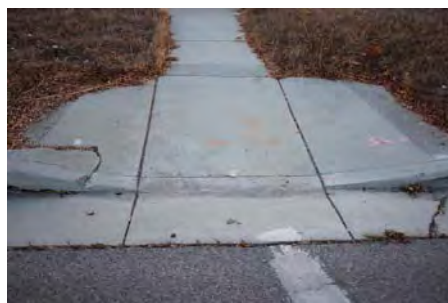
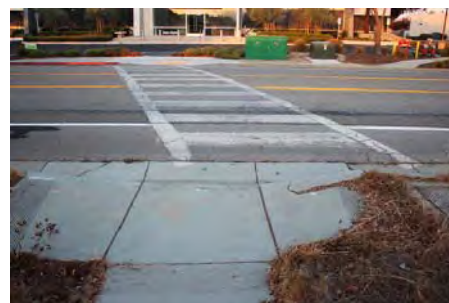
COD	CONDITION DESCRIPTION	ACTUAL
B14	Counter slopes of adjoining gutters and road surfaces immediately adjacent to and within 24 inches of the curb ramp are not steeper than 1:20 (5.0%). (ADAS 406.2)	13.4%
B18	If curb ramp is located at marked crossing, the transition is wholly contained within the markings. (ADAS 406.5)	Approx. half of transition is not within markings.

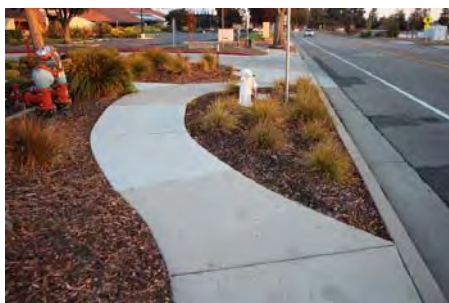
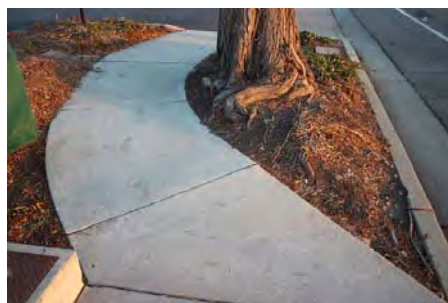
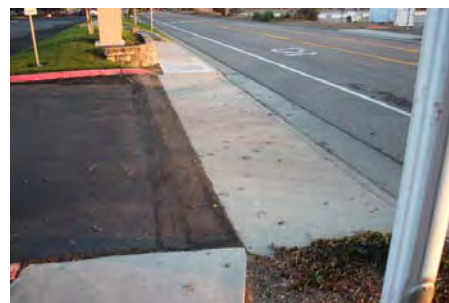
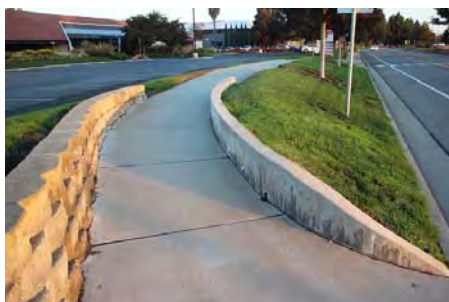
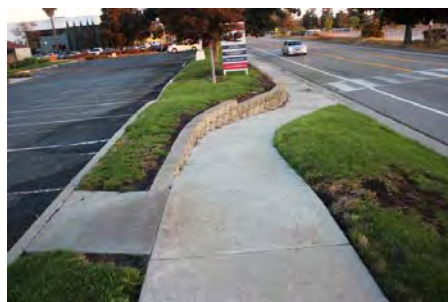
COD	CONDITION DESCRIPTION	ACTUAL
B16	Cross slope (perpendicular to direction of travel) is 1:48 (2.08%) max. (ADAS 403.3)	Approx. 40' L is 3.5% to 5.8% at 1 hill and drive apron.
B17	Running slope (parallel to direction of travel) is 1:20 (5.0%) max. (ADAS 403.3)	Approx. 120' L is 6.3% to 10.4% at sides of 3 hills and 1 drive apron.

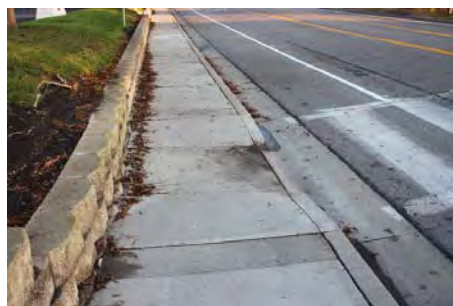
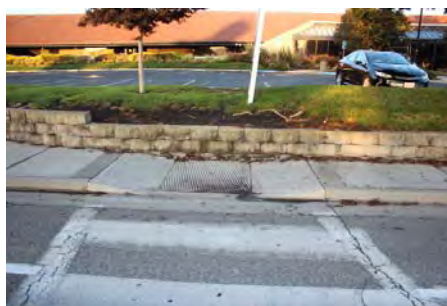
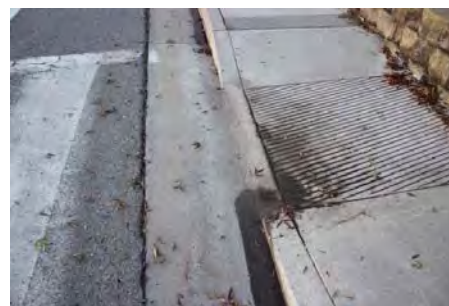
COD	CONDITION DESCRIPTION	ACTUAL
B11	Top landing is as wide as the ramp and 36" min. in length. (ADAS 406.4)	None
B14	Counter slopes of adjoining gutters and road surfaces immediately adjacent to and within 24 inches of the curb ramp are not steeper than 1:20 (5.0%). (ADAS 406.2)	7.9%
A17	Where no top landing is provided at an existing ramp, side flare slopes are 8.33% max. (ADAS 406.4)	16.8% left side, 14.2% right side.

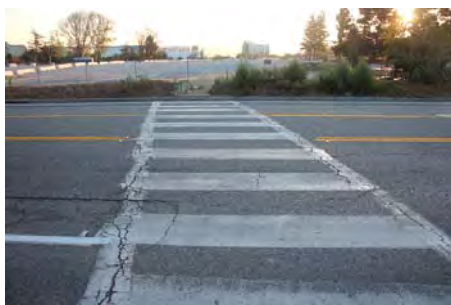
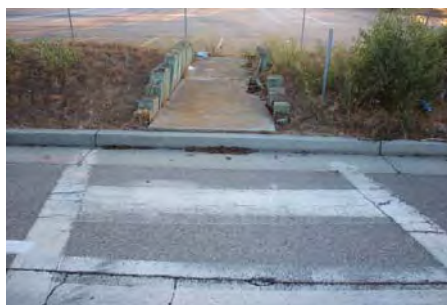
COD	CONDITION DESCRIPTION	ACTUAL
B15	No level changes greater than 1/2" (except by accessible ramp or other means). (ADAS 303.4)	6" high vertical edge at curb and 2" high vertical edge at walkway leading to Blue Lot #1.
