Case No. 5:16-cv-07013-LHK (SVK)

**DECLARATION OF JEFFREY SCOTT
MASTIN IN SUPPORT OF PLAINTIFFS'
MOTION FOR CLASS CERTIFICATION**

NEVAREZ V 49ERS - ACCESSIBILITY ASSESSMENT

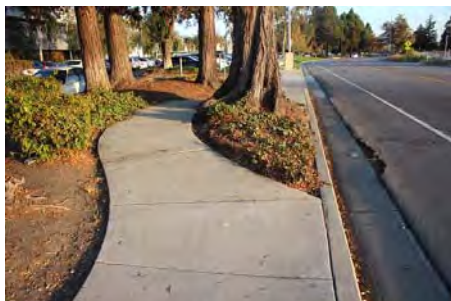
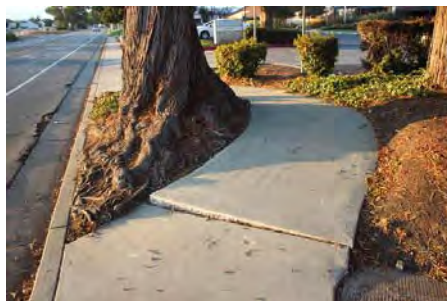
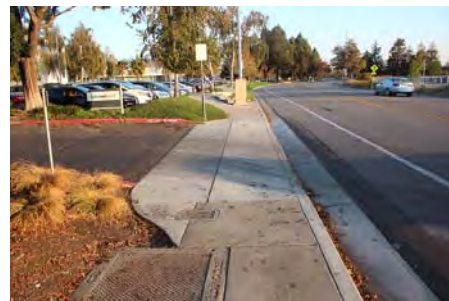
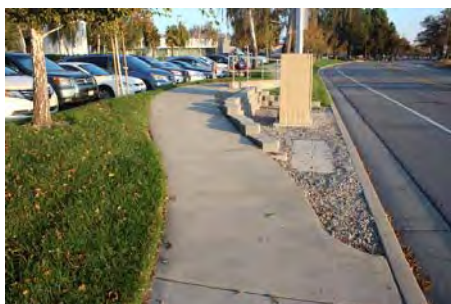
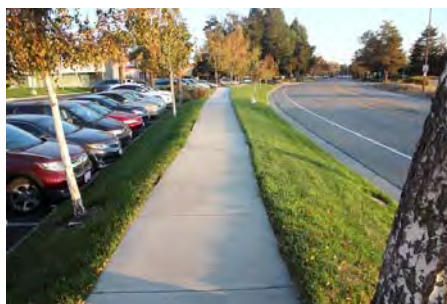
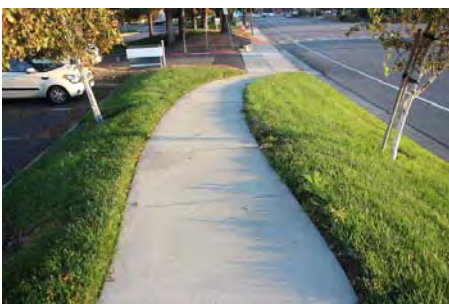
COD	CONDITION DESCRIPTION	ACTUAL
B12	Gaps/openings in ground or floor surfaces do not allow the passage of a sphere more than 1/2" in diameter. (ADAS 302.3)	2 3/4" W gap.
B15	No level changes greater than 1/2" (except by accessible ramp or other means). (ADAS 303.4)	3" high vertical edge.
B16	Cross slope (perpendicular to direction of travel) is 1:48 (2.08%) max. (ADAS 403.3)	Approx. 60' L is 3.5% to 9.7%.
B17	Running slope (parallel to direction of travel) is 1:20 (5.0%) max. (ADAS 403.3)	5.9% to 15.0% at 6 sides of hills and 1 driveway apron.

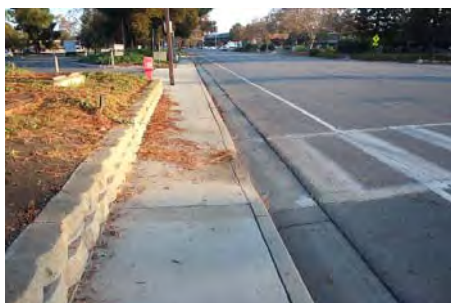
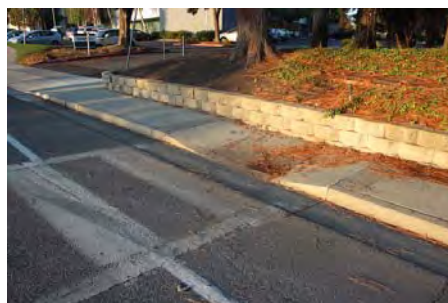
COD	CONDITION DESCRIPTION	ACTUAL
B05	Surface of ramp and landings complies with requirements for an accessible path of travel (stable, firm, slip-resistant, without gaps over 1/2" wide or edges over 1/4" high). (ADAS 302.1, 403.2, 403.3, 403.4)	Covered with plant debris.
B11	Top landing is as wide as the ramp and 36" min. in length. (ADAS 406.4)	None
B14	Counter slopes of adjoining gutters and road surfaces immediately adjacent to and within 24 inches of the curb ramp are not steeper than 1:20 (5.0%). (ADAS 406.2)	8.6%
A17	Where no top landing is provided at an existing ramp, side flare slopes are 8.33% max. (ADAS 406.4)	13.0% left side, 15.0% right side.

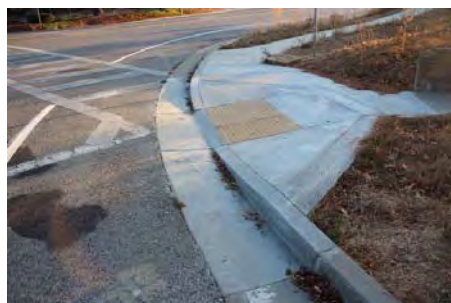
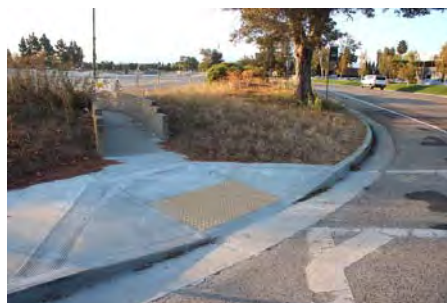
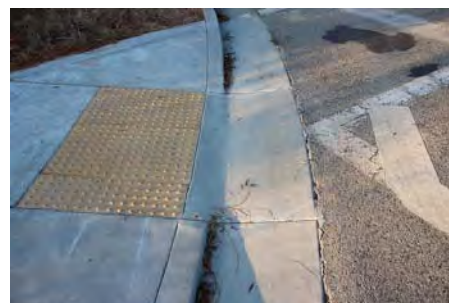
COD	CONDITION DESCRIPTION	ACTUAL
B03	Running slope of ramp is 1:12 (8.33%) max. (ADAS 405.2)	16.8% across curb face and up to 8.8% general slope.
B14	Counter slopes of adjoining gutters and road surfaces immediately adjacent to and within 24 inches of the curb ramp are not steeper than 1:20 (5.0%). (ADAS 406.2)	10.1%
B19	DIAGONAL: If curb ramp is located at marked crossing, 48" min. clear space is provided within the markings. (ADAS 406.6)	22" clear to markings.

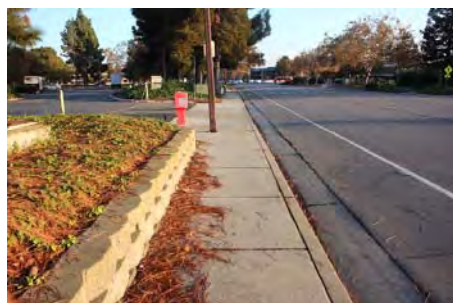
COD	CONDITION DESCRIPTION	ACTUAL
B16	Cross slope (perpendicular to direction of travel) is 1:48 (2.08%) max. (ADAS 403.3)	5.7% at driveway apron.
B17	Running slope (parallel to direction of travel) is 1:20 (5.0%) max. (ADAS 403.3)	13.0% and 14.1% at driveway apron.

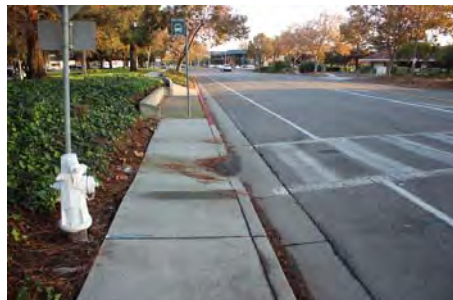
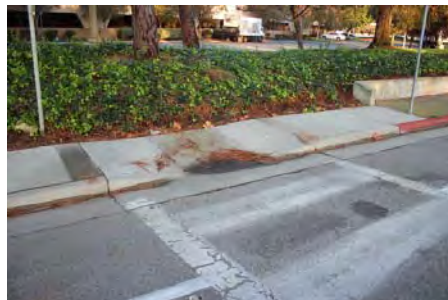
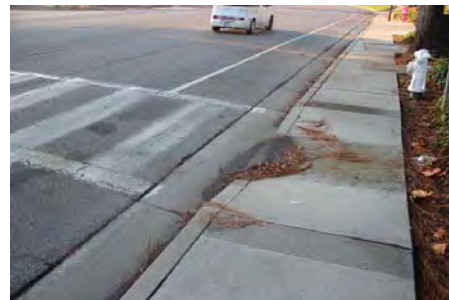
COD	CONDITION DESCRIPTION	ACTUAL
B03	Running slope of ramp is 1:12 (8.33%) max. (ADAS 405.2)	12.4% across curb face.
B05	Surface of ramp and landings complies with requirements for an accessible path of travel (stable, firm, slip-resistant, without gaps over 1/2" wide or edges over 1/4" high). (ADAS 302.1, 403.2, 403.3, 403.4)	1 1/2" W gap at asphalt transition at btm. landing and ramp covered by plant debris.
B11	Top landing is as wide as the ramp and 36" min. in length. (ADAS 406.4)	None
B14	Counter slopes of adjoining gutters and road surfaces immediately adjacent to and within 24 inches of the curb ramp are not steeper than 1:20 (5.0%). (ADAS 406.2)	10.1%
A17	Where no top landing is provided at an existing ramp, side flare slopes are 8.33% max. (ADAS 406.4)	15.1% right side, 16.2% left side.

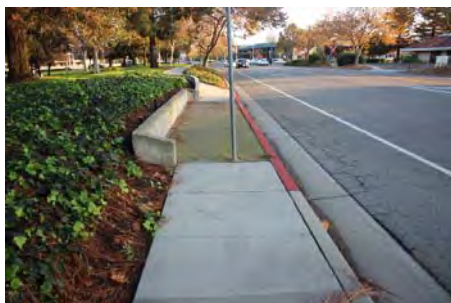
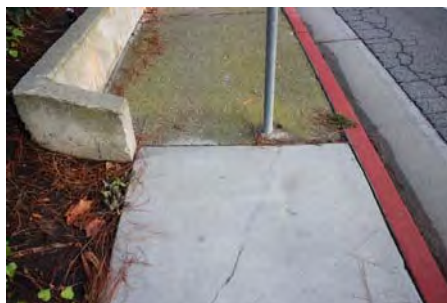
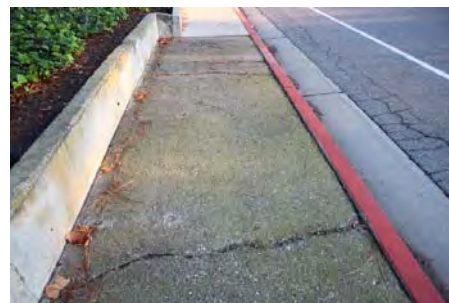
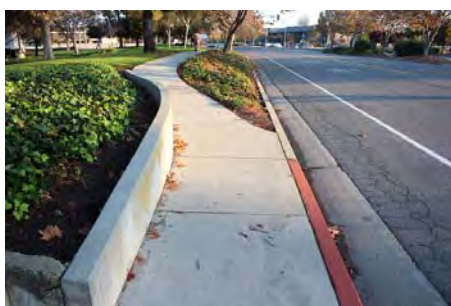
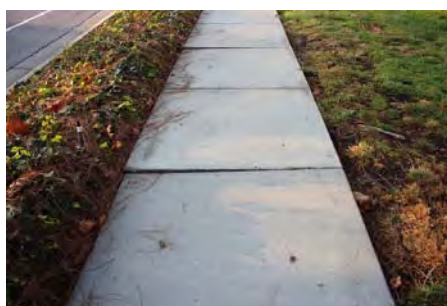
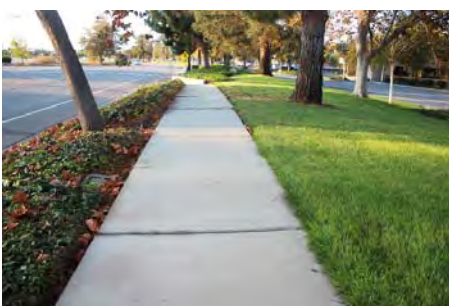
COD	CONDITION DESCRIPTION	ACTUAL
B02	36" min. clear width of exterior walkway. (ADAS 403.5.1)	33" clear at bus sign post.
B15	No level changes greater than 1/2" (except by accessible ramp or other means). (ADAS 303.4)	3/4" to 2" high vertical edges at 4 places.
B16	Cross slope (perpendicular to direction of travel) is 1:48 (2.08%) max. (ADAS 403.3)	Approx. 180' L is 3.6% to 7.0%.
B17	Running slope (parallel to direction of travel) is 1:20 (5.0%) max. (ADAS 403.3)	9.0% at hill.

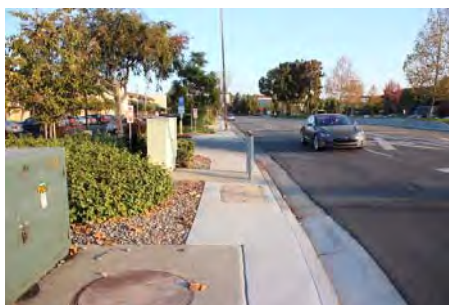
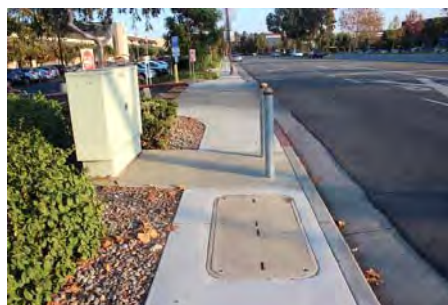
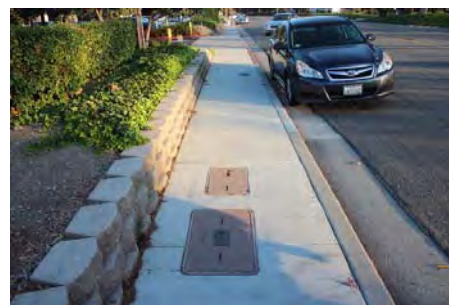
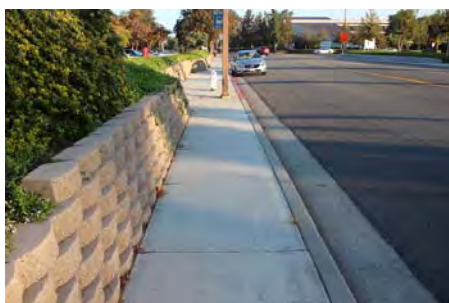
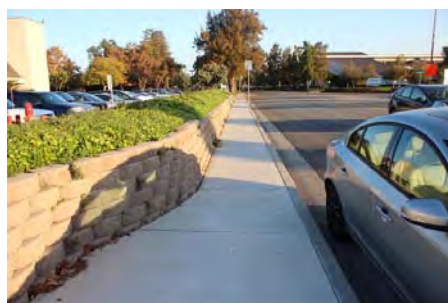
COD	CONDITION DESCRIPTION	ACTUAL
B16	Cross slope (perpendicular to direction of travel) is 1:48 (2.08%) max. (ADAS 403.3)	Approx. 150' L is 2.8% to 4.3%.

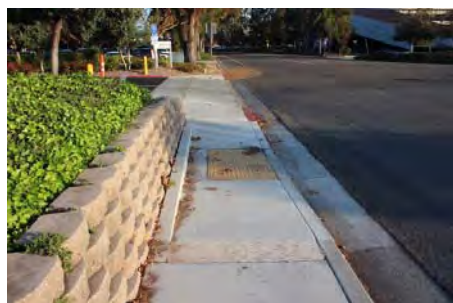
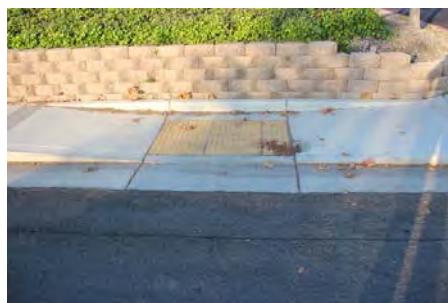
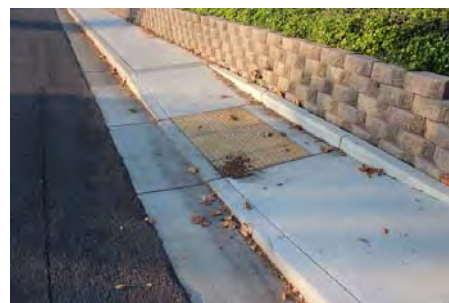
COD	CONDITION DESCRIPTION	ACTUAL
B06	Transition to walk, gutter or street is flush and free of abrupt changes. (ADAS 406.2)	3/8" high vertical edge
B13	Counter slopes of adjoining gutters and road surfaces immediately adjacent to and within 24 inches of the curb ramp are not steeper than 1:20 (5.0%). (ADAS 406.2)	6.2%

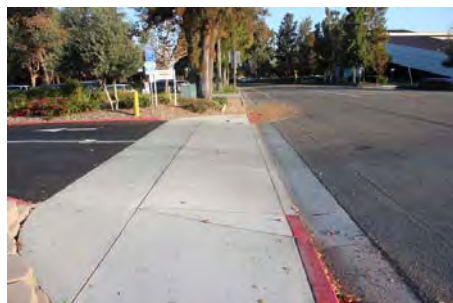
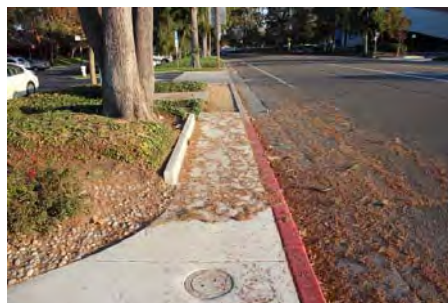
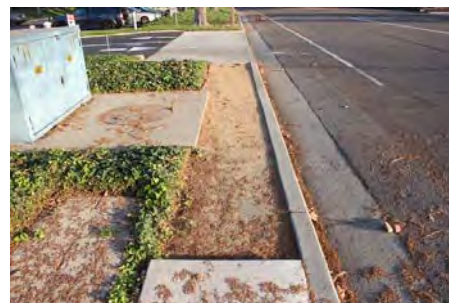
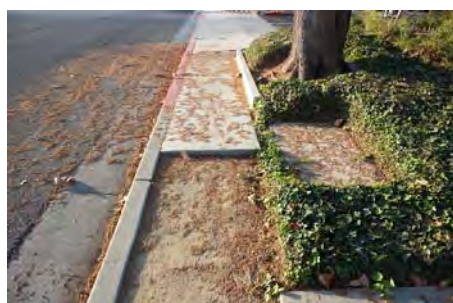
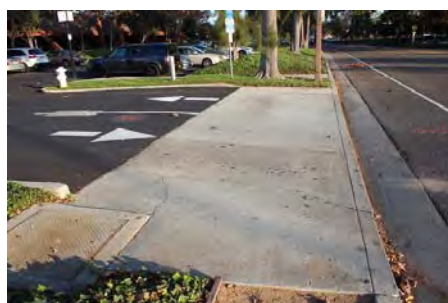
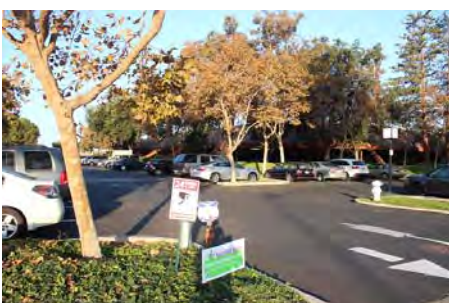
COD	CONDITION DESCRIPTION	ACTUAL
B02	36" min. clear width of exterior walkway. (ADAS 403.5.1)	32 1/2" W at dirt portion.
B11	Surface is firm, stable and slip-resistant. (ADAS 302.1)	Dirt surface for approx. 20' L.
B15	No level changes greater than 1/2" (except by accessible ramp or other means). (ADAS 303.4)	2 1/2" high vertical edge at end of concrete.
B16	Cross slope (perpendicular to direction of travel) is 1:48 (2.08%) max. (ADAS 403.3)	Portion of concrete is 3.2%.

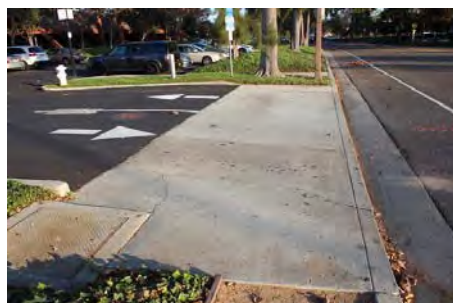
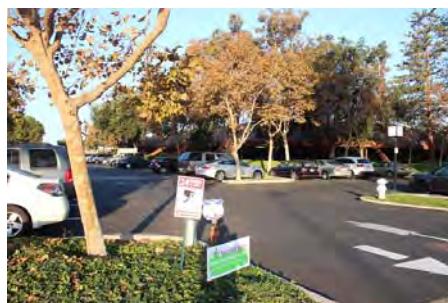
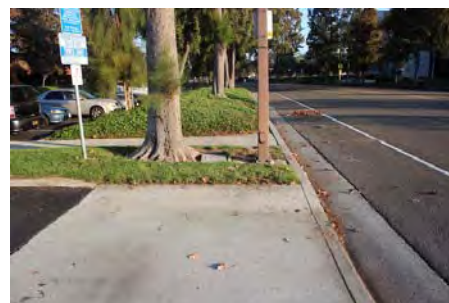
COD	CONDITION DESCRIPTION	ACTUAL
B02	36" min. clear width of exterior walkway. (ADAS 403.5.1)	Obstructed by 2 sign posts utility cover and tree.
B11	Surface is firm, stable and slip-resistant. (ADAS 302.1)	Grass surface.

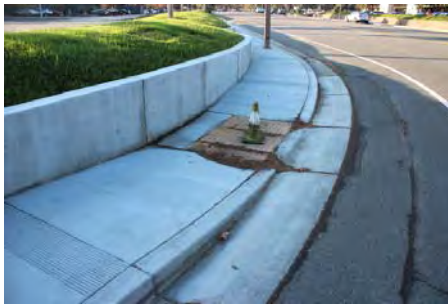
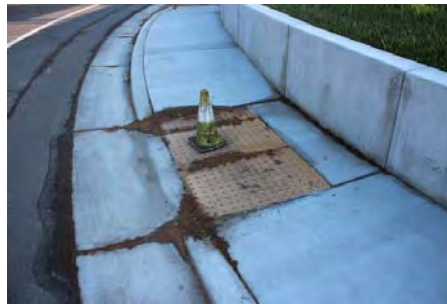
COD	CONDITION DESCRIPTION	ACTUAL
B02	The width of curb ramp is 36" min. (ADAS 405.5)	Obstructed by traffic cone.
B03	Running slope is 1:12 (8.33%) max. (ADAS 405.2)	8.6% and 1" at btm. is 18.2%.
B05	Surface of ramp and landings complies with requirements for an accessible path of travel (stable, firm, slip-resistant, without gaps over 1/2" wide or edges over 1/4" high). (ADAS 405.4)	Partially covered with debris.
B13	Counter slopes of adjoining gutters and road surfaces immediately adjacent to and within 24 inches of the curb ramp are not steeper than 1:20 (5.0%). (ADAS 406.2)	6.8%

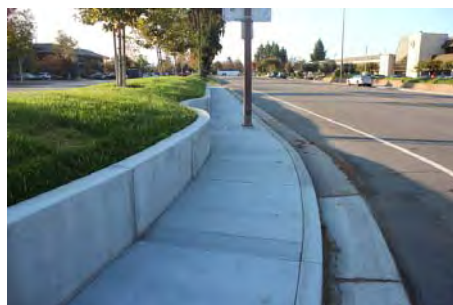
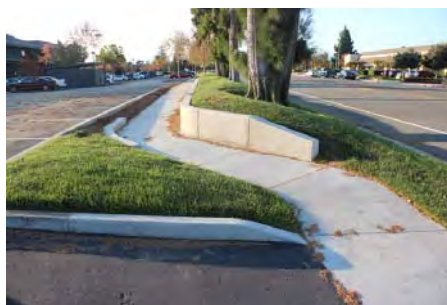
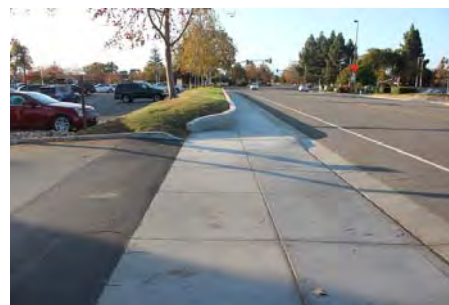
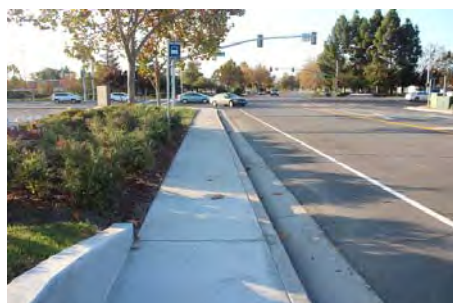
COD	CONDITION DESCRIPTION	ACTUAL
B16	Cross slope (perpendicular to direction of travel) is 1:48 (2.08%) max. (ADAS 403.3)	Approx. 120' L is 2.6% to 3.8%.

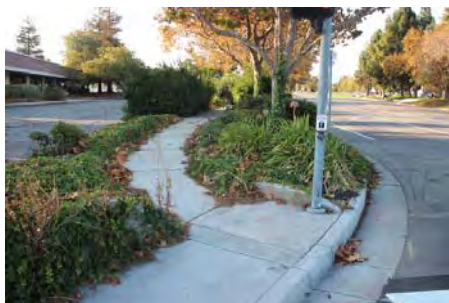
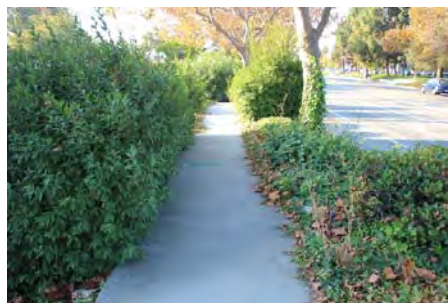
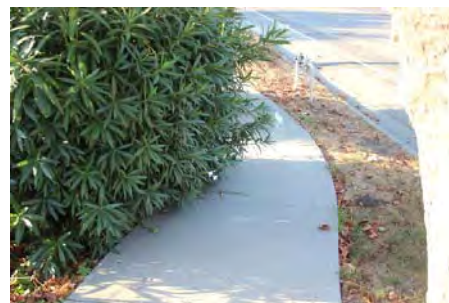
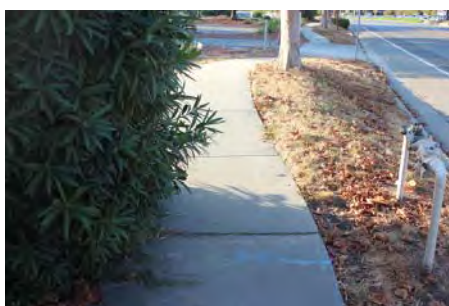
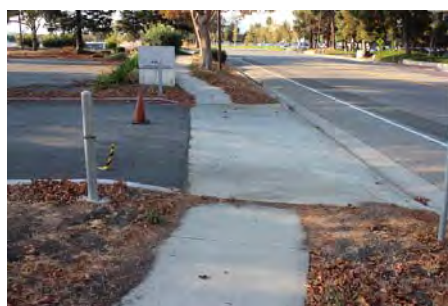
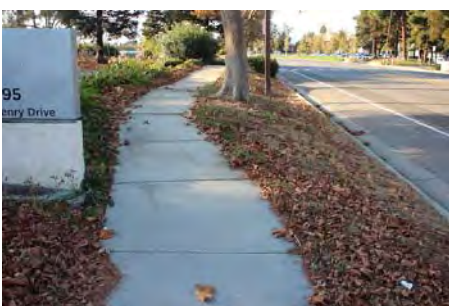
COD	CONDITION DESCRIPTION	ACTUAL
B02	36" min. clear width of exterior walkway. (ADAS 403.5.1)	Obstructed by plants.
B15	No level changes greater than 1/2" (except by accessible ramp or other means). (ADAS 303.4)	1 1/4" high vertical edge.
B16	Cross slope (perpendicular to direction of travel) is 1:48 (2.08%) max. (ADAS 403.3)	Approx. 120' L is 2.8% to 8.2%.
B17	Running slope (parallel to direction of travel) is 1:20 (5.0%) max. (ADAS 403.3)	5.6% to 10.2% at 5 sides of hills.

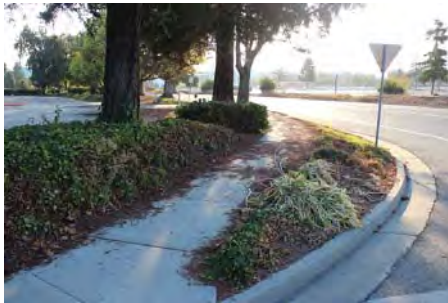
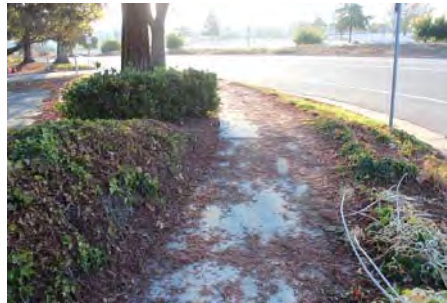
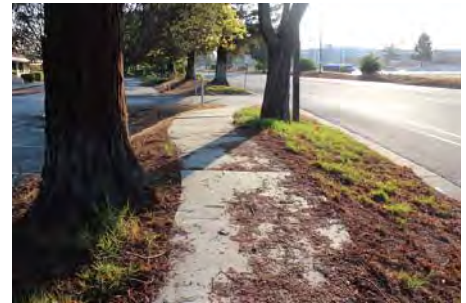
COD	CONDITION DESCRIPTION	ACTUAL
B11	Surface is firm, stable and slip-resistant. (ADAS 302.1)	Covered with Pine needles and sidewalk dead ends.
B15	No level changes greater than 1/2" (except by accessible ramp or other means). (ADAS 303.4)	1" and 1 1/2" high vertical edges.
B16	Cross slope (perpendicular to direction of travel) is 1:48 (2.08%) max. (ADAS 403.3)	Approx. 40' L is 3.5% to 6.1%.
B17	Running slope (parallel to direction of travel) is 1:20 (5.0%) max. (ADAS 403.3)	Approx. 40' L is 5.3% to 12.8%.

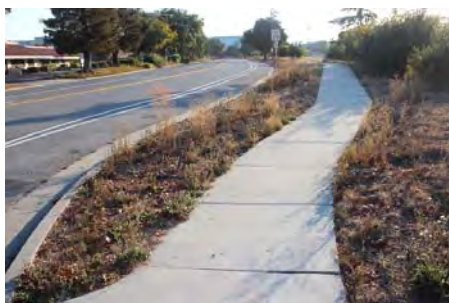
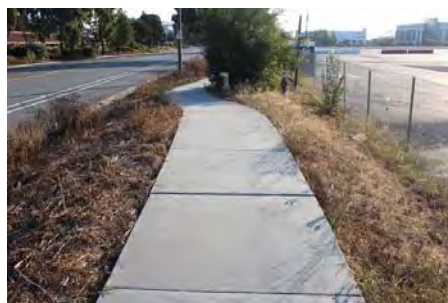
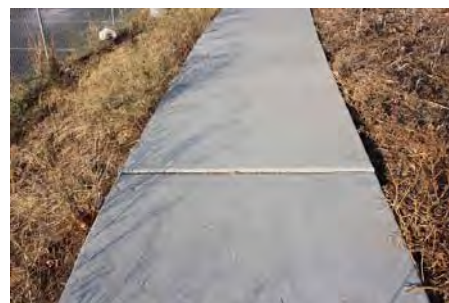
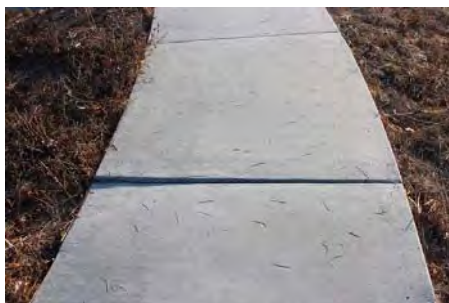
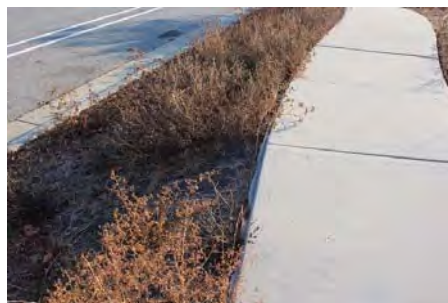
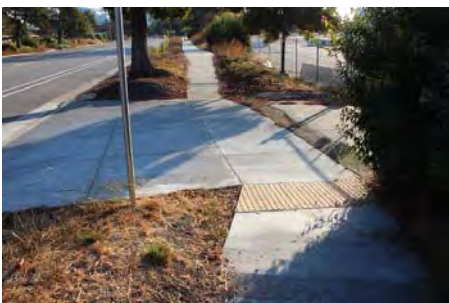
COD	CONDITION DESCRIPTION	ACTUAL
B15	No level changes greater than 1/2" (except by accessible ramp or other means). (ADAS 303.4)	1" high vertical edge.
B16	Cross slope (perpendicular to direction of travel) is 1:48 (2.08%) max. (ADAS 403.3)	Approx. 100' L is 2.6% to 4.7%.
B17	Running slope (parallel to direction of travel) is 1:20 (5.0%) max. (ADAS 403.3)	Apporx. 60' L is 5.8% to 7.2%.

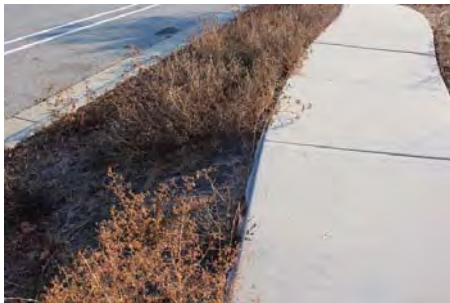
COD	CONDITION DESCRIPTION	ACTUAL
B11	Abrupt changes in level over 4" high are identified either by a curb or guide rail. (28 CFR 35.130(a), ADAS 405.9, CBC 11B-303.5)	Drop off at one side exceeds 4" H near top of hill.

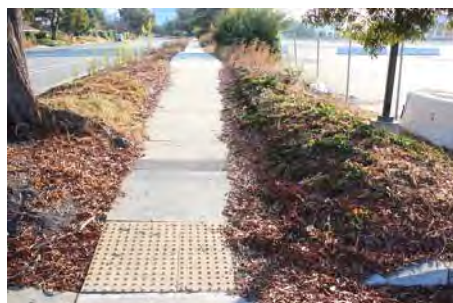
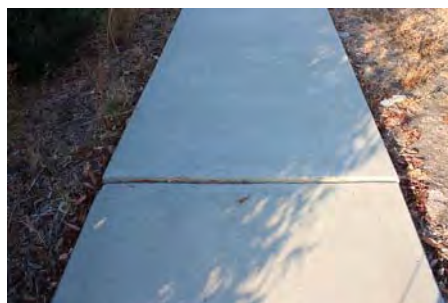
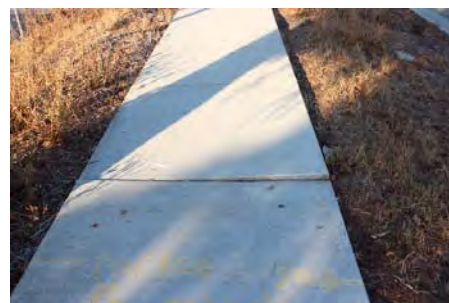
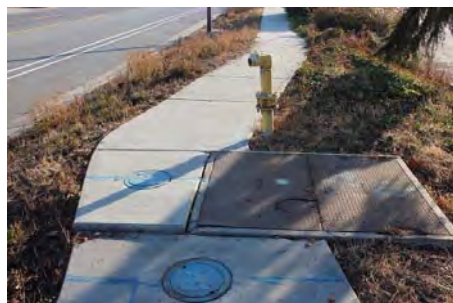
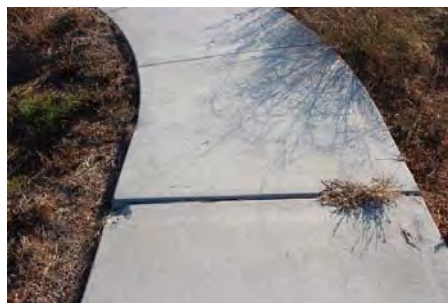
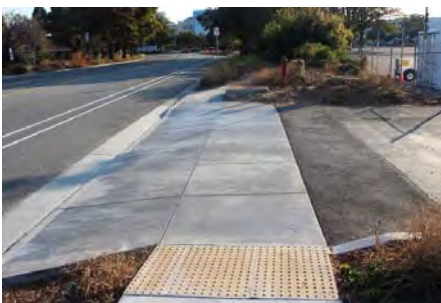
COD	CONDITION DESCRIPTION	ACTUAL
B15	No level changes greater than 1/2" (except by accessible ramp or other means). (ADAS 303.4)	3/4" to 2" high vertical edges at 8 places.
B16	Cross slope (perpendicular to direction of travel) is 1:48 (2.08%) max. (ADAS 403.3)	Approx. 220' L is 2.6% to 4.5%.
B17	Running slope (parallel to direction of travel) is 1:20 (5.0%) max. (ADAS 403.3)	Apporx. 10' L is up to 8.9%.

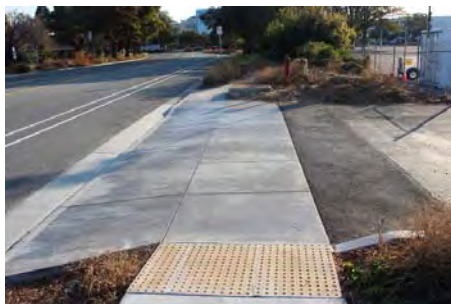
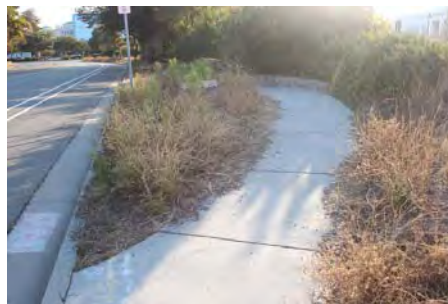
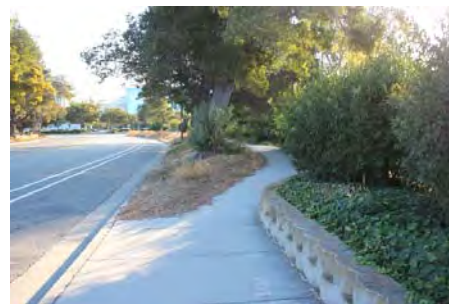
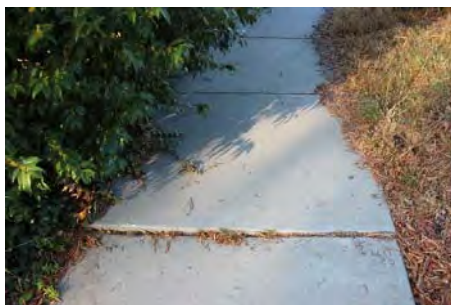
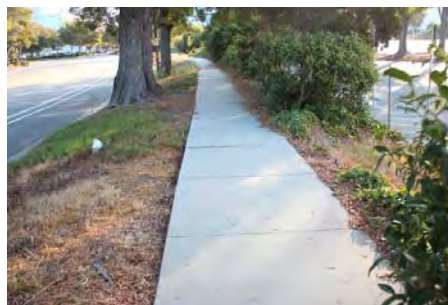
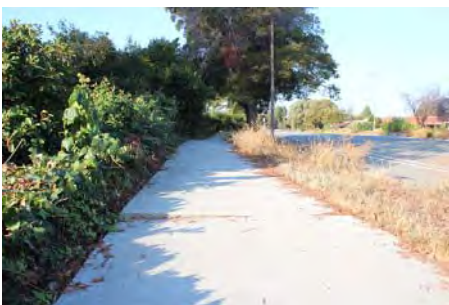
COD	CONDITION DESCRIPTION	ACTUAL
B15	No level changes greater than 1/2" (except by accessible ramp or other means). (ADAS 303.4)	1" to 1 1/4" high vertical edges at 4 places.
B16	Cross slope (perpendicular to direction of travel) is 1:48 (2.08%) max. (ADAS 403.3)	Approx. 200' L is 2.6% to 6.8%.
B17	Running slope (parallel to direction of travel) is 1:20 (5.0%) max. (ADAS 403.3)	Up to 7.8% at 2 hills and approx. 20' L is 7.8% to 10.3%.

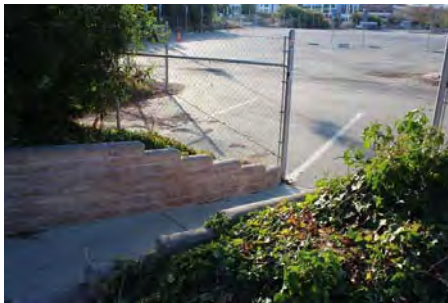
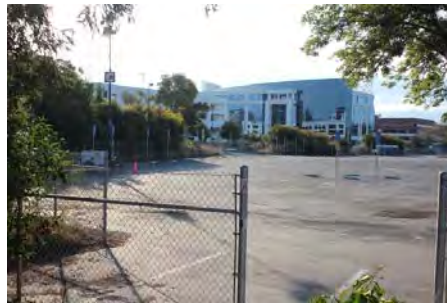
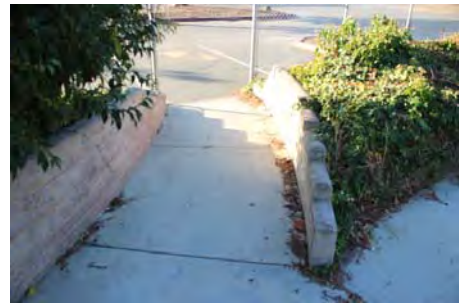
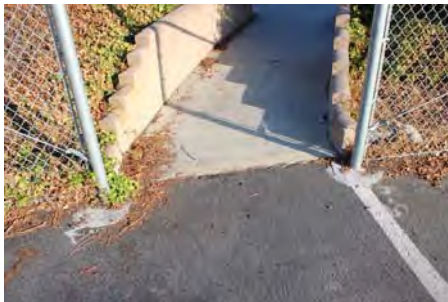
NEVAREZ V 49ERS - ACCESSIBILITY ASSESSMENT**FACILITY/SITE: 5. Democracy Wy.****SEQ.
#****506****FEATURE: #11 ACC ROUTE OF TRAVEL****LOCATION: S side of the street.****MEMO: Lateral pedestrian walk to Blue Lot #1.****Notes:**

COD	CONDITION DESCRIPTION	ACTUAL
B17	Running slope (parallel to direction of travel) is 1:20 (5.0%) max. (ADAS 403.3)	Entire length is 5.7% to 11.2%.

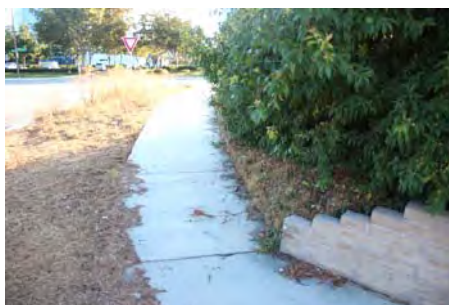
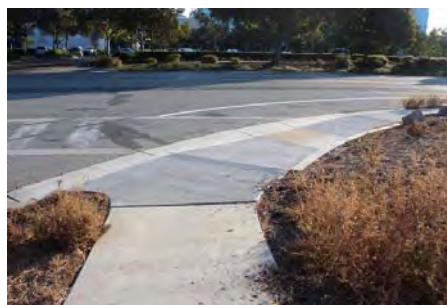
COD	CONDITION DESCRIPTION	ACTUAL
B16	Cross slope (perpendicular to direction of travel) is 1:48 (2.08%) max. (ADAS 403.3)	Apporx. 10' L is 2.9%.

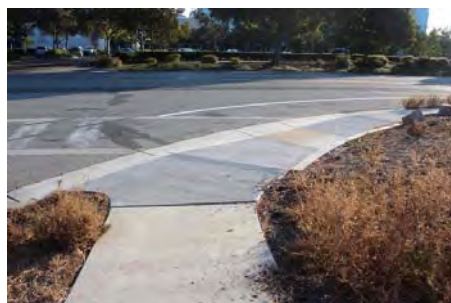
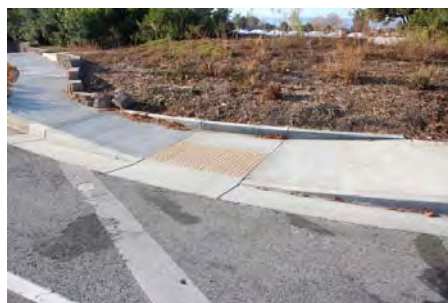
COD	CONDITION DESCRIPTION	ACTUAL
C12	Turning space at bottom of curb ramp slopes 1:48 (2.08%) max. in any direction (ADAS 403.3)	9.2% across curb face.
B13	Counter slopes of adjoining gutters and road surfaces immediately adjacent to and within 24 inches of the curb ramp are not steeper than 1:20 (5.0%). (ADAS 406.2)	10.2%

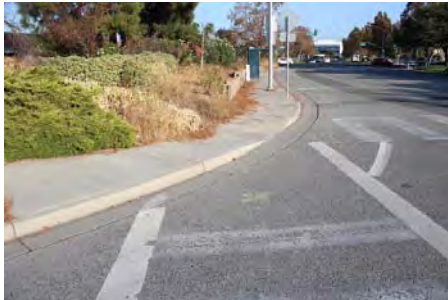
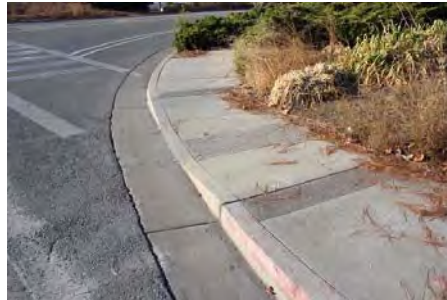
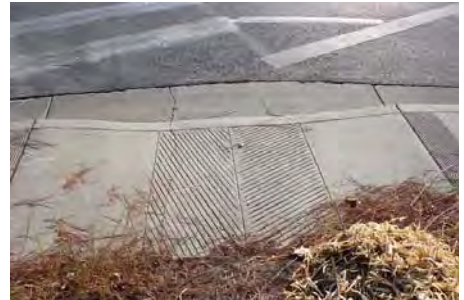
COD	CONDITION DESCRIPTION	ACTUAL
B03	Running slope of ramp is 1:12 (8.33%) max. (ADAS 405.2)	14.7% across curb face.
B11	Top landing is as wide as the ramp and 36" min. in length. (ADAS 406.4)	None
B14	Counter slopes of adjoining gutters and road surfaces immediately adjacent to and within 24 inches of the curb ramp are not steeper than 1:20 (5.0%). (ADAS 406.2)	10.4%
A17	Where no top landing is provided at an existing ramp, side flare slopes are 8.33% max. (ADAS 406.4)	13.2% right side, 12.0% left side.
B19	DIAGONAL: If curb ramp is located at marked crossing, 48" min. clear space is provided within the markings. (ADAS 406.6)	35" clear within markings.

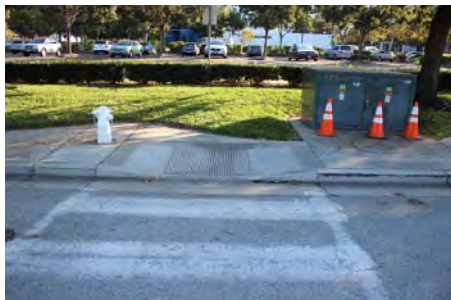
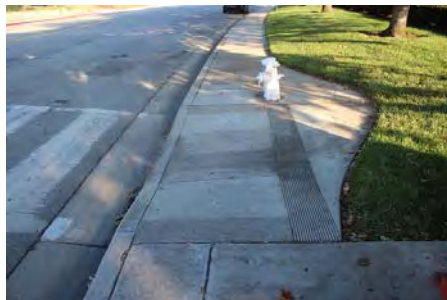
COD	CONDITION DESCRIPTION	ACTUAL
B03	Running slope of ramp is 1:12 (8.33%) max. (ADAS 405.2)	16.8% across curb face.
B05	Surface of ramp and landings complies with requirements for an accessible path of travel (stable, firm, slip-resistant, without gaps over 1/2" wide or edges over 1/4" high). (ADAS 302.1, 403.2, 403.3, 403.4)	3.5% cross slope at top landing.
B11	Top landing is as wide as the ramp and 36" min. in length. (ADAS 406.4)	24" L.
B14	Counter slopes of adjoining gutters and road surfaces immediately adjacent to and within 24 inches of the curb ramp are not steeper than 1:20 (5.0%). (ADAS 406.2)	9.9%
A17	Where no top landing is provided at an existing ramp, side flare slopes are 8.33% max. (ADAS 406.4)	13.6% left side, 13.7% right side.

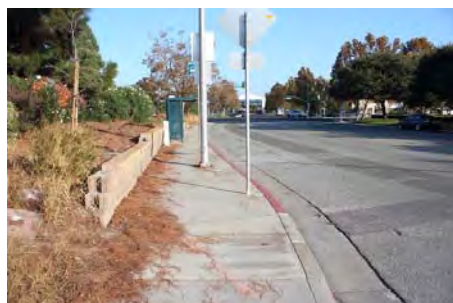
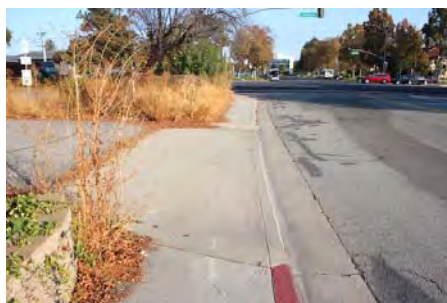
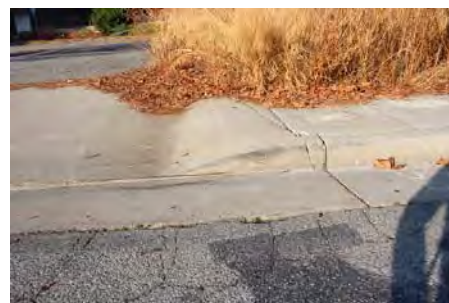
COD	CONDITION DESCRIPTION	ACTUAL
B16	Cross slope (perpendicular to direction of travel) is 1:48 (2.08%) max. (ADAS 403.3)	7.6% for approx. 20' L at driveway apron.
B17	Running slope (parallel to direction of travel) is 1:20 (5.0%) max. (ADAS 403.3)	20.8% and 25.6% at sides of driveway apron.

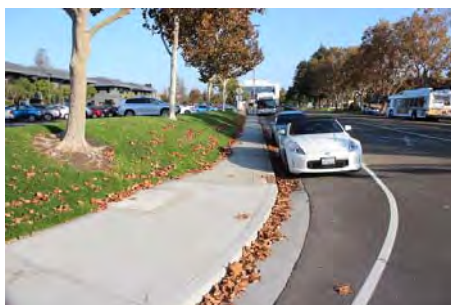
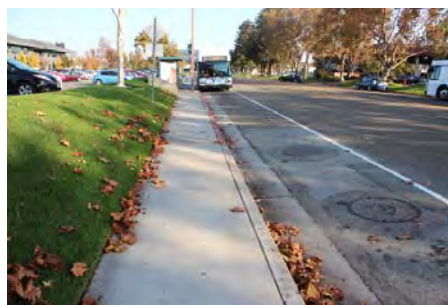
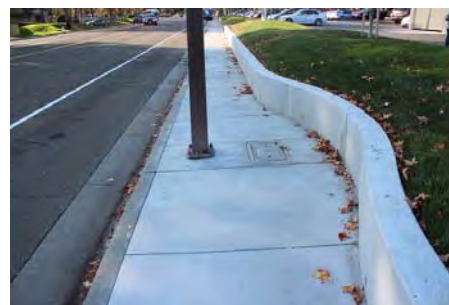
COD	CONDITION DESCRIPTION	ACTUAL
B16	Cross slope (perpendicular to direction of travel) is 1:48 (2.08%) max. (ADAS 403.3)	Approx. 70' L is 2.8% to 3.9%.

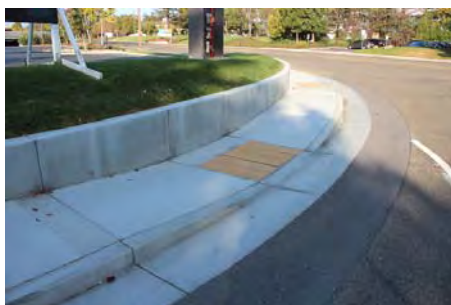
COD	CONDITION DESCRIPTION	ACTUAL
B13	Counter slopes of adjoining gutters and road surfaces immediately adjacent to and within 24 inches of the curb ramp are not steeper than 1:20 (5.0%). (ADAS 406.2)	6.8%

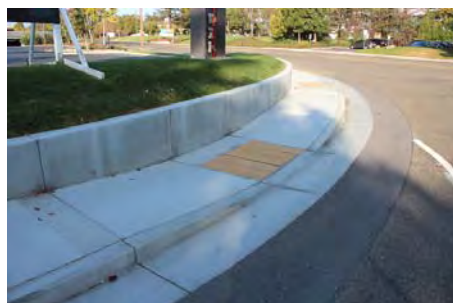
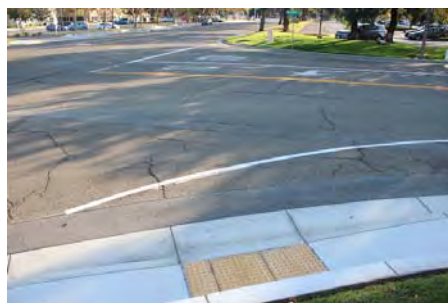
COD	CONDITION DESCRIPTION	ACTUAL
B11	Surface is firm, stable and slip-resistant. (ADAS 302.1)	No sidewalk.
B15	No level changes greater than 1/2" (except by accessible ramp or other means). (ADAS 303.4)	No curb access.

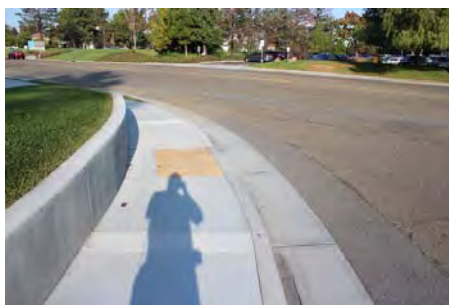
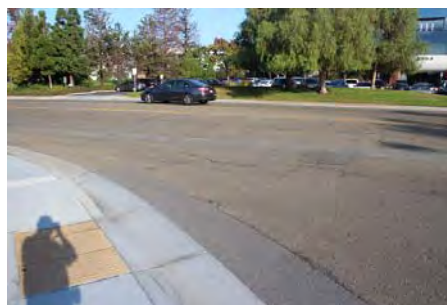
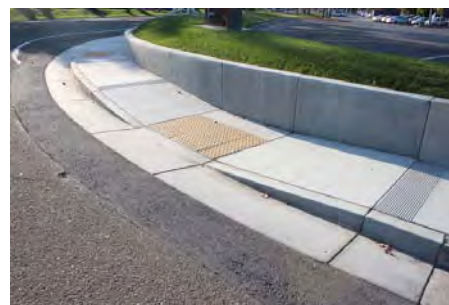
COD	CONDITION DESCRIPTION	ACTUAL
B13	Counter slopes of adjoining gutters and road surfaces immediately adjacent to and within 24 inches of the curb ramp are not steeper than 1:20 (5.0%). (ADAS 406.2)	7.4%

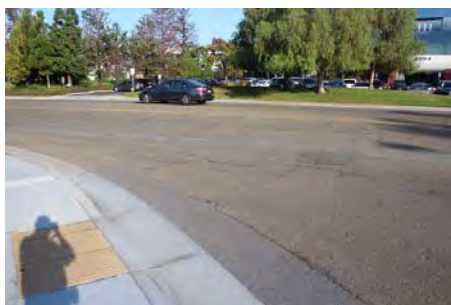
COD	CONDITION DESCRIPTION	ACTUAL
B15	No level changes greater than 1/2" (except by accessible ramp or other means). (ADAS 303.4)	No curb ramp.

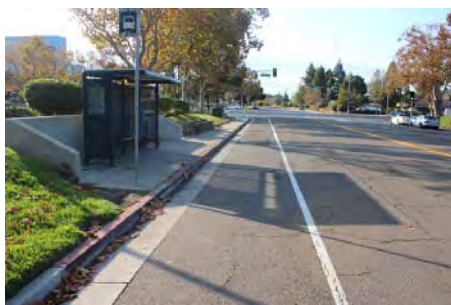
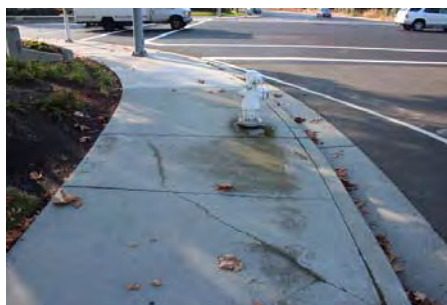
COD	CONDITION DESCRIPTION	ACTUAL
B16	Cross slope (perpendicular to direction of travel) is 1:48 (2.08%) max. (ADAS 403.3)	Approx. 10' L is up to 4.7% near Tasman Drive.

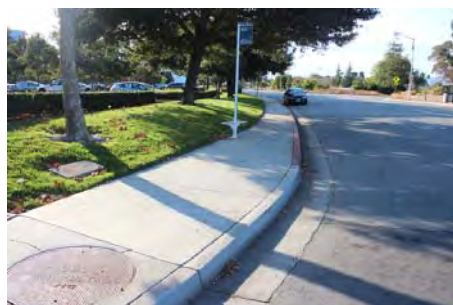
COD	CONDITION DESCRIPTION	ACTUAL
B16	Cross slope (perpendicular to direction of travel) is 1:48 (2.08%) max. (ADAS 403.3)	Approx. 120' L is 2.7% to 4.4%.

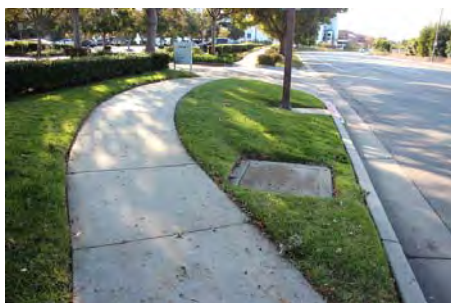
COD	CONDITION DESCRIPTION	ACTUAL
B17	Running slope (parallel to direction of travel) is 1:20 (5.0%) max. (ADAS 403.3)	7.5% at one side of hill.

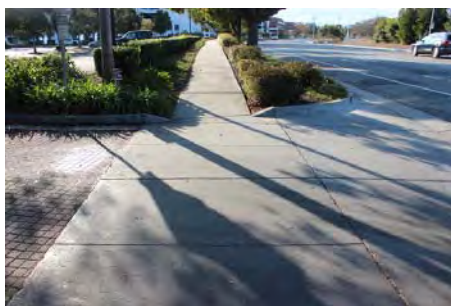
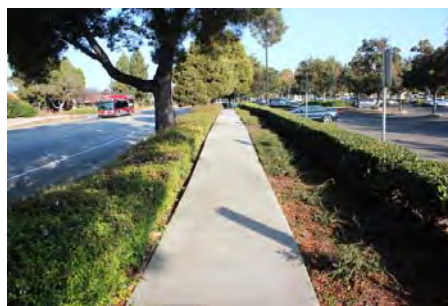
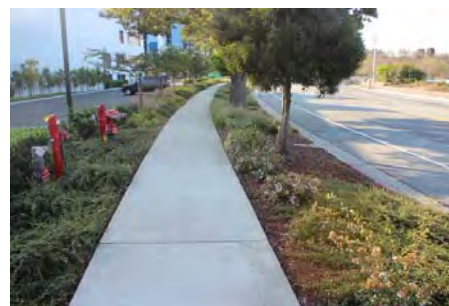
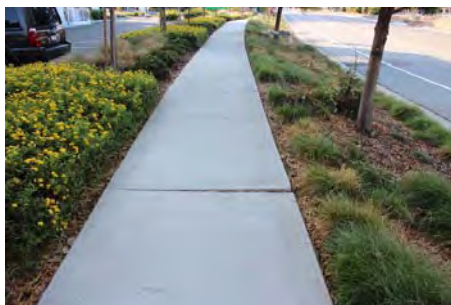
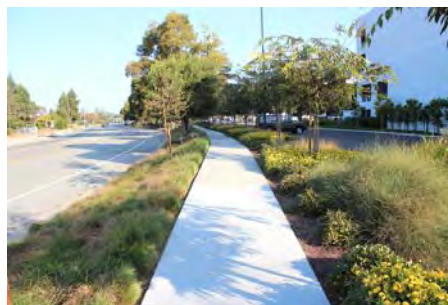
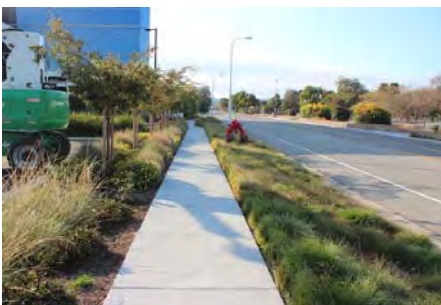
Sidewalk with artificial hills. Excessive cross/running slope occurs in conjunction.

COD	CONDITION DESCRIPTION	ACTUAL
B15	No level changes greater than 1/2" (except by accessible ramp or other means). (ADAS 303.4)	1" high vertical edge.
B16	Cross slope (perpendicular to direction of travel) is 1:48 (2.08%) max. (ADAS 403.3)	Approx. 260' L is 3.1% to 5.6%.
B17	Running slope (parallel to direction of travel) is 1:20 (5.0%) max. (ADAS 403.3)	6.0% at one side of hill.

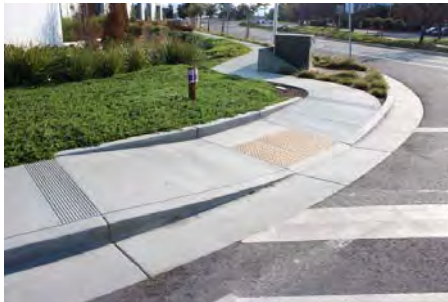
COD	CONDITION DESCRIPTION	ACTUAL
C12	Turning space at bottom of curb ramp slopes 1:48 (2.08%) max. in any direction (ADAS 403.3)	9.6% across curb face.
B13	Counter slopes of adjoining gutters and road surfaces immediately adjacent to and within 24 inches of the curb ramp are not steeper than 1:20 (5.0%). (ADAS 406.2)	10.7%

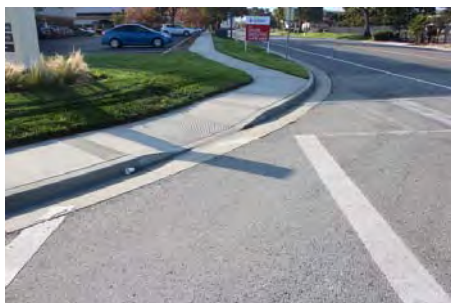
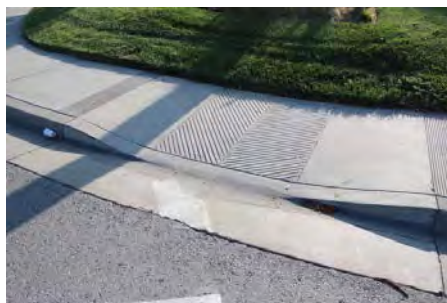
COD	CONDITION DESCRIPTION	ACTUAL
B03	Running slope of ramp is 1:12 (8.33%) max. (ADAS 405.2)	14.3% for 3" L at btm.
B11	Top landing is as wide as the ramp and 36" min. in length. (ADAS 406.4)	None
B14	Counter slopes of adjoining gutters and road surfaces immediately adjacent to and within 24 inches of the curb ramp are not steeper than 1:20 (5.0%). (ADAS 406.2)	10.4%
A17	Where no top landing is provided at an existing ramp, side flare slopes are 8.33% max. (ADAS 406.4)	13.6% left side, 13.8% right side.

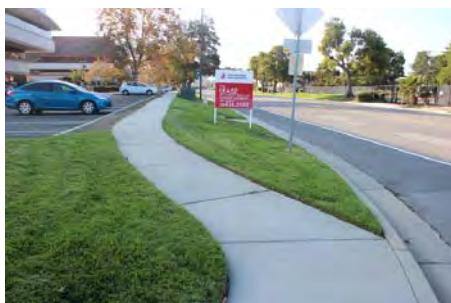
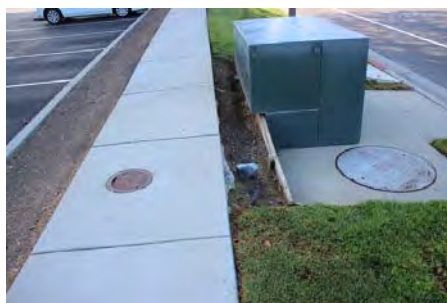
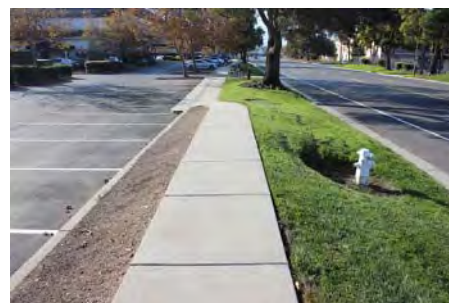
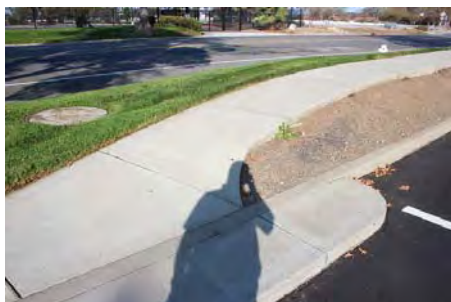
COD	CONDITION DESCRIPTION	ACTUAL
B16	Cross slope (perpendicular to direction of travel) is 1:48 (2.08%) max. (ADAS 403.3)	Approx. 50' L is 2.7% to 6.8%.
B17	Running slope (parallel to direction of travel) is 1:20 (5.0%) max. (ADAS 403.3)	9.1% and 17.7% at 2 sides of hills.

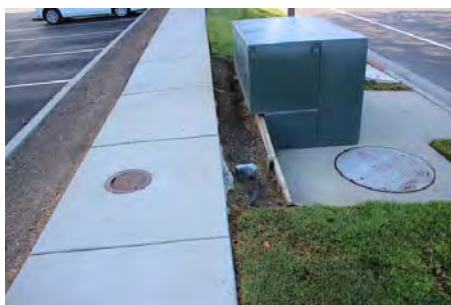
COD	CONDITION DESCRIPTION	ACTUAL
B11	Abrupt changes in level over 4" high are identified either by a curb or guide rail. (28 CFR 35.130(a), ADAS 405.9, CBC 11B-303.5)	Approx. 10' L has 9" high drop off at one side.

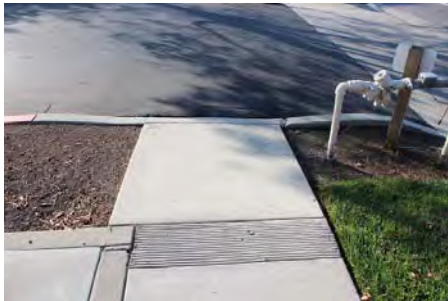
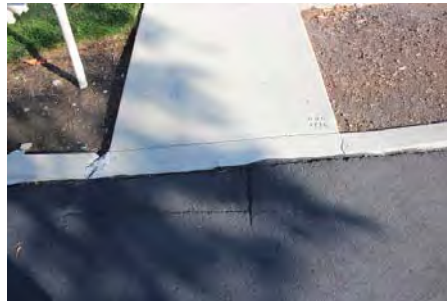
COD	CONDITION DESCRIPTION	ACTUAL
B03	Running slope of ramp is 1:12 (8.33%) max. (ADAS 405.2)	10.3%
B04	Cross slope of ramp is 1:48 (2.08%). (ADAS 405.3)	3.7%
B06	Transition to walk, gutter or street is flush and free of abrupt changes. (ADAS 406.2)	1/2" high vertical edge and 2" W gap.
B16	Maximum slope of flared sides is 1:10 (10.0%). (ADAS 406.2)	None provided and up to 3" H drop off.

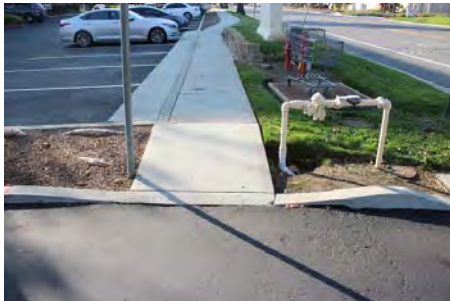
COD	CONDITION DESCRIPTION	ACTUAL
B03	Running slope of ramp is 1:12 (8.33%) max. (ADAS 405.2)	10.4%
B04	Cross slope of ramp is 1:48 (2.08%). (ADAS 405.3)	3.6%
B06	Transition to walk, gutter or street is flush and free of abrupt changes. (ADAS 406.2)	3/4 high vertical edge and 1" W gap.
B16	Maximum slope of flared sides is 1:10 (10.0%). (ADAS 406.2)	None provided and up to 4" drop off.

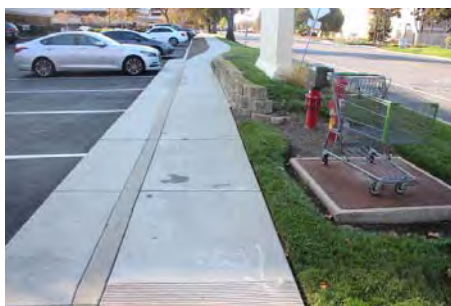
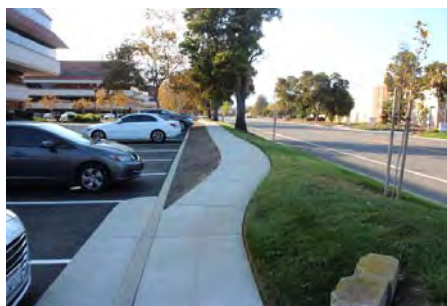
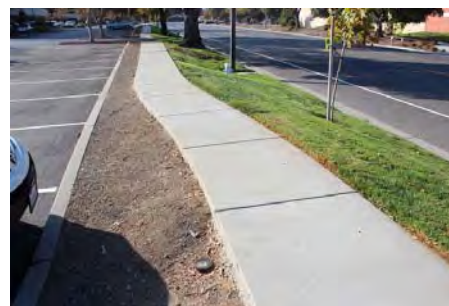
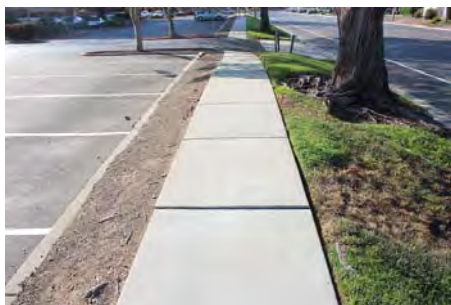
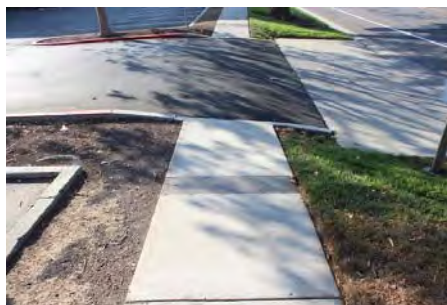
COD	CONDITION DESCRIPTION	ACTUAL
B15	No level changes greater than 1/2" (except by accessible ramp or other means). (ADAS 303.4)	3/4" high vertical edge.
B16	Cross slope (perpendicular to direction of travel) is 1:48 (2.08%) max. (ADAS 403.3)	Approx. 160' L is 2.7% to 4.8%.
B17	Running slope (parallel to direction of travel) is 1:20 (5.0%) max. (ADAS 403.3)	8.8% at side of one hill.

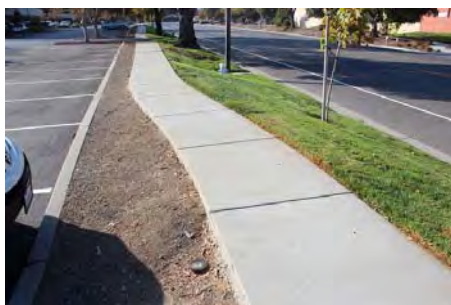
COD	CONDITION DESCRIPTION	ACTUAL
B11	Abrupt changes in level over 4" high are identified either by a curb or guide rail. (28 CFR 35.130(a), ADAS 405.9, CBC 11B-303.5)	6" drop off along portion of one side approx. 20' L.

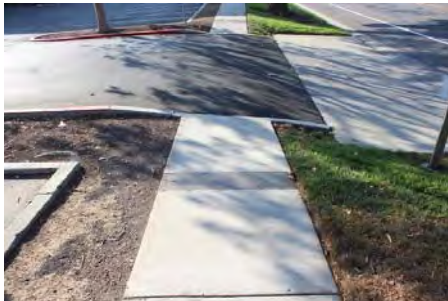
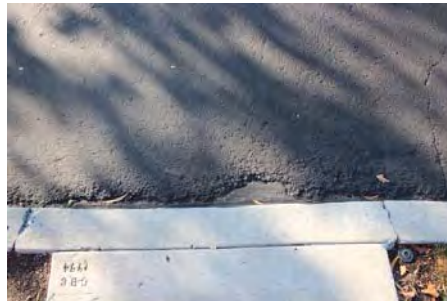
COD	CONDITION DESCRIPTION	ACTUAL
B04	Cross slope of ramp is 1:48 (2.08%). (ADAS 405.3)	6.4%
B05	Surface of ramp and landings complies with requirements for an accessible path of travel (stable, firm, slip-resistant, without gaps over 1/2" wide or edges over 1/4" high). (ADAS 302.1, 403.2, 403.3, 403.4)	6.1% running slope at top landing, 8.6% cross slope at btm. landing.
B06	Transition to walk, gutter or street is flush and free of abrupt changes. (ADAS 406.2)	3/4" high vertical edge and 1" W gap.

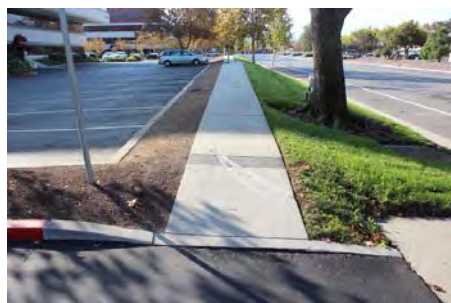
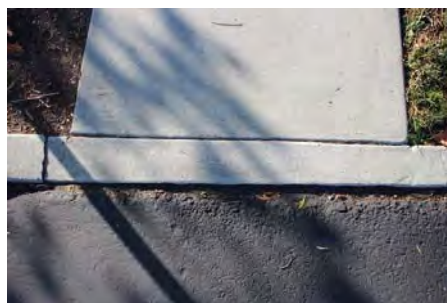
COD	CONDITION DESCRIPTION	ACTUAL
B03	Running slope of ramp is 1:12 (8.33%) max. (ADAS 405.2)	12.3%
B04	Cross slope of ramp is 1:48 (2.08%). (ADAS 405.3)	4.0%
B05	Surface of ramp and landings complies with requirements for an accessible path of travel (stable, firm, slip-resistant, without gaps over 1/2" wide or edges over 1/4" high). (ADAS 302.1, 403.2, 403.3, 403.4)	12.2% running slope at top landing, 6.9% cross slope at btm. landing.
B06	Transition to walk, gutter or street is flush and free of abrupt changes. (ADAS 406.2)	3/4" high vertical edge and 2" W gap.
