Case No. 5:16-cv-07013-LHK (SVK)

**DECLARATION OF JEFFREY SCOTT
MASTIN IN SUPPORT OF PLAINTIFFS'
MOTION FOR CLASS CERTIFICATION**

NEVAREZ V 49ERS - ACCESSIBILITY ASSESSMENT

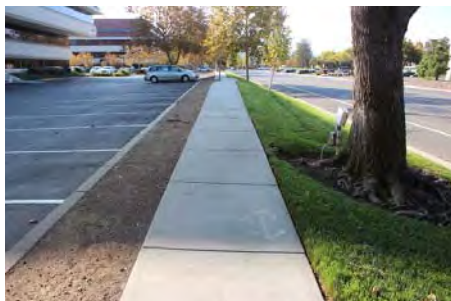
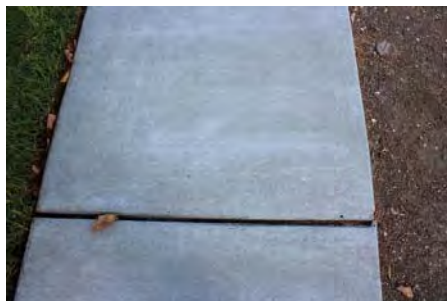
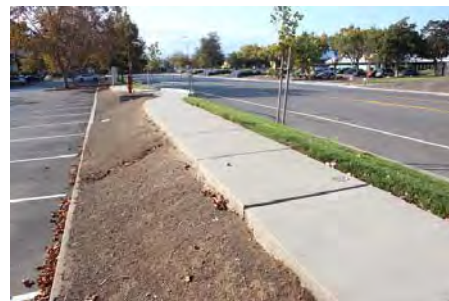
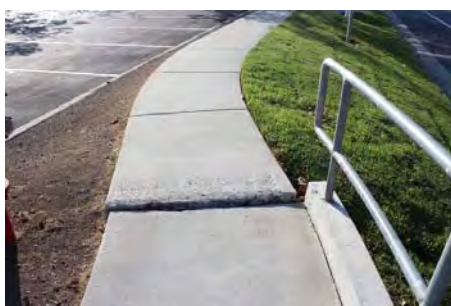
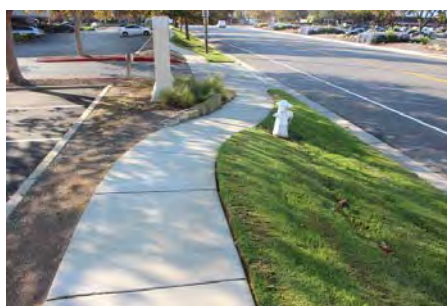
COD	CONDITION DESCRIPTION	ACTUAL
B12	Gaps/openings in ground or floor surfaces do not allow the passage of a sphere more than 1/2" in diameter. (ADAS 302.3)	3/4" W gaps at 2 places.
B15	No level changes greater than 1/2" (except by accessible ramp or other means). (ADAS 303.4)	2" high vertical edge
B16	Cross slope (perpendicular to direction of travel) is 1:48 (2.08%) max. (ADAS 403.3)	Approx. 200' L is 2.9% to 5.4%.
B17	Running slope (parallel to direction of travel) is 1:20 (5.0%) max. (ADAS 403.3)	11.1% at side of one hill.

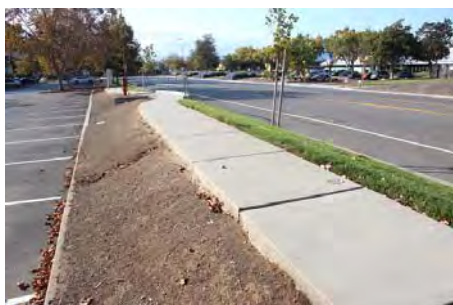
COD	CONDITION DESCRIPTION	ACTUAL
B11	Abrupt changes in level over 4" high are identified either by a curb or guide rail. (28 CFR 35.130(a), ADAS 405.9, CBC 11B-303.5)	Approx. 30' L drops off up to 9" high at one side.

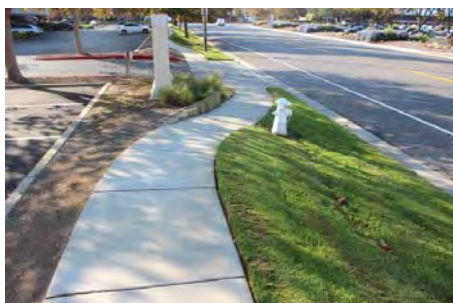
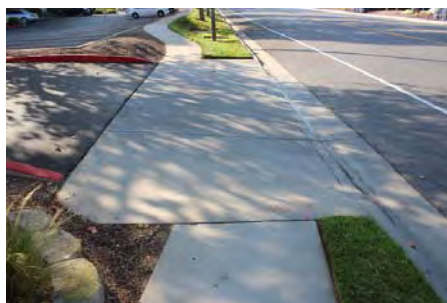
COD	CONDITION DESCRIPTION	ACTUAL
B16	Cross slope (perpendicular to direction of travel) is 1:48 (2.08%) max. (ADAS 403.3)	7.2%
B17	Running slope (parallel to direction of travel) is 1:20 (5.0%) max. (ADAS 403.3)	Up to 14.5%.

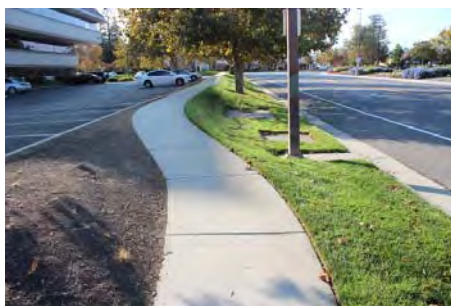
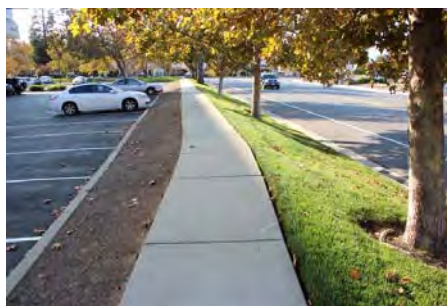
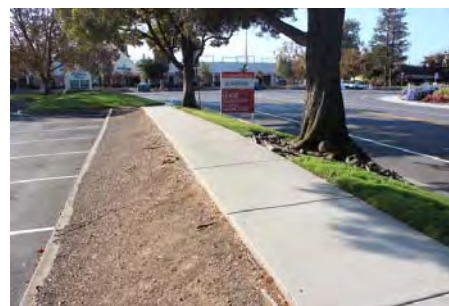
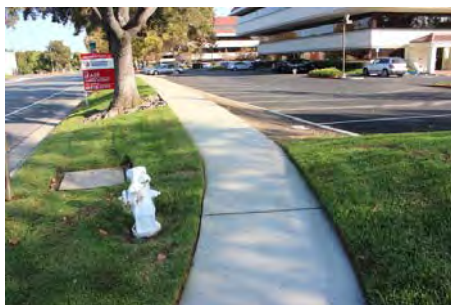
COD	CONDITION DESCRIPTION	ACTUAL
B15	No level changes greater than 1/2" (except by accessible ramp or other means). (ADAS 303.4)	3/4" high vertical edge.
B16	Cross slope (perpendicular to direction of travel) is 1:48 (2.08%) max. (ADAS 403.3)	Approx. 220' L is 2.7% to 6.5%.
B17	Running slope (parallel to direction of travel) is 1:20 (5.0%) max. (ADAS 403.3)	7.9% and 7.1% at 2 sides of hills.

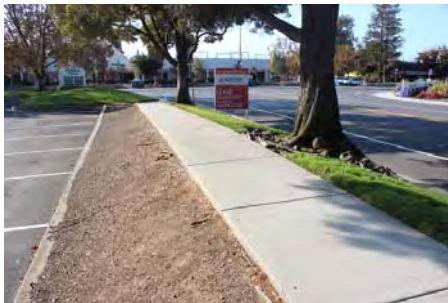
COD	CONDITION DESCRIPTION	ACTUAL
B11	Abrupt changes in level over 4" high are identified either by a curb or guide rail. (28 CFR 35.130(a), ADAS 405.9, CBC 11B-303.5)	Drop off along one side exceeds 4" H for approx. 40' L.

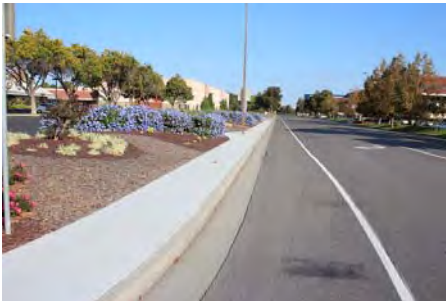
COD	CONDITION DESCRIPTION	ACTUAL
B11	Surface is firm, stable and slip-resistant. (ADAS 302.1)	Approximate 700' long dead end with no indication at intersection of Patrick Henry Drive that the route is not accessible.

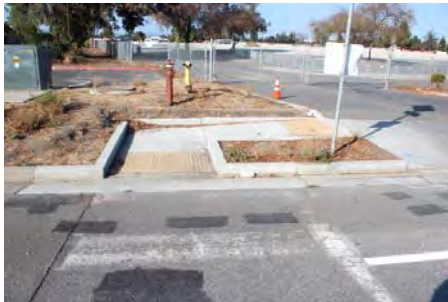
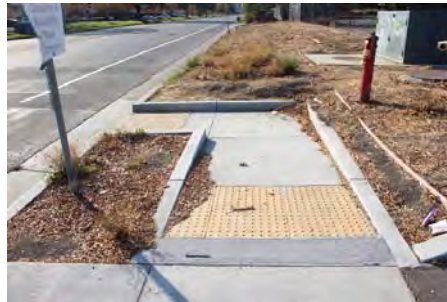
COD	CONDITION DESCRIPTION	ACTUAL
B06	Transition to walk, gutter or street is flush and free of abrupt changes. (ADAS 406.2)	3/8" high vertical edge.
B13	Counter slopes of adjoining gutters and road surfaces immediately adjacent to and within 24 inches of the curb ramp are not steeper than 1:20 (5.0%). (ADAS 406.2)	10.3%

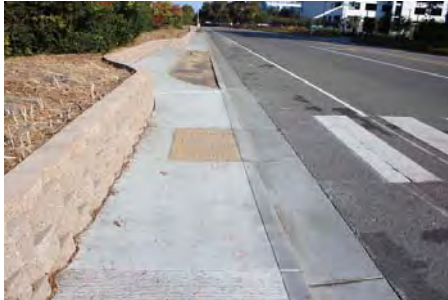
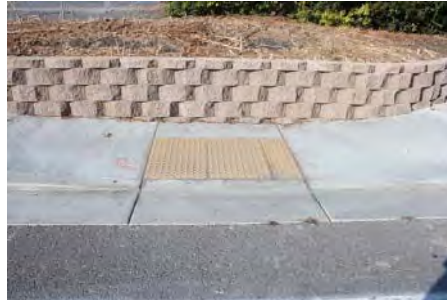
COD	CONDITION DESCRIPTION	ACTUAL
C12	Turning space at bottom of curb ramp slopes 1:48 (2.08%) max. in any direction (ADAS 403.3)	10.7% across curb face.
B13	Counter slopes of adjoining gutters and road surfaces immediately adjacent to and within 24 inches of the curb ramp are not steeper than 1:20 (5.0%). (ADAS 406.2)	13.8%

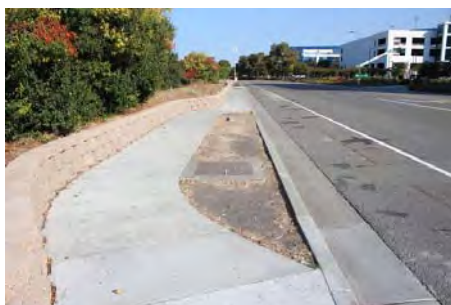
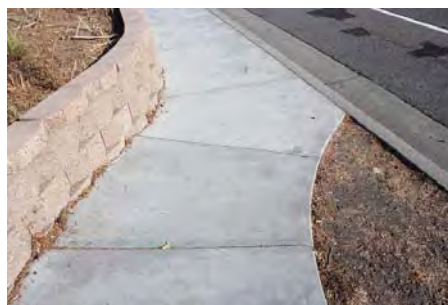
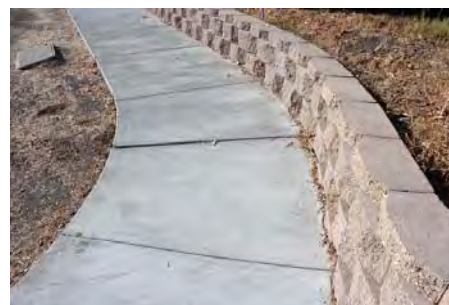
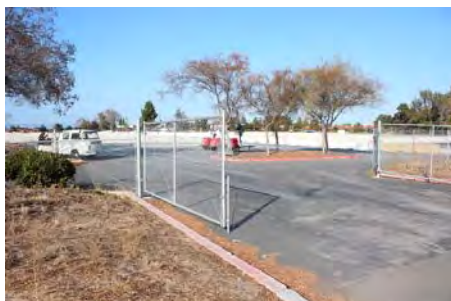
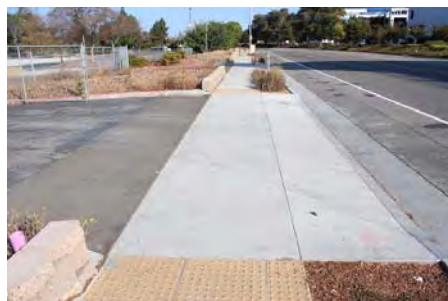
COD	CONDITION DESCRIPTION	ACTUAL
B16	Cross slope (perpendicular to direction of travel) is 1:48 (2.08%) max. (ADAS 403.3)	5' L is 5.3%.

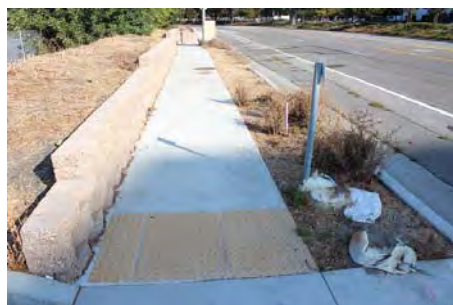
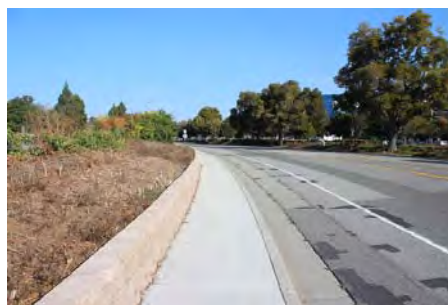
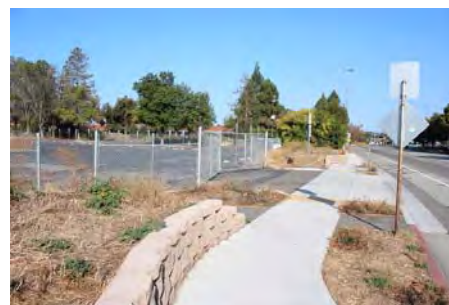
COD	CONDITION DESCRIPTION	ACTUAL
B16	Cross slope (perpendicular to direction of travel) is 1:48 (2.08%) max. (ADAS 403.3)	Approx. 40' L is 2.7% to 3.5%.

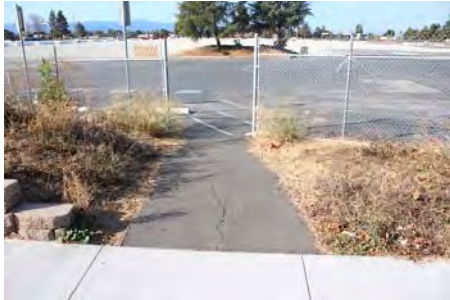
COD	CONDITION DESCRIPTION	ACTUAL
B16	Cross slope (perpendicular to direction of travel) is 1:48 (2.08%) max. (ADAS 403.3)	Up to 3.7%.
B17	Running slope (parallel to direction of travel) is 1:20 (5.0%) max. (ADAS 403.3)	Up to 7.4%.

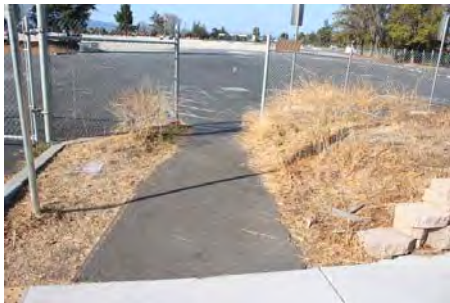
COD	CONDITION DESCRIPTION	ACTUAL
B17	Running slope (parallel to direction of travel) is 1:20 (5.0%) max. (ADAS 403.3)	Up to 5.8%.

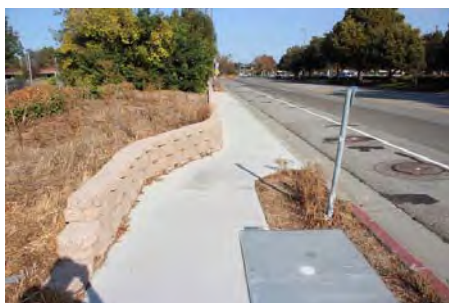
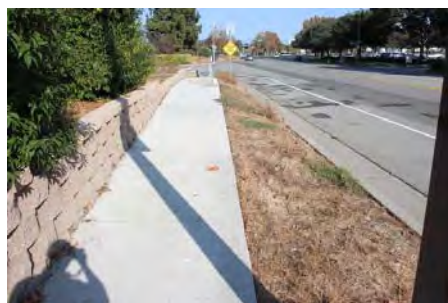
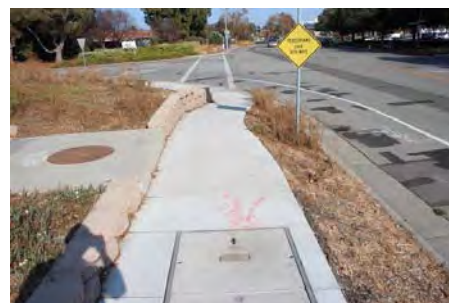
COD	CONDITION DESCRIPTION	ACTUAL
B17	Running slope (parallel to direction of travel) is 1:20 (5.0%) max. (ADAS 403.3)	5.9% at one side of hill.

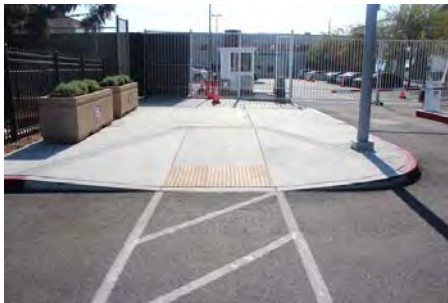
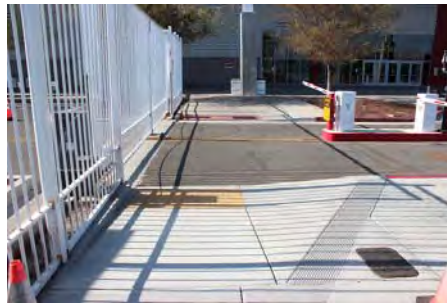
CODE	CONDITION DESCRIPTION	ACTUAL
B16	Maximum slope of flared sides is 1:10 (10.0%). (ADAS 406.2)	10.8% right side.

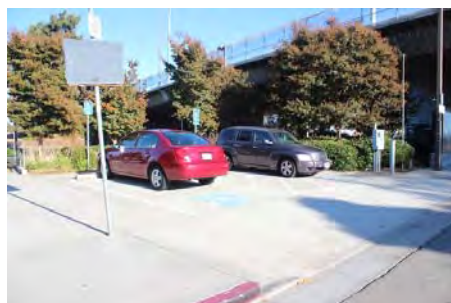
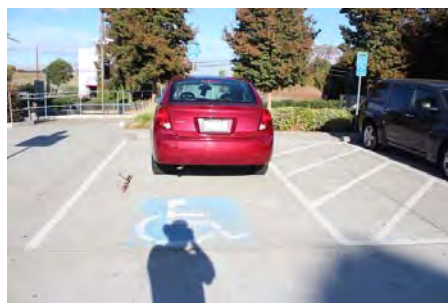
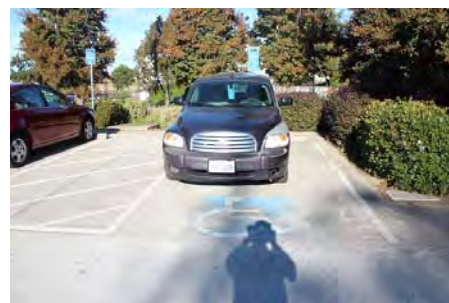
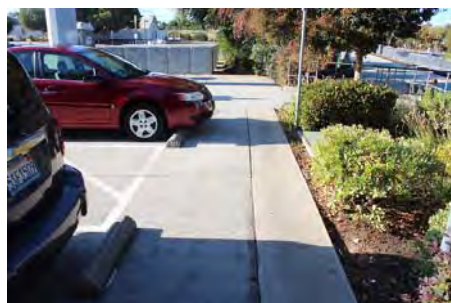
COD	CONDITION DESCRIPTION	ACTUAL
B31	Slopes do not exceed 1:48 (2.08%)	Up to 3.0% at portions of both spaces and access aisle.

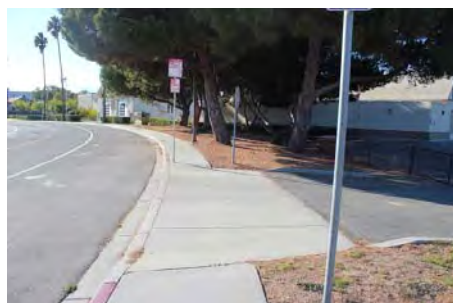
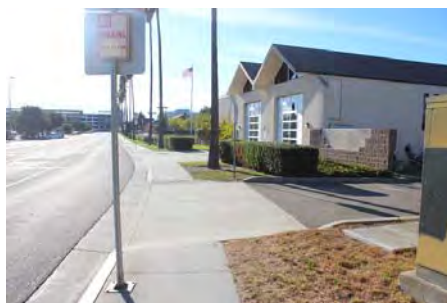
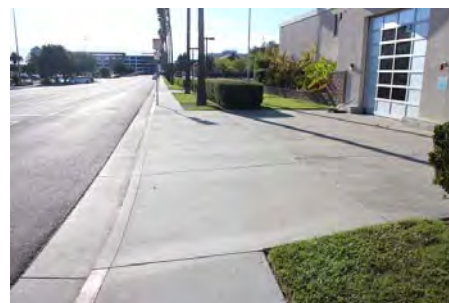
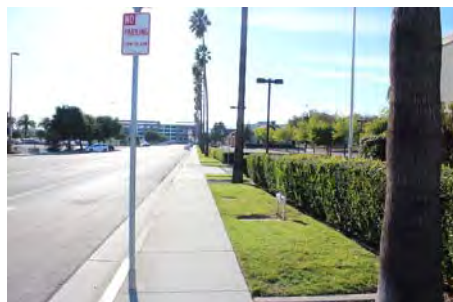
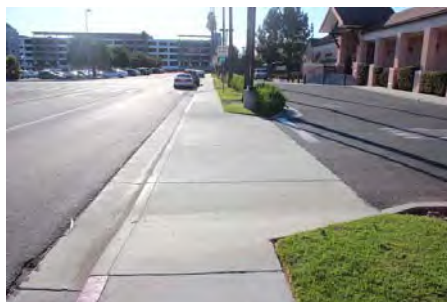
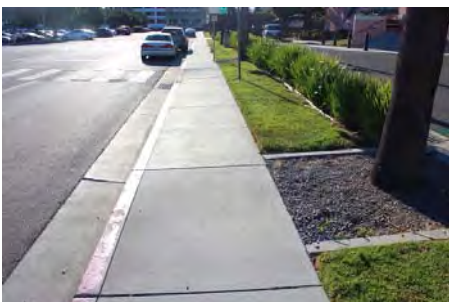
COD	CONDITION DESCRIPTION	ACTUAL
B16	Cross slope (perpendicular to direction of travel) is 1:48 (2.08%) max. (ADAS 403.3)	Approx. 120' L is 2.7% to 5.6%.
B17	Running slope (parallel to direction of travel) is 1:20 (5.0%) max. (ADAS 403.3)	11.1% to 16.7% at 10 sides of driveway aprons.

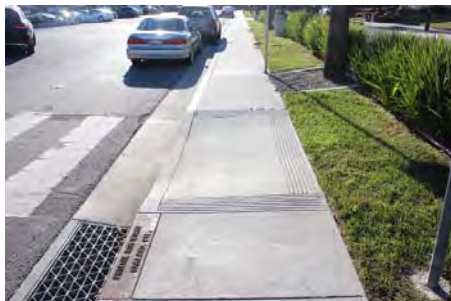
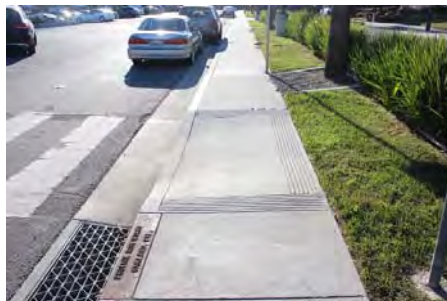
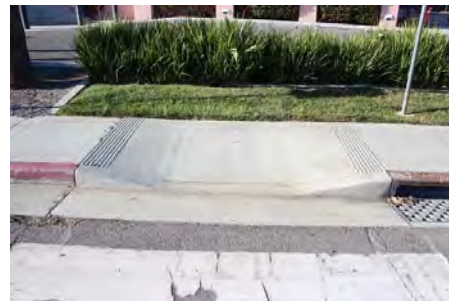
COD	CONDITION DESCRIPTION	ACTUAL
B03	Running slope of ramp is 1:12 (8.33%) max. (ADAS 405.2)	12.2% to 13.3%.
B11	Top landing is as wide as the ramp and 36" min. in length. (ADAS 406.4)	None
B14	Counter slopes of adjoining gutters and road surfaces immediately adjacent to and within 24 inches of the curb ramp are not steeper than 1:20 (5.0%). (ADAS 406.2)	7.8%
A17	Where no top landing is provided at an existing ramp, side flare slopes are 8.33% max. (ADAS 406.4)	16.7% right side, 15.3% left side.

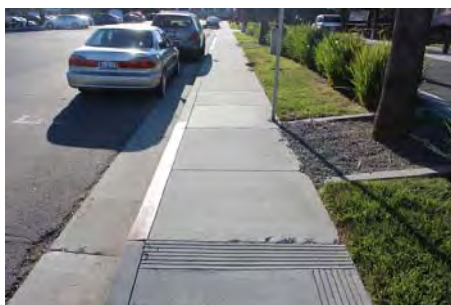
COD	CONDITION DESCRIPTION	ACTUAL
B16	Cross slope (perpendicular to direction of travel) is 1:48 (2.08%) max. (ADAS 403.3)	Approx. 70' L is 3.5% to 4.1%.

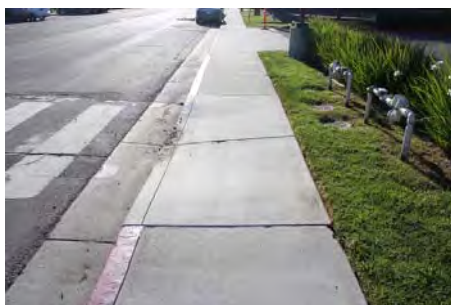
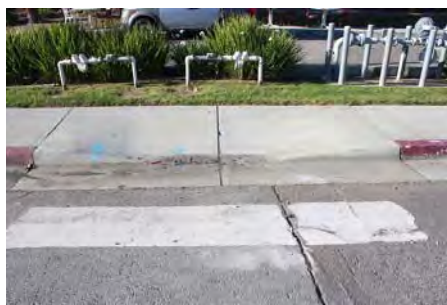
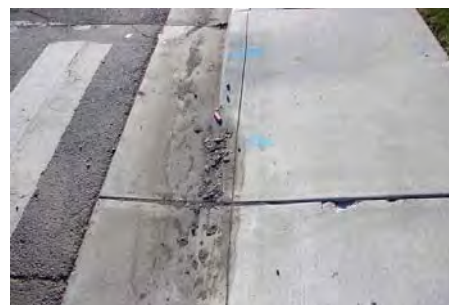
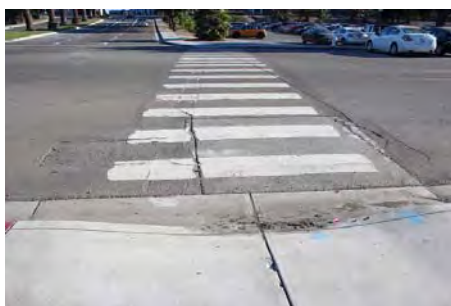
COD	CONDITION DESCRIPTION	ACTUAL
B03	Running slope of ramp is 1:12 (8.33%) max. (ADAS 405.2)	11.5% to 13.0%.
B05	Surface of ramp and landings complies with requirements for an accessible path of travel (stable, firm, slip-resistant, without gaps over 1/2" wide or edges over 1/4" high). (ADAS 302.1, 403.2, 403.3, 403.4)	Debris on btm. Landing.
B11	Top landing is as wide as the ramp and 36" min. in length. (ADAS 406.4)	None
A17	Where no top landing is provided at an existing ramp, side flare slopes are 8.33% max. (ADAS 406.4)	11.7% right side, 14.4% left side.

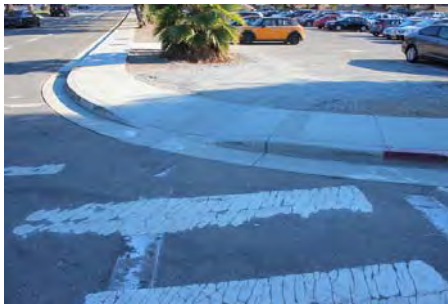
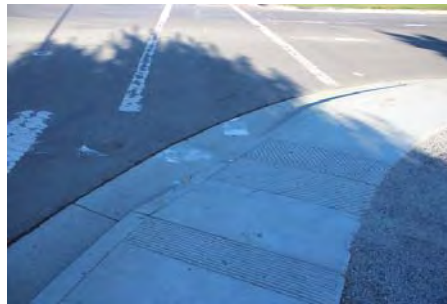
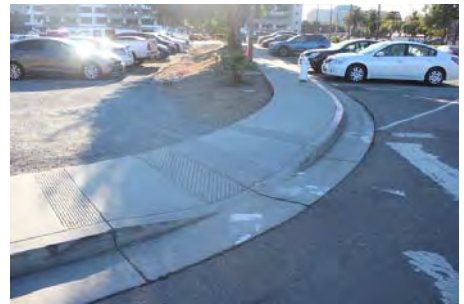
COD	CONDITION DESCRIPTION	ACTUAL
B03	Running slope of ramp is 1:12 (8.33%) max. (ADAS 405.2)	9.1% to 12.6%.
B05	Surface of ramp and landings complies with requirements for an accessible path of travel (stable, firm, slip-resistant, without gaps over 1/2" wide or edges over 1/4" high). (ADAS 302.1, 403.2, 403.3, 403.4)	1/2" high vertical edges on ramp and btm. Landing.
B11	Top landing is as wide as the ramp and 36" min. in length. (ADAS 406.4)	None
A17	Where no top landing is provided at an existing ramp, side flare slopes are 8.33% max. (ADAS 406.4)	18.6% right side, 14.1% left side.

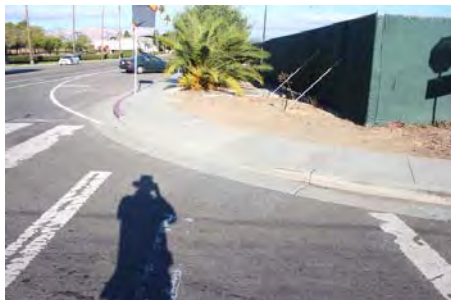
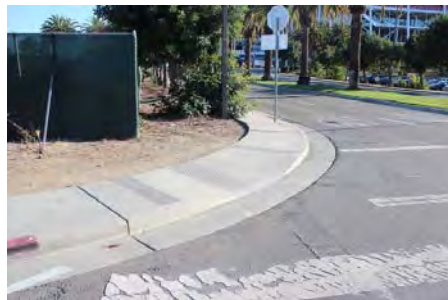
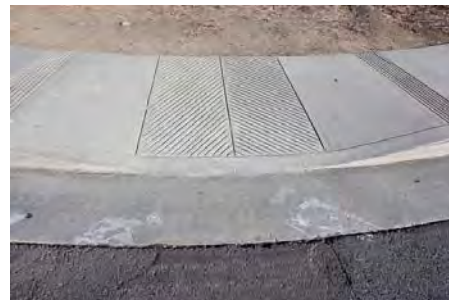
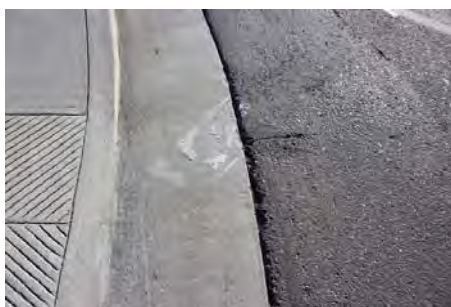
COD	CONDITION DESCRIPTION	ACTUAL
B03	Running slope of ramp is 1:12 (8.33%) max. (ADAS 405.2)	8.5% to 11.3%.
B05	Surface of ramp and landings complies with requirements for an accessible path of travel (stable, firm, slip-resistant, without gaps over 1/2" wide or edges over 1/4" high). (ADAS 302.1, 403.2, 403.3, 403.4)	1 1/2" high vertical edge at asphalt transition at btm. landing.
B11	Top landing is as wide as the ramp and 36" min. in length. (ADAS 406.4)	None
B14	Counter slopes of adjoining gutters and road surfaces immediately adjacent to and within 24 inches of the curb ramp are not steeper than 1:20 (5.0%). (ADAS 406.2)	9.1%
A17	Where no top landing is provided at an existing ramp, side flare slopes are 8.33% max. (ADAS 406.4)	13.9% left side, 12.5% right side.

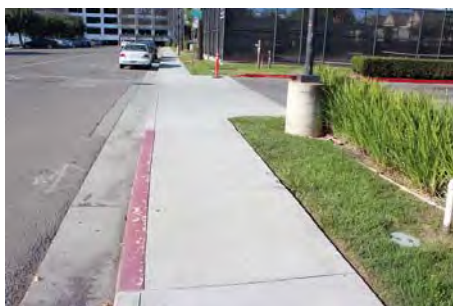
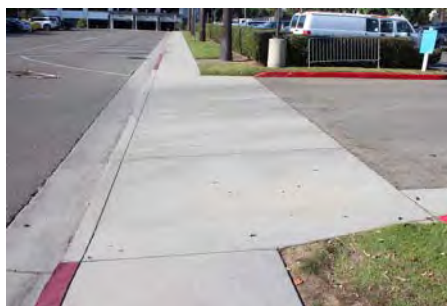
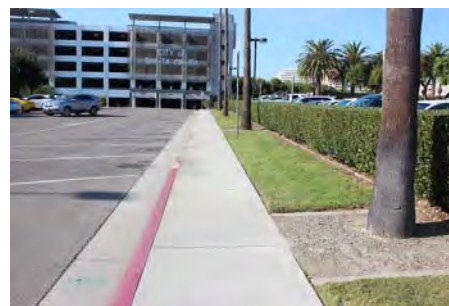
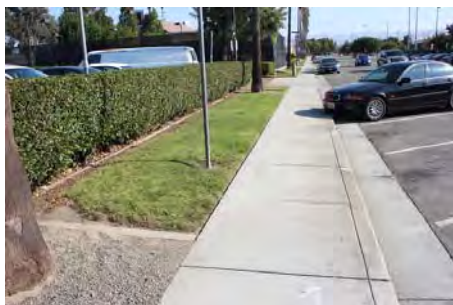
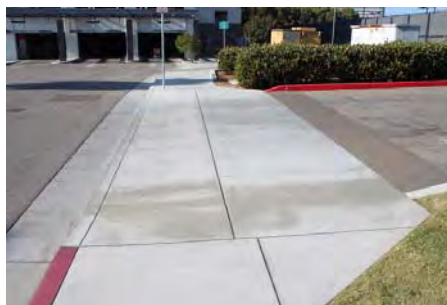
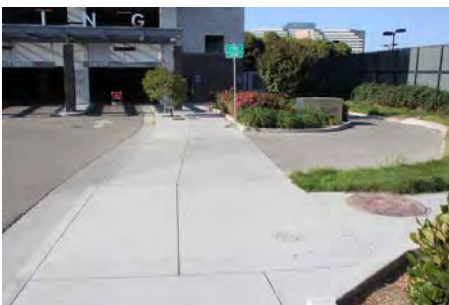
COD	CONDITION DESCRIPTION	ACTUAL
B02	36" min. clear width of exterior walkway. (ADAS 403.5.1)	30" car overhang potentially reduces 60" wide sidewalk to 30" clear width at 14 parking spaces.
B16	Cross slope (perpendicular to direction of travel) is 1:48 (2.08%) max. (ADAS 403.3)	Approx. 300' L is 2.6% to 7.8%.
B17	Running slope (parallel to direction of travel) is 1:20 (5.0%) max. (ADAS 403.3)	11.9% to 16.6% at 4 sides of driveway apron.

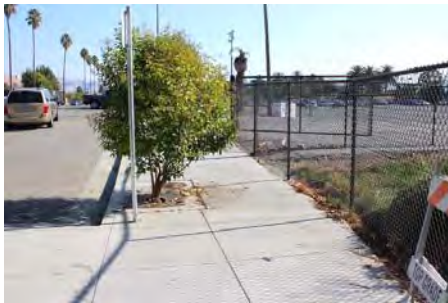
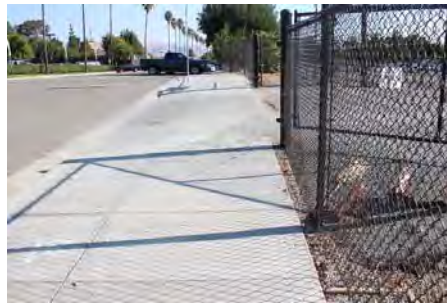
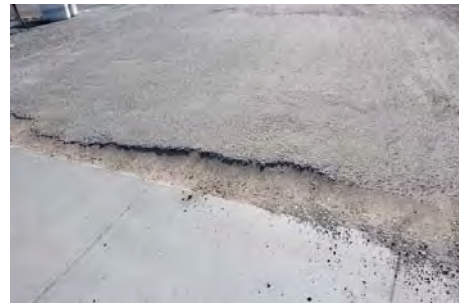
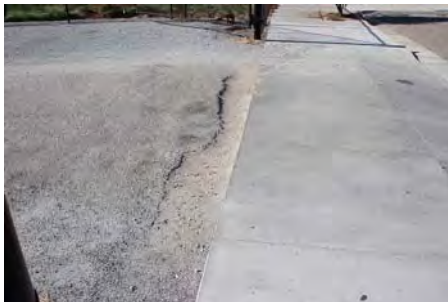
COD	CONDITION DESCRIPTION	ACTUAL
B11	Surface is firm, stable and slip-resistant. (ADAS 302.1)	Partially covered with gravel at drive entrance.

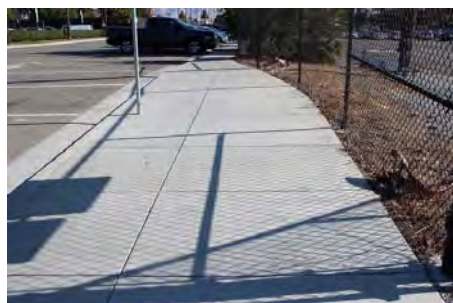
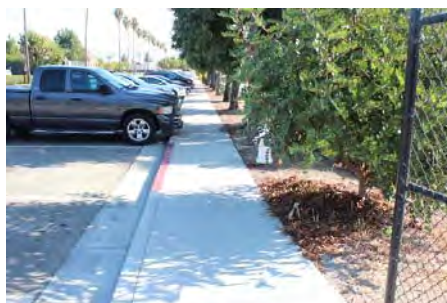
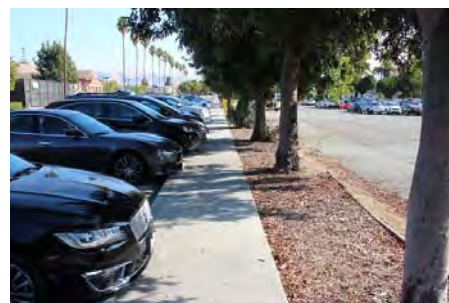
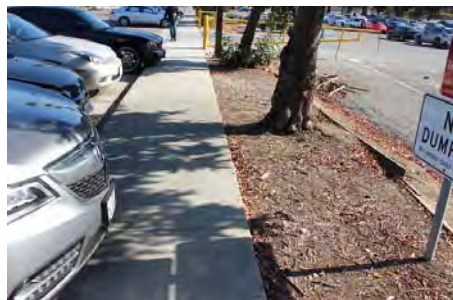
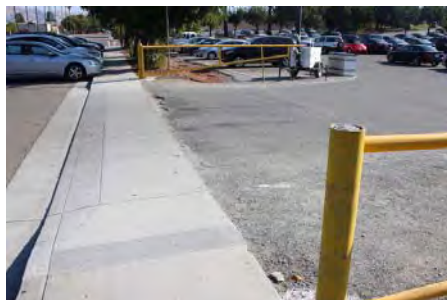
COD	CONDITION DESCRIPTION	ACTUAL
B02	36" min. clear width of exterior walkway. (ADAS 403.5.1)	30" car overhang potentially reduces 60" wide sidewalk to 30" clear width at 23 parking spaces.
B16	Cross slope (perpendicular to direction of travel) is 1:48 (2.08%) max. (ADAS 403.3)	10' L is 3.0%.

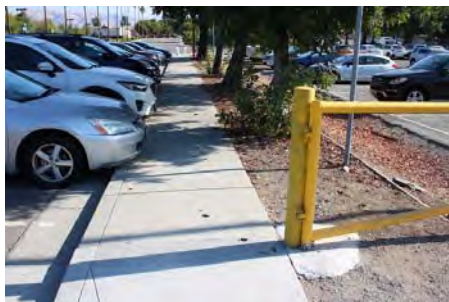
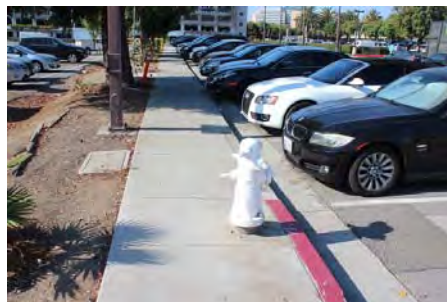
COD	CONDITION DESCRIPTION	ACTUAL
B02	36" min. clear width of exterior walkway. (ADAS 403.5.1)	30" car overhang potentially reduces 60" wide sidewalk to 30" clear width at 13 parking spaces and 33" clear at fire hydrant.
B16	Cross slope (perpendicular to direction of travel) is 1:48 (2.08%) max. (ADAS 403.3)	Approx. 20' L is 2.6% to 3.1%.

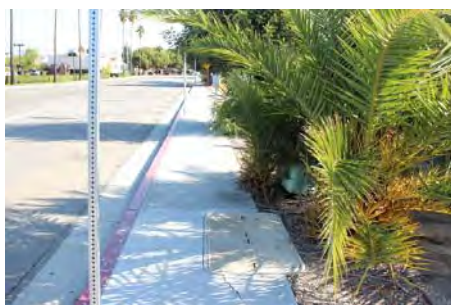
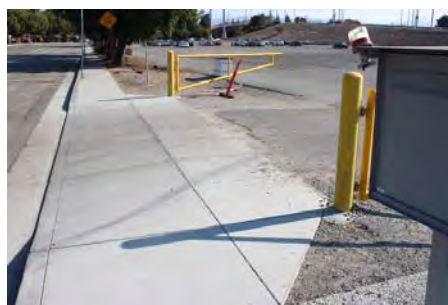
COD	CONDITION DESCRIPTION	ACTUAL
B02	36" min. clear width of exterior walkway. (ADAS 403.5.1)	30" car overhang potentially reduces 60" wide sidewalk to 30" clear width at 4 parking stalls and partially obstructed by plants.

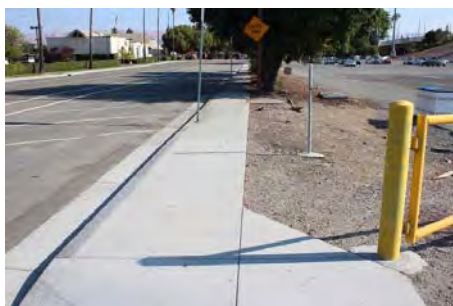
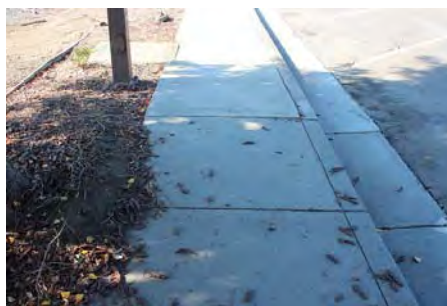
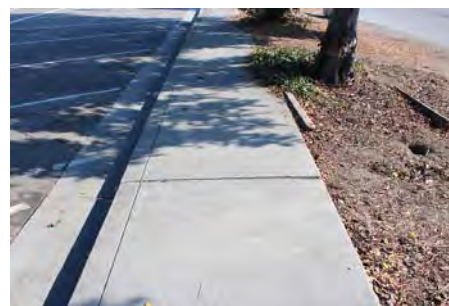
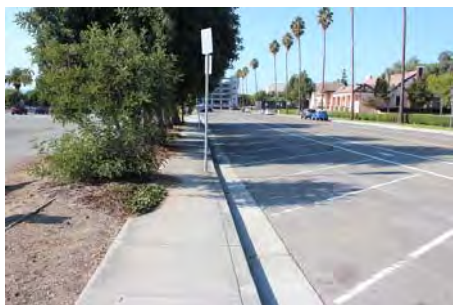
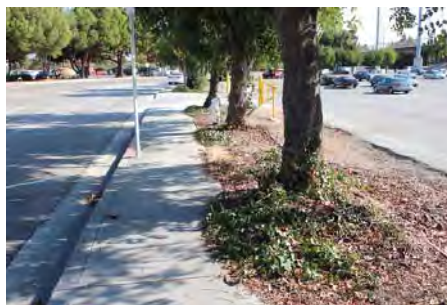
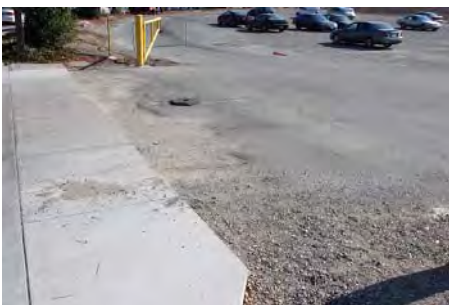
COD	CONDITION DESCRIPTION	ACTUAL
B02	36" min. clear width of exterior walkway. (ADAS 403.5.1)	30" car overhang potentially reduces 60" wide sidewalk to 30" clear width at 27 parking spaces.
B15	No level changes greater than 1/2" (except by accessible ramp or other means). (ADAS 303.4)	3/4" high vertical edge at tree.
B16	Cross slope (perpendicular to direction of travel) is 1:48 (2.08%) max. (ADAS 403.3)	3.1% at tree.

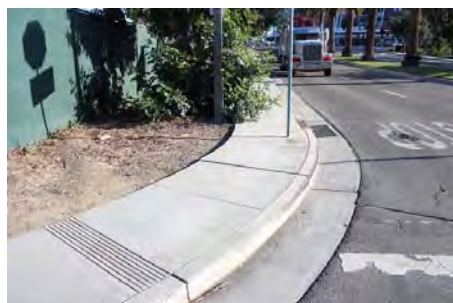
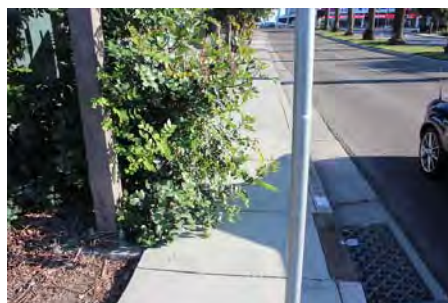
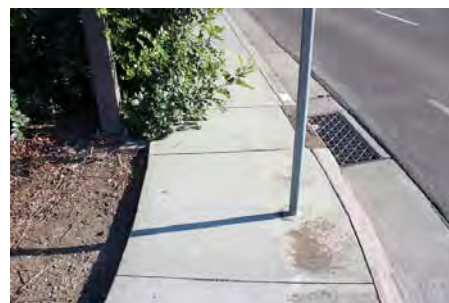
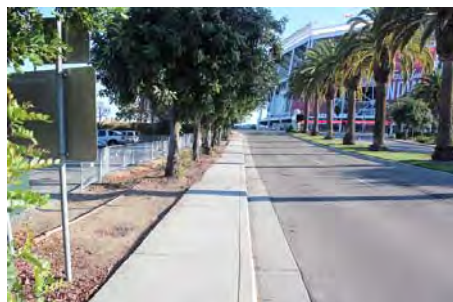
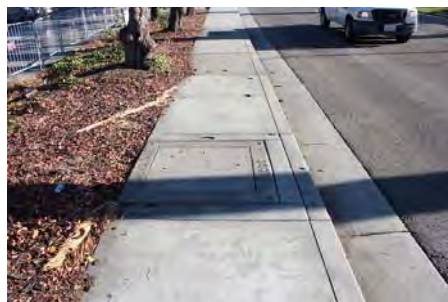
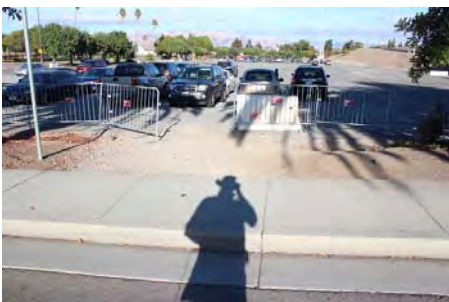
COD	CONDITION DESCRIPTION	ACTUAL
B02	36" min. clear width of exterior walkway. (ADAS 403.5.1)	Obstructed by plants at N end.
B15	No level changes greater than 1/2" (except by accessible ramp or other means). (ADAS 303.4)	5/8" and 3/4" high vertical edges.

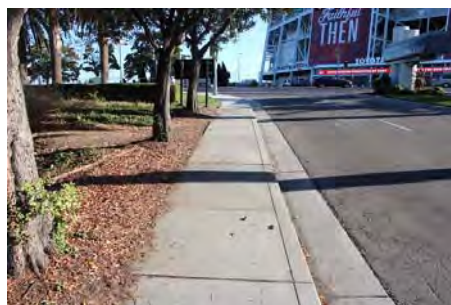
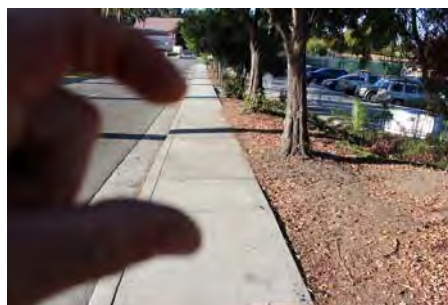
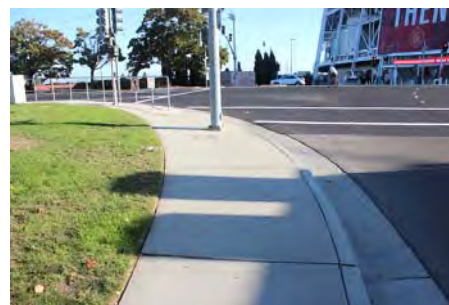
COD	CONDITION DESCRIPTION	ACTUAL
B16	Cross slope (perpendicular to direction of travel) is 1:48 (2.08%) max. (ADAS 403.3)	Approx. 40' L is 3.0% to 4.4%.

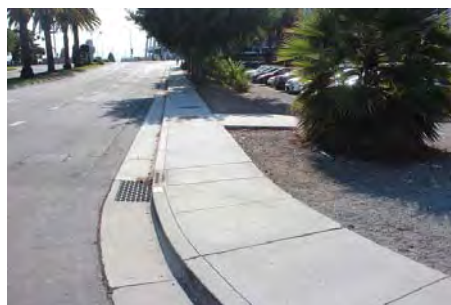
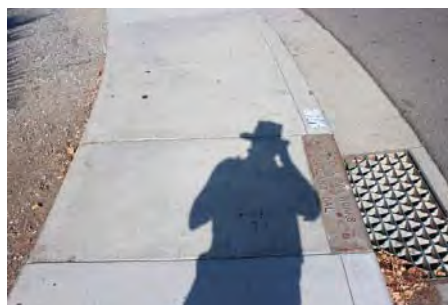
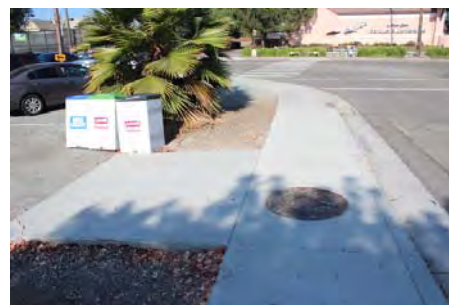
COD	CONDITION DESCRIPTION	ACTUAL
B16	Cross slope (perpendicular to direction of travel) is 1:48 (2.08%) max. (ADAS 403.3)	5' L is 3.8%.

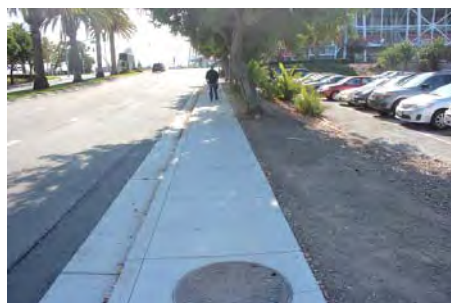
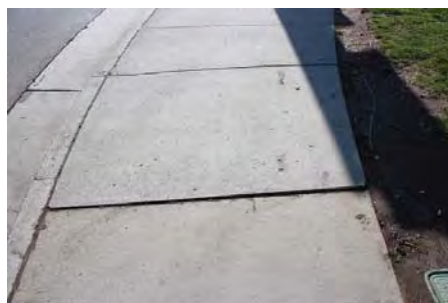
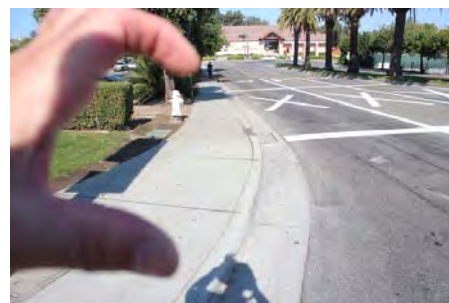
COD	CONDITION DESCRIPTION	ACTUAL
B15	No level changes greater than 1/2" (except by accessible ramp or other means). (ADAS 303.4)	5/8" high vertical edge.
B16	Cross slope (perpendicular to direction of travel) is 1:48 (2.08%) max. (ADAS 403.3)	Approx. 110' L is 2.6% to 4.0%.
B17	Running slope (parallel to direction of travel) is 1:20 (5.0%) max. (ADAS 403.3)	Up to 5.8%, generally matching street slope.

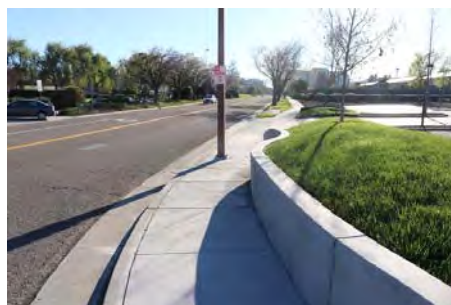
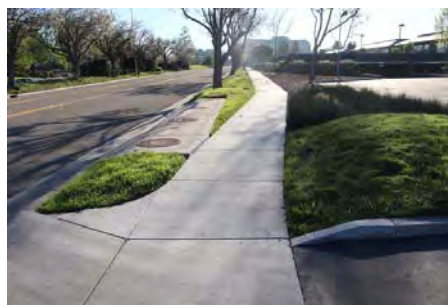
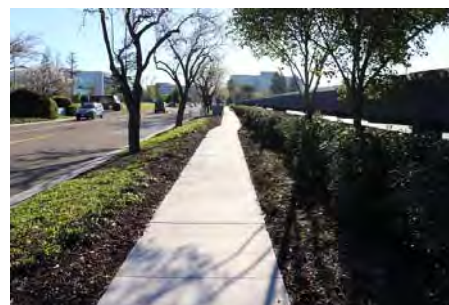
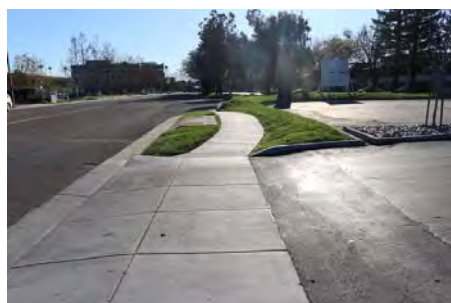
COD	CONDITION DESCRIPTION	ACTUAL
B17	Running slope (parallel to direction of travel) is 1:20 (5.0%) max. (ADAS 403.3)	At drive aisle near Patrick Henry Dr. up to 6.2% for approx. 8'.

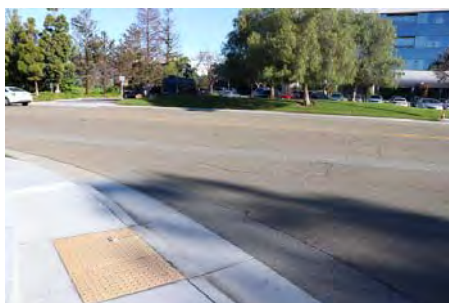
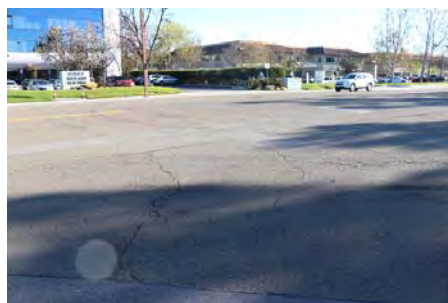
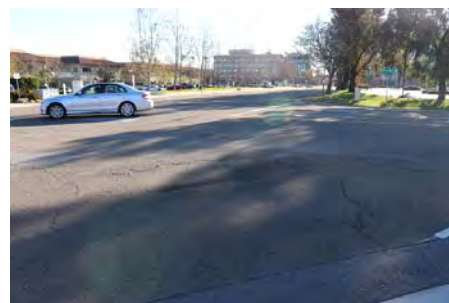
COD	CONDITION DESCRIPTION	ACTUAL
B15	No level changes greater than 1/2" (except by accessible ramp or other means). (ADAS 303.4)	No curb ramp at N side of street.

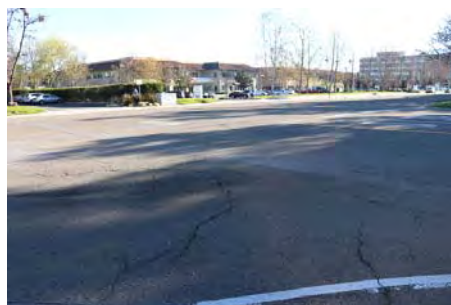
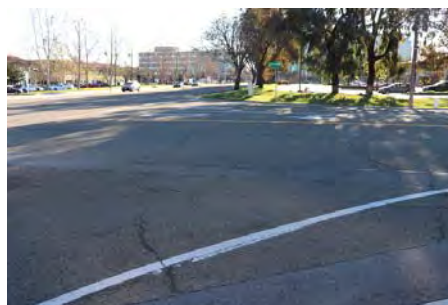
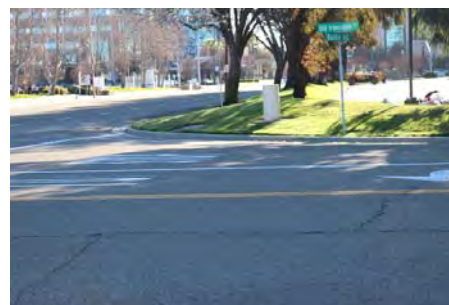
COD	CONDITION DESCRIPTION	ACTUAL
B15	No level changes greater than 1/2" (except by accessible ramp or other means). (ADAS 303.4)	No curb ramp access at SE corner or N side of the street.

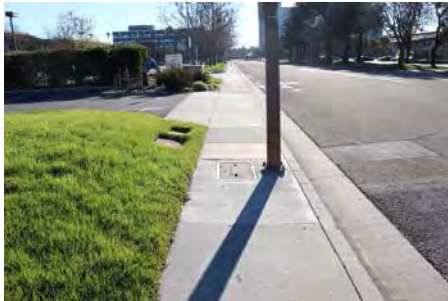
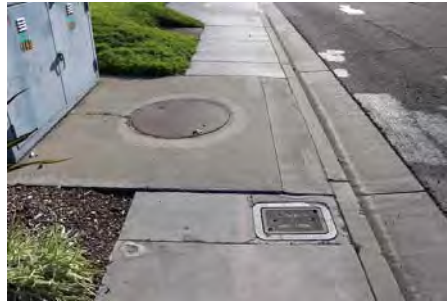
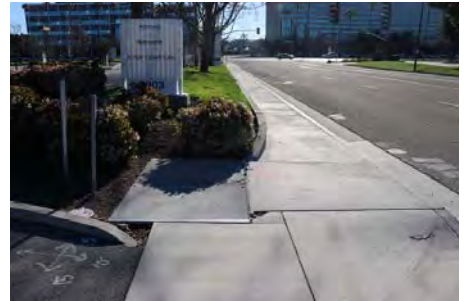
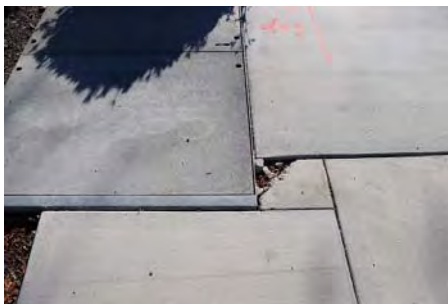
All except W end appears recently constructed and sidewalk does not continue to the W.

COD	CONDITION DESCRIPTION	ACTUAL
B12	Gaps/openings in ground or floor surfaces do not allow the passage of a sphere more than 1/2" in diameter. (ADAS 302.3)	Pothole, 4" wide x 9" L x 1 1/2" deep.
B15	No level changes greater than 1/2" (except by accessible ramp or other means). (ADAS 303.4)	3/4" high vertical edge.
B16	Cross slope (perpendicular to direction of travel) is 1:48 (2.08%) max. (ADAS 403.3)	Approx. 30' L is 2.5% to 3.6% and 7.0% at drive aisle.
B17	Running slope (parallel to direction of travel) is 1:20 (5.0%) max. (ADAS 403.3)	11.3% and 11.3% at drive aisle.

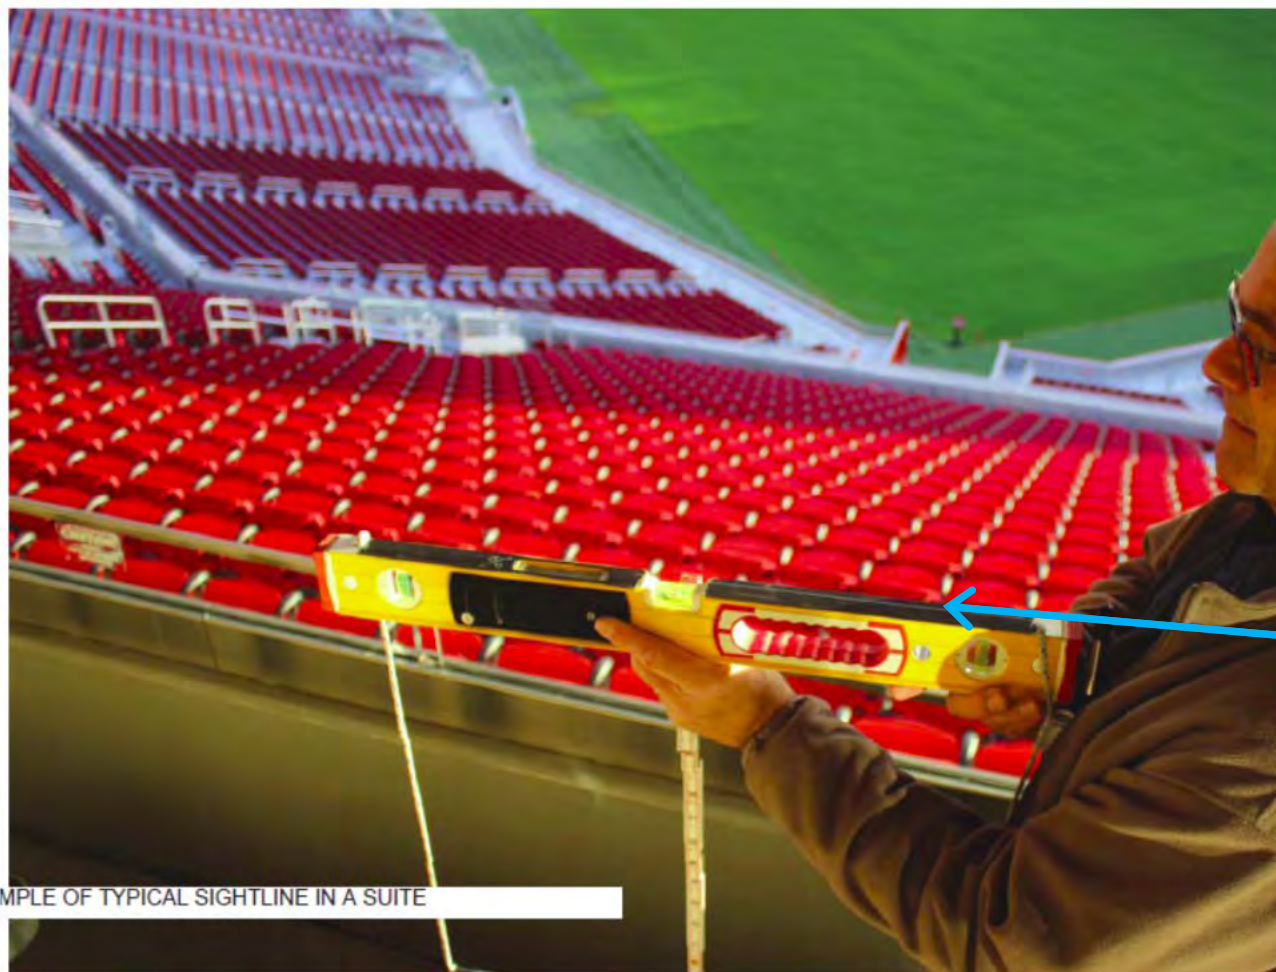
Shoulder
height of
standing
spectator in
front =
55.65" AFF

TYPICAL LUXURY SUITE SIGHTLINE FROM WHEELCHAIR ACCESSIBLE SEAT
Vantage point: eye height of a standing spectator = 63.45" AFF

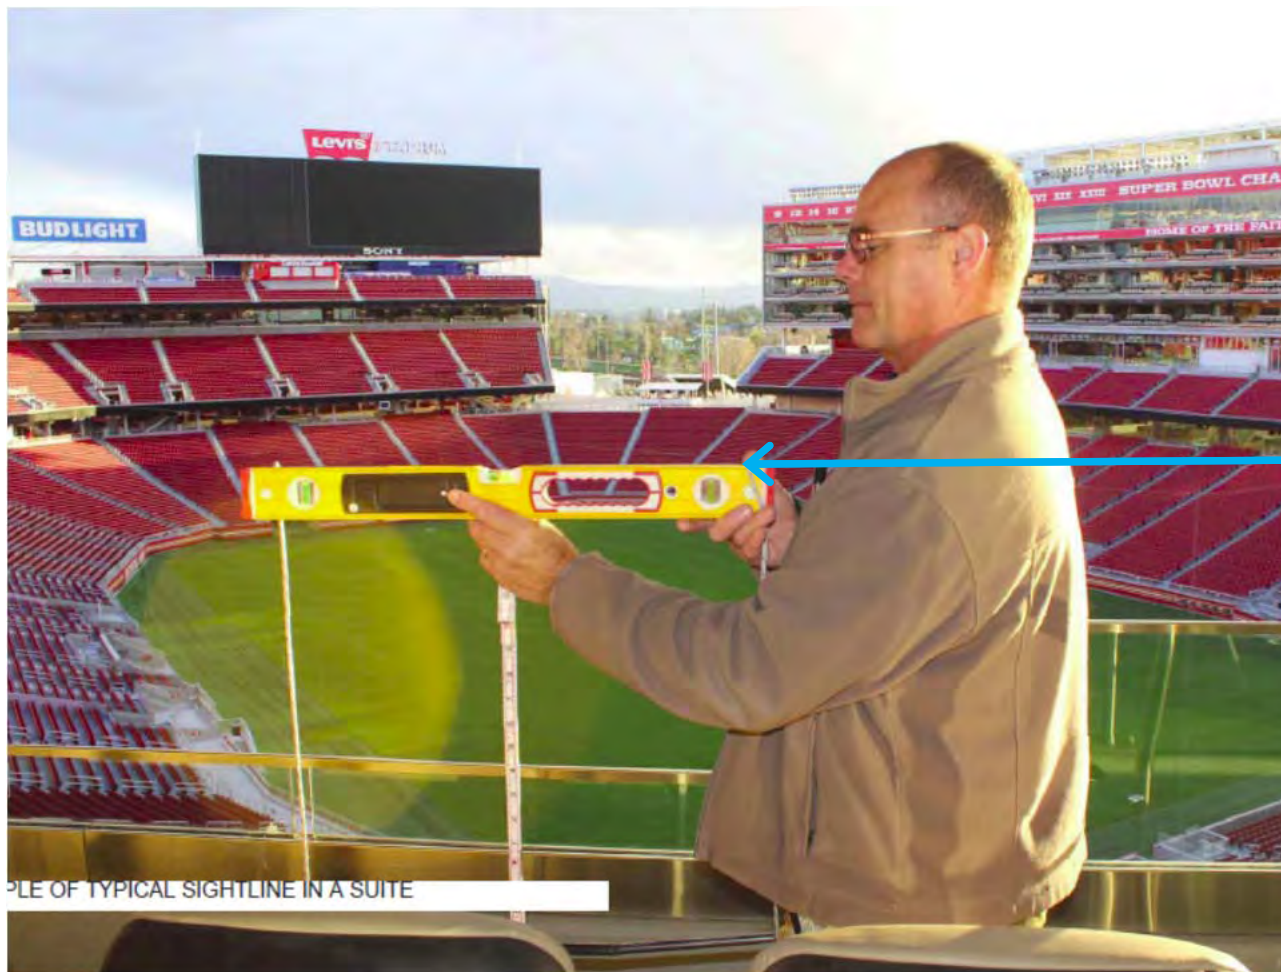
Shoulder
height of
standing
spectator in
front =
55.65" AFF

TYPICAL LUXURY SUITE SIGHTLINE FROM WHEELCHAIR ACCESSIBLE SEAT

Vantage point: wheelchair occupant eye height = 43" AFF

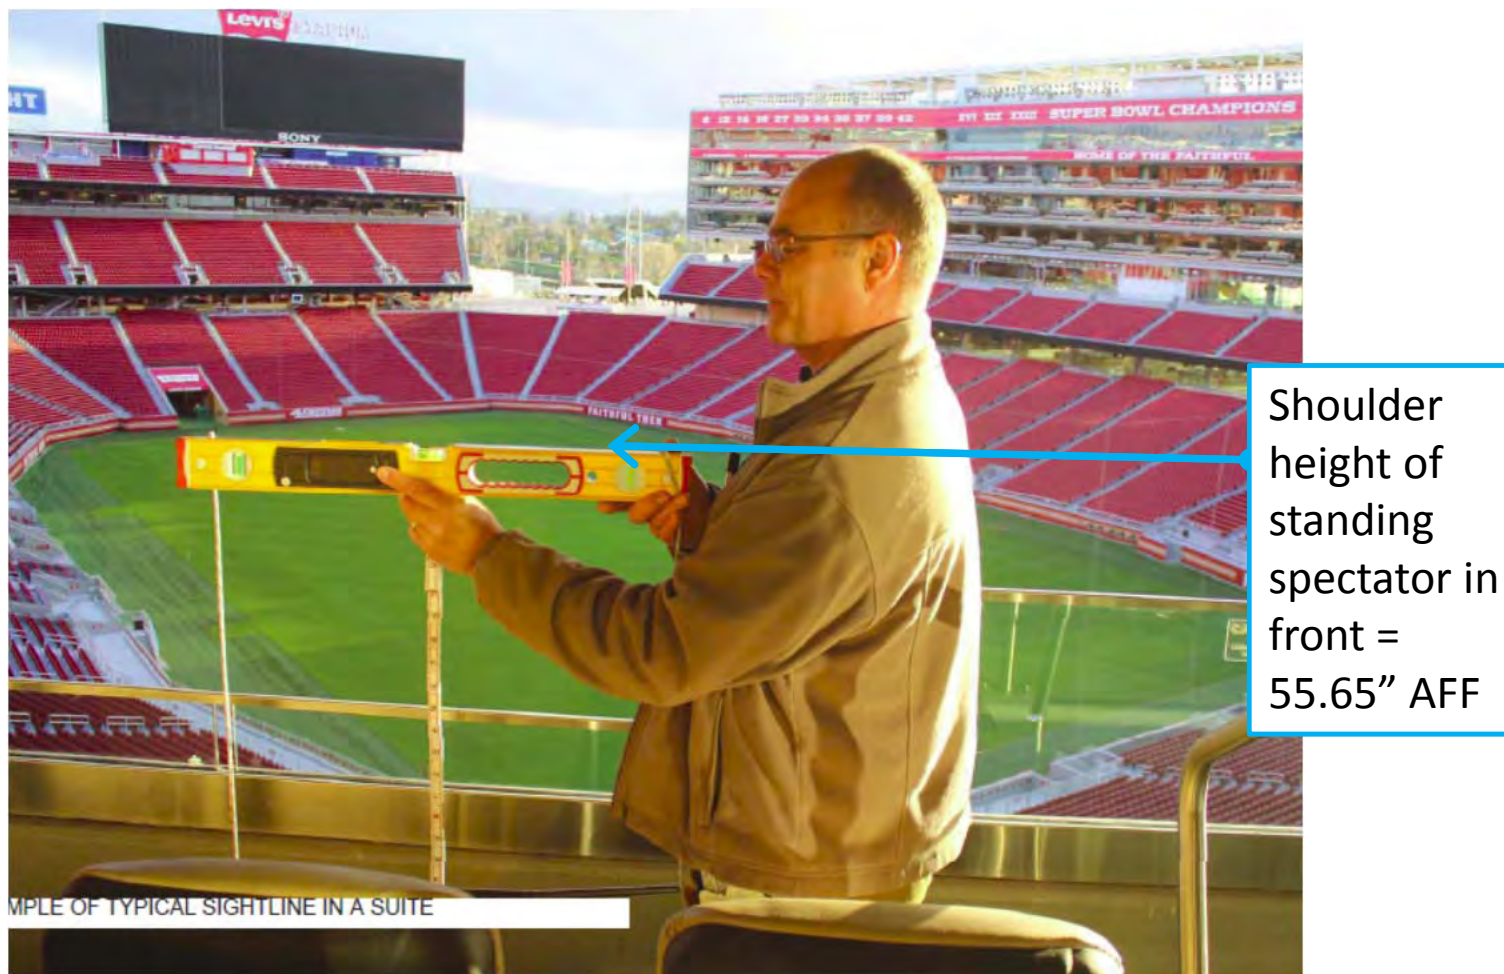
TYPICAL LUXURY SUITE SIGHTLINE FROM WHEELCHAIR ACCESSIBLE SEAT

Vantage point: wheelchair occupant eye height = 47.45" AFF, the height prescribed in USA v Ellerbe Becket Consent Order – represents the mean
