Case No. 5:16-cv-07013-LHK (SVK)

**DECLARATION OF JEFFREY SCOTT
MASTIN IN SUPPORT OF PLAINTIFFS'
MOTION FOR CLASS CERTIFICATION**

NEVAREZ V 49ERS - ACCESSIBILITY ASSESSMENT

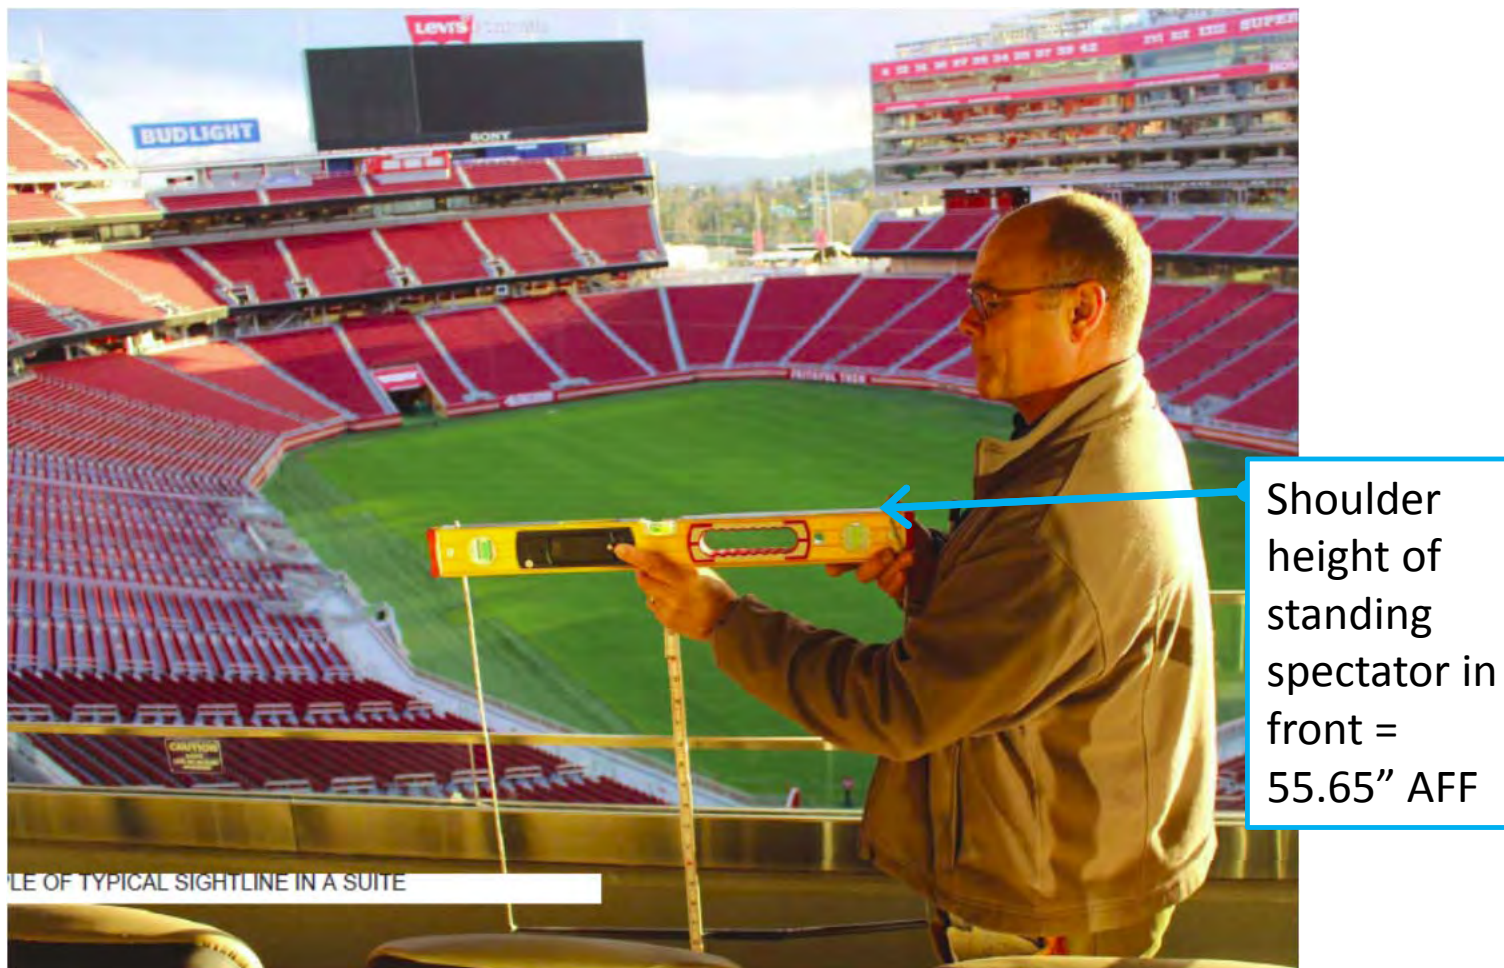
TYPICAL LUXURY SUITE SIGHTLINE FROM WHEELCHAIR ACCESSIBLE SEAT

Vantage point: wheelchair occupant eye height = 52" AFF

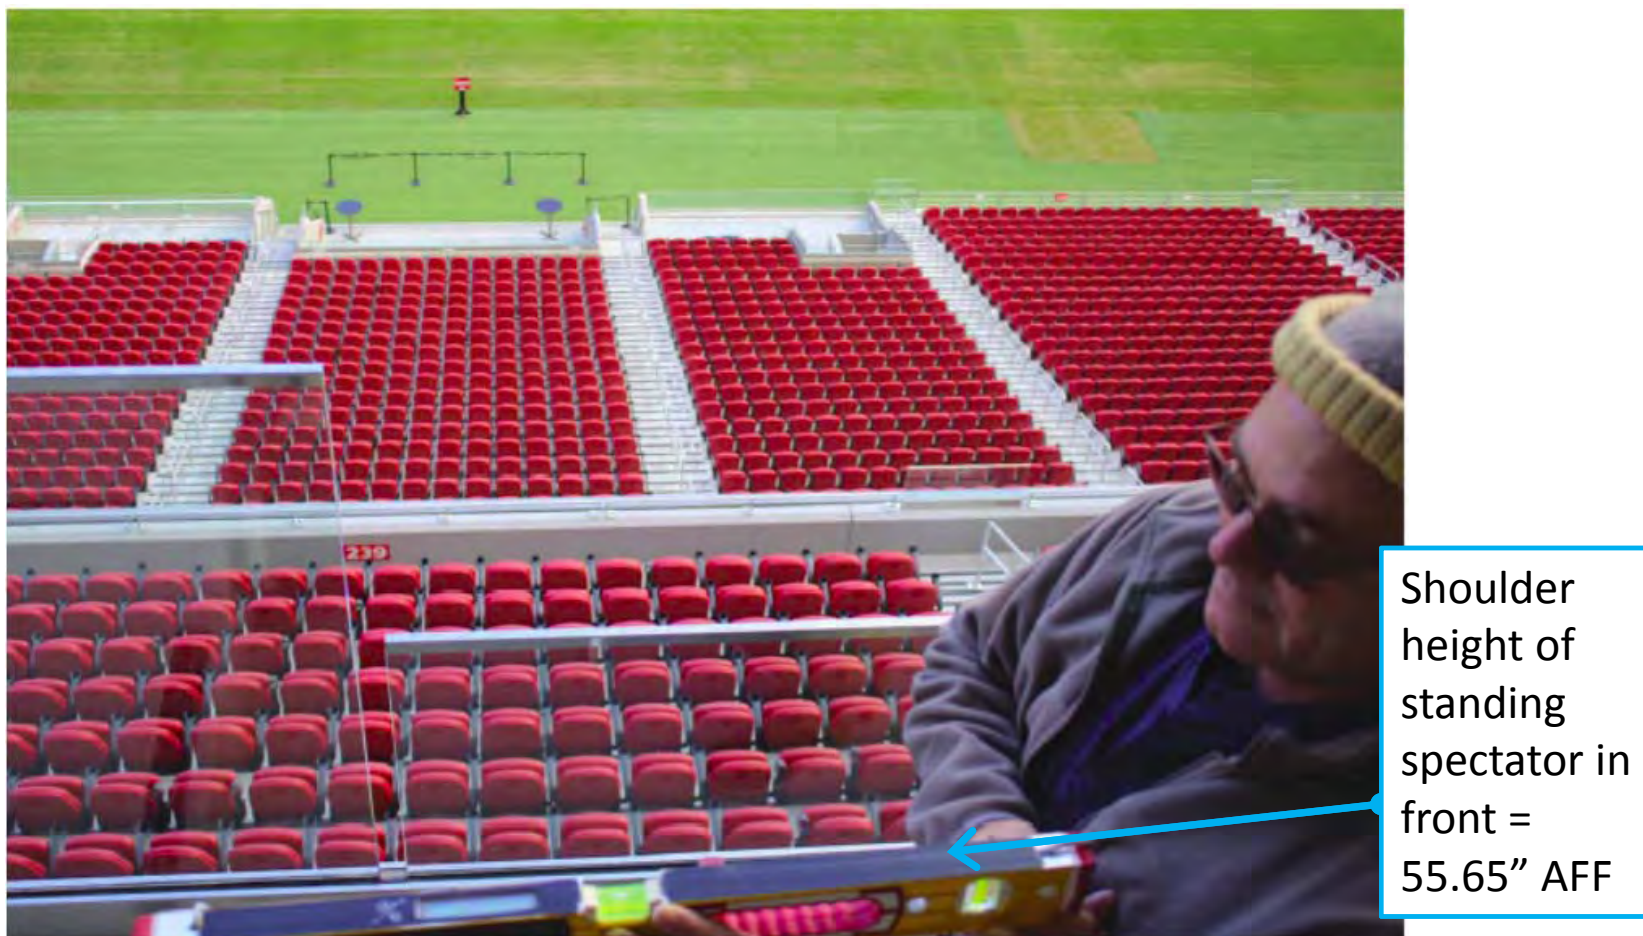
FAVORABLE VIEW LUXURY SUITE SIGHTLINE FROM WHEELCHAIR ACCESSIBLE SEAT

Vantage point: eye height of a standing spectator = 63.45" AFF

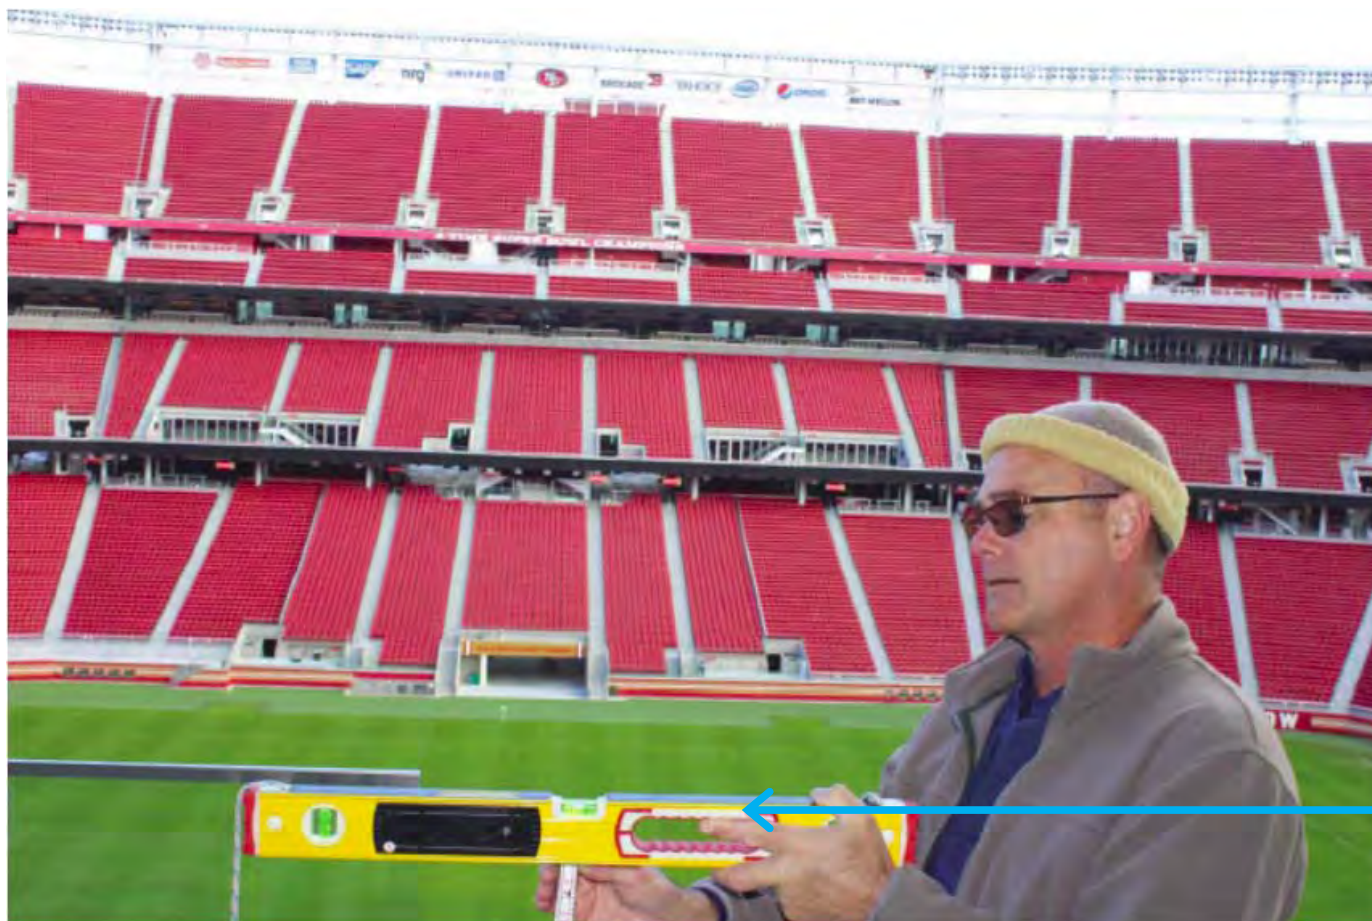
Shoulder
height of
standing
spectator in
front =
55.65" AFF

FAVORABLE VIEW LUXURY SUITE SIGHTLINE FROM WHEELCHAIR ACCESSIBLE SEAT

Vantage point: wheelchair occupant eye height = 43" AFF

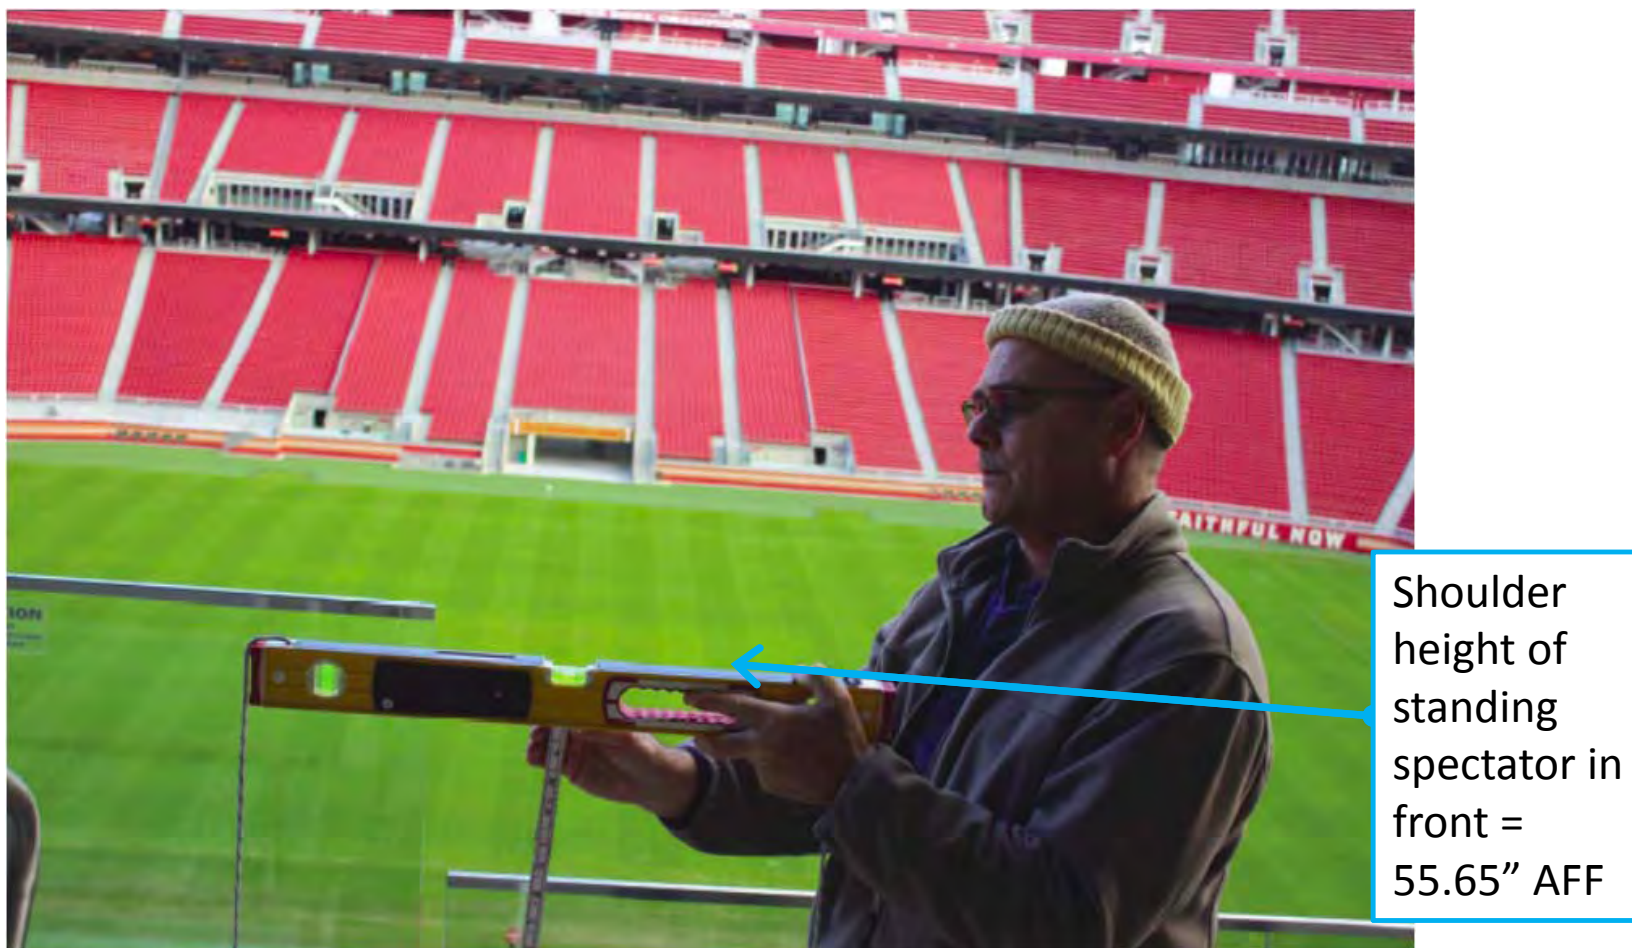
FAVORABLE VIEW LUXURY SUITE SIGHTLINE FROM WHEELCHAIR ACCESSIBLE SEAT

Vantage point: wheelchair occupant eye height = 47.45" AFF, the height prescribed in USA v Ellerbe Becket Consent Order – represents the mean

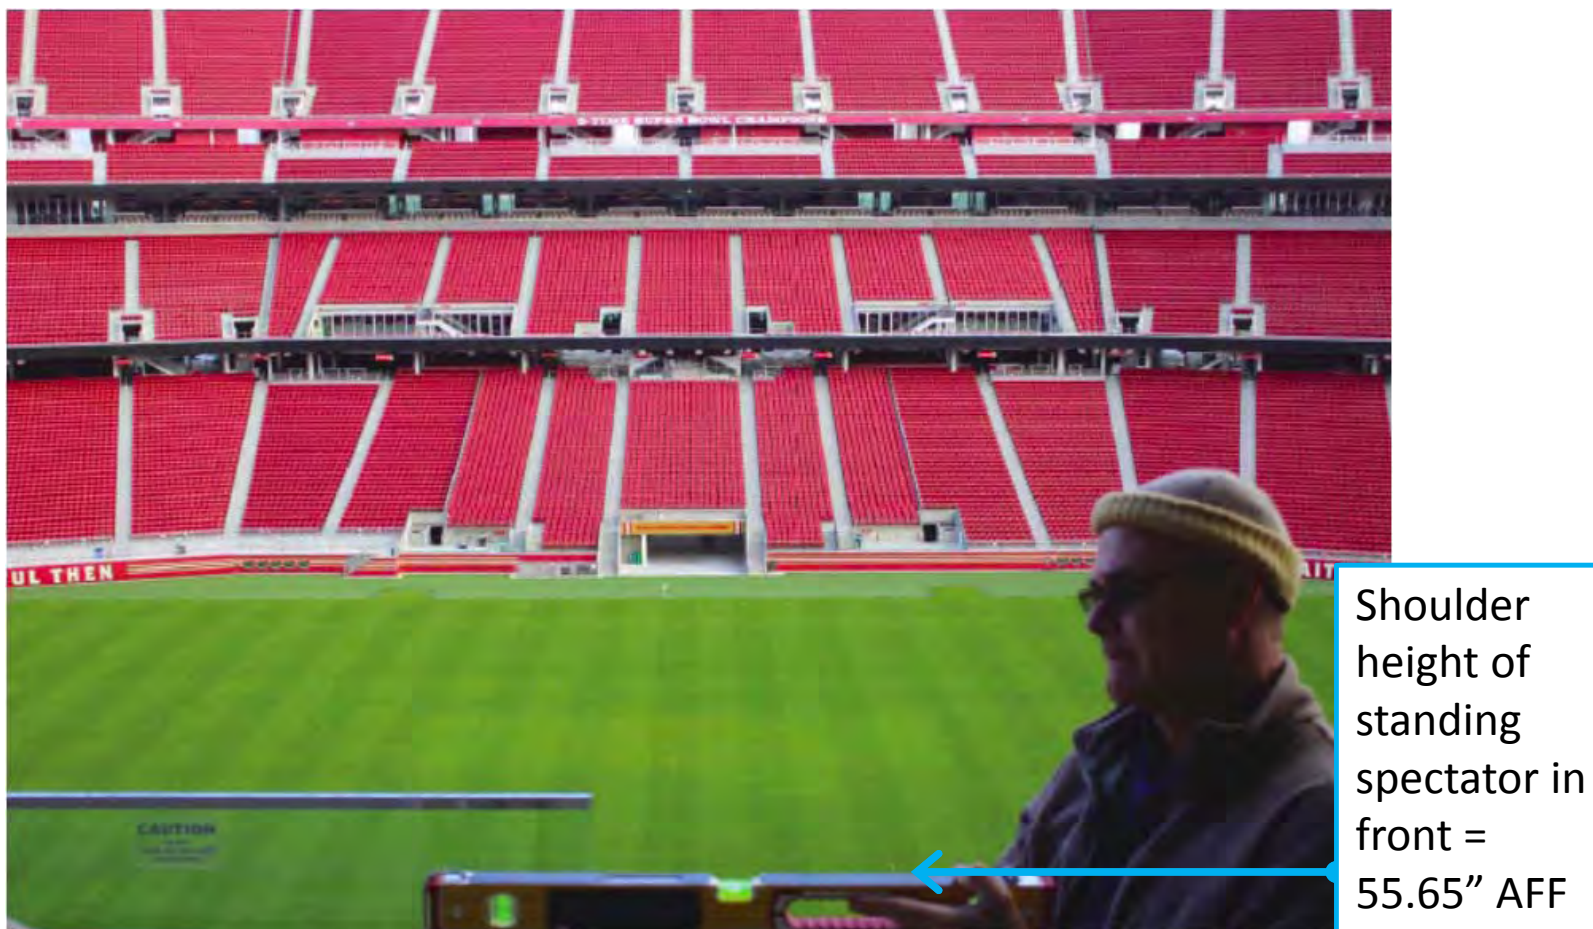
FAVORABLE VIEW LUXURY SUITE SIGHTLINE FROM WHEELCHAIR ACCESSIBLE SEAT

Vantage point: wheelchair occupant eye height = 52" AFF

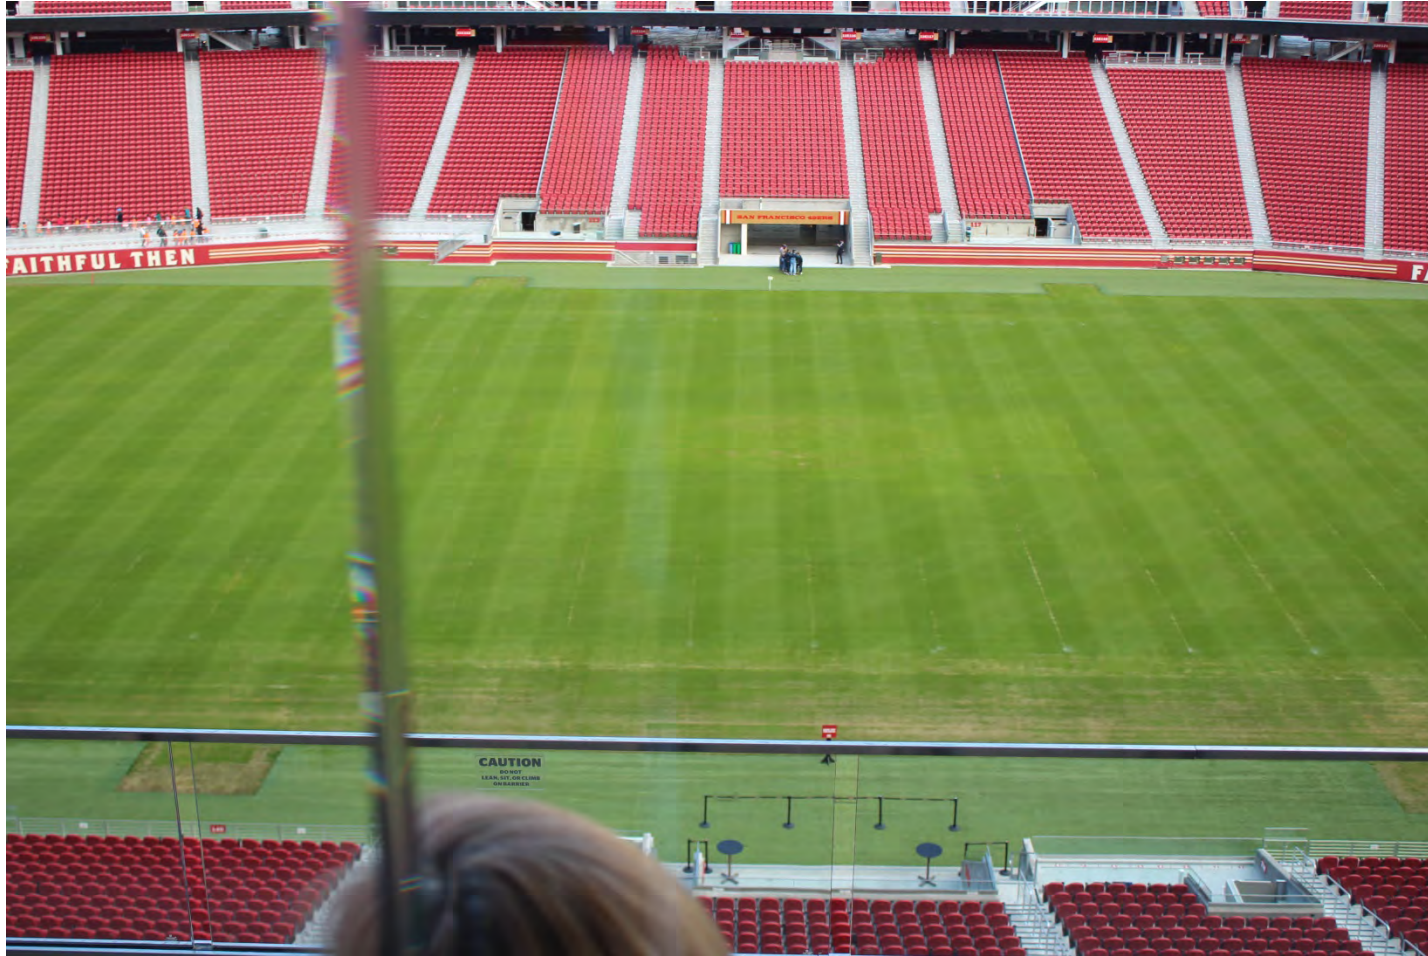
LUXURY SUITE - VIEW FROM WINDOW DINING COUNTER – WINDOWS IN PLACE
Vantage point: eye height of a standing spectator = 63.45" AFF

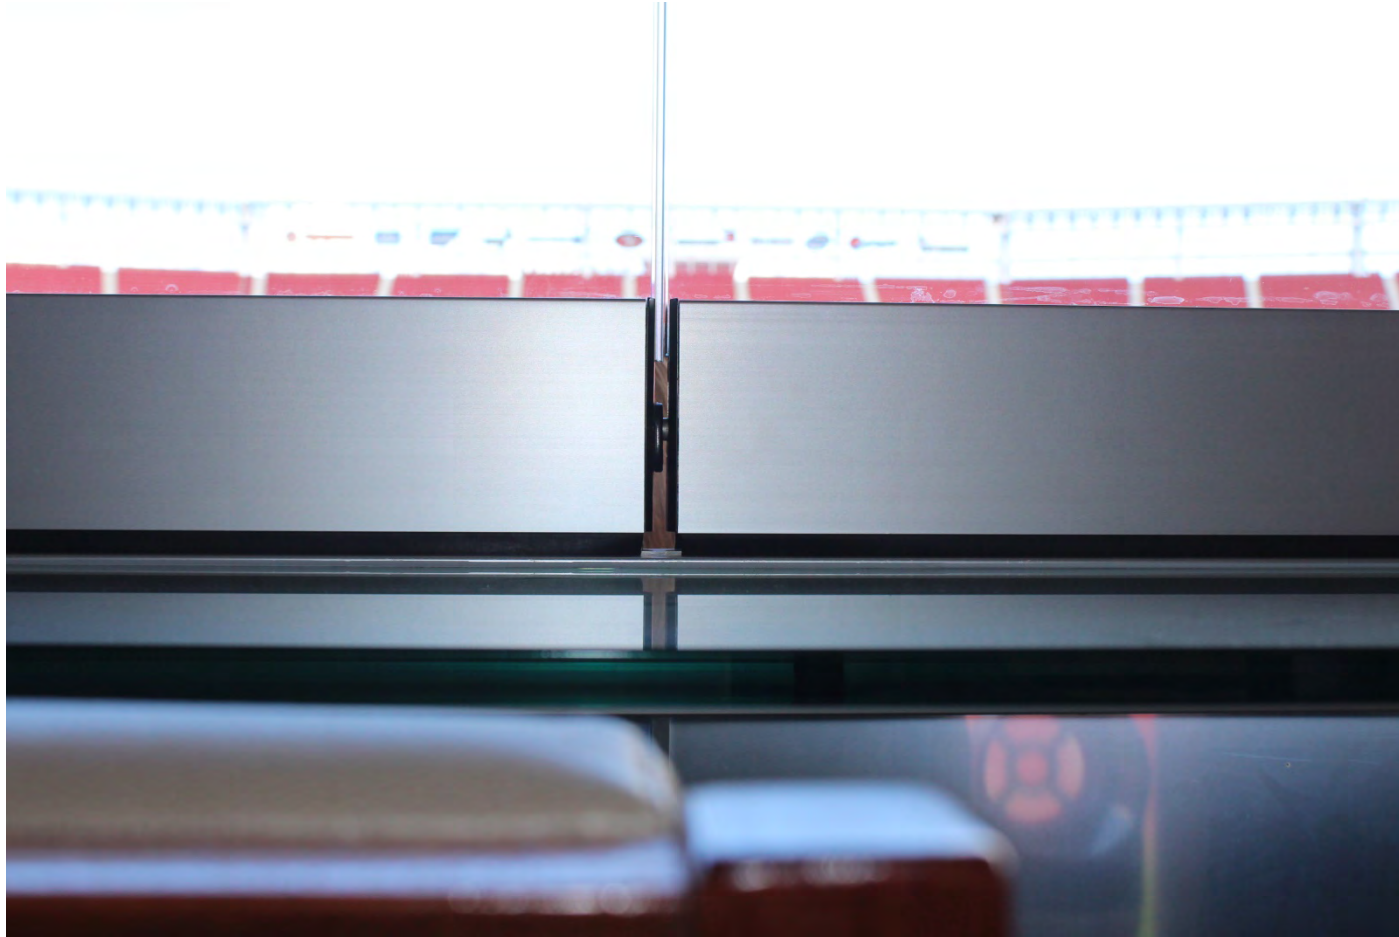
LUXURY SUITE - VIEW FROM WINDOW DINING COUNTER – WINDOWS IN PLACE

Vantage point: wheelchair occupant eye height = 43" AFF

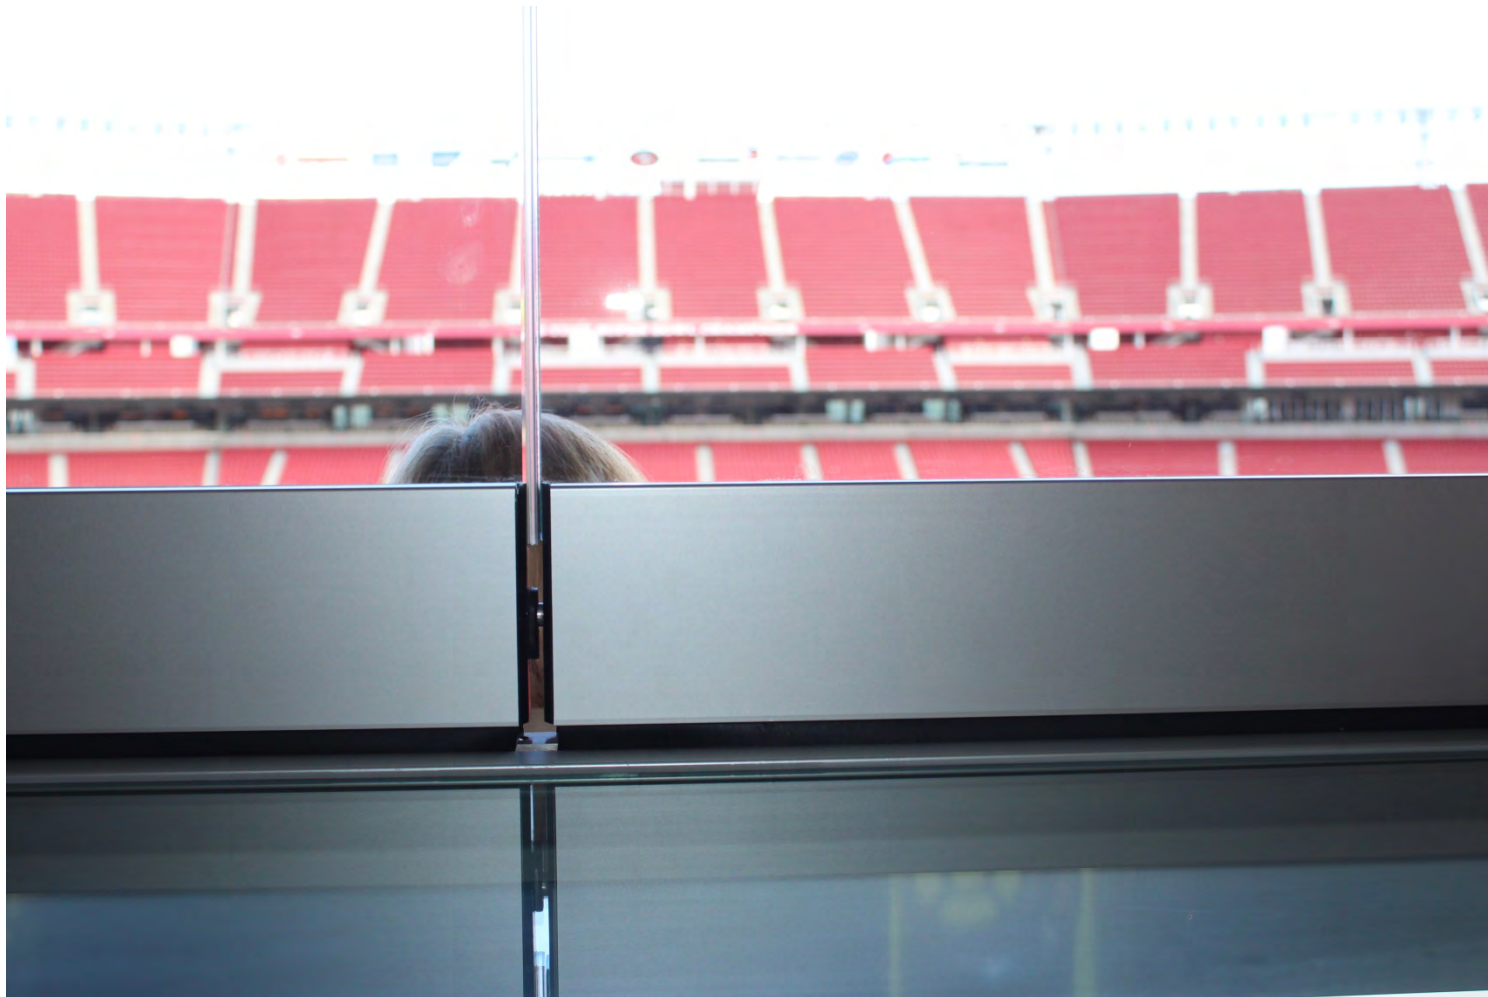
LUXURY SUITE - VIEW FROM WINDOW DINING COUNTER – WINDOWS IN PLACE

Vantage point: wheelchair occupant eye height = 47.45" AFF, the height prescribed in USA v Ellerbe Becket Consent Order – represents the mean

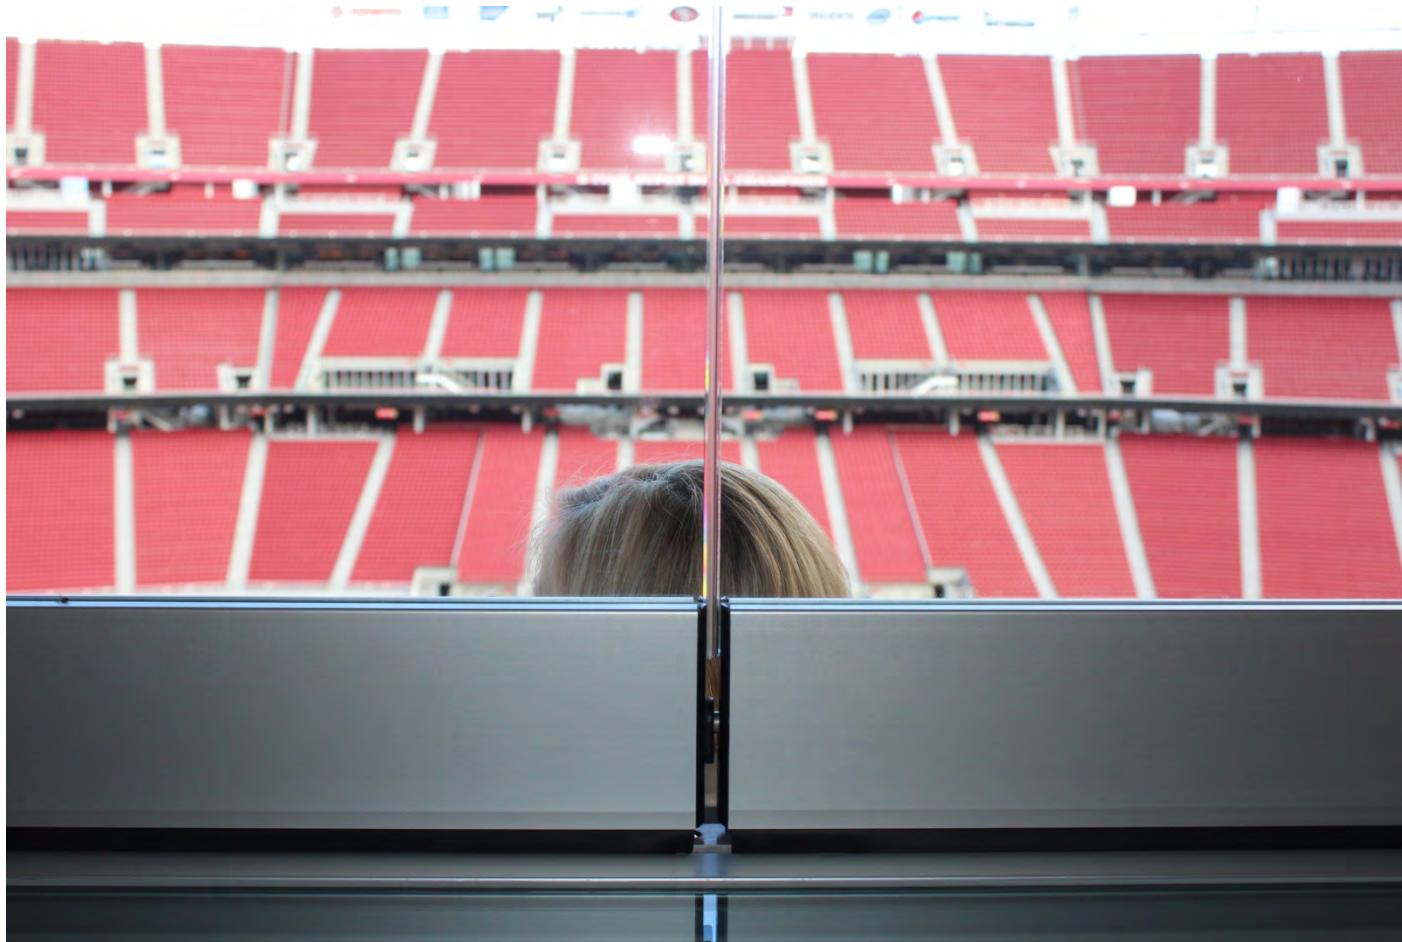
LUXURY SUITE - VIEW FROM WINDOW DINING COUNTER – WINDOWS IN PLACE

Vantage point: wheelchair occupant eye height = 52" AFF

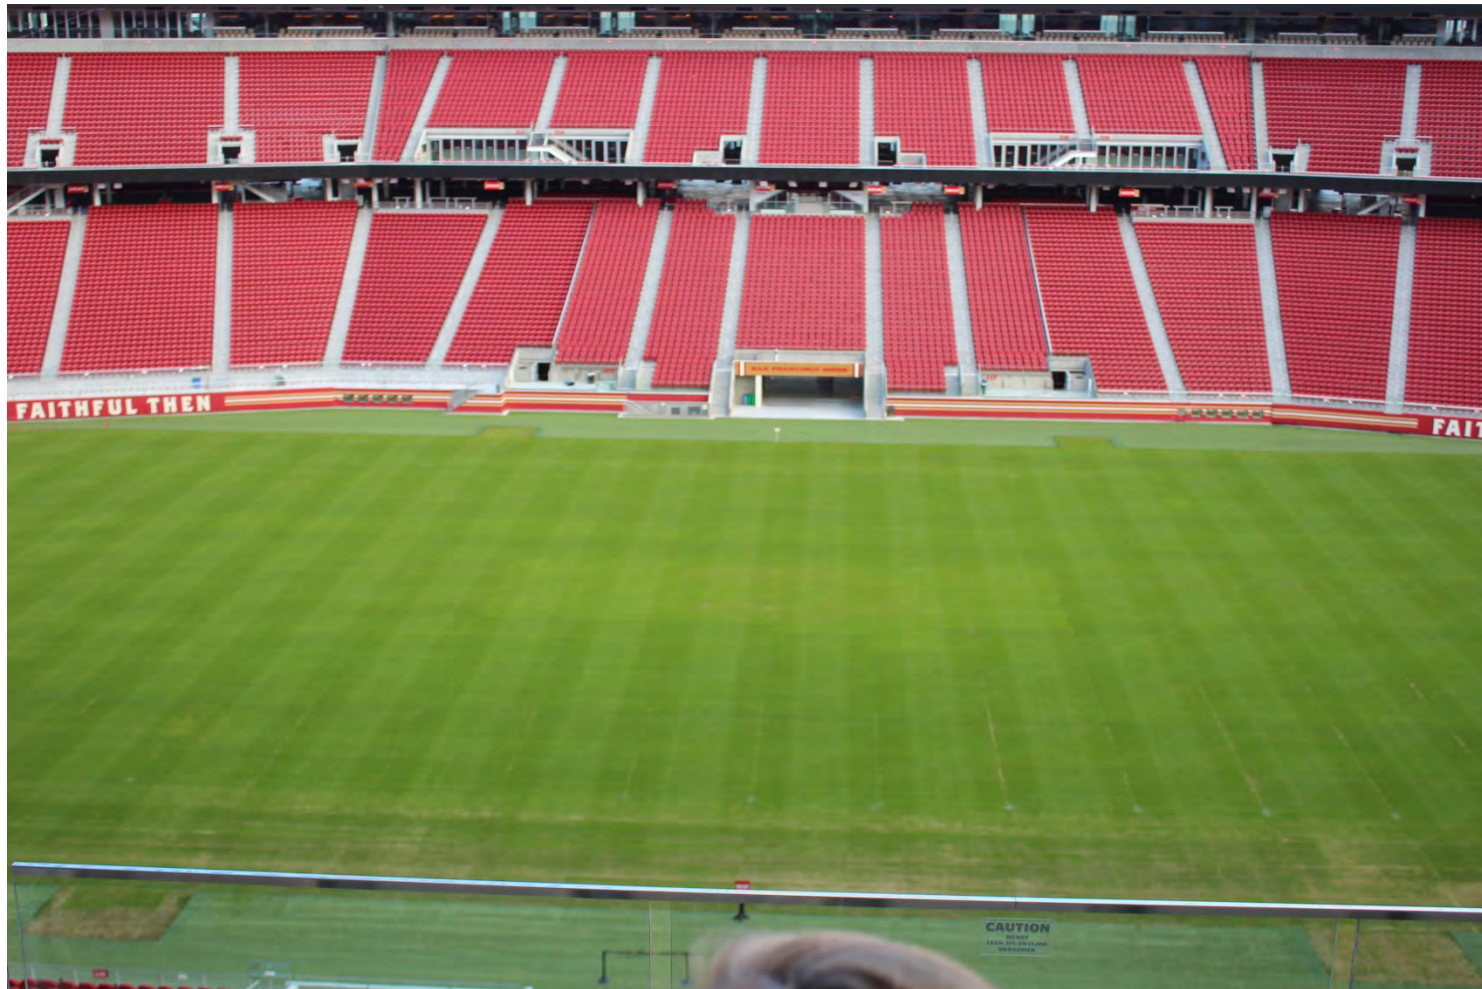
LUXURY SUITE - VIEW FROM WINDOW DINING COUNTER – WINDOWS RETRACTED
Vantage point: eye height of a standing spectator = 63.45" AFF

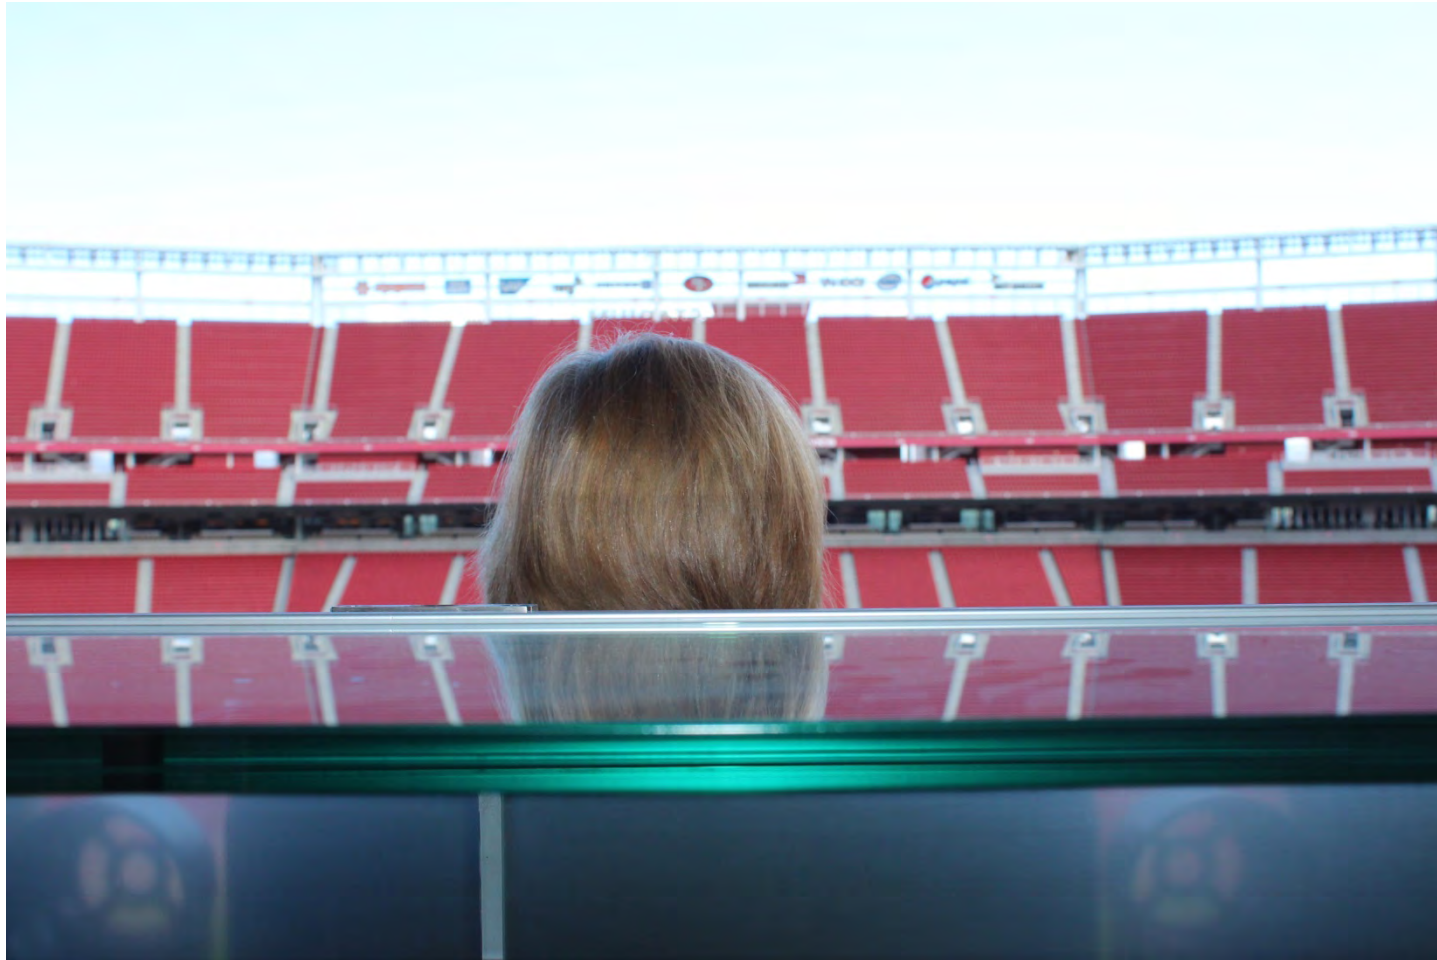
LUXURY SUITE - VIEW FROM WINDOW DINING COUNTER – WINDOWS RETRACTED

Vantage point: wheelchair occupant eye height = 43" AFF

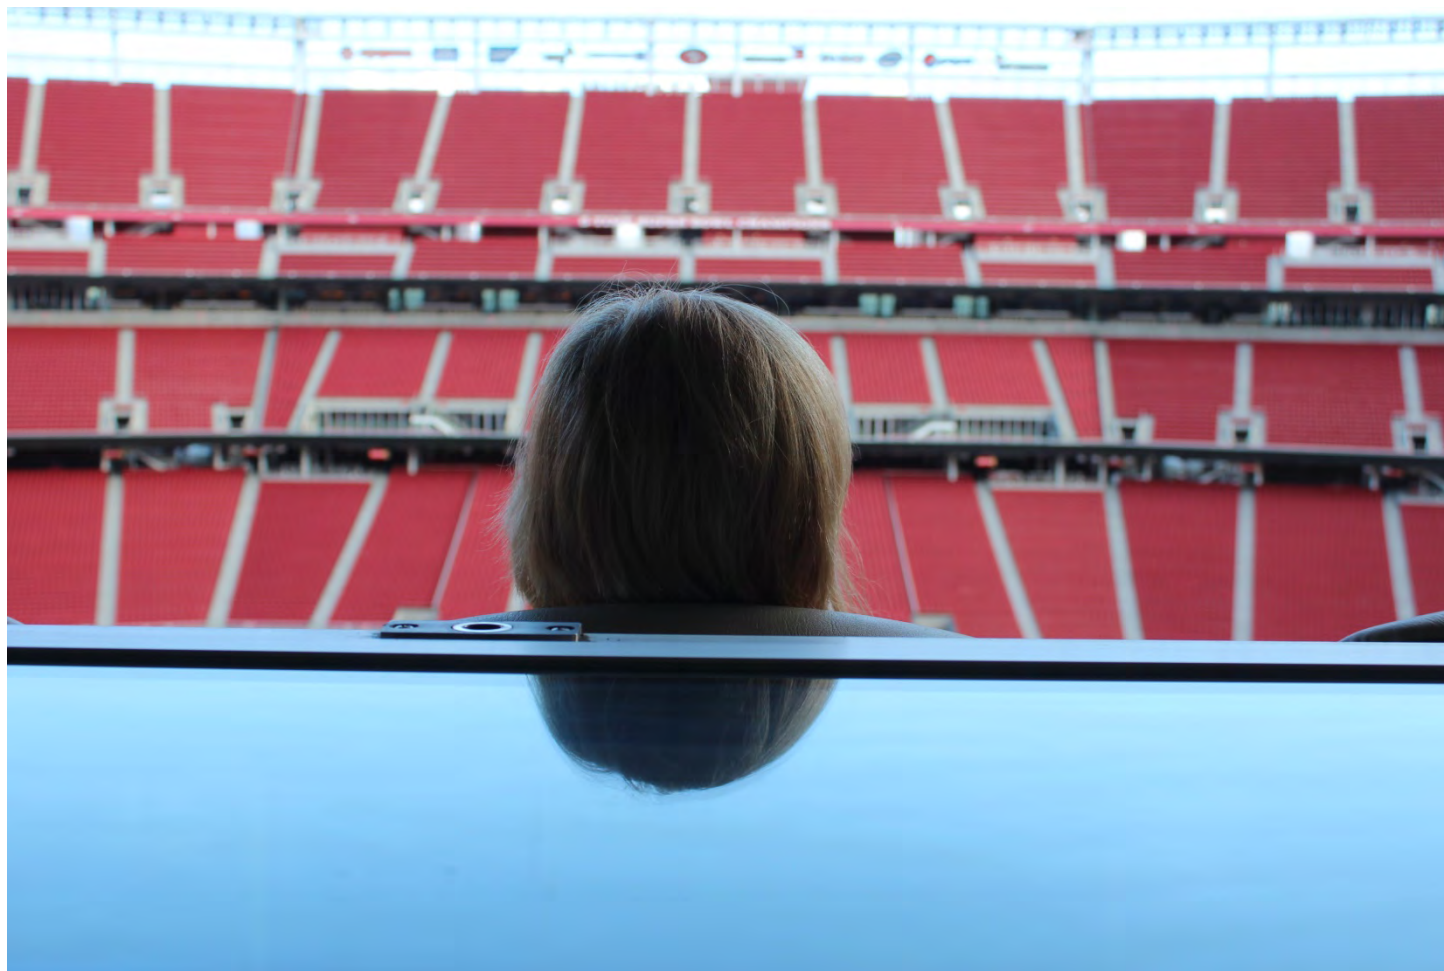
LUXURY SUITE - VIEW FROM WINDOW DINING COUNTER – WINDOWS RETRACTED

Vantage point: wheelchair occupant eye height = 47.45" AFF, the height prescribed in USA v Ellerbe Becket Consent Order – represents the mean

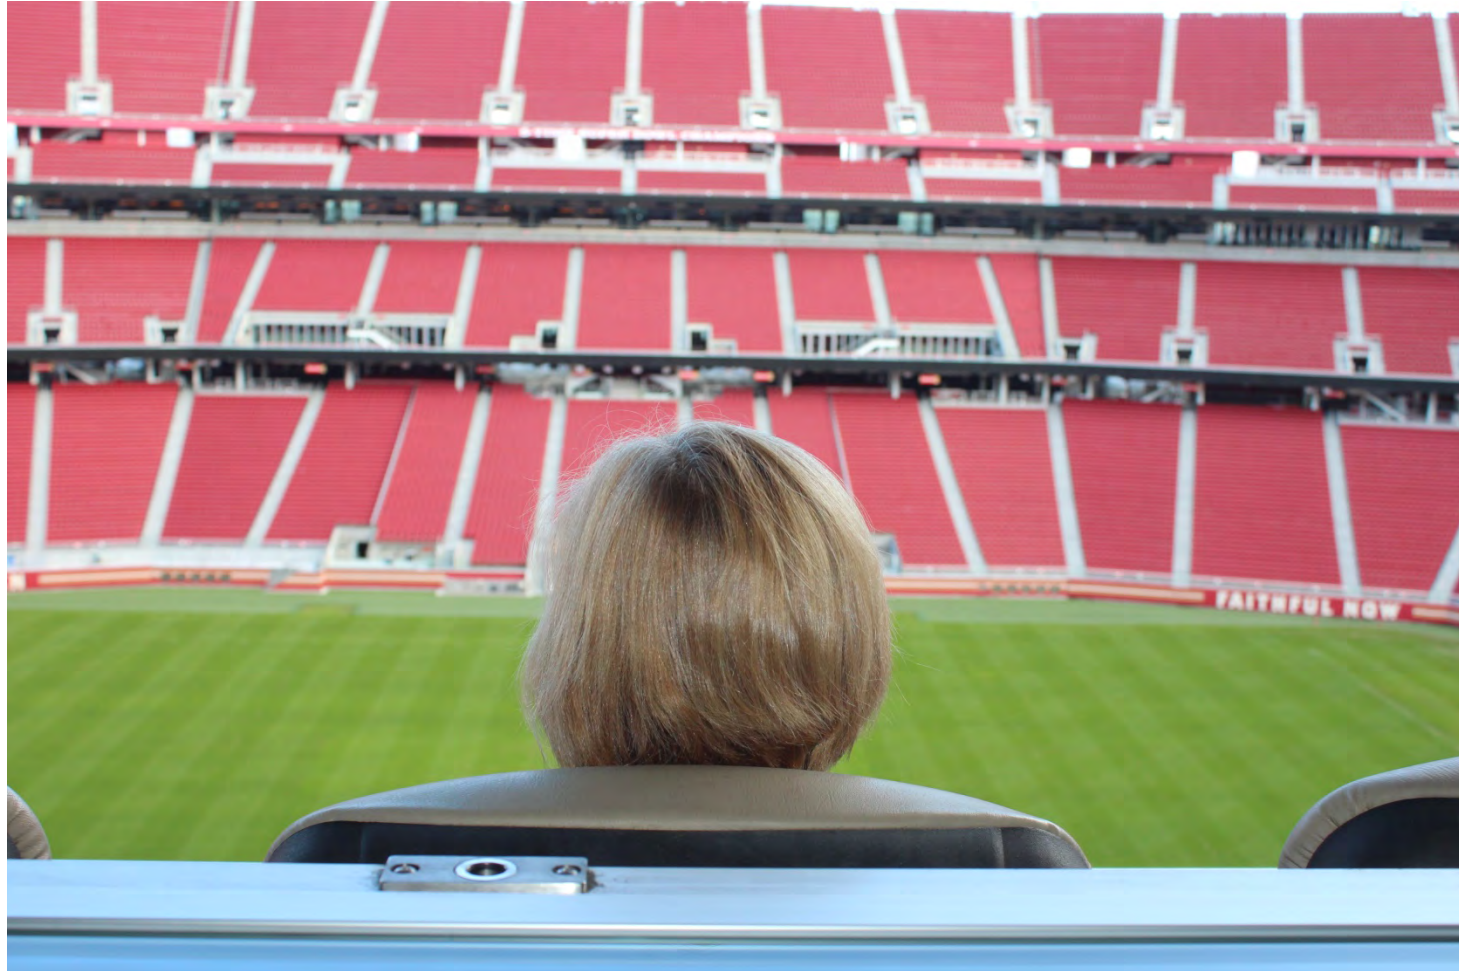
LUXURY SUITE - VIEW FROM WINDOW DINING COUNTER – WINDOWS RETRACTED

Vantage point: wheelchair occupant eye height = 52" AFF
