# EXHIBIT D

Case No. 5:16-cv-07013-LHK (SVK)

**DECLARATION OF WILLIAM SCOTT  
MCBRAYER IN SUPPORT OF  
PLAINTIFFS' MOTION FOR CLASS  
CERTIFICATION**

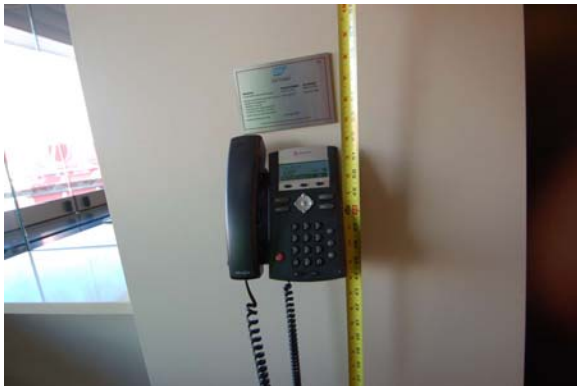
25- (752)

Item	Location	Description of Identified Barrier	As-Built	2010 ADAS	2010 CBC	1991 ADAAG	Photo
709		At the ice sink, where the base cabinets have been configured to allow for a forward approach, barriers to a forward approach to the ice sink include: 1. The drain line is not fully insulated. 2. The space below the ice sink is not free from sharp or abrasive surfaces, there are sharp edges at the corners of the ice sink and at the drain piping. 3. Stainless steel ice sink is not insulated to protect against contact.	See Photos	606.5	1117B.9.2	4.24.6	25- 751
710		At the closet, the clothes rod, at 65" AFF, and shelf, at 69" AFF, are above the maximum accessible height of 48". There is a provision to reposition the clothes rod to an accessible height, however, there is no provision to reposition the shelf.	See Photos	308.3.1	1125B.3	4.25.3	25- 751
711		All operable parts of the telephone are not within a 48" maximum high accessible reach range.	49-3/4" AFF	308.3.1			25- 752

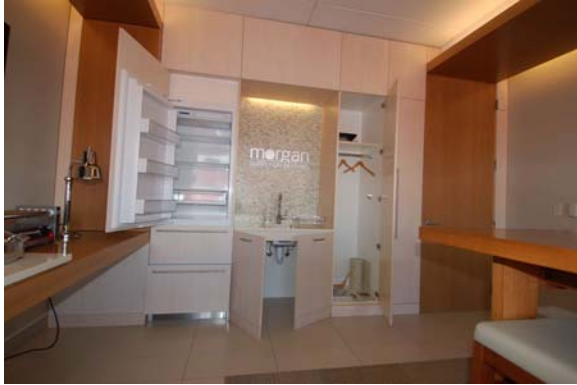
25- (797)

Item	Location	Description of Identified Barrier	As-Built	2010 ADAS	2010 CBC	1991 ADAAG	Photo
724		At the sink, where the base cabinets have been configured to allow for a forward approach, barriers to a forward approach to the sink include: 1. Water supply lines are not fully insulated to protect against contact. 2. The space below the sink is not free from sharp or abrasive surfaces, there are sharp edges at the corners of the sink. 3. Stainless steel sinks are not insulated to protect against contact.	See Photos	606.5	1117B.9.2	4.24.6	25- 796
725		At the closet, the clothes rod, at 65" AFF, and shelf, at 69" AFF, are above the maximum accessible height of 48". There is a provision to reposition the clothes rod to an accessible height, however, there is no provision to reposition the shelf.	See Photos	308.3.1	1125B.3	4.25.3	25- 796
726		All operable parts of the telephone are not within a 48" maximum high accessible reach range.	49-1/2" AFF	308.3.1			25- 797

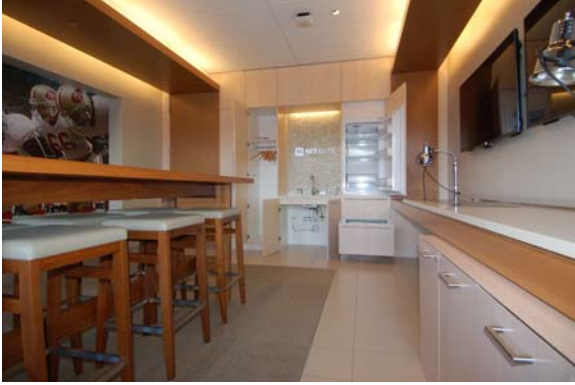
25- (820)

Item	Location	Description of Identified Barrier	As-Built	2010 ADAS	2010 CBC	1991 ADAAG	Photo
739		At the sink, where the base cabinets have been configured to allow for a forward approach, barriers to a forward approach to the sink include: 1. Water supply lines are not fully insulated to protect against contact. 2. The space below the sink is not free from sharp or abrasive surfaces, there are sharp edges at the corners of the sink. 3. Stainless steel sinks are not insulated to protect against contact.	See Photos	606.5	1117B.9.2	4.24.6	25- 819
740		At the closet, the clothes rod, at 65" AFF, and shelf, at 69" AFF, are above the maximum accessible height of 48". There is a provision to reposition the clothes rod to an accessible height, however, there is no provision to reposition the shelf.	See Photos	308.3.1	1125B.3	4.25.3	25- 819
741		All operable parts of the telephone are not within a 48" maximum high accessible reach range.	49-3/4" AFF	308.3.1			25- 820

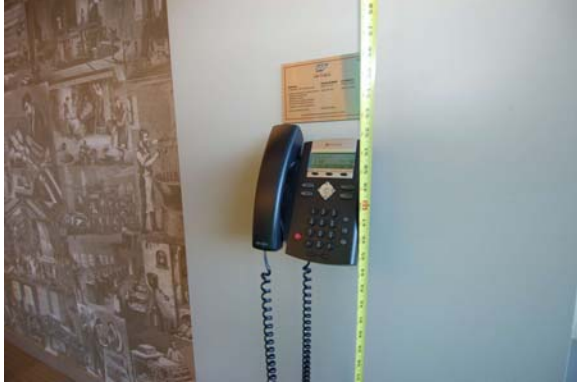
25- (845)

Item	Location	Description of Identified Barrier	As-Built	2010 ADAS	2010 CBC	1991 ADAAG	Photo
754		At the sink, where the base cabinets have been configured to allow for a forward approach, barriers to a forward approach to the sink include: 1. Water supply lines are not fully insulated to protect against contact. 2. The space below the sink is not free from sharp or abrasive surfaces, there are sharp edges at the corners of the sink. 3. Stainless steel sinks are not insulated to protect against contact.	See Photos	606.5	1117B.9.2	4.24.6	25- 841
755		At the closet, the clothes rod, at 65" AFF, and shelf, at 69" AFF, are above the maximum accessible height of 48". There is a provision to reposition the clothes rod to an accessible height, however, there is no provision to reposition the shelf.	See Photos	308.3.1	1125B.3	4.25.3	25- 841
756		All operable parts of the telephone are not within a 48" maximum high accessible reach range.	49-3/4" AFF	308.3.1			25- 845

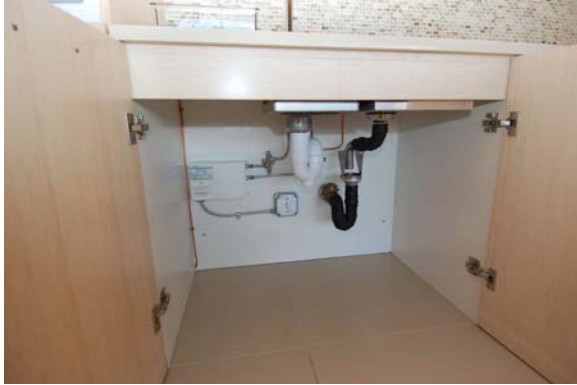
25- (889)

Item	Location	Description of Identified Barrier	As-Built	2010 ADAS	2010 CBC	1991 ADAAG	Photo
784		At the sink, where the base cabinets have been configured to allow for a forward approach, barriers to a forward approach to the sink include: 1. Water supply lines are not fully insulated to protect against contact. 2. The space below the sink is not free from sharp or abrasive surfaces, there are sharp edges at the corners of the sink. 3. Stainless steel sinks are not insulated to protect against contact.	See Photos	606.5	1117B.9.2	4.24.6	25- 889, 25-890
785		At the ice sink, where the base cabinets have been configured to allow for a forward approach, barriers to a forward approach to the ice sink include: 1. The drain line is not fully insulated. 2. The space below the ice sink is not free from sharp or abrasive surfaces, there are sharp edges at the corners of the ice sink and at the drain piping. 3. Stainless steel ice sink is not insulated to protect against contact.	See Photos	606.5	1117B.9.2	4.24.6	25- 889. 25-891

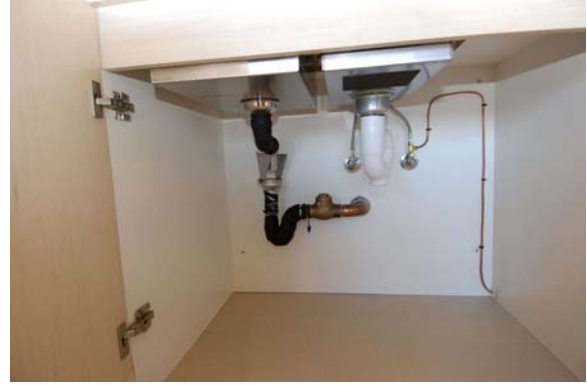
26- (39)

Item	Location	Description of Identified Barrier	As-Built	2010 ADAS	2010 CBC	1991 ADAAG	Photo
790		At the sink, where the base cabinets have been configured to allow for a forward approach, barriers to a forward approach to the sink include: 1. Water supply lines are not fully insulated to protect against contact. 2. The space below the sink is not free from sharp or abrasive surfaces, there are sharp edges at the corners of the sink. 3. Stainless steel sinks are not insulated to protect against contact.	See Photos	606.5	1117B.9.2	4.24.6	26- 39, 26-40
791		At the ice sink, where the base cabinets have been configured to allow for a forward approach, barriers to a forward approach to the ice sink include: 1. The drain line is not fully insulated. 2. The space below the ice sink is not free from sharp or abrasive surfaces, there are sharp edges at the corners of the ice sink and at the drain piping. 3. Stainless steel ice sink is not insulated to protect against contact.	See Photos	606.5	1117B.9.2	4.24.6	26- 39, 26-40
